DEPARTMENT OF PUBLIC UTILITIES

PIPELINE ENGINEERING AND SAFETY DIVISION

INCIDENT REPORT

71 Such Drive, Attleboro, Massachusetts
February 9, 2013

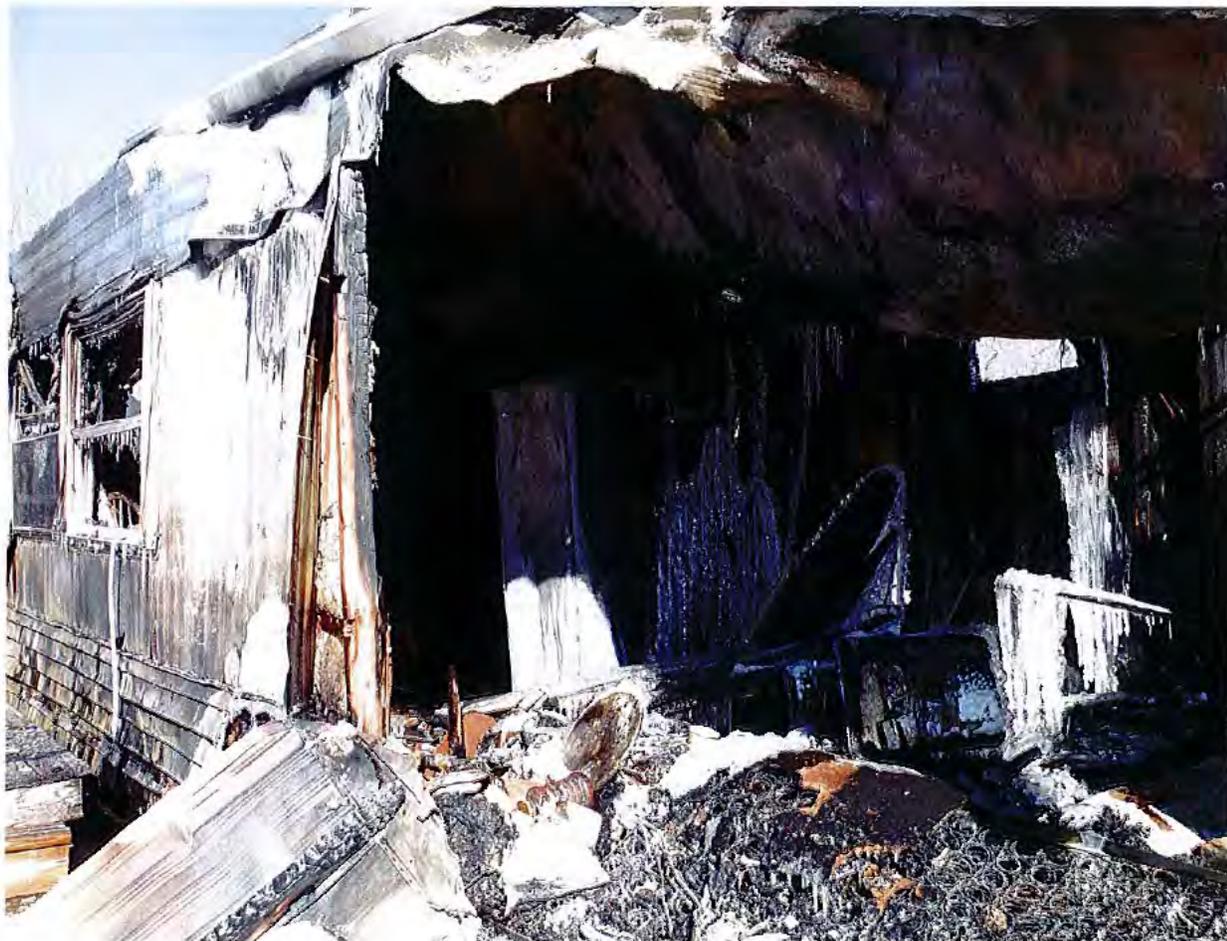
Exhibit 3

Upon arrival, the Department investigators observed that a residential one story mobile home with asphalt shingle roof had been completely destroyed (Exh.3). Gas leaking from a fractured service² riser (Exh. 4), at the meter location, may have contributed to the fire. The

Photographs of the destroyed building

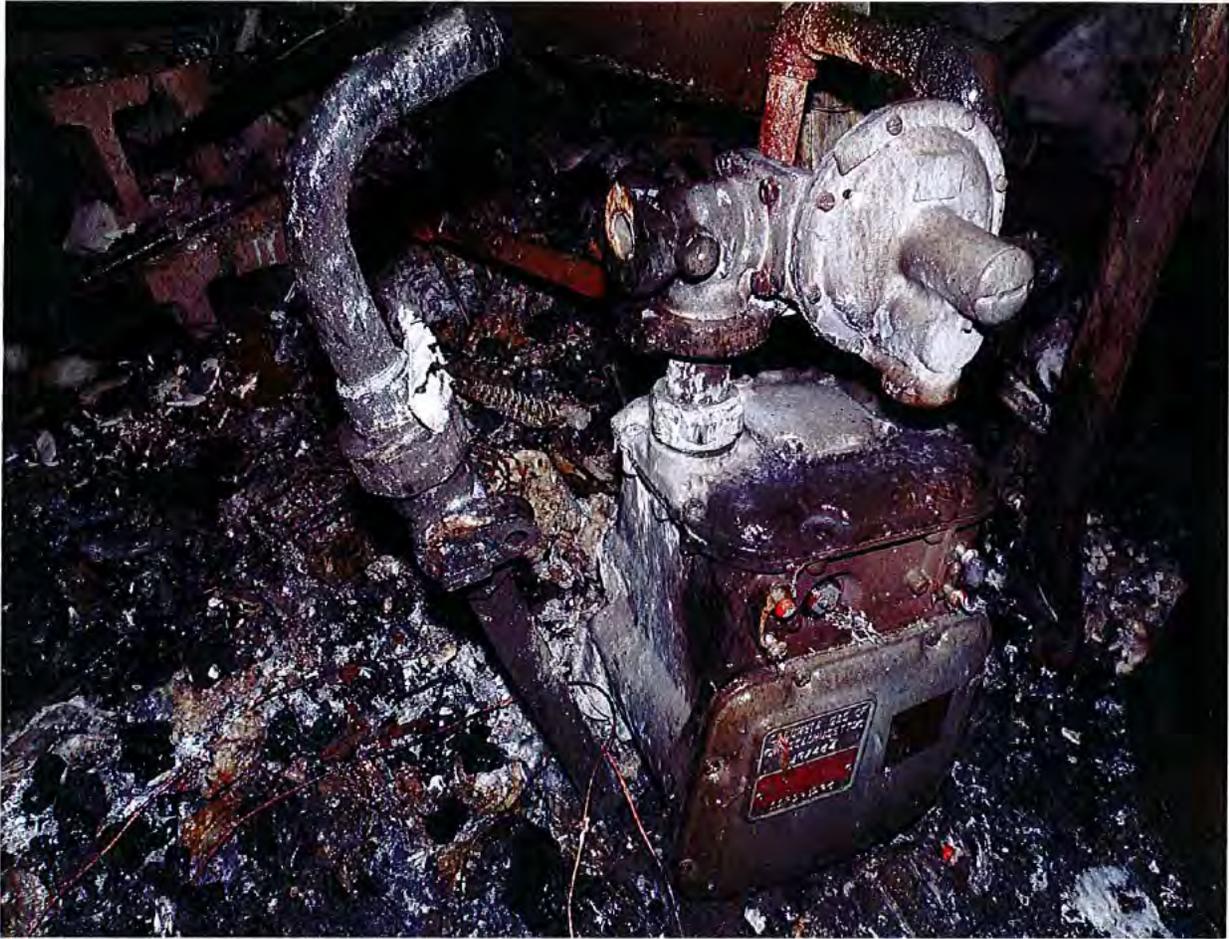
Exhibit 4

“The fire damage to 71 Such Drive was consistent with the riser pipe break being the source of the incident, but the break itself is unusual in multiple ways. First, although the

bollard was apparently struck at some point, likely by a car, the meter and regulator next to it did not exhibit impact damage. Second, the riser pipe was pulled away from the stopcock completely rather than just exhibiting a more typical crack; this indicates a reasonable amount of applied force beyond which most people are capable without mechanical assistance. Third, corrosion was not a factor in this pipe break and no defects were noted in the jurisdictional equipment that might have caused or contributed to such a break or made its creation easier. There was no obvious reason for this break detected by this investigation.”

“While no obvious reason for the pipe break was detected by this investigation, a possible scenario does exist that would explain the markings on the meter and the pulled away orientation of the riser. If a snowbank or similar pile adjacent to or surrounding the gas equipment were struck by a car, then enough force to break the riser could easily be applied and the equipment would not necessarily be impact damaged beyond the break. The mound of shifting snow could provide enough cushioning to avoid obvious dents and scrapes. The subsequent fire would melt any such snow pile. Incidentally, a snow pile of this type could also explain why the meter and regulator were so intact, despite their proximity to such extensive residence damage.”

Photograph of the service riser

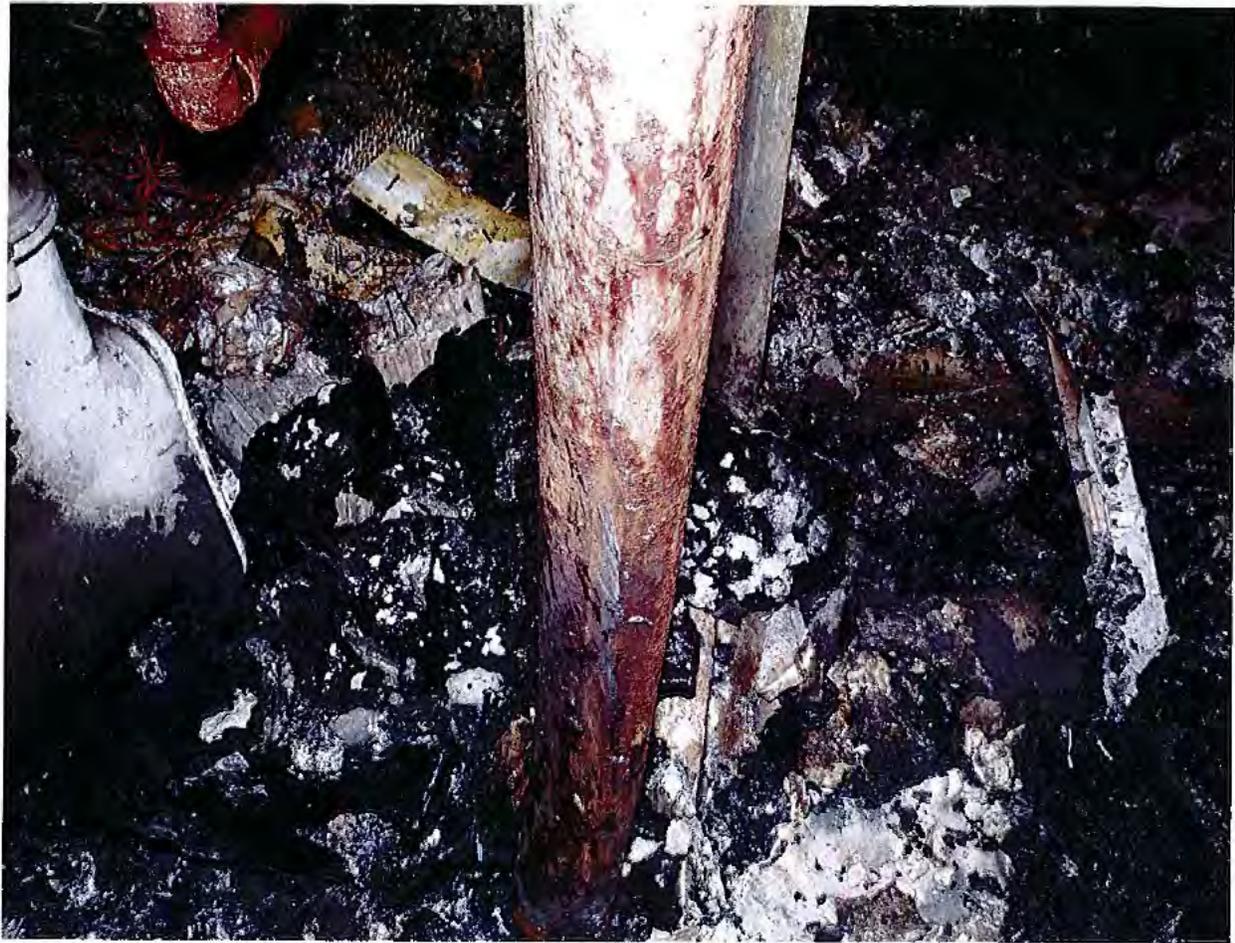
Exhibit 5

Photograph of the meter post

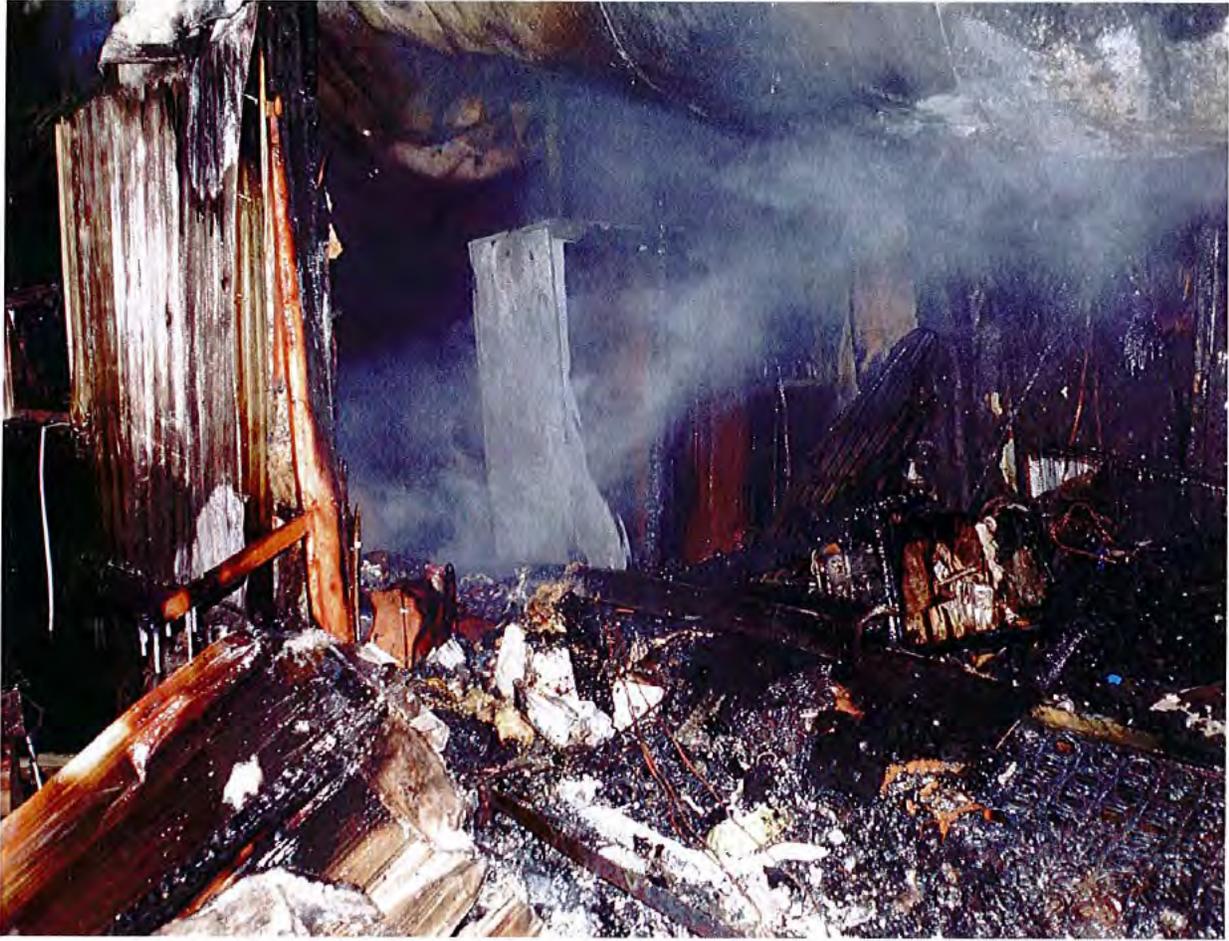
Exhibit 6

The mobile home at 71 Such Drive, Attleboro was completely consumed by the fire. The southeast portion of the mobile home, which was the front bedroom, sustained most of the damage (Exh. 6). This section of the home was adjacent to the gas meter supplying natural gas to the mobile home. The aluminum side wall and its supporting wood structure were burned away leaving a gaping hole in the side of the mobile home.

Photograph of the most significant damage
