# **Coastal Pollutant Remediation Program Stormwater BMP Operation, Maintenance, and Performance Evaluation**

## **Review of Stormwater Treatment Systems Installed Between 2000 and 2004 Summary Report**

**June 27, 2006**

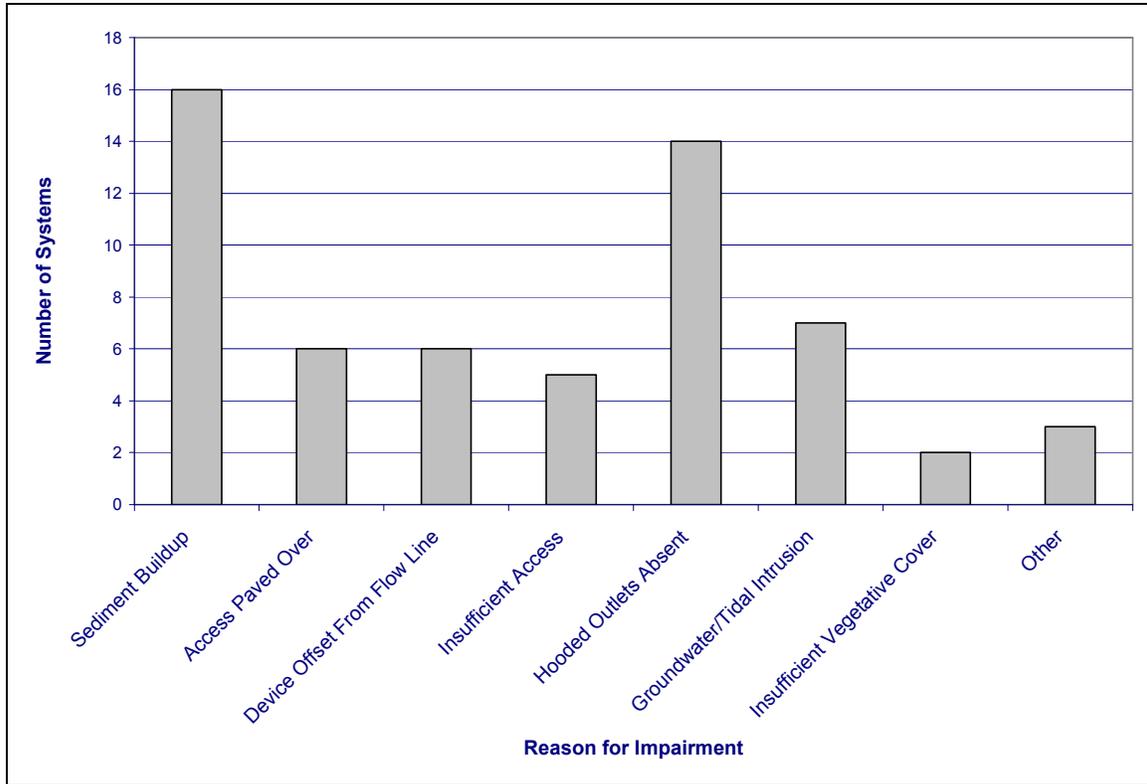
The most common causes of impairment were the buildup of sediment in stormwater collection and treatment devices (16 systems) and the lack of hoods on outlet pipes (14 systems). Other common sources of impairment and maintenance failures included paved-over manhole covers (6 systems), insufficient access to collection/treatment devices for various reasons (5 systems), or insufficient vegetative cover (2 sites). Stormwater BMPs were usually classified as non-functional due to compounded problems at each site, the most common of which were the siting of systems in high

ground water/tidally influenced areas (7 sites) and/or installation of treatment devices outside of the primary stormwater flow line (i.e., stormwater runoff wasn't being effectively captured by the practice; 6 sites). Figure 2 provides an overview of the number of stormwater systems affected by each major type of impairment.

**Figure 1. Causes of impairment to stormwater collection/treatment devices (note that some systems exhibit multiple causes of impairment)**
