PRESERVATION GUIDELINES FOR MUNICIPALLY OWNED HISTORIC BURIAL GROUNDS AND CEMETERIES

THIRD EDITION

**These Guidelines are a publication of the
Massachusetts Department of Conservation
and Recreation (DCR), Executive Office of
Energy and Environmental Affairs (EOEEA)**

Prepared by Walker-Kluesing Design Group
for the DCR Historic Cemeteries Preservation
Initiative.

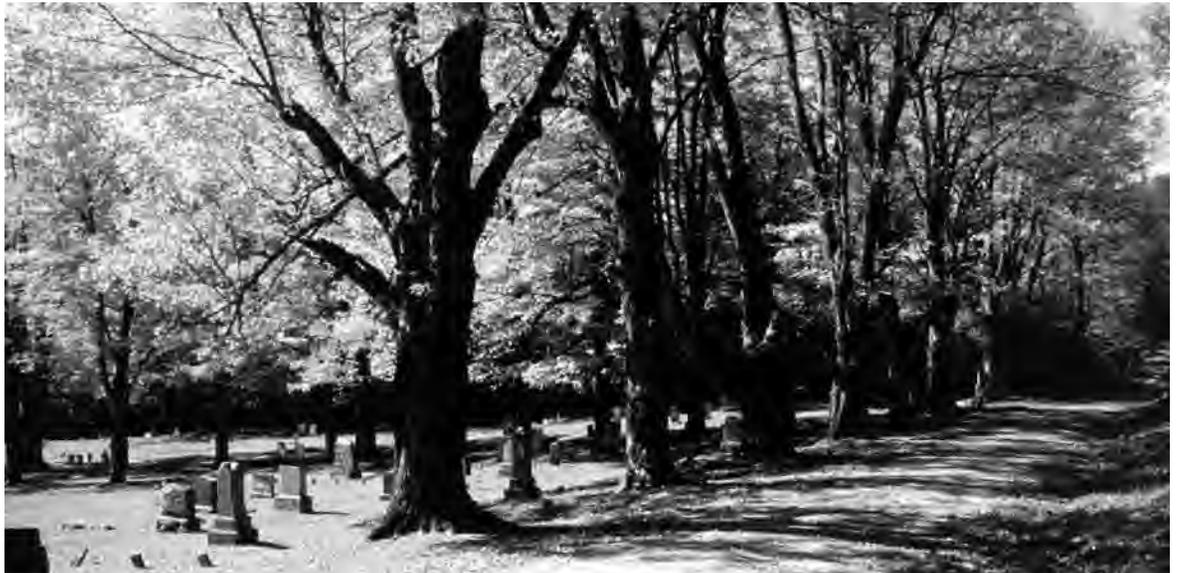
View west along Nillingdon Road

Lawns are in fair to poor condition with many small bare spots, moss and herbaceous weeds. Some slumping is evident on the steep south facing slopes. There are also mounds or small hummocks on these slopes that could be early burials.

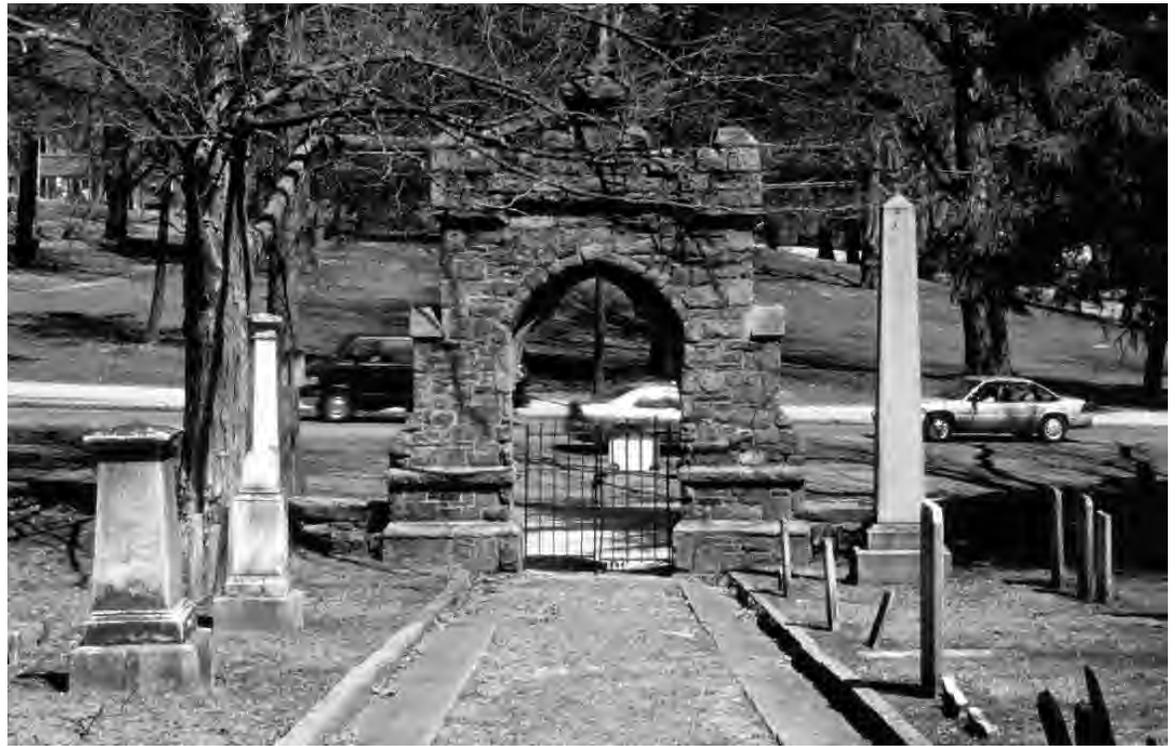
Main Street entrance arch

The 1878 Main Street entrance consists of a passage through a monumental stone arch made up of relatively small, mortared granite units, probably quarried in nearby Monson. The cut stone is coursed. The arch is in fair condition. Although there has been little, if any, shifting and displacement of the stonework, there is evidence of extensive water infiltration into the joints and behind the stones.

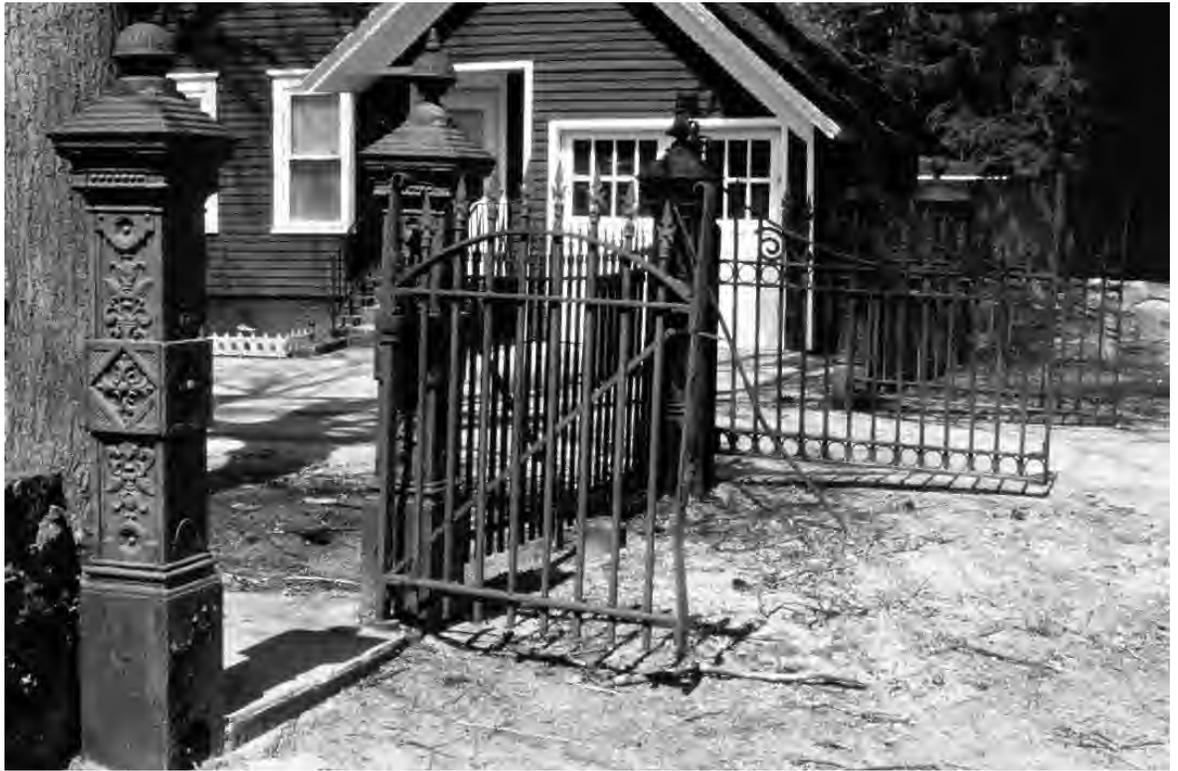
Oak Ridge Avenue entrance gate and fence

Oak Ridge Avenue Entrance Gate and Fence: This assembly consists of a green painted central double swing vehicular gate with single leaf pedestrian gates at the ends separated with an 8'-11.5" long section of fence. The north pedestrian gate is chained and welded closed. The overall assembly has 6 cast iron posts and spear headed picket fences and gates. Overall it is in poor to fair condition. The posts are made up of several cast iron pieces that snap or seat together to make up each decorative square post, base, tapering cap and finial. Damage from vehicle impact and general wear and tear have caused some of iron pieces to break or separate, such that the south vehicular gate post has been damaged and has welded repairs. It is also diagonally braced with a steel channel and bolts. The north pedestrian gate post is askew and the top is missing allowing water infiltration. Other post tops are loose or damaged. The fences are in generally good condition although a few of the spearheads are missing and some of the pickets are bent. There is also extensive corrosion and rust jacking where decorative bent bars on the gates scroll together and overlap at the bottom of the gate leaves and at the top center.
