Massachusetts College of Art and Design

ADA Compliance Plan 2011

ADA Compliance Plan
Consultant Services
Contract #10-08

The Institute for Human Centered Design

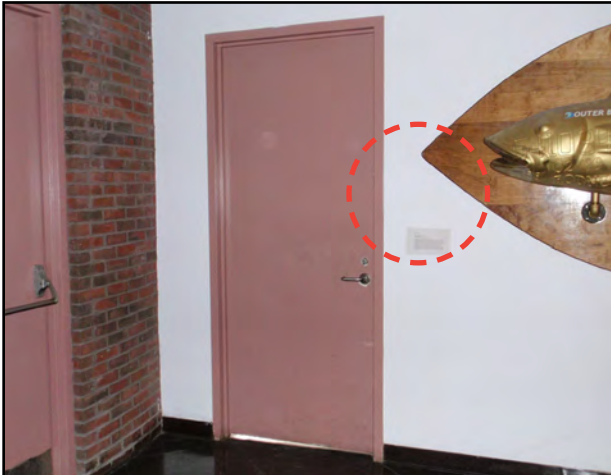
FIG.2 TOWER - 8th Floor missing signage

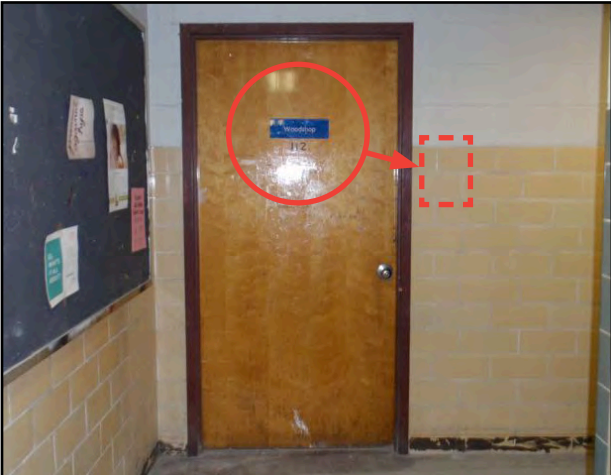
FIG.3 EAST - Basement Woodshop wrong location and non-compliant for character proportion and size

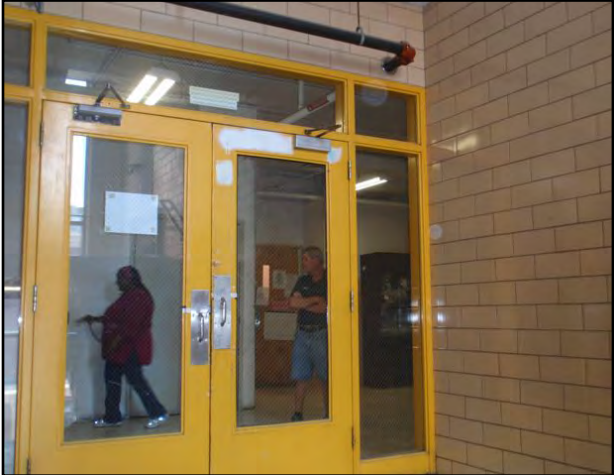
FIG.1 KENNEDY - 3rd Floor signage missing

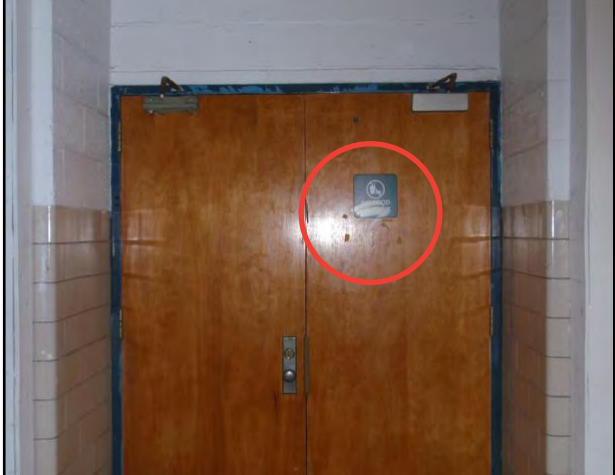
FIG.2 KENNEDY - 4th Floor signage ADA non-compliant

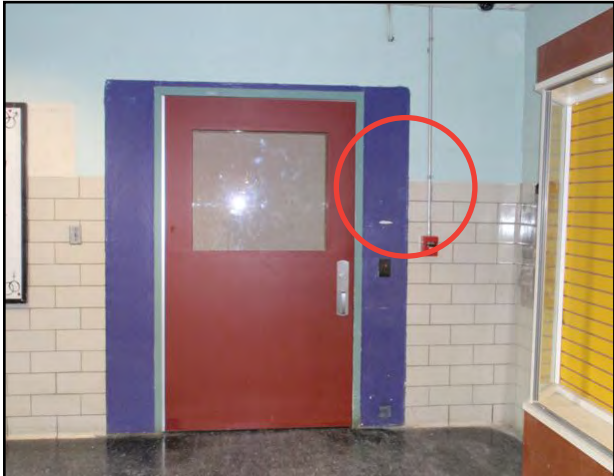
FIG.7 KENNEDY - 2nd Floor signage missing

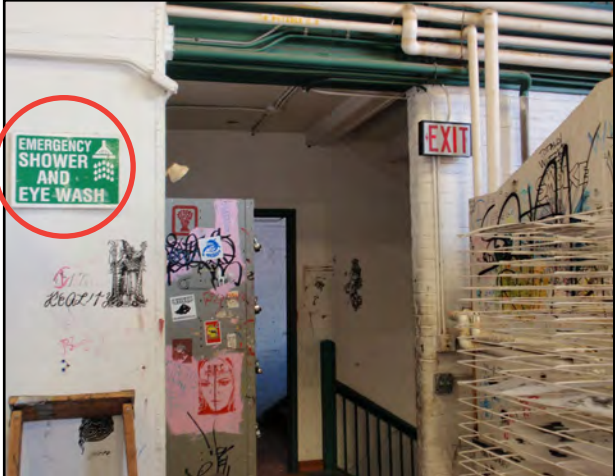
FIG.8 EAST - 2nd Floor - signage ADA non-compliant

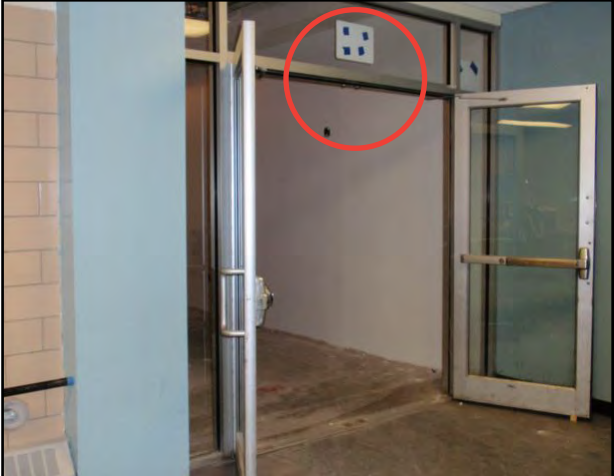
FIG.9 SOUTH - 2nd Floor - Signage missing

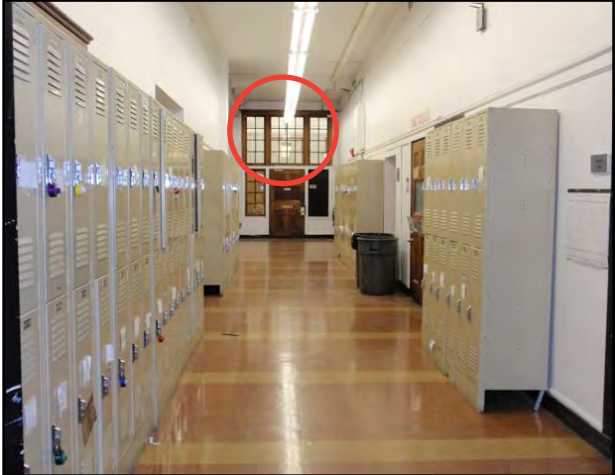
FIG. SOUTH - 2nd Floor exit sign missing

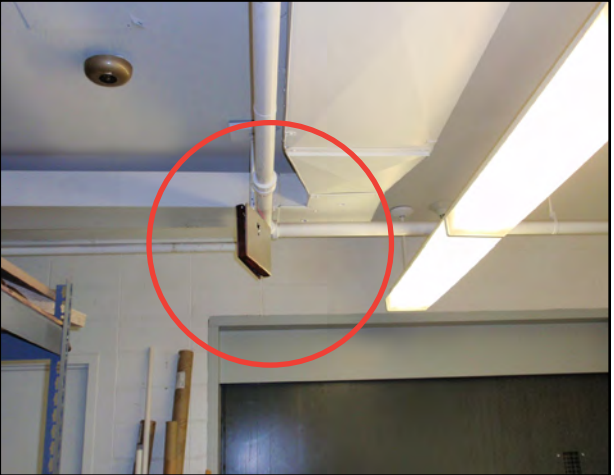
FIG. TOWER - 10th Floor exit sign as been turned to face wall so it can't be seen.

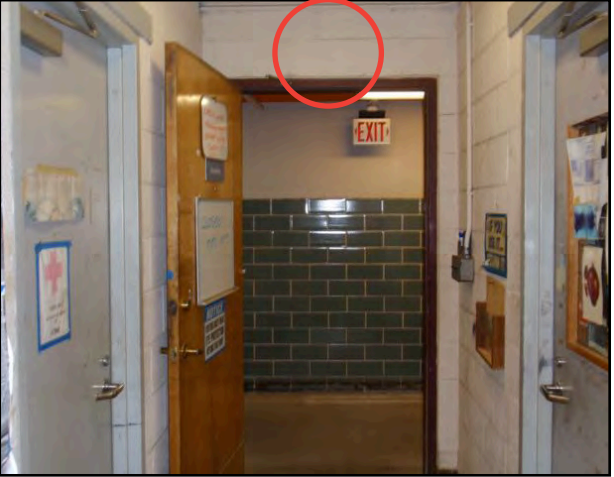
FIG. EAST - Basement exit sign missing in room

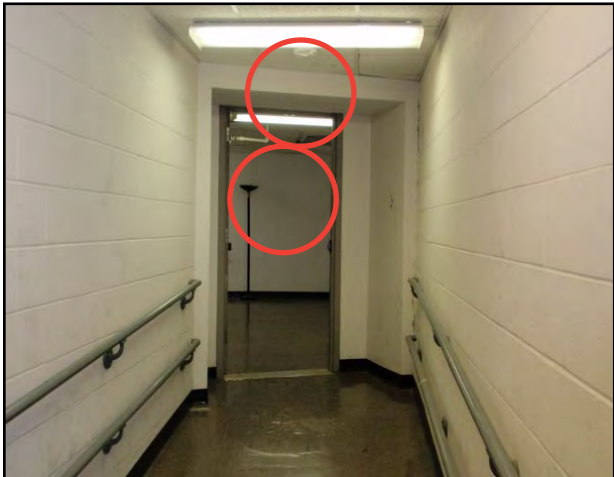
FIG. BETWEEN TOWER & EAST - 2nd Floor exit sign missing

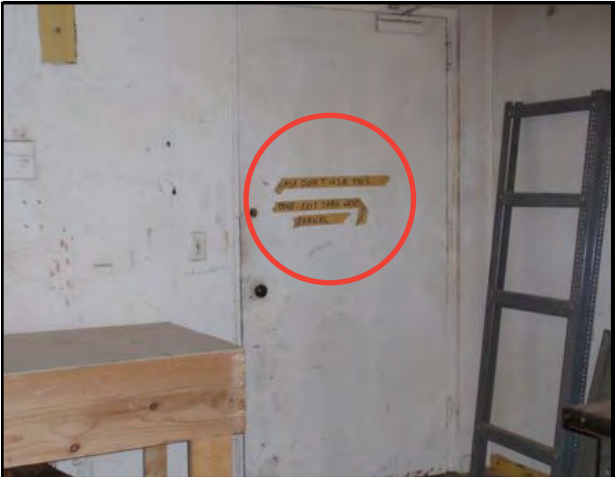
FIG. EAST - Basement egress signage hand-written on masking tape that is peeling off

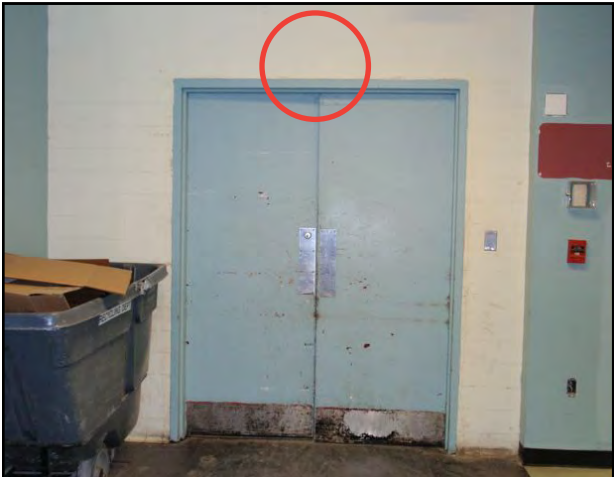
FIG. SOUTH - 2nd Floor exit sign missing

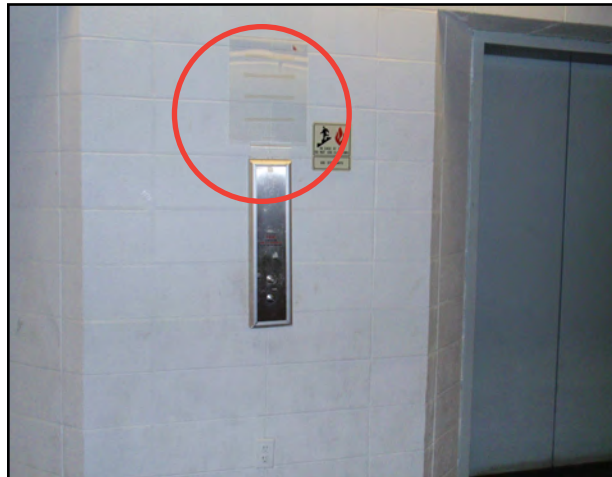
FIG. TOWER- 10th Floor Elevator Lobby Directory missing

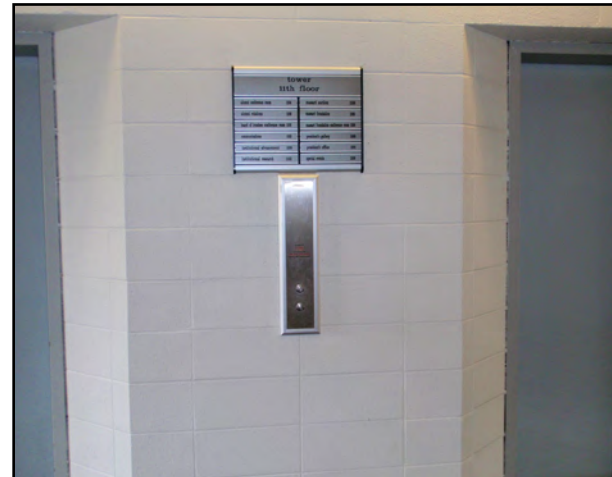
FIG. TOWER- 11th Floor Elevator Lobby Directory is too high. Height makes it difficult for a seated person to read

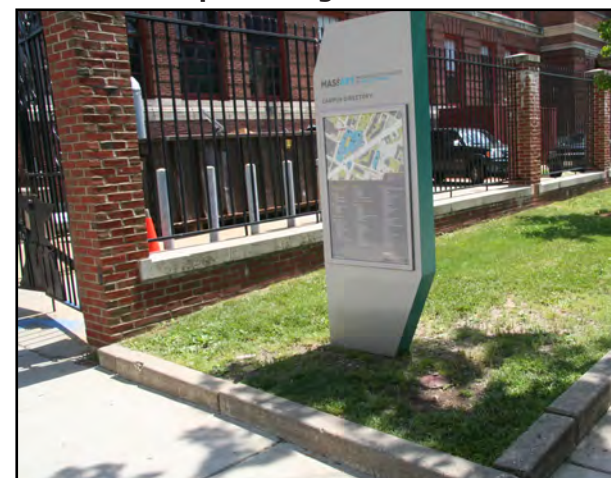
EXTERIOR - Palace/Tetlow curb and grass makes directory inaccessible

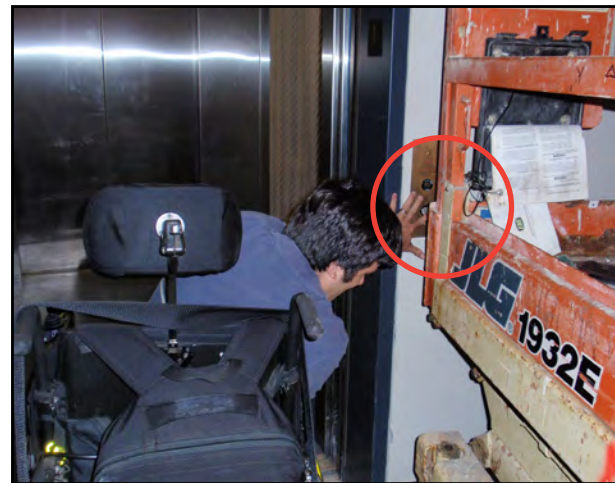
LOCATION| 105

Obstruction to controls

SMALL MAINTENANCE: Consider relocating electric scissor lift to an area where it will not be an obstruction to accessible routes or controls or at least park the lift in such a way that the elevator-controls are not obscured

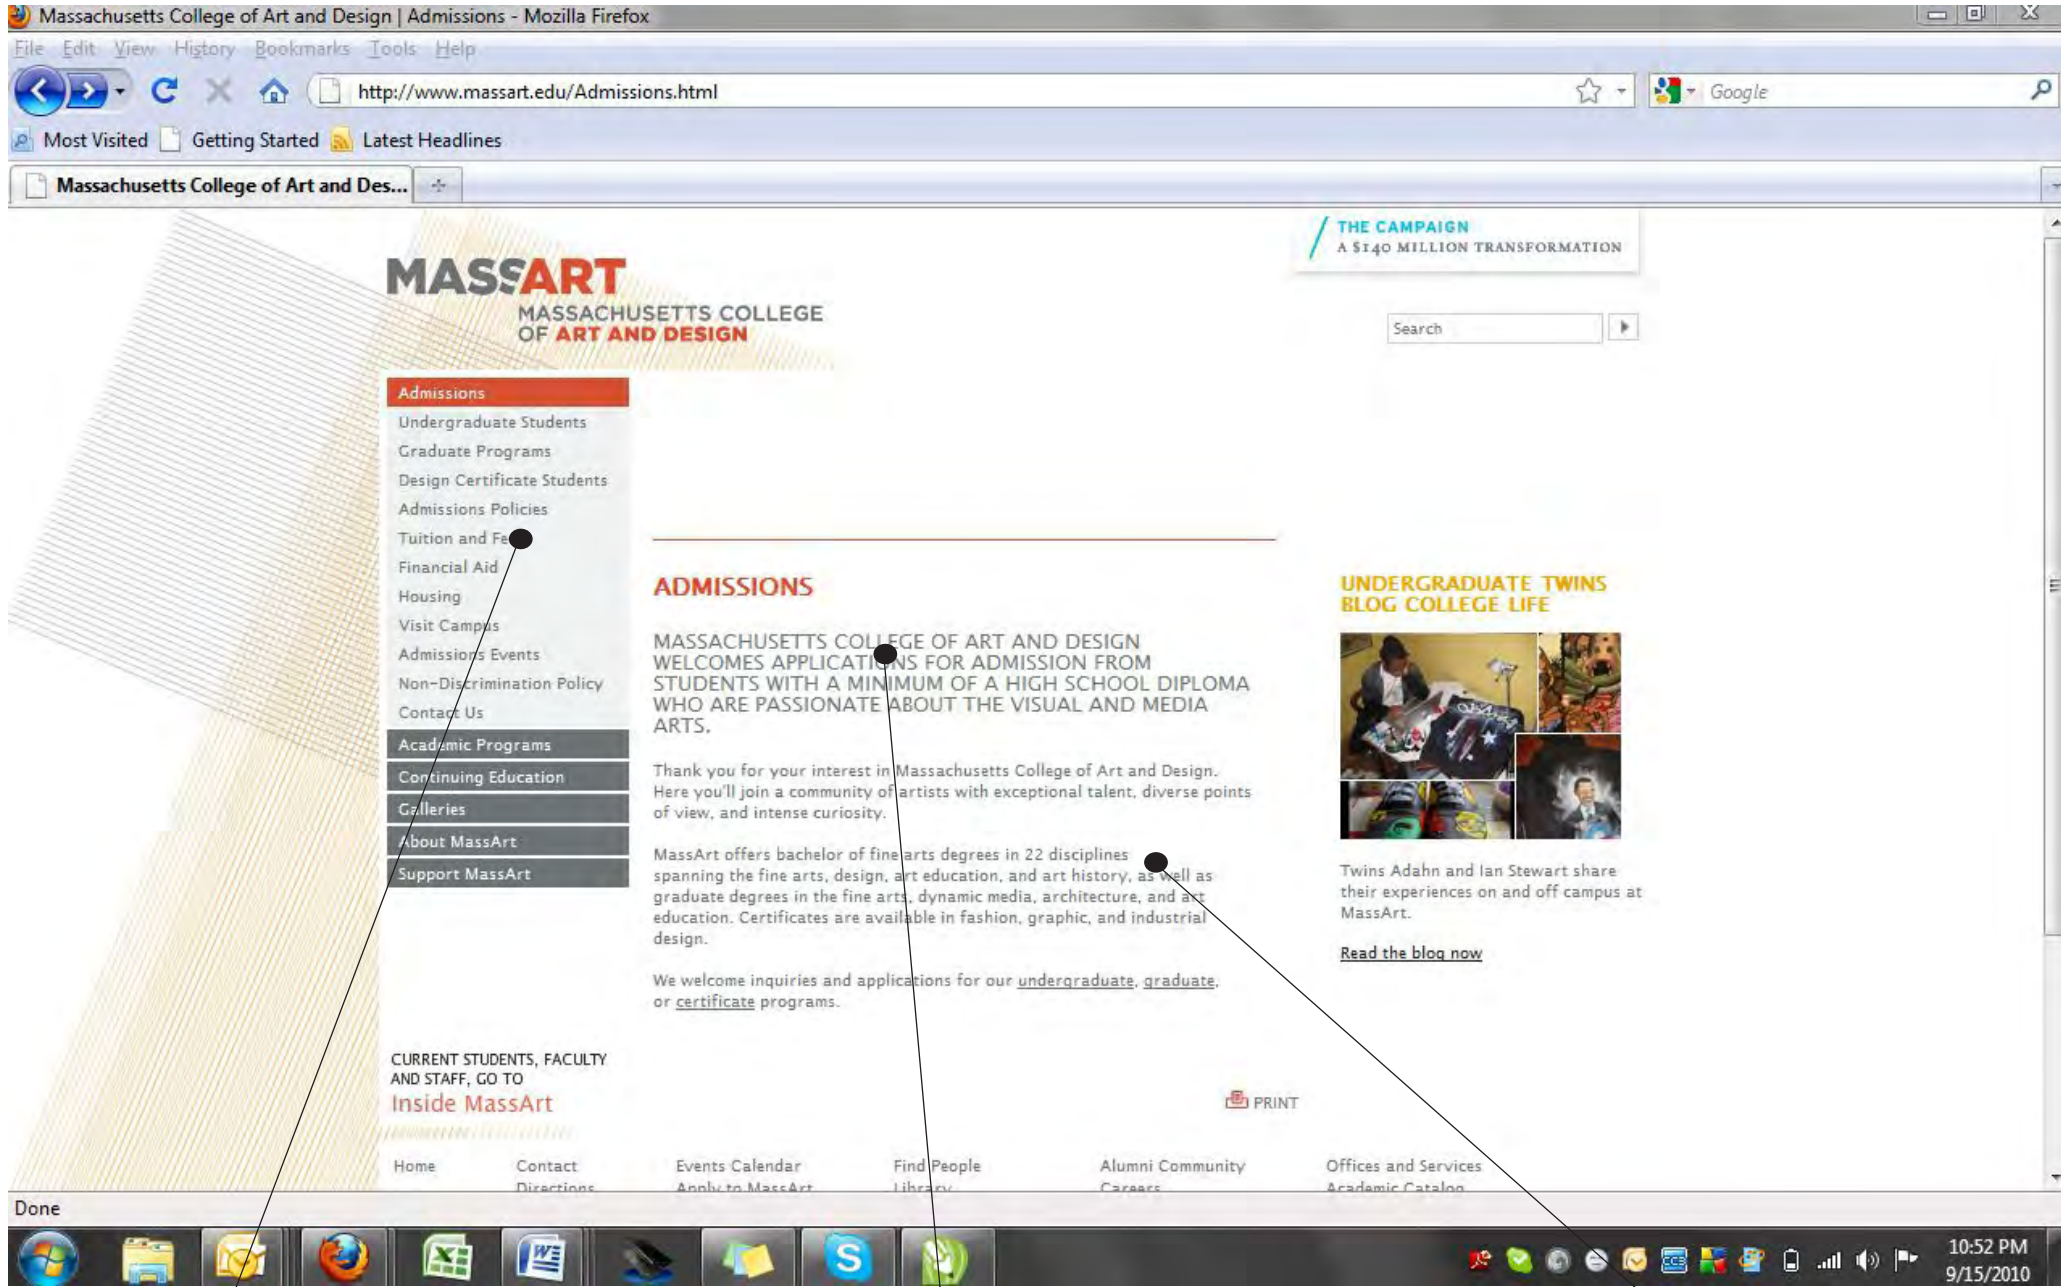
The red box is a nice graphic effect to highlight the location of the browser however the light gray text does not provide enough contrast against the lighter gray background color and coupled with the small font size it makes legibility difficult.
