Massachusetts College of Art and  
Design

Tower Building Analysis

MASS State Project #MCA 1301-HS1

Issue | November 19, 2013

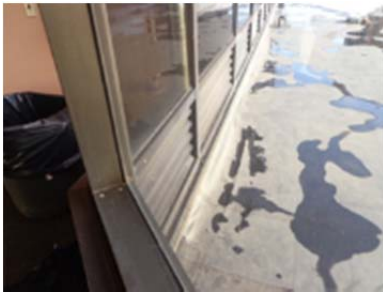
Level 5 – Visual observation was gained from the adjacent corridor. Areas of ponding water/ice were observed. Sandbags were being used to weigh down areas of loose roof membrane, figures 2.4.7 – 2.4.10.

Figure 2.4.7 Water ponding

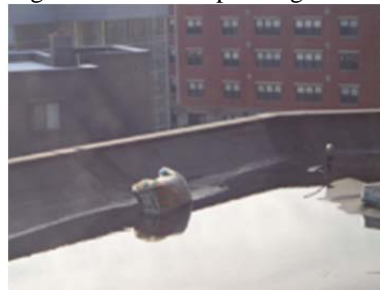
Figure 2.4.10 Sandbags on membrane

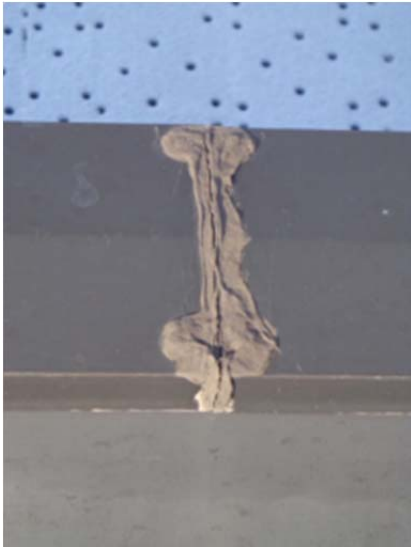
some locations, figure 2.4.11. In addition, exposed fasteners thru the top of the coping were observed, figure 2.4.12.

Figure 2.4.11 Poor sealant installation

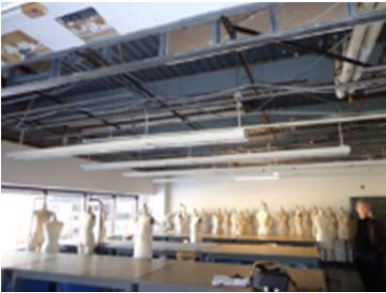
Clarity of construction type was difficult to discern. Examples include inconsistencies in fire-proofing of the structural members, inconsistent or missing fire-stopping along the slab edge and occupancy separation, figures 2.4.20 – 2.4.23. These items were observed in varying stages of questionable compliance throughout the building.

Figure 2.4.20 Inconsistent fireproofing

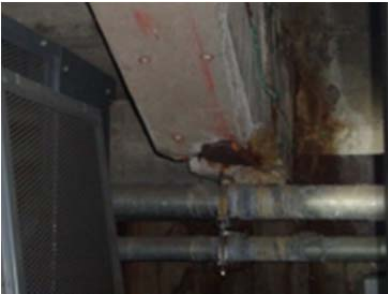
In the existing electrical transformer room, areas of spalled concrete were observed at one Obeam location. This left the steel beam underneath exposed to the elements and it appeared to be corroded, figure 4.26. There was also evidence of water staining on the walls of this room.

Figure 2.4.26 Beam in Electrical Transformer Room

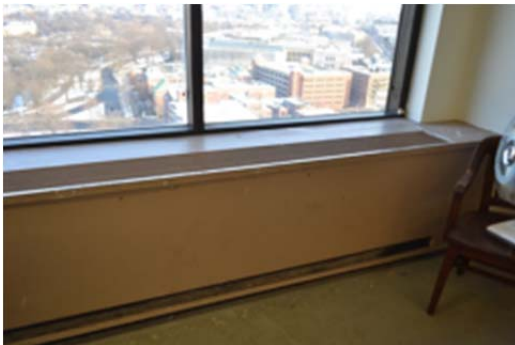
In addition to the unit ventilators, wall exhaust fans are also installed along the perimeter. The wall exhaust fans are not operational. Back draft dampers at wall exhaust fans have failed, allowing unconditioned air to enter the space during heavy winds. A typical unit ventilator and exhaust fan installation is shown below in figures 2.7.6 and 2.7.7.

Figure 2.7.6 Unit ventilator

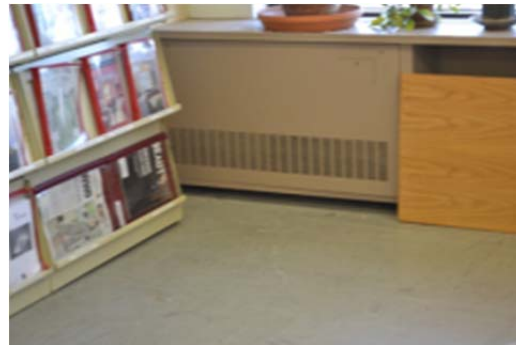
Figure 2.7.7 Exhaust fan at perimeter

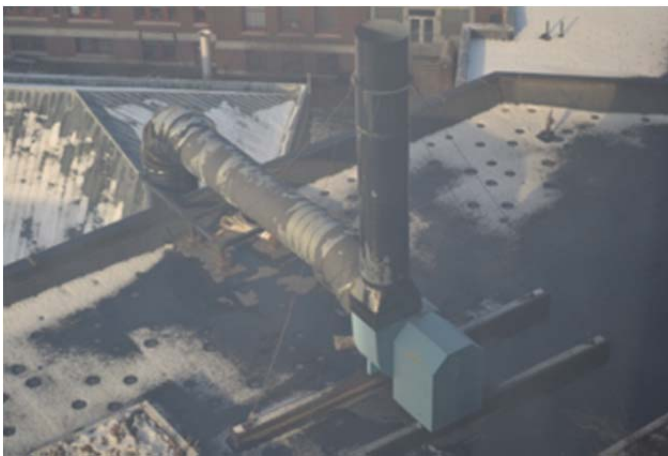
A wood shop exhaust duct is routed on the exterior of the building and terminates on a low roof. The wood shop exhaust termination is shown below in figure 2.7.8. Ductwork routed on the exterior of the building is indicative of tenant renovations installed after the original building construction and has the potential to impact building aesthetics.

Figure 2.7.8 Wood shop exhaust

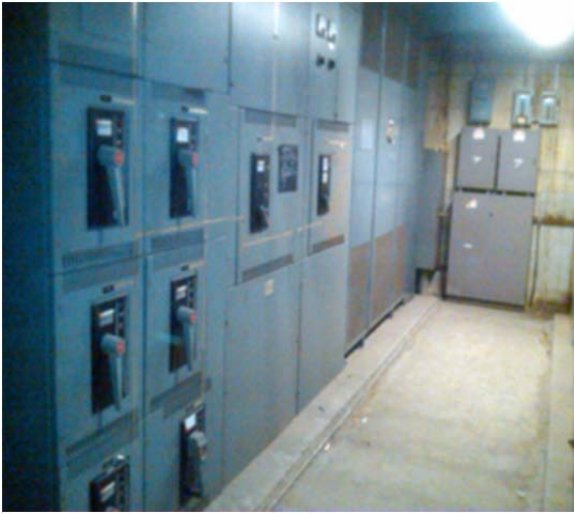
It was highlighted to us that a fault and failure occurred in December 2012 to one of the aluminum bus ducts and required repairs. Additionally, facilities maintenance personnel noted there is a combination of aluminum and copper wiring and bussing used in the buildings electrical distribution system. All the original bus-ducts and some original wiring are aluminum; however some copper wiring and bussing have been added throughout the years. Using both aluminum and copper wiring, equipment and associated fittings throughout the same electrical distribution system has the potential to cause electrical failures over time due to the corrosive effects of connecting dissimilar metals.

Figure 2.8.2: Existing MCAD Switchboard is old and beyond its useful service life.

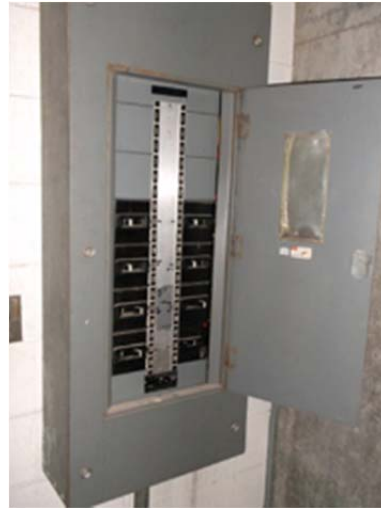
| Electrical<br>(Section 2.8.1) | <p>The existing secondary electrical distribution equipment is old and has exceeded its useful life. The original equipment is also manufactured by Federal Pacific Electric (FPE) and is currently obsolete. Components of the main switchgear and secondary distribution equipment have already failed and emergency repairs were provided. As new FPE replacement parts are not available; another main distribution component failure could result in a significant and extended outage.</p> |

Figure 2.8.3 Typical FPE panelboard is old and beyond its useful service life.

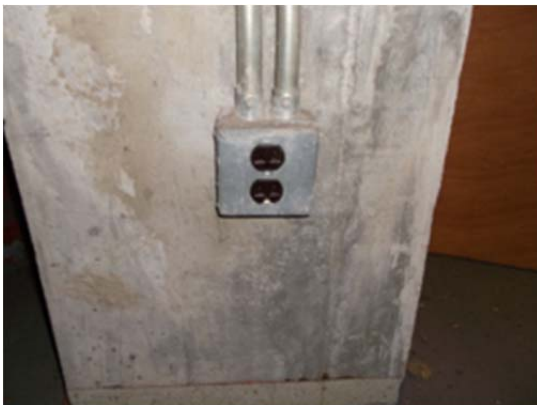
Figure 2.8.4: Receptacles are original and beyond their useful service life.

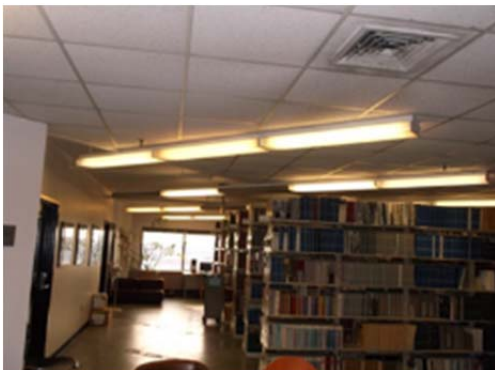
Figure 2.8.8 Existing light fixtures are original and are beyond their useful service life

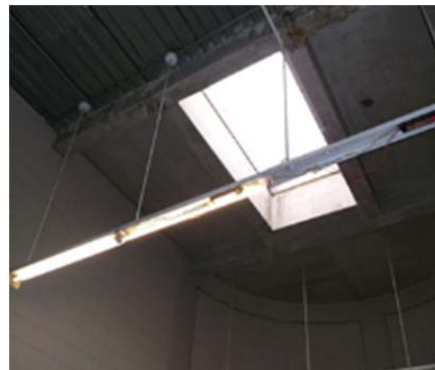
Figure 2.8.9 Some light fixtures are missing lenses and falling apart.

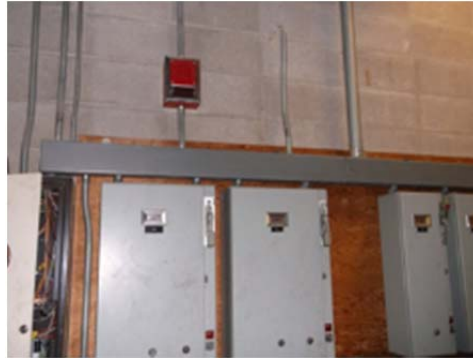
Figure 2.8.11 Fire alarm wiring is routed in raceway used for power wiring.

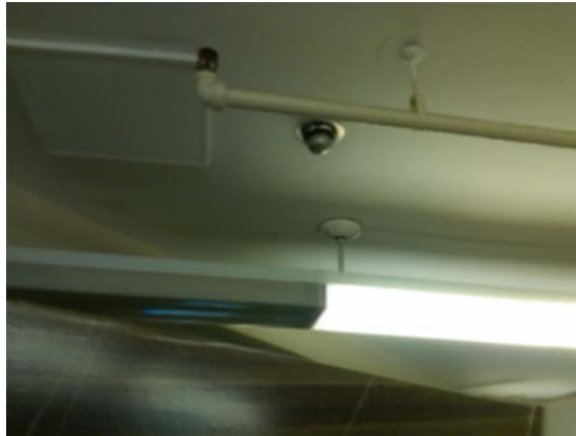
Figure 2.8.13 Existing original heat detectors are still being used and are beyond their useful service life.

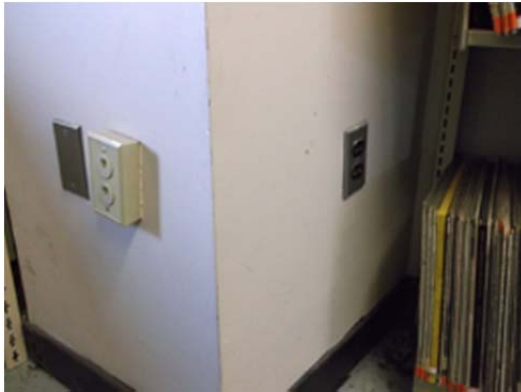
Figure 2.8.14 Existing telephone outlets are original and beyond their service life.

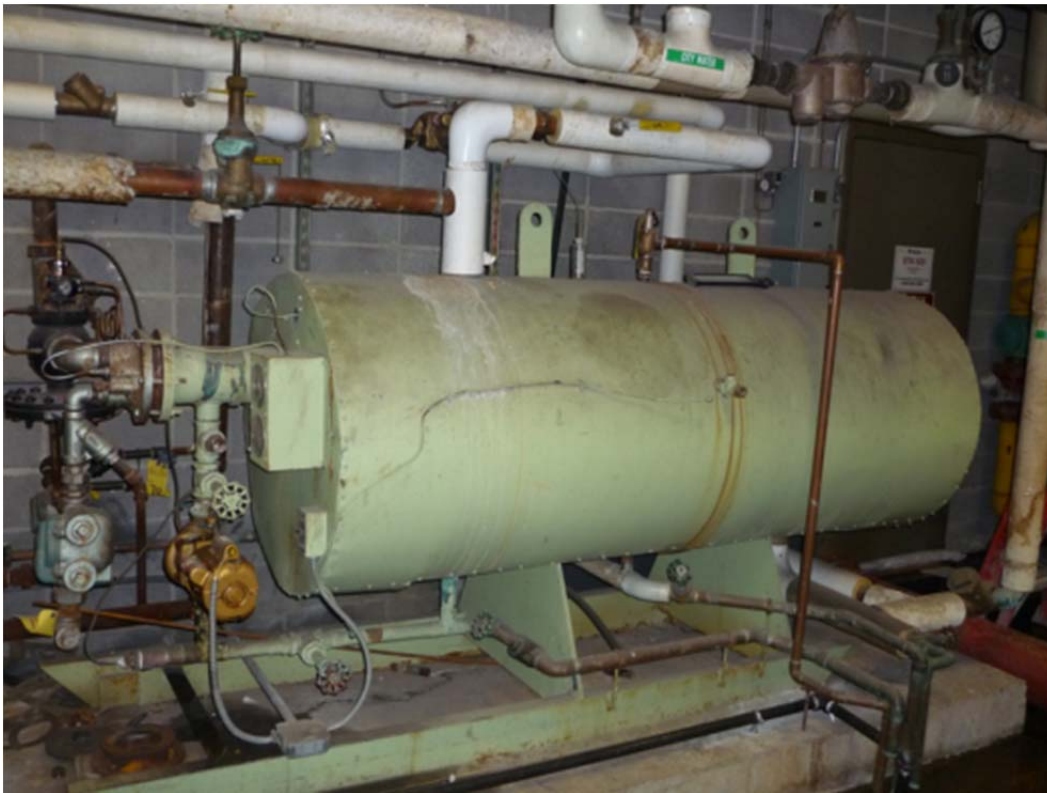
Boosting the water to 180°F is not only dangerous and can cause scalding if the master mixing valve were to fail, it is also wasting energy and gas.

Figure 2.9.2 Original steam water heater

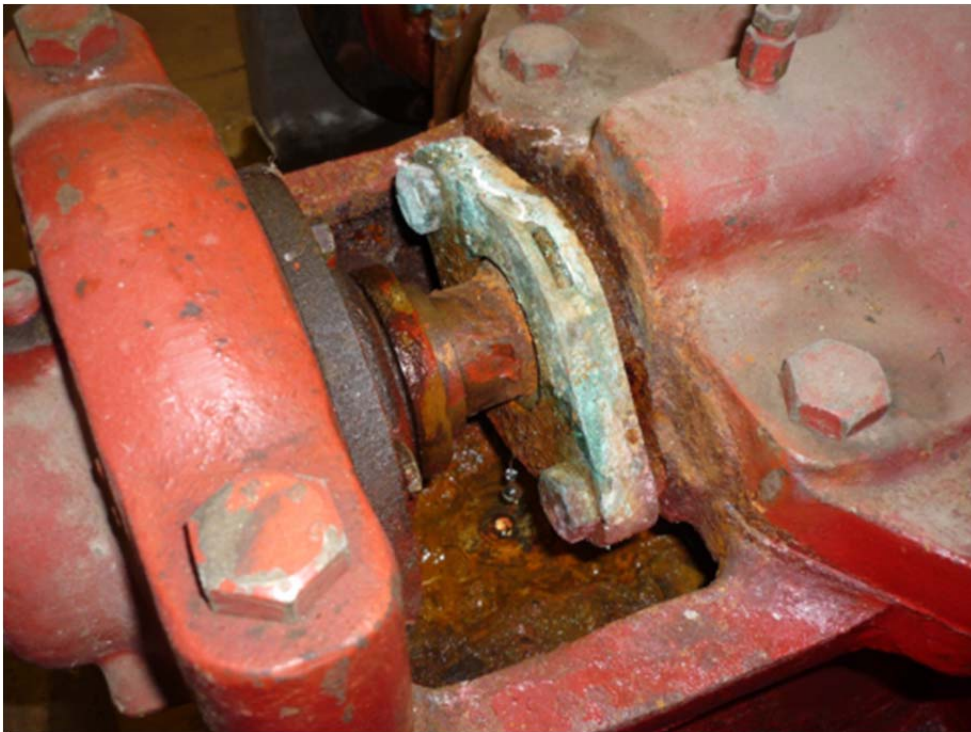
In speaking with the facility staff we understand the fire pump is tested annually and is in working order. However upon our site visit we notice the pump is leaking from the casing. While leaks are common this leak seems to be extensive and going on for quite some time as it is starting to corrode the fire pump casing and supports.

Figure 2.10.2 Fire pump leaking from casing

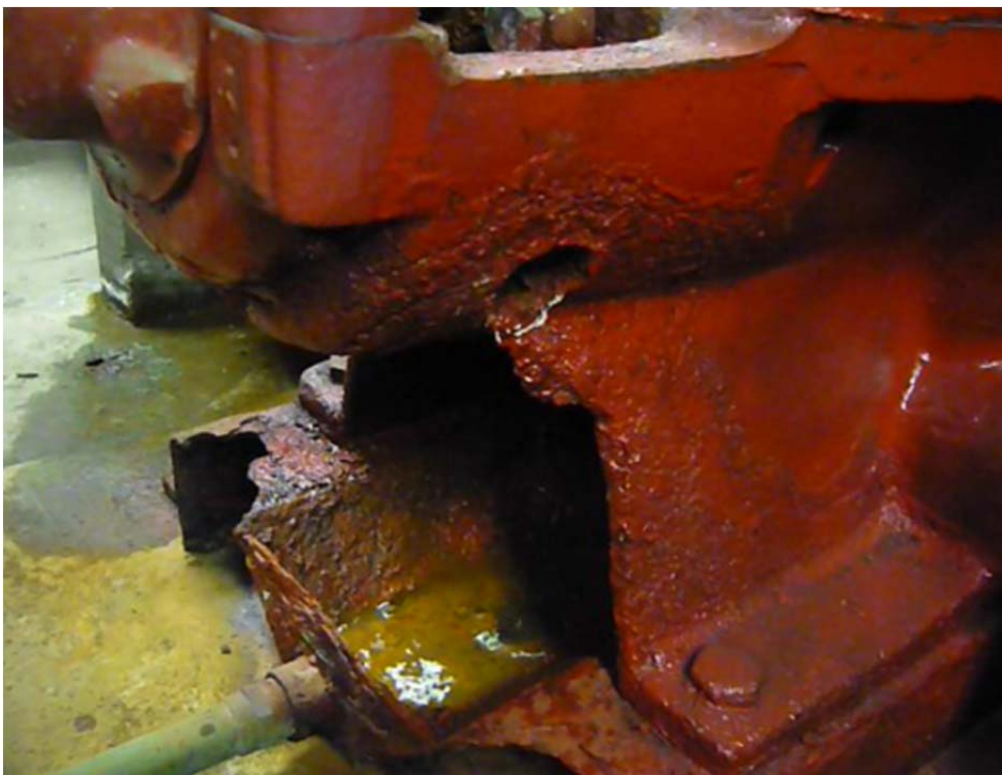
| Fire Protection Systems<br>(Section 2.10.1) | <p>The fire pump is leaking from the casing. This leak appears to be extensive and is starting to corrode the fire pump casing and its supports.</p> |

Figure 2.10.3 Corroded casing and supports for the fire pump

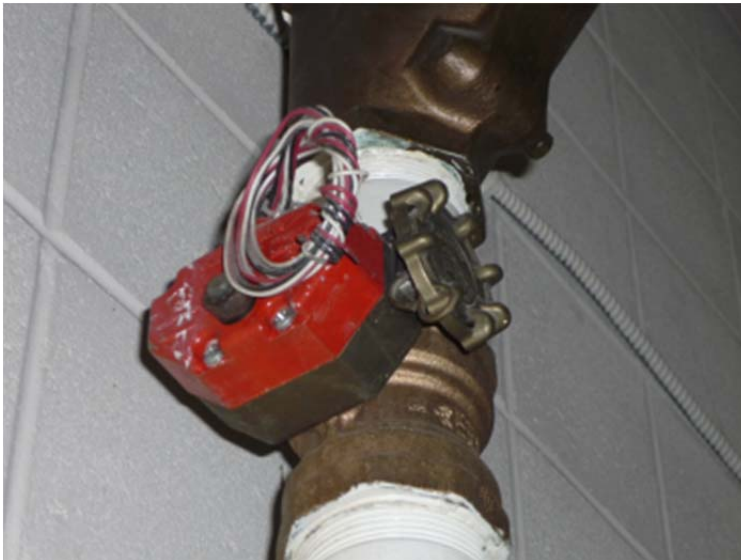
Some of the fire alarm devices installed in the sprinkler system, such as flow switches, are not connected to the fire alarm system.

Figure 2.10.6. Flow switch not connected to fire alarm.

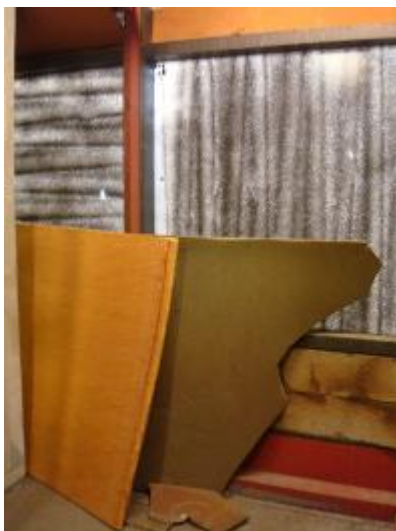
Figure 2.11.1

The spandrel panels are also likely insulated below current code requirements. As seen in the 13<sup>th</sup> floor mechanical room, the insulation is delaminating or completely off of the enclosure panels as the adhesive has failed, figure 2.11.1. Efforts to secure the insulation have been made, figure 2.11.2, but the insulation is still clearly detached from the exterior panel. Hence, the performance of the insulation has been compromised and is providing little to no protection from thermal transfer. Water infiltration damage was also evident in the insulation at several locations, refer to figure 2.11.1.

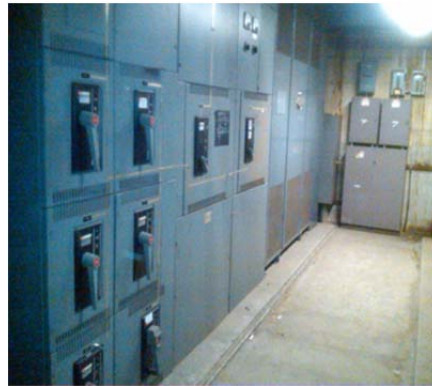
During our site visit we observed the main electrical room with a double-ended, secondary unit substation that has exceeded its useful life, is manufactured by Federal Pacific Electric (FPE) which is obsolete; and is currently operating with one transformer and tie circuit breaker closed which results in a high risk of future prolonged failure.

Figure 3.3.1 Existing switchboard

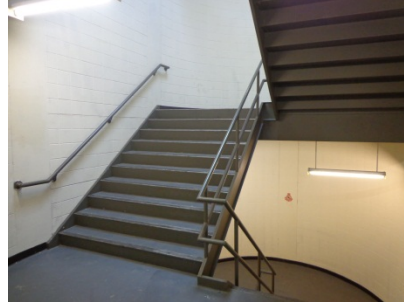
During our site visit we observed that although the building is classified as a high rise building, the three (3) egress stairs do not have stair pressurization systems.

Figure 3.3.3 Typical egress stair

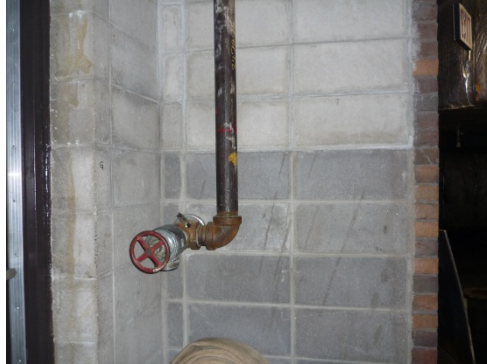
Each standpipe riser has a 2½” hose valve connection located at every floor level; however these connections are located within the occupied floor space and not within the stair enclosure, as required by NFPA 14.

Figure 3.3.5 Hose valve connection outside the stair enclosure

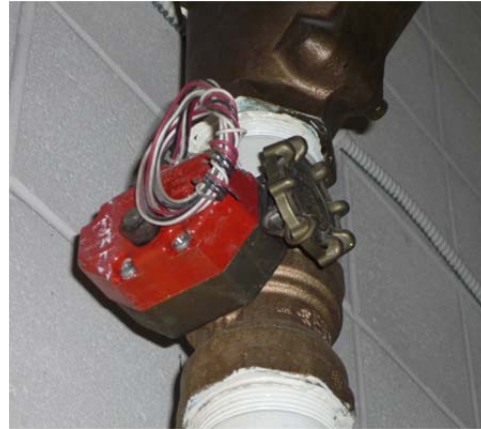
Figure 3.3.6 Fire alarm device not connected to fire alarm system

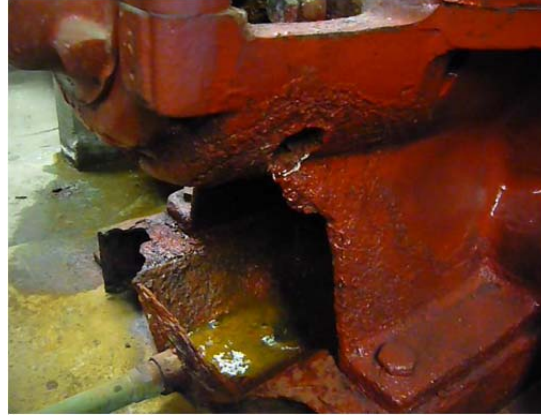
During our site visit we noticed that the fire pump is leaking from the casing. The leak appeared to be extensive and showed evidence of starting to corrode the fire pump casing and supports.

Figure 3.3.7 Fire pump corroded casing and supports

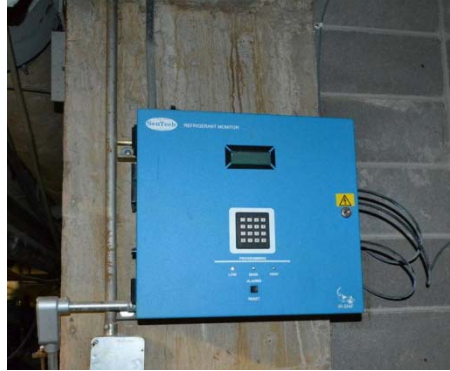
During our site visit, we observed an exhaust fan and refrigerant leak detection system are present in the chiller room and operational but are not connected to each other.

Figure 3.3.9 Existing Refrigerant Monitor Panel

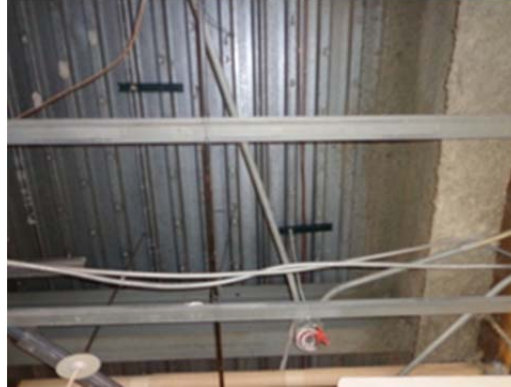
During our site visit, inconsistencies in fireproofing continuity were evident throughout the building.

Figure 3.3.12 Inconsistent fireproofing
