Comprehensive Wastewater Resilience Feasibility Study

Town of Scituate, Massachusetts

June 30, 2019

File No. 01.0173977.00

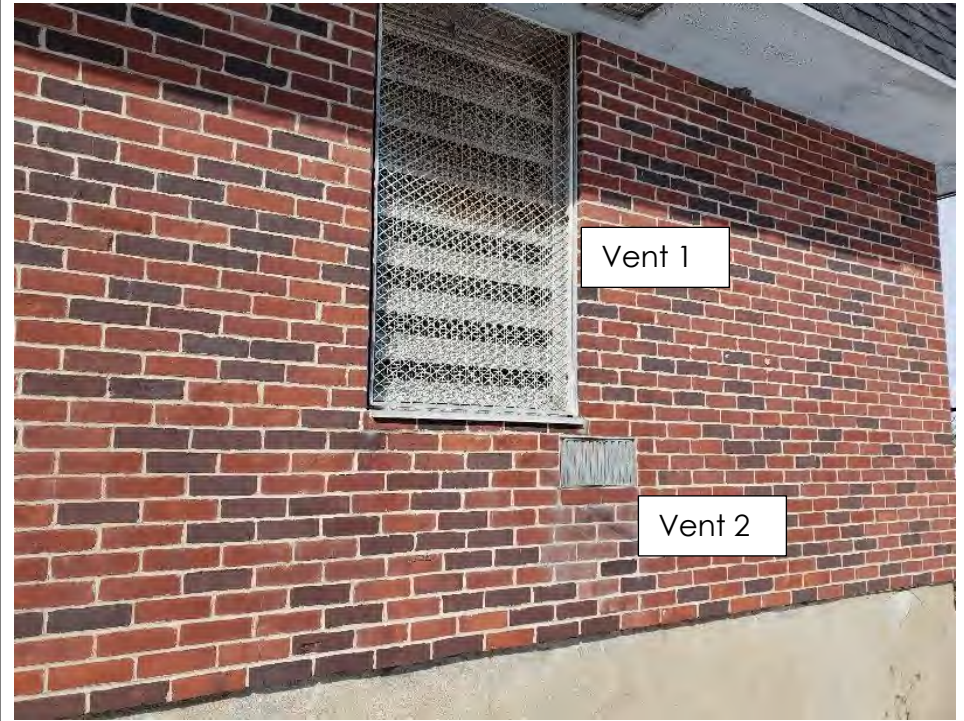
Photo 4 Chain Pond PS Louvered Vents

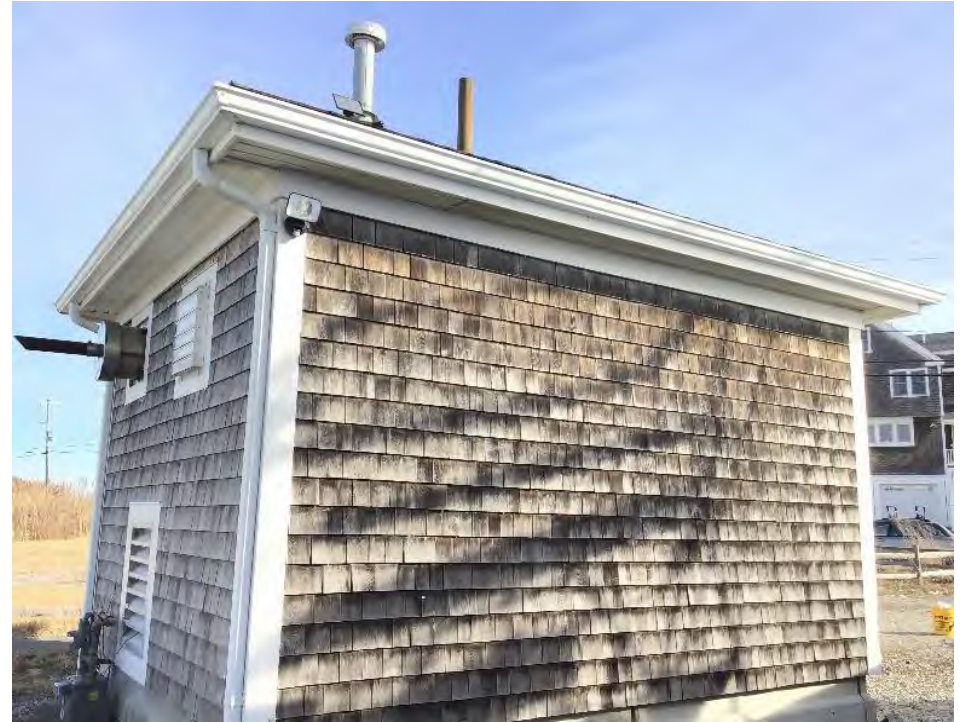
Photo 4 South Side of Edward Foster PS

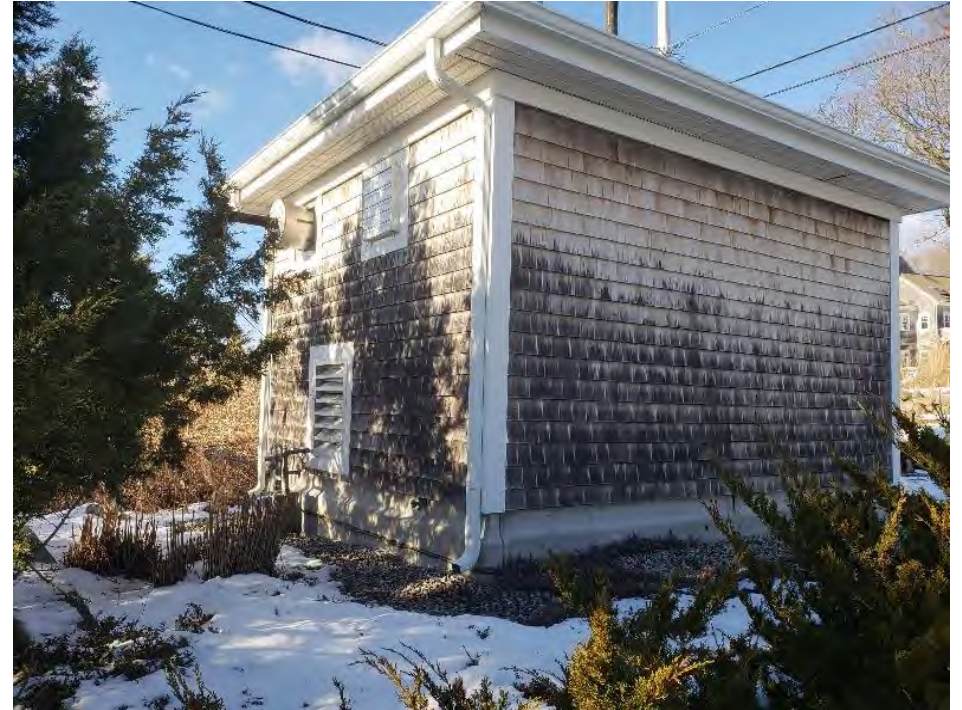
Photo 4 Peggotty Beach PS Fresh Air Intake

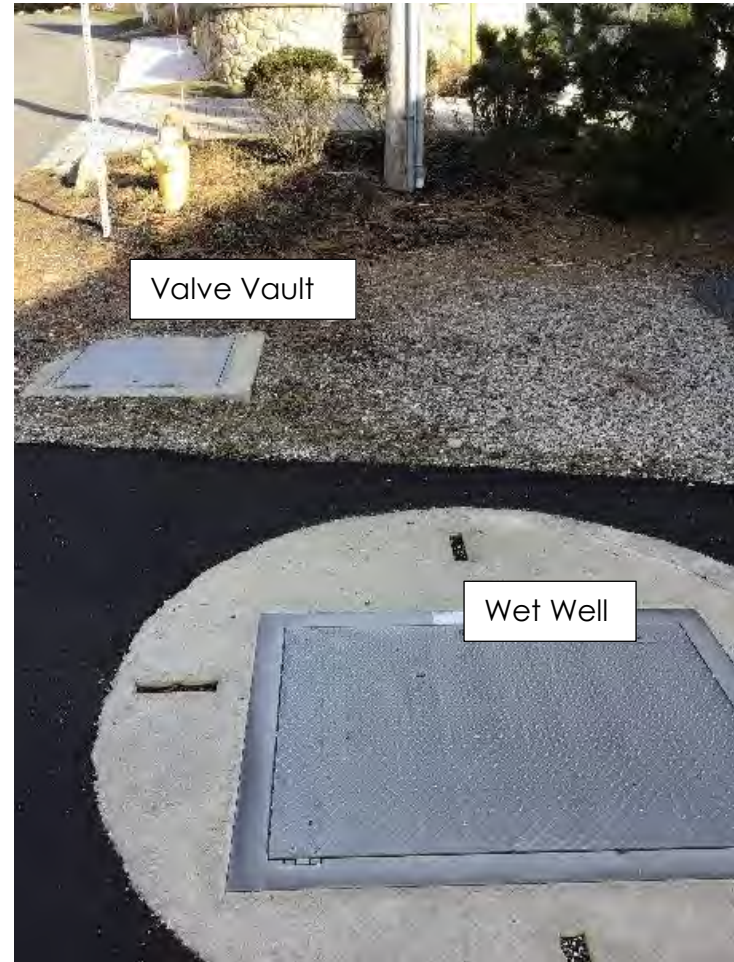
Photo 4 Collier road PS Wet Well Hatch

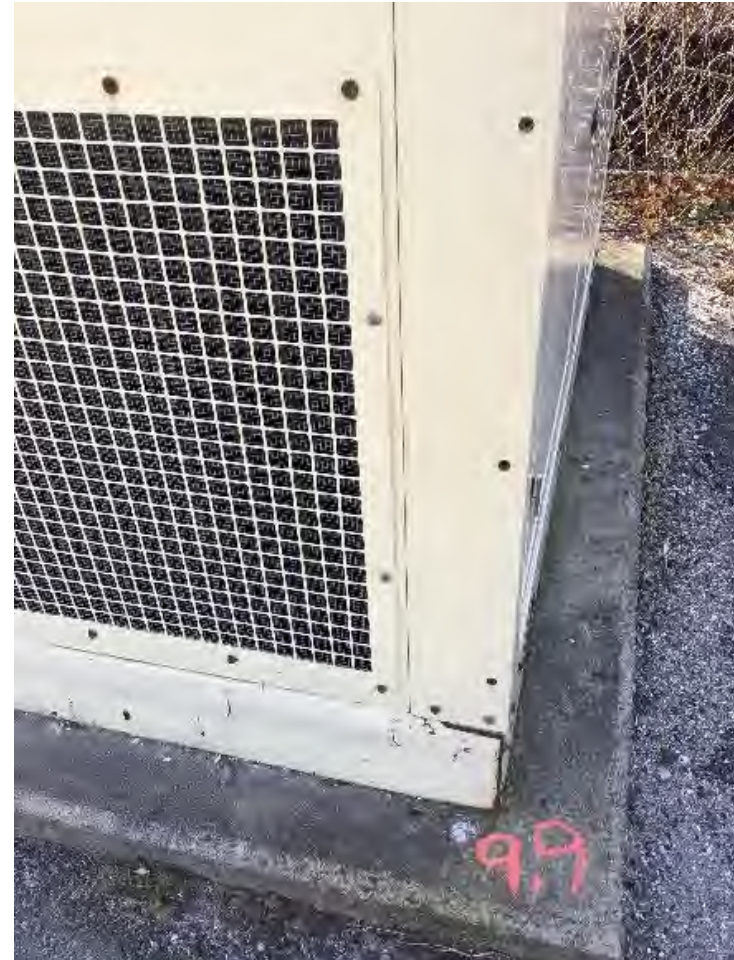
Photo 4 Photo 28 Herring Brook PS Generator Elevation

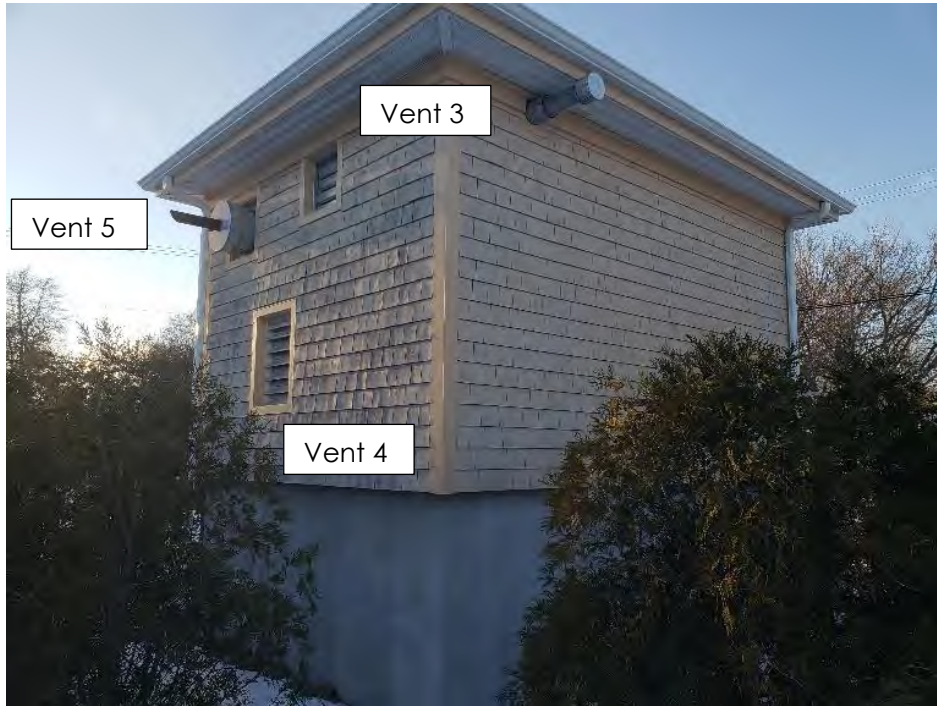
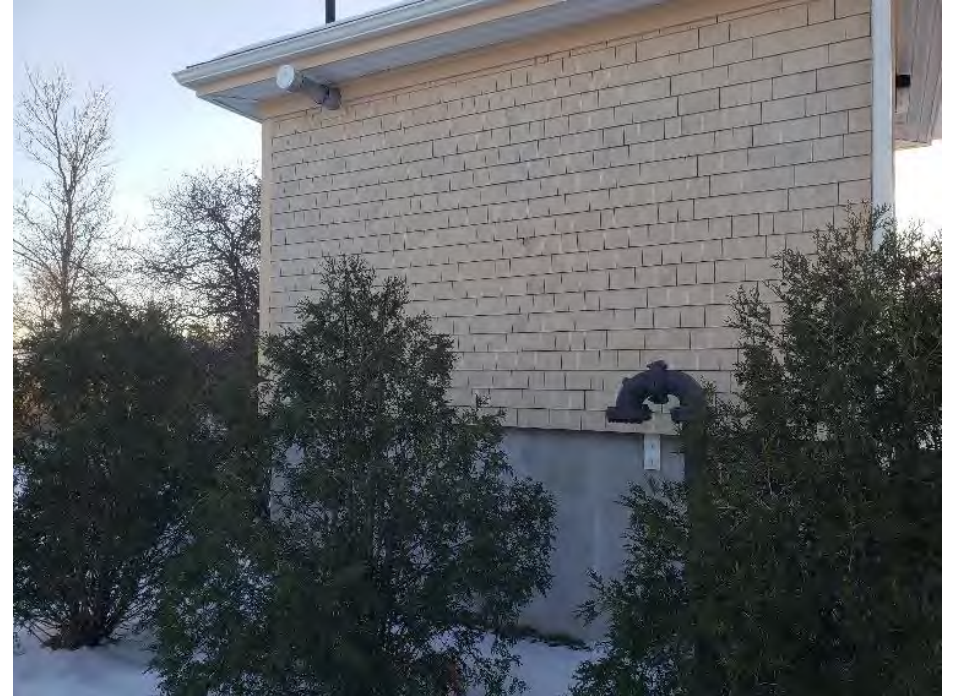
Photo 4 East Side of Musquashicut Avenue PS

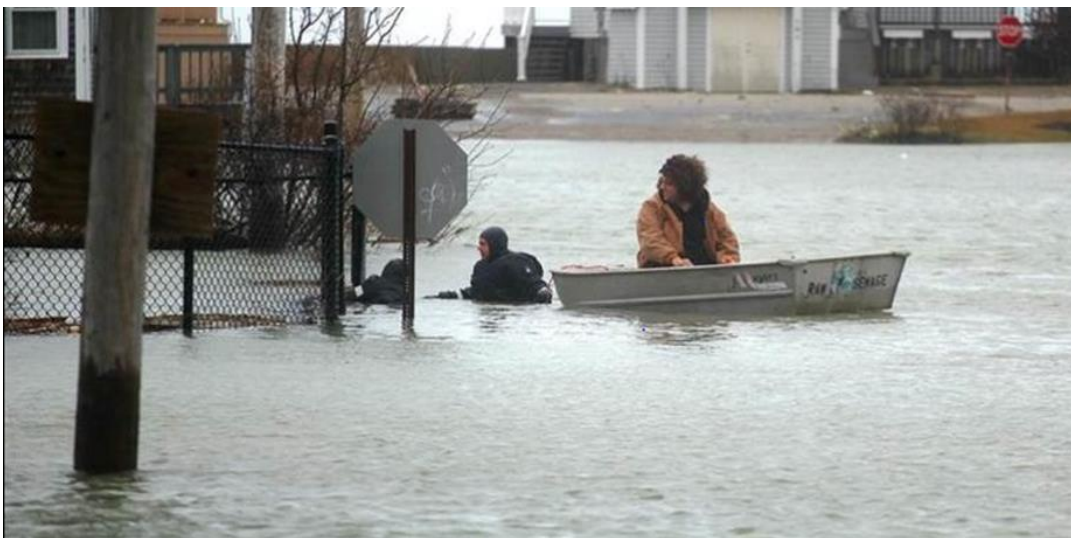
The March 1-3, 2018 nor'easter was a powerful storm that adversely impacted the operations of some components of the sewer system in Scituate. The Sewer Division estimated the economic impacts from the nor'easter exceeded \$200,000 in storm-related damages caused primarily by coastal flooding. The impacts from the March 2018 nor'easter resulted in extensive flooding that inundated: 1) the Sand Hills Pump Station on Scituate Avenue (see **Figure 60** below); 2) the parking lot and portions of the Chain Pond Pump Station; and 3) sewer collection areas (see **Figure 61** on the following page) providing access to sewer pumping stations and supporting wastewater infrastructure.

Figure 4-60: Scituate Police Divers guide Sewer Department Supervisor William Branton along Scituate Ave. to activate emergency pumps at the Sand Hills Pump Station towards the end of March 2, 2018 nor'easter ("Winter Storm Riley").
