Report of
Facility Condition Assessment

Bay State Correctional Center
28 Clark Street
Norfolk, Massachusetts 02056

September 29, 2019

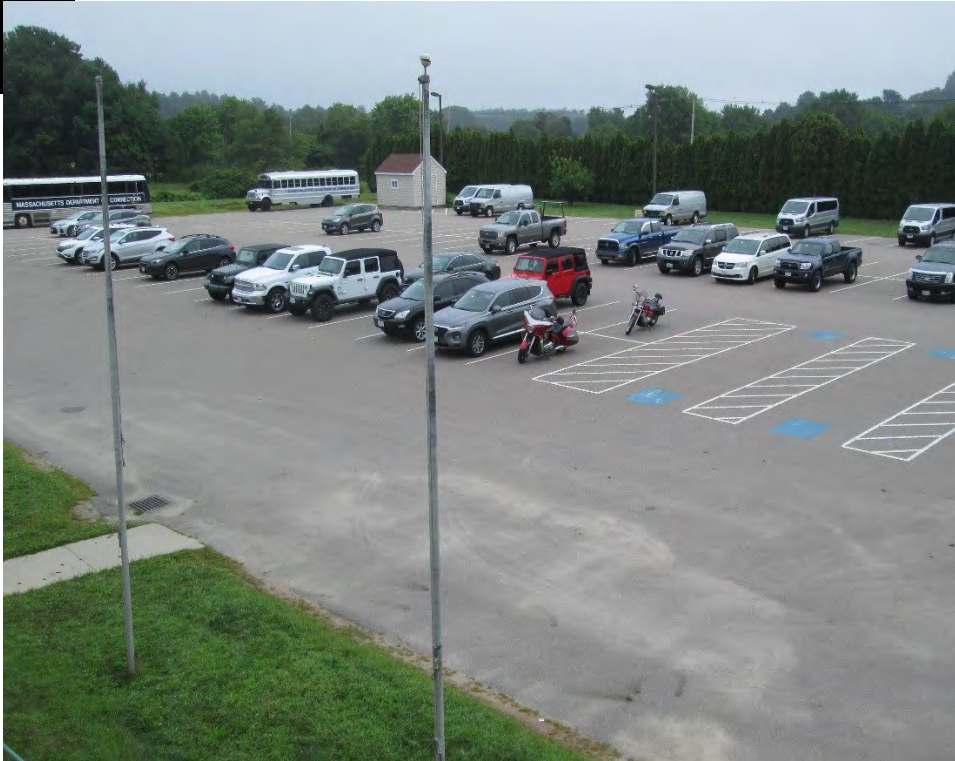
Photograph No. ST-01

Front parking lot.

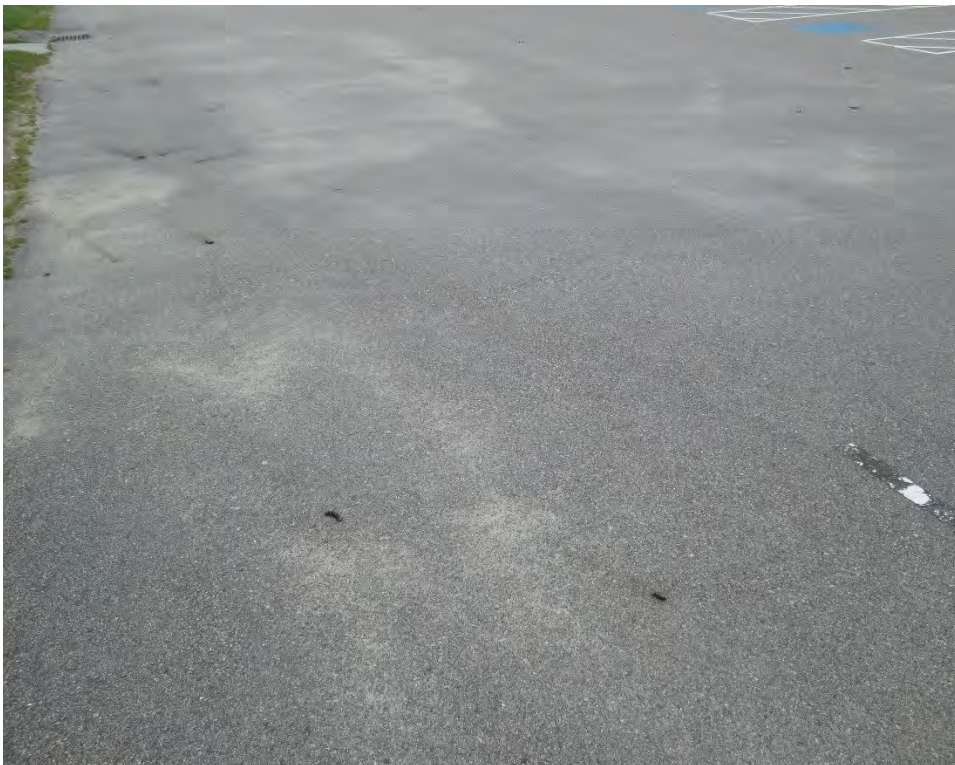
Photograph No. ST-02

Surface of parking lot in good condition.

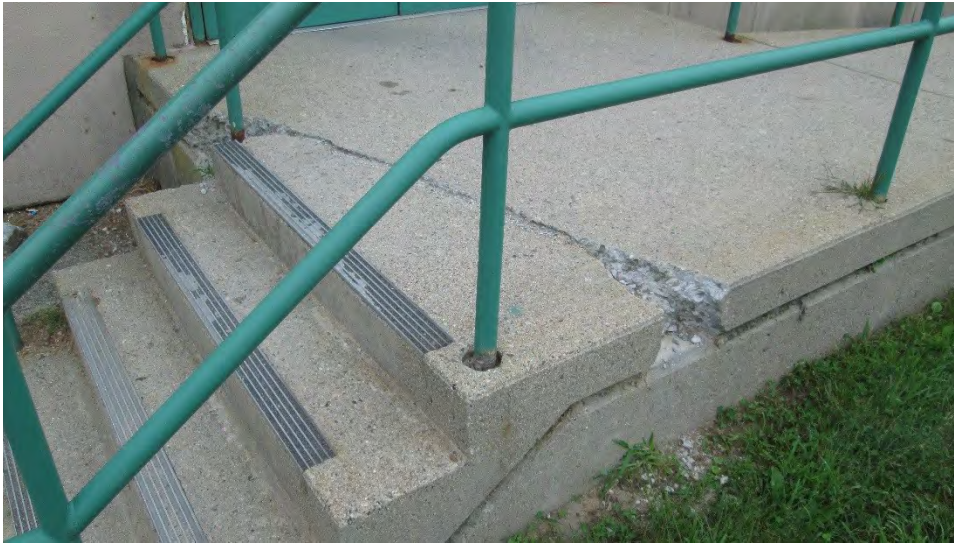
Photograph No. ST-03

Failed concrete at Gate House steps.

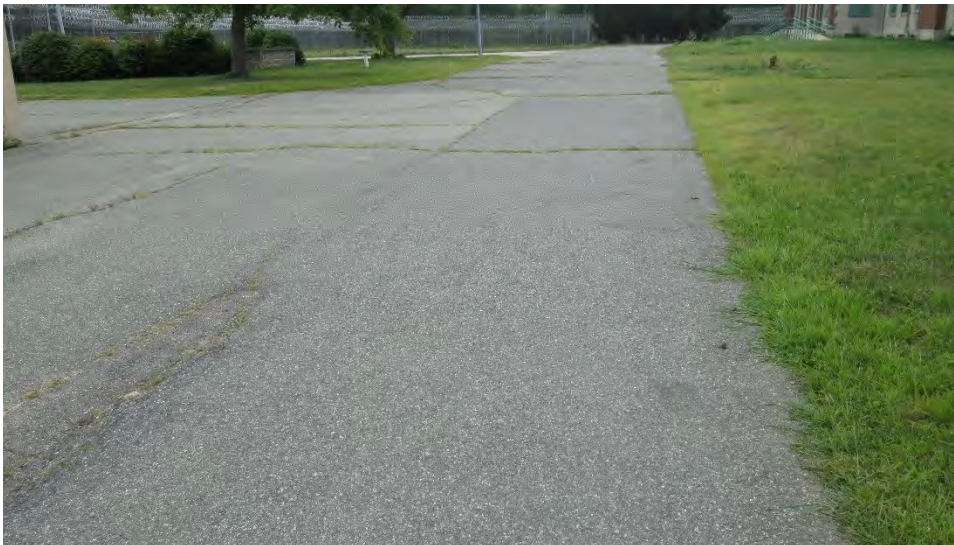
Photograph No. ST-04

Typical condition of interior roadway.

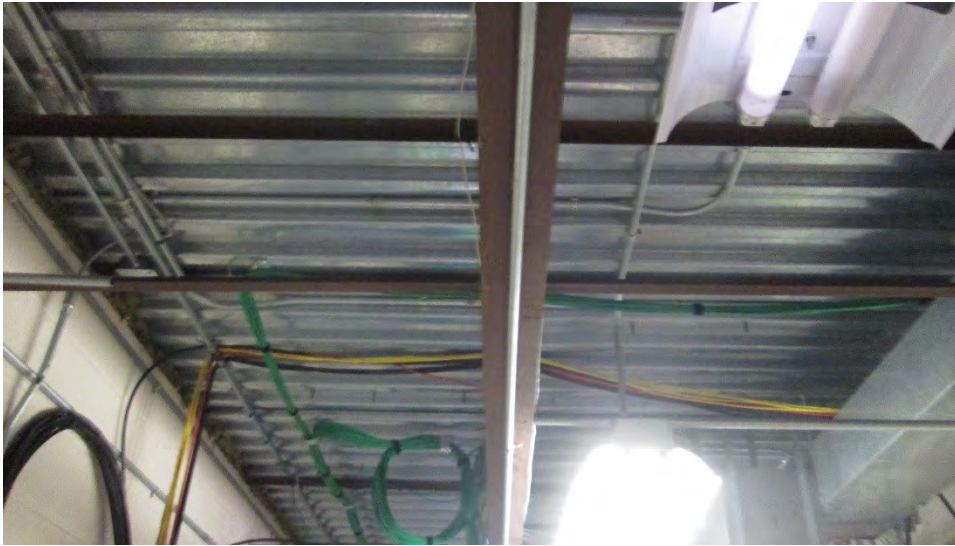
Photograph No. S-01

Roof structure at Gate House

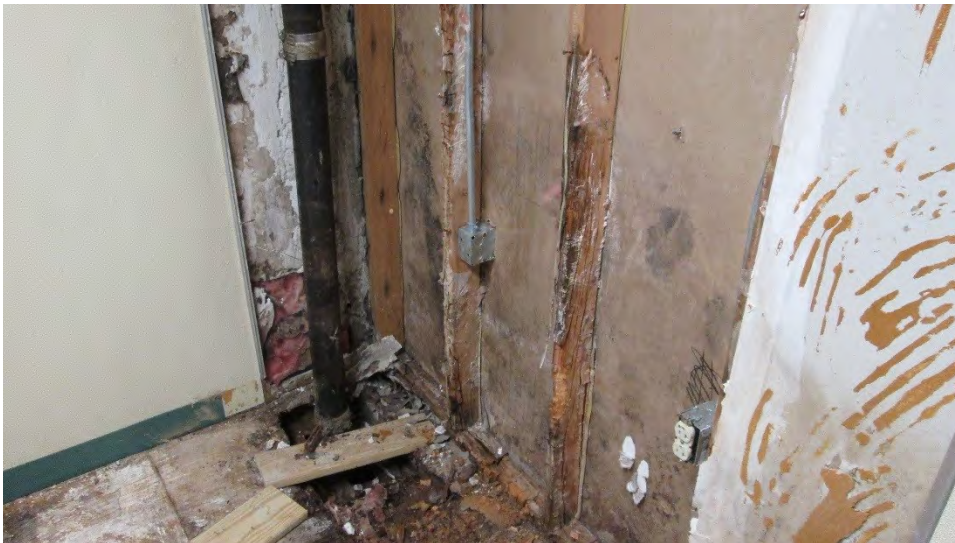
Photograph No. S-01

Failed structure at Modular Housing

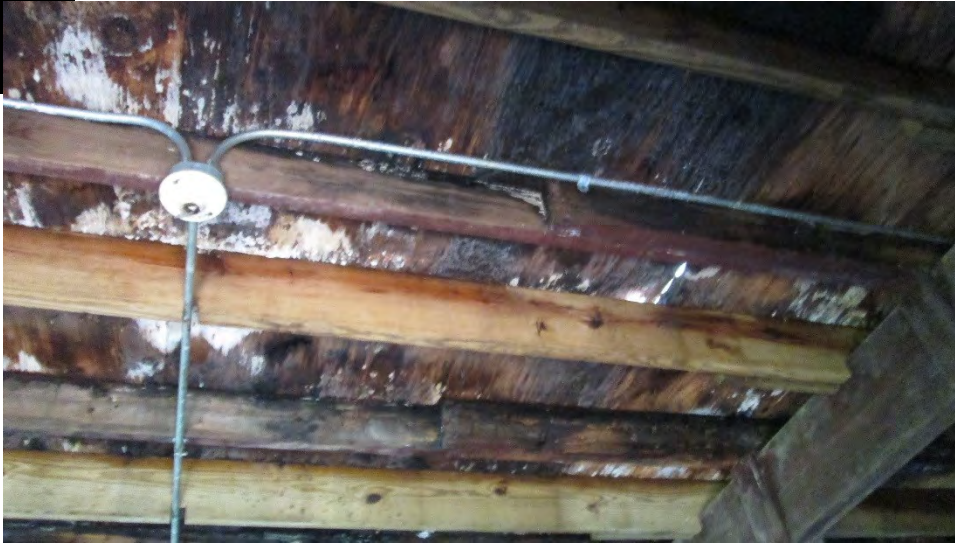
Photograph No. S-03

Failed roof framing and decking at Quonset Hut extension.

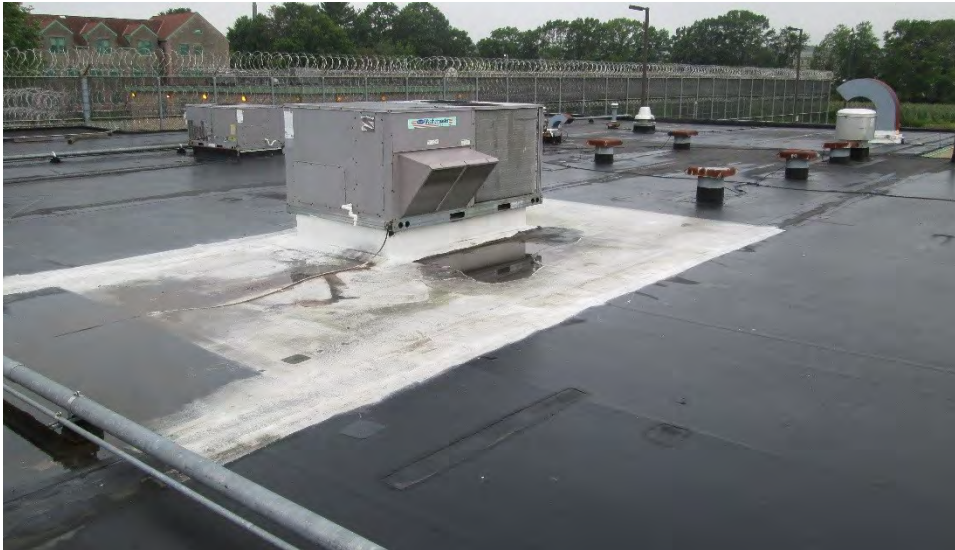
Photograph No. R-1

Gate House roof.

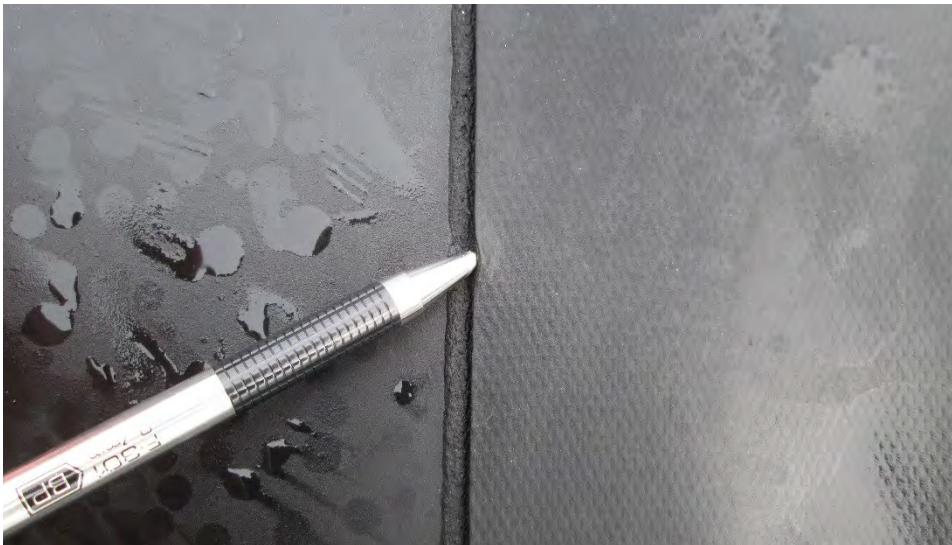
Photograph No. R-3

Failed seam at Gate House roof.

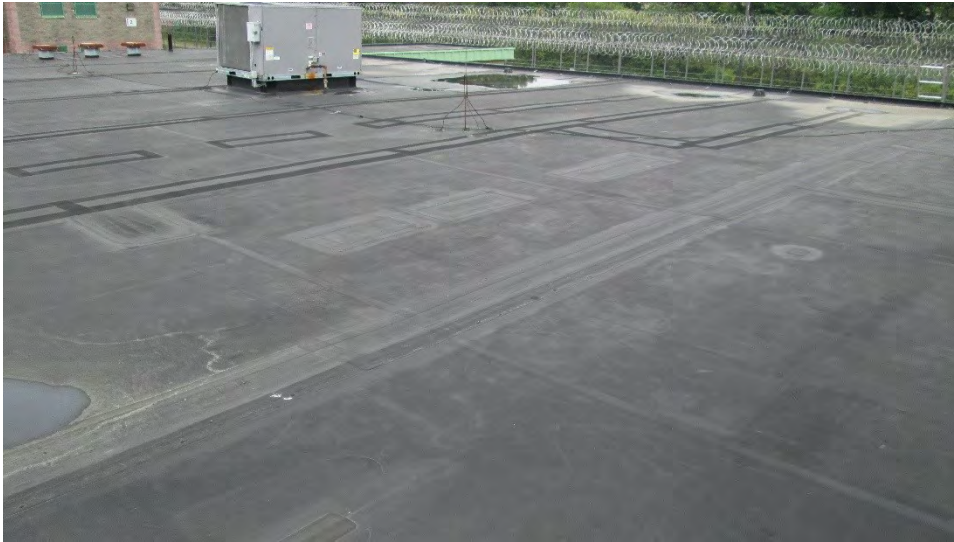
Photograph No. R-4

Visitor Building roof.

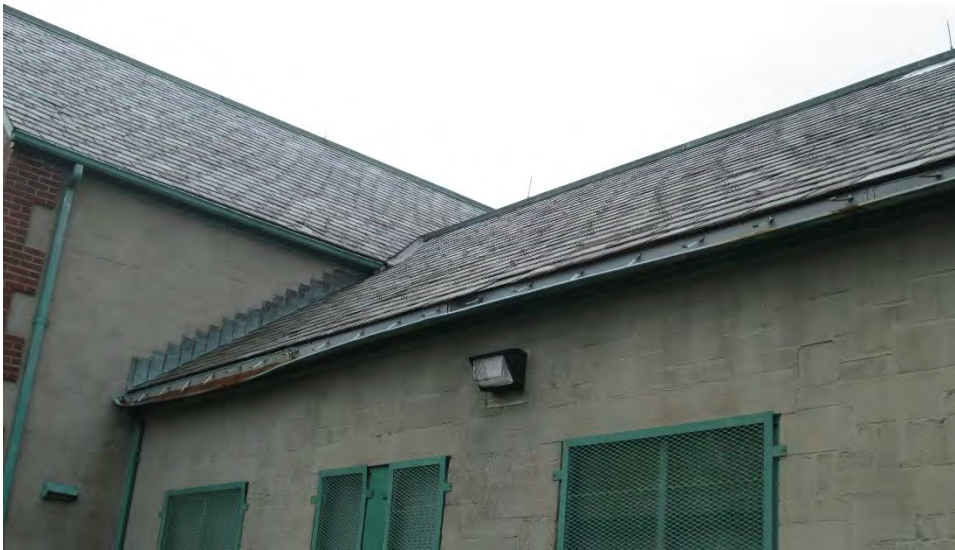
Photograph No. R-6
Failed gutter at
Administration Building.

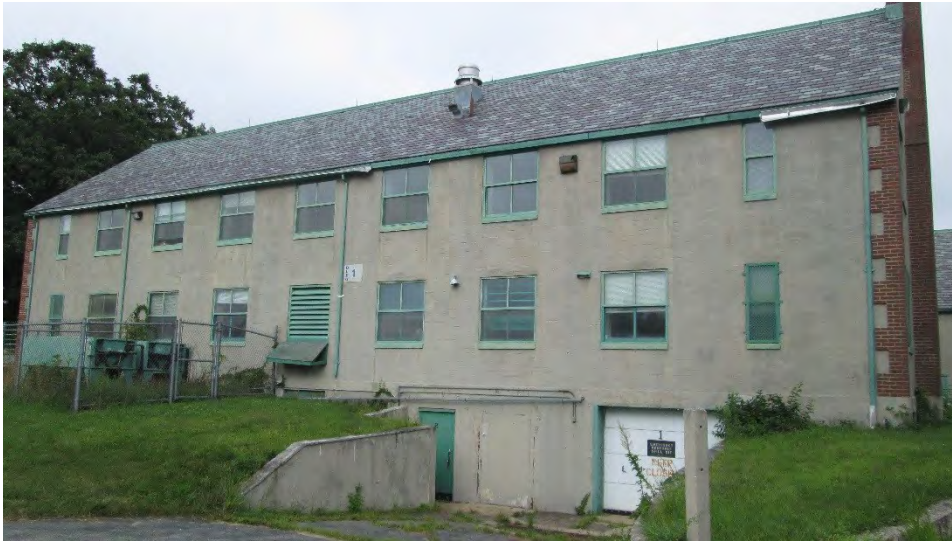
Photograph No. R-7
Missing gutter at
Administration Building.

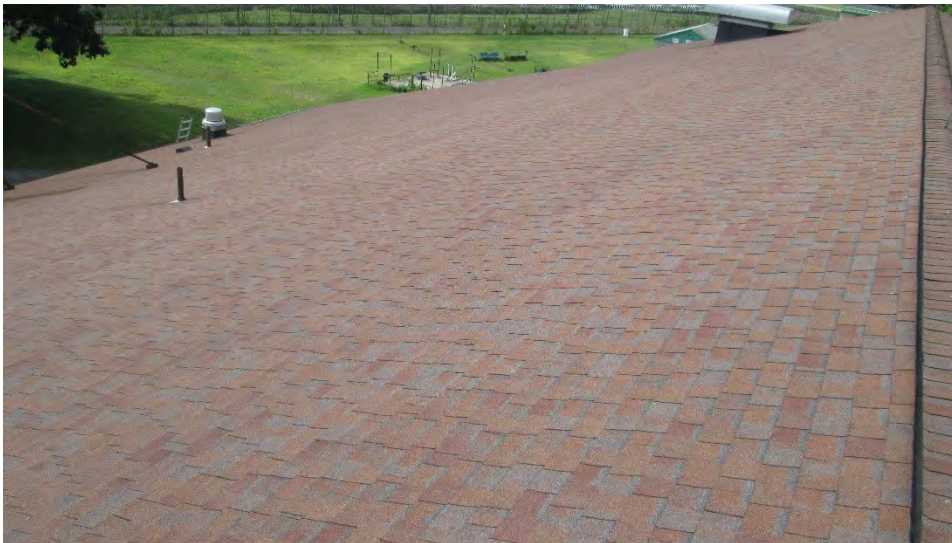
Photograph No. R-8
Shingle roof at Main
Housing.

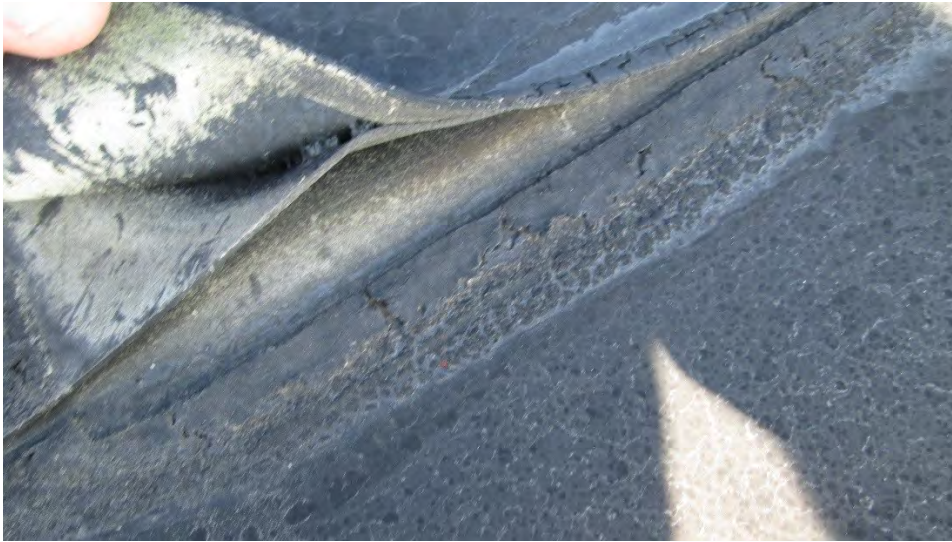
Photograph No. R-11

Failed seam at Modular Housing roof.

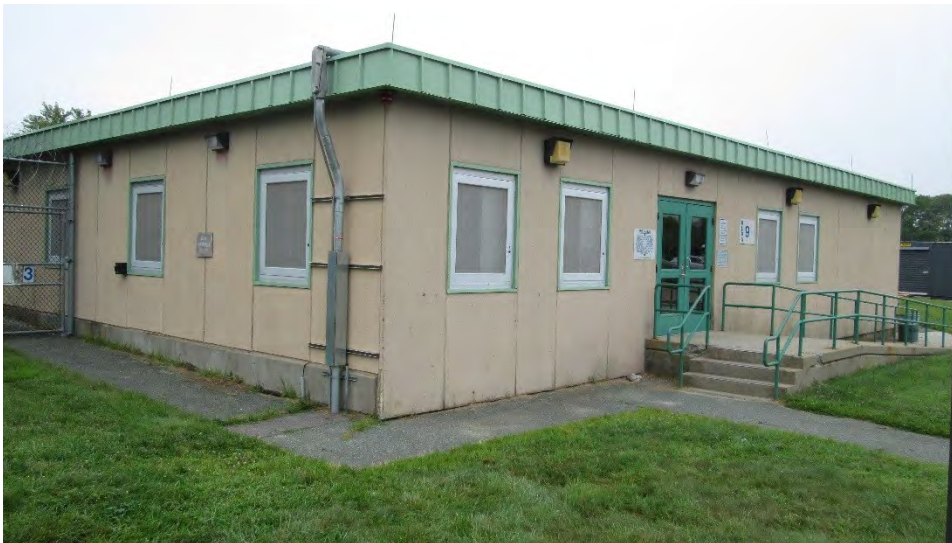
Photograph No. EX-1

Gate House building.

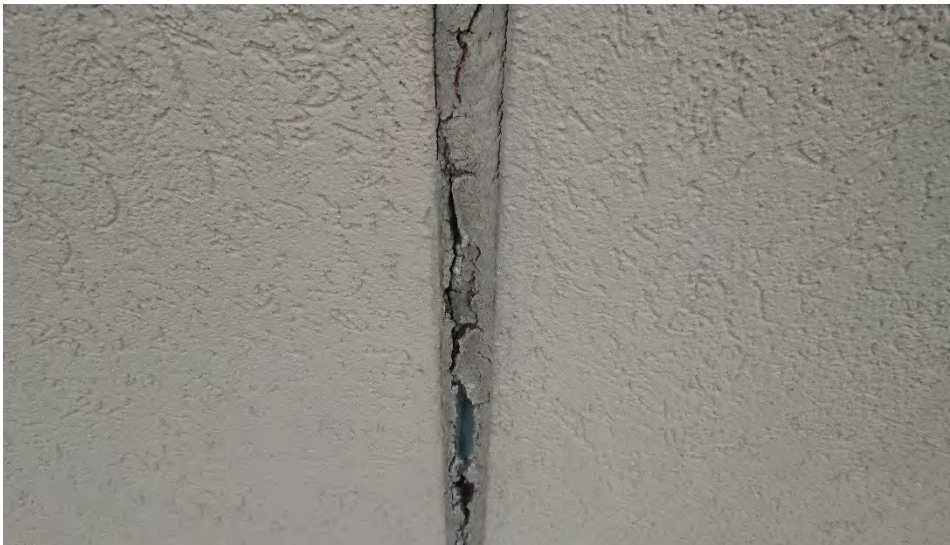
Photograph No. EX-3
Failed sealant at Gate House wall.

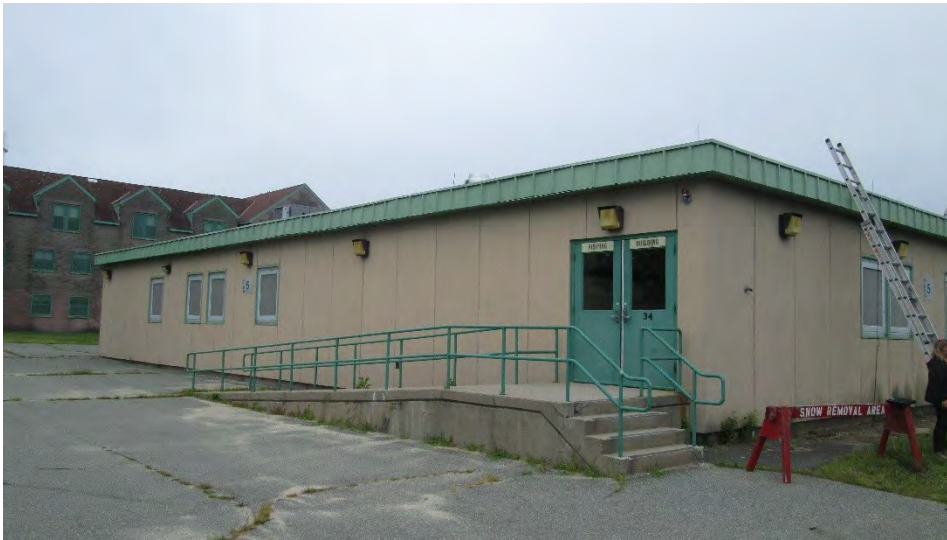
Photograph No. EX-4

Visitor building.

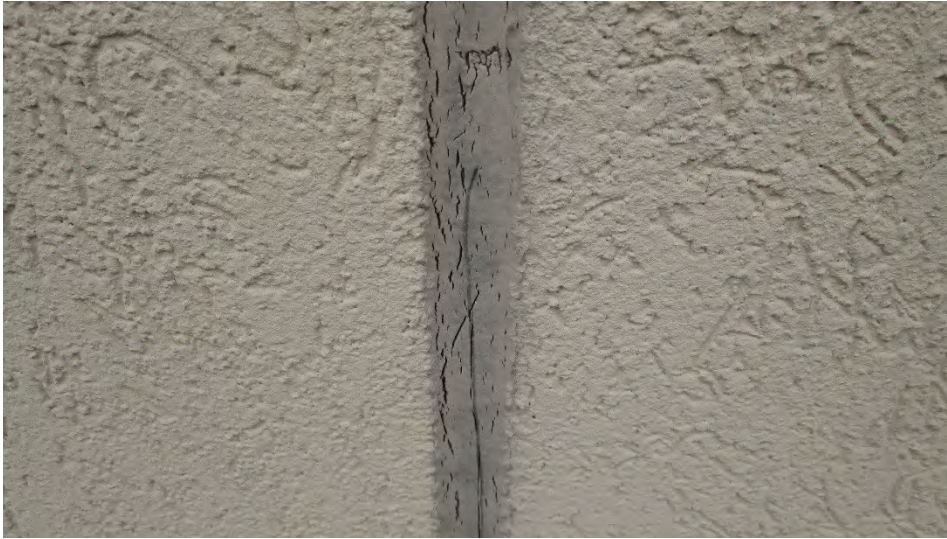
Photograph No. EX-6
Failed sealants at Visitor Building.

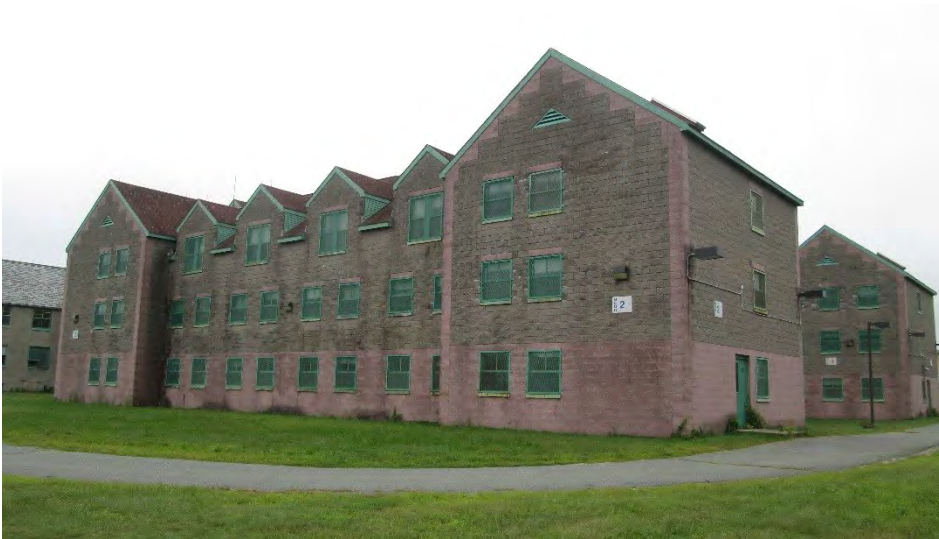
Photograph No. EX-7
Exterior of Main Housing.

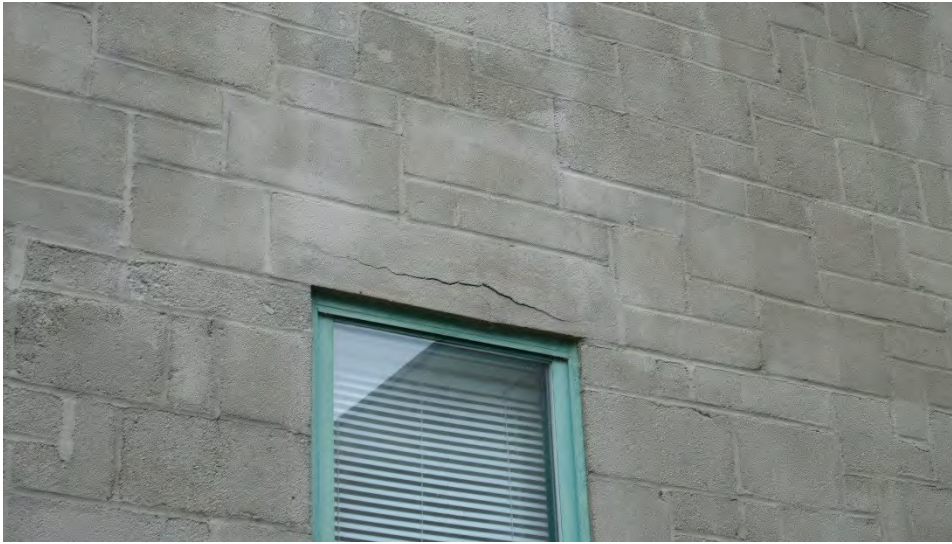
Photograph No. EX-8

Cracked lintel at
Administration Building.

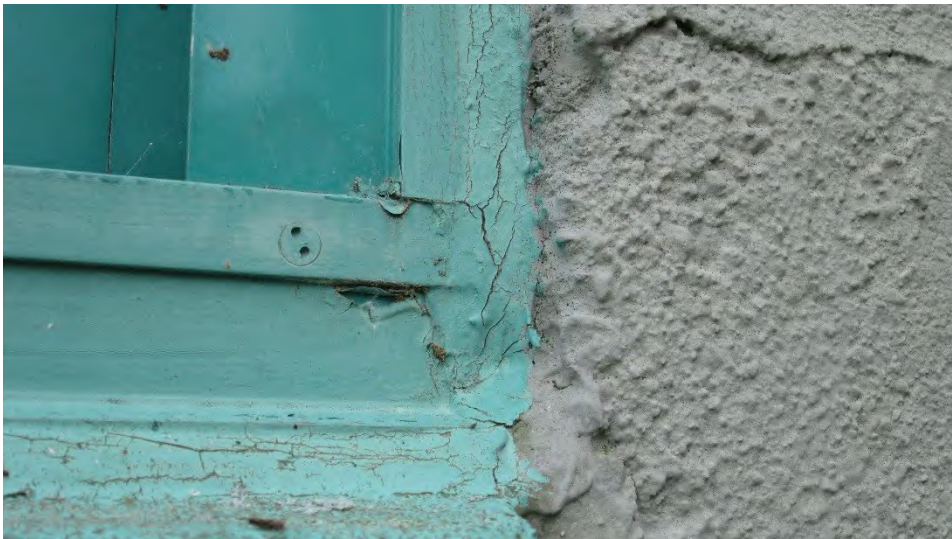
Photograph No. EX-9

Failed sealant at
Administration Building.

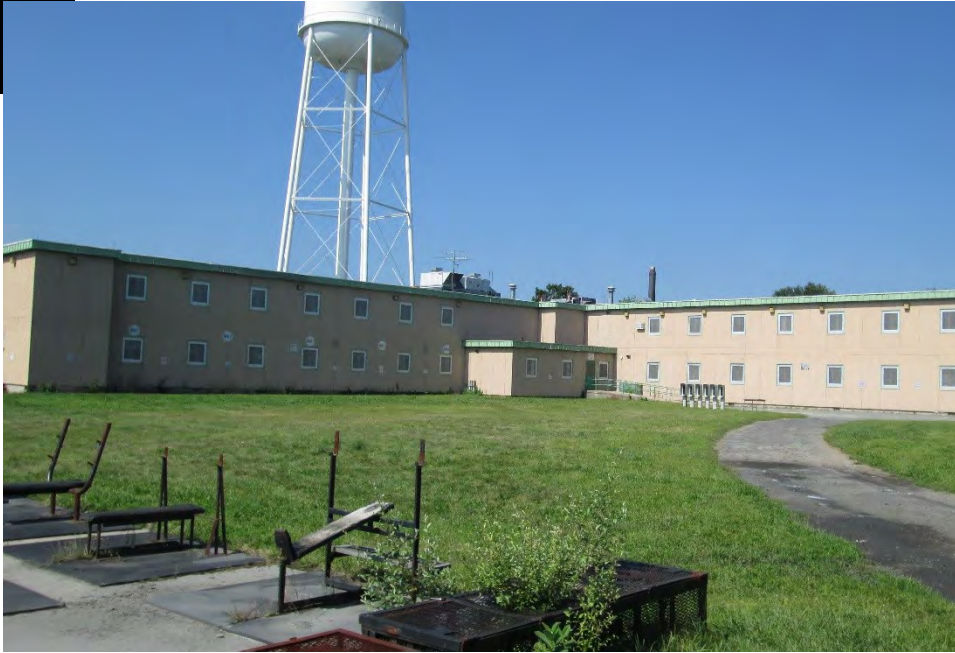
Photograph No. EX-12

Overview of Modular Housing.

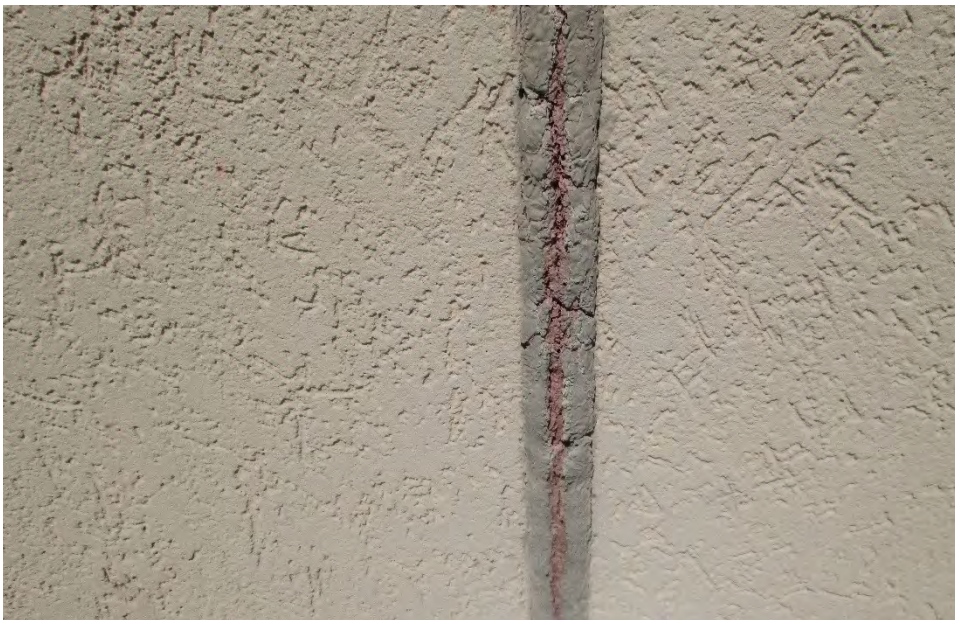
Photograph No. EX-13

Failed sealant at Modular Housing.

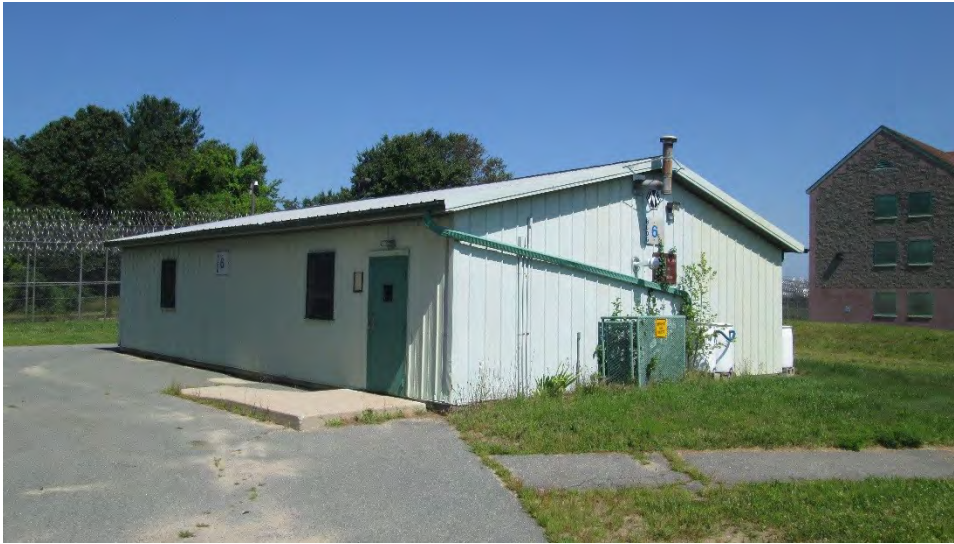
Photograph No. EX-14

Morton building.

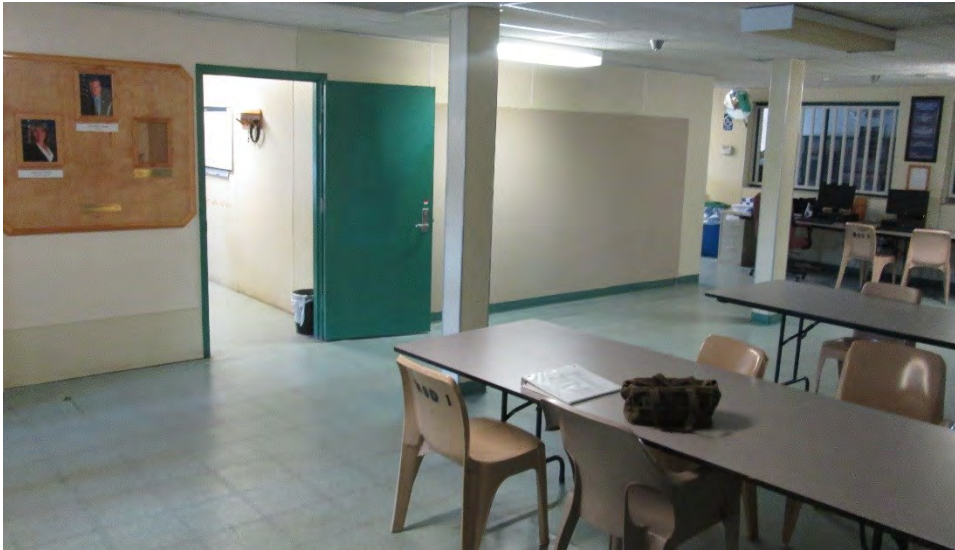
Photograph No. I-1

Interior of Gate House.

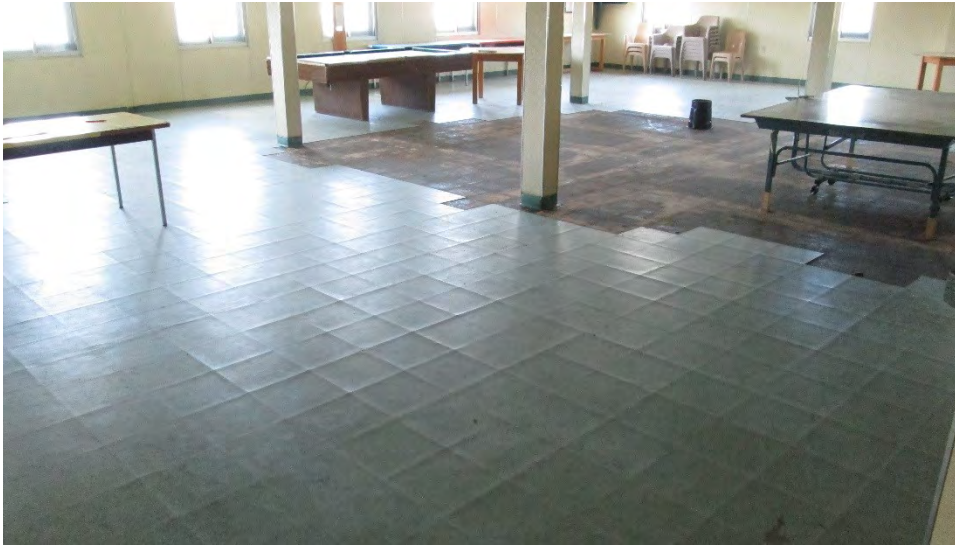
Photograph No. I-6
Failed flooring at Modular
Housing, upper level.

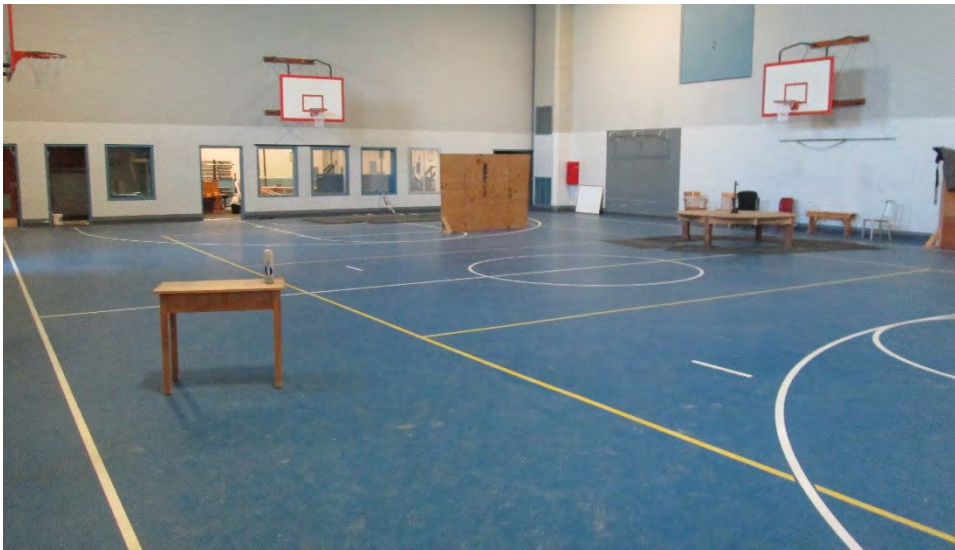
Photograph No. I-7
Gymnasium interior.

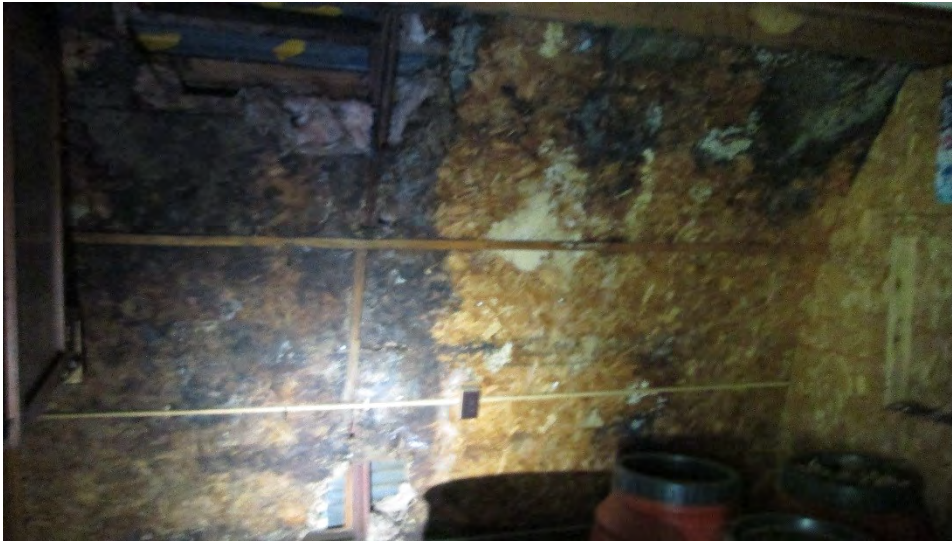
Photograph No. I-7

Failed interior wall at
Quonset Hut.

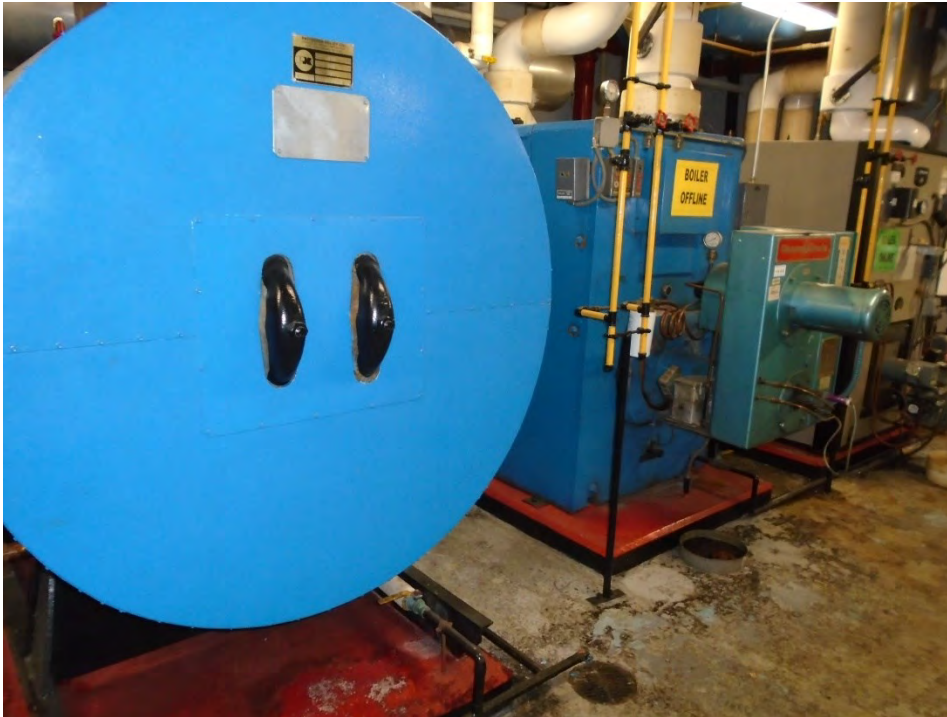
Photograph No. M-01

Boilers and hot water storage tank

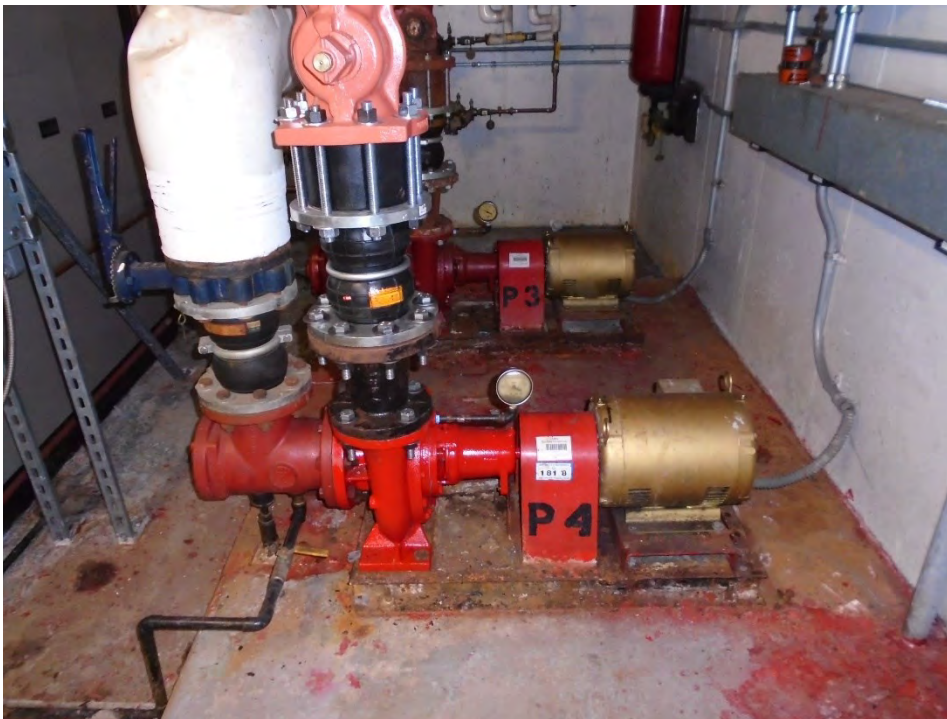
Photograph No. M-02

Heating water pumps

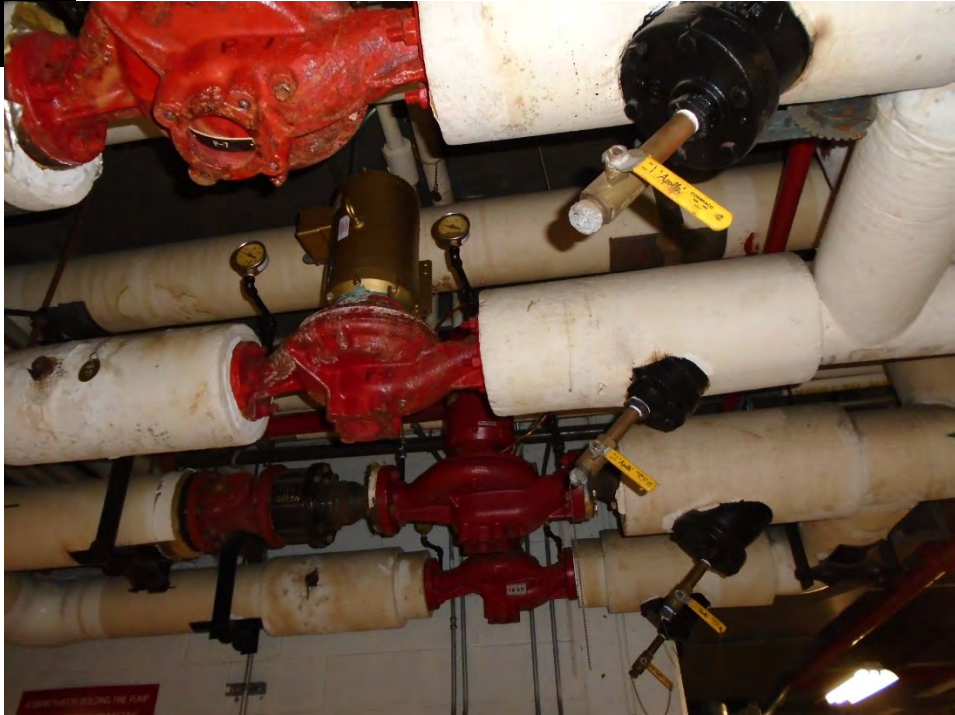
Photograph No. M-03
Heating water zone pumps

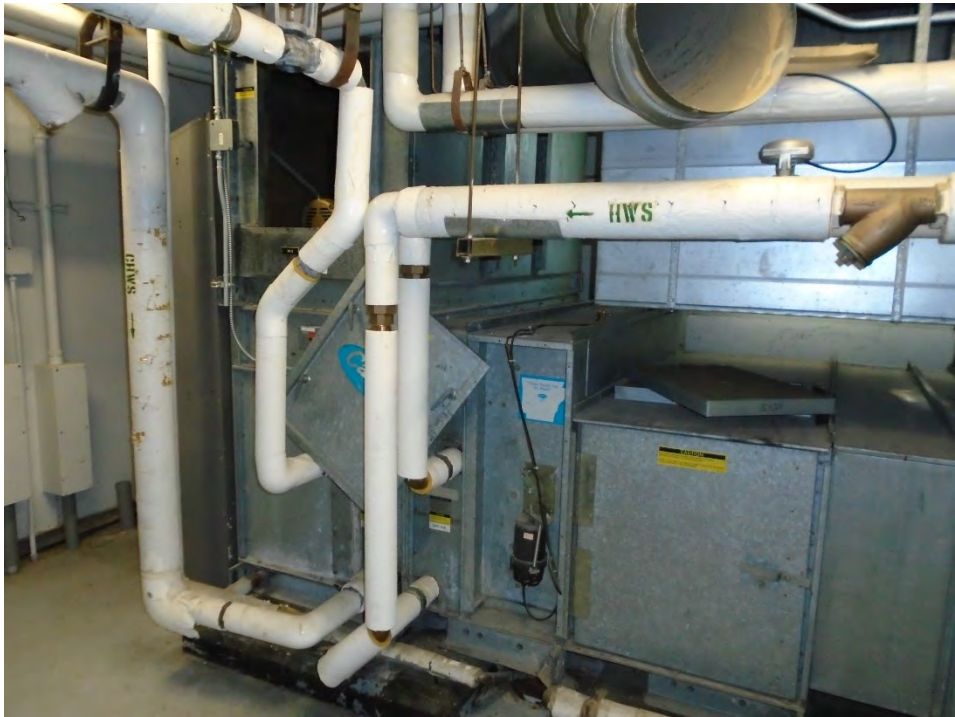
Photograph No. M-04
Central station air handling unit with chilled water coils serving the Administration office areas

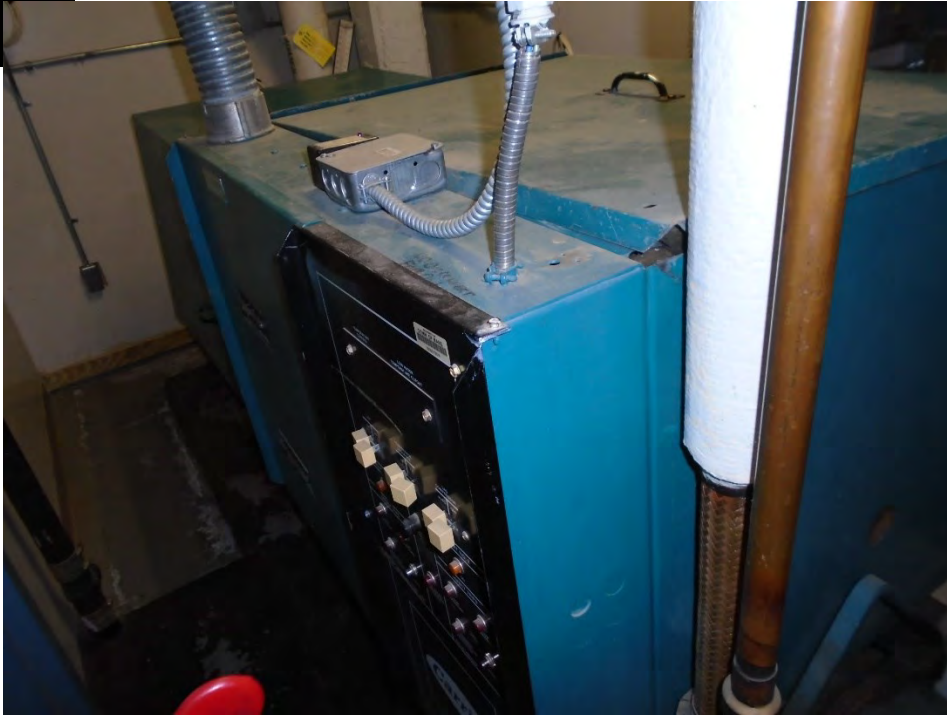
Photograph No. M-05

Carrier reciprocating
chiller (1988 vintage)

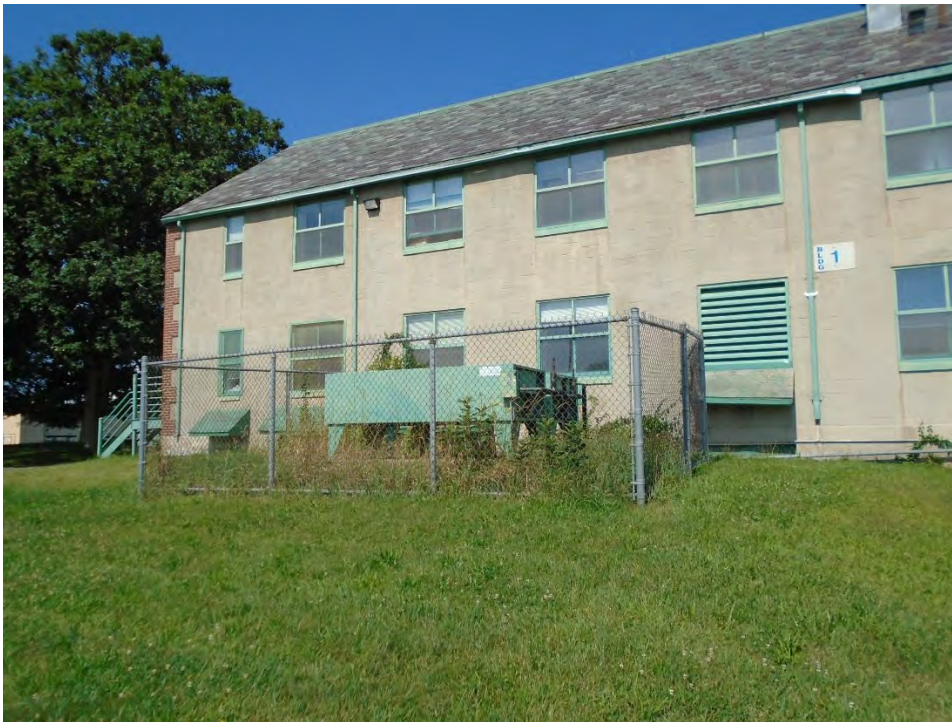
Photograph No. M-06

Air-cooled condenser

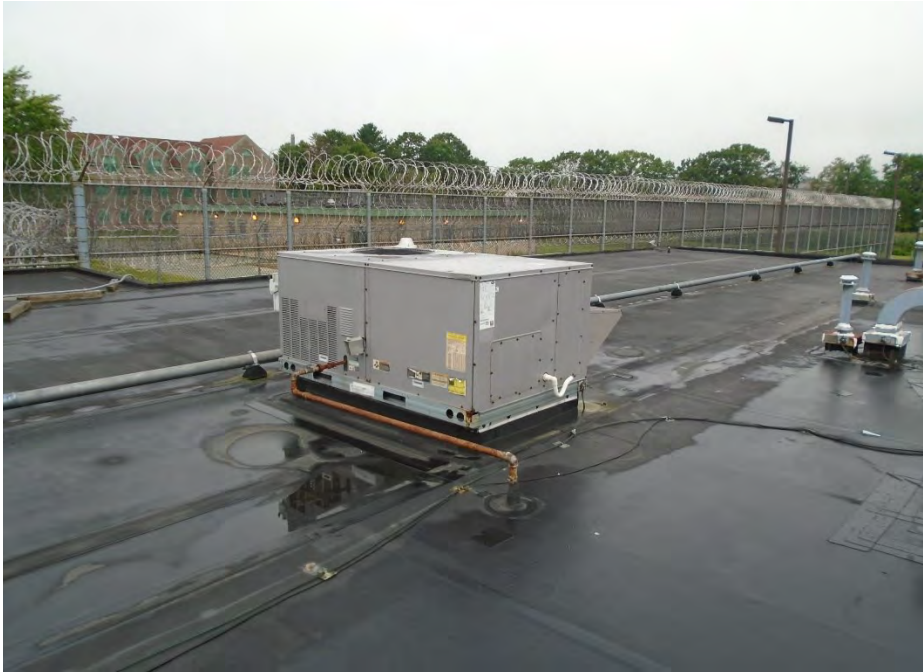
Photograph No. M-07

Gate House packaged rooftop air conditioning unit

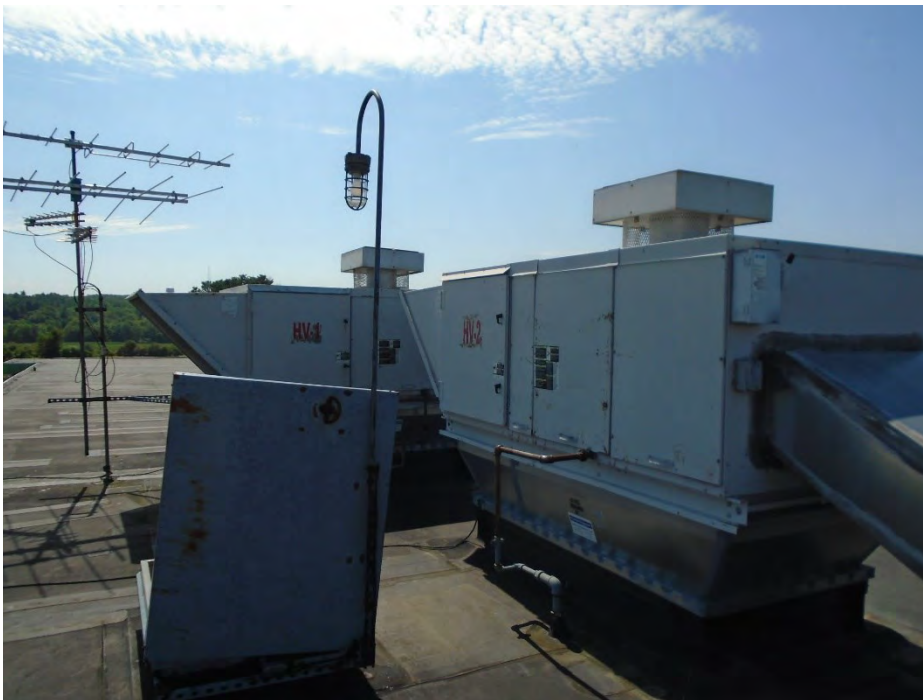
Photograph No. M-08

Modular Housing gas-fired furnaces

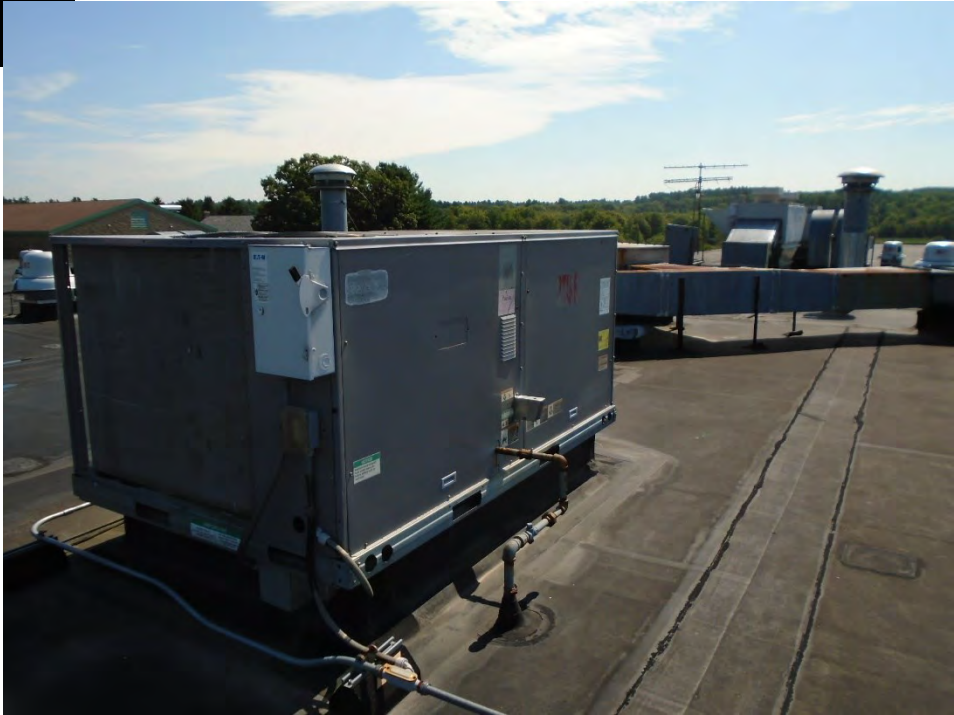
Photograph No. M-09

Modular Housing
packaged rooftop air
conditioning unit

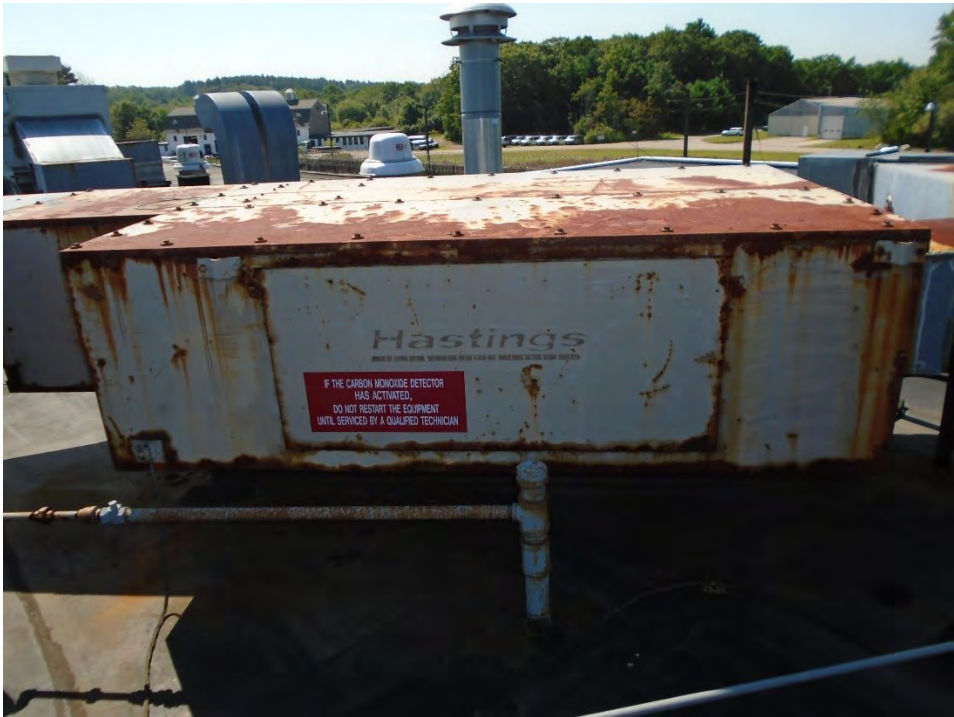
Photograph No. M-10

Original gas-fired furnace
serving Modular Housing

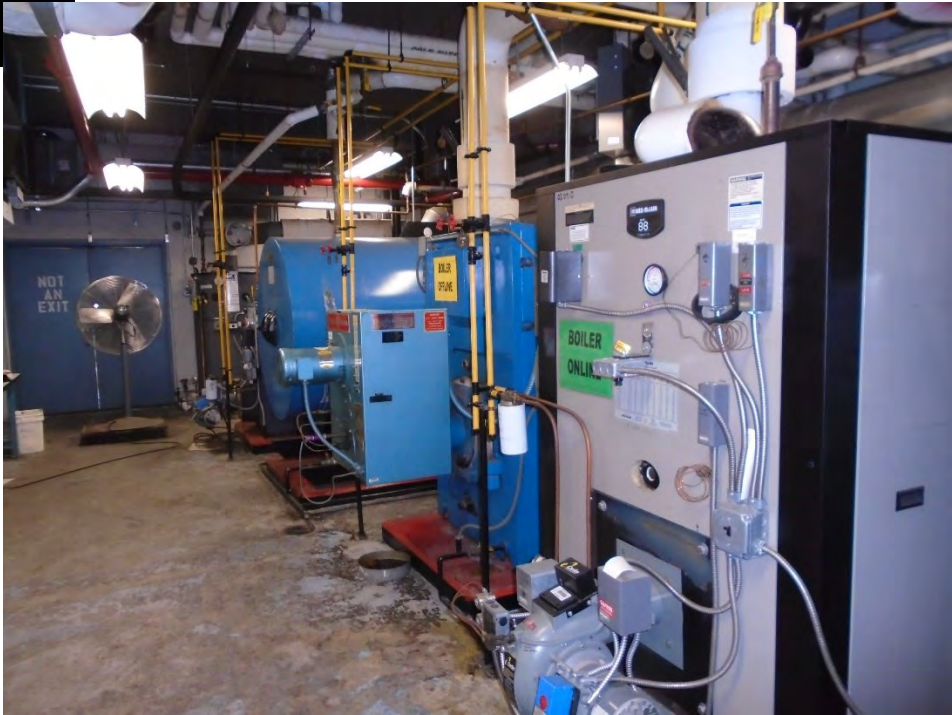
Photograph No. M-11
Heating water boilers
