Report of
Facility Condition Assessment

Bay State Correctional Center
28 Clark Street
Norfolk, Massachusetts 02056

September 29, 2019

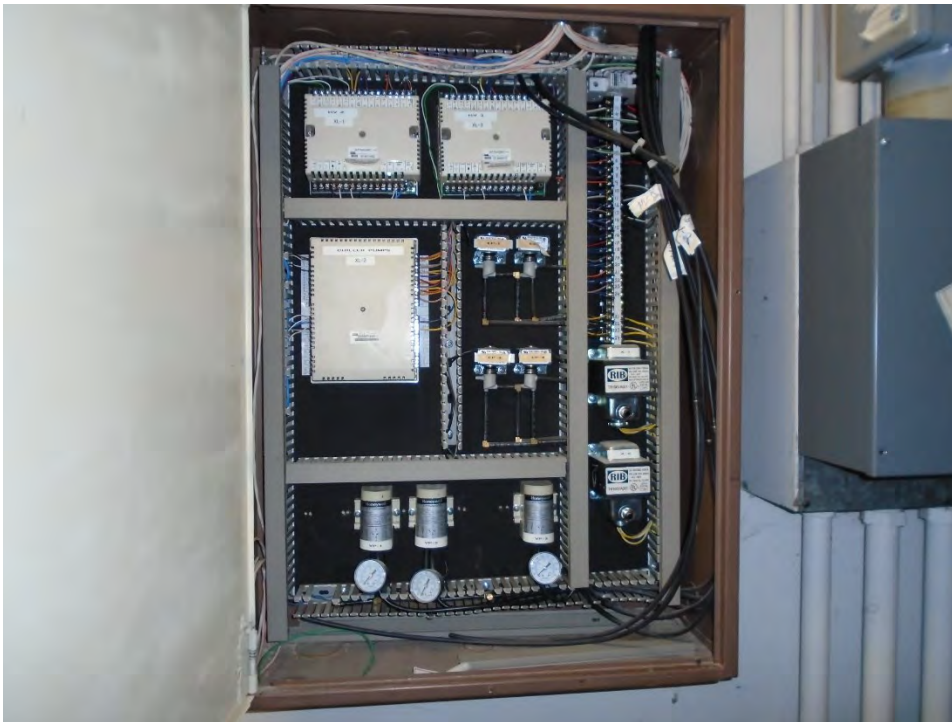
Photograph No. M-12
Hybrid Pneumatic / Digital
HVAC system controls

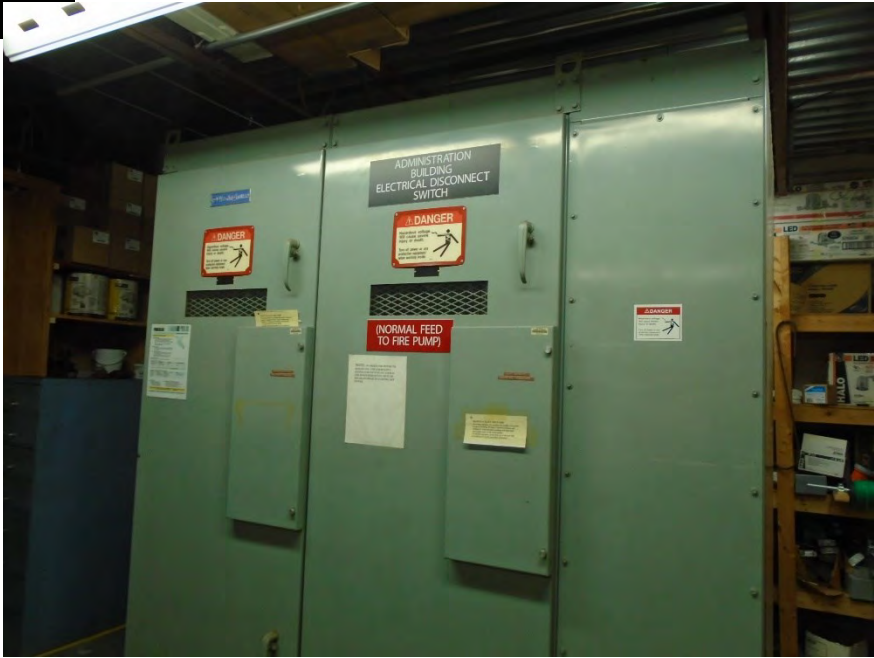
Photograph No. E-01

4,160-volt service disconnects

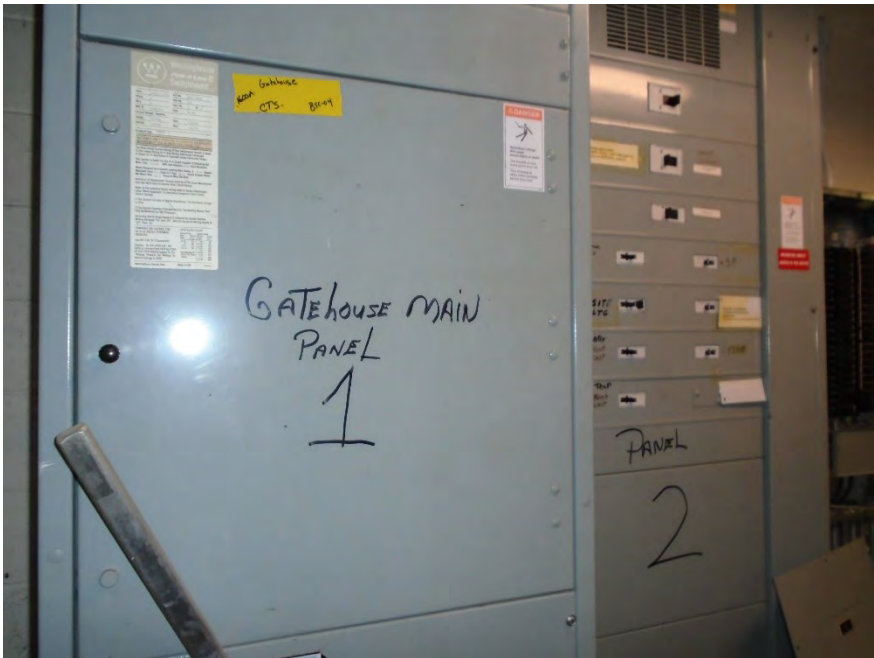
Photograph No. E-02

Gate House primary electrical service (subfeeds 1990's expansion effort)

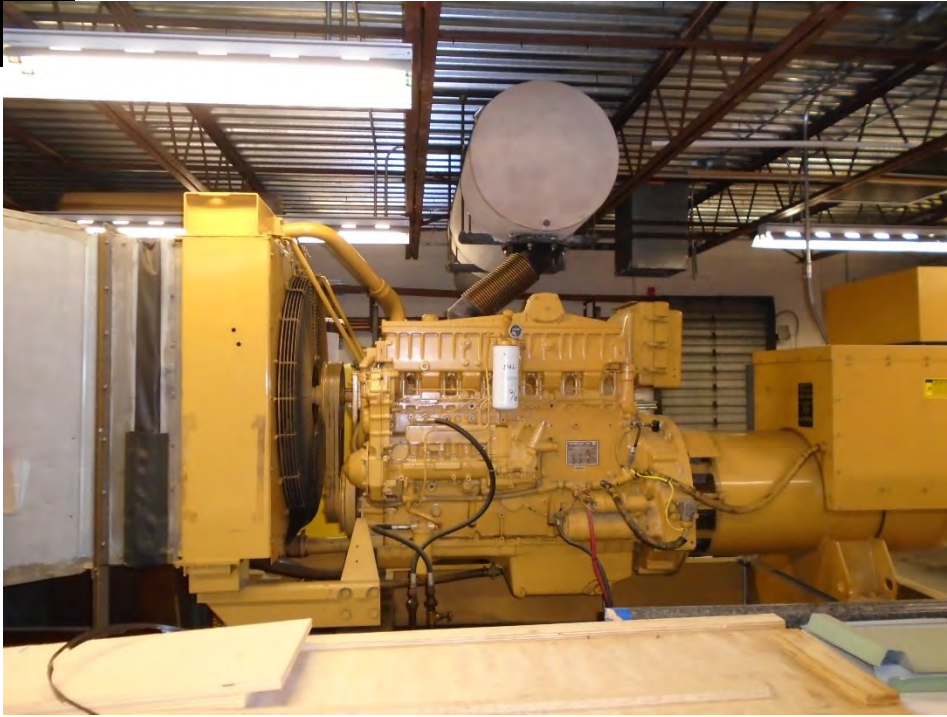
Photograph No. E-05
350-kilowatt diesel generator (Modular Housing, Visitor Building, Gate House, Morton)

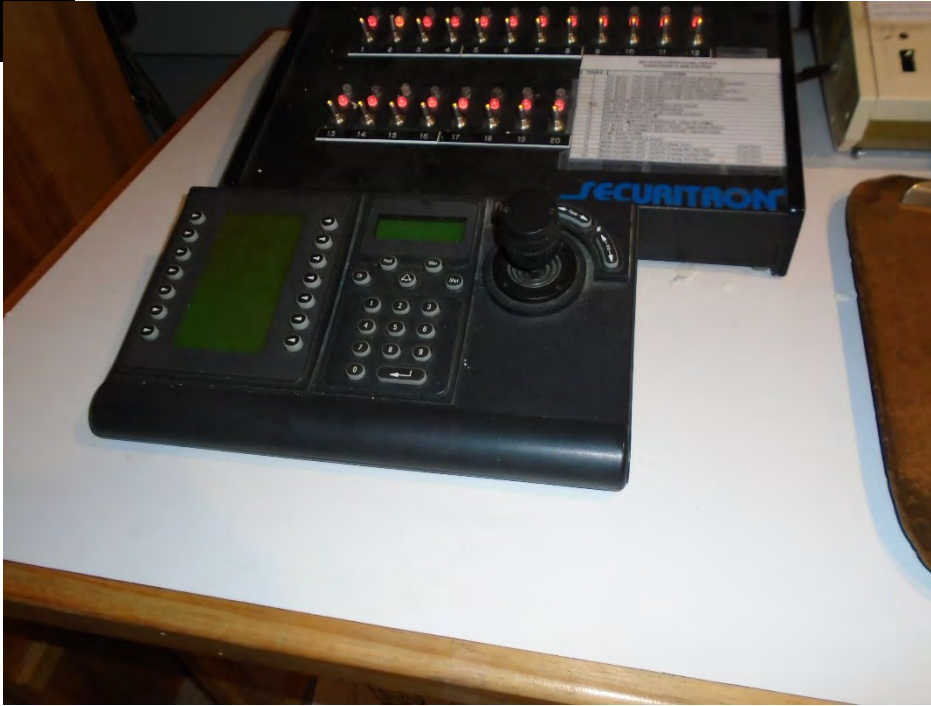
Photograph No. E-07

Door alarm control panel and Bosch CCTV camera controls

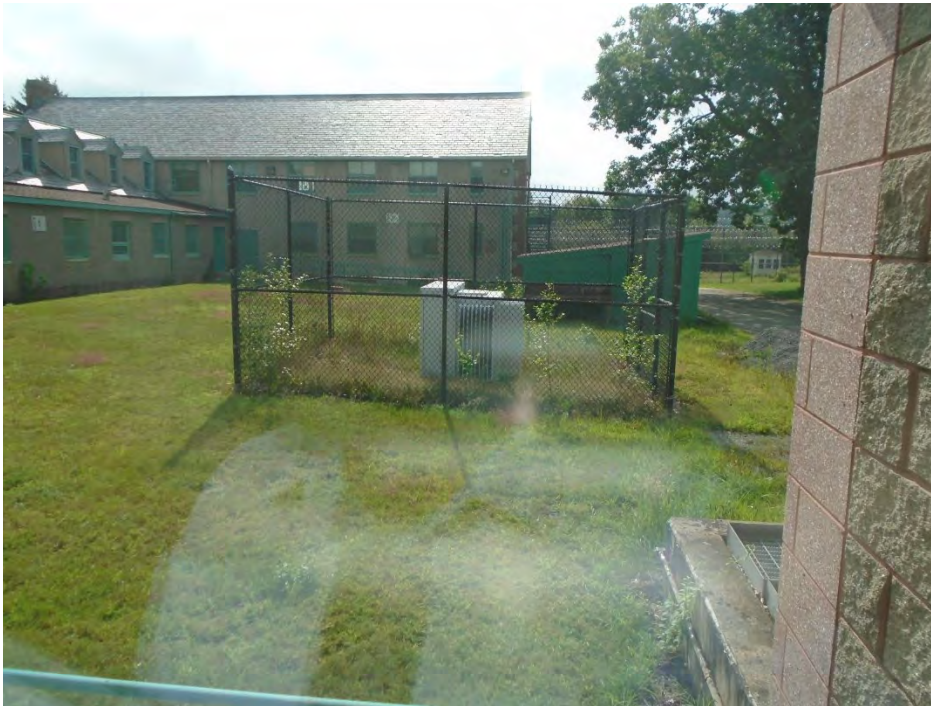
Photograph No. E-08

Pad mounted electrical service transformer

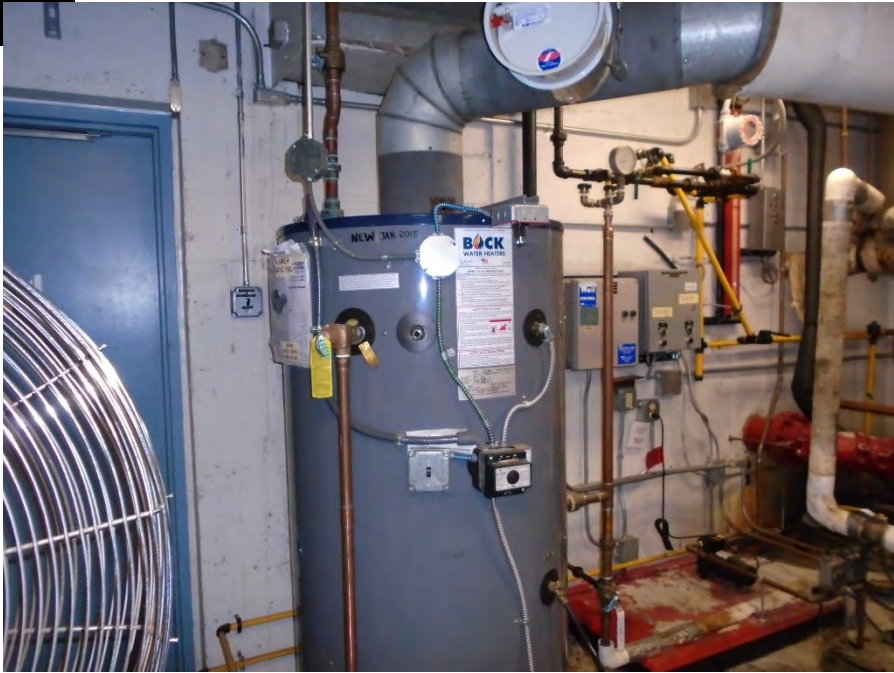
Photograph No. P-01

Kitchen water heater

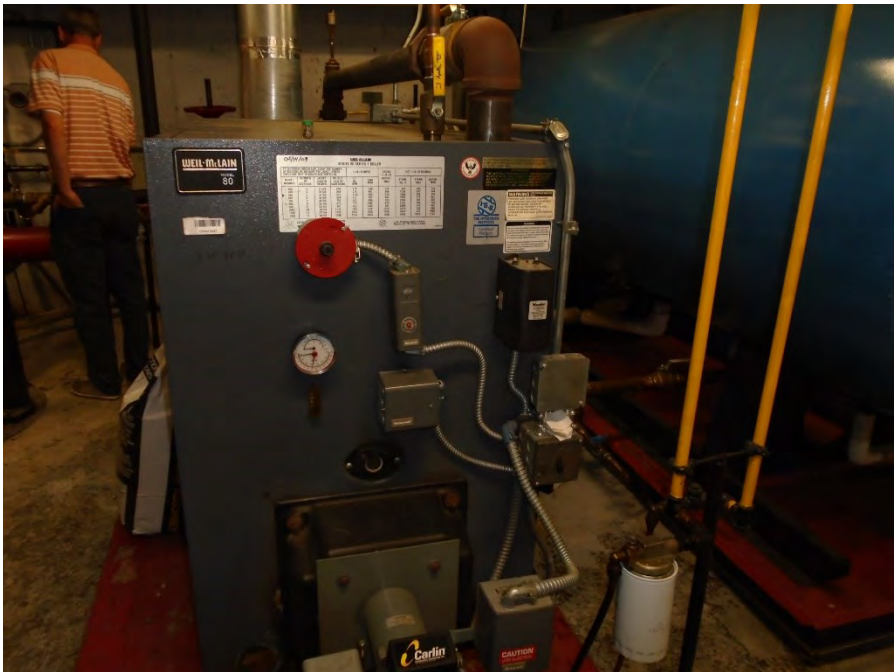
Photograph No. P-02

Main Housing /
Administration domestic
hot water boiler

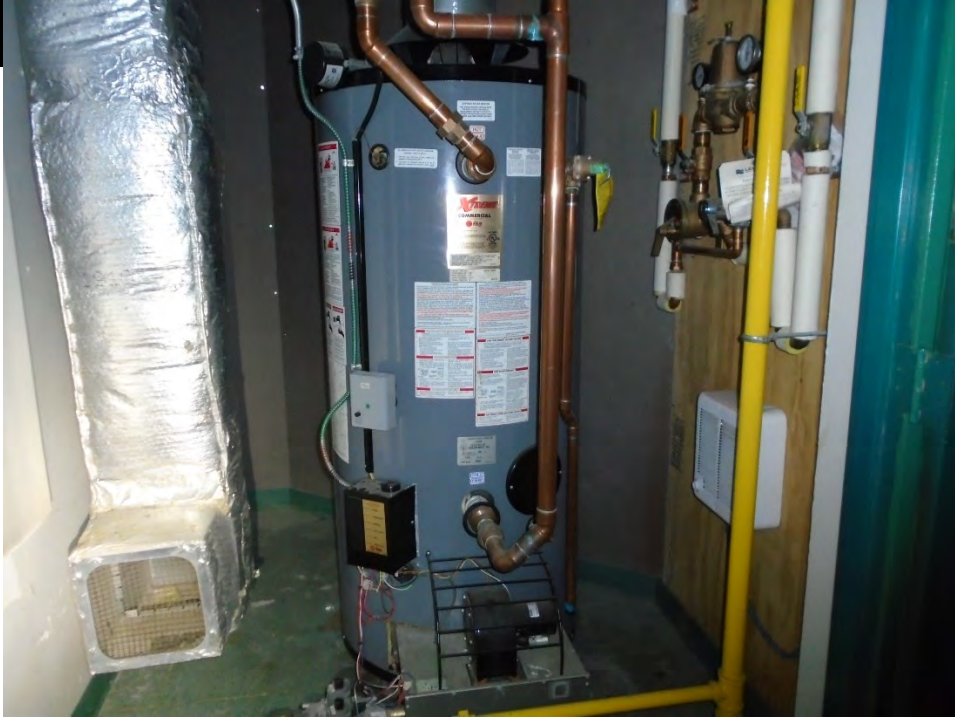
Photograph No. P-03
Typical modular housing
domestic water heater

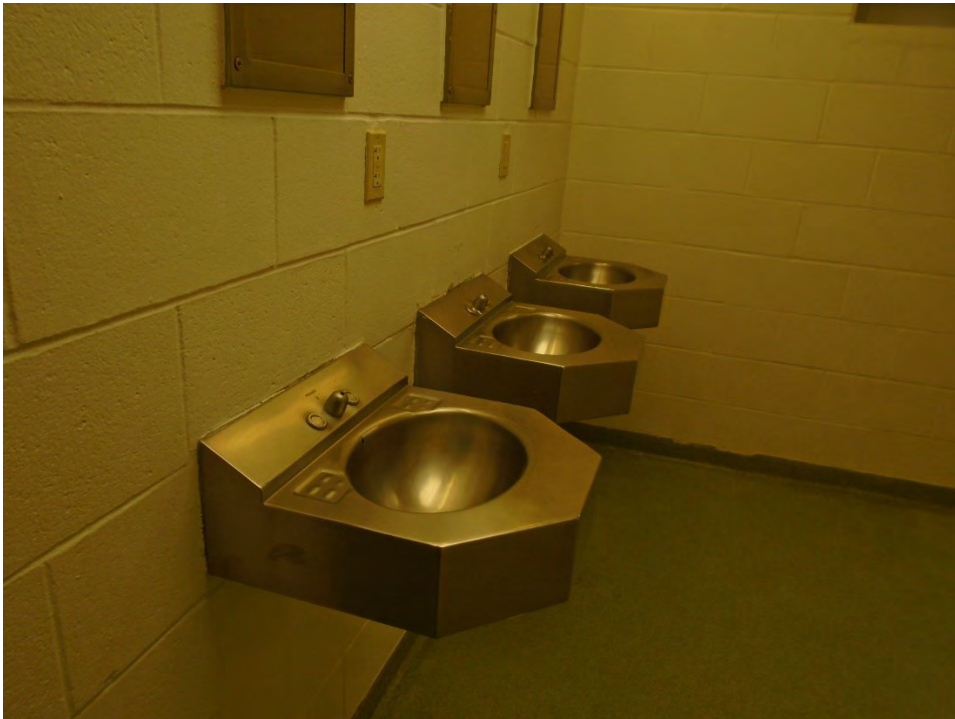
Photograph No. P-04
Typical correctional grad
plumbing fixtures

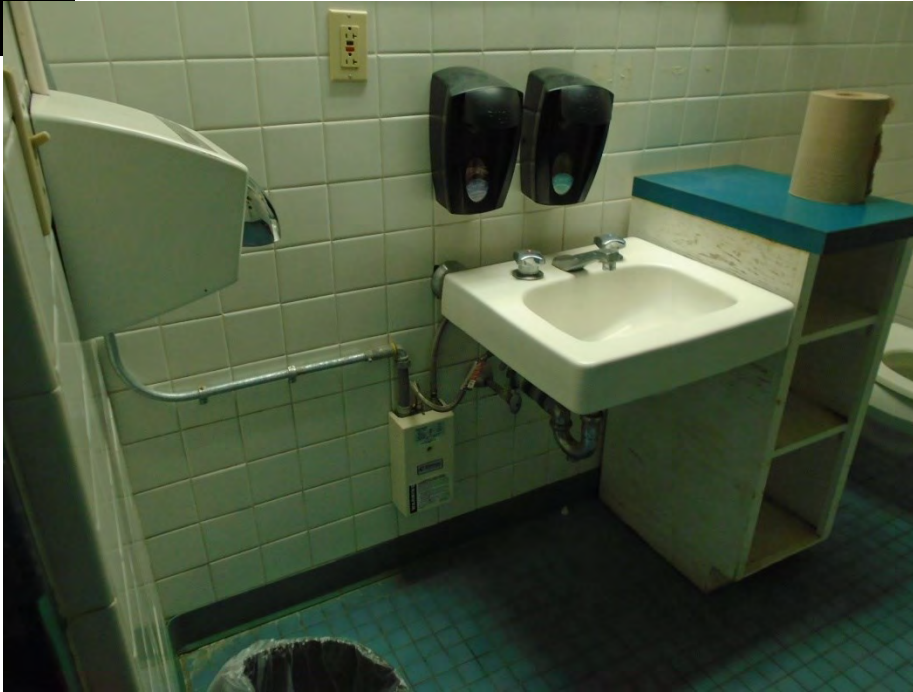
Photograph No. P-05

Typical Staff Restroom
Fixtures and Finishes

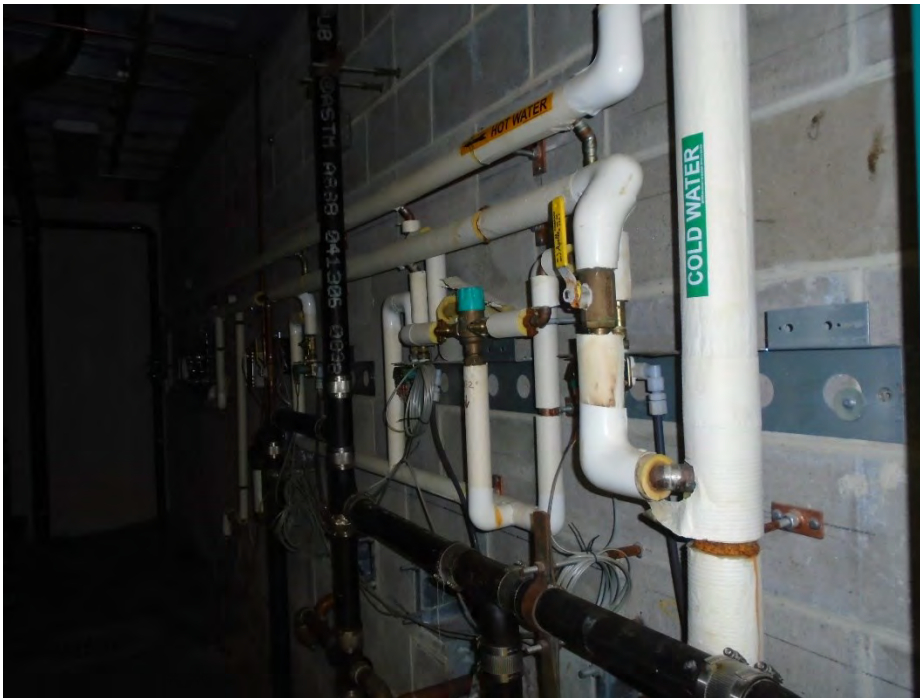
Photograph No. P-06

Modular housing plumbing
chase

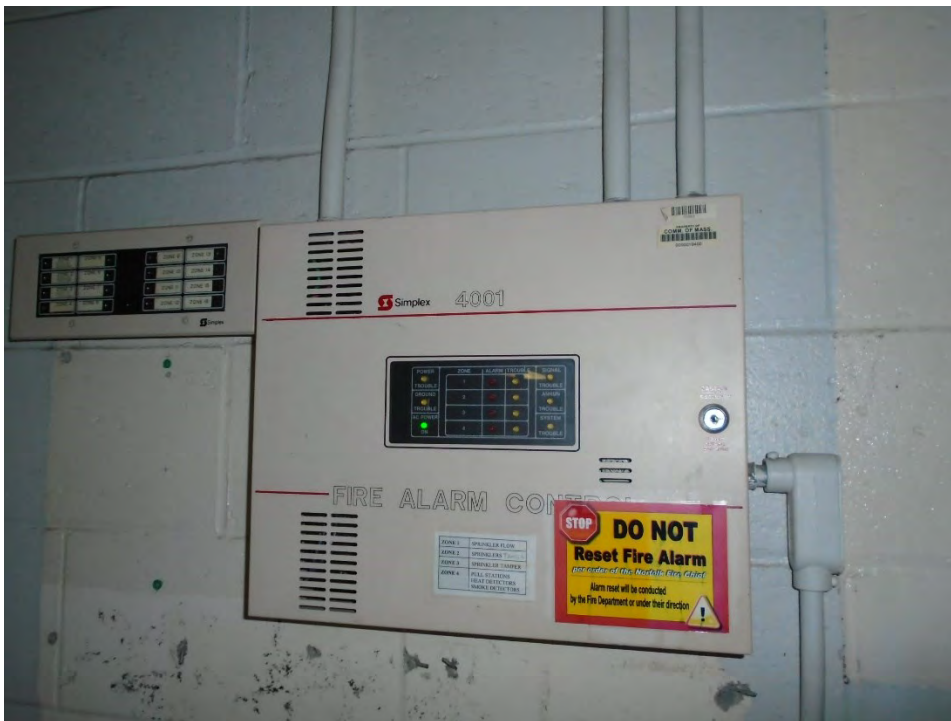
Photograph No. FLS-02

Fire Alarm Control Panel
(Gate House)

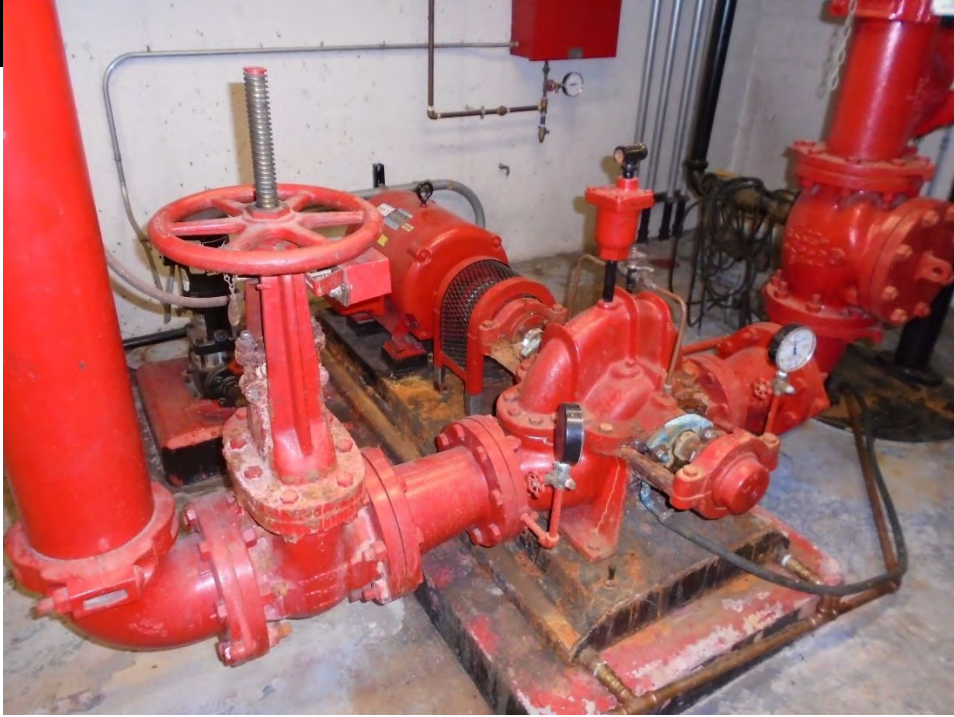
Photograph No. FLS-03
Electric fire pump
