**Report of**  
**Facility Condition Assessment**  
South Middlesex Correctional Center  
135 Western Avenue  
Framingham, Massachusetts 01702

July 26, 2019

Reference: Report of Facility Condition Assessment  
South Middlesex Correctional Center  
135 Western Avenue  
Framingham, Massachusetts 01702  
Faithful+Gould Project No. 100066196

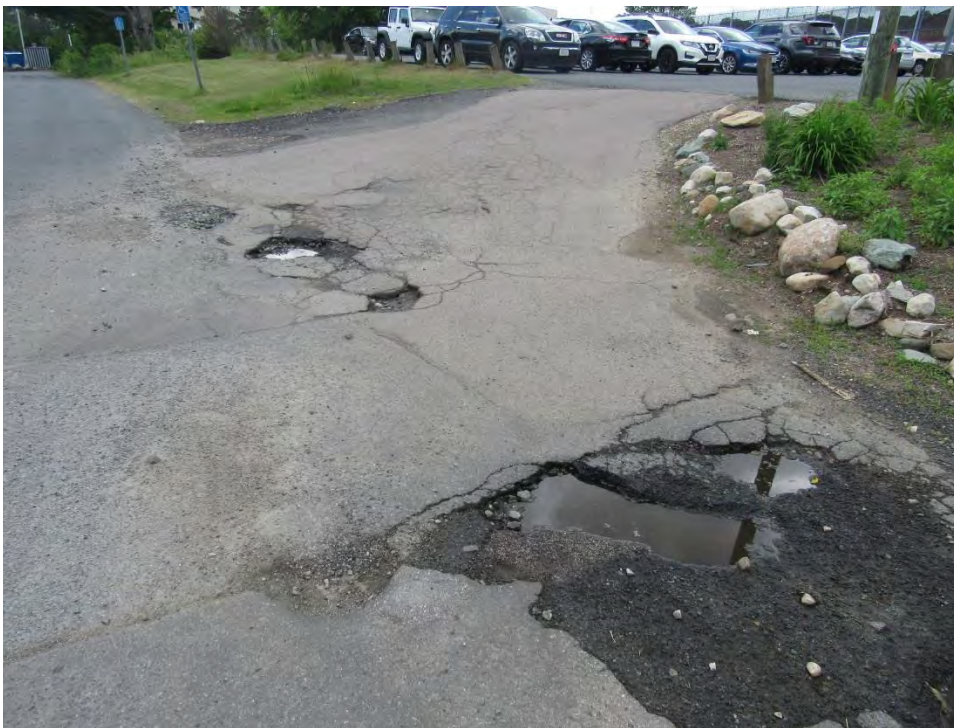
**Photograph No. ST-04**

the North, round to the side and rear of the Main Building was in fair to poor condition. We noted areas of shallow to medium depth longitudinal and transverse cracks, dissipation of the asphaltic chemicals from the wearing surface, faded surface markings, and general deterioration of the pavement wearing surface. We have recommended that the parking lot and roadways be resurfaced within the next three to five years, and subject to periodic cracking filling, seal coating and restriping on a five-year cycle thereafter.

Deterioration of Asphalt at  
Entrance to Staff Parking  
Lot

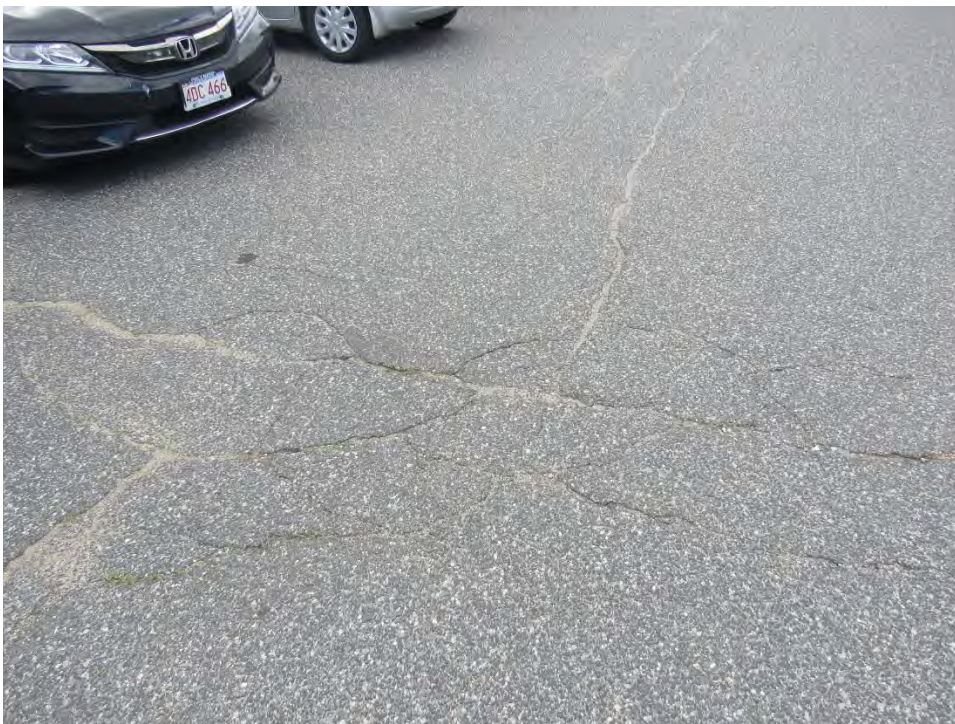
**Photograph No. ST-06**

The parking area that is reserved for staff was in fair condition. Throughout the parking lot we noted areas of shallow longitudinal and transverse cracks, general dissipation of the asphaltic chemicals from the wearing surface, faded surface markings, and at the entrance off Herring Avenue significant areas of rutting. We have recommended that the parking lot be crack filled, seal coated, restriped and areas of rutting be subject to full depth repair within the next three years, and that within the next seven to ten years the asphalt be resurfaced.

Cracks at Staff Parking Lot

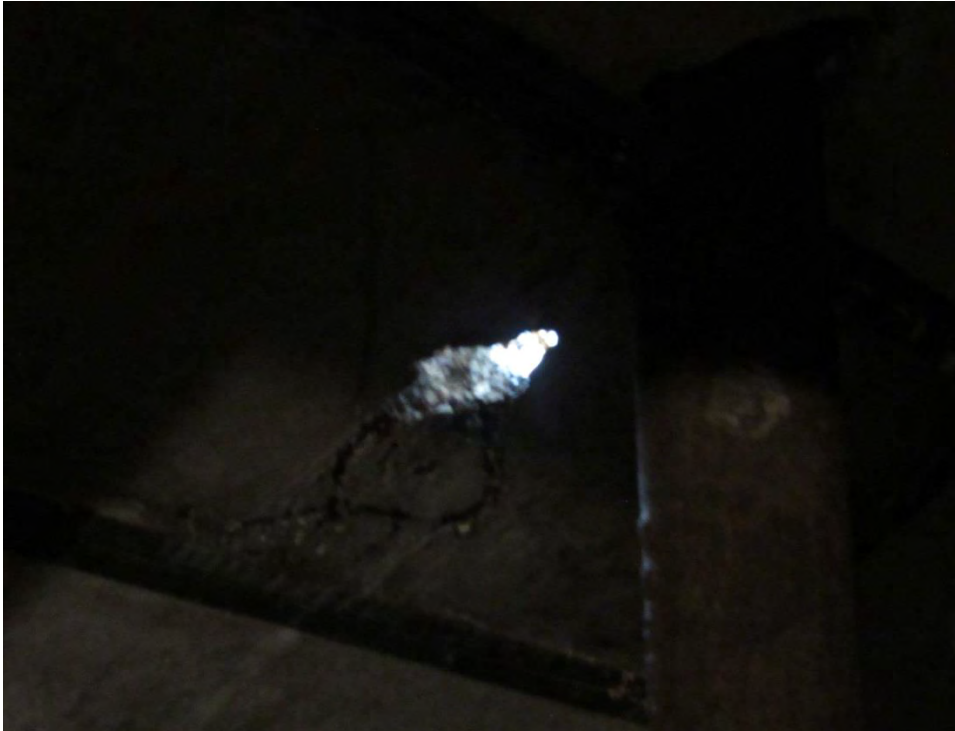
**Photograph No. R-2**

Sunlight Through Roof Deck at Main Building

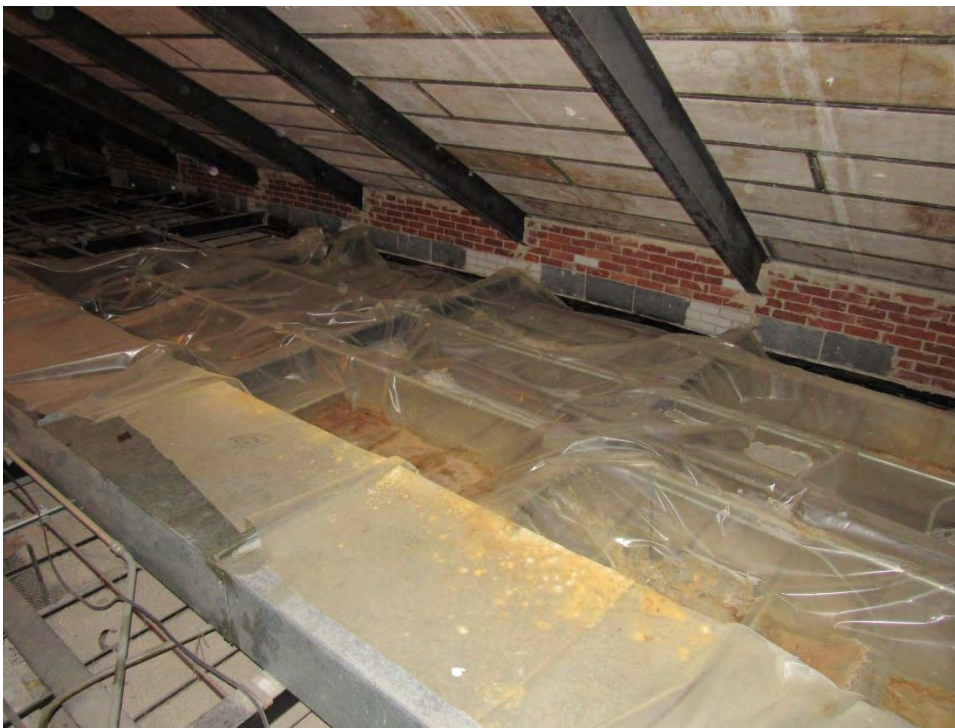
**Photograph No. R-3**

Sheeting Provided at Main Building Due to Roof Leaks

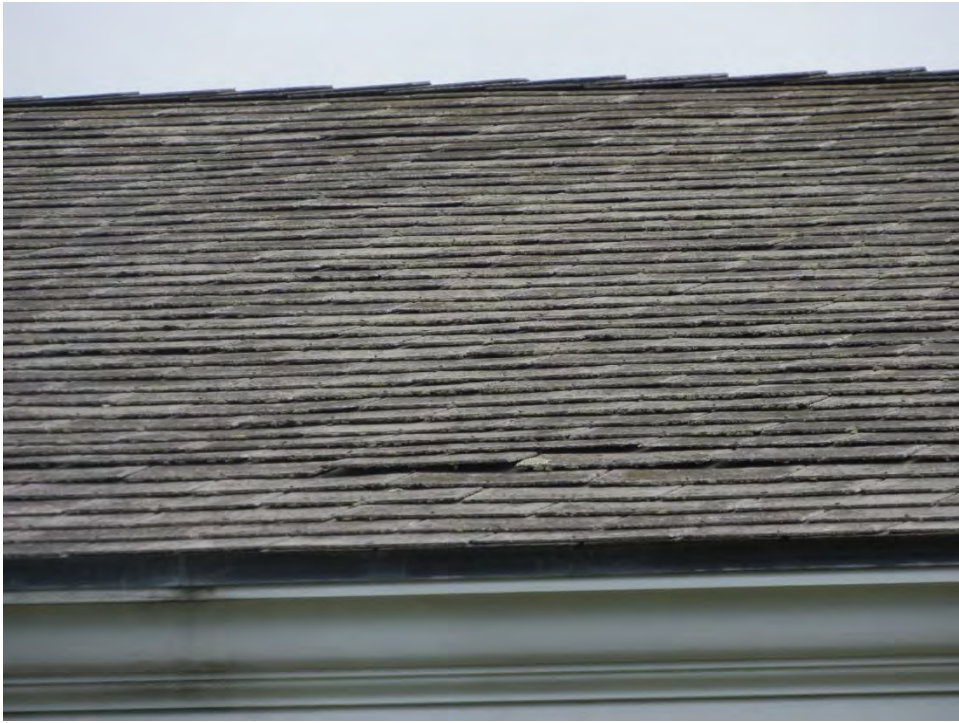
**Photograph No. R-4**

Lifting Tiles at Main Building Roof

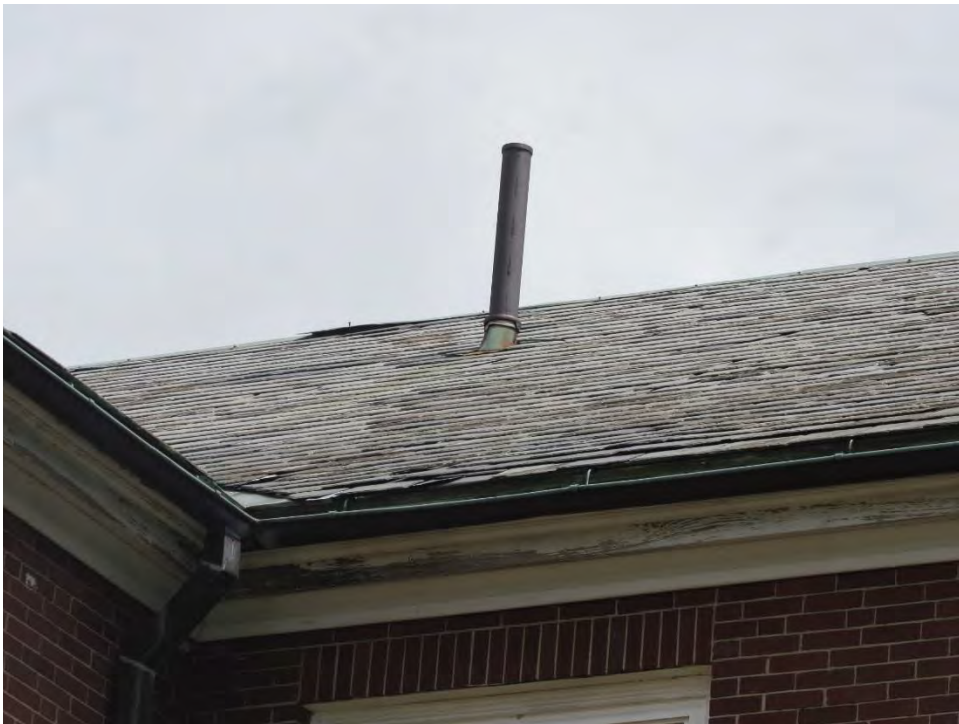
**Photograph No. R-5**

Lifting Tiles at Main Building Roof

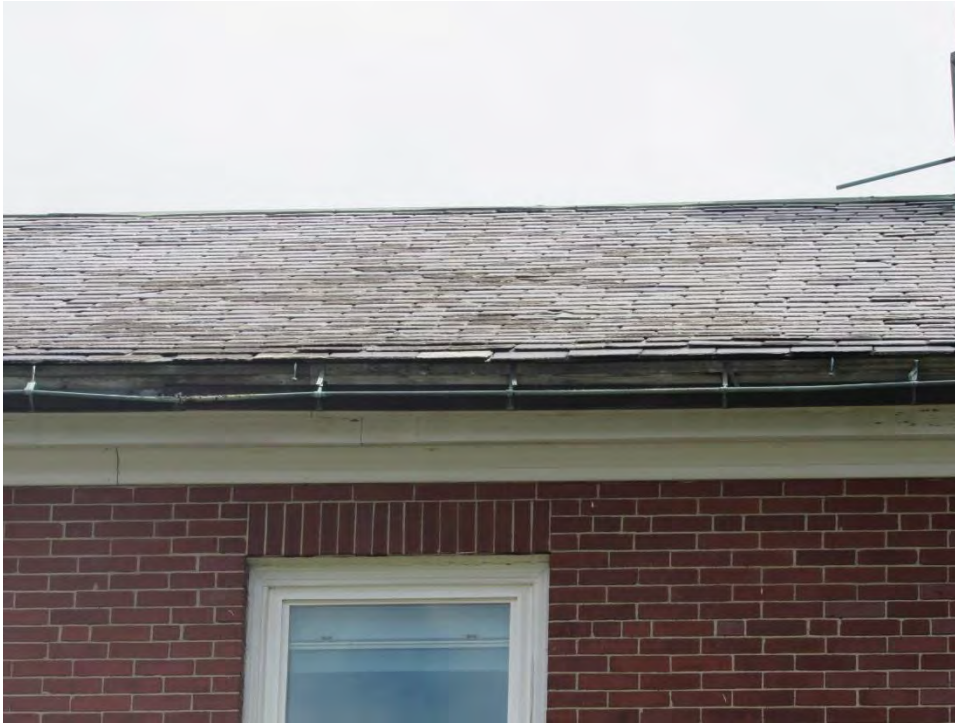
**Photograph No. R-6**

Bent Gutter at Main Building Roof

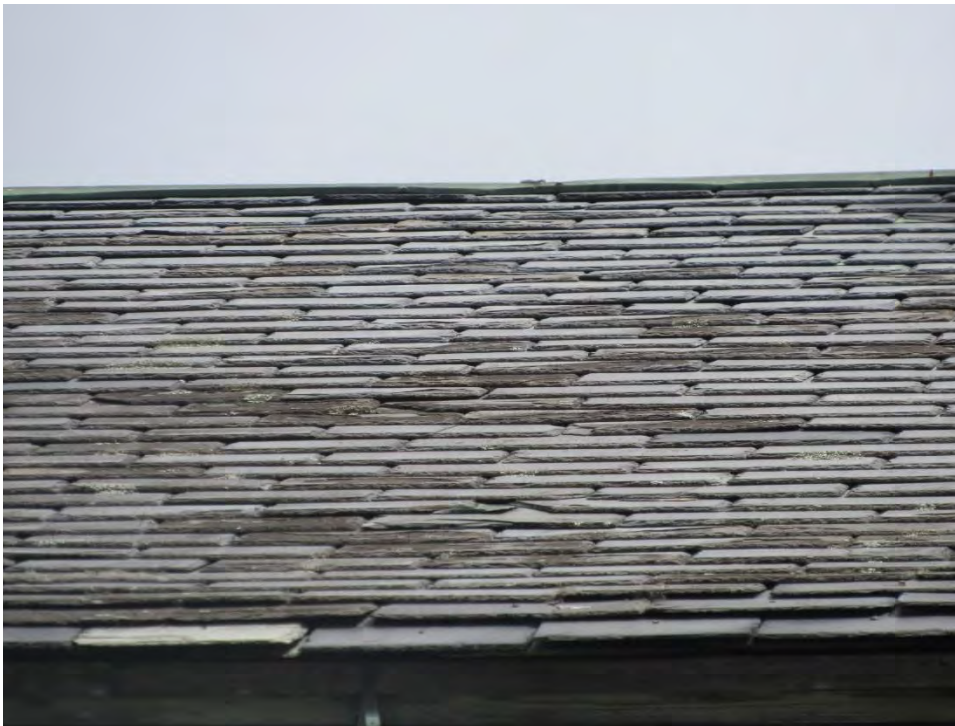
**Photograph No. R-6**

Delaminated Tiles at Main Building Roof

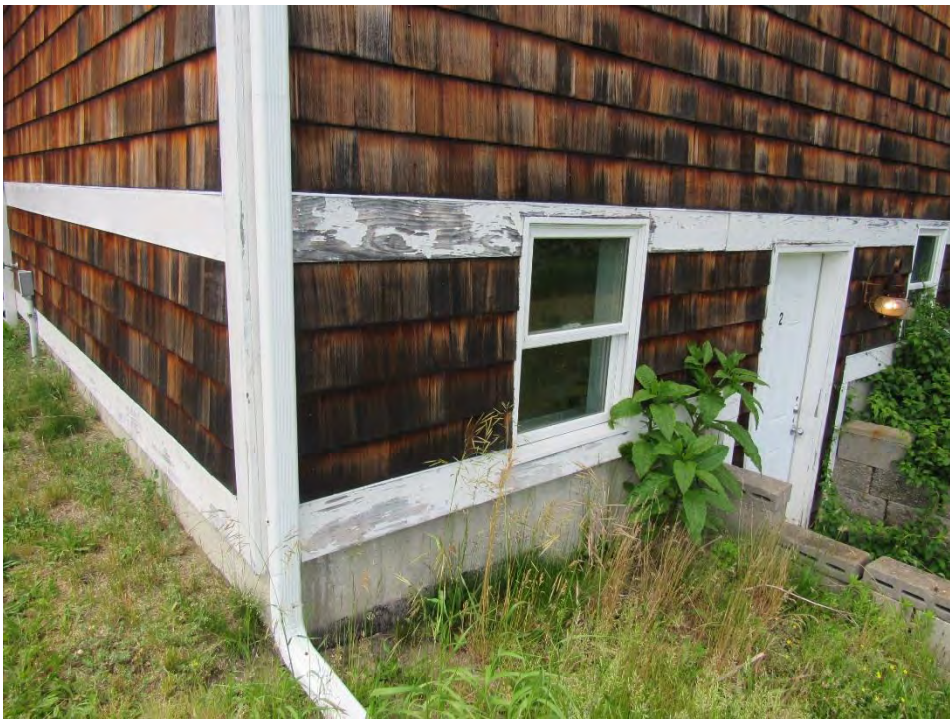
**Photograph No. EX-12**

Deteriorated Paint Cover  
at Reunification Building
