Springfield Prep Charter School

# Feasibility Study

2071 Roosevelt Ave, Springfield MA

# ACQUISITION PROPERTY CONDITION REPORT

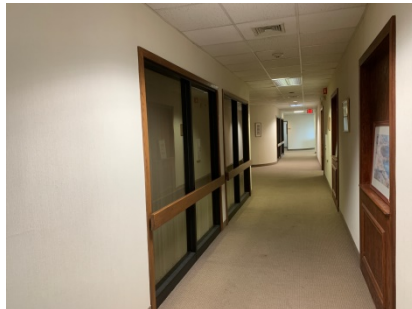
Typical interior construction.

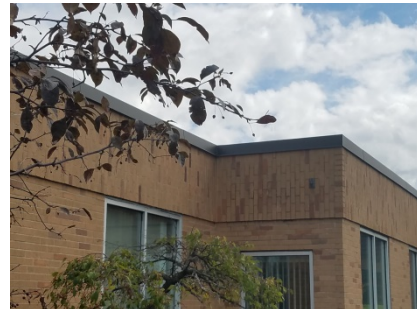
**Roof:** Single ply TPO membrane is in fair condition with evidence of ponding. Reported by owner to be 25 years old it is at the end of life expectancy.

Roof is low sloping with no parapet.

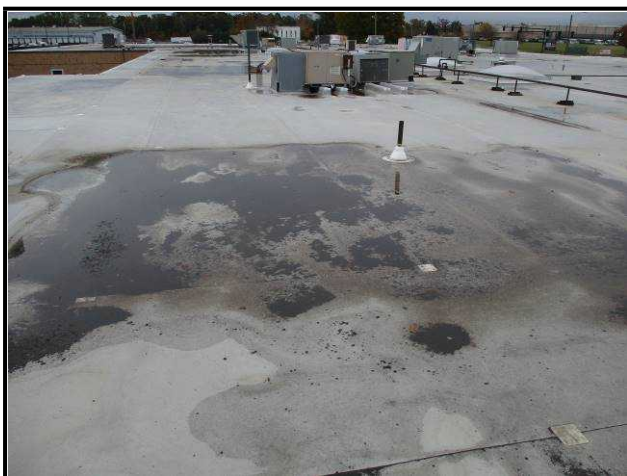
The flat roof has several roof drains, however, there was standing water observed throughout the roof area. The roof does not appear to have sufficient pitch to divert the water towards the drains.

Severe ponding was observed throughout the roof area.

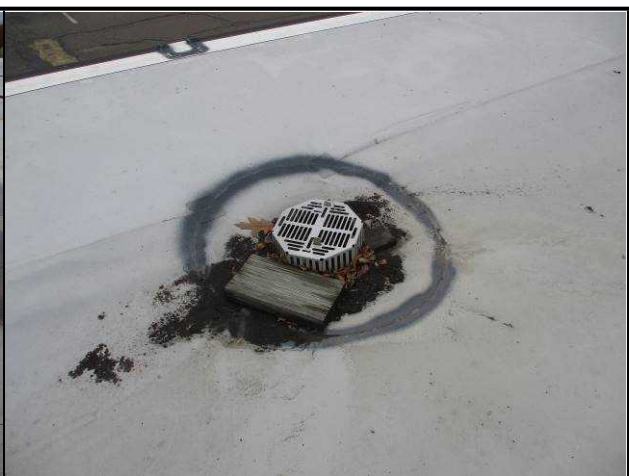
Several of the roof drains were found to be clogged with debris.

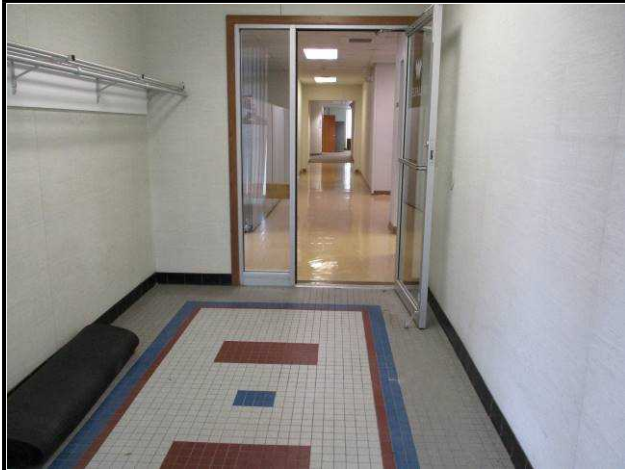
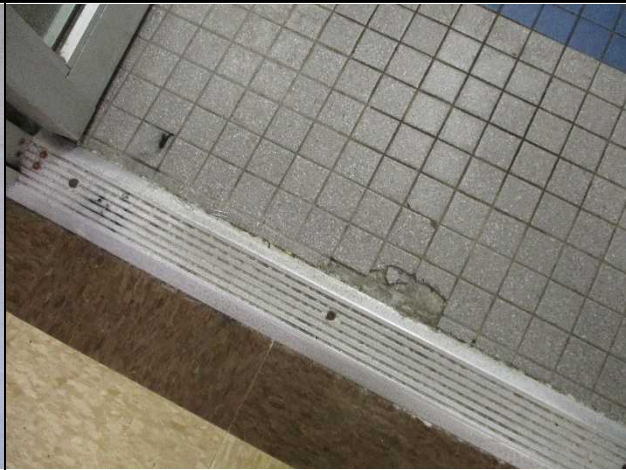
The entrance lobby and vestibule areas were found to be in generally good condition. However, cracked, damaged, and missing mosaic ceramic floor tiles were observed in several of the rear vestibules. Based on the observed conditions, Short Term Repairs are recommended to replace all cracked, damaged, or missing ceramic floor tiles.

Cracked, damaged, and missing mosaic ceramic floor tiles in several of the rear vestibules.	Cracked, damaged, and missing mosaic ceramic floor tiles in several of the rear vestibules.

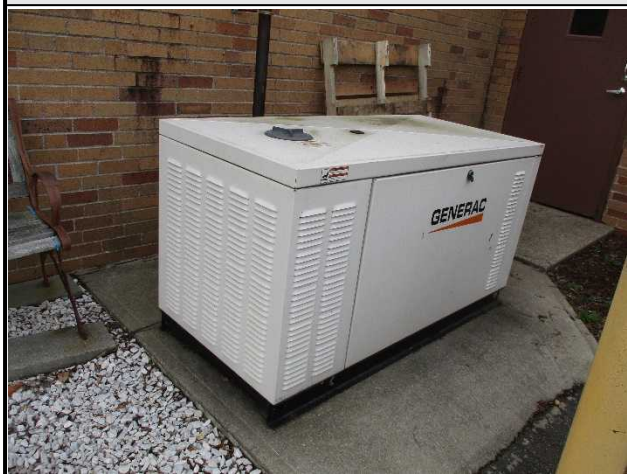
Emergency generator condition.

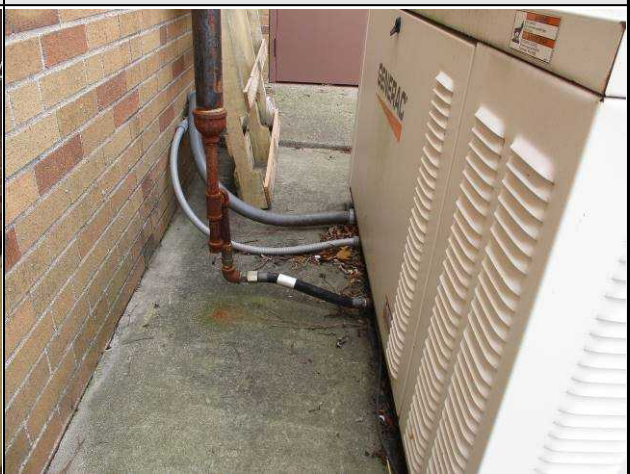
Natural gas piping to the emergency generator.

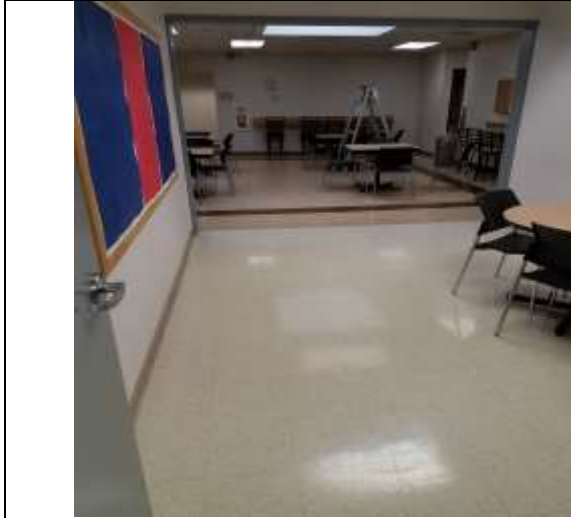
Newer floor tile in cafeteria
