**Crossing Assessment for the Sandy Neck Barrier Beach System Area  
of Critical Environmental Concern (ACEC)**

**Suggested Citation:** Duffey, S.M. and A.L. Pappal. 2019. Crossing Assessment for the Sandy Neck Barrier Beach System Area of Critical Environmental Concern (ACEC). Massachusetts Office of Coastal Zone Management, Boston, MA.

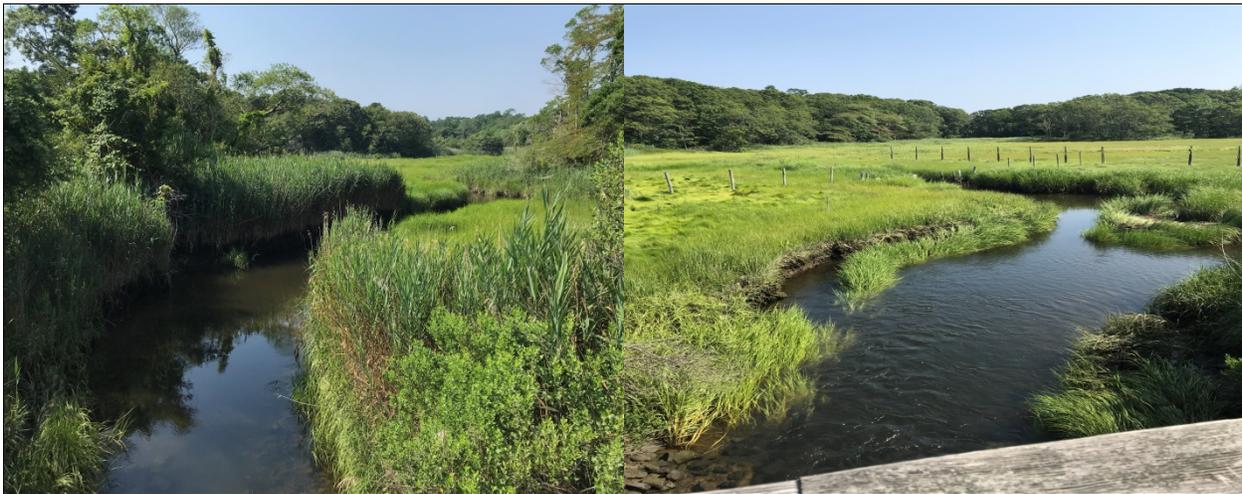
**Figure 9:** The wetland area immediately upstream of site S19. Notice the invasive common reed (*Phragmites australis*) stands along the creek bank.

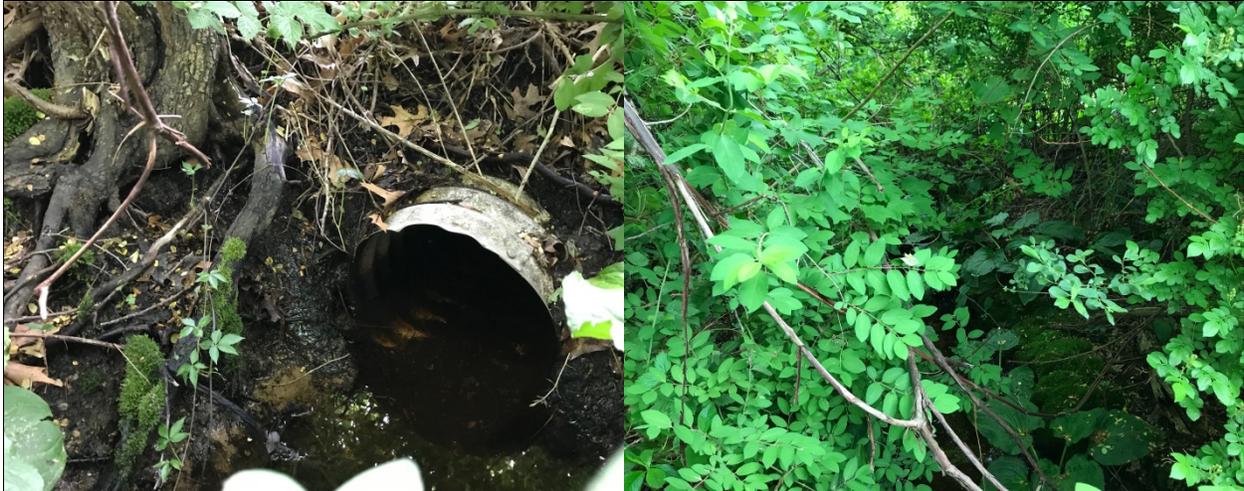
**Figure 23: The downstream corrugated metal pipe culvert at site S12.**

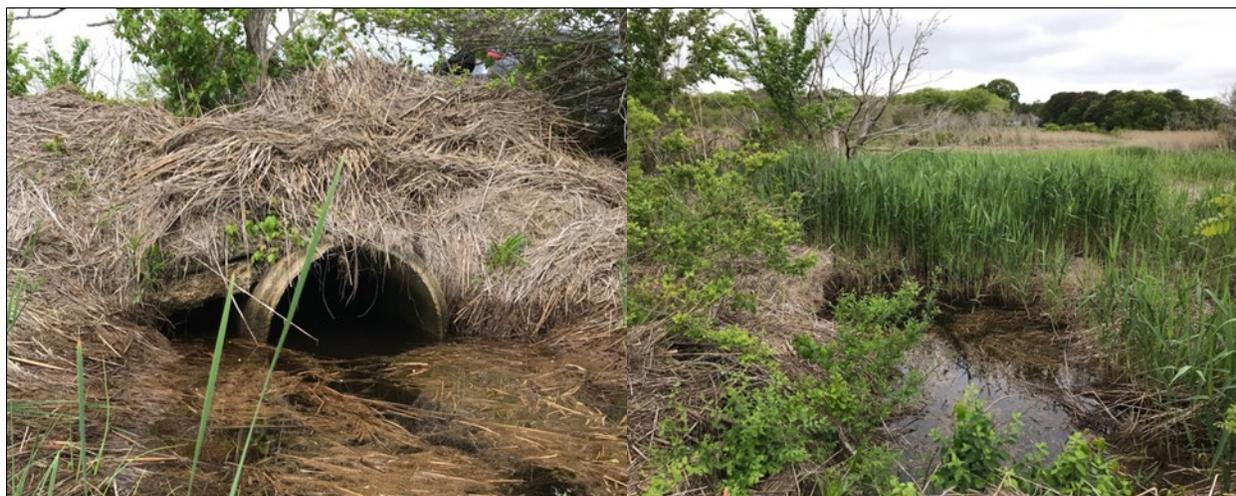
**Figure 26: The downstream culvert is covered in wrack, indicative of how the structure was impacted by the blizzard in January 2018 and northeasters in March 2018 at site B1.**

split among multiple private landowners. Upstream of this crossing the waterway joins the portion of Scorton Creek that drains into Cape Cod Bay. Consequently, it is here that the upstream area of this crossing merges with the upstream area of S10 (pg. 21). In the Cape Cod Atlas of Tidally Restricted Salt Marshes, the pipe is identified as being in good condition and unclogged in 2001. Fringing invasive common reed (*Phragmites australis*) was also documented on the upstream side (Justus et al. 2001). In the current assessment, however, the structure was observed to be at least partially clogged, as evidenced by very little active water flow through the structure. The vegetation upstream is moderately different from downstream; both sides are indicative of a brackish to freshwater wetland, but *P. australis* is much more prevalent on the upstream side. Visual indicators of a restriction include ponded water, scouring basins, vegetation die-back on both sides, and bank erosion on the upstream side. The higher prevalence of *P. australis* on the upstream side may also be evidence of a restriction at the site, as it prefers less saline waters. Based on observations from the current assessment, the structure may need to be unclogged to allow better flow through the culvert.

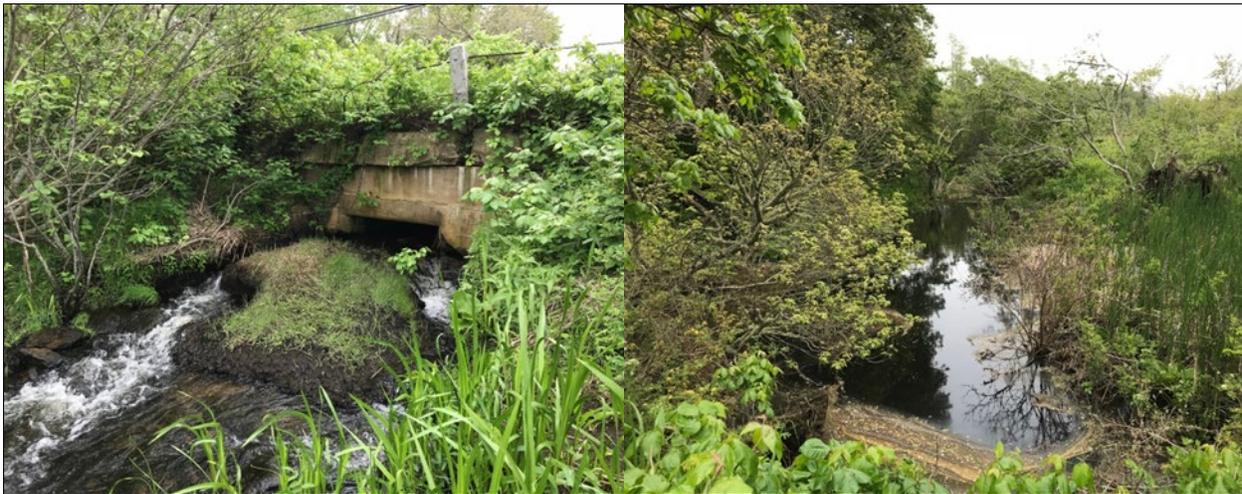
**Figure 37: A large mass of peat is partially blocking flow on the downstream side of site B7, most likely rafted up during the blizzard in January 2018 or the northeasters in March 2018.**

In 2019, the Town of Barnstable stocked Mill Pond with river herring in an effort to restore the anadromous fish run in Boat Cove Creek between Barnstable Harbor and the Pond. The large mass of peat on the downstream side (which may cause both a physical barrier and contribute to higher water flow velocities moving out of the structure) and clogging of the upstream side of the crossing by high amounts of debris may be impeding the movement of anadromous fish at this site. The

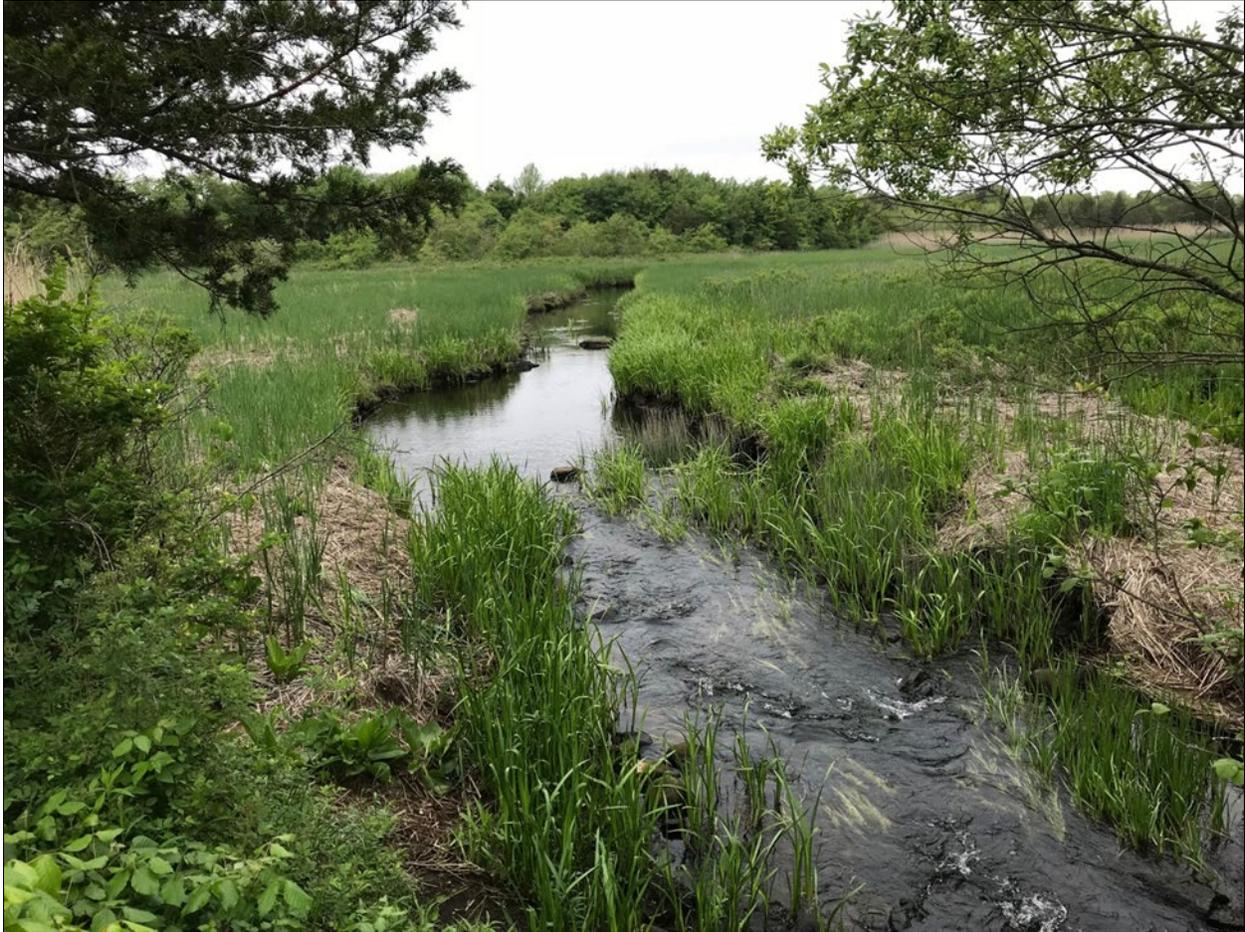
Although observations from this assessment indicate this site is not tidally influenced on a daily basis, this structure is clearly impacted at the very least by storm events. High accumulations of wrack were observed in the downstream area, and a large mass of peat was rafted right up to (and partially blocking) the downstream structure opening (Figure 37). This material was likely deposited during the major storms in the winter of 2018, including a blizzard in January that resulted in the highest high tide ever recorded (15.16 feet) at the National Oceanic and Atmospheric Administration (NOAA) tide gauge station in Boston (NOAA 2018), as well as several northeasters in March 2018 that also significantly impacted this site and Massachusetts coast-wide.

**Figure 39: View from the roadway showing the high accumulation of wrack on the downstream side of site B7.**

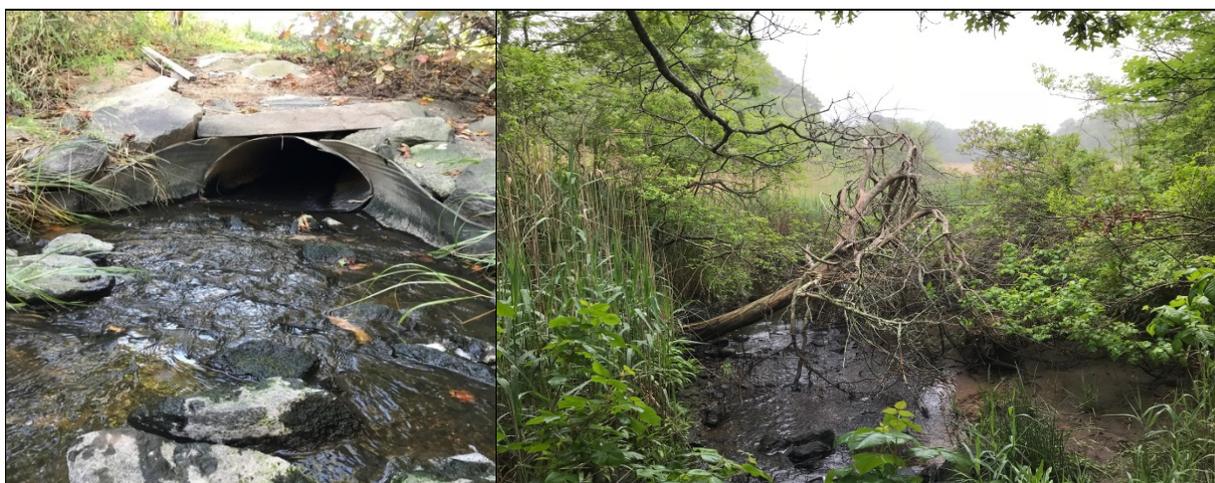
At this location, Maraspin Creek flows under Commerce Road through a corrugated metal pipe. The pipe appears to be in poor condition and is partially collapsed on both the upstream and downstream sides of the culvert. Visible utilities at the site include overhead electrical wires and underground water/sewer pipes. Crossing B25 (pg. 39) is located downstream and could be contributing to the restriction at this site by impairing flow and drainage, and therefore should be considered with any restoration efforts at B26. There is a mix of ownership on both the upstream

**Figure 48:** The metal culvert is partially collapsed on both sides of site B26. Shown here is the upstream side of the pipe, which is more profoundly collapsed than the downstream side.

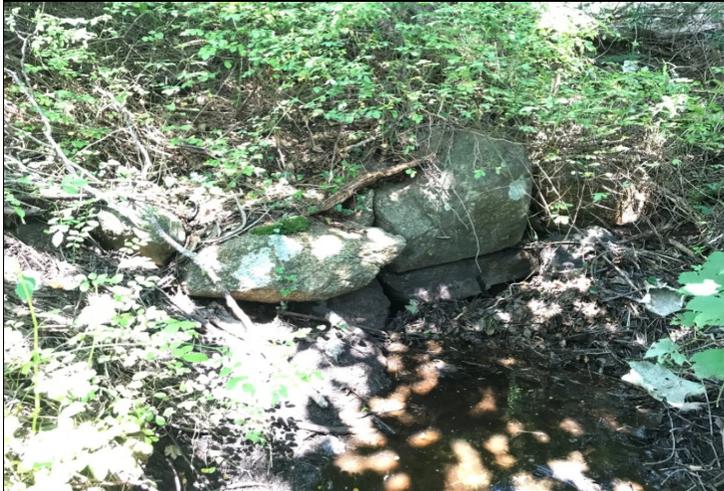
**Figure 69:** Field observers were unable to identify what kind of structure was covered by the stone at site Y4, shown here on the upstream side. Due to the small opening beneath the stone, debris has accumulated at the crossing.

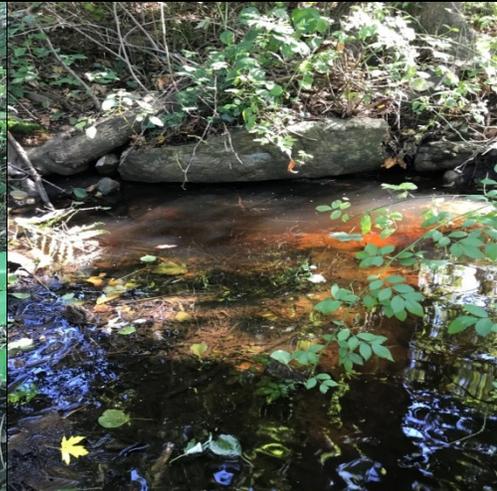
**Figure 70:** Much like the upstream structure, there is stone covering the downstream opening at site Y4. At the time that the crossing was assessed, very minimal water flow was observed through the structure.
