*Massachusetts Coastal Infrastructure  
Inventory and Assessment Project  
Massachusetts Department of Conservation and Recreation  
Office of Waterways*

## Upper Cape Cod

**Falmouth**

**July 6, 2009**

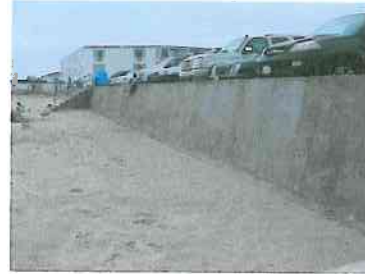
This structure is a concrete seawall fronting the northern parking lot at Old Silver Beach. There is some cracking on the wall face but it is generally in good condition.

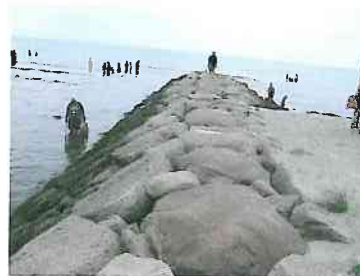
This structure is the north jetty at Old Silver Beach. There is some minor slumping at the crest and a few cracked armor stones. Overall the structure is in good condition.

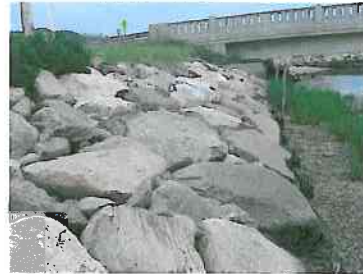
This structure is a stone revetment fronting a dirt parking lot, east of Quaker Road. There is minor weathering of armor stone. The side slopes and crest are in good condition.

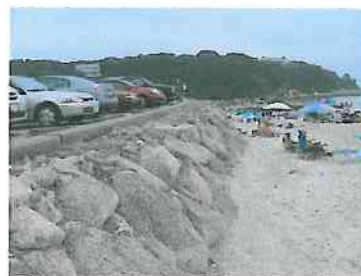
This structure is a concrete seawall fronting the southern parking lot at Old Silver Beach. The wall is fronted by grouted armor stone. There is weathering of the wall crest. There is also some slumping and patching of the stone crest and there is missing grout.

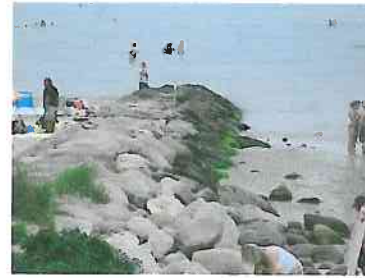
This structure is a single stone groin at the southern portion of Old Silver Beach. There is some minor weathering of armor stone. The structure is in good condition. The groin is filled on the south side with some offset of the beach on the north side.

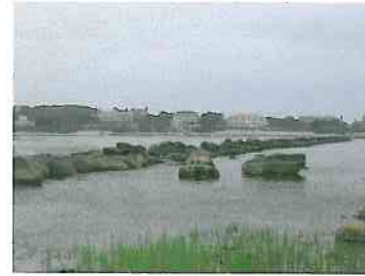
This structure is the north jetty at the entrance to West Falmouth Harbor. There are some slumping armor stones at the head. The armor stones throughout are weathered and cracked. The landward section of the jetty is very low profile with sand leaking through to the south forming a bar.

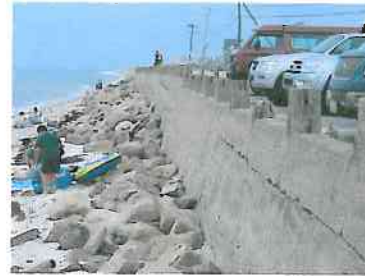
This structure is a concrete seawall fronted by dumped stone at the southern section of Chapoquoit Beach. The wall is cracked and spalled. Some cracks are quite large. The stone is weathered and shows no interlocking.

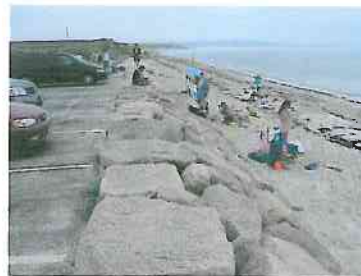
This structure is the long revetment fronting Chapoquoit Road at Chapoquoit Beach. The side slopes and crest are in good condition throughout. The armor stones are also in fine condition.

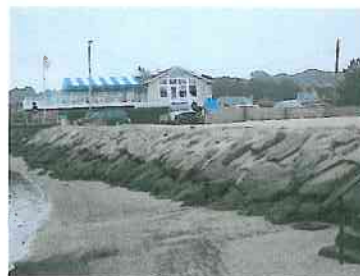
This structure is a stone revetment along the inside of Megansett Harbor. The toe area shows some slumping, and the grout has fractured and some toe stones are loose. The side slopes remain relatively intact.

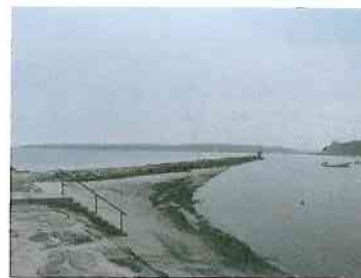
This structure is the rubble mound breakwater at the entrance to Megansett Harbor. There is no core stone visible. The armor is cracked and weathered. There are multiple areas of slumping and armor stones becoming unraveled.

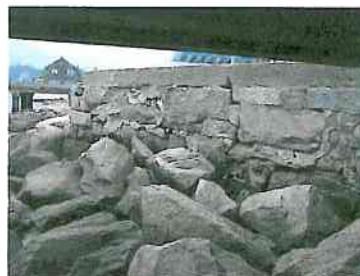
This structure is a stone seawall fronting the parking lot at Megansett Harbor. The armor stones at the toe are loose. The stones are weathered and missing grout.

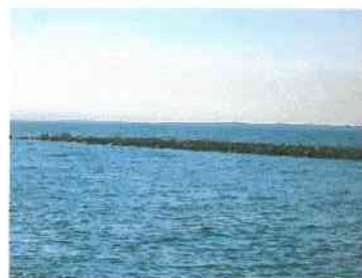
This structure is the west jetty at the entrance to Waquoit Bay. There are some slumped sections with displaced and/or damaged armor stones. There is little interlocking between the armor stone along the landward section of the structure. The jetty head has come unraveled.

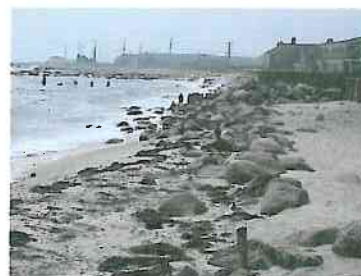
This structure is a stone revetment fronting 6 homes along Ocean Avenue. The side slope and crest are generally in good condition along the western portion of the structure. However the revetment is failing at the eastern end with a loss of crest elevation and no interlocking of adjacent armor stones.

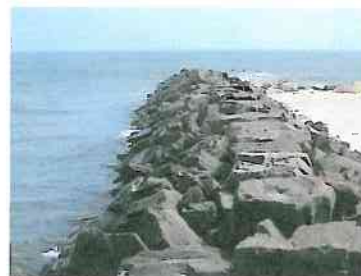
This structure is a single stone groin at the terminus of Vineyard Street. The side slopes and crest are generally in good condition. The armor stone is becoming unraveled at the head.

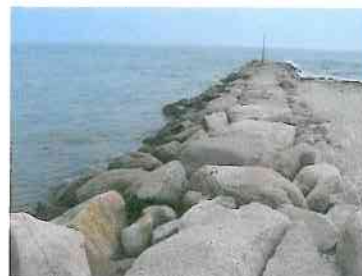
This structure is the west jetty at the entrance to Green Pond. The structure is generally in good condition. The side slopes and head are unraveled in sections towards the outer end of the jetty.

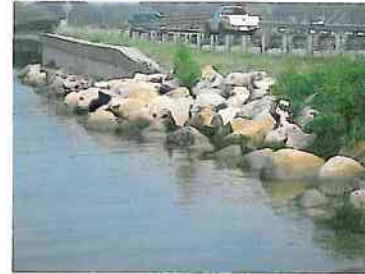
This structure is the riprap bank protection along the west side of Menauhant Road over Green Pond. The armor stones are loosely piled along the side of the bridge abutments. They are becoming unraveled.

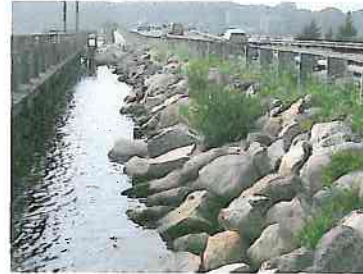
This structure is the riprap bank protection along the west side of Menauhant Road over Green Pond. The armor stones are loosely piled along the side of the bridge abutments. They are becoming unraveled.

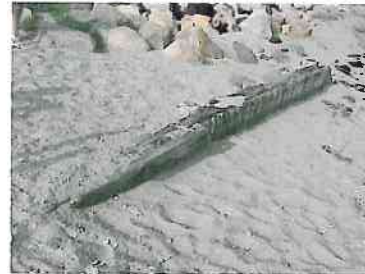
This structure is a wooden bulkhead which lies mostly buried in the beach east of the entrance to Bournes Pond. The small portion which is exposed is severely weathered and cracked. The reported length is for the visible section only. No further inspection was possible.

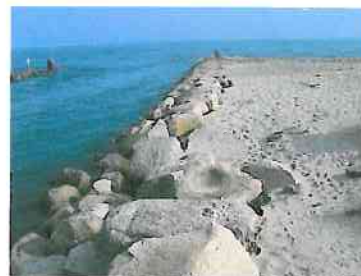
This structure is the west jetty at the entrance to Bourmes Pond. A section of armor stone along the trunk has come unraveled and slumped down. There is erosion is evident behind the damaged area.

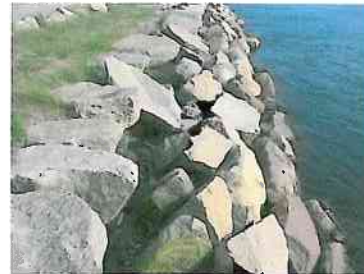
This structure is the east jetty at the entrance to Bournes Pond. Sections of the jetty trunk see the side slopes slumping down and away from the crest, creating a gap between the two sections. There is erosion evident behind the damaged area.

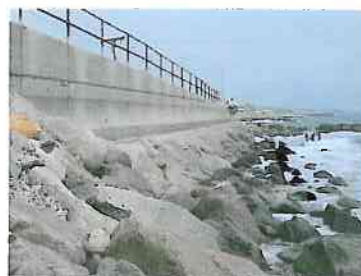
This structure is a revetment running along the shoreline east of the entrance to Great Pond. The structure is a stone revetment with a recurved concrete cap. The side slope of armor stone is in good condition. The concrete seawall shows minor weathering.

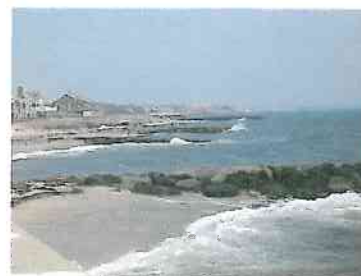
This structure is a field of 4 stone groins east of the entrance to Great Pond. The armor stones are unraveled at the heads and the sides are starting to slump. The crests are generally level and in good condition.

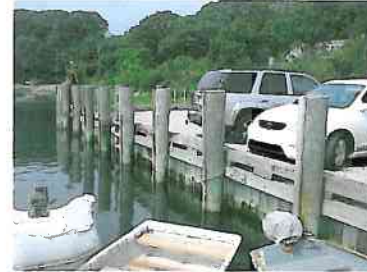
This structure is a filled bulkhead/dock at the east end of Quissett Harbor. The timbers are clear and solid. The structure is in excellent condition.

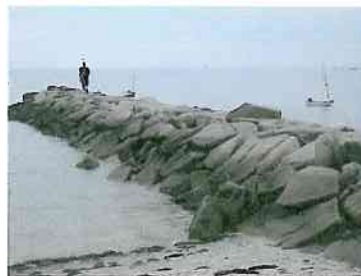
This structure is the stone jetty at the southern side of the entrance to Wild Harbor. There is a concrete wall within the crest of the jetty along the landward portion of the structure. This concrete wall is broken and failing. The sideslopes and crest of the jetty itself show some minor stone displacement. The head is starting to unravel.

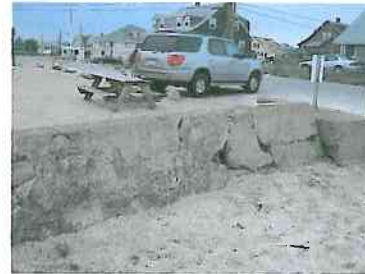
This structure is a small concrete wall fronting a parking lot at Silver Beach. A section of the wall is badly failed and there is cracking and spalling evident on the remainder.

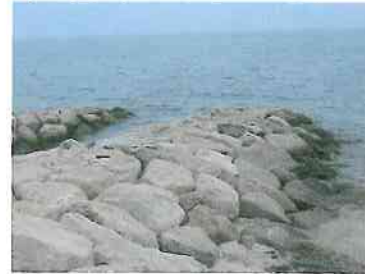
This structure is the south jetty at Trunk River. The armor stone shows signs of weathering but are solid. The side slopes and crest are in good condition.

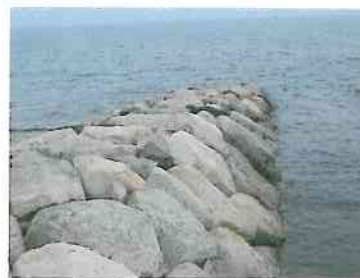
This structure is the north jetty at Trunk River. The armor stone shows signs of weathering but are solid. The side slopes and crest are in good condition.

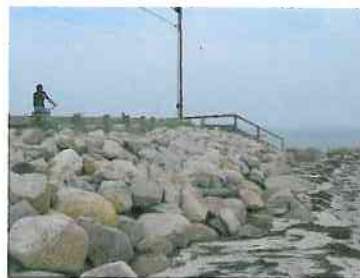
This structure is a stone revetment at the far west end of Surf Drive beach. The structure exhibits a clear crest and side slopes. Some armor stones are broken and there is one section where the crest is slumping.

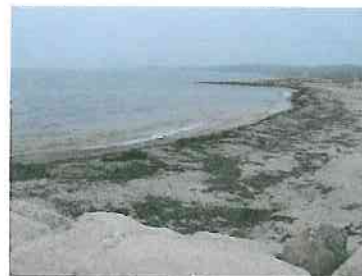
This structure is the 6 stone groins at the eastern end of Surf Drive Beach. The armor stones are weathered and the heads of the groins are becoming unraveled. There are also some cracked and displaced stones.
