**Roderick L. Ireland Courthouse  
Springfield, MA**

## **HVAC SYSTEM EVALUATIONS COVID-19**

Office of Court Management

September 14, 2021

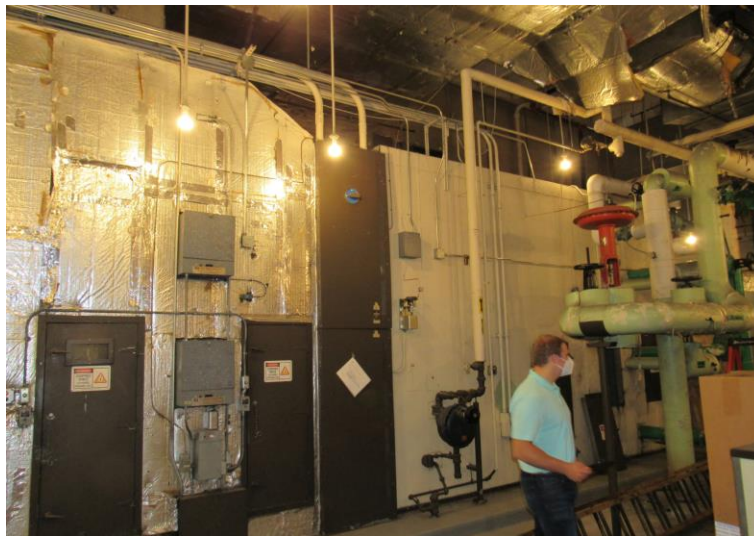
Photo 1 –Typical Air Handler and Return Fan

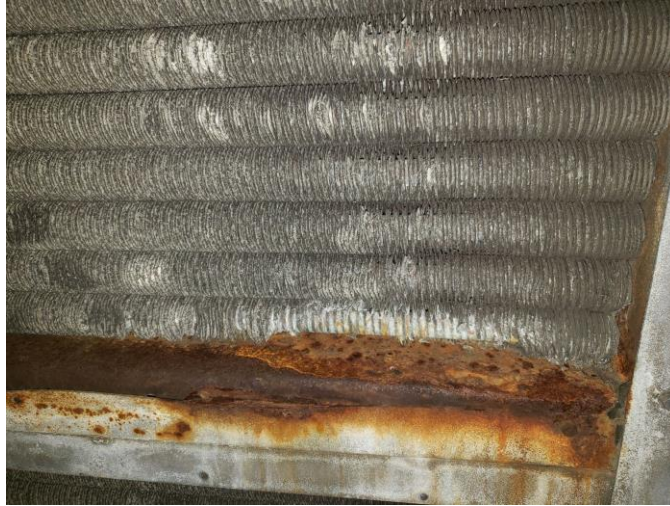
The hot/chilled water coil for AHU-1 is in very poor condition and should be replaced. The outside air dampers for AHU-4 were not working at the time of the visit, possibly due to a linkage issue. All coils were dirty and in need of cleaning. The MERV 13 filters were also dirty and starting to bend. All AHU's were set to a minimum outside air actuator position of 20%, but some outside air dampers appeared to be just starting to open at this actuator position. This indicates that the outside air being provided may be less than the design flow rate.

Photo 2 –AHU-1 Water Coil

The water coil for AHU-1 is in very poor condition and should be replaced. The fins are very corroded and breaking off the tubing in several areas.

### **2.7.1 Replace the AHU-1 Water Coil, and Professionally Clean the Remaining AHU Coils**

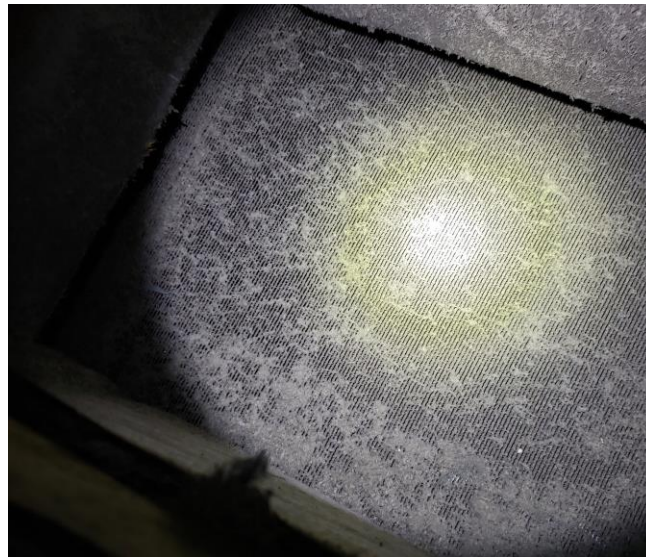
Each AHU serves many building zones. Each zone has a hot water reheat coil in the supply air ductwork serving the zone, controlled by a local thermostat. While onsite, we observed a representative reheat coil through an access panel. The coil was fairly dirty, but appeared to be in relatively good condition.

Photo 3 –Dirty Reheat Coil

Based on the reheat coil we observed, it is likely that many of the reheat coils are dirty, and that the buildup is affecting airflow. Consider cleaning all reheat coils.

As the hot water reheat coils regulate the supply air temperature delivered to each space, we also recommend verifying control operation of each reheat coil by adjusting the thermostat serving each space during the heating season and verifying that the supply air temperature varies in response.

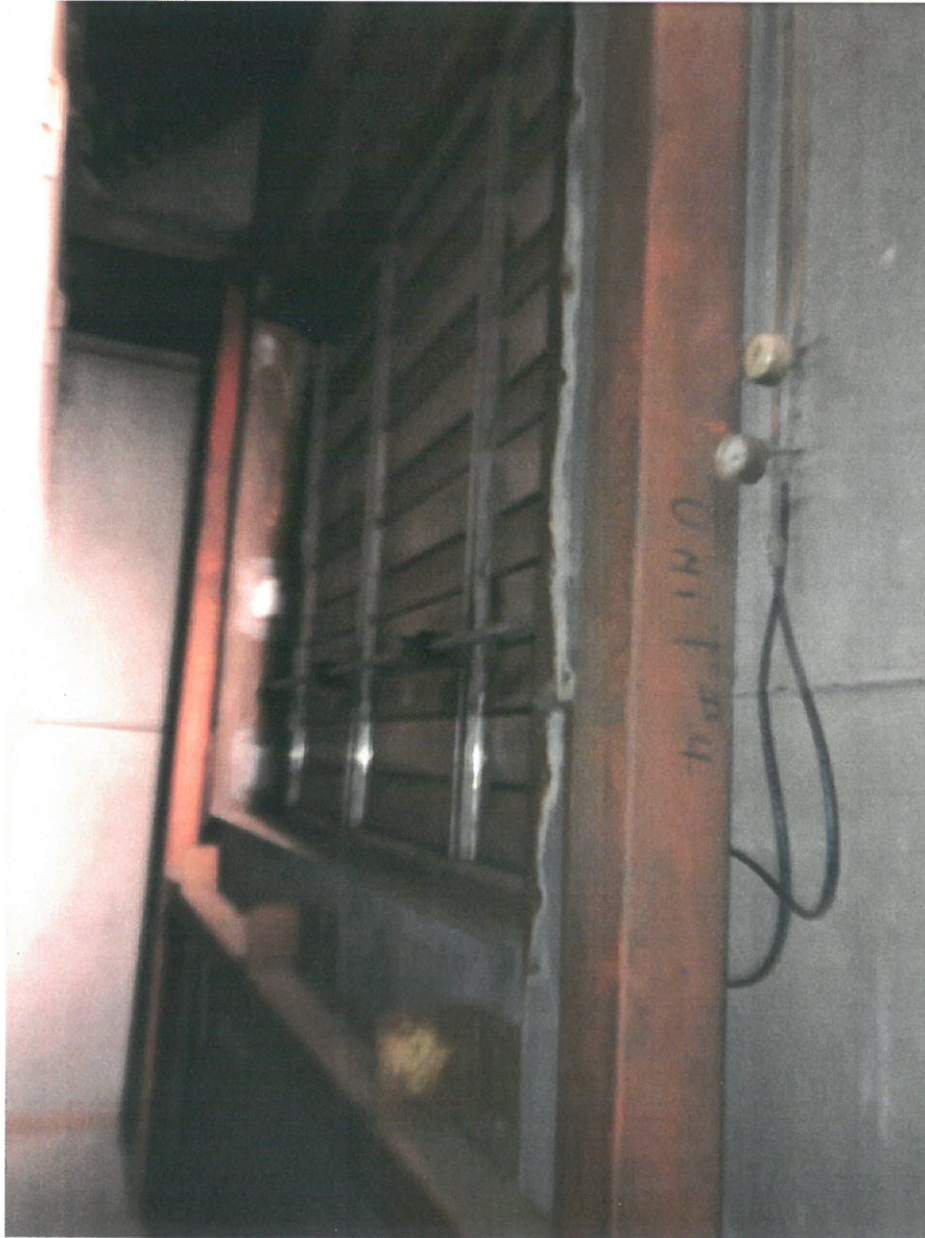
Total airflow readings were taken on AHU-4 was taken with a 36" Pitot tube. We noted that the outside air damper did not move when commanded to 20% open; see attached picture. Unit 4 was the only fan system we verified the total airflow on. During the testing, we also recorded new supply fan static pressures for all 4 systems.

**Outside Air Damper – AHU-4**  
Position when commanded 20%

Replace dampers and actuators that are not functioning.
