Chapter 3

PROPERTY INVENTORY AND ANALYSIS

Introduction

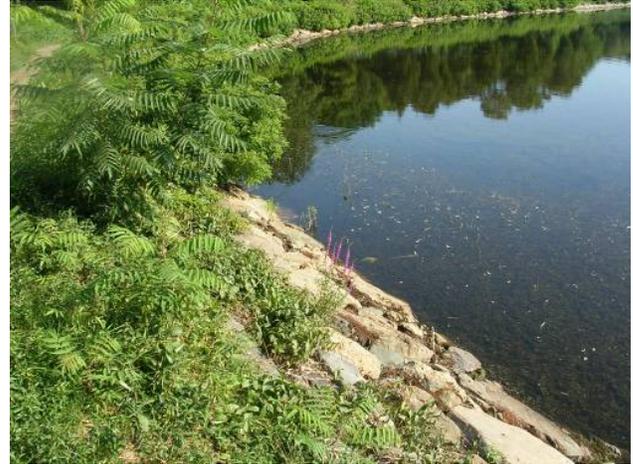
Figure 3.6: Upland successional vegetation growing in rip-rap (2005)

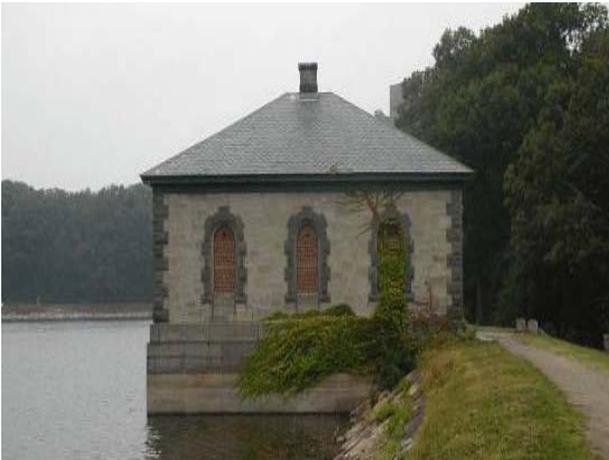
Figure 3.8: Gatehouse #1 upper structure (2005)

The slate covered hipped roof is supported with exposed rafters and decking, forming a cathedral style space. The roof framing is generally in good condition but there appear to be potential leaks at the hips, especially near the bottoms where the hip rafters sit on the corners of the building. The slate joints at the hips appear to be covered with a raised copper cap, although this was difficult to confirm during the 2005 field survey as the roof slope is fairly shallow and the exterior walls are over sixteen feet high.

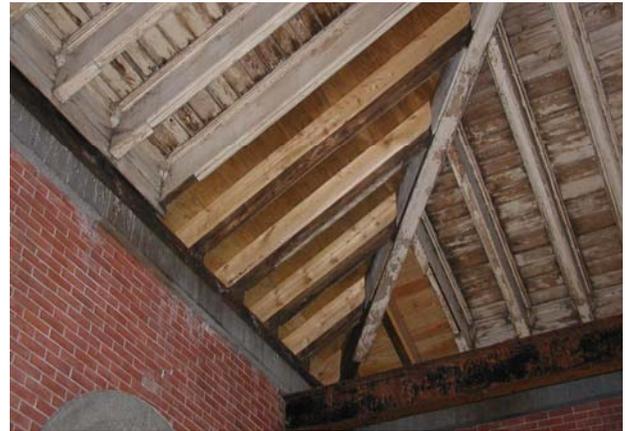
Although there were no signs on the floor of any roof leakage during the recent field survey, the southwest corner of the roof has been rebuilt with modern 2"x4' rafters and plywood; the brick wall below this repair has light efflorescence stains. The brick walls at the northwest corner also have light efflorescence on their surfaces. The paint at all four corners is peeling and the wood is darkened, especially at the southeast corner.

While the roof is in good condition overall, it should be assumed that there is some moisture damage in the decking and possibly the rafters at the four corners. The

Figure 3.9: Modern materials in southwest corner of roof (2005)

roof structure would need to be repaired before the building could be designated for public use.

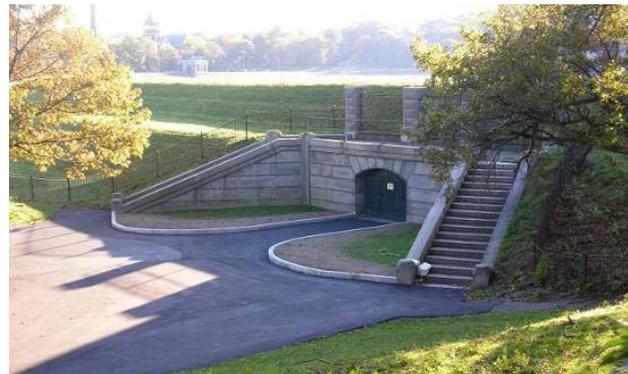
Each stair consists of individual tread stone units and heavy side wall units. While the stairs appear to be in good condition, there is evidence of past movements among the various stone units. The side cheek walls appear to have tilted or shifted laterally, creating wide gaps between units that were subsequently filled with mortar. The wide mortared joints are generally intact but many are cracked. Although there are no immediate or major public safety concerns, some level of repair and stabilization of the steps and cheek walls is warranted.

Figure 3.11: Gatehouse #1 lower structure and double stairs (2005)

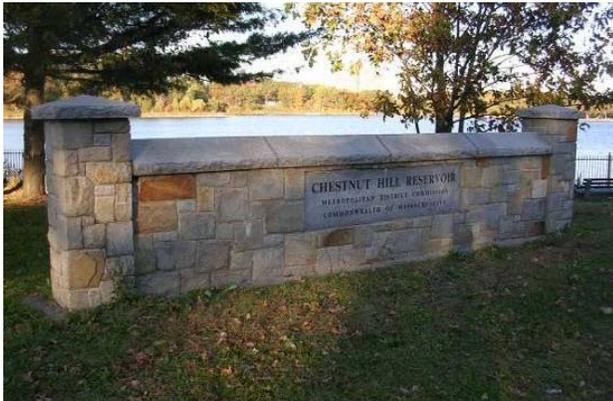
Figure 3.13: Freestanding stone wall at Beacon Street Entrance (2005)

Most of the mortar joints for all three walls are in good condition, but deterioration is starting to affect the masonry. Almost all of the capstone butt joints have small cracks and some moss is taking hold at the butt joints that absorb moisture and dry slowly. A few of the joints between the stone units show calcium carbonate deposits. Water infiltration is beginning to work into the wall but no significant damage has occurred yet. Repair work is warranted given the existing damage and in order to prevent any future deterioration.

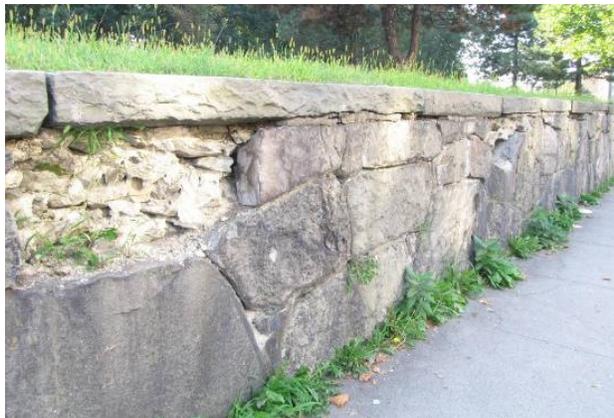
Figure 3.15: Stone retaining wall along Chestnut Hill Avenue (2005)

The stones are mortared together and the mortar between stone units is generally cracked, missing, disintegrated or is an inappropriate white mortar color used for a previous

re-pointing. In spite of the mortar deterioration, the large size of the stone units has ensured the stability of the wall, there being no significant displacement of the wall as a system or of most of the stone units individually. However, several cap stones at the curve in the retaining wall near Commonwealth Avenue have been displaced outward about six inches. Also, small stones at the surface have toppled out of the wall at roughly ten to fifteen foot intervals.

The deterioration is caused by moisture infiltrating the interior of the wall and freezing or dissolving the constituents of the mortar. In the retaining wall, moisture enters the back of the wall from the soil; in the freestanding wall, moisture enters initially through cracked butt joints between the cap stones and then later through cracked mortar joints in general. It is possible to make repairs at the freestanding wall that will last for some time but repairs at the retaining wall will need frequent maintenance, in the absence of a waterproof membrane on the earth side. Immediate repairs may be necessary to prevent future deterioration.

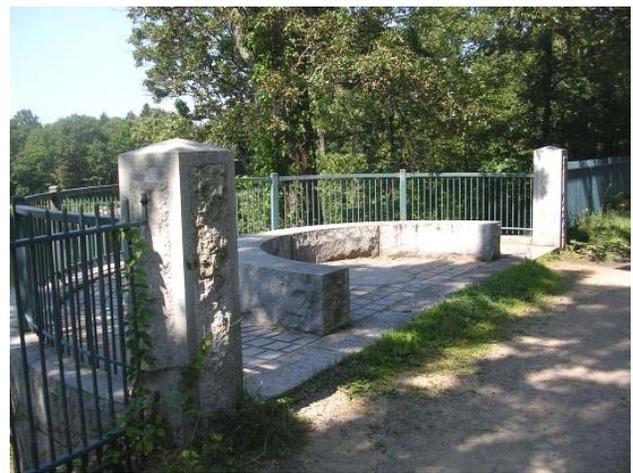
Figure 3.16: 1977 overlook (2005)

The overlook and all its associated features are in fair to good condition. However, there is a slight step-down to the adjacent packed dirt pathway that presents a tripping hazard as well as being aesthetically unattractive. This also effectively makes the overlook inaccessible to persons with physical disabilities.

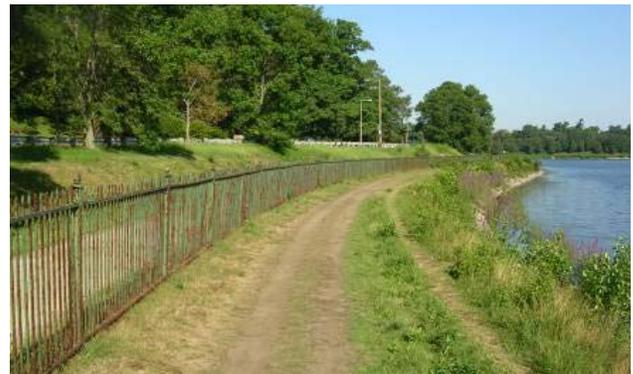
Figure 3.23: Worn dirt path running inside the perimeter fence and alongside Beacon Street (2005)

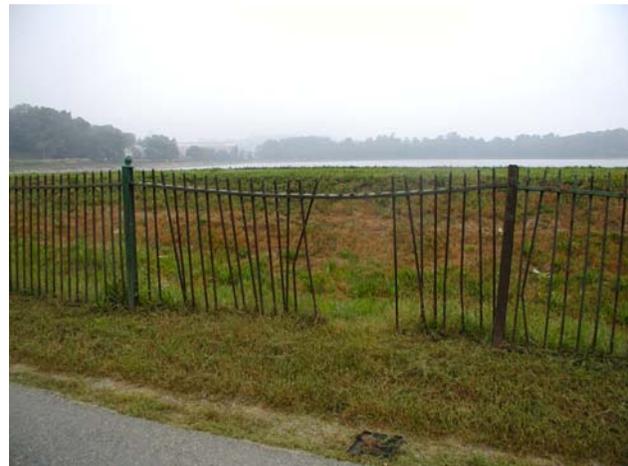
Figure 3.30: Typically damaged 1928-29 panels (2005)

- The paint is completely deteriorated and some of the pickets are pitted from corrosion;
- Ten percent of the top rails are bent;
- Fifty percent of the pickets are bent or corroded in some degree, with about ten percent severely bent, missing or corroded;
- Forty percent of the panels have bottom rails that are significantly corroded and unsalvageable because they are buried in earth or vegetation;
- Twenty-five percent of the panels are in reasonably good condition and can be easily repaired;
- Thirty-five percent of the panels are in mixed condition, with damage and deterioration that could be repaired with replacement components;
- The posts appear to be set in concrete but many are corroded to some extent near the ground. Less than ten percent of the posts have broken off at the ground.

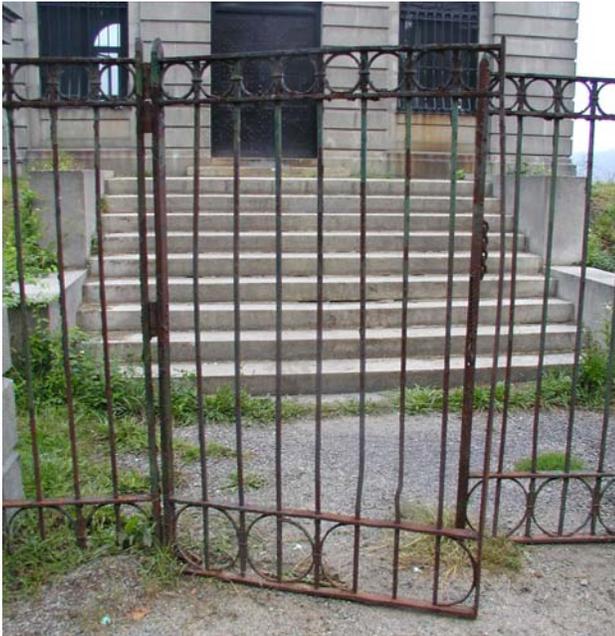
Figure 3.33: Gatehouse #.2 gate with missing circular elements (2005)

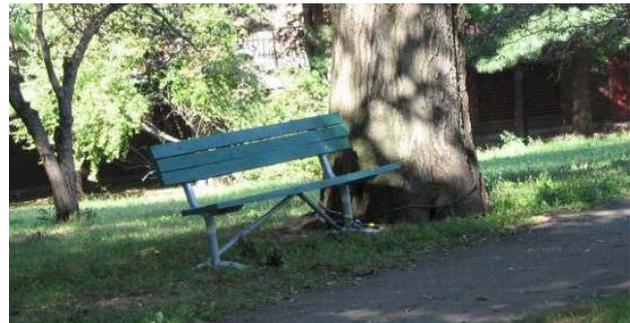
The Type 3 benches are in fair to good condition, but are not an appropriate style for the Reservation, because they are not permanent installations and as mentioned above, the security cables damage the trees and fence.

Figure 3.38: Type 3 bench attached to tree (2005)
