INDOOR AIR QUALITY ASSESSMENT

**Massachusetts Rehabilitation Commission
888 Purchase Street
New Bedford, Massachusetts**

Prepared by:
Massachusetts Department of Public Health
Bureau of Environmental Health
Indoor Air Quality Program
December 2015

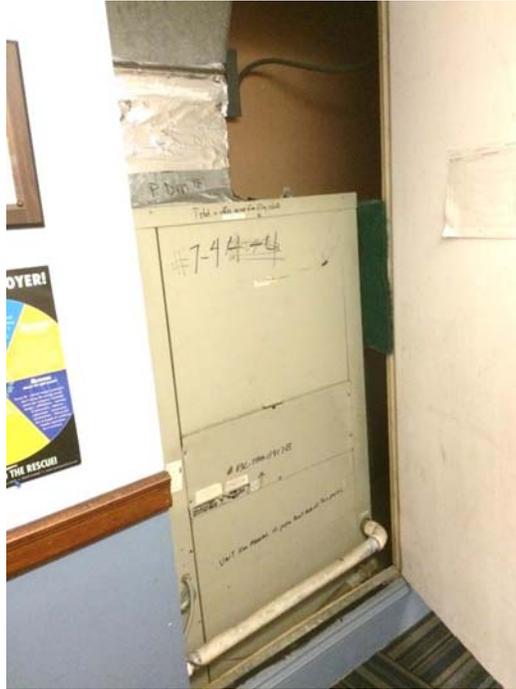
Picture 1

It can be seen from Table 1 that carbon dioxide levels were above 800 parts per million (ppm) in twelve of seventeen areas tested, indicating a lack of air exchange at the time of assessment. There is no mechanical ventilation system that introduces/exhausts outside air in these offices, instead there are four air handling units (AHUs) which heat/cool and recirculate air only. Two of these AHUs are in mechanical closets (Picture 1) and two are located above ceiling tiles (Picture 2). Fresh air to this space is introduced solely through the use of openable windows.

Air handling unit in mechanical closet

1. Use windows (weather-permitting) to introduce fresh/outside air.
2. Consider setting digital thermostats to the fan “on” setting to provide continuous airflow/filtration.

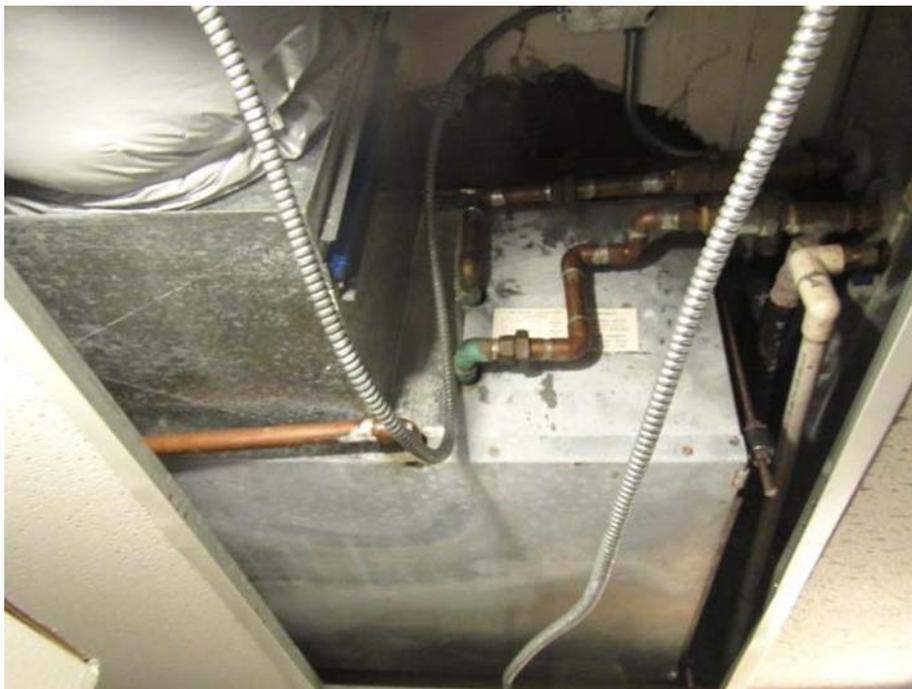
Picture 2

Air handling unit above ceiling tiles

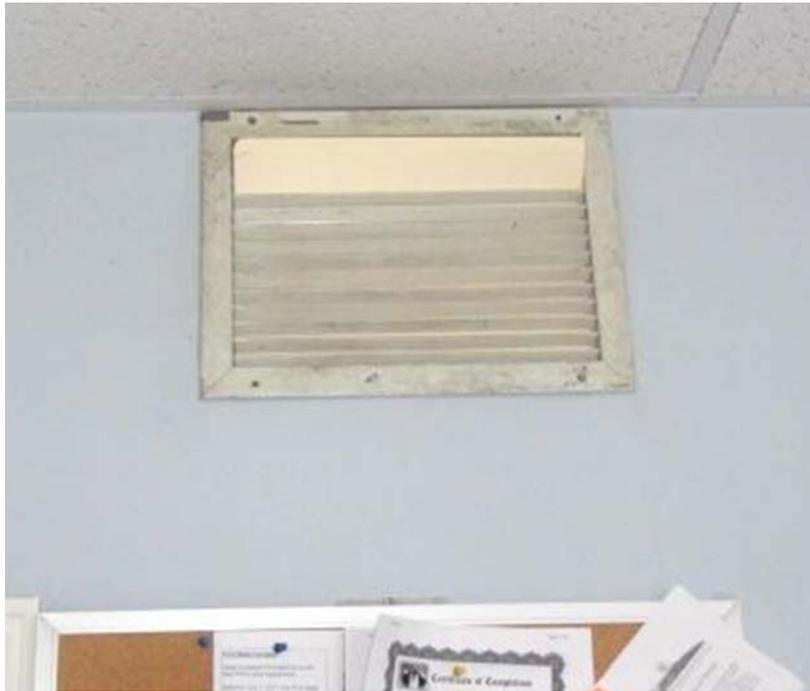
Picture 3

Temperature readings in occupied areas during the assessment ranged from 71°F to 75°F, which were within the MDPH recommended comfort guidelines (Table 1). The MDPH recommends that indoor air temperatures be maintained in a range of 70°F to 78°F in order to provide for the comfort of building occupants. In many cases concerning IAQ, fluctuations of temperature in occupied spaces are typically experienced, even in a building with an adequate fresh air supply. The heating/cooling system is controlled by digital wall-mounted thermostats. In a few areas, supply vents were blocked with folders in an attempt to maintain comfort (Picture 3).

Supply vent blocked with folder

3. To avoid comfort complaints, consider installing adjustable/louvered air diffusers.
4. The building envelope/exterior brickwork along the east-facing wall should be thoroughly examined to identify missing/damaged mortar, cracks or breaches and be properly repaired/repointed to prevent further water intrusion/damage to interior building materials.

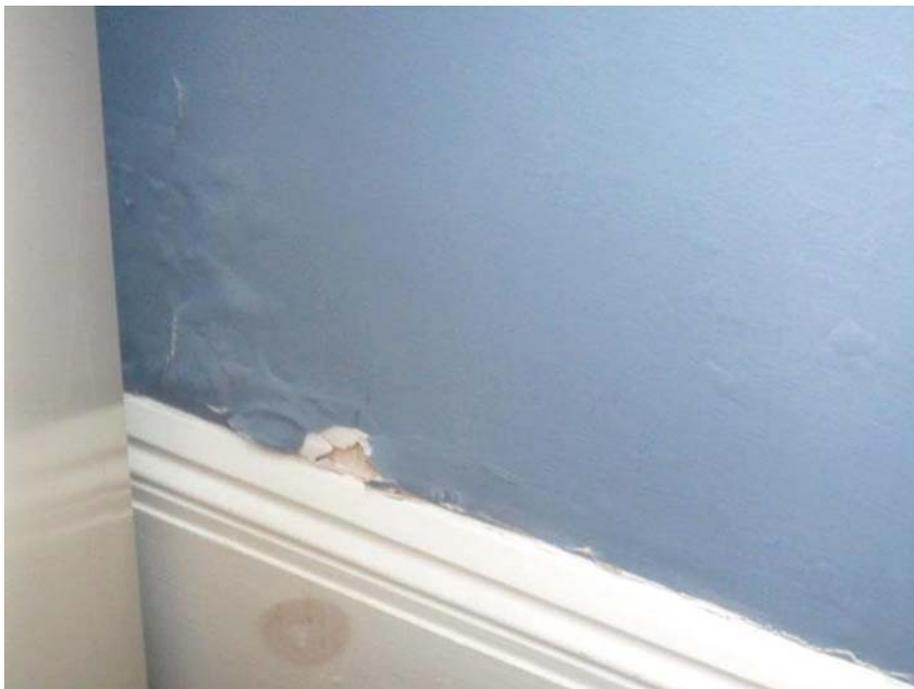
Picture 4

Water infiltration was reported and observed in the form of peeling paint on interior plaster walls (Pictures 4 and 5) along the rear/east wall facing the waterfront (Picture 6). This water damage is likely the result of water infiltration through exterior brickwork (Pictures 7 and 8), which is probably in need of repointing.

Peeling paint along rear interior wall

5. Peeling paint and water-damaged plaster surfaces should be repaired/painted.
6. For buildings in New England, periods of low relative humidity during the winter are often unavoidable. Therefore, scrupulous cleaning practices should be adopted to minimize common indoor air contaminants whose irritant effects can be enhanced when the relative humidity is low. To control for dusts, a high efficiency particulate arrestance (HEPA) filter equipped vacuum cleaner in conjunction with wet wiping of all surfaces is recommended. Avoid the use of feather dusters. Drinking water during the day can help ease some symptoms associated with a dry environment (throat and sinus irritation).

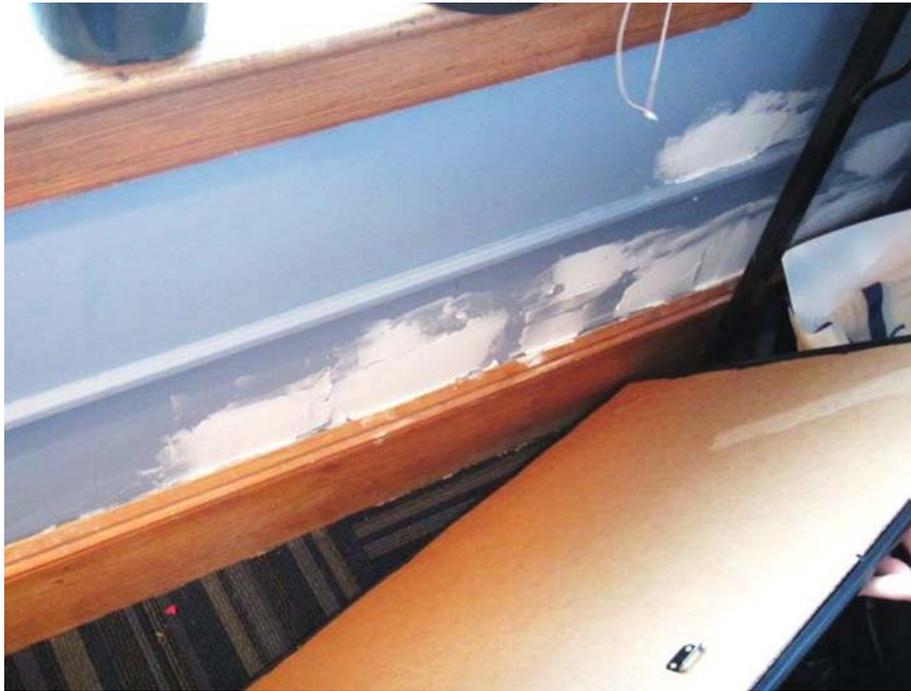
Picture 5

Repaired water damage along rear interior wall

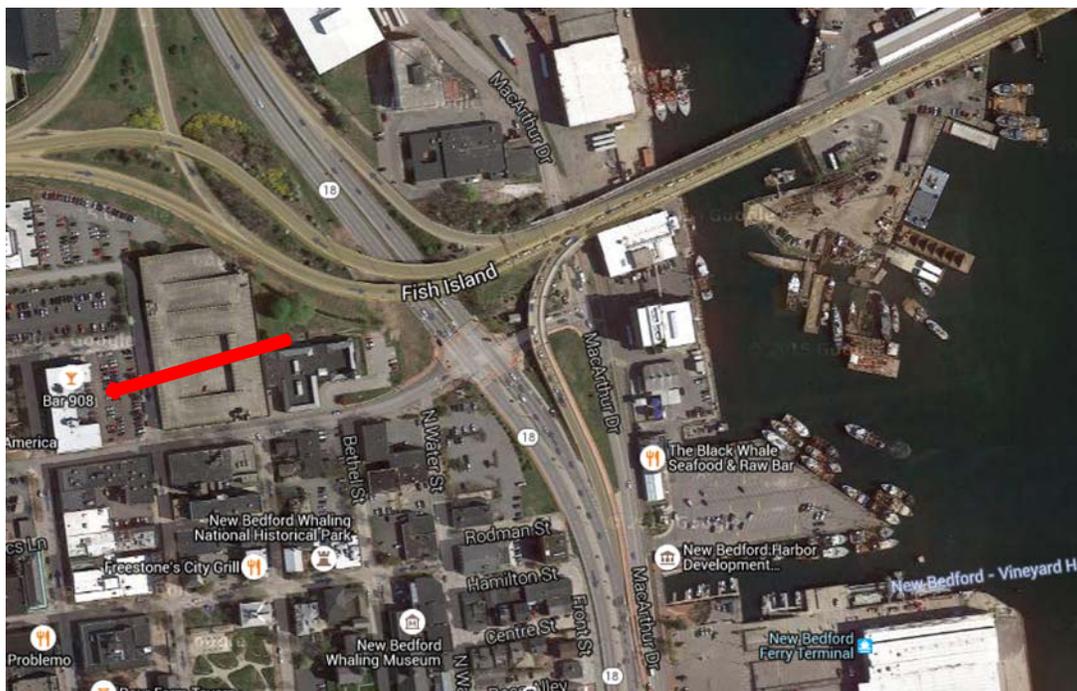
Picture 6

Arrow indicates rear/east-facing wall where peeling paint/water damage occurs

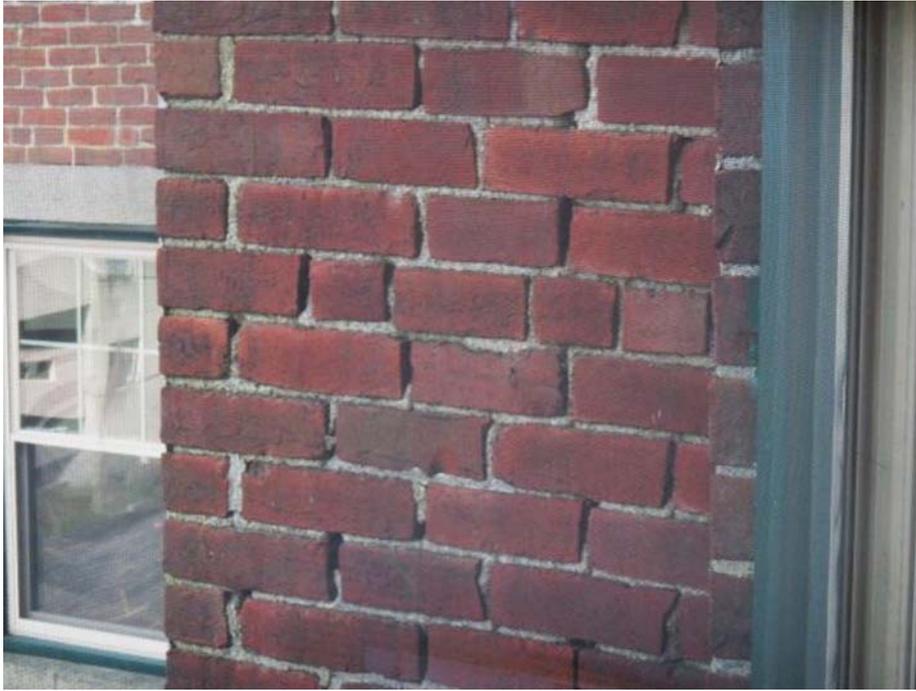
Picture 7

Missing/damaged mortar around exterior brick on east-facing wall

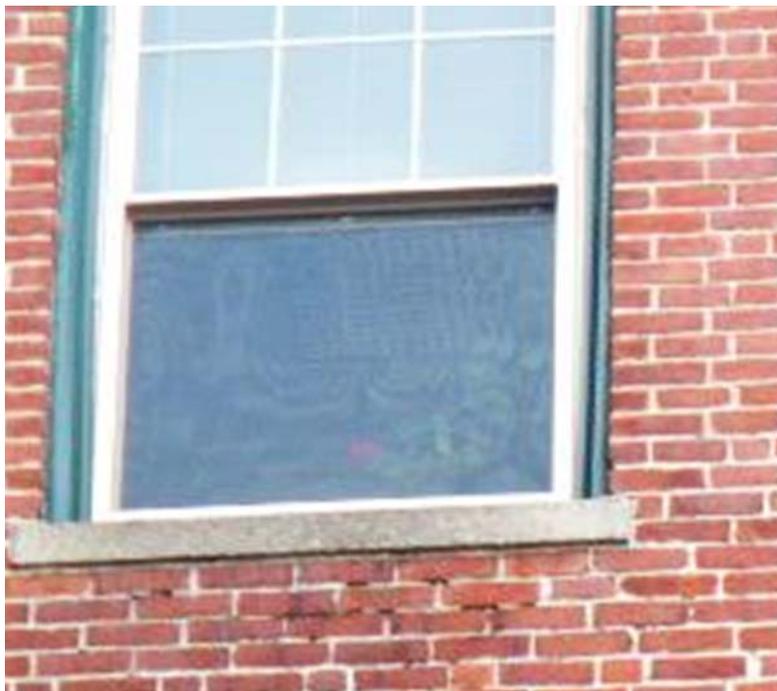
Picture 8

Missing/damaged mortar around exterior brick on east-facing wall (below window)

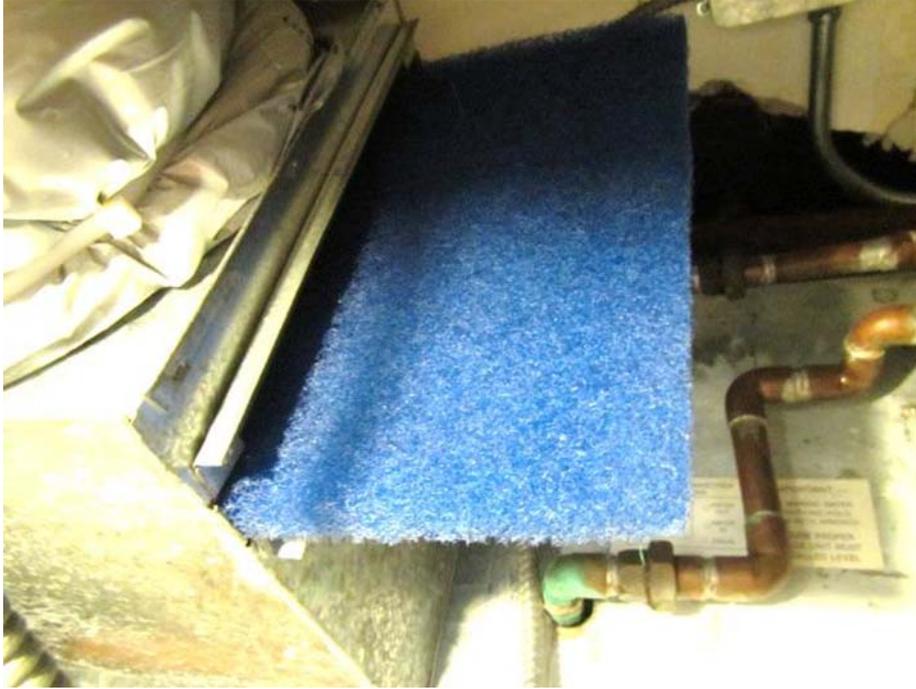
Picture 9

Finally, AHUs were equipped with a filter medium that provides minimal filtration (Pictures 9 and 10). Pleated filters with a dust spot efficiency of 40 percent are typically recommended. The dust spot efficiency is the ability of a filter to remove particulates of a certain diameter from air passing through the filter. Filters that have been determined by ASHRAE to meet its standard for a dust spot efficiency of a minimum of 40 percent would be sufficient to reduce many airborne particulates (Thornburg, 2000; MEHRC, 1997; ASHRAE, 1992). Pleated filters with a Minimum Efficiency Reporting Value dust-spot efficiency of 9 or higher are recommended. Note that increasing filtration can reduce airflow (called pressure drop), which can subsequently reduce the efficiency of the unit due to increased resistance. Prior to any increase of filtration, each AHU unit should be evaluated by a ventilation engineer to ascertain whether it can maintain function with more efficient filters.

Filter media installed in AHU above ceiling

7. Change AHU filters 2 to 4 times a year or as per the manufacturer’s instructions.
8. Consider upgrading existing filter media to pleated filters with a MERV dust-spot efficiency of 9 (40%) or higher accounting for manufacturer limitations with pressure drop.

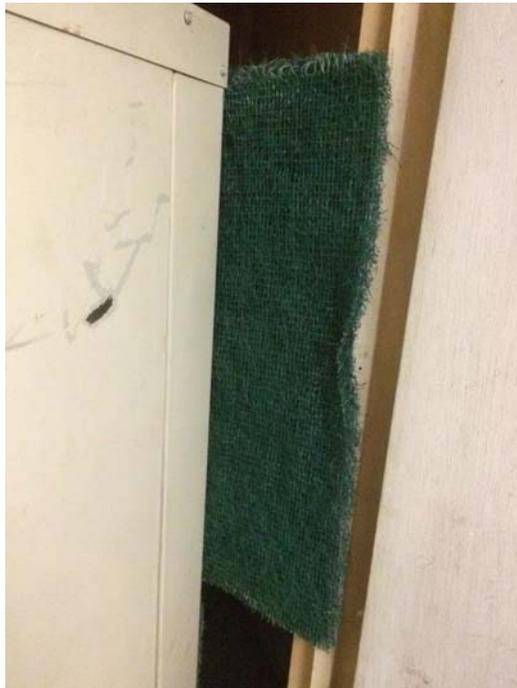
Picture 10

Filter media installed in AHU in mechanical room
