A. Architecture Appendices

1. Existing Building Evaluation

ARCHITECTURE AND INTERIORS

Building Inventory and Evaluation

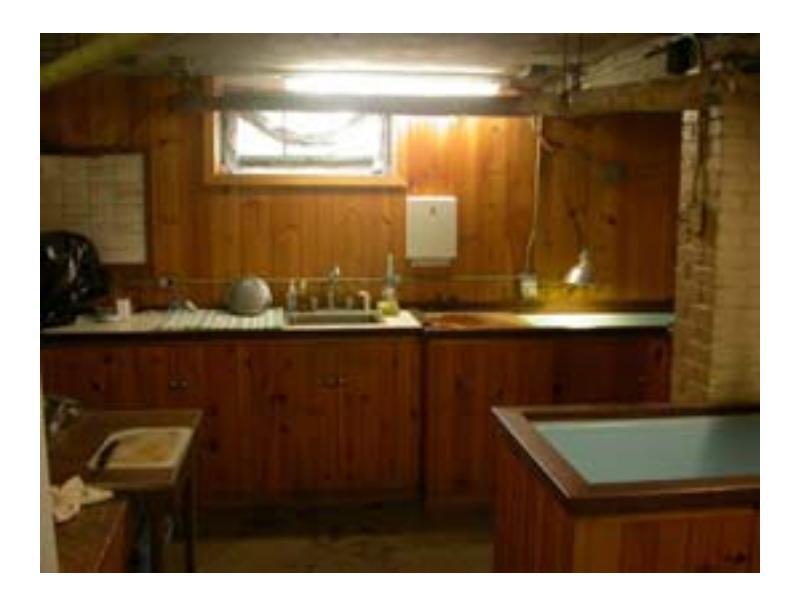
Basement animal quarantine. Unfinished walls and exposed wiring and pipes.

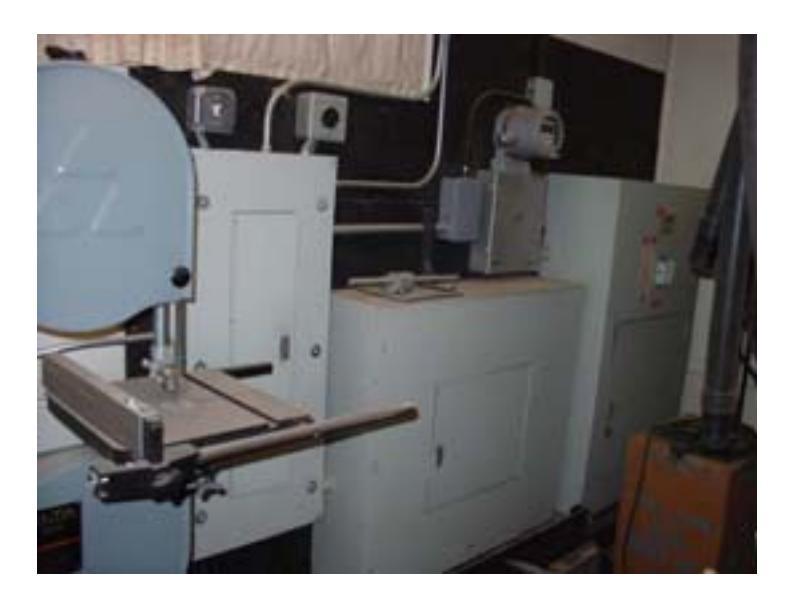
Electrical service panels.

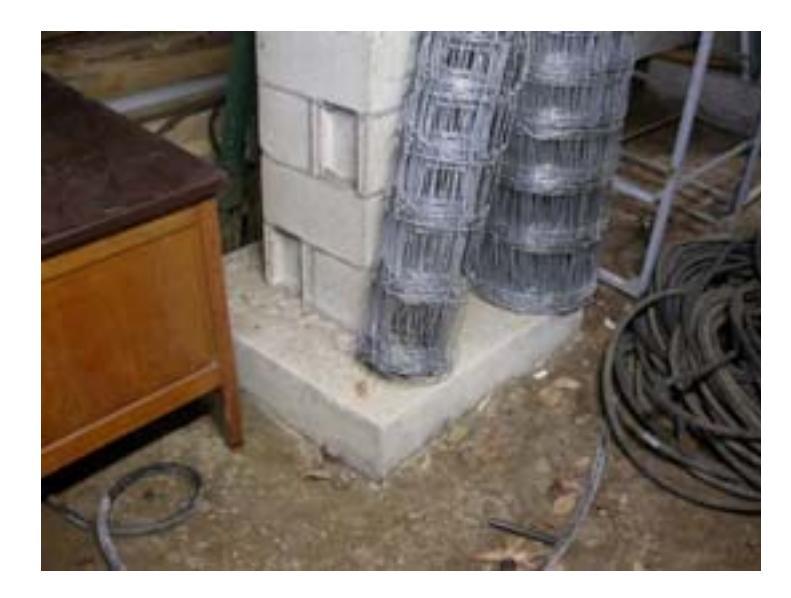
Basement level at exhibit hall. Currently used for general storage. Space is damp and lacks heat and ventilation.

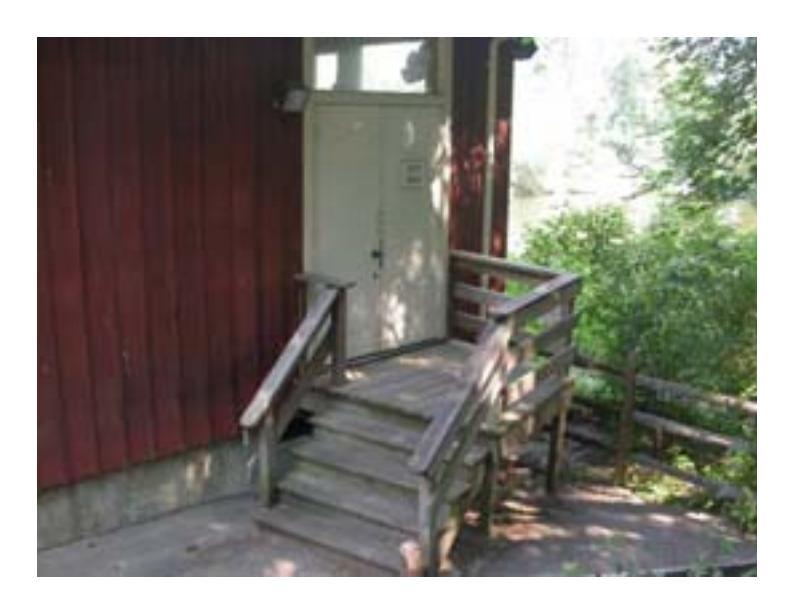
Northeast corner of exhibit hall. Uncovered emergency egress stair.

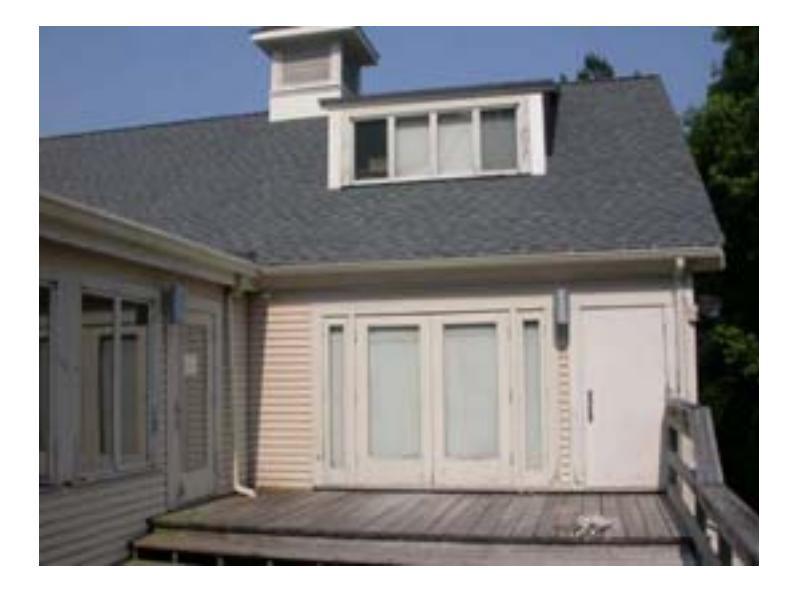
South façade of connector. Note uncovered wood exit stair and metal fire escape.

There are three exits from the main lecture hall, all leading to uncovered exterior wood stairs at the north and south sides of the complex. These stairs and the adjacent decks are very weathered. Most exits to the exterior have a sign indicating "emergency exit only", indicating the challenge of preventing visitors from using them in non-emergency conditions.
