Brockton Superior Court Brockton, MA

HVAC SYSTEM EVALUATIONS COVID-19

Office of Court Management

November 29, 2021

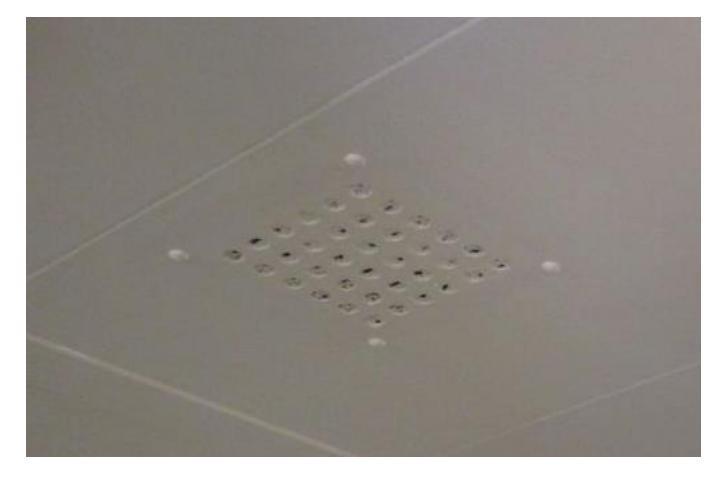
Photo 1 – Painted Grille

Several registers in the holding cells have been painted over and appear to have restricted airflow. Once the unit ventilator and exhaust fans have been repaired or replaced, we recommend rebalancing these registers, and cleaning or replacing them if needed to attain the proper airflow.

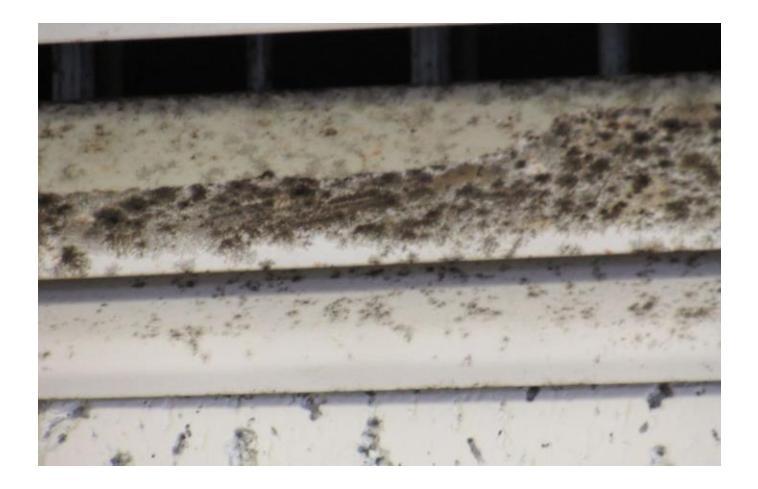
During the walkthrough, we noted several areas with visible mold growth on registers, suspended ceilings, and on piping above the drop ceiling. This may be a result of improper pressurization, envelope issues, and the combination of spaces with and without air conditioning. According to staff, the building has had ongoing humidity issues.

Photo 2 - Mold on Supply Registers

In several occupied areas, mold was visible on registers and on suspended ceiling tiles. The presence of mold is a significant health concern that negatively impacts IAQ and can increase susceptibility to infection from viruses like COVID-19. We recommend engaging a reputable mold testing company to test various surfaces and wall cavities for the presence of mold and types of mold present. Any contaminated materials should be properly cleaned or discarded based on the findings of the mold testing.

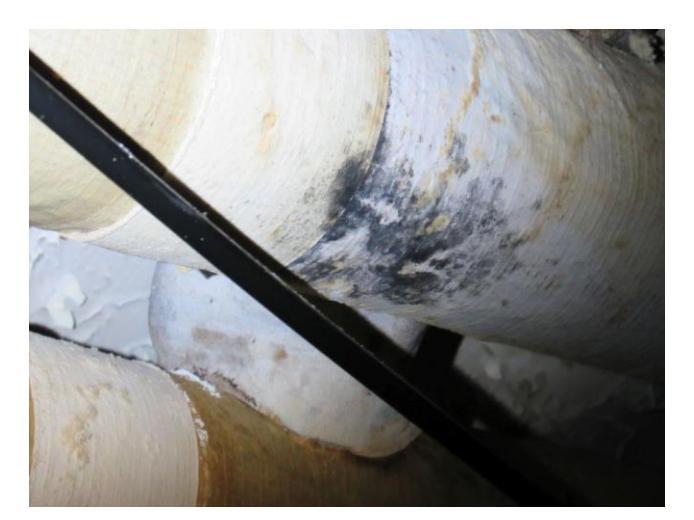
Photo 3 – Mold on Pipe Insulation

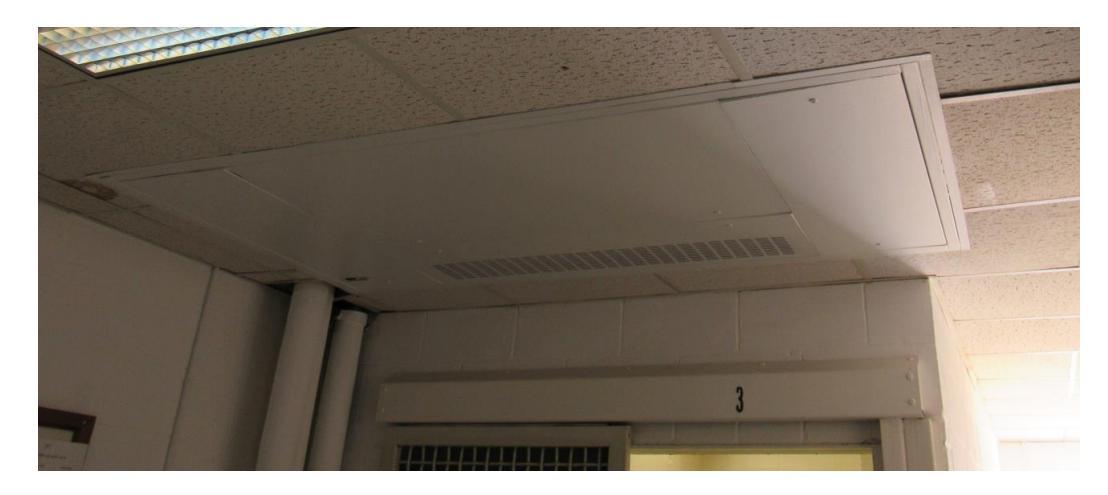
Ventilation air is provided to the lockup area via UV-1. Supply air is provided to the areas outside the cells and to some of the cells and exhausted from the cells. At the time of the visit, there was no supply airflow, and the exhaust airflow was very weak. The exhaust fan may not have been working. Some screened security exhaust grilles had been painted over, blocking much of the grille area. According to staff, UV-1 has not operated for many years. There is also a potential issue with the supply and exhaust air balance. According to the drawings, there is 350 CFM more lockup supply air than exhaust air. Generally, the

Photo 4 – Unit Ventilator in Lockup Area

We recommend repairing or replacing the Unit Ventilator serving the holding cell area to provide proper ventilation to the space and makeup air for the exhaust fan.
