Existing Building Investigation & Evaluation Report

Work Area – Alteration Level 3 Compliance Method

456 Main Street
Anywhere, MA 00002

August 31, 2016

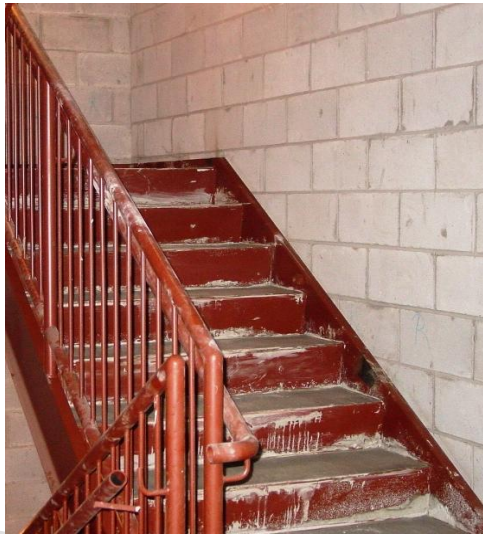
Damage at North Stair

Assessment: The maximum design occupant load for the building is 495 occupants. Two (2), fully enclosed, fire-rated stairways, remotely located are provided in accordance with Table 1006.3.1. However, noticeable concrete spawling was observed at the north stair posing tripping hazards under normal use. Additionally, stair lighting levels do not meet minimums required by 780 CMR, Section 1008.2.1 which establishes that ". . . means of egress illumination level shall be not less than 1 footcandle at the walking service". Each deficiency is due to lax maintenance and each will be appropriately remedied during the project renovation.
