# Existing Building Investigation & Evaluation Report

## *Work Area – Alteration Level 3 Compliance Method*

456 Main Street  
Anywhere, MA 00002

August 31, 2016

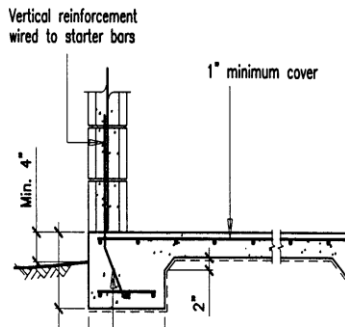
Typical Exterior Wall Detail

- Eight (8) inch split-faced, concrete masonry unit (CMU) exterior bearing walls, fully grouted and reinforced with #5 bars @ 4'-0" o.c.;
- Interior 8" x 8" nominal steel tube columns support, wide flange steel beams in 20'-0" bays;
- Open-web, steel bar joists @ 2'-0" o.c. roof structure with corrugated metal decking, light-weight concrete surface, rigid insulation and adhered, EPDM roof membrane (*see typical details below*).
- Interior walls are non-bearing, steel studs with ½" g.w.b. and skim coat of plaster.
