Framingham District Court Framingham, MA

HVAC SYSTEM EVALUATIONS COVID-19

Office of Court Management

October 12, 2021

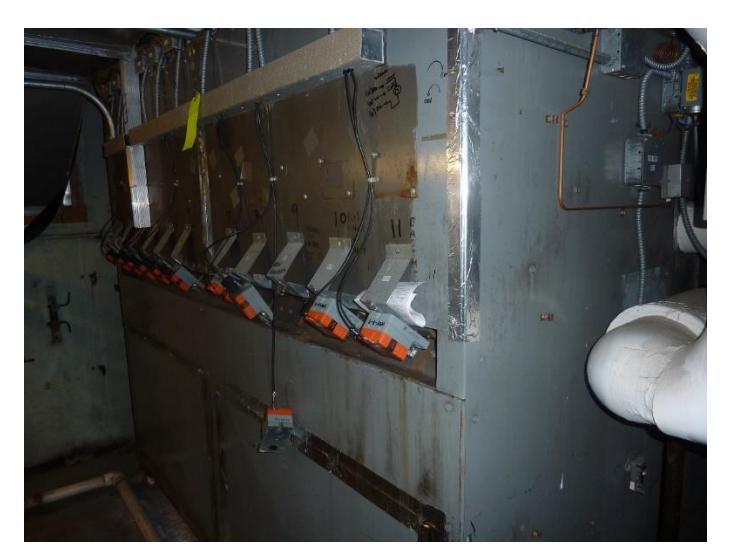
AC-1 is a Worthington unit with 10 active zones and one inactive zone. AC-2 is a McQuay unit serving five zones. The individual zone dampers appear to be original equipment, but the actuators were upgraded to electronic (Belimo) in 2008. These units have 2" thick MERV-10 filters in a v-bank arrangement. Cooling for the multizone units is provided by a roof-mounted air-cooled condensing unit, and a Trane 50-ton air-cooled condensing unit, pad-mounted on grade. According to facilities personnel, this condensing unit is oversized and only one of the two refrigeration circuits is used.

Photo 1 – Representative Air Handler

The coils in air handlers appear to be original, and Tighe & Bond does not know how regularly they have been cleaned. There was a visible accumulation of dust and debris on the coils in AC-1 and AC-2.

RE-2: Clean air handler coils.

Replacing the air handlers should be considered within 3-5 years. Indoor central station air handling units have a life expectancy of 35-40 years. The multizone units appear to be much older than that, and they have components that are in poor condition and subject to imminent failure, which will result in an immediate and extended interruption to Courthouse activities. The small size of the mechanical rooms, particularly for AC-2, will present a challenge. Original exhaust fans and unit ventilators should be replaced as well.

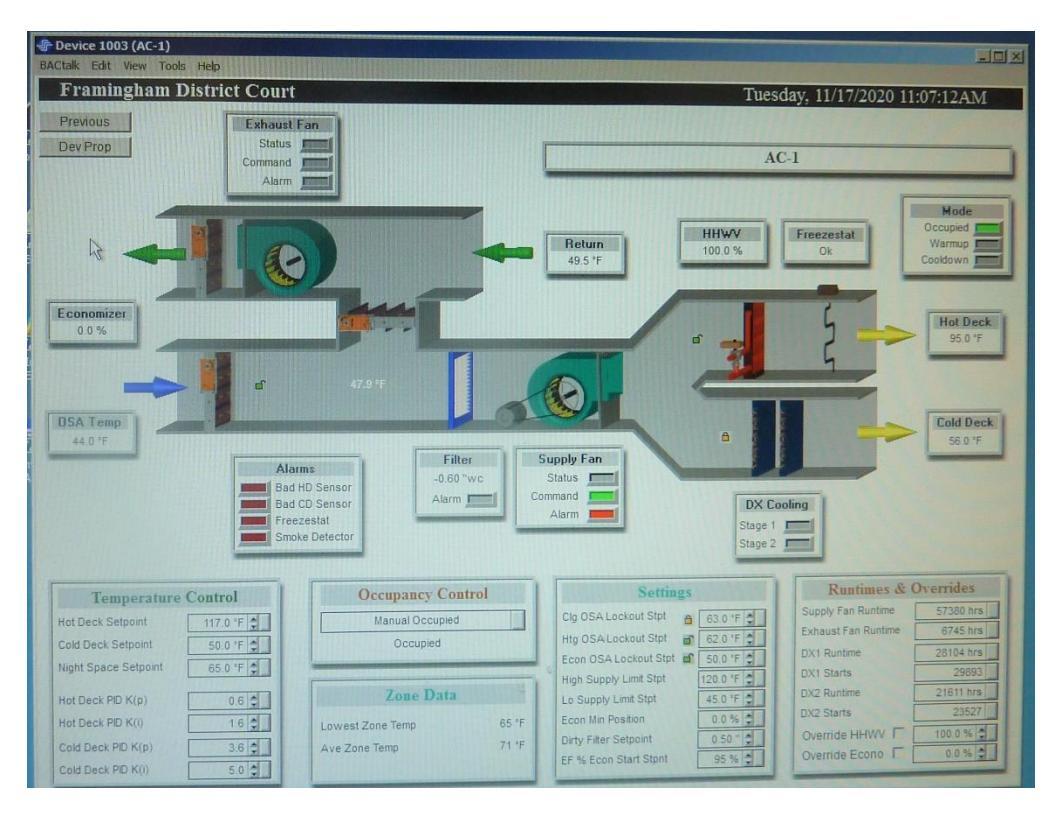
Displays from the BMS showed a wide variation in zone supply air temperatures. It is not known if this is due to damper adjustment or temperature sensor calibration.

We observed that the supply air temperatures for zones with the same damper position varied widely. The AC-1 zones calling for full heat, with the cold deck fully closed, varied between 72°F and 101°F. The supply air temperatures for AC-1 zones in full cool, with the cold deck 100% open, ranged from 60°F to 70°F. All zones on AC-2 were calling for full cooling with the cold deck 100% open, and supply air temperatures varying between 72°F and 84°F.

Other issues observed were the filter pressure drop in AC-1 was a negative value, and the supply fan statuses were negative in AC-1 and AHU-2 although the fans were running. Each of the air handlers were showing several active alarms.

Photo 2 - Representative BMS Screen

Wide variations in discharge air temperature for zones in AC-1 and AC-2 with the same displayed damper position demonstrate that dampers are not at the position indicated on the BMS. Repair or replace the dampers and actuators that are not opening and closing fully, or not going to the position commanded by the controls.

The filter pressure drop displayed for AC-1 was -0.60" w.g., which is actually a pressure rise. It is possible that the taps for the upstream and downstream pressures are reversed. We recommend testing and calibrating this sensor so that it can accurately flag when filters should be replaced.

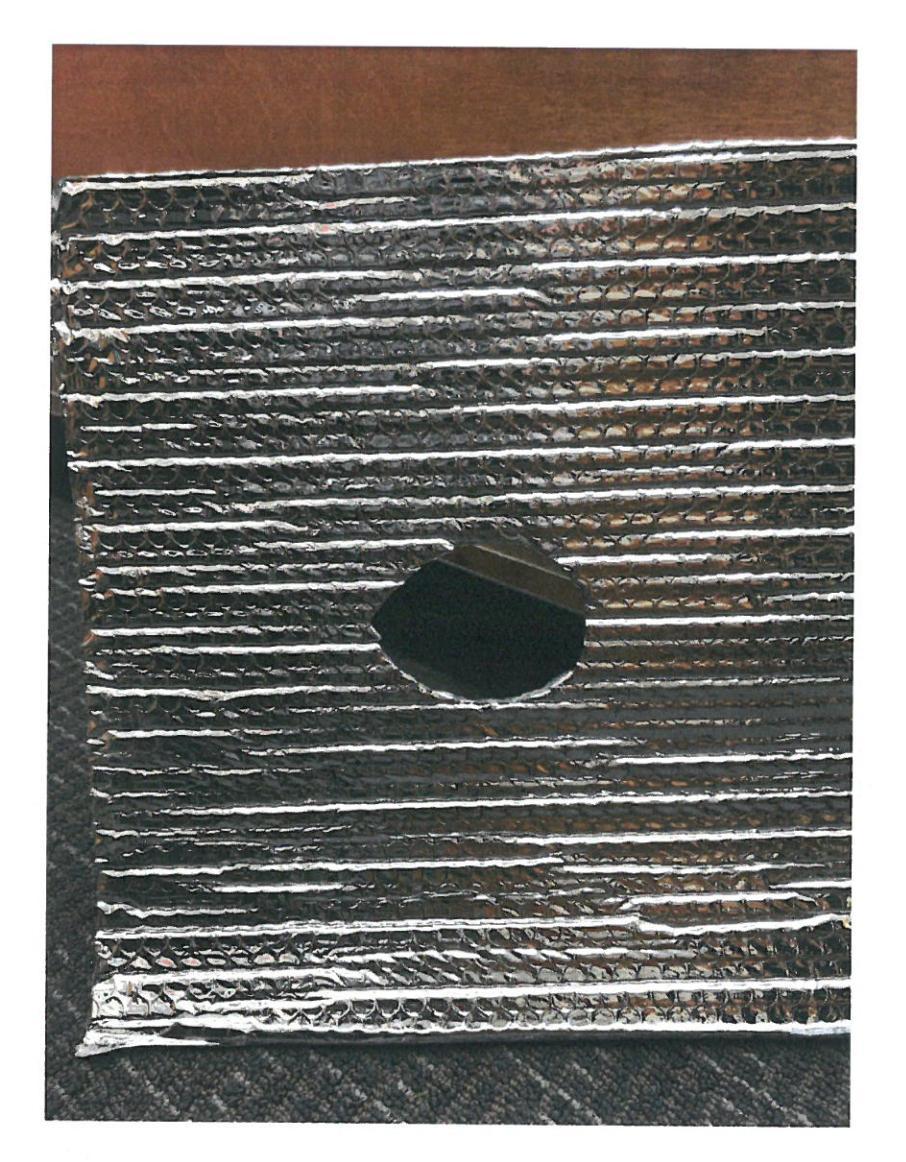
Court-3 (Room 205) Found inside Supply Diffuser

(4) We found aluminium foam on the collar, as shown in picture, second reading when piece was removed.
