The Commonwealth of Massachusetts

DEPARTMENT OF PUBLIC UTILITIES

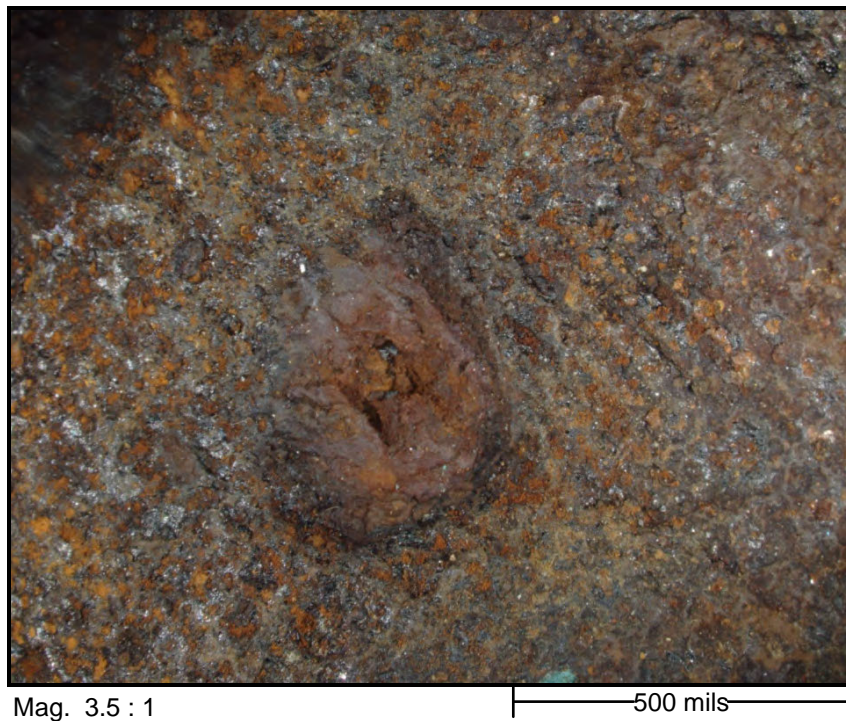
Figure 61: Failed location at 4 o'clock: An overall view of the corroded spot on OD.

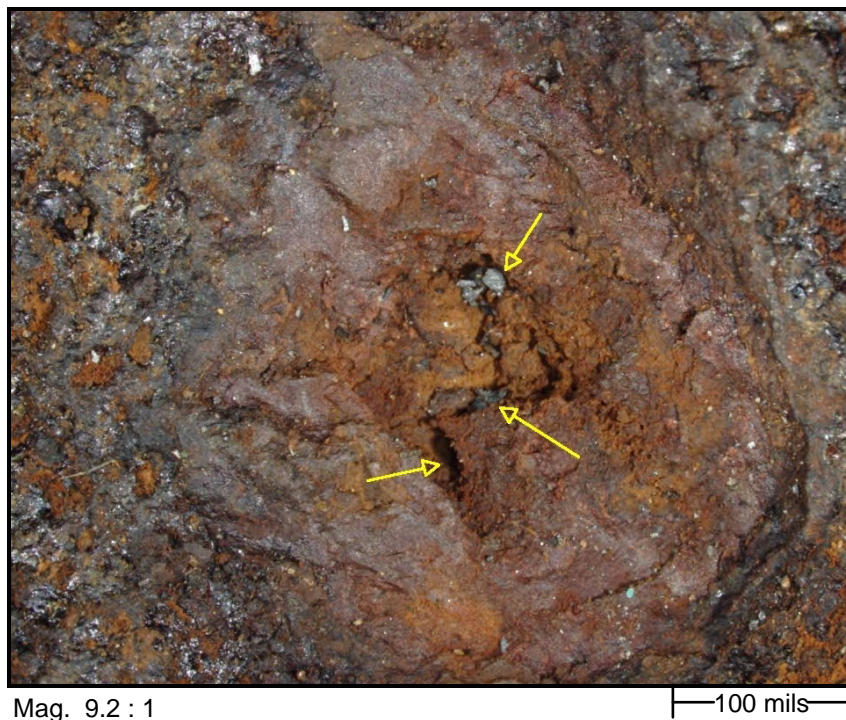
Figure 62: Failed location at 4 o'clock: An overall view of the corroded spot on OD. A higher magnification view of the previous image. Arrows point to possible through wall corrosion.

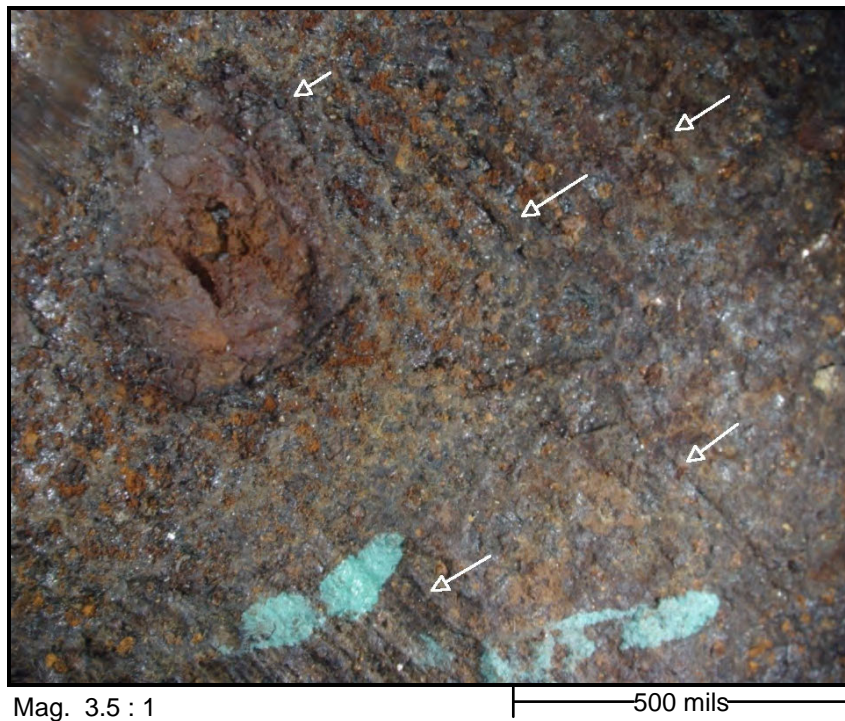
Figure 63: Failed location at 4 o'clock: An overall view of the corroded spot on OD. Arrows point to parallel line type surface impression around the corroded spot.

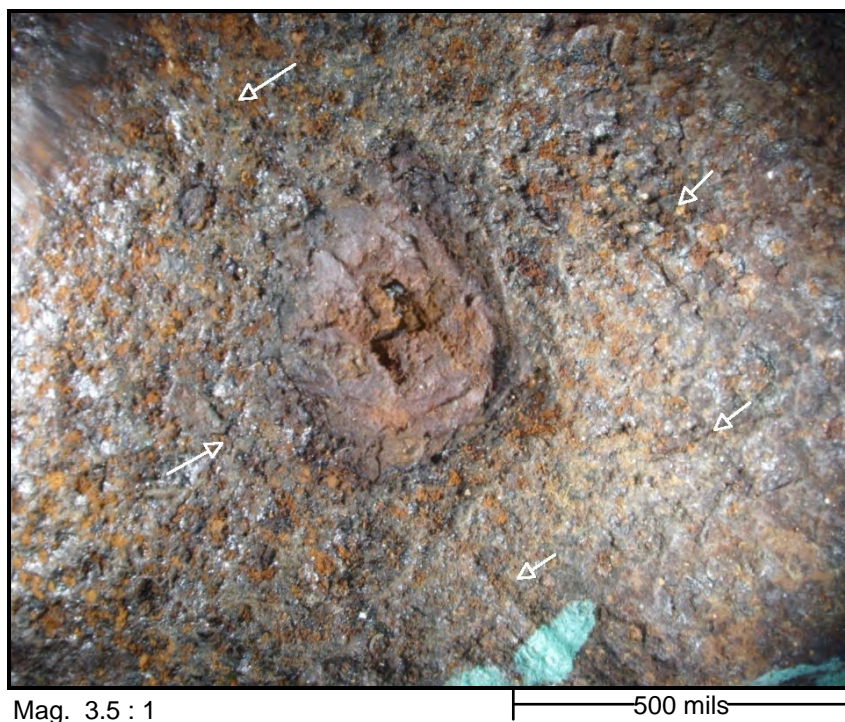
Figure 64: Failed location at 4 o'clock: An overall view of the corroded spot on OD. Arrows point to parallel line type surface impression around the corroded spot. Another view.

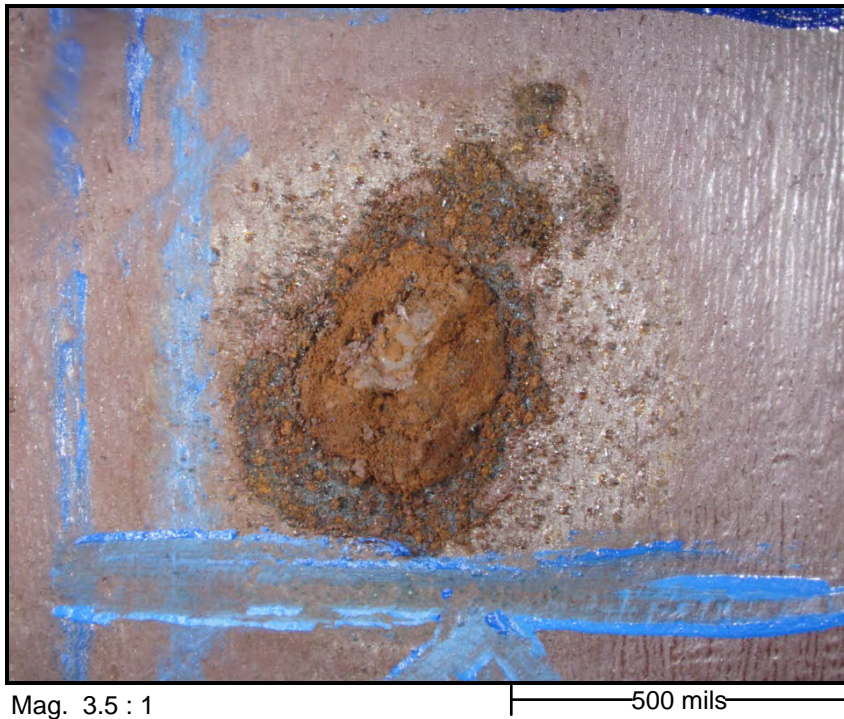
Figure 65: Failed location at 4 o'clock: An overall view of the corroded spot on ID. Note the packed corrosion debris.

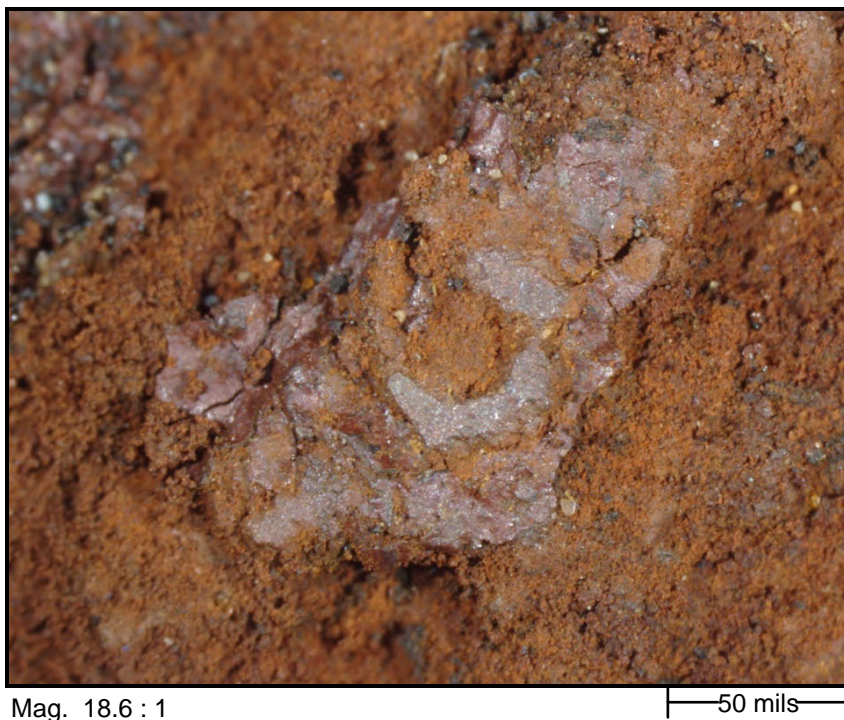
Figure 66: Failed location at 4 o'clock: An overall view of the corroded spot on ID. Note the packed corrosion debris. A higher magnification view of the previous image.

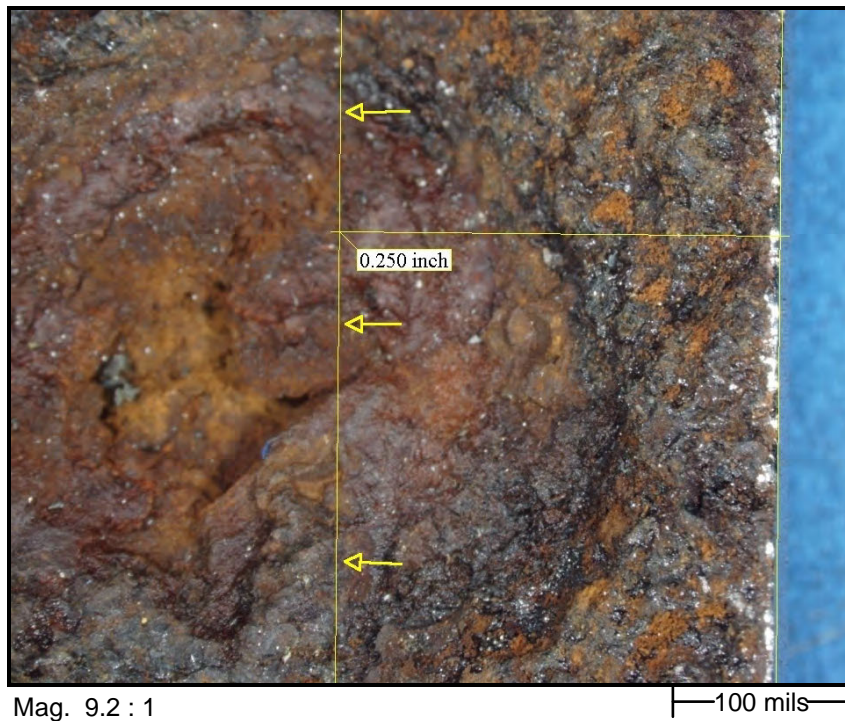
Figure 67: 4 o'clock anomaly: Arrows point to the mounted plane.

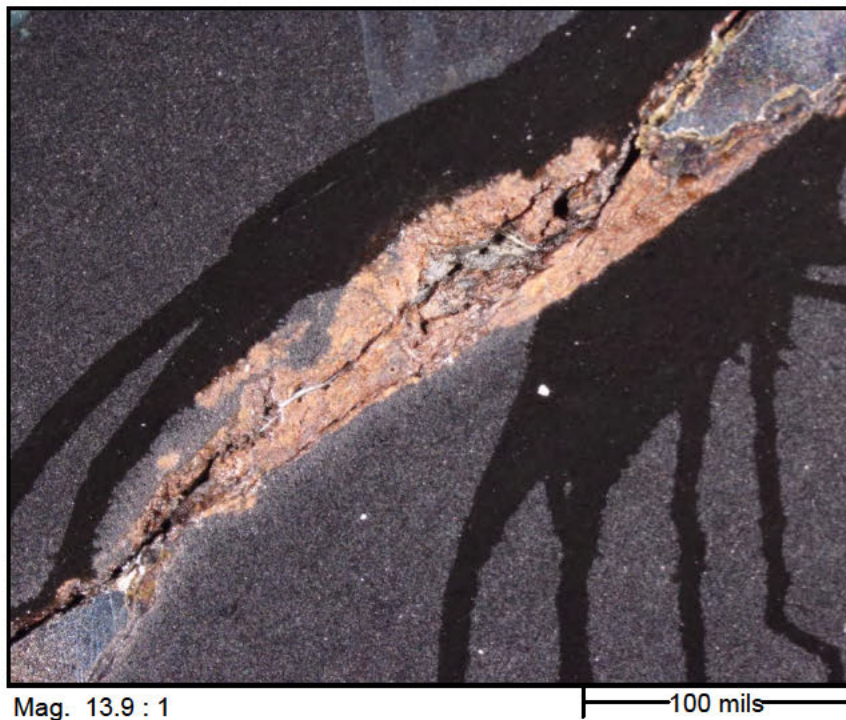
Figure 91: 4 o'clock: An overall view of the mounted cross-section. A higher magnification view of the corrosion debris tightly packed in the pit.

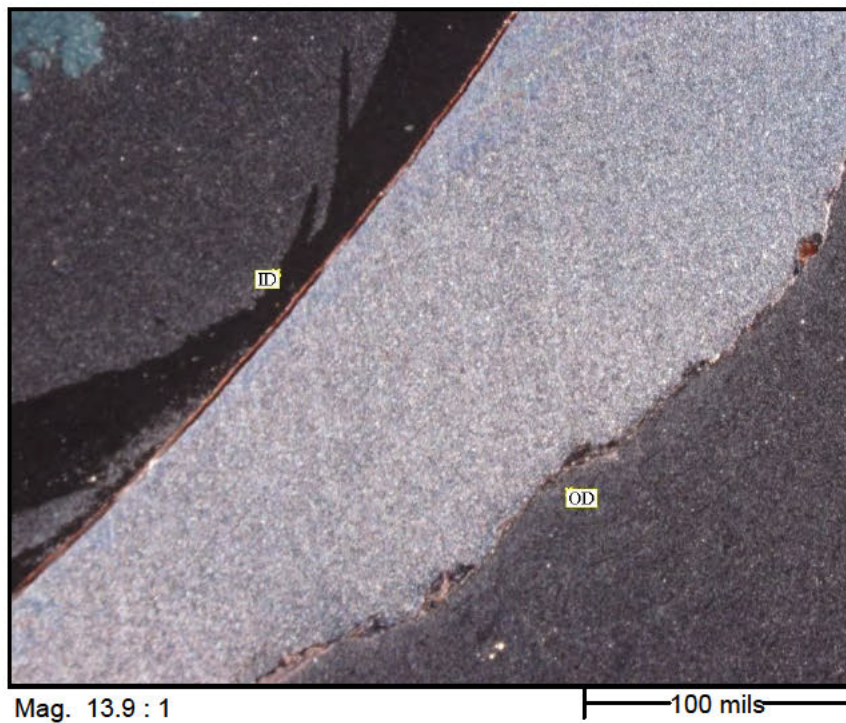
Figure 92: 4 o'clock: An overall view of the mounted cross-section. Note general corrosion on the OD. On the ID a reddish coating layer is present; no corrosion on the ID.

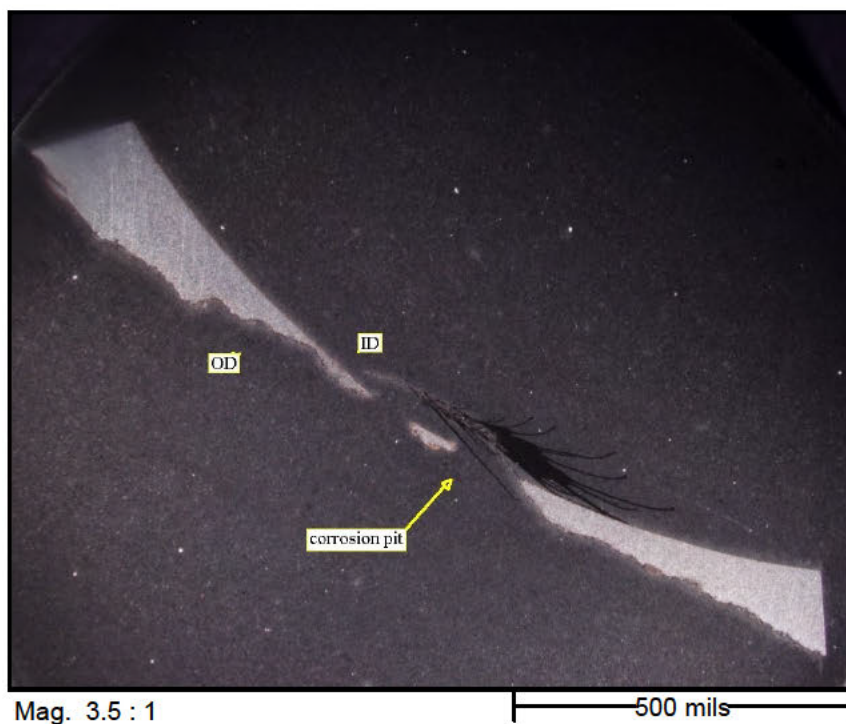
Figure 93: 7 o'clock: An overall view of the mounted cross-section.

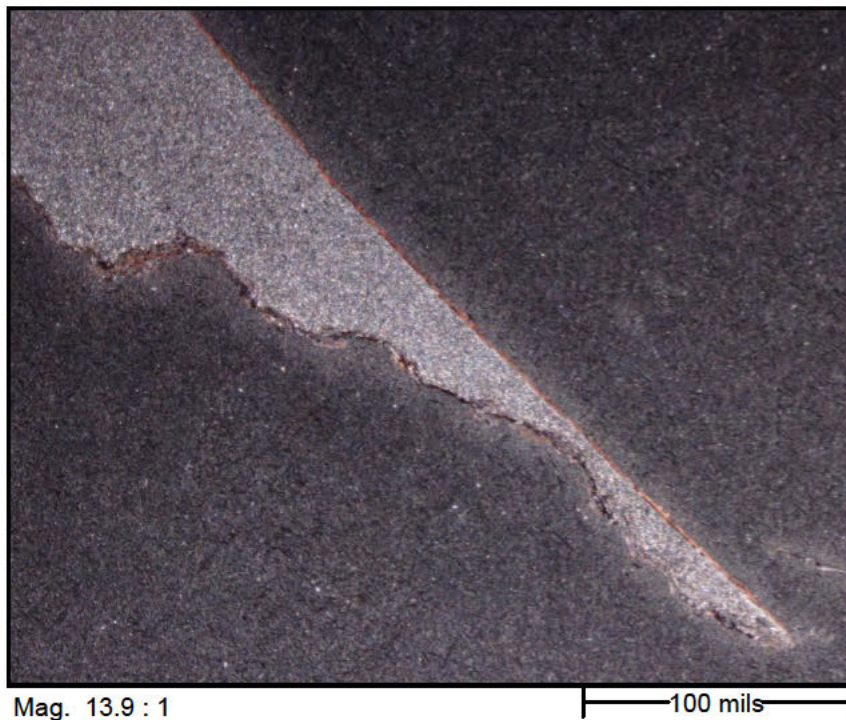
Figure 95: 7 o'clock: An overall view of the mounted cross-section. A higher magnification view of the pit edge. Note the general wall thinning due to corrosion on the tube from the OD and reduction of the wall to knife edge.

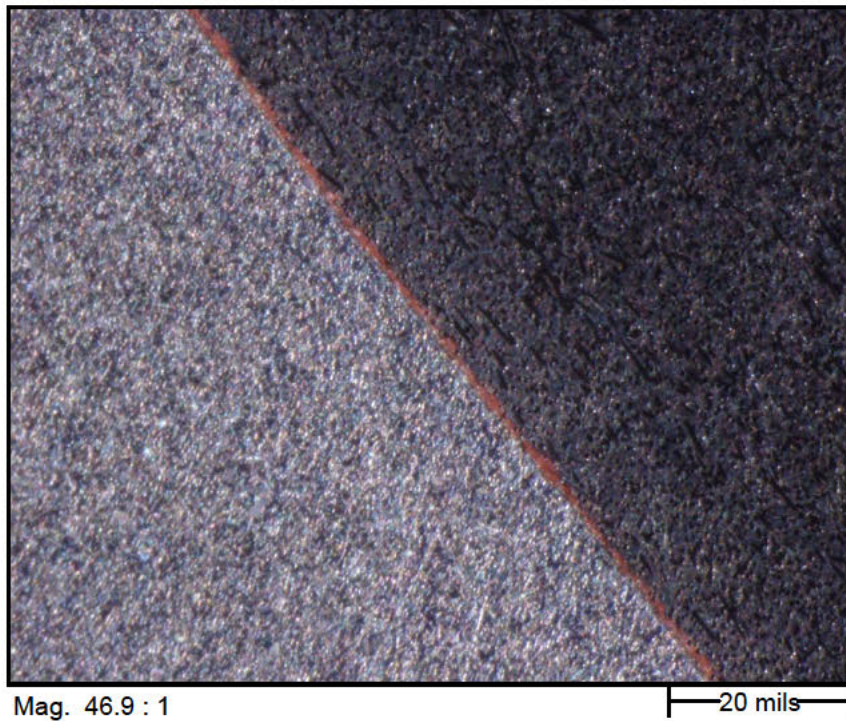
Figure 96: 7 o'clock: Note the reddish paint layer on the ID and no corrosion.

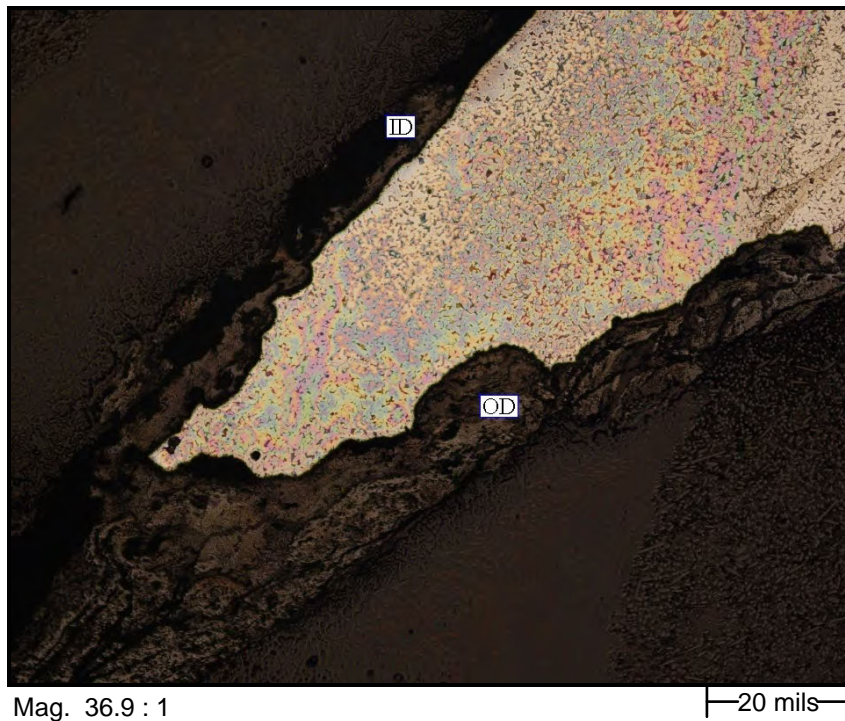
Figure 97: Mount at 4 o'clock: the view shows an edge of the through wall corrosion pit.

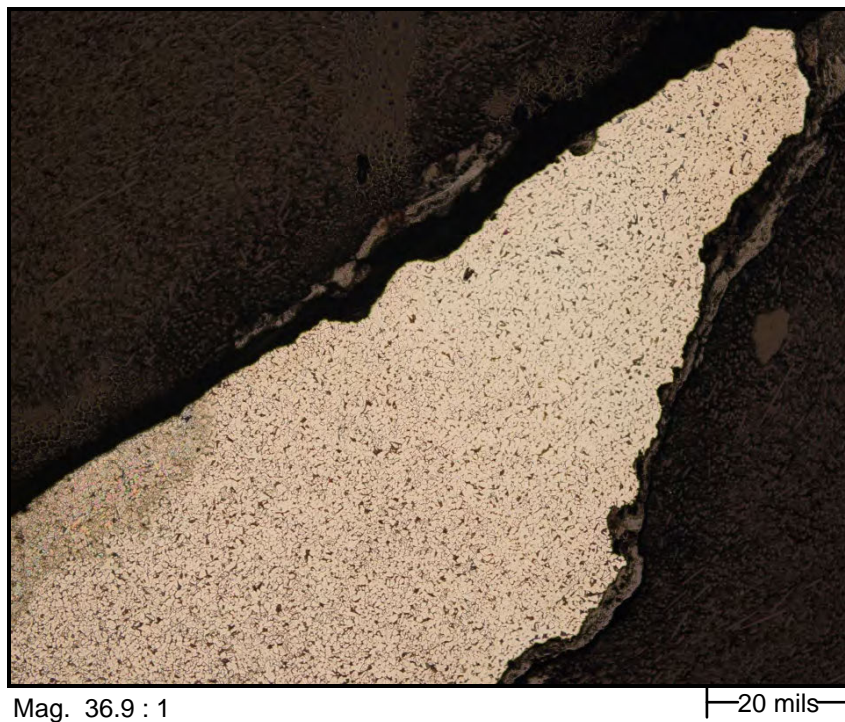
Figure 98: Mount at 4 o'clock: the view shows the opposite edge of the through wall corrosion pit.

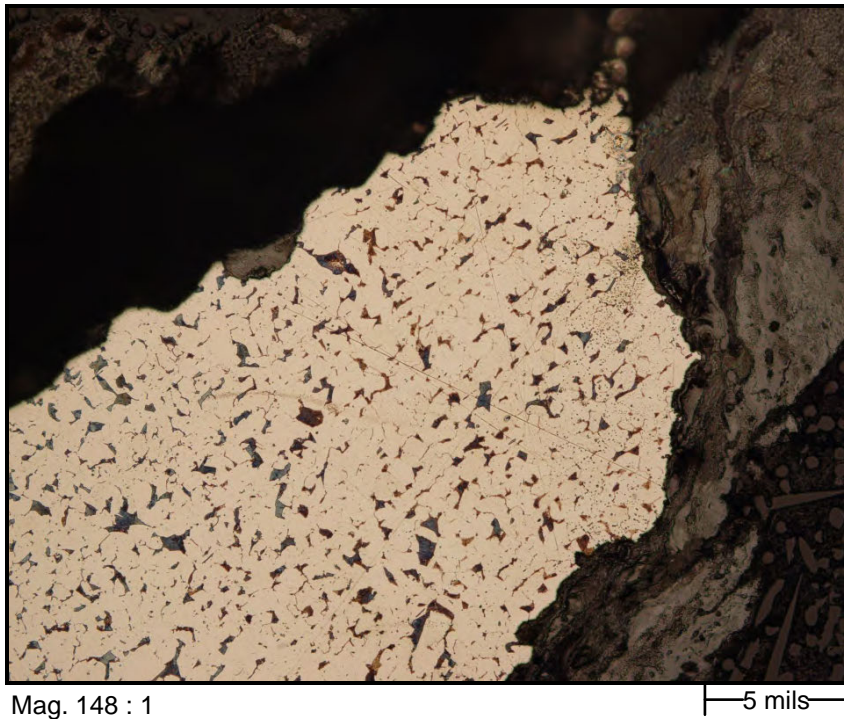
Figure 99: Mount at 4 o'clock: the view shows the opposite edge of the through wall corrosion pit. A higher magnification view of the previous image showing the microstructure.

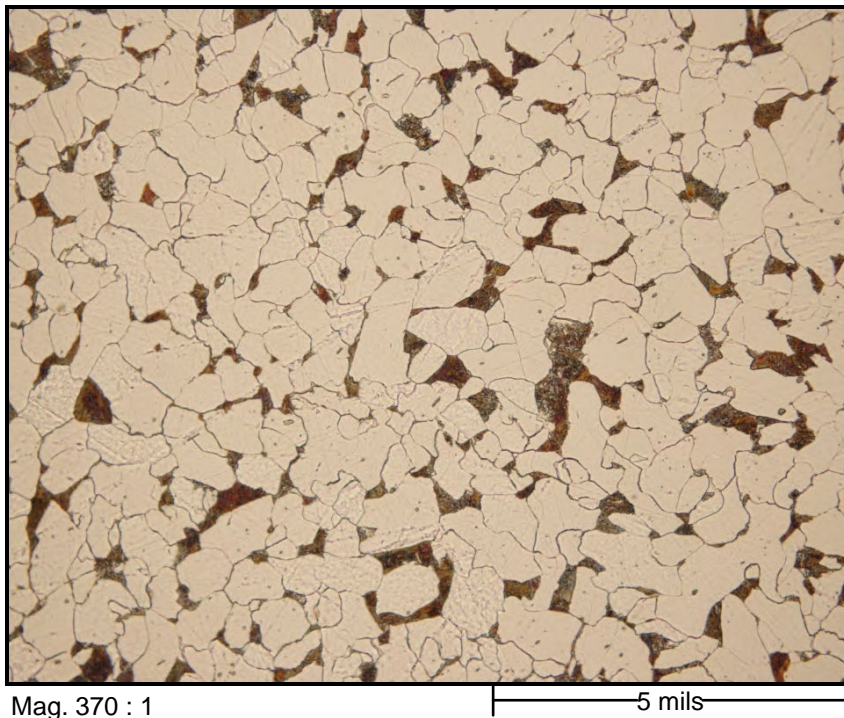
Figure 100: Mount at 4 o'clock: A representative view of the microstructure.

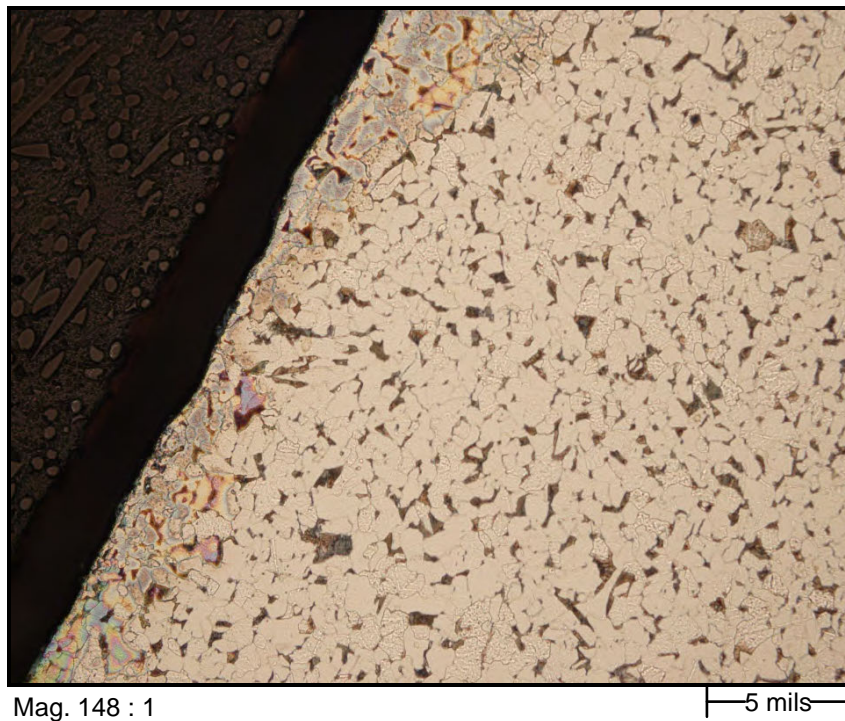
Figure 101: Mount at 4 o'clock: The ID of the tube shows no corrosion.

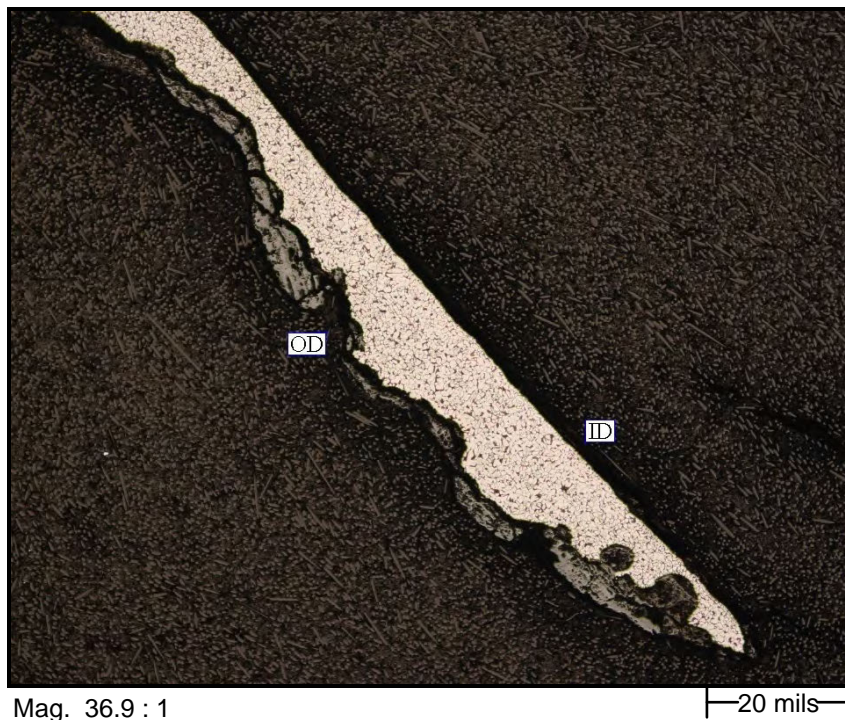
Figure 102: Mount at 7 o'clock: the view shows an edge of the through wall corrosion pit.

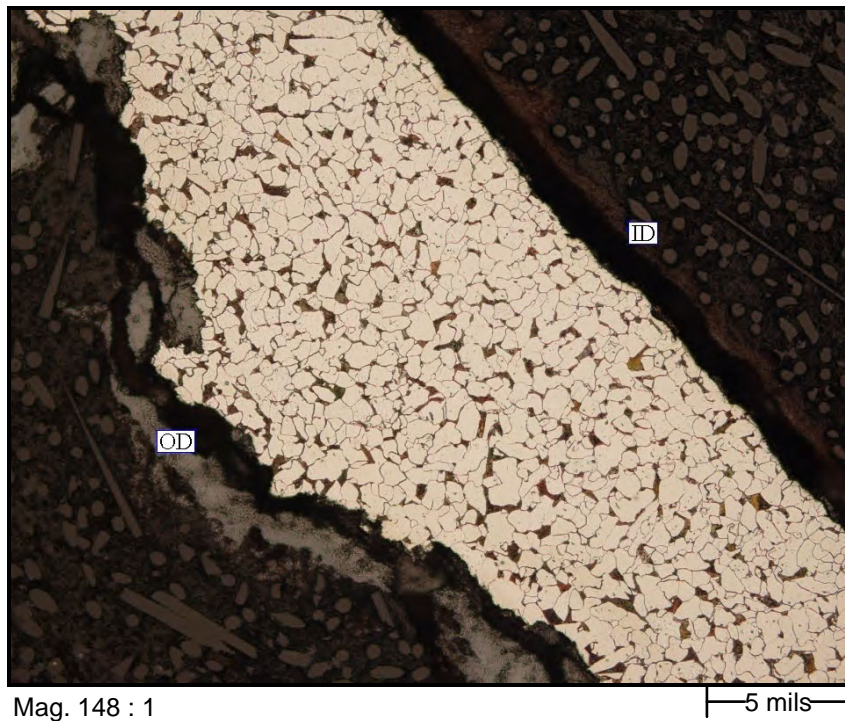
Figure 103: Mount at 7 o'clock: the view shows general corrosion attack on the OD. No corrosion noted on the ID.

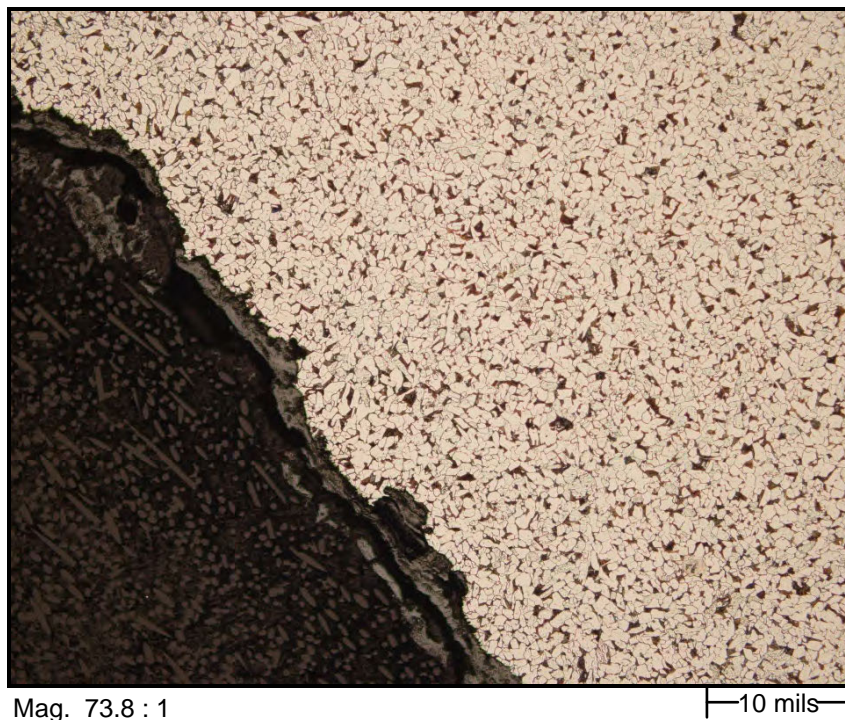
Figure 104: Mount at 7 o'clock: the view shows general corrosion attack on the OD.

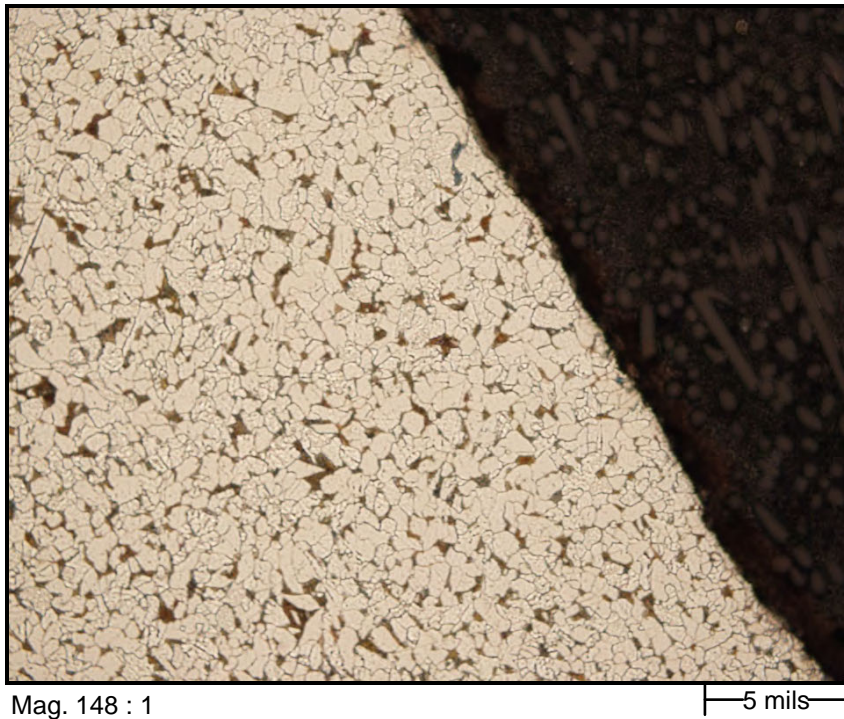
Figure 105: Mount at 7 o'clock: the view shows no corrosion attack on the ID.
