Independent Assessment of Columbia Gas of Massachusetts' Merrimack Valley Restoration Program

Commissioned by the Massachusetts Department of Public Utilities

Document type	Final Report
Project name	CMA MV Restoration Program Assessment
Date	June 22, 2020
Draft status	Final Report
	Department of Public Utilities (DPU)
Prepared for	Executive Office of Energy Environmental Affairs (EEA)
	Commonwealth of Massachusetts
Project number	BD-19-1033-DPU01-DPU01-31885
Request number	19DPUUSGAMY4
Prepared by	Dynamic Risk Assessment Systems, Inc.
Project number	SOMA_2019_02
Revision	0

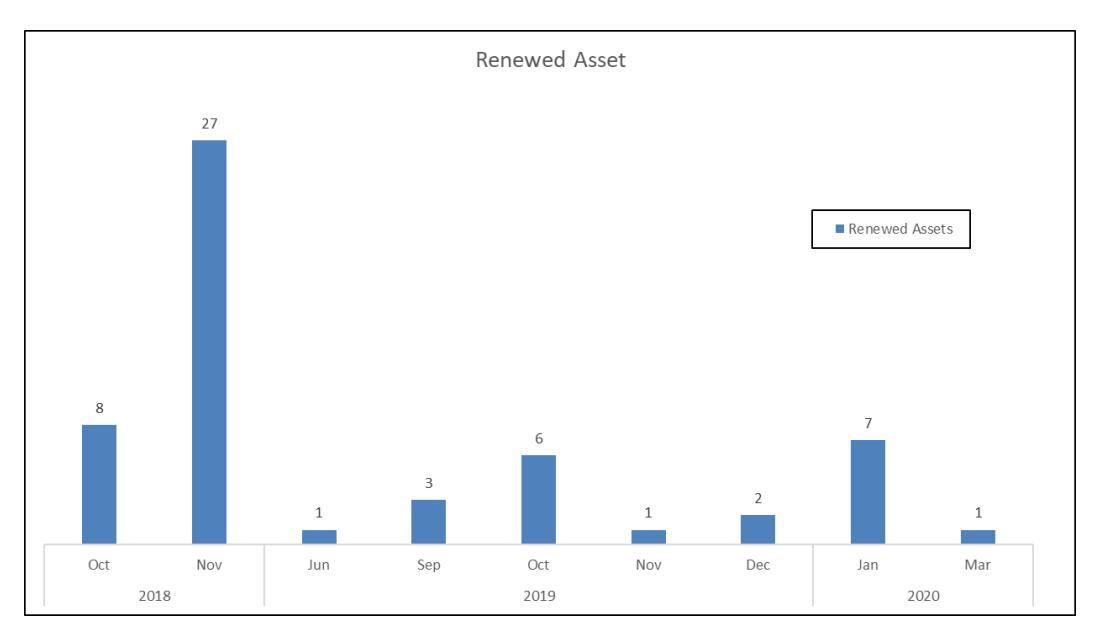
Figure 2: Gas Leaks on Renewed Assets Since In-service Date

CMA reported 54 gas leaks discovered on the Renewed Assets since they were put into service. ²¹⁰ As can be seen in Figure 2,²¹¹ the gas leaks on the Renewed Assets started out high, then dropped and then modestly increased. This increase correlates to CMA's increase in the number of leak surveys in the fall of 2019. The second increase appears be connected to CMA's decision to utilize a more sensitive leak survey tool, known as Picarro[™] which can detect smaller leaks.

CMA calculated its leak ratios on the Renewed Assets the first 6 months following installation and the second six months. The overall increase in leaks per 100 miles would be expected with the use of Picarro[™] as shown in January 2020. See Table 10.

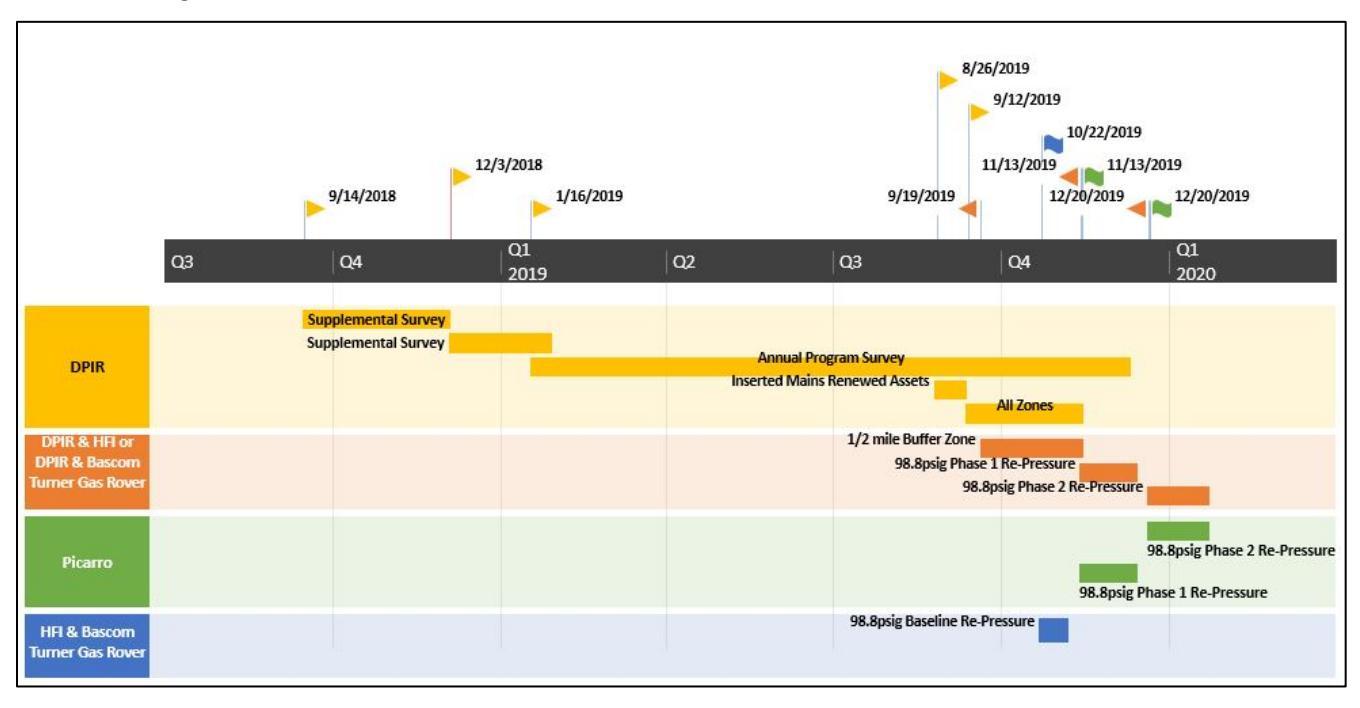
Figure 3 Timing of Leak Survey

CMA initially attributed the increased leak rate resulted from an increase in supplemental leak surveys.²¹² After the technical teams further reviewed how the leak leaks were discovered, only 9 out of 37 leaks in the fourth quarter of 2018 were previously discovered with a supplemental survey. See Figure 3.

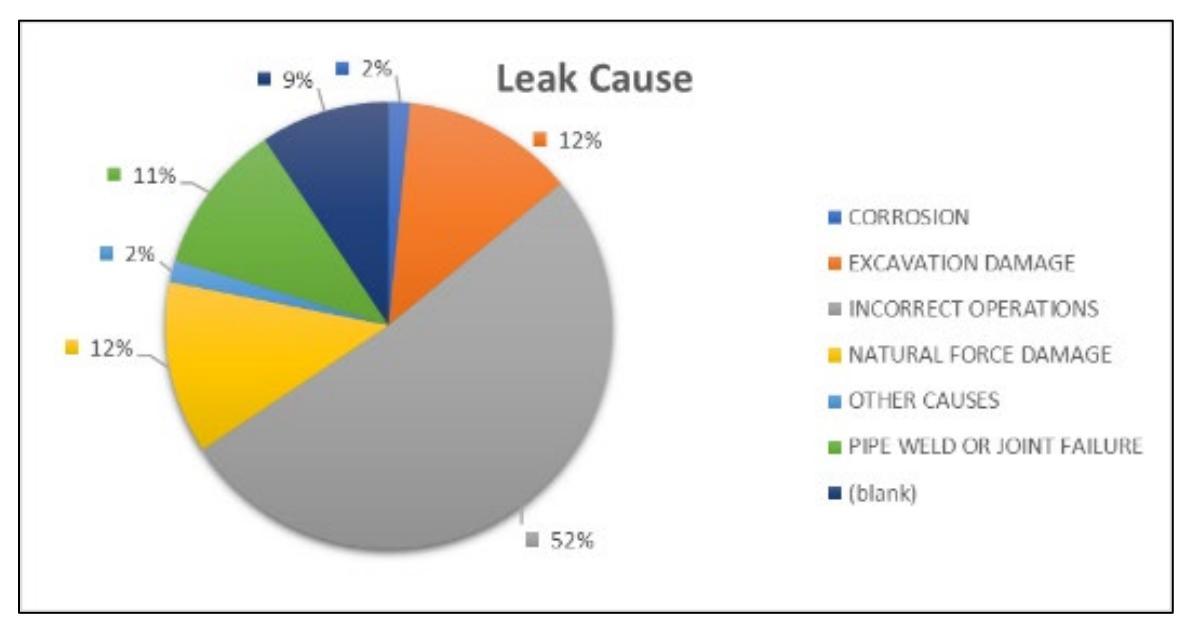
Figure 4: Gas Leaks by Cause on Renewed Assets Since In-service Date

The majority of the gas leaks on the Renewed Assets were caused by incorrect operations²¹³ as a result of issues with installing mechanical fittings²¹⁴ such as service tee caps and fittings, but other causes were also reported. For example, three leaks that occurred on saddle tees which CMA asserts were the results of issues arising from the manufacturing process. See Figure 4 and Figure 5 for more details on Leak cause and Gas Leak by Asset type, respectively.

²¹³ Most of the leaks were related to the incorrect installation of mechanical fittings. CMA classified these leaks as incorrect operations based upon the PHMSA failure cause classification.

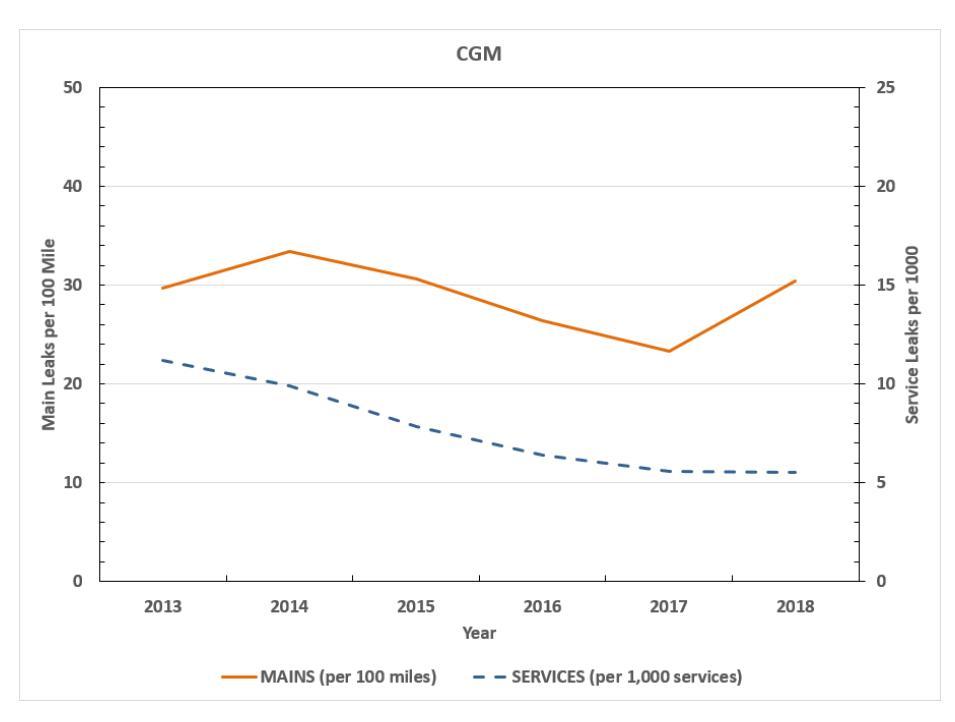
Figure E-1: Columbia Leak Ratio (Mains and Services)

- Overall leak ratio trend is downward, with a recent uptick in main ratios;
- Ratios are comparatively high;
- Causes include corrosion, joint failure, natural force damage and other supporting continuing strong renewal programs for GSEP and pre-70's vintage assets;
- Analyze why progress in reducing leaks through GSEP appears have reversed course in 2017; and
- Monitor leak ratios and consider pipe replacement selection to ensure remediation remains ahead of general system deterioration.

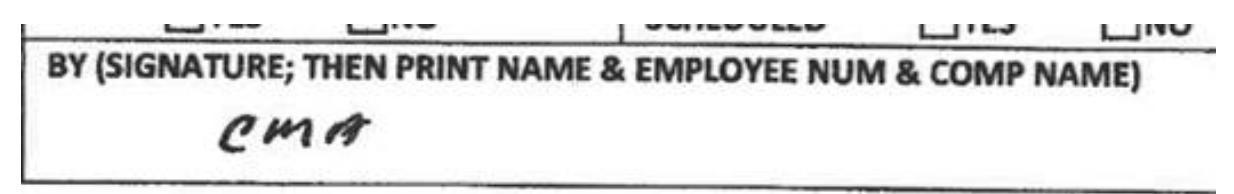
Figure G-7: CMA Tap Card Signature

Figure G-6: CMA Summary with Mismatches in Pressure and Duration
Figure G-7 is an example of the signature block that is completed by someone writing in the letters "CMA" rather than having an individual sign the tap card. There were approximately 75 such Tap Cards.

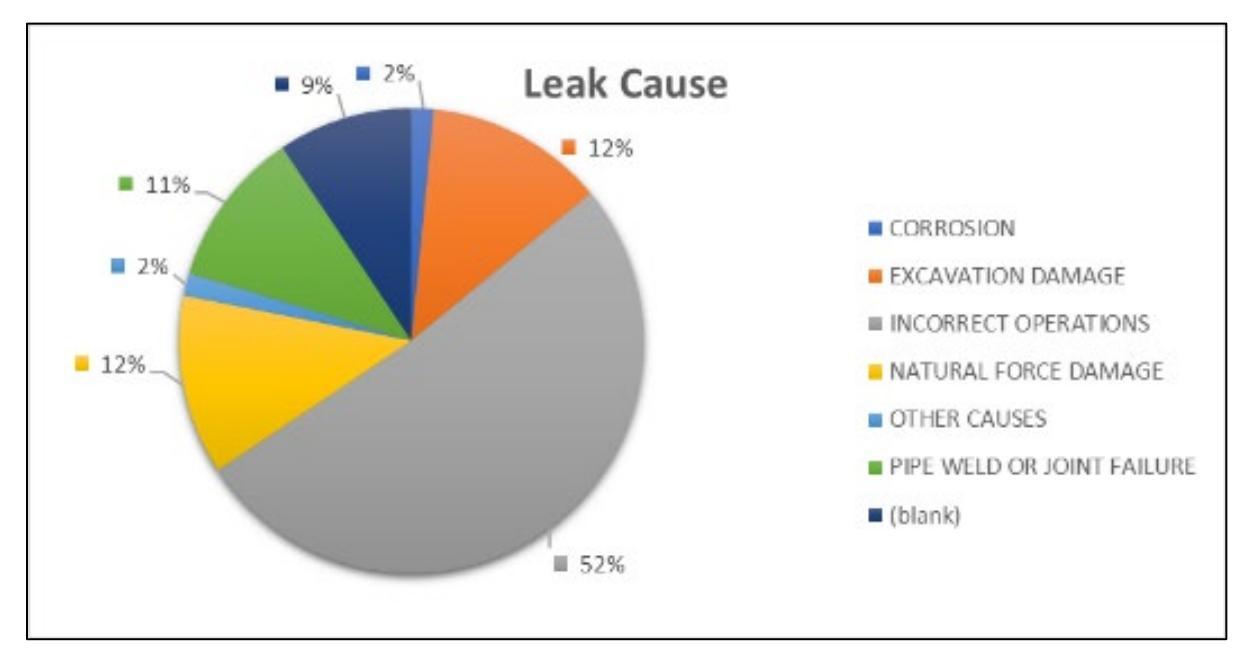
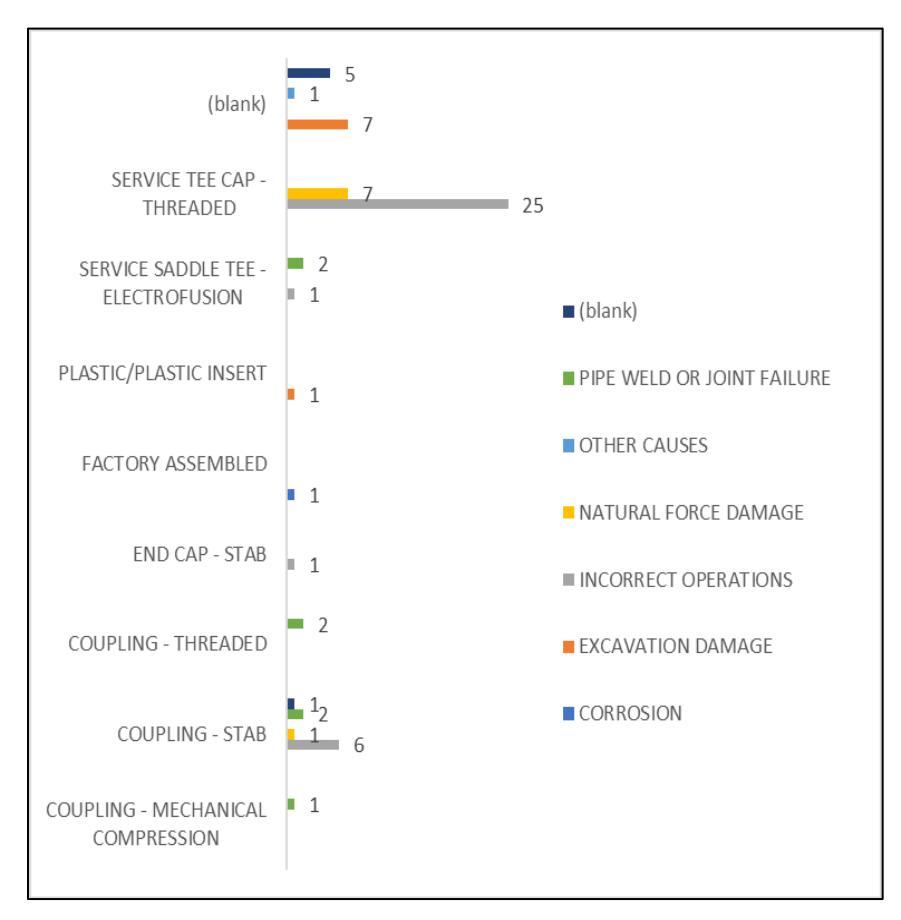
From the time the Renewed Asset was put into service to March 22, 2020, the majority of leaks on the Renewed Asset were caused by incorrect operations which is a term that is defined by PHMSA. CMA uses this term to include issues with installation and construction. These leaks are also attributed to service tee caps and stab fittings. See Figure K-1 and Figure K-2.

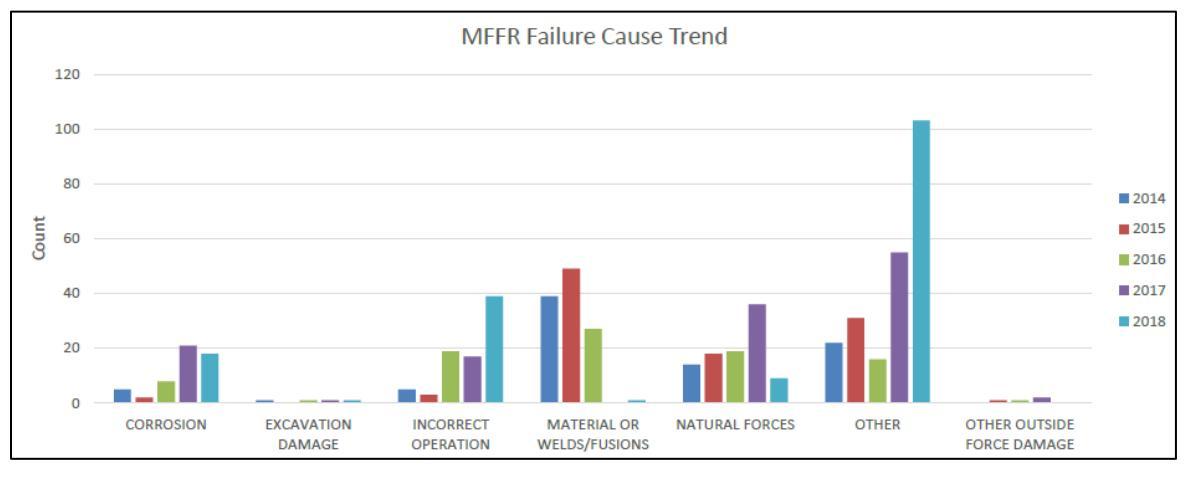
Figure K-3: Materials Facility Failure Report Failure Cause Trend (Attachment CMA_MV 15.24(d))

CMA compared their failure causes (Attachment CMA_MV 15.24(d)) over the last five years, which revealed an upward trend in their incorrect operations. In the 4th quarter of 2018, 28 of their leaks were caused by incorrect operations. This means that more than half of CMA's leaks were caused by incorrect operations in 2018. See Figure K-3.

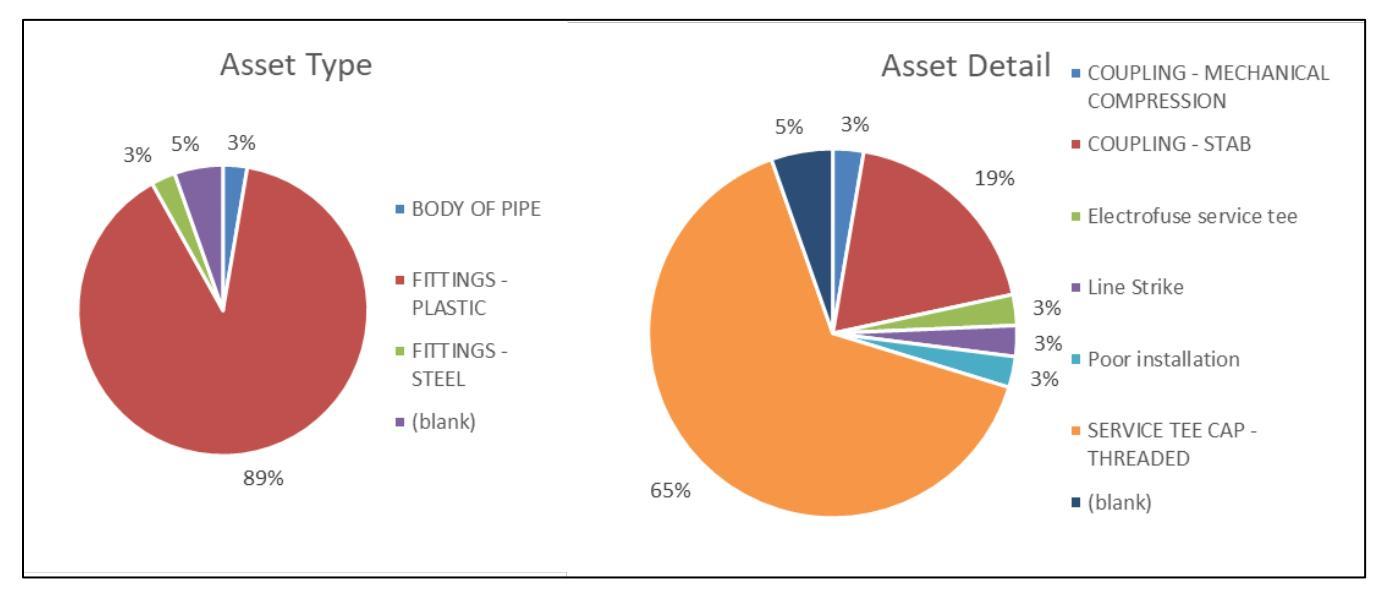
Figure K-4: Leaks by Asset Type and Asset Detail

Out of 37 leaks on the Renewed Assets in the 4th quarter of 2018, a majority (94%) of the leaks were attributed to Service Tee Caps (see Figure 6). Their report claimed these surveys were performed for QC and that they are not a typical practice for new construction. If QC were a point of focus, their leak analysis could have been performed sooner than 2/3/2020. Further, these surveys could have raised concern immediately about quality and the success of the Restoration Project for the renewed asset. A new system that has many leaks immediately after a system is put into service does not provide confidence in CMA's quality of work or QC and inspection programs. CMA could have completed a review in material selection, construction and inspection. Lastly, testing could have been performed based on their findings. See Figure K-4.
