# Climate Change Water Resource Vulnerability and Adaptation Strategy Assessment – Integrated Management Plan

TOWN OF CARVER, MASSACHUSETTS

prepared by  
FUSS & O'NEILL

JUNE 2019

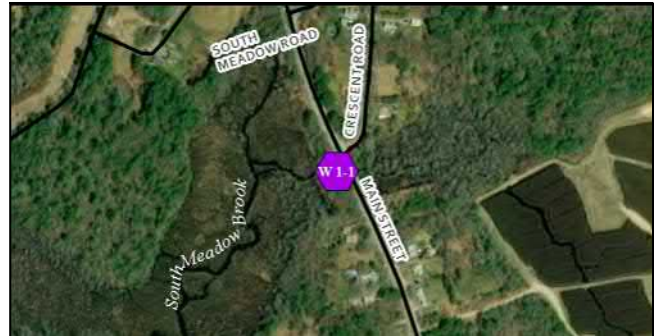
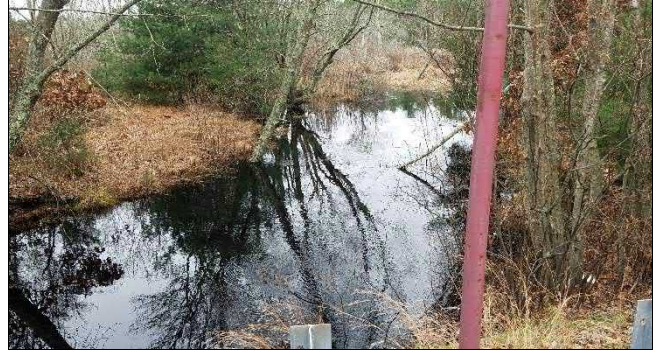
- Waterbody Name: Unnamed Tributary
- Estimated Surface Area: N/A
- Depth Near Shore: Greater than 2 feet

Dredge water supply sediment bottom to required depths and clear bank vegetation to allow access year round.

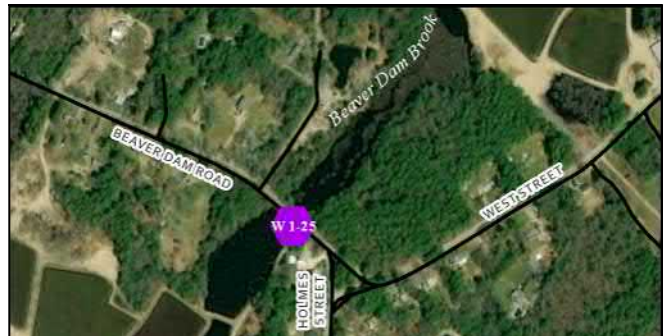
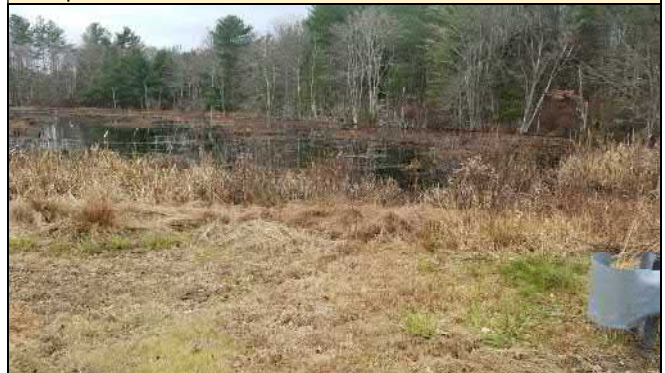
## Fire Department Water Supply Site #2 – W 1-25

- Waterbody Name: Beaver Dam Brook
- Estimated Surface Area: 96,500 sf
- Depth Near Shore: Less than 2 feet

Dredge sediment bottom to required depths and area, use control structures to maintain high water levels, clear bank and aquatic vegetation, and plant new emergent aquatic vegetation.

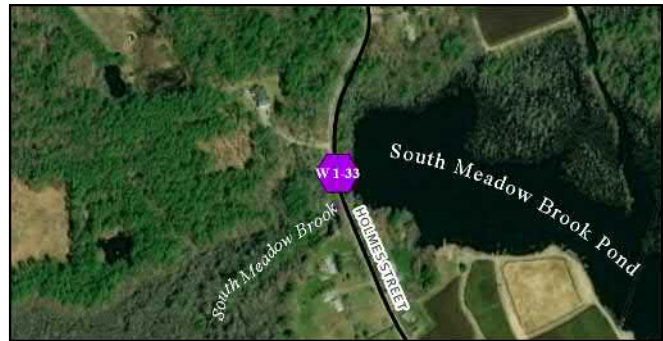
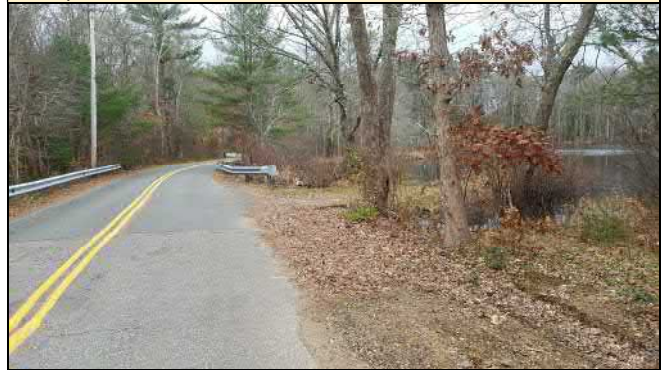
### Fire Department Water Supply Site #3 – W 1-33

- Waterbody Name: South Meadow Brook Pond
- Estimated Surface Area: 1,080,000 sf
- Depth Near Shore: Greater than 2 feet

Dredge sediment bottom to required depths and area, clear bank and aquatic vegetation, and plant new emergent aquatic vegetation.

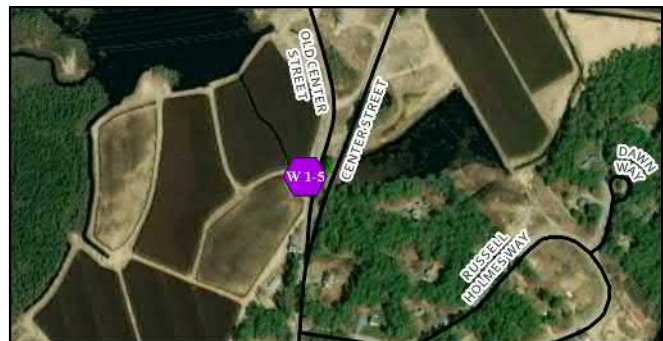
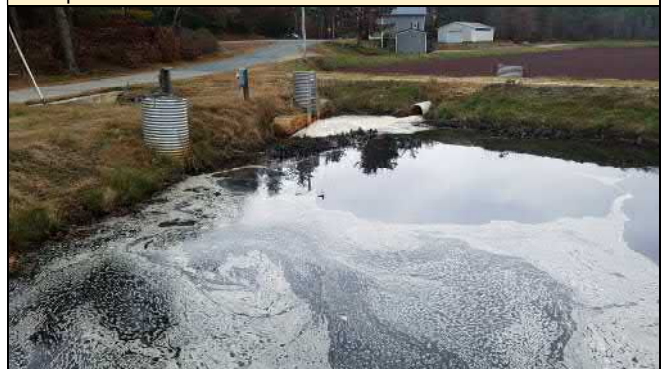
### Fire Department Water Supply Site #4 – W 1-5

- Waterbody Name: Unnamed Reservoir
- Estimated Surface Area: N/A
- Depth Near Shore: Greater than 2 feet

Dredge sediment bottom to required depths and area, and utilize cranberry farm irrigation control structures to maintain higher water levels within the water source during drought conditions.

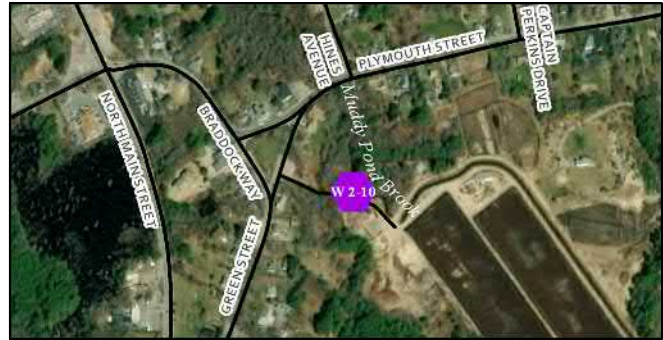
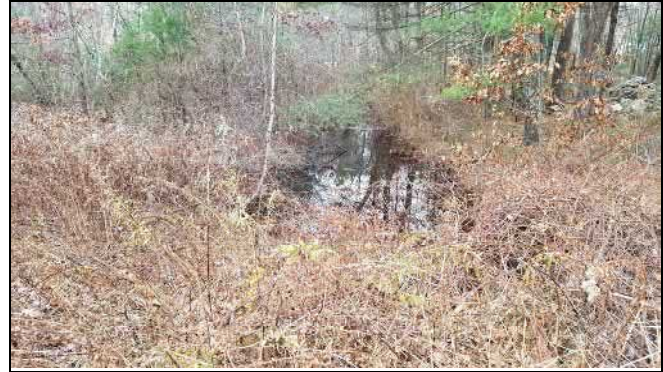
### Fire Department Water Supply Site #5 – W 2-10

- Waterbody Name: Muddy Pond Brook
- Estimated Surface Area: N/A
- Depth Near Shore: Greater than 2 feet

Dredge sediment bottom to required depths, utilize upstream cranberry farm irrigation control structures to maintain higher water levels within the water source, and clear banks of vegetation.

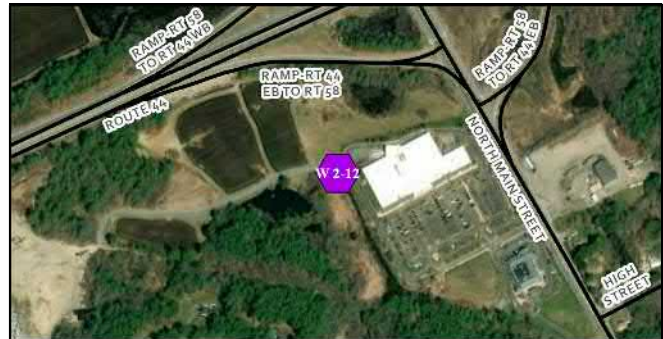
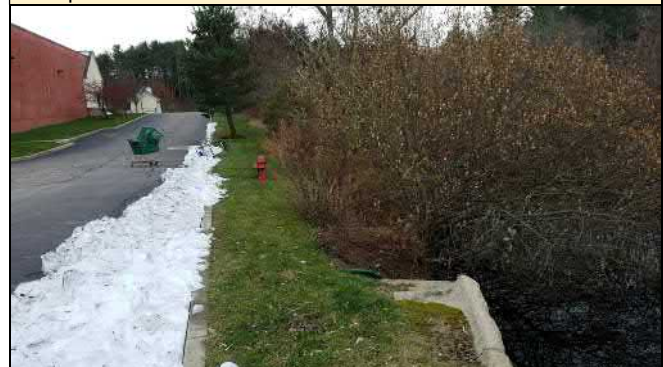
### Fire Department Water Supply Site #6 – W 2-12

- Waterbody Name: Unnamed Conduit
- Estimated Surface Area: N/A
- Depth Near Shore: Less than 2 feet

Dredge sediment bottom to required depths and area, clear bank and aquatic vegetation to ensure seasonal access and prevent potential pumping obstructions.

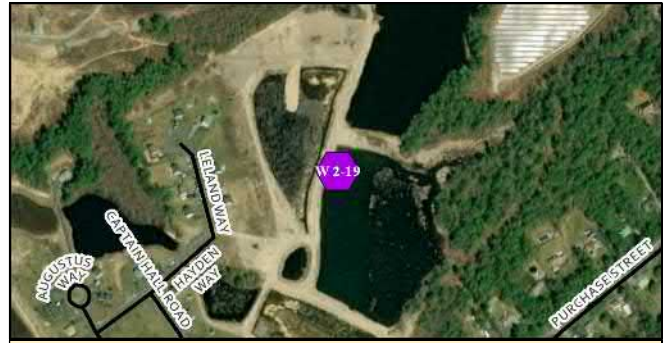
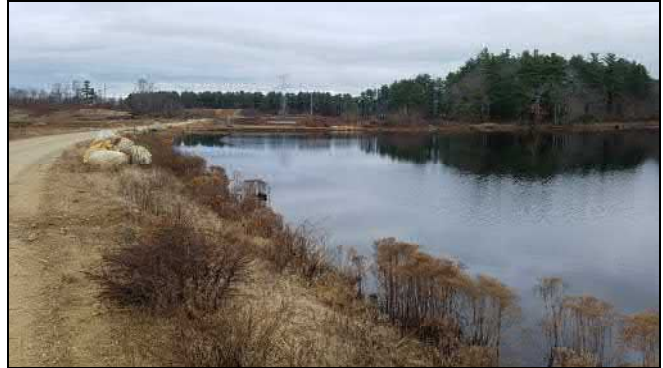
### Fire Department Water Supply Site #7 – W 2-19

- Waterbody Name: Unnamed Reservoir
- Estimated Surface Area: 298,000 sf
- Depth Near Shore: Greater than 2 feet

Dredge sediment bottom to required depths and area, and utilize upstream cranberry farm irrigation control structures to maintain higher water levels within the water source.

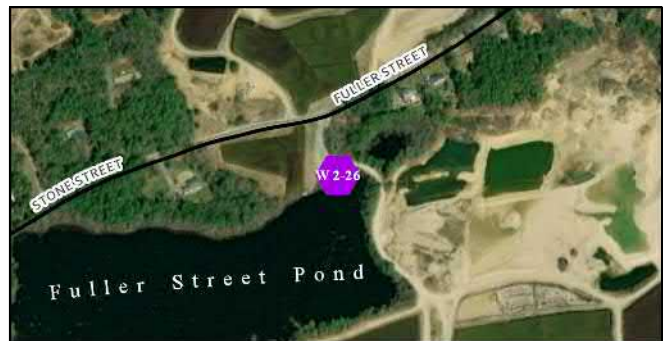
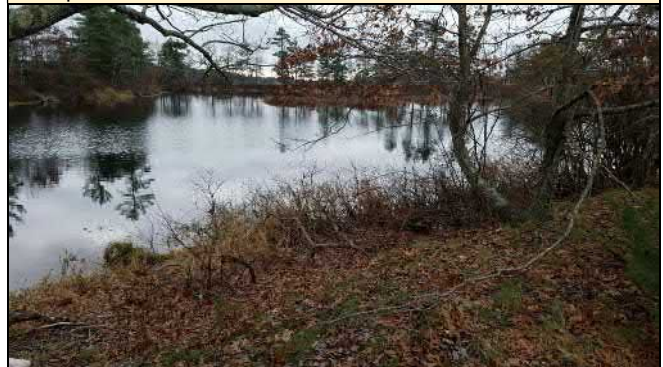
### Fire Department Water Supply Site #8 – W 2-26

- Waterbody Name: Fuller Street Pond
- Estimated Surface Area: 970,000 sf
- Depth Near Shore: Greater than 2 feet

Dredge sediment bottom to required depths and area, use control structures to maintain high water levels, clear bank and aquatic vegetation, and plant new emergent aquatic vegetation.

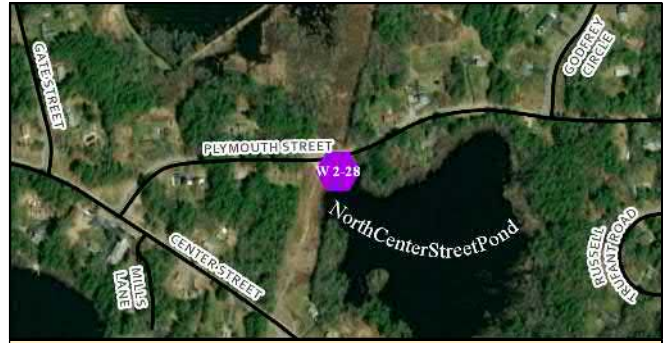
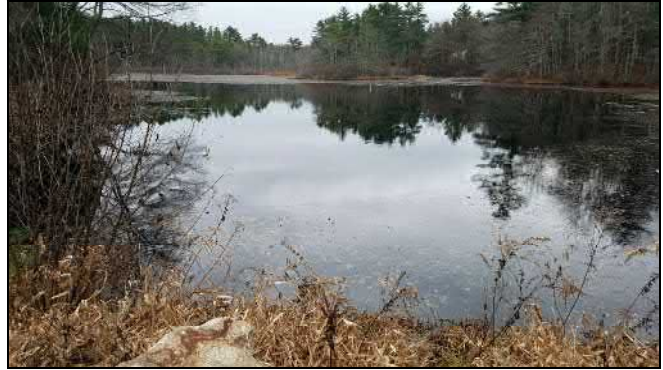
### Fire Department Water Supply Site #9 – W 2-28

- Waterbody Name: North Center Street Pond
- Estimated Surface Area: 515,000 sf
- Depth Near Shore: Greater than 2 feet

Dredge sediment bottom to required depths and area, clear bank vegetation to allow access year round, and plant new emergent aquatic vegetation.

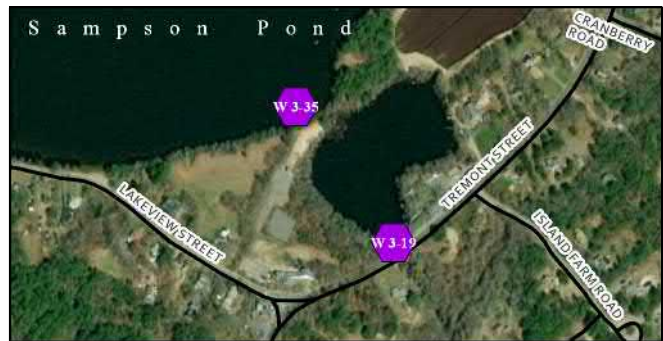
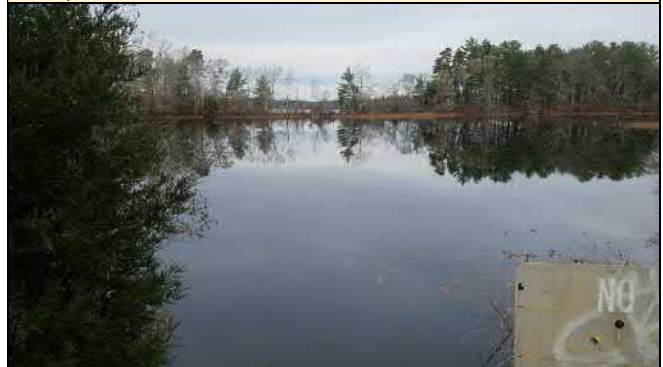
### Fire Department Water Supply Site #10 – W 3-19

- Waterbody Name: Lower Sampson Pond
- Estimated Surface Area: 257,000 sf
- Depth Near Shore: Greater than 2 feet

Dredge sediment bottom to required depths and area, maintain higher water levels with control structures, clear bank and aquatic vegetation and plant new emergent aquatic vegetation.

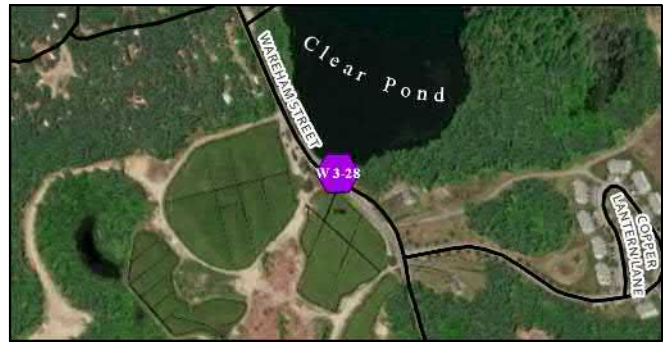
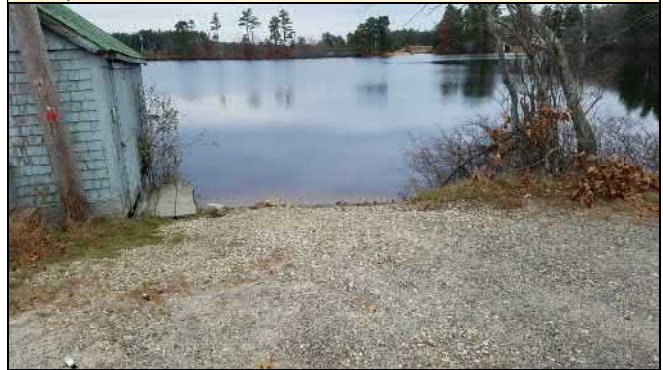
## Fire Department Water Supply Site #11 – W 3-28

- Waterbody Name: Clear Pond
- Estimated Surface Area: 480,000 sf
- Depth Near Shore: Greater than 2 feet

Dredge sediment bottom to required depths and area, use control structures to maintain high water levels, clear bank vegetation for additional access, and plant new emergent aquatic vegetation.

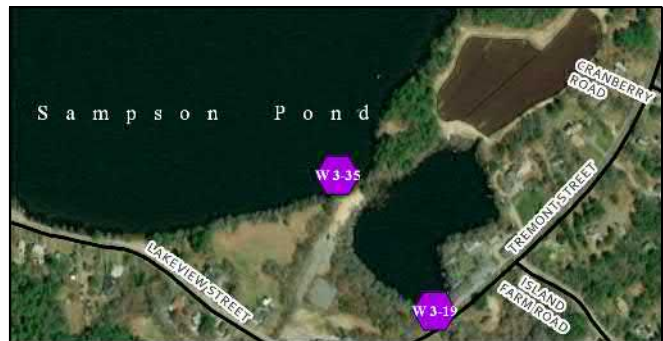
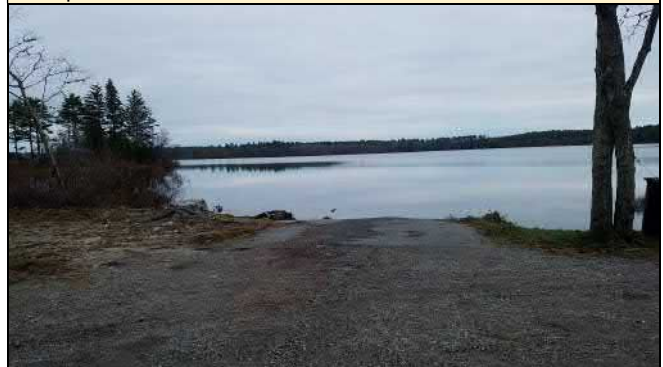
## Fire Department Water Supply Site #12 – W 3-35

- Waterbody Name: Sampson Pond
- Estimated Surface Area: 12,900,000 sf
- Depth Near Shore: Greater than 2 feet

Dredge sediment bottom to required depths and area, maintain higher water levels within supply, remove aquatic vegetation and invasive species, and plant new emergent aquatic vegetation.

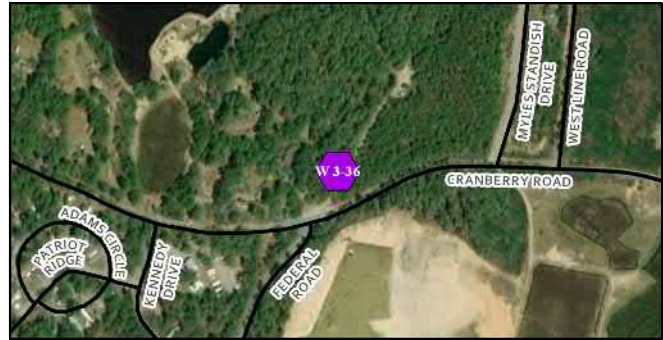
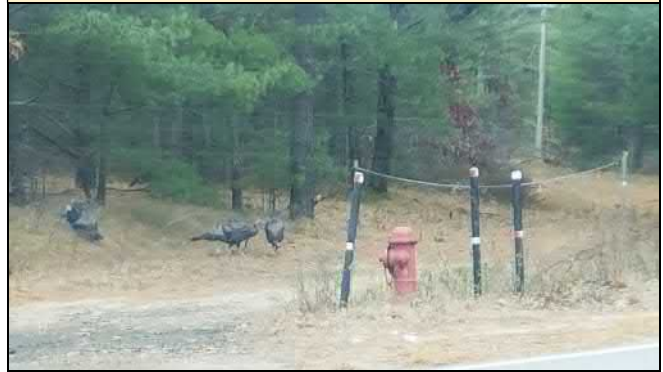
### Fire Department Water Supply Site #13 – W 3-36

- Waterbody Name: Unnamed Well
- Estimated Surface Area: N/A
- Depth Near Shore: N/A

A detailed site-specific investigation is necessary. The preliminary recommendation is to increase capacity with an installation of an underground cistern or well system to improve the site's ability to supply water.

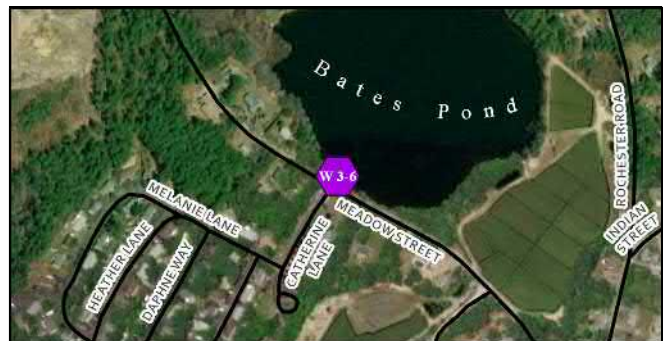
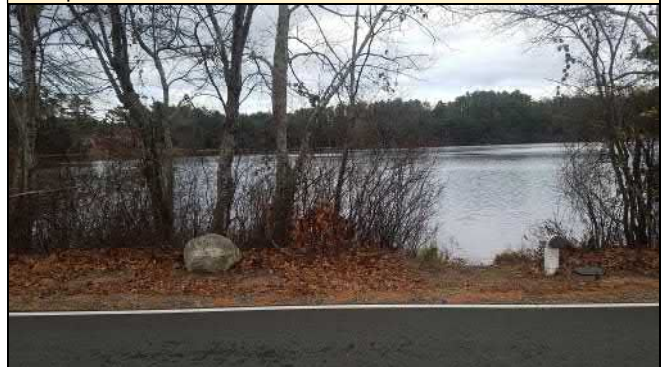
### Fire Department Water Supply Site #14 – W 3-6

- Waterbody Name: Bates Pond
- Estimated Surface Area: 925,000 sf
- Depth Near Shore: Less than 2 feet

Dredge sediment bottom to required depths and area, use control structures to maintain high water levels, clear bank vegetation for additional access, and plant new emergent aquatic vegetation.

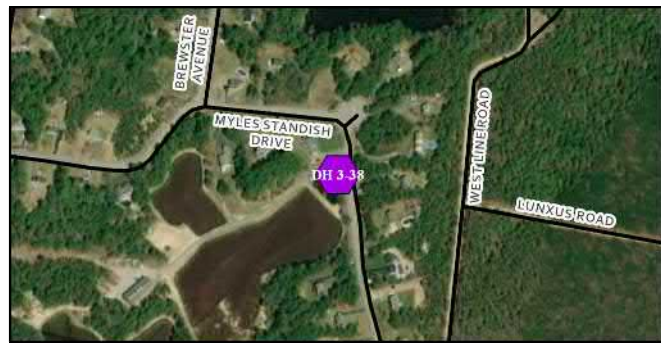
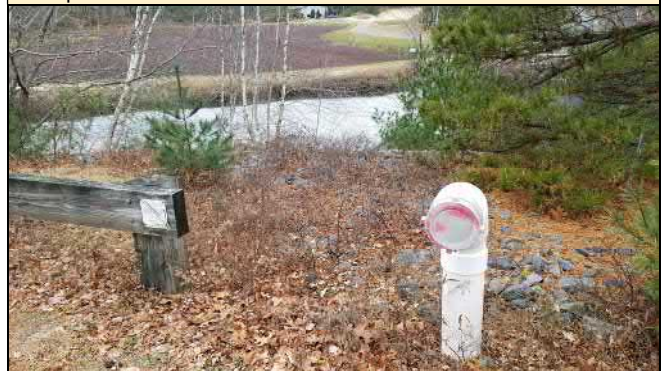
## Fire Department Water Supply Site #15 – DH 3-38

- Waterbody Name: Unnamed Reservoir
- Estimated Surface Area: 9,000 sf
- Depth Near Shore: Greater than 2 feet

Dredge sediment bottom to required depths and area, and utilize cranberry farm irrigation control structures to maintain higher water levels within the water source.
