The Commonwealth of Massachusetts  
Office of the Inspector General

May 6, 2011

**The Cost of the Project at 21-27 Temple Place and the Permit Fees Paid to ISD**

## **The Examination of the Project Plans by ISD**

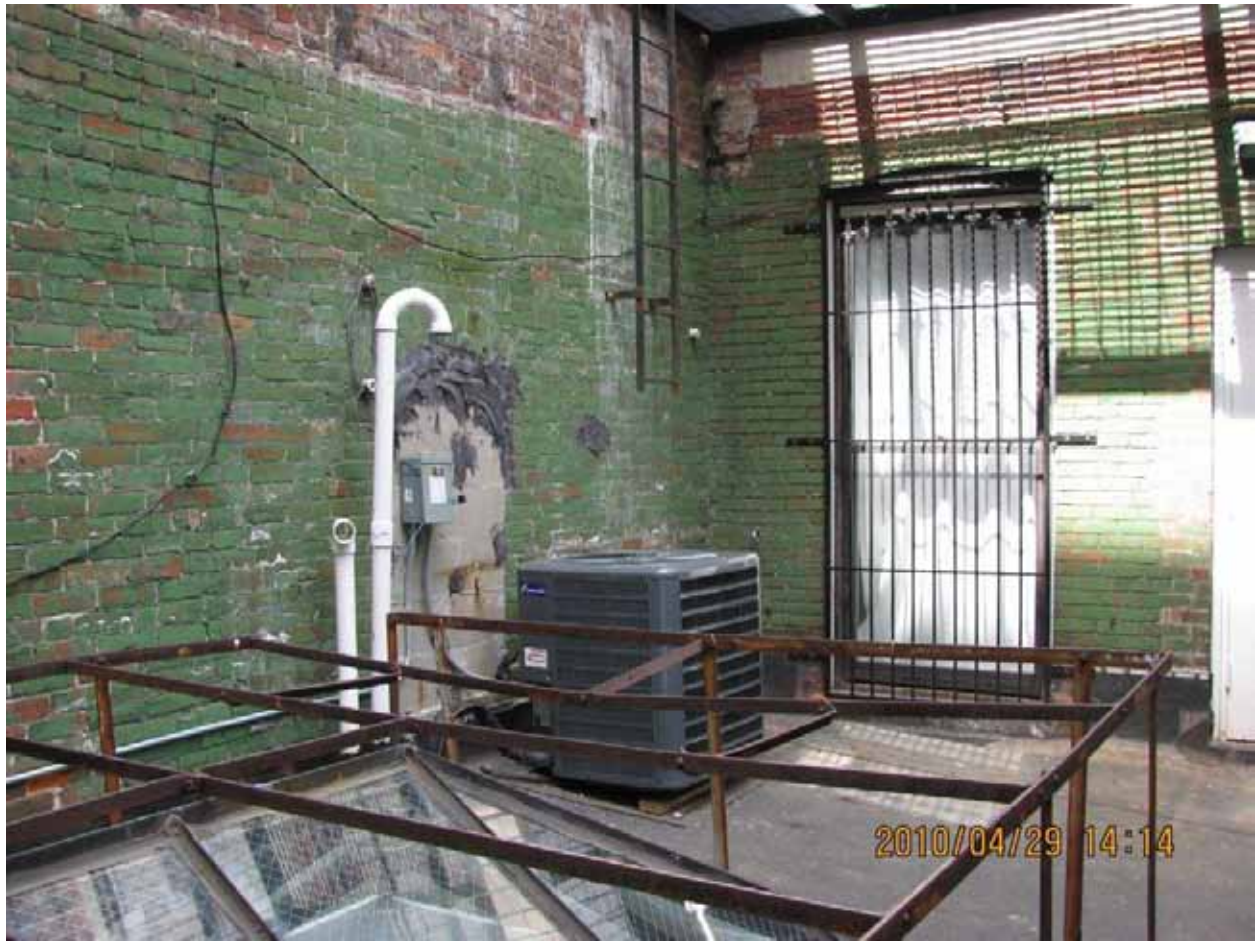
2010/04/29 14:14

The Plans Examiner stated that there should be no ladders as a means of egress on the rear of this property. The Plans Examiner was shown photographs of the rear portion of 21-27 Temple Place taken by the OIG on 4/29/10. Some of these pictures show a long ladder as a means of egress from the fifth and fourth floors of the property, dropping down to the third floor in the rear of the property. The Plans Examiner stated that this was totally unacceptable and not in conformity with the final plans submitted by the architect that he (The Plans Examiner) approved. The Plans Examiner advised that a fire escape must be located where the ladder is now located. (See attached Photo). This provides significant further evidence of the owner's efforts to avoid required additional costs and arrogantly ignore the direct order of the Plans Examiner that ladders cannot be used as a method of egress. Moreover, the owner's architect submitted new plans showing egress only by fire escape but the ladder egress in fact remained unchanged for many months to come.

As you know, the egress by ladder problem continued undetected (certainly in our opinion a fire hazard involving the safety of the building's tenants) until the OIG with the concurrence of the United States Attorney's Office requested a new inspection of the property in April 2010. At that time one of your building inspectors, a City of Boston Fire Inspector and several OIG investigators met at the owner's building. The Building Inspector and the Fire Inspector conducted an inspection of the rear portion of the premises.

During the inspection, the ISD Building Inspector discovered that the ladder egress situation may be problematical. He subsequently learned that the ladder egress was a deviation from the plans approved by the Plans Examiner and he issued a violation which the owner initially ignored. I am aware of the fact that ISD has now taken the owner to court on this matter and the owner is finally taking appropriate steps to resolve the matter. However the fact remains that between April 17, 2009 when the ISD Plans Examiner informed the owner that ladder egress was not allowed and April

29, 2010 when the above inspection disclosed that egress from the rear by ladder still existed, the tenants were improperly exposed to a public safety issue. The truth is that but for the April 29, 2010 inspection of the rear of 21-27 Temple Place, this fire safety problem would still exist.

- The ISD should immediately conduct a thorough and comprehensive inspection of the premises at 21-27 Temple Place, inside and out to insure that all of the issues raised by the ISD Plans Examiner set forth above have been resolved. These issues include the beauty salon problem; the ladder/fire escape problem; the egress from the rear of Units Four and Six should be doors rather than windows problem; and the barred door/window problem involving the rear of Unit Two. Moreover, each separate Unit, including residences, offices and businesses should be inspected to insure that every one of them have two legally appropriate means of egress.
