RESOURCE MANAGEMENT PLAN
**NATIONAL MONUMENT
TO THE FOREFATHERS**
PLYMOUTH, MASSACHUSETTS

September 2006

Massachusetts Department of Conservation and Recreation
Division of Planning and Engineering
Resource Management Planning Program

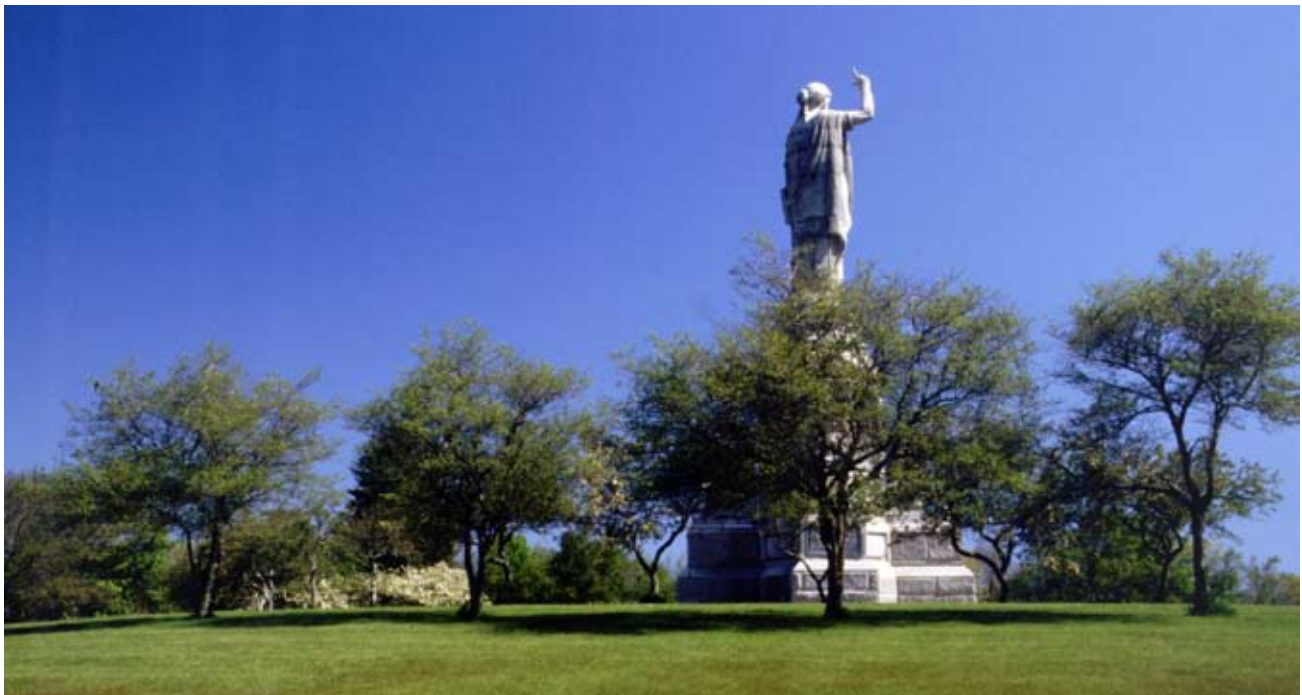
*Vegetation impeding view
of monument from rear*

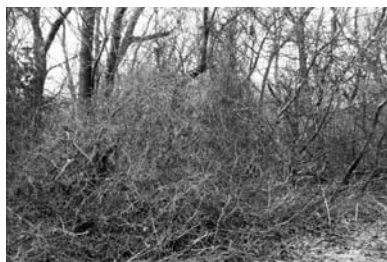
*Bull Brier,
invasive volunteer growth*

Improve Wooded Areas: Remove the invasive volunteer growth. Many are weak wooded trees and they present a public safety hazard. The removal of invasive vegetation [brier, poison ivy, etc.] could be considered an appropriate volunteer project.

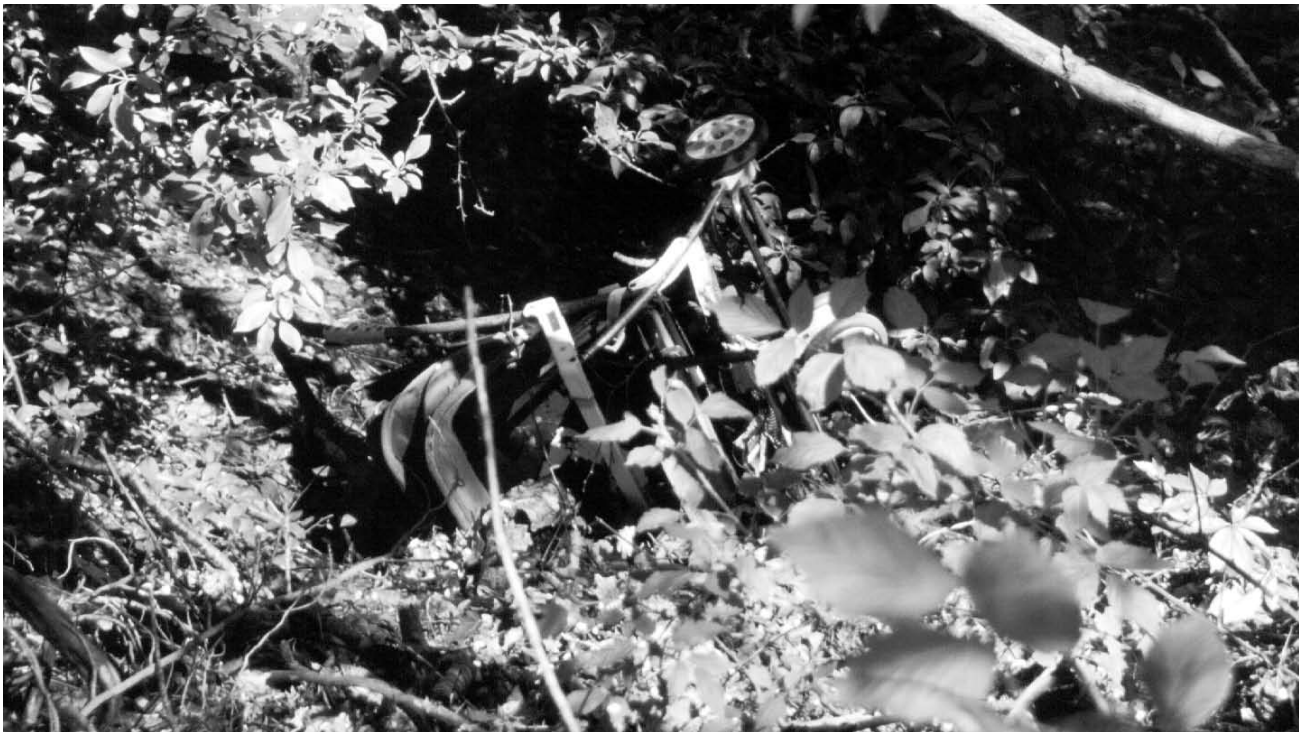
While much of the developed area of the site is clean and open, wooded areas on the site have apparently not been maintained in many years. The forest floor is littered with trash and debris on north, south and west sides. Tires, a baby carriage, household furnishings, crushed stone, debris piles, wood pallets and firewood were found as well as dead trees and trees with significant amounts of dead wood.

Trash and debris in the woods

New facilities should be placed outside the circular drive and screened from view with vegetation. Clean up wooded areas removing trash, debris and dead trees. Prune to remove hazardous dead wood.

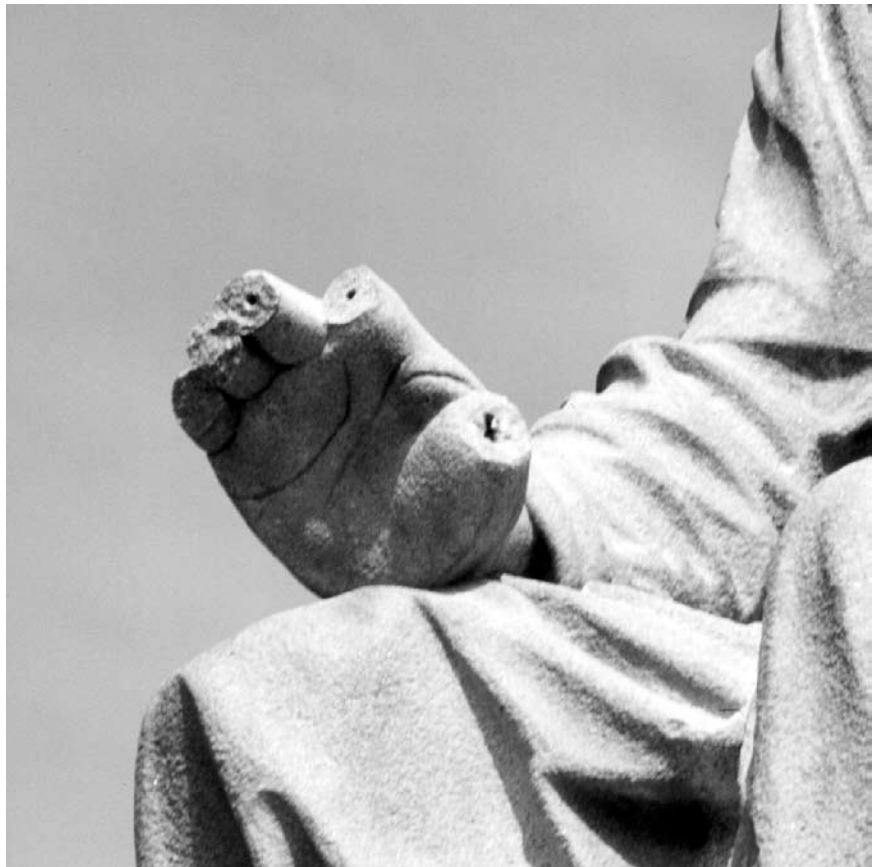
*Detail of lost fingers
at the figure Law*

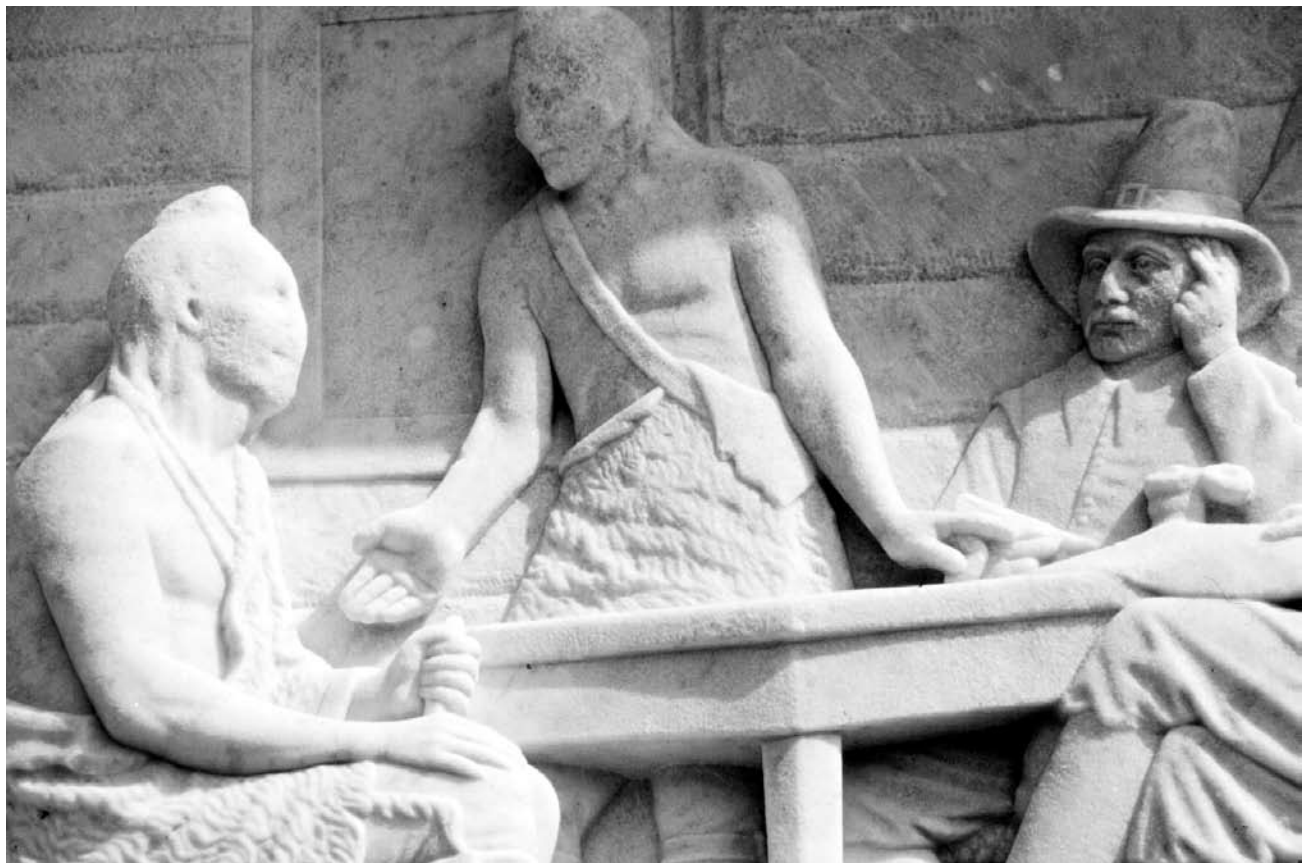
Landing at Plymouth [under Liberty]: This sculpture shows erosion at the most projecting surfaces, particularly the facial features. This type of weathering away of the crystals at the stone surface is referred to as sugaring which results in a roughened surface and loss of detail. The sugaring is most severe where the work is least shielded from wind, rain and salt spray. The edges and recessed areas are in better condition than the central area and projecting features. This tablet shows limited salt accumulation on the surface and has only limited fine cracks in the stone surface and has little surface soiling.

Detail of erosion at bas-relief

Conservation of Marble Bas-Relief Panels at the Monument: Conserve each bas-relief stone surface with a gentle poultice to remove soil and salts by a trained conservator. Stabilize and fill cracks. Restoration of weathered, blurred or lost detail is not recommended except that the missing chair leg at the "Signing of the Social Compact" relief should be restored. *[Completed in FY 2006]*

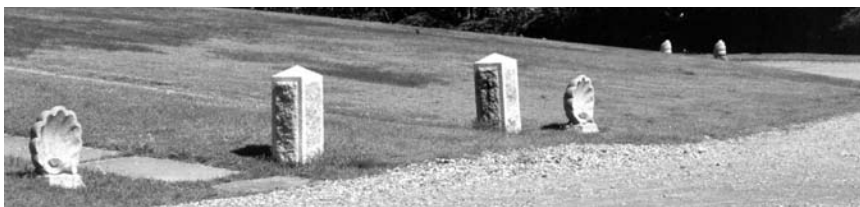
Granite shells and bollards

Conserve/Relocate the Remaining Stone Site Features: Maintain the granite shells and bollards in their current locations. Reset them to upright condition on proper foundations. Remove the granite platforms and concrete post if an appropriate new function is not identified. Provide further study on the cut granite pieces to determine their age and origin, and determine an appropriate treatment for them. Place the granite marker in storage, off site, so as not to confuse visitors.

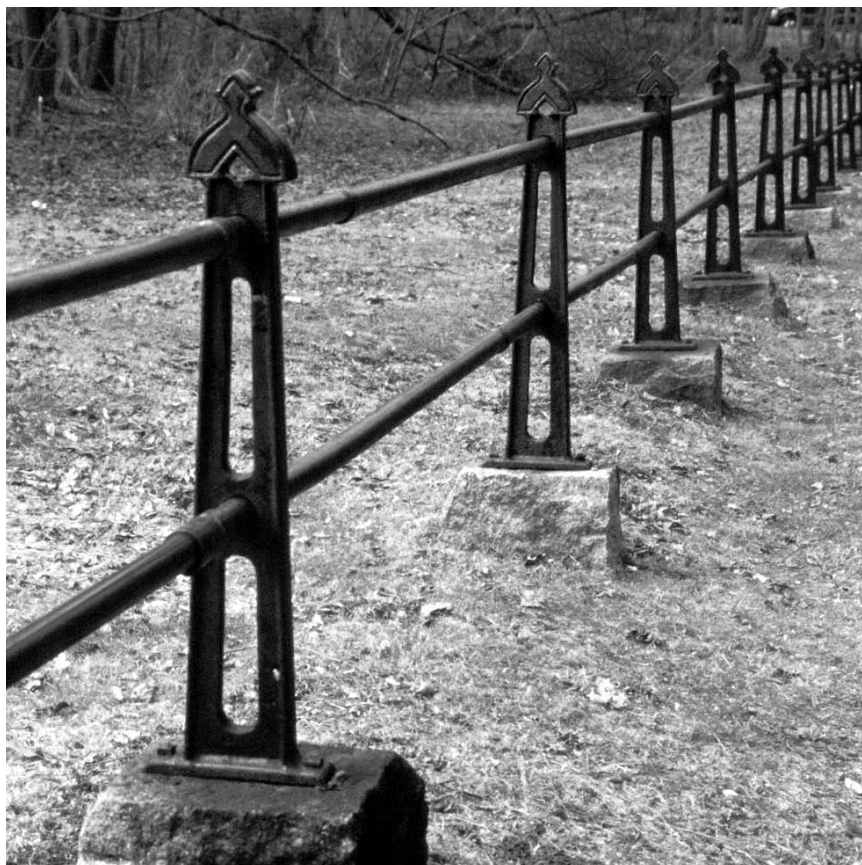
Iron fence along Allerton Street

Complete Restoration of the Historic Iron Fence along Allerton Street: Reposition the iron posts that are not plumb and reset bases that have settled to proper grade and alignment. Repair cracked iron post bases. Reattach iron posts no longer fastened to base stones. Strip back the sediment covering the tops of granite bases to expose them. Prepare, prime and paint the ironwork.

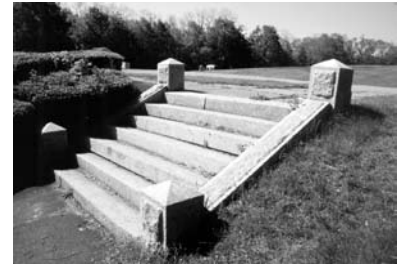
Granite steps on the path to the Dedication Panel

Path to Dedication Panel: Reset the lower concrete step where the path meets Allerton Street. Remove and rebuild the granite steps and cheek walls above. Repair the broken step by providing threaded stainless steel rods set in epoxy across the crack, and use epoxy adhesive to bond the sections. Replace the foundation as required. These stairs have no railings, which may be required if they are reconstructed. The pedestrian path leading to the dedication panel was restored in the fall of 2003 and is in excellent condition. It should be monitored and any pavers that become badly cracked, broken or missing should be replaced in kind. A potential east-west extension of this path across Allerton Street to Court Street was recently precluded with subdivision of the Monument House property and construction of a new home in the axis. The path extension to Court Street could have assisted with and become part of the "Pilgrim Path" walking tour concept that was conceived some years ago by providing a more direct pedestrian connection to Court Street and downtown.

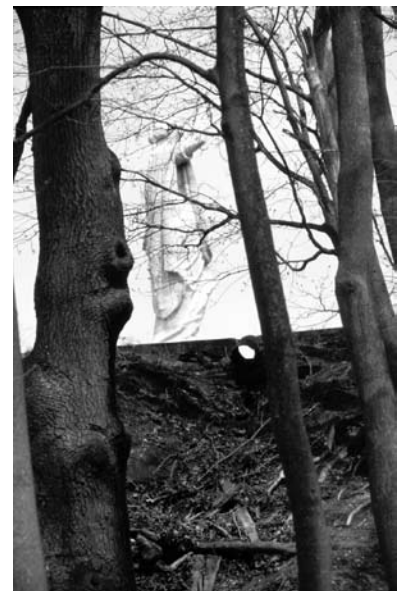
*Corrugated metal pipe
at the concrete curb
on the circular drive*

Replace Curbing with Barrier Rails: Remove the concrete curb and drainage structures on the outer edge of the circular drive and replace with an appropriate barrier rail that will provide a higher degree of public safety. This action will also significantly reduce down slope erosion conditions created by the curbing and drainage structures.

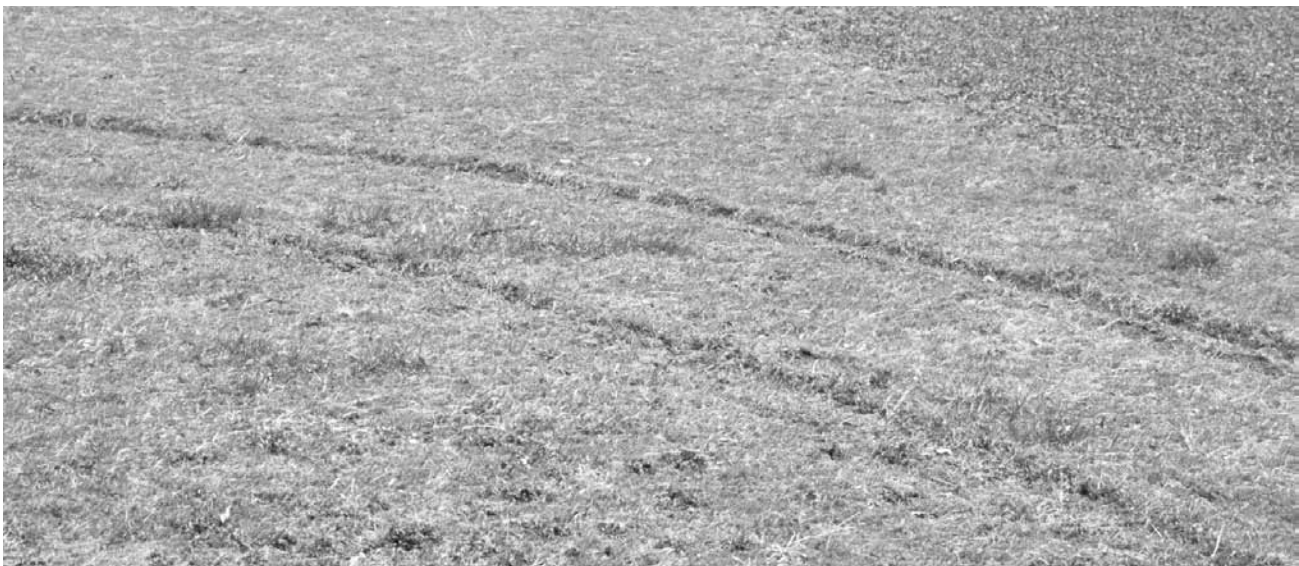
Tire ruts in lawn
