# Stormwater Management Master Plan

## Town of Auburn, MA

**DECEMBER 30, 2009**  
**UPDATED MARCH 5, 2010**  
**UPDATED MARCH 22, 2010**

Comprehensive Environmental Inc.  
225 Cedar Hill Street  
Marlborough, MA 01752

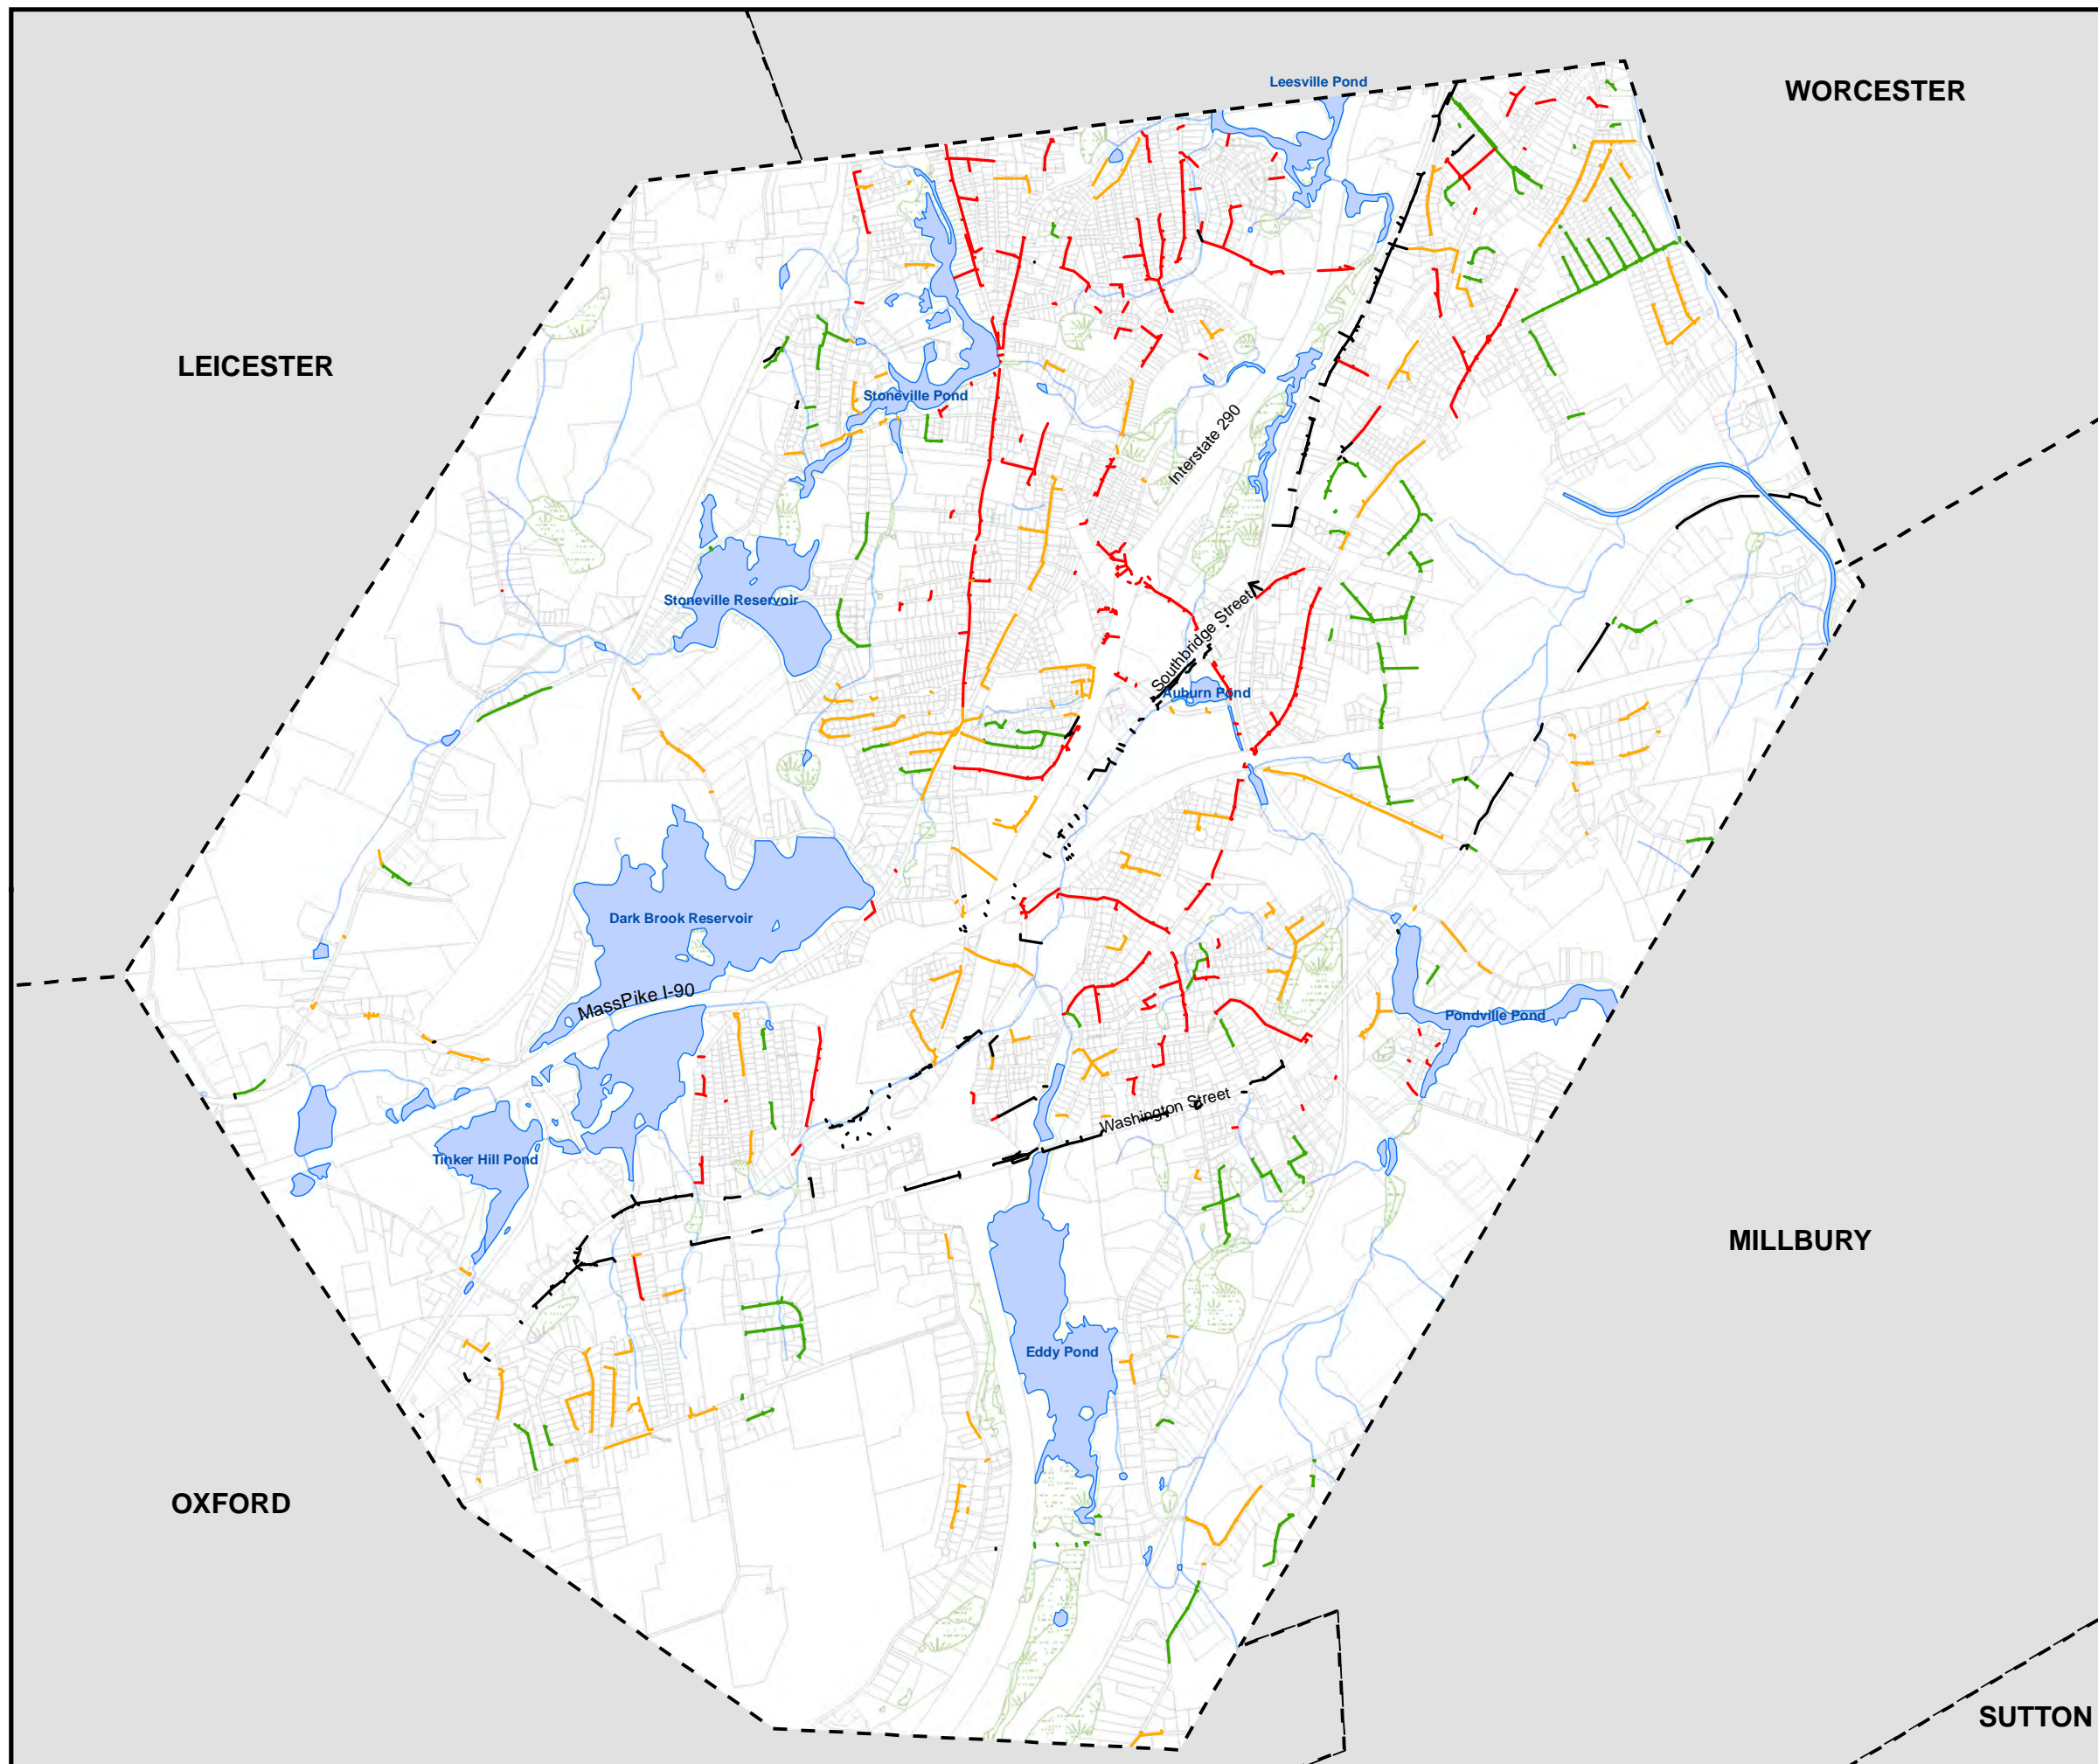
- 23 outfalls with heavy erosion in need of stabilization – Scour marks or ruts are often present at these outfalls, a result of high stormwater flows and velocities. Such locations are often structurally unprotected (i.e. no headwall, rip rap, flared ends) and can cause excessive erosion and instability to the outfall itself. The eroded sediment can cause water quality problems downstream. A list of these outfalls is included in Table 3-3. Refer to Figure 3-3 for locations.
- 30 outfalls with cracks, corrosion or undermined headwalls in need of repair – These outfalls had varied insufficiencies including cracked or corroding pipes, partially buried or collapsed pipes, and unstable headwalls. Several locations with severe erosion had undermined outfall structures causing damage and

Table 3-4. Summary of Outfalls in Need of Repair		
Outfall ID	Pipe Condition	Comment
A-08	Unknown	Undermined headwall
B-04	Other*	Dislodged pipe
B-33	Cracked	
B-36	Cracked	
C-03	Cracked	
C-04	Corroded	
C-16	Good	Undermined outfall
C-17	Good	Undermined outfall
C-28	Other*	Pipe crushed, covered
C-30	Cracked	Badly eroded
C-35	Corroded	
D-01	Corroded	
E-15	Unknown	
E-17	Cracked	Buried
G-01	Cracked	
H-08	Cracked	Pipe dislodged, sinkhole
H-15	Good	Undermined outlet pipe
H-17	Corroded	
H-18	Other*	Partially crushed
H-22	Corroded	
H-23	Corroded	
H-43	Cracked	
H-45	Exposed Steel	
I-05	Corroded	
I-18	Cracked	Instable headwall
I-19	Good	Instable headwall
I-23	Cracked	
I-24	Corroded	
M-11	Corroded	
M-13	Corroded

#### #4b Repair Outfalls

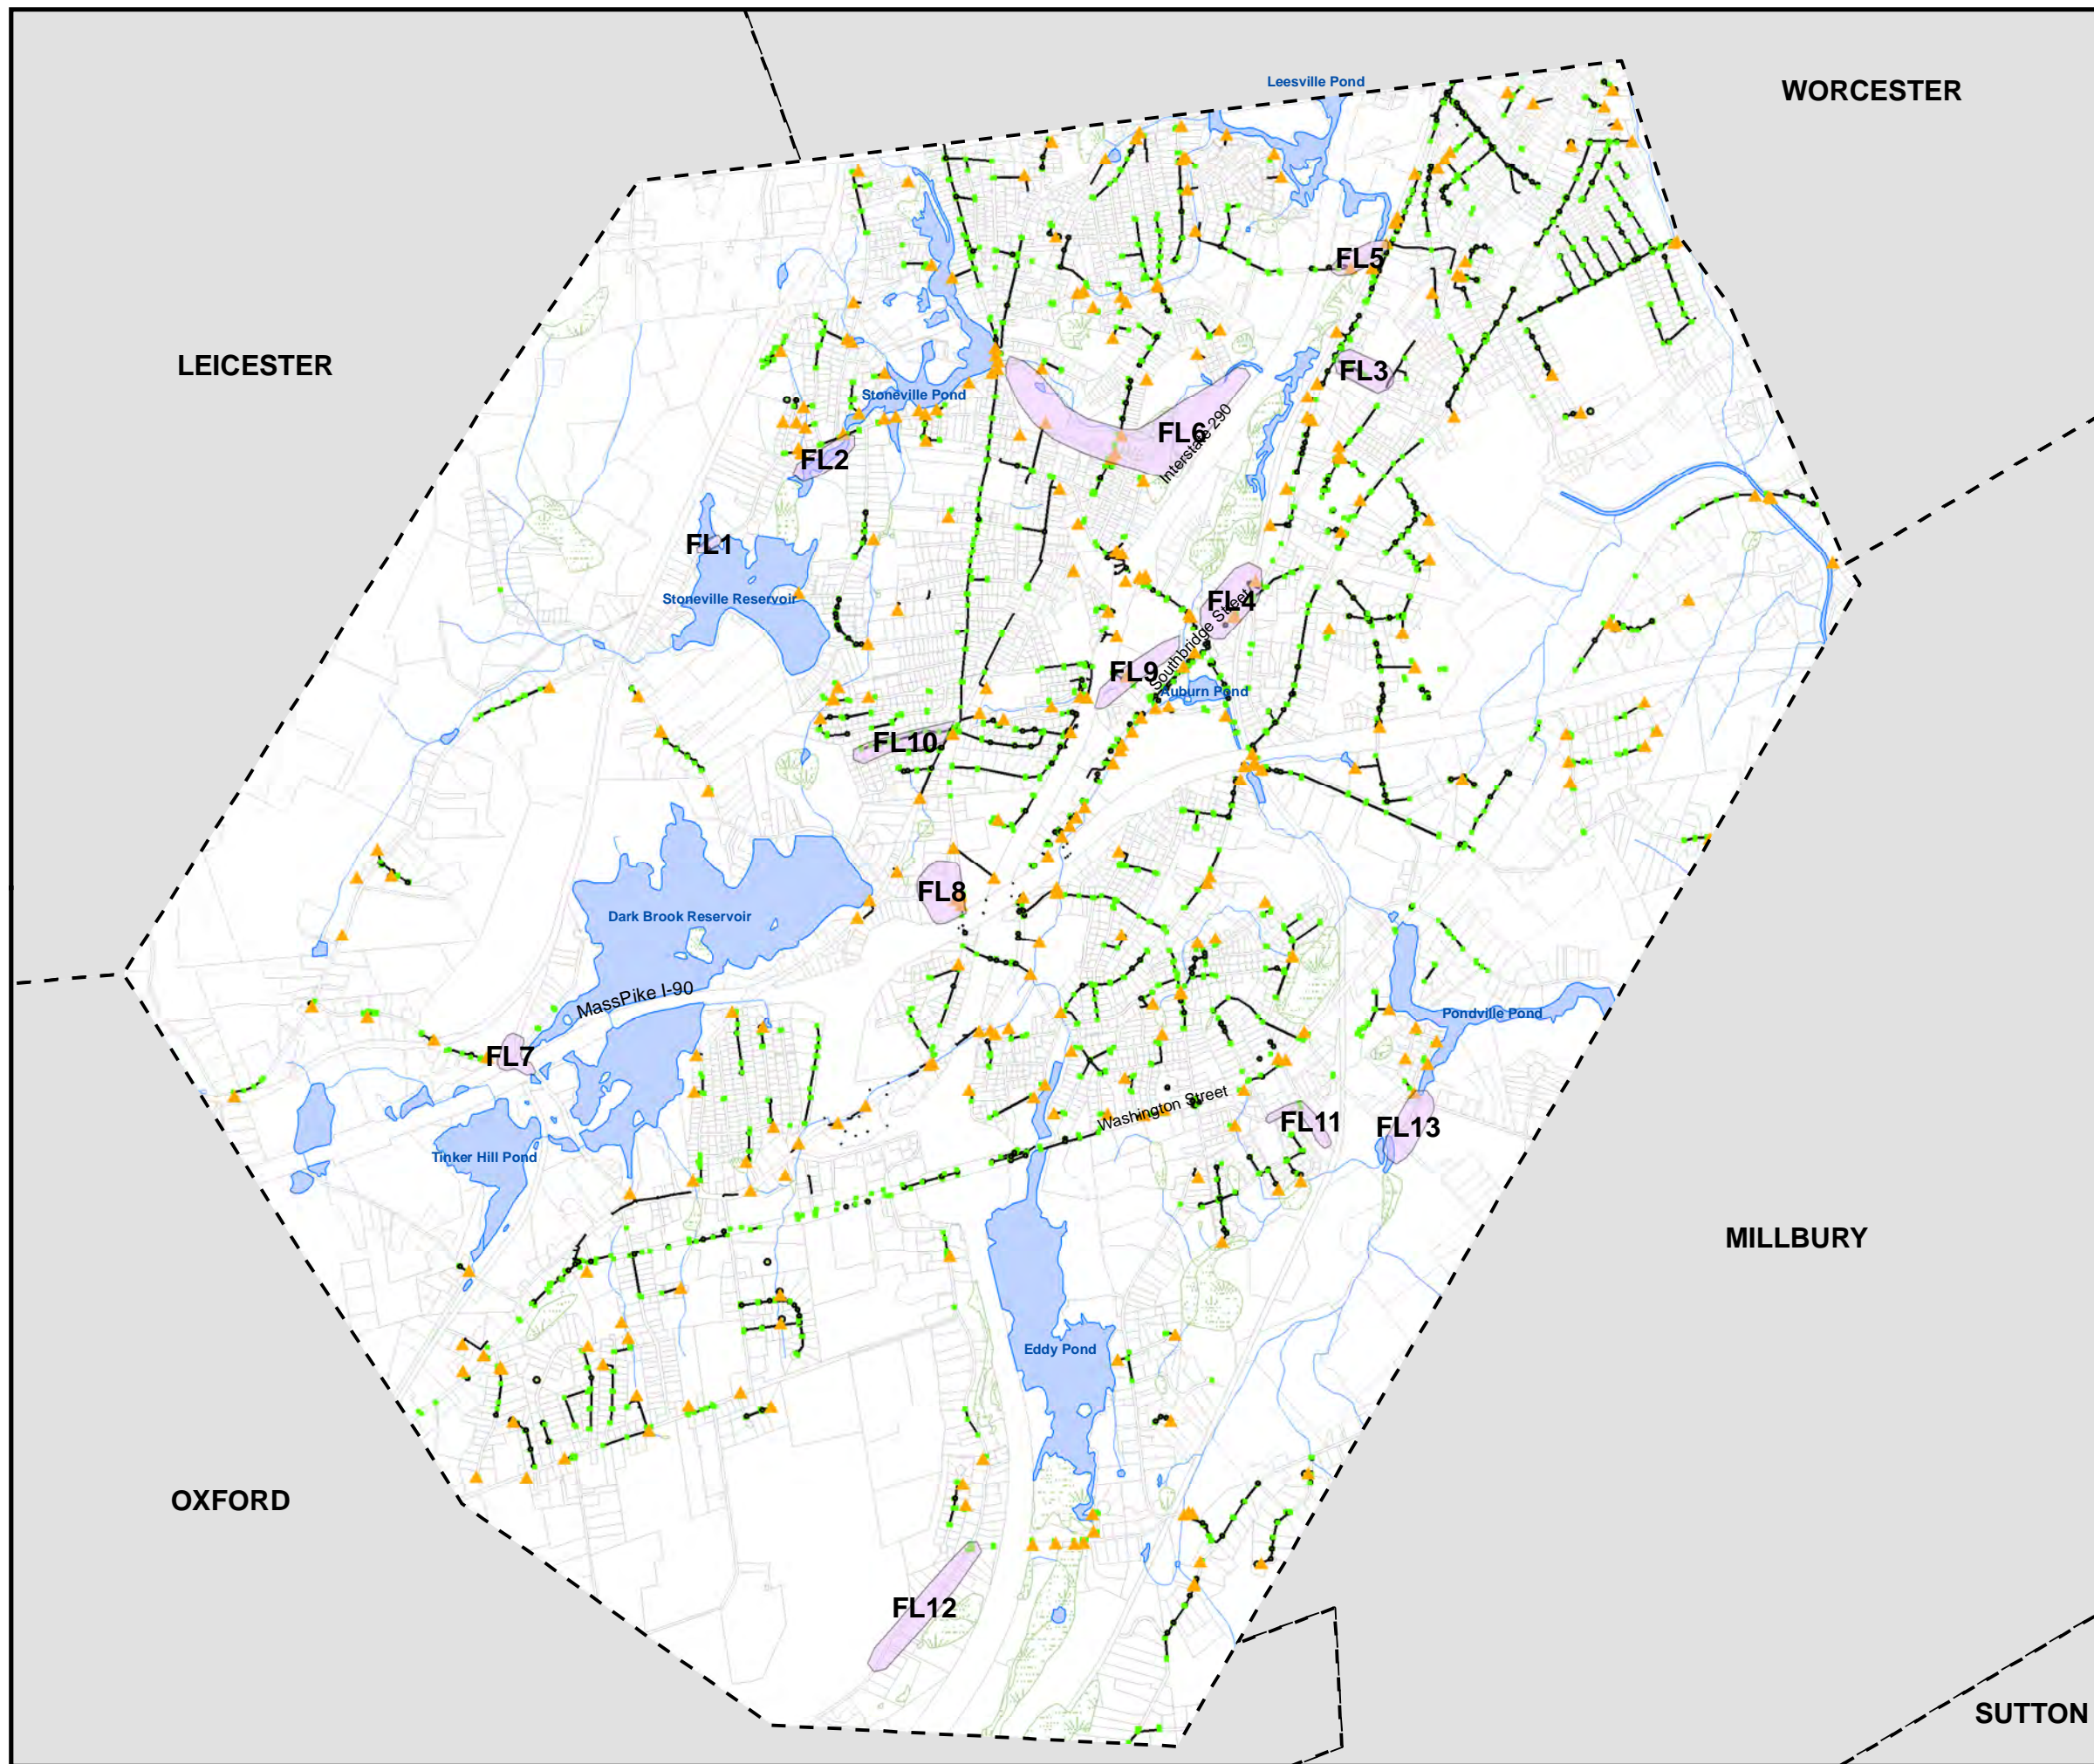
Figure 3-4  
**Flooding Sites**  
 Auburn, MA

Sub-watershed	Site ID	Flooding Site	Location Description	Observed Flooding Problem	Possible Causes	Land Use	Drainage Area (acres)	Length of Road	Drainage Network	Comments	Possible Improvements
A	A-1	Rochdale St.	Rochdale St. where it crosses Stoneville Reservoir. The road surface is not much higher than the reservoir water level.	During heavy rain events, water flows over the road from the northern portion of Stoneville Reservoir.	Undersized, filled culverts.	Forest	61.3	380 feet	2 - 18" HDPE drainage pipes, each 50' long under Rochdale St., connecting northern portion of reservoir to southern portion.	No other drainage networks or structures on this portion of Rochdale Street or the associated drainage area. 2-18" HDPE pipes are partially filled with debris.	Cleaning, install larger diameter culverts at same location.
B	B-1	Stoneville Pond	Along Rochdale St.	Southwestern portion of the pond observed to flood residential properties abutting the pond. Located within 100-year flood plain.	High flood waters.					Pondville Pond water level is controlled by the dam at the pond outlet. Influx of water from Stoneville Reservoir increases pond water levels in the southwestern segment of the pond.	Undetermined.

C	C-1	Eaton Avenue	Off western side of Hampton St. sloping steeply down to where it meets Southbridge St. (Route 12).	Stormwater runoff bypasses catch basins due to steep slopes. Stormwater observed to scour the edges of Eaton Ave. Sediment and debris deposited at the base of the hill where Eaton Ave. intersects with Southbridge Street.	Ineffective drain network.	Moderate to high-density residential (1/4 to 1/2 acre).	8.24	880 feet	Stormwater collected in five catch basins. 316 feet of 12" pipe drains into 240 feet of 15" of drainage pipes along Eaton Ave. Outfall on the western side of Southbridge St. into Kettle Brook.	Excessive sediment and debris observed on the road surface at the base of the hill and scouring along the edges of Eaton Ave. There is a storm drain network in place along Eaton Ave., however, it is ineffective at collecting all stormwater runoff.	Installation of drain network along entire length of street.

C	C-4	Kettle Brook	Brook Rd. & Perry Place are affected by flooding.	Flooding during heavy rain storms occurs along Kettle Brook from the Stoneville Pond dam to the I-290 culvert. Brook Rd. & Perry Place are within 100-year flood plain.	High flood waters.	High-density residential.	Kettle Brook watershed includes drainage from Auburn, Leicester & Worcester.				Undetermined.
G	G-1	West St.	West St. near the intersection with Hardscrabble Rd. & under the I-90 overpass.	Stormwater often pools at this depression, creating a hazard to motorists.	Lack of storm drain network.	Industrial, highway, & forested.	4.99	1,004 feet & I-90 overpass	Stormwater from portions of West St., Hardscrabble Rd., and the I-90 overpass drain to this location. No installed storm drain networks at or within this flooding location. Portions of West Street further west have storm drain networks, as well as portions of Hardscrabble Rd.		Installation of drain network along this portion of the street.

H	H-1	Oxford St. North	South of the Auburn Police Station on Oxford St. North and north of I-90 overpass.	During heavy rains, stormwater floods this topographic depression. Flooding at this location has damaged motor vehicles & is a public safety concern.	Ineffective drain network.	High-density residential.	12.64	2,048 feet not including I-90 and its off ramp	Two catch basins at low point on Oxford St. North discharge adjacent to road. Other outfalls from nearby roads discharge within the vicinity of the flooding area, including 8", 12", 15" & 24" outfalls. No observed pipes or outfalls draining flooding area.		Installation of drainage piping.
H	H-2	Swanson Rd.	Near Swanson Rd. and I-290 off ramp. A significant stream draining a large area enters a culvert at this location, conveying stormwater under commercial developments on Swanson Rd. & the Auburn High School athletic fields. The culvert discharges in Dunns Brook, several hundred feet north of Southbridge St.	The 42" culvert pipe is partially filled with sediment and debris. Backwater floods some areas upstream of the culvert & portions of the commercial areas along Swanson Rd. & the athletic fields at Auburn High School. Some of the flooding may be a result of high levels at Dunns Brook during heavy rains.	Constricted flow, debris and sediment deposits.	High-density residential, highway & commercial.	88.96	12,595 feet not including commercial parking lots & development along Swanson Rd.	There are several drainage networks present in the drainage area. They all discharge (or eventually discharge) to the stream that enters the culvert near Swanson Rd. The 42" culvert is 1,200 feet long.	42" culvert is partially filled with sediment.	Cleaning of existing culvert, installation of sediment forebay.

H	H-3	Briarcliff Rd.	New development on Briarcliff Rd.	Existing stormwater infrastructure was clogging from erosion associated with construction of a new development. Inadequate erosion controls were used by the developer, allowing sediment to enter stormwater catch basins. The Town retrofitted existing catch basins with filter fabric to prevent heavy sediments from entering existing storm drains. A new storm drain network will be functioning at the completion of the development.	Lack of construction stormwater controls.					The Town is in the process of correcting this flooding problem.	Cleaning of existing structures.

K	K-1	Oxford St. South	Several hundred feet south of the intersection with Cedar St.	Stormwater runoff from the street and abutting residential properties has been observed to collect and flood lower lying properties along the western side of Oxford St. South.	Lack of storm drain network.	Low-density residential.	4.41	900 feet of Oxford St. South	No storm drain networks present within this flooding area or along this portion of Oxford St. South. The nearest storm drain network is several hundred feet north at the intersection with Cedar St.	Road surface deterioration caused by lack of storm drainage in this area.	Town has addressed with temporary solution: installation of infiltrating catch basins.
M	M-1	Elm St. & Brook St.	Elm and Brook St. in the vicinity of Pondville Pond. Unnamed brook draining subwatershed M and portions of Millbury enters Pondville Pond at this location.	Located within 100-year flood plain. Flooding appears to be the result of high water levels in the brook & pond during heavy rain events.	High flood waters.	Low-density residential & forest.					Undetermined.

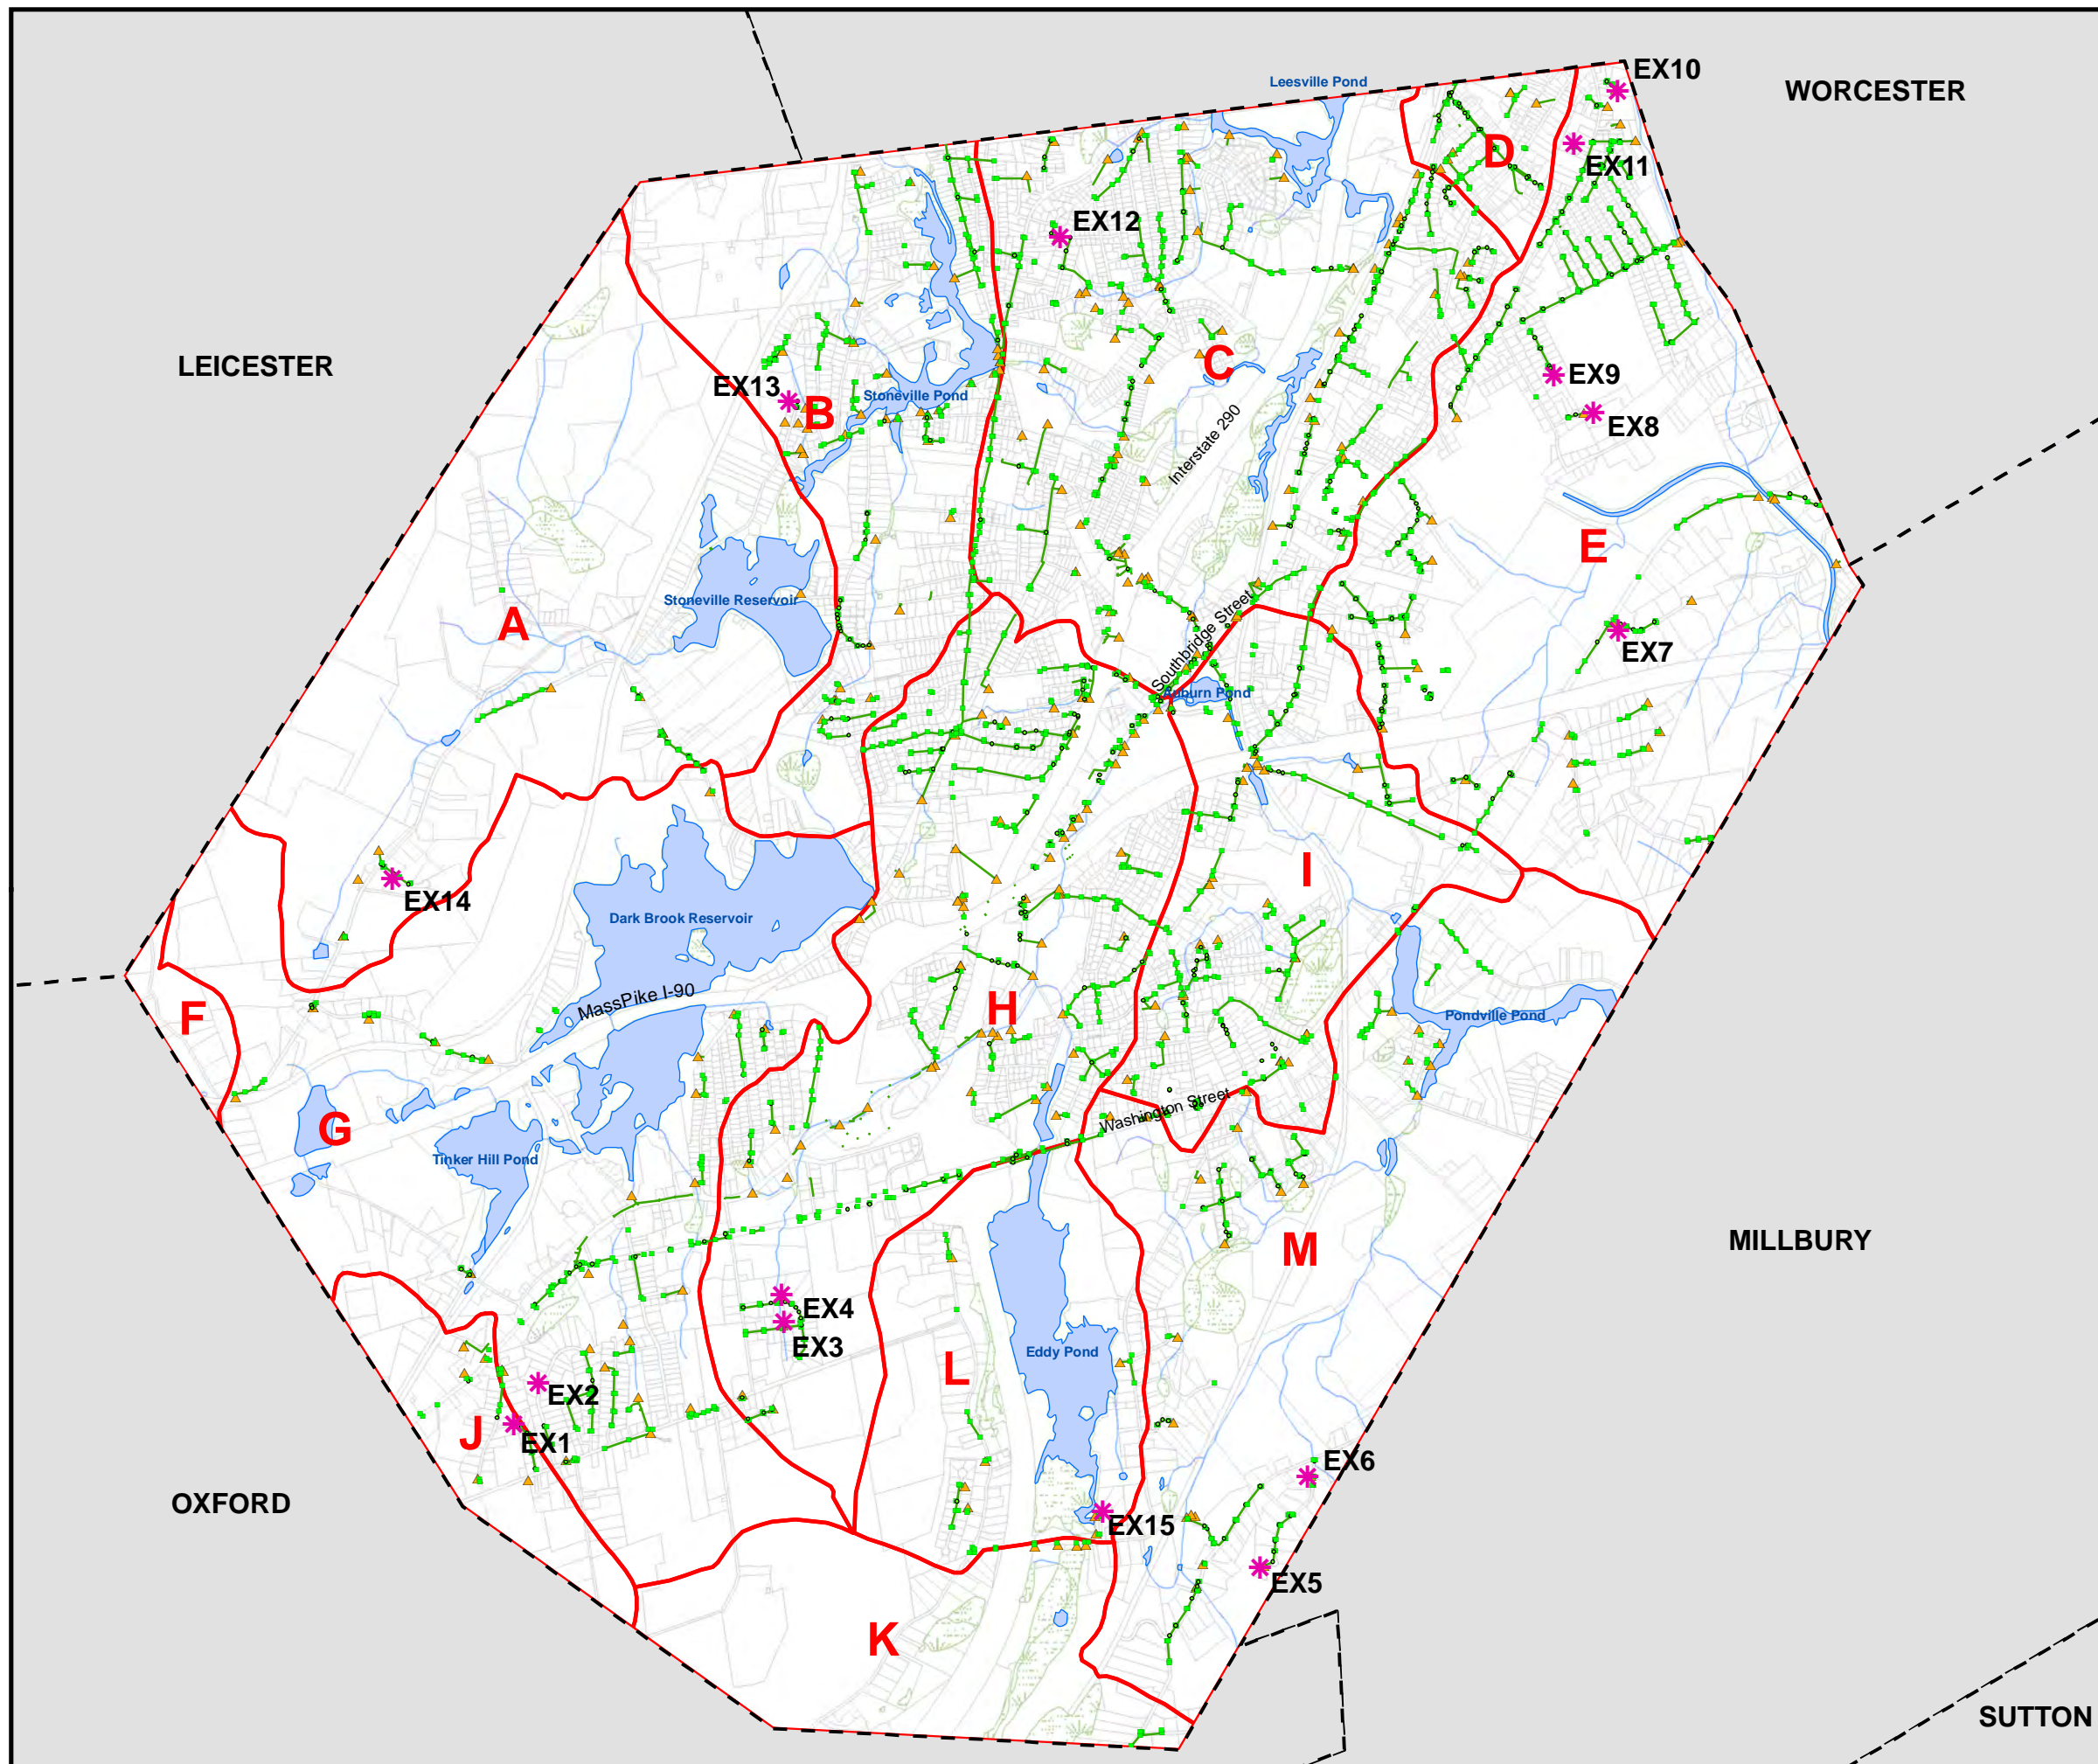
Figure 4-2

Fifteen detention basins and one water quality BMP were identified during these investigations. These are shown on Figure 4-2. The field inspection log providing the results of the investigations, including the existing condition and proposed improvements are included as Table 4-5. Most of the BMPs require maintenance to remove heavy vegetative growth and accumulated sediments and many will benefit from improvements such as the installation of sediment forebays to provide an easy access point for maintenance.
