Request for Proposals for the Rehabilitation, Reuse and Maintenance of:

Beartown Headquarters House Building Conditions Survey Update
Beartown State Forest, Monterey, MA

BEARTOWN STATE FOREST
OLD SUPERINTENDENT'S HOUSE
MONTEREY, MA

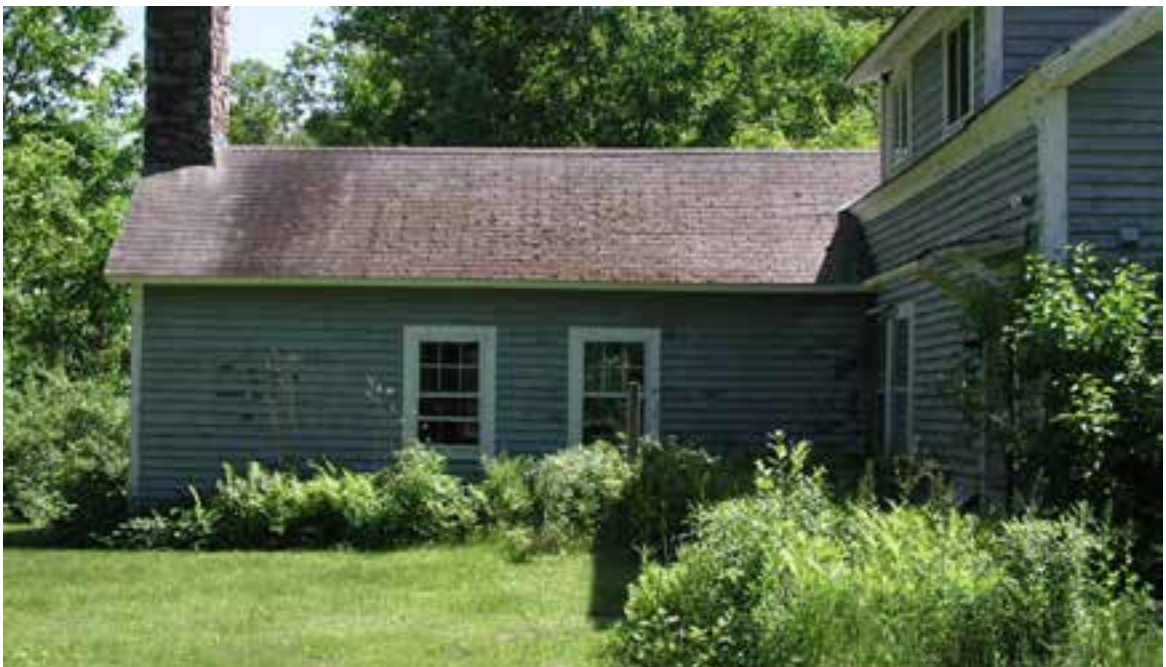
Site drainage must be reconfigured in the immediate area around the house, in order to protect the framing and wood cladding from further damage (Fig. 1.5).

Fig. 1.5. Landscaping and "mulched-up" grade adjacent to house. As part of a coordinated effort to re-route roof drainage, the grounds should be regraded to pitch away from the building.

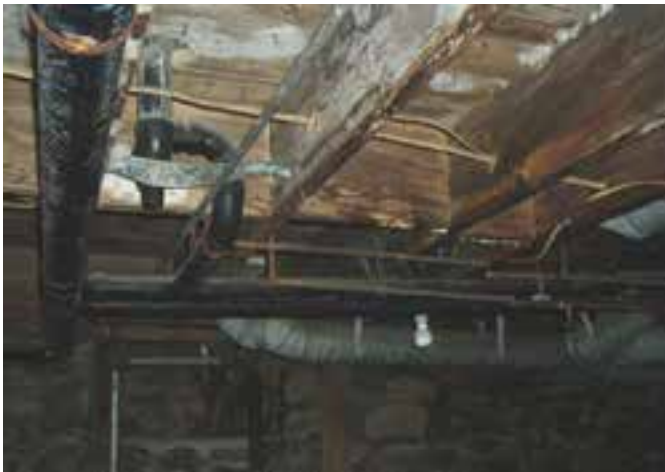
Fig. 4.1. Typical condition, basement ceiling (first-floor framing).

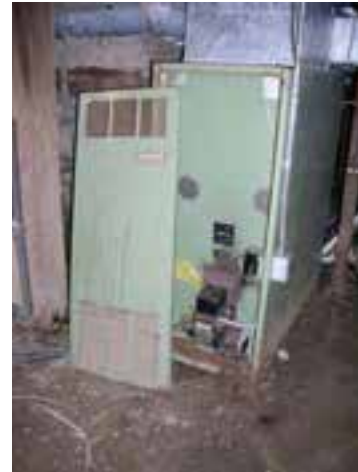
The mechanical systems are generally old, have apparently been unused for nearly ten years and remain in poor- to failed condition. An oil-fired Air Ease hot-air furnace (Fig. 4.2) with associated 275-gallon oil storage tank (Fig. 4.5) and trim is situated in the basement; the equipment would require complete review by a certified technician to make it operable again. The associated supply and return ductwork is in poor condition due to basement atmosphere (damp, mold, dust and insulation; see Fig. 4.1). The associated flue to the existing chimney does not appear to be code-compliant; chimney lining, sleeve penetration and flue replacement would be required in order to bring the existing system into compliance.

Fig. 4.2. Furnace.

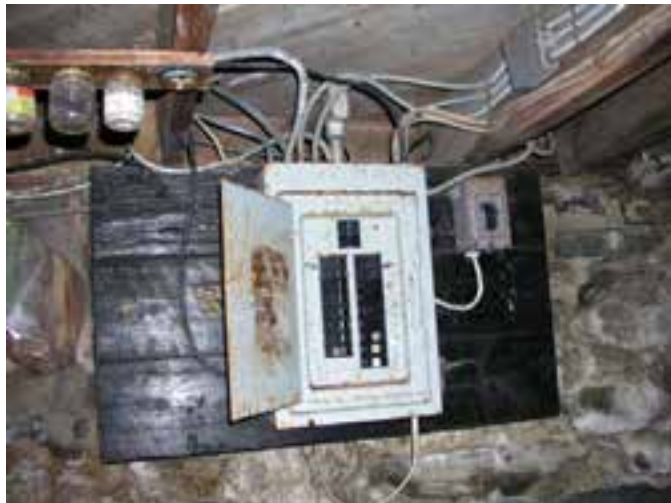
Fig. 4.4. Main distribution panel.

Receptacles and light switches vary in location, quantity and quality throughout the building. The overall system is in poor condition and would require complete upgrade to meet current code as part of any building renovation project.

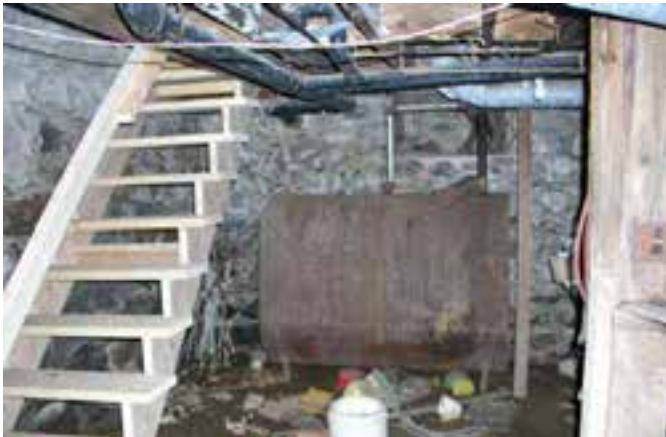
Fig. 4.5. Existing 275-gallon oil tank.

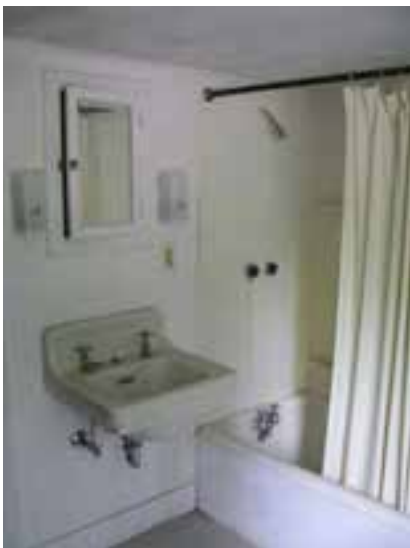
At this time, the entire plumbing system is inoperable. The overall condition of the piping, connections and fixtures remains poor, if not failed, due to age and lack of use.

Fig. 4.6. Second-floor bathroom fixtures.

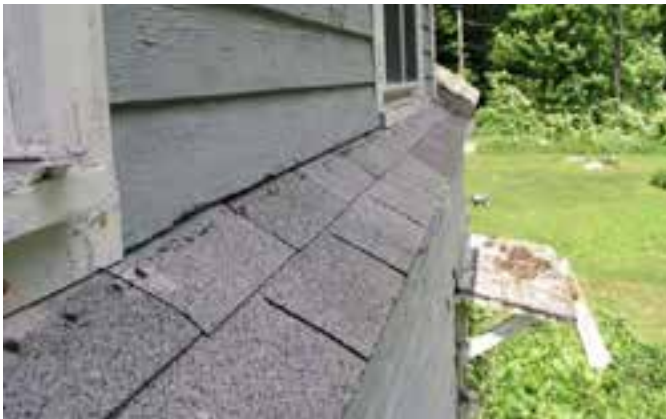
The asphalt shingles are in fair condition, with several areas evidencing biological growth. A number of areas of shingling are worn or broken. As the 1994 report noted, the raking cornices (i.e., gable ends) are poorly detailed, such that the dimensional wood sheathing is exposed at its vulnerable end-grain (Fig. 5.3). Replacement of the roof system is recommended; preparation of the roof "substrate" should include installation of ice-and-water barrier at the ridges, valleys and perimeter (i.e., at eave and raking cornices).

Fig. 5.1. Roof adjacent to east dormer.

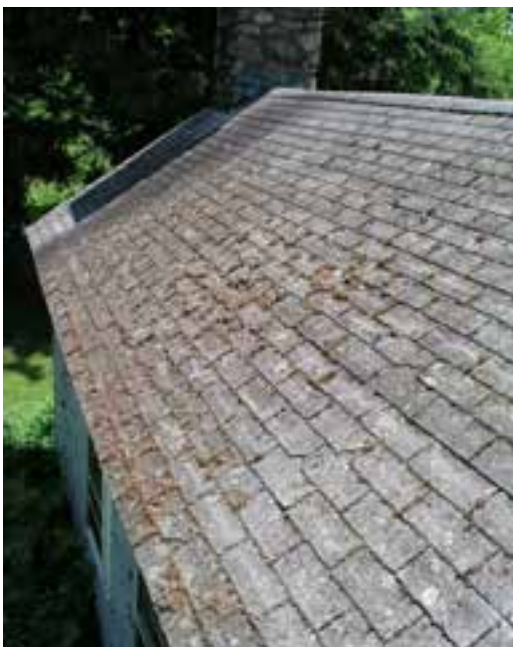
Fig. 5.2. Condition of shingles at ell.

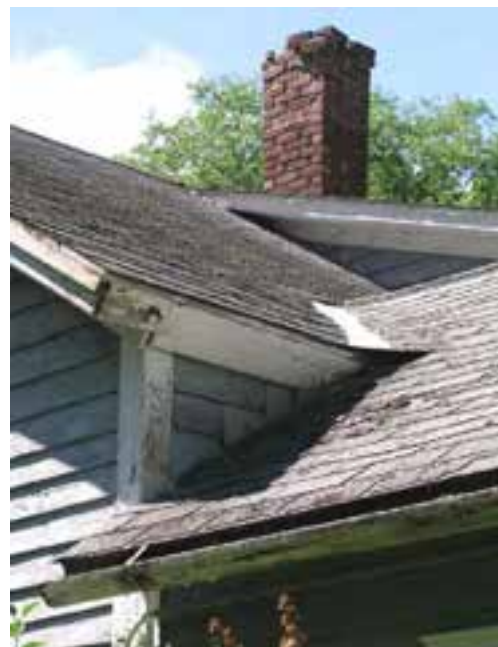
Fig. 5.3. Existing valleys and stepped flashing.

In conjunction with the re-roofing effort, the stepped flashing identified in the prior report (Fig. 5.3) should be improved or replaced so that it properly sheds water away from the dormer assemblies. Similarly, the existing open valleys should be replaced with new valleys; new metal work should be separated from the ice-and-water barrier to allow thermal expansion to occur without self-destruction of the assembly.

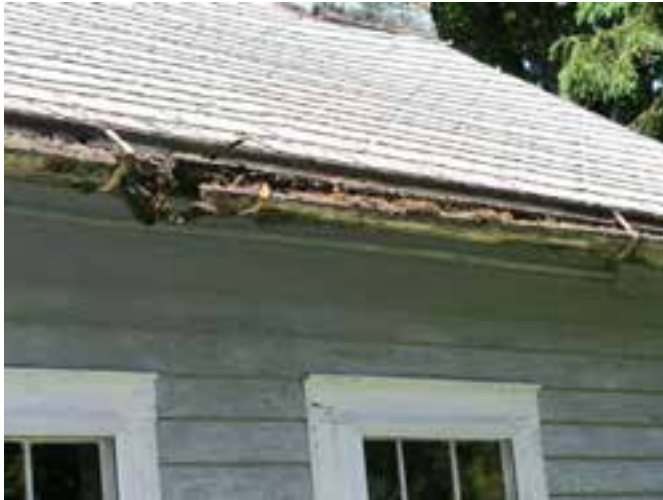
Fig. 5.4 Rotted gutter section.

Where they exist at all, existing gutters are in poor condition (Fig. 5.4). Uncontrolled roof drainage has become a major problem, as much of the roof drainage water channeled via the valleys east of the house has been funneled directly into the basement, via the unprotected areaways. This condition has further deteriorated the basement floor and created a high-humidity environment promoting rot, mold-growth and pest-infestation (Fig. 5.5). Consequently, a high-priority should be placed on reconstruction of the roof drainage system, together with restoration of the areaways and basement windows and regrading of the immediate area to direct runoff away from the house.

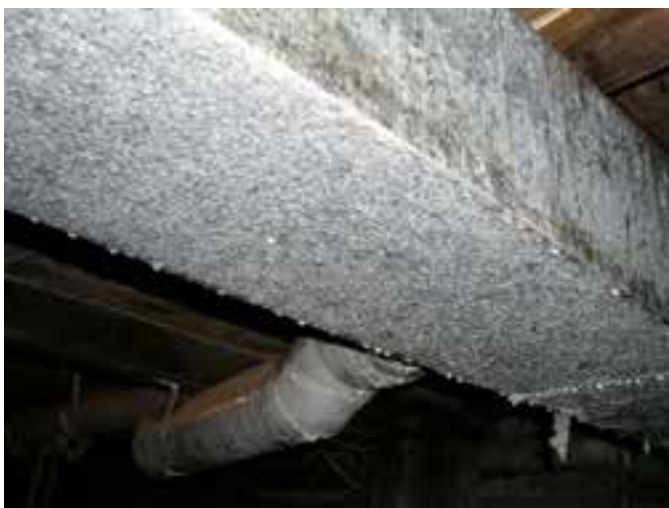
Fig. 5.5. Extreme humidity in basement aggravated by uncontrolled roof runoff is deteriorating structural framing and HVAC equipment.

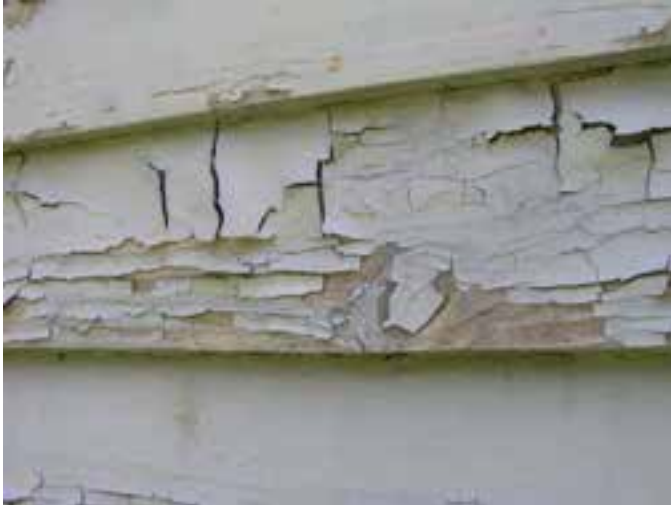
Various finish-carpentry repairs are needed throughout the exterior of the house, including replacement of deteriorated siding and trim. The siding and trim does not appear to have been painted since just before the 1994 report was written, and the paint finishes are in poor condition. Where the paint film has peeled off completely, leaving bare wood exposed to UV degradation, the wood grain should be consolidated by light sanding and application of spar varnish, prior to priming and painting.

Fig. 5.6. Typical condition at clapboard siding, 2007.

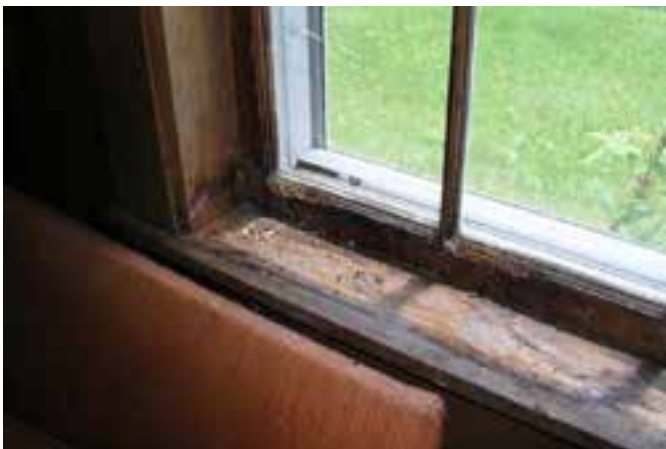
Although all windows were reportedly restored and painted by the time of the 1994 report, they have suffered typical weathering and moisture-related deterioration. In addition, windows in the ell have pest-related damage (i.e., rodents trying to escape, Fig. 5.7).

Fig. 5.7. Ell window; note damage to stool and sash.

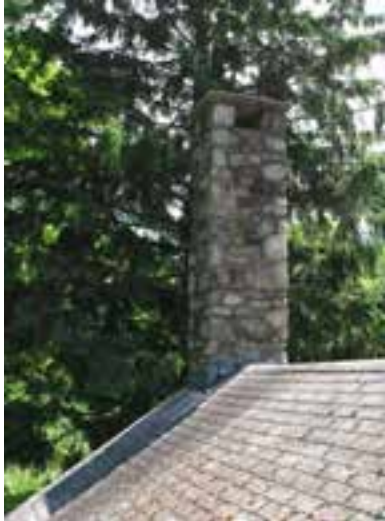
The rustic stone chimney located at the east end of the ell requires spot-repointing in several areas. In addition, the gaps between the chimney and the adjacent wood-framed walls must be filled with insulation, backer and sealant, where possible.

Fig. 5.8. Ell chimney.

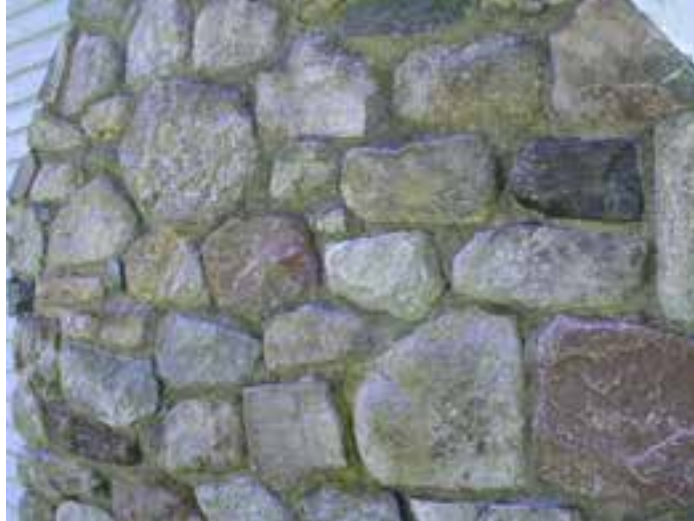
Fig. 5.9. Stone masonry needs spot-repointing.

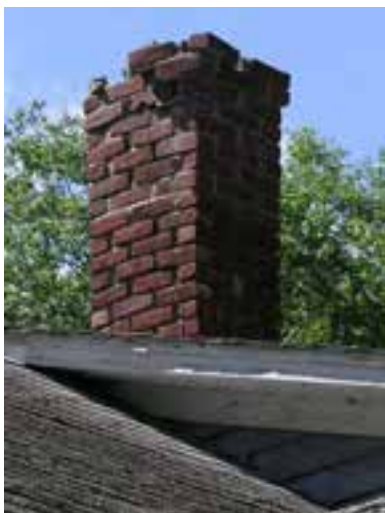
The brick chimney (reconstructed as a heating system-flue at some point) is in extremely poor condition above the roof and needs to be rebuilt (Fig. 5.10). As part of this process, the clay-tile flue liner should be inspected and repaired. From the attic (Fig. 5.11), the masonry appears to be in fair to good condition, but should be inspected in more detail, nonetheless, to check for leaks.

Fig. 5.10. Brick (flue) chimney.

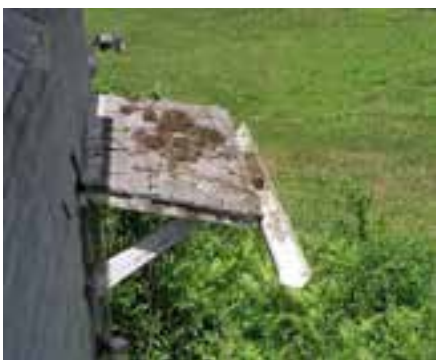
The portico over the rear door (Fig. 5.14) is in poor condition and could either be rebuilt and re-roofed, or removed, as part of a larger renovation project.

Fig. 5.14. Rear portico.

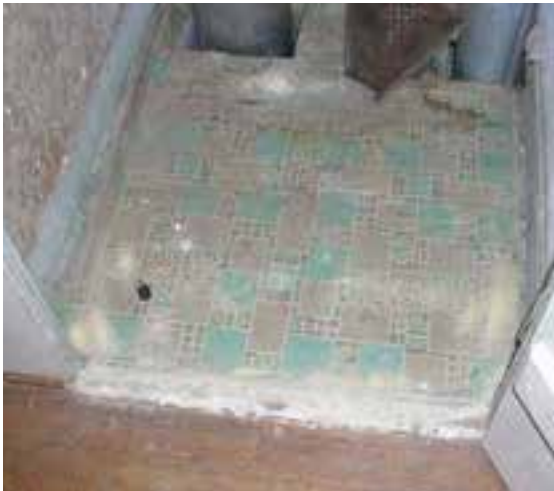
Fragments of early- to mid-century linoleum and wallpaper exist in closets. If these must be removed, they should first be documented photographically, and representative samples should be submitted to DCR for archival purposes. More-recent flooring surfaces and wallpapers (e.g., the kitchen) appear to be non-contributing and can be removed.

Fig. 6.3. Linoleum flooring in closet: original location – or moved?

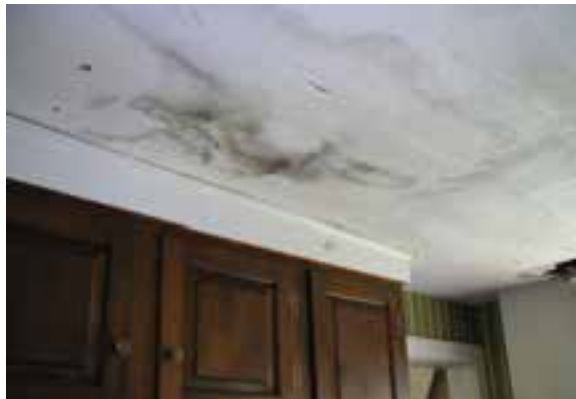
Fig. 6.5. Water damage and mold at kitchen ceiling.

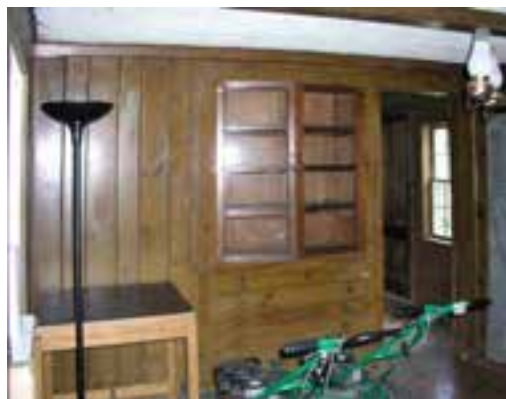
Fig. 6.6. Paneling and beams at Dining Room.
Note apparent difference in wood species between paneling and glass-fronted cupboard.

The Dining Room ceiling is faced with timber “beams” that are apparently decorative in nature (Fig. 6.6). Together with the V-groove pine wall paneling and built-in cabinets, the room retains its historic character and is worthy of preservation, even if required structural changes and other improvements are made to the adjacent kitchen and the wall dividing the two rooms. The cabinet along the east wall of the dining room appears to have been modified, in that the glass doors and china cabinet are of different wood species from that of the built-in plan files below them/

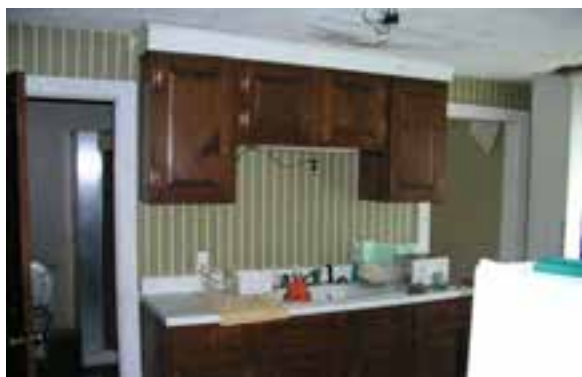
Fig. 6.7. The existing kitchen cabinets and wallpaper.

Modern wallpaper and other finishes in the kitchen (Fig. 6.7) can be removed and discarded, as part of an overall kitchen renovation.

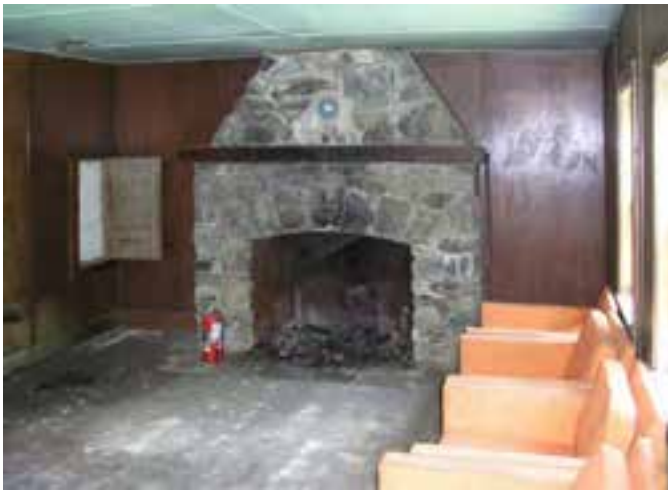
The large fieldstones that comprise the fireplace demonstrate the stonemason's art and introduce a rustic quality to the house, recalling the "Great Camps" of the Adirondacks. The fireplace and its prominent chimney may represent the influence of the National Park Service in sponsoring what has been called the "Golden Age of Rustic Design" of parks and recreation structures. The fireplace appears to be in reasonably good condition, but the damper needs renewal in order to return to functionality, the stonework needs repointing, and the gap between the chimney and the east wall must be properly filled and sealed. As an important and "anchor" feature of the building and the site, the fireplace must be preserved.

Fig. 6.8. Stone fireplace in ell. Note also the wood paneling, which is in need of renewal.

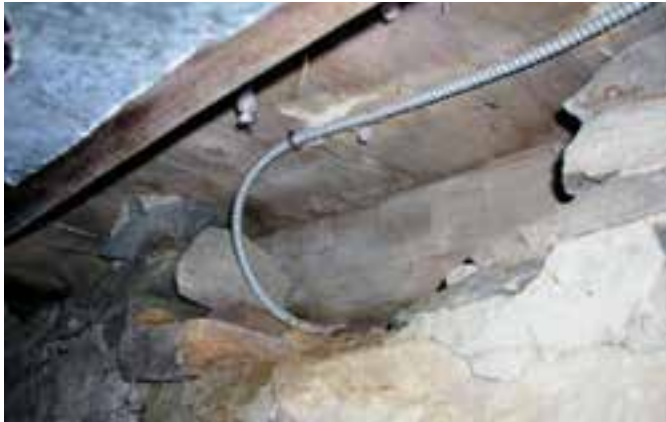
Due to the volume of roof drainage and runoff water that has been allowed to run directly into the basement, moisture conditions were extreme during the time of the site visit, with condensed water dripping from metal and wood surfaces alike. The conditions have resulted in punky wood at some beams and joists, with the potential for compression and eventual failure.

Fig. 6.9. The sill of the house is exposed to the basement interior in only a couple of spots; therefore an accurate determination of its condition is difficult without more extensive testing and/or removal of exterior cladding.

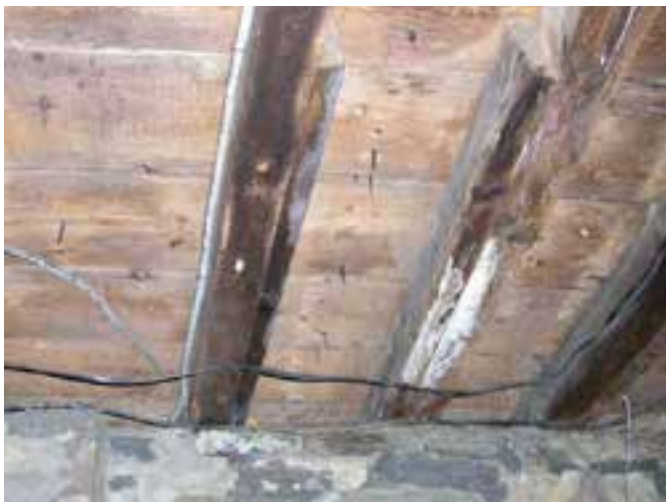
Fig. 6.10. First floor framing evidencing mold growth.
