-- ANY LAKE DAM--

PHASE I INSPECTION / EVALUATION REPORT

Dam Name:Any Lake DamNational ID No.:MA11111Owner:MA Dept of Conservation ResearchTown:Hindsdale, MassachusettsConsultant:Eng. Corp., Inc.Date of Inspection:June 1, 2021

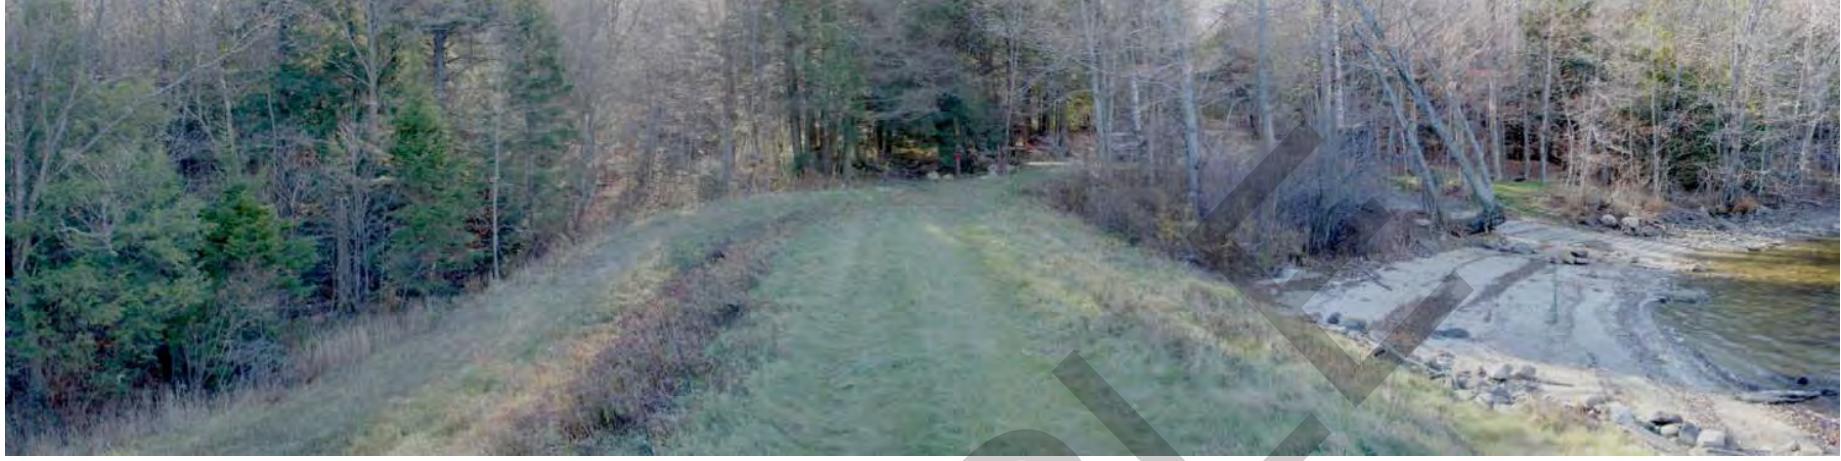
- The right embankment crest is grass covered and appears to be in good condition. Minor rutting was observed in the crest, but no significant erosion was observed. See Photographs A1 through A6.
- The left embankment crest was poorly maintained, not vegetated or protected, and covered with sticks and leaves. The left crest was relatively level and no significant rutting or erosion was observed. See Photographs A7 through A8.
- Downstream Slope

Photo A1 – Panorama composite - Right abutment from embankment crest*

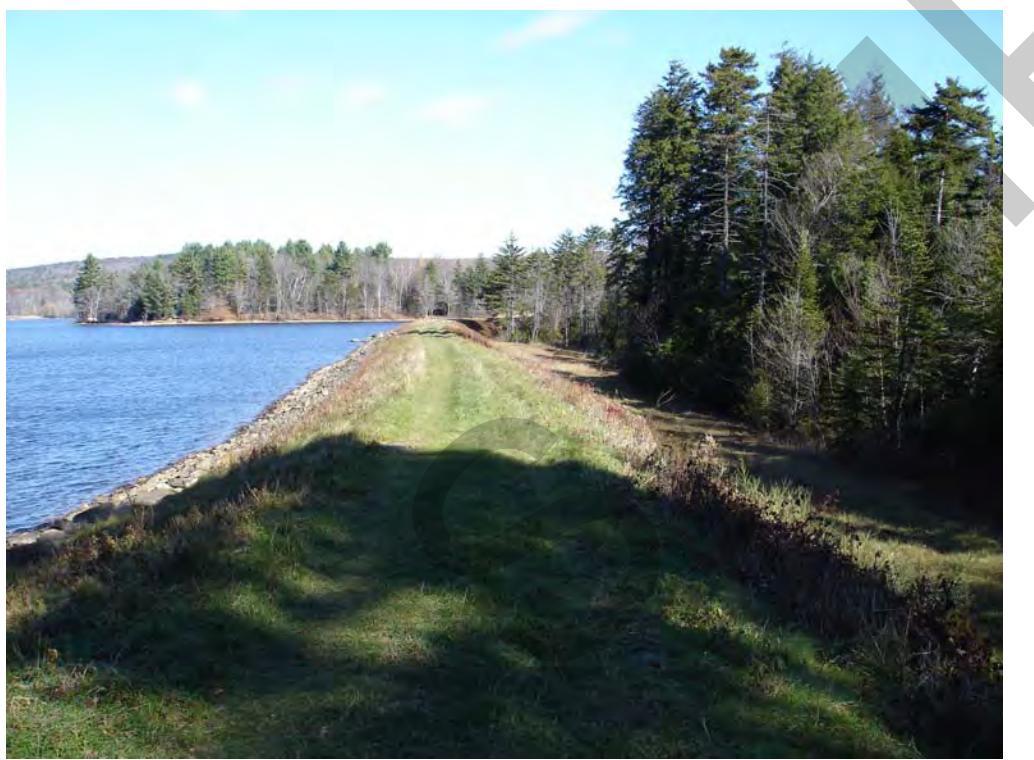
Photo A2 – Embankment from right embankment

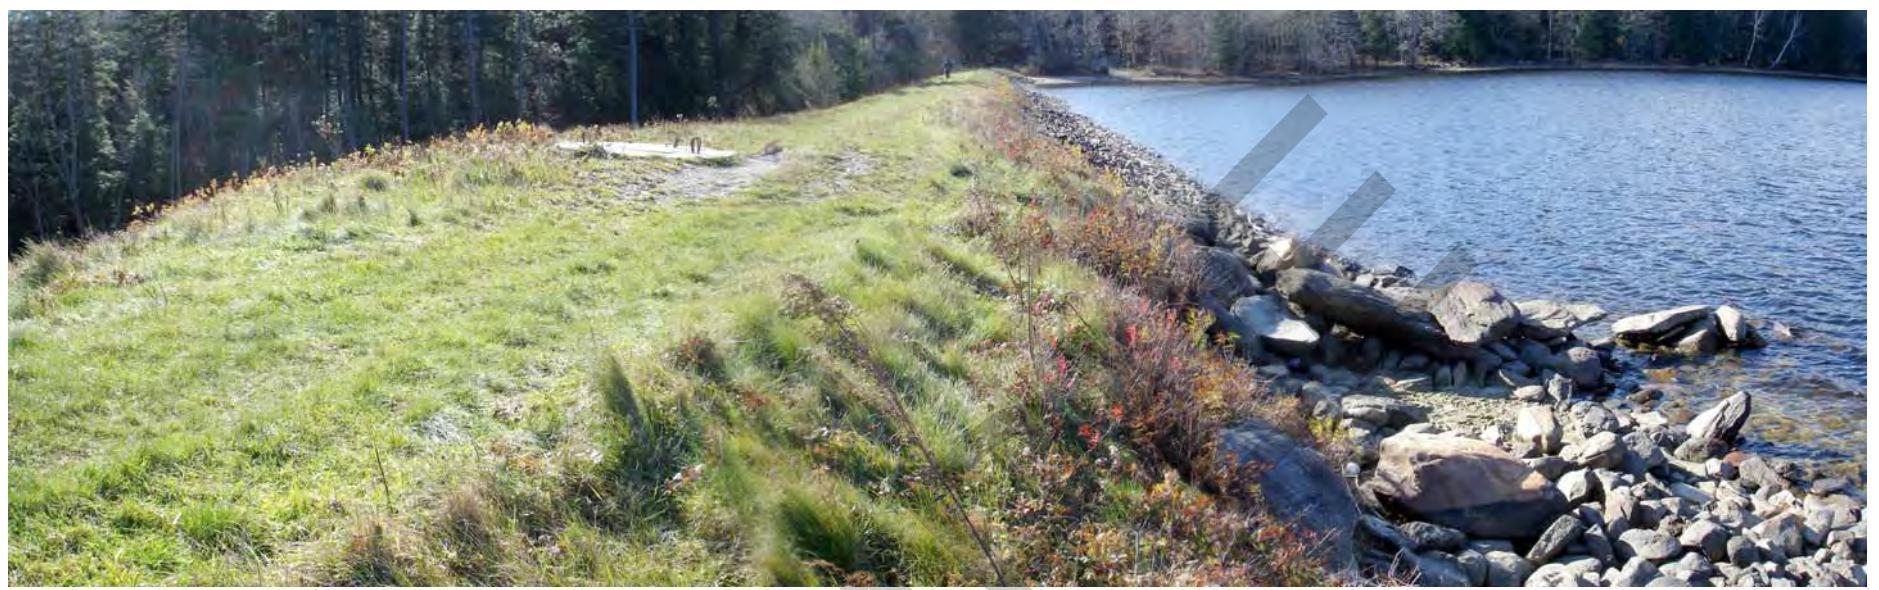
- The butterfly valve at the embankment crest was protected by a locked manhole and was not accessible. See Photograph A3.
- In general, the headwall and concrete wing walls at the downstream end of the outlet pipe appeared to be in good condition and the remaining portions of the original stone masonry outlet structure appeared stable. See Photograph A17.
- The visible portions of the outlet pipe and downstream butterfly valve appeared to be in good condition. The controls for the valve were not accessible and valve was not operated during the inspection.
- The discharge channel for the outlet pipe was lined with riprap near the end of the pipe and no visible signs of channel deterioration were observed.
- Fallen trees blocked the channel downstream of the outlet and may impede flow during periods of significant discharge.

Photo A3 – Panorama composite – Crest and upstream slope from ~Sta. 5+50 toward right abutment*

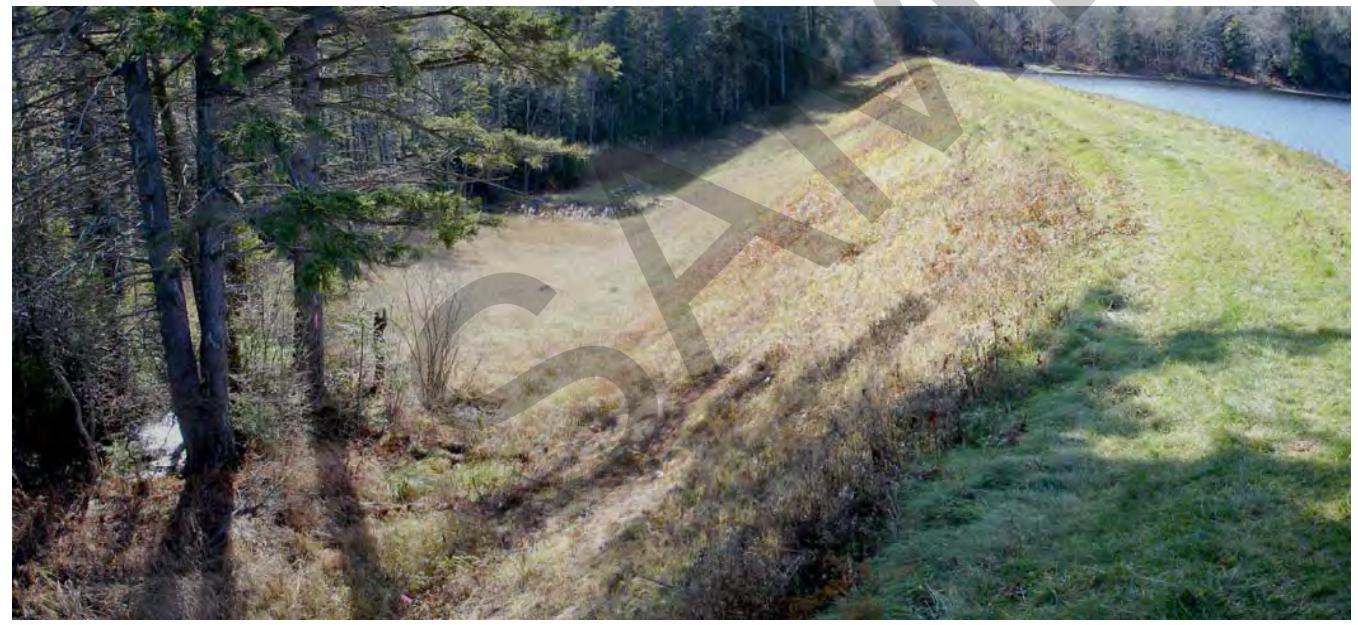
Photo A4 – Panorama composite – Crest and downstream slope from ~Sta. 7+00 toward right abutment*

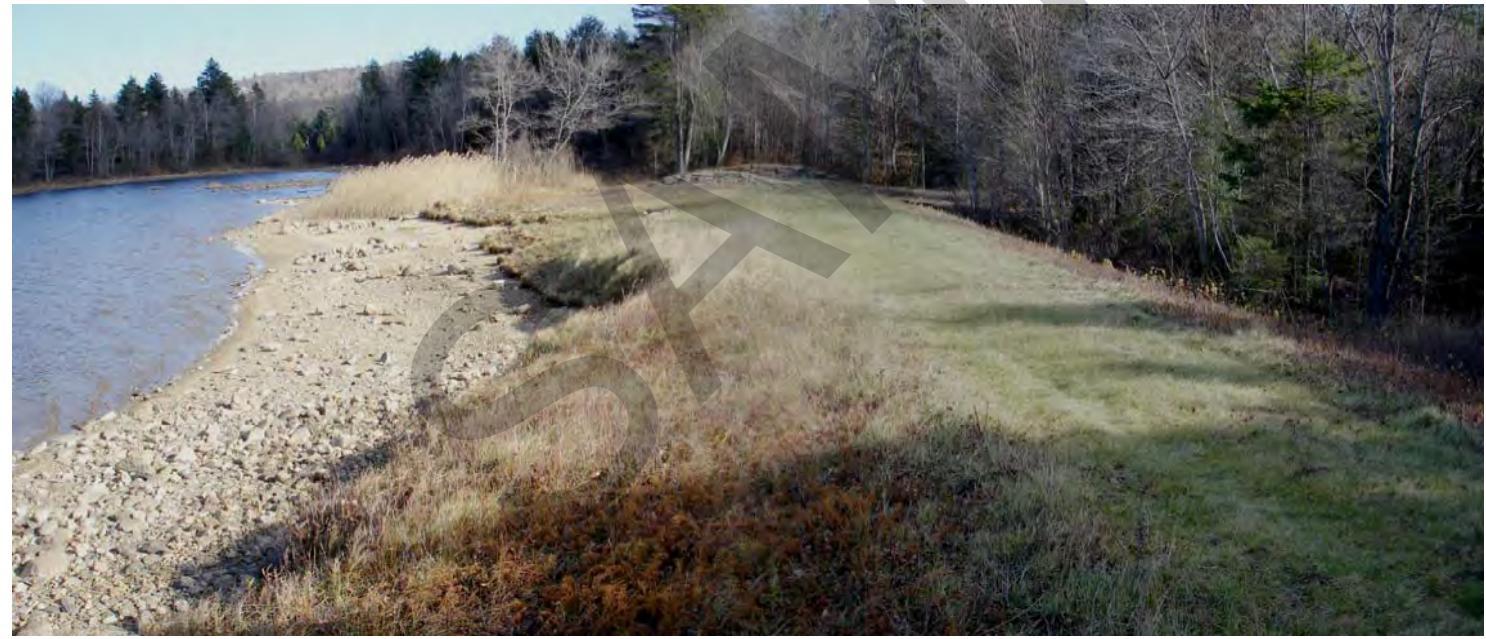
- From about Sta. 10+75 to the left side of the spillway no riprap was observed. The slope in this area is covered with grass and low-cut brush and contains several erosion scarps including a 3-foot high erosion scarp. See Photographs A6 and A11.

Photo A6 – Panorama composite – Crest and upstream slope from ~Sta. 9+00 toward left abutment*

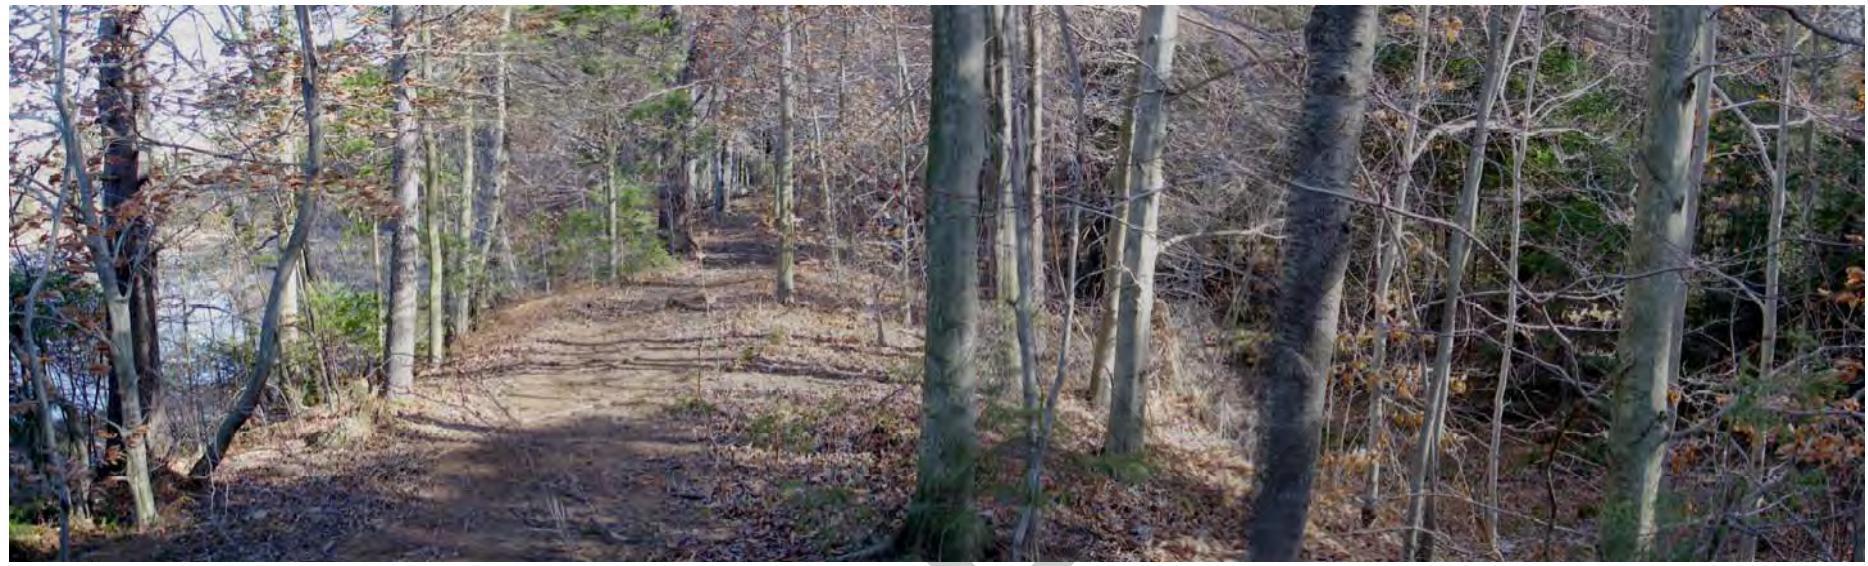
- No riprap was observed on the upstream slope of the left embankment, from spillway to the left abutment. This embankment is heavily wooded with trees and brush. There are approximately 20 trees on the slope and the size of the tree growth ranges from several inches to greater than 12 inches in diameter on upstream slope. Only a few of the trees appear to be dead. The roots visible above the ground surface appeared to be as large as 4 inches in diameter. The brush was approximately 2.5 ft high and covered about 25% of the slope. See Photographs A7 and A8.

- The downstream toes of the left and right embankments are heavily wooded. The thick woods start near the toe at the right abutment and just past the crest at the left abutment.
- Wet and soft areas were observed along the embankment toe at the curved section, and along the toe of the right embankment.
- The left embankment downstream slope is heavily wooded with trees and brush. The size of the tree growth ranges from several inches to greater than 12 inches in diameter on upstream and downstream slopes as described in Section 2.1.2. See Photographs A7 and A8.

Photo A7 - Composite panorama - Left embankment from spillway toward left abutment*

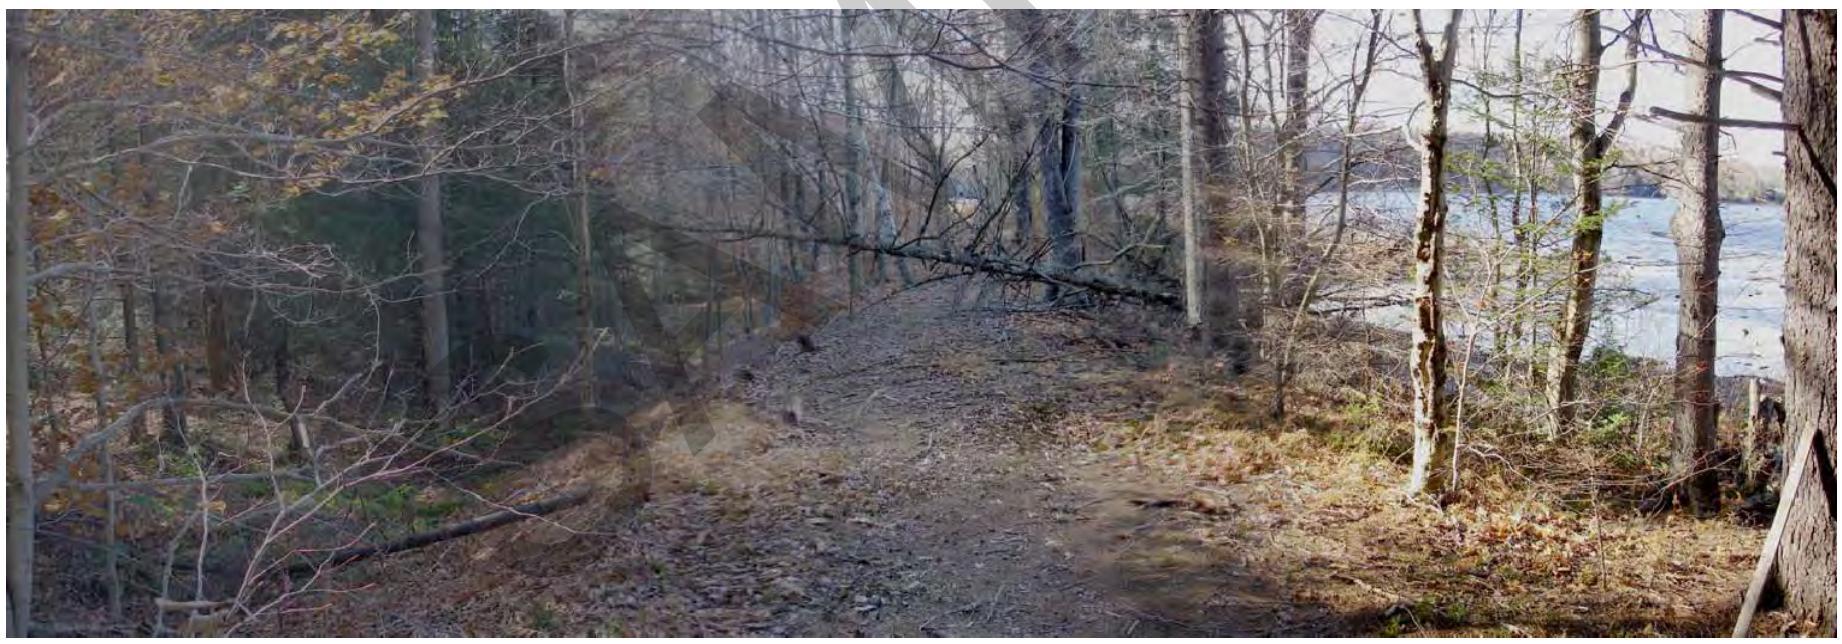
Photo A8 – Composite panorama – Left embankment from left abutment*

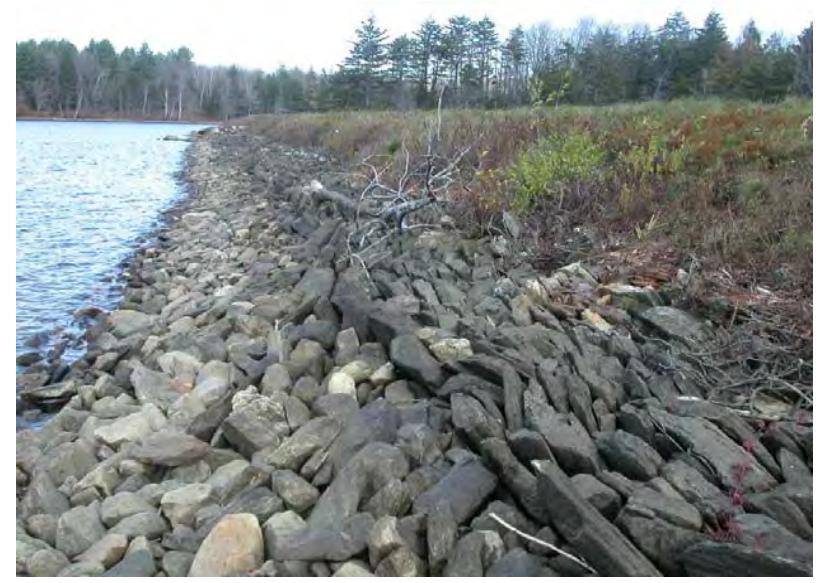
Photo A9 – Typical riprap and scarp on upstream slope

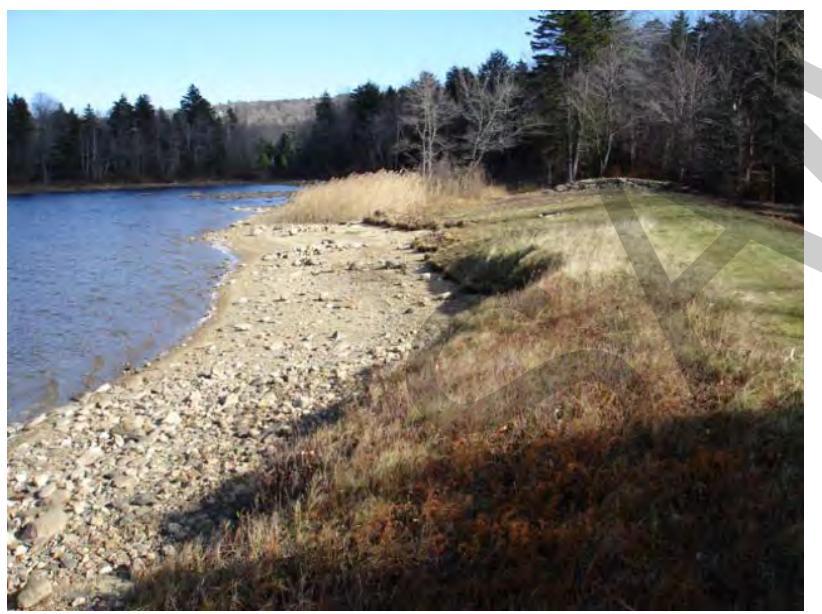
Photo A11 – Upstream slope from ~Sta. 10+75 toward spillway

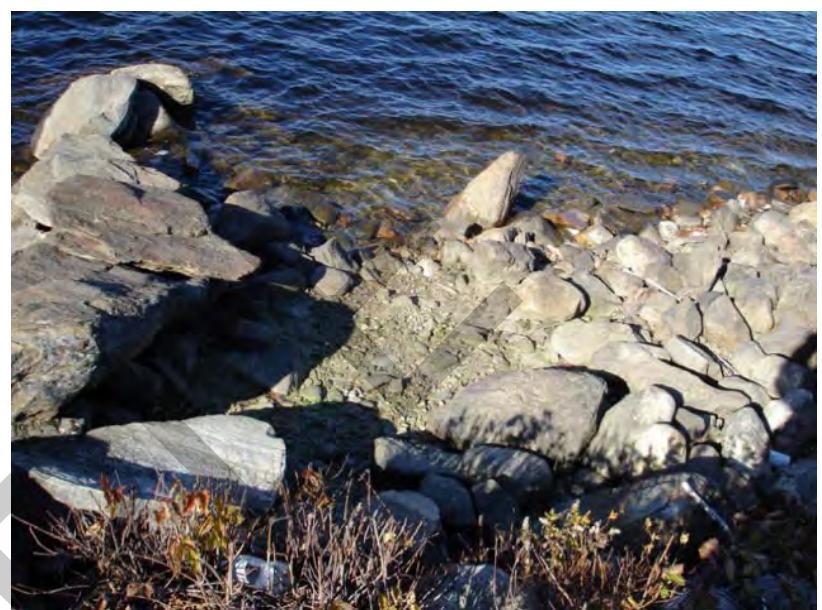
Photo A10 – Upstream slope near low-level outlet

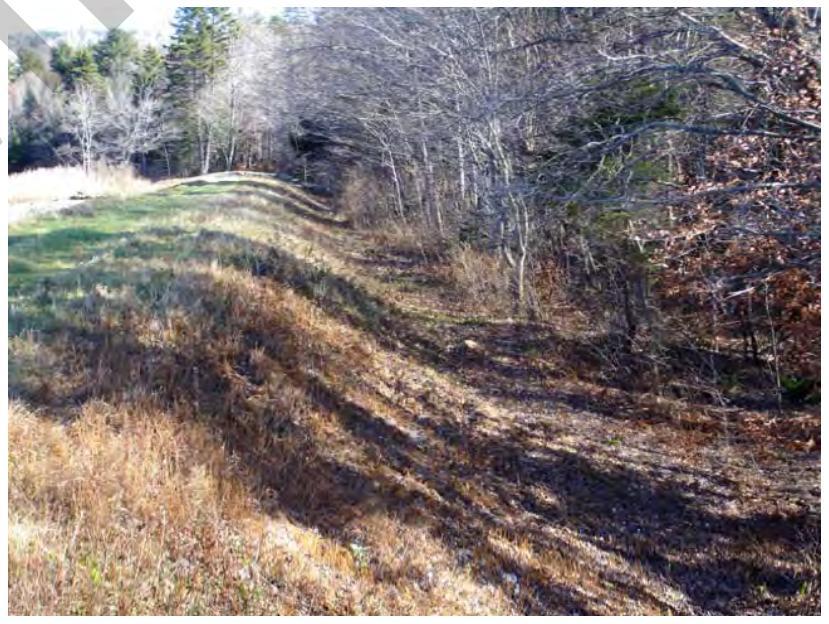
The downstream slope of the embankments are relatively steep (2H:1V or steeper). No signs of slope movement, erosion, or animal burrows were observed. Photographs A1, A2, A4, A5, A7, A8, and A12 show the downstream slope and toe area.

Photo A12 – Downstream slope from ~Sta. 10+75 toward spillway

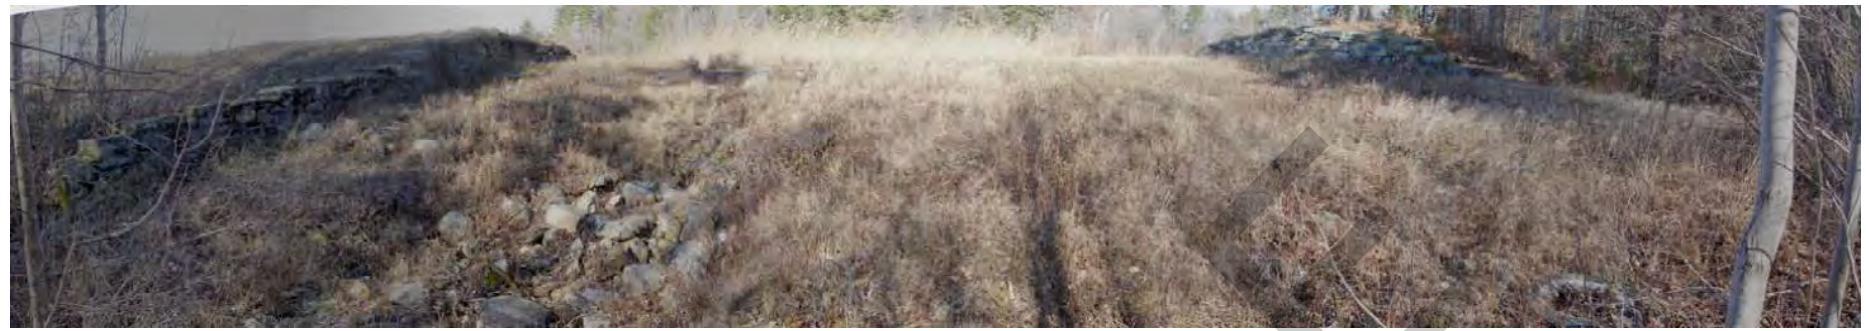
Photo A13 – Composite panorama – Spillway from downstream channel looking upstream*

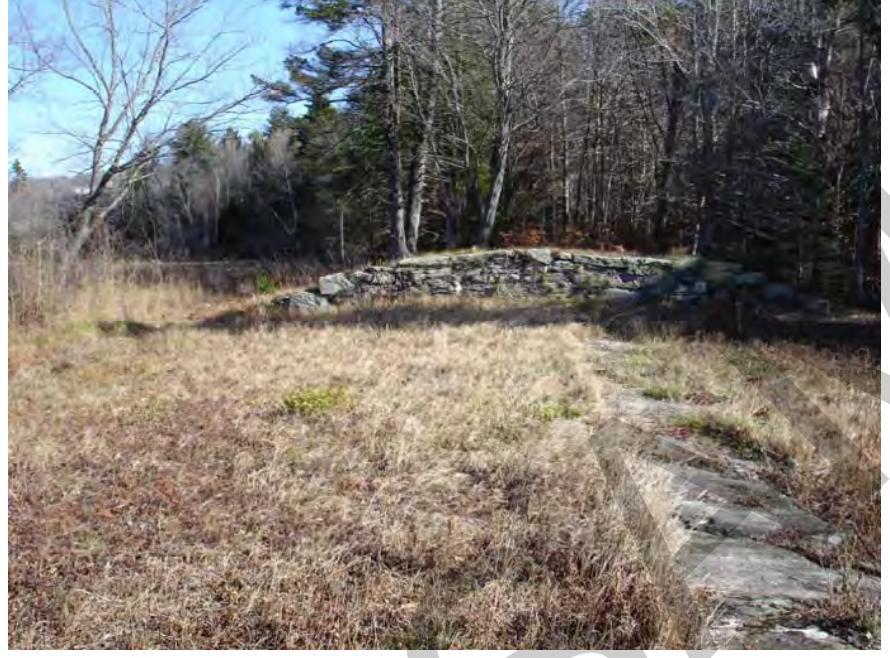
Photo A14 – Spillway from right training wall

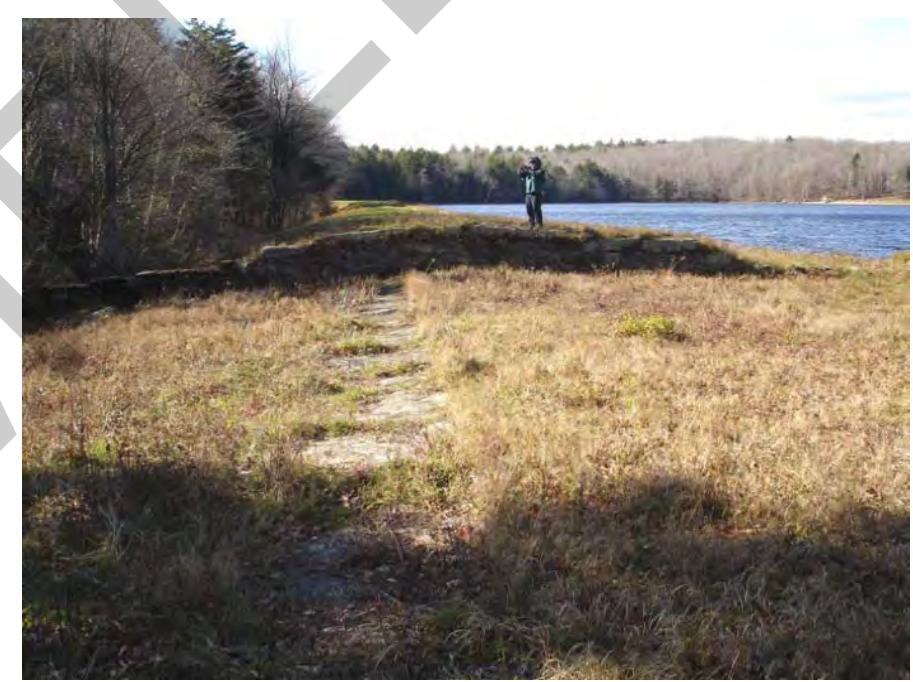
Photo A15 – Spillway from left training wall

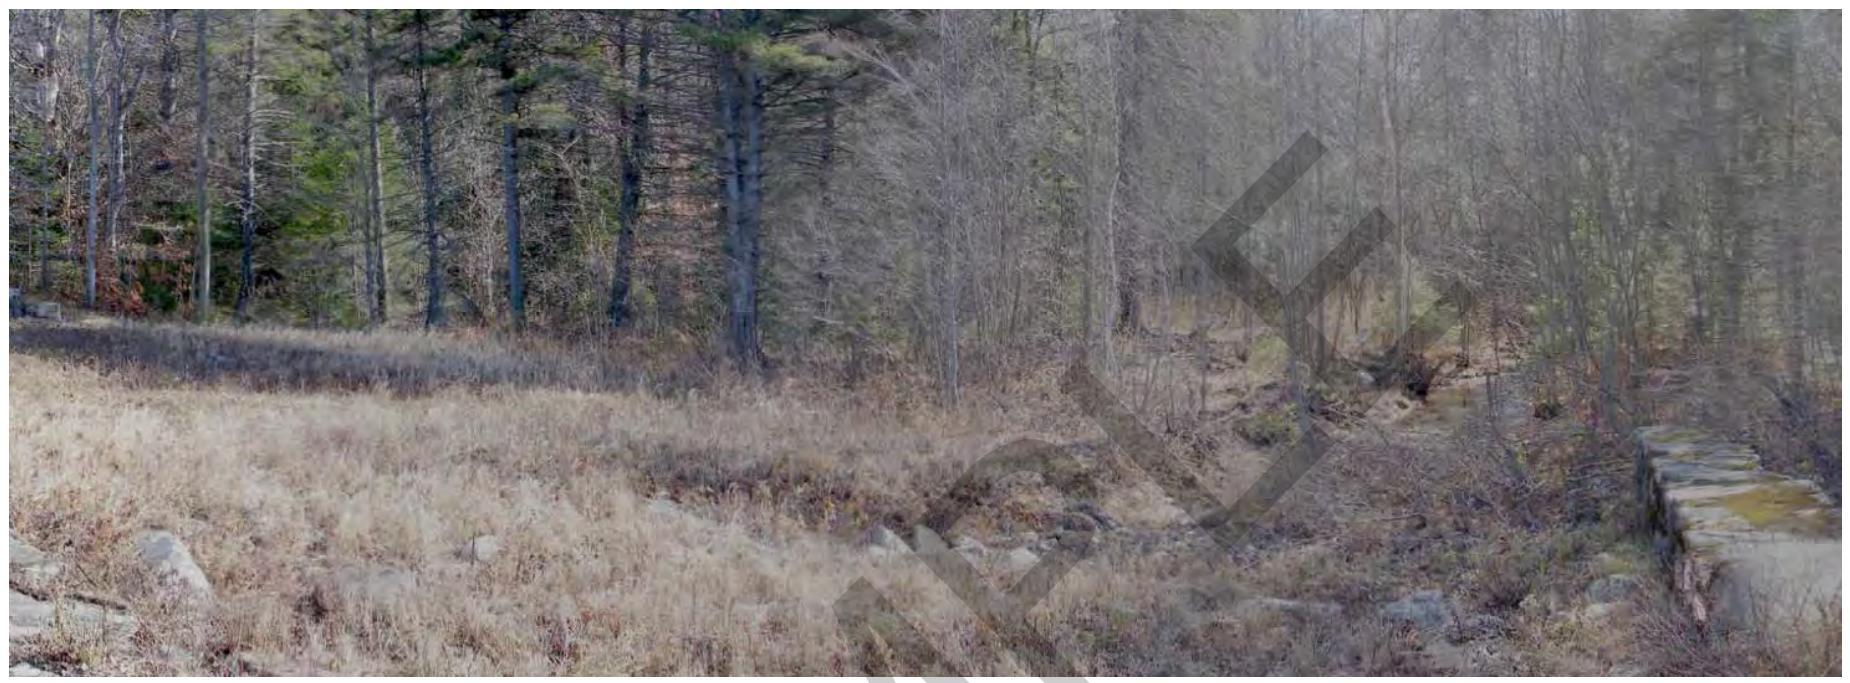
Photo A16 – Downstream end of spillway & spillway channel looking downstream from spillway

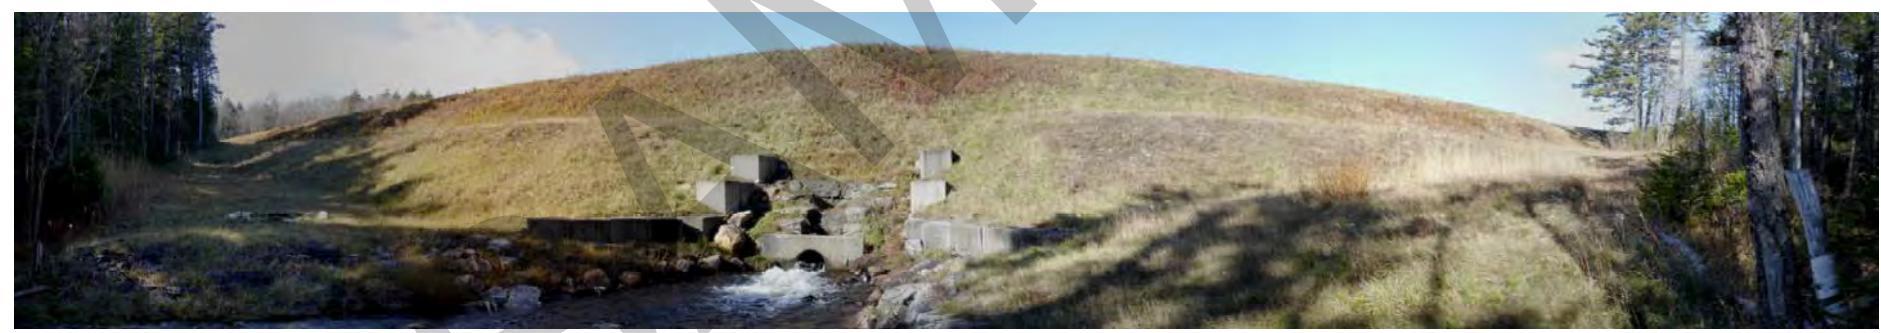
Photo A17 – Panorama composite – Downstream slope and low-level outlet discharge structure*

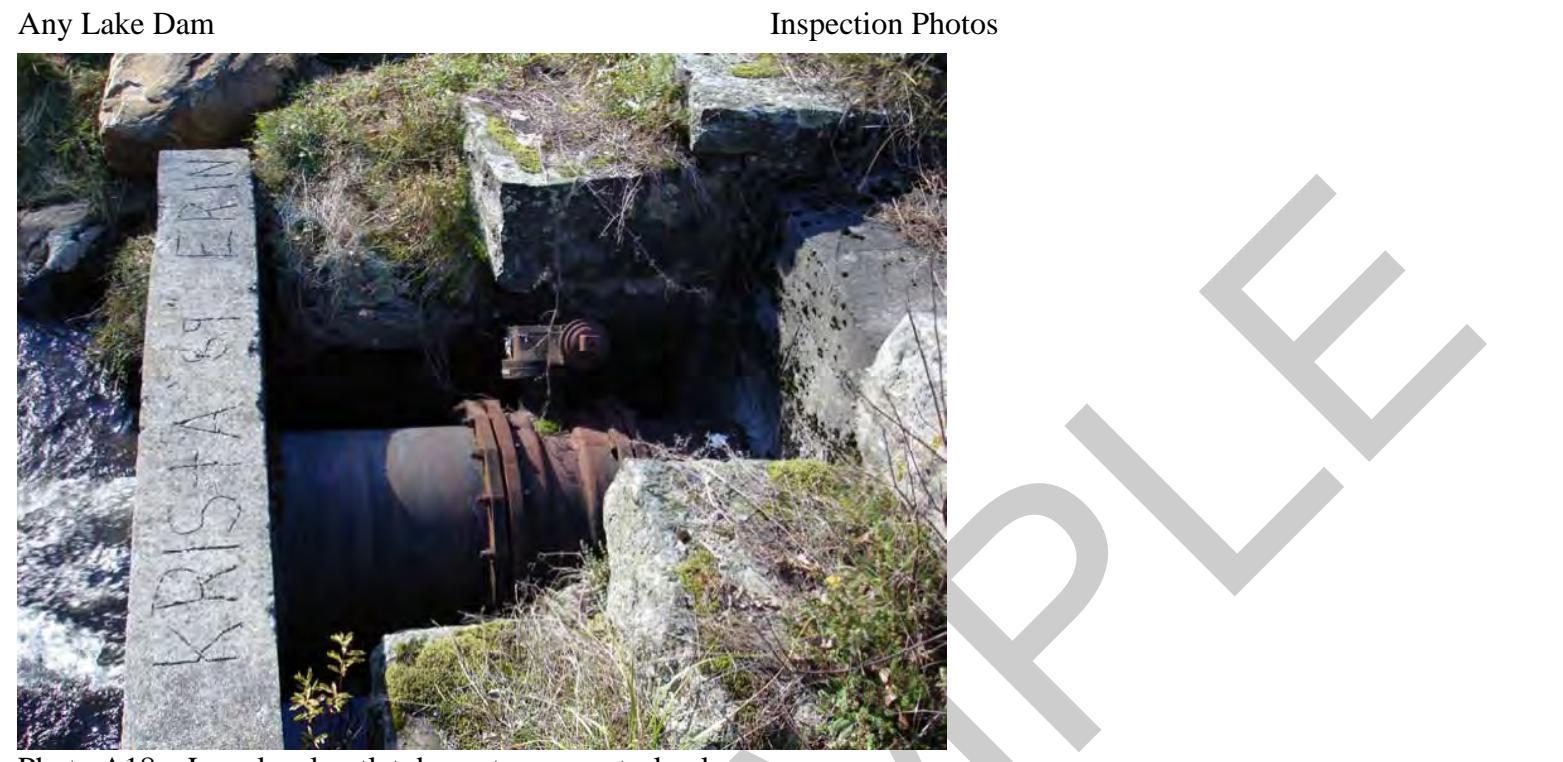
Photo A18 – Low-level outlet downstream control valve
