Model Refinement and Calibration Report

Stormwater System Modeling for Improved Communications and Development of Green Infrastructure

April 8, 2019

Stantec

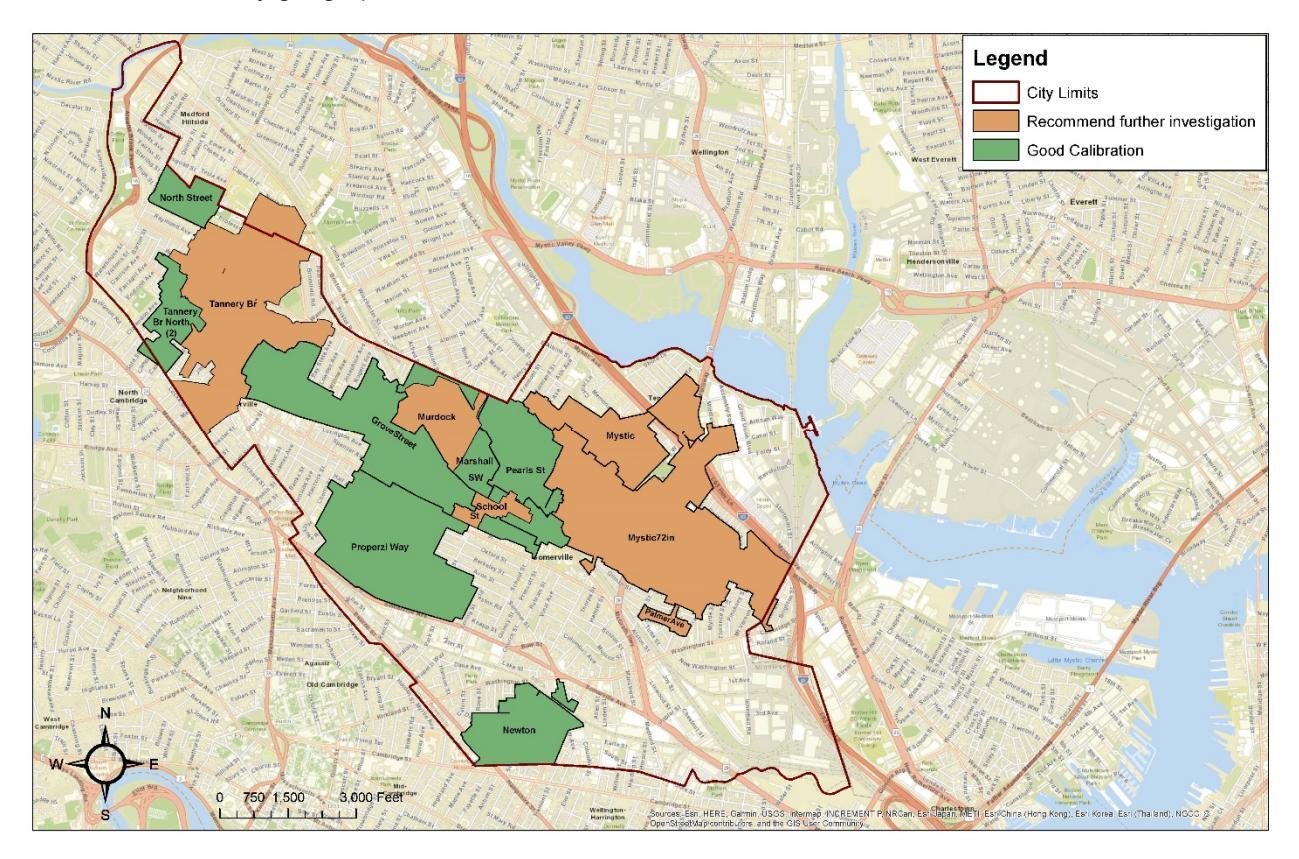
Figure 11. Calibration Status

The Refined Model after calibration and validation is deemed appropriate for planning purposes but further understanding of the system is necessary in certain areas, especially Tannery Brook and Mystic Ave, prior to proceeding with significant design of capital improvement projects. Figure 11 depicts calibration results by geographic area.

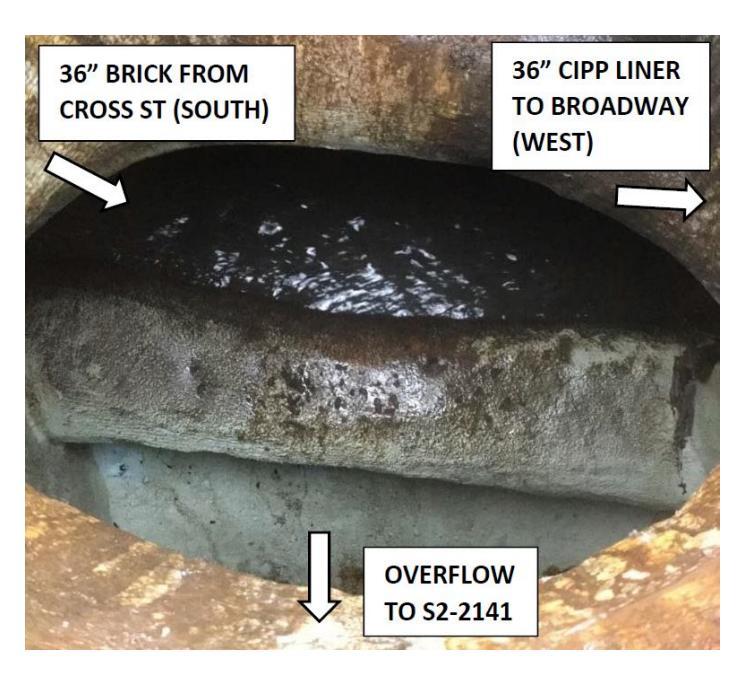
Figure A.1 – MH S2-2767 Weir and overflow to S2-2141

Confined space entries were performed at manhole S2-2767 and S2-2141 at the intersection of Broadway Street and Cross Street. Manhole S2-2767 is lined along with the 36-inch outlet pipe on Broadway headed west. The inlet pipe into manhole S2-2767 is a 36-inch brick pipe and makes the bend from Cross Street. The 18-inch VCP in-line connection from Broadway was confirmed into the 36-inch brick pipe. A weir and overflow connection were observed from S2-2767 over to S2-2141 (See **Figure A.1**).

The overflow is a tapered brick channel measured to be 5.1'Wx1.4'H on the upstream end and then increases in height to 5'Wx2.3'H on the downstream end at manhole S2-2141.

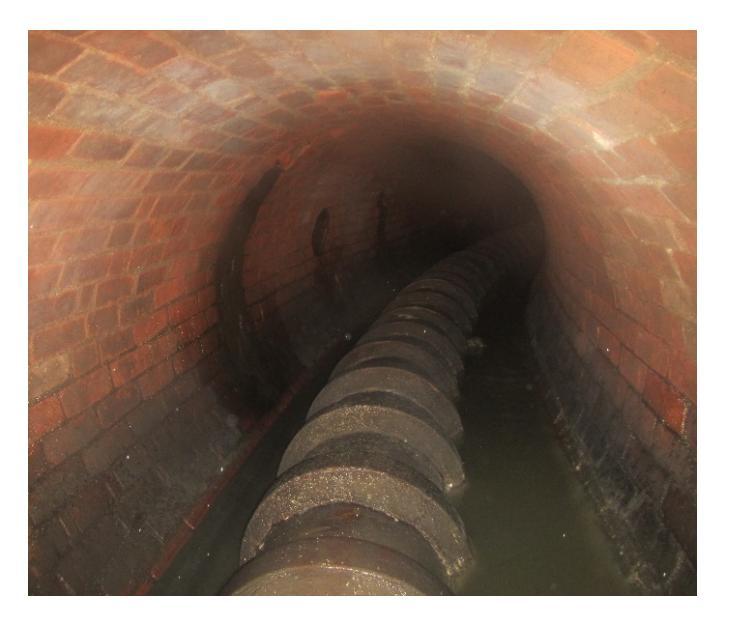
Figure A.2 – MH S2-2141 36" Brick Inlet with 12" VCP sleeve at invert

Manhole S2-2141 is partially lined with the liner in poor condition at the manhole invert. The mainline inlet and outlet was measured to be a 41-inch brick pipe and sleeved inside the mainline is a 12-inch vitrified clay pipe that sits within the mainline invert. The 12-inch pipe has an open tee connection providing access within the limits of the manhole (See **Figure A.2**). There are also (2) inlets coming from the direction of Cross Street East. The source of these connections could not be determined.

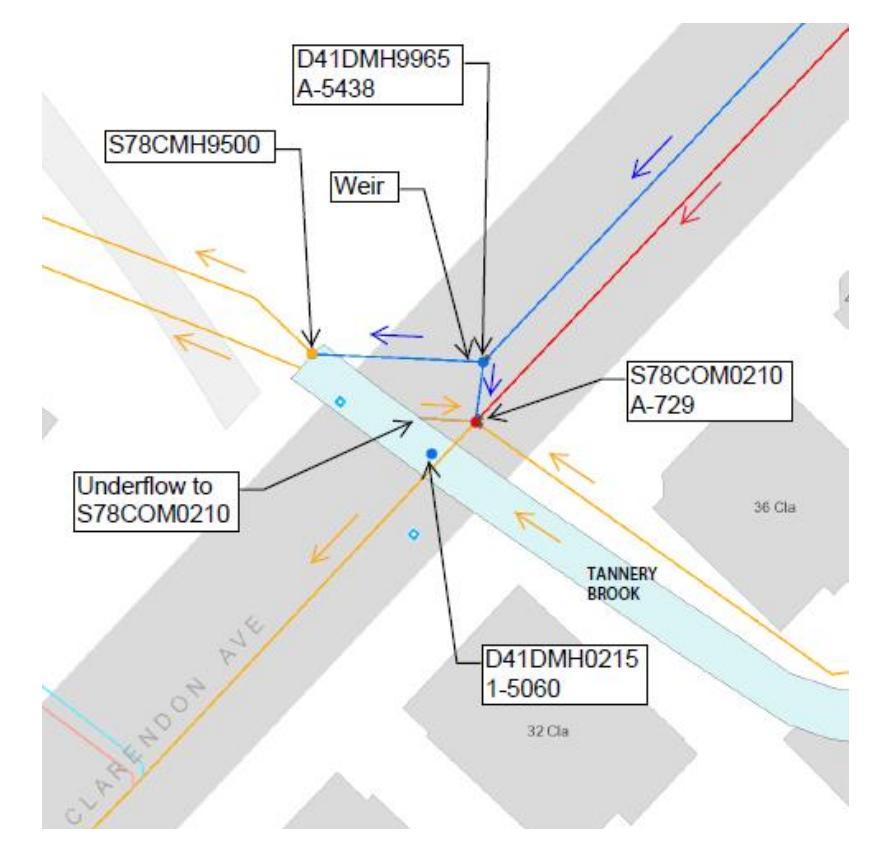
Figure A.3 – Clarendon Ave Tannery Brook Connectivity

A confined space entry was conducted within manhole S78CMH9500 to better understand the Tannery Brook conduit and the connectivity between the drain, sewer, and combined sewer on Clarendon Avenue. These inspections were conducted within the limits of Cambridge; however, this area has hydraulic impacts to the Somerville conveyance system upstream. The Somerville GIS system is not fully built out in this area, but the Cambridge GIS appears to match the connectivity observed in the field (See **Figure A.3**). The Cambridge structure identification numbers were used during the investigation along with the Somerville identification numbers if available.

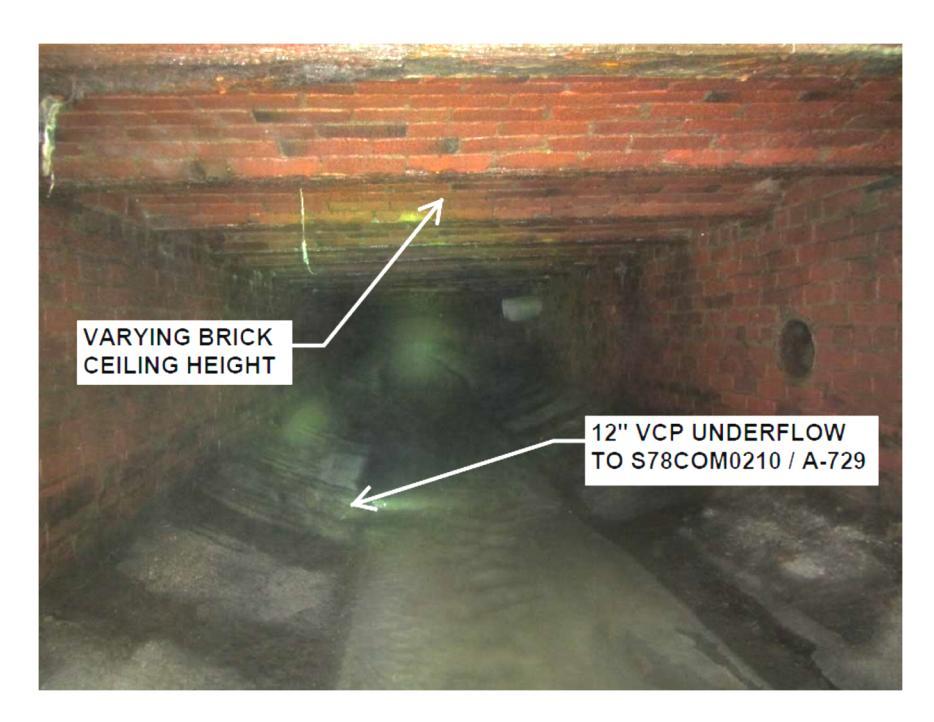
Figure A.4 – Clarendon Ave Tannery Brook Conduit (Inlet as observed from S78CMH9500)

The major findings included the observed 10-inch vitrified clay underflow connection from the Tannery Brook conduit over to A-729. This connection is approximately 6-inches below the Tannery Brook conduit directing base flows into S78COM0210 / A-729. In addition, a brick weir was observed within D41DMH9965 / A-5438 directing base flows into S78COM0210 / A-729. In this location, the Tannery Brook conduit is a rectangular channel and has a concrete invert with brick sides and a brick ceiling. The ceiling has consistent waves with varying heights. The conduit was measured to be 7.3'Wx4.1'H at its lowest point and 7.3'Wx4.4'H at its highest (See **Figure A.4**).

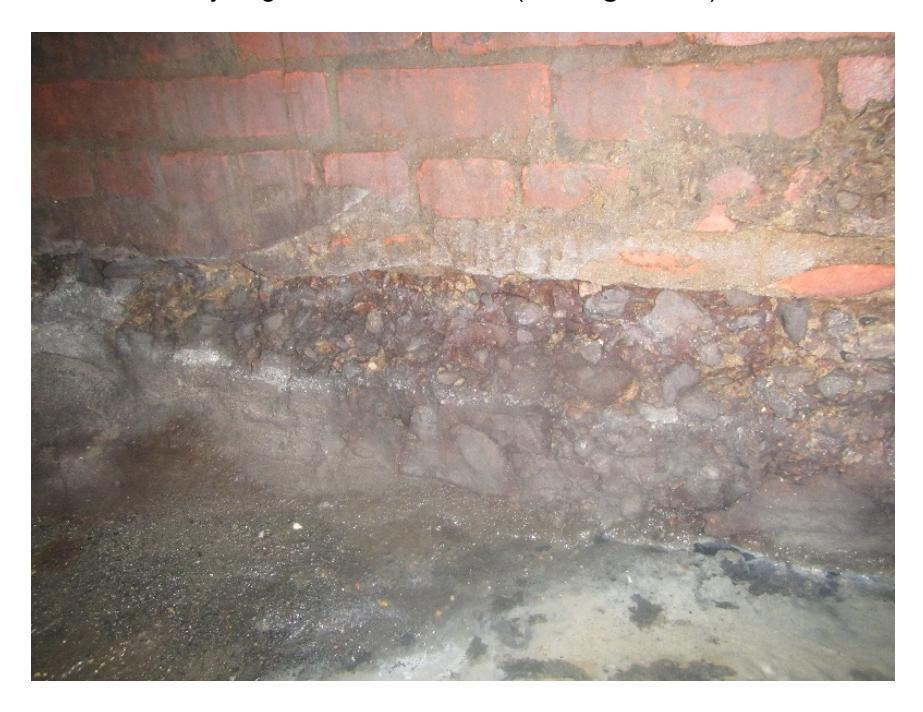
The concrete invert of the Tannery Brook Conduit displayed signs of degradation with exposed aggregate and soil suspected to be from hydrogen sulfide corrosion (See **Figure A.5**).

Figure A.5 – Concrete invert corrosion within Clarendon Ave Tannery Brook Conduit

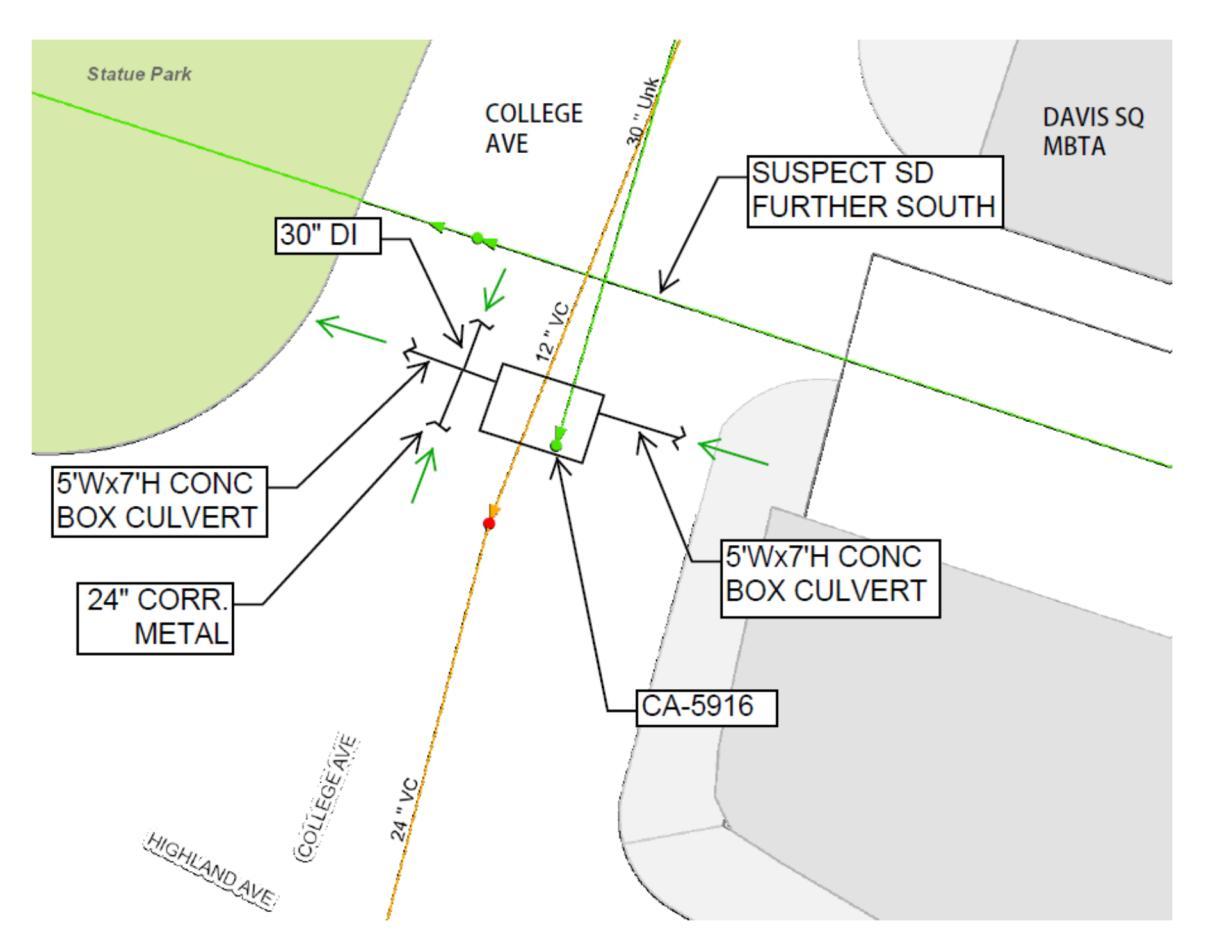
Figure A.6 – MH CA-5916 GIS Markup

A confined space entry was conducted within drain manhole CA-5916 on College Avenue adjacent to the Davis Square MBTA entrance. The City GIS depicts a 30-inch drain on College Avenue ending at this manhole with no outlet. A large 10'Wx10'L concrete chamber was observed with a 5'Wx7'H concrete box culvert inlet and outlet going parallel to the MBTA tunnel from east to west (See **Figure A.6**). The College Avenue 30-inch ductile iron inlet was observed coming from the north in-line into the mainline box culvert along with an additional 24-inch corrugated metal inlet pipe coming from the south and connecting in-line. The source of the 24-inch inlet is unknown. In addition, a conduit passes through the chamber and it appears the structure was cast-in-place to allow for this crossing. This crossing is suspected to either allow for the combined sewer to pass through or a private utility.

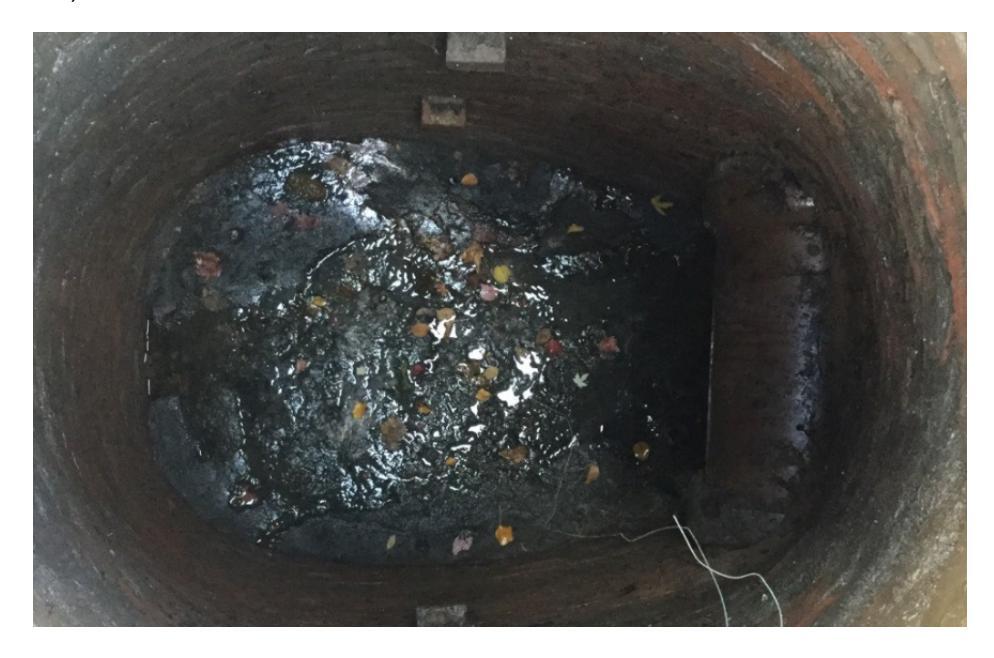
Most manholes inspected appeared to be in good condition and did not appear to require cleaning. However, manhole A-533, at the intersection of Elmwood Street and Harrison Road, appeared to need cleaning due to suspected sanitary service weeping up through debris or potential groundwater infiltration (See **Figure A.7**).

Figure A.7 – MH A-533 in need of cleaning

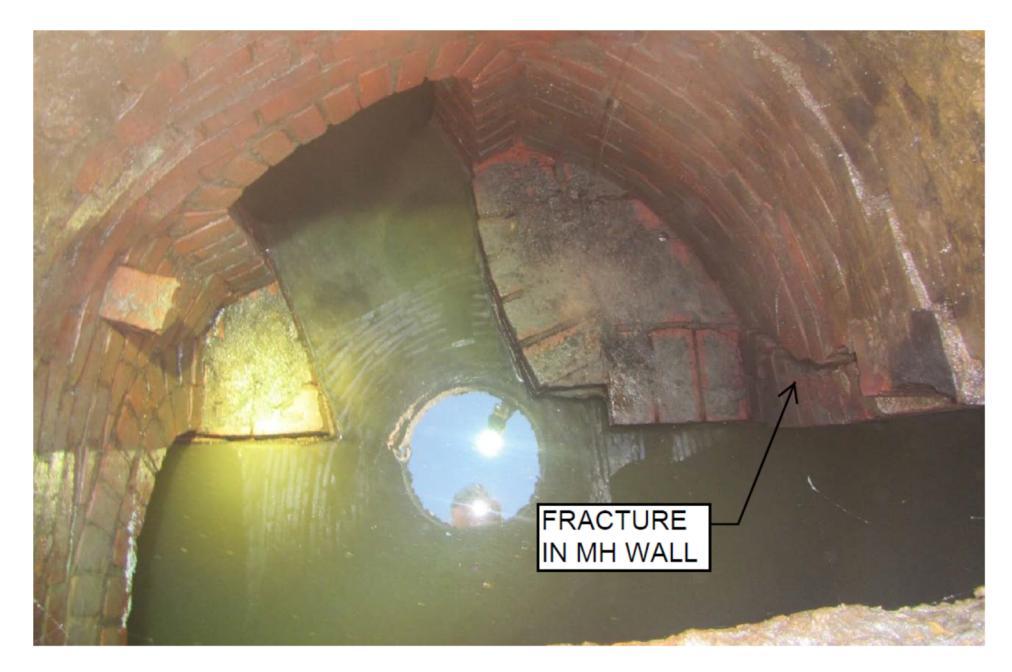
A fracture was observed on the interior brick manhole wall within manhole S2-2686 at the intersection of Medford Street and School Street (See **Figure A.8**).

Figure A.8 – MH S2-2686 with interior fracture
