Waltham District / Juvenile Court Waltham, MA

HVAC SYSTEM EVALUATIONS COVID-19

Office of Court Management

February 16, 2022

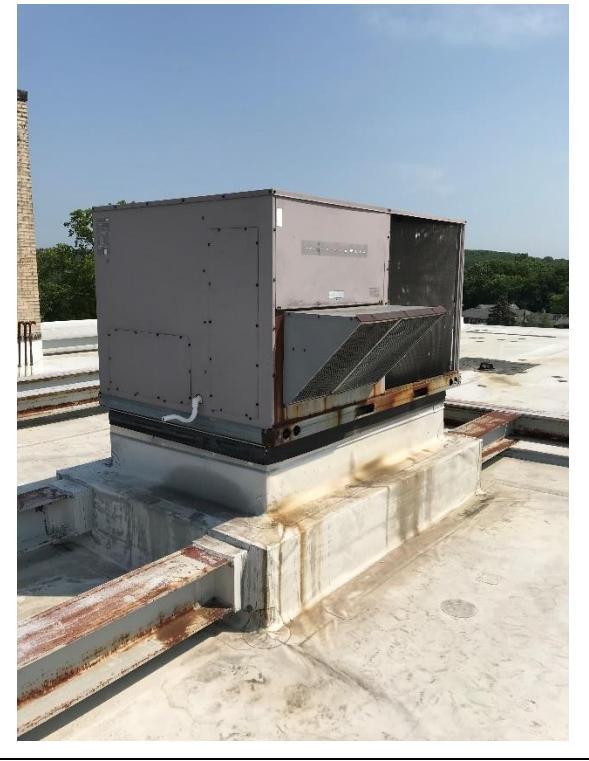
The Waltham District Courthouse was constructed in 1941, renovated in 1996 and is approximately 27,000 square feet in size. Three constant volume RTUs provide ventilation and cooling to the three courtrooms. A 100% outside air make-up AHU and exhaust fan provide ventilation to the lockup area. Perimeter steam radiators provide heat to the building. There does not appear to be any mechanical ventilation provided to the building outside of the three courtrooms and the lock-up area. There are what appear to be some very old unit ventilators in some spaces however, during the site visit it was noted that the outside air louvers for these units had been sealed.

Each rooftop unit contains a supply fan, refrigerant (DX) cooling coils, and 2" MERV 13 filter. These units are all cooling only units and therefore do not operate during the winter when there is no call for cooling. The rooftop units were installed in 1996 and appear to be in poor condition. The DX cooling coil for each unit is dirty. The outdoor air dampers are old and rusting but appear to be operational. Each RTU is believed to be a single zone unit that serves a dedicated courtroom. Due to lack of mechanical plans, Tighe & Bond has made assumptions as to which courtroom is served by each unit based on the unit's location, size, and the size of the courtrooms.

TABLE 1 Existing Air H	landling Units			
Unit	Original Design Airflow (CFM)	Original Design Min. O.A. (CFM)	Pre/Final Filters	Condition
RTU-1	Unknown	Unknown	2" MERV 13	Poor
RTU-2	Unknown	Unknown	2" MERV 13	Poor
RTU-3	Unknown	Unknown	2" MERV 13	Poor
AHU-1	Unknown	Unknown	2" MERV 13	Good

Photo 1 – Representative Air Handler

Rooftop air handling units have a life expectancy of 25 years, and ASHRAE states that the median life for these units is 15 years. The air handlers are approximately 25 years old and are in poor condition. Consider replacing these units in the next 5 years. We recommend replacing these with units that are capable of providing heating and cooling to allow for year-round ventilation. This recommendation is an energy saving and operations and maintenance measure and does not directly improve the indoor air quality of the building. It should be noted that replacing the existing RTUs will not have an impact on air quality or safety from COVID-19. It is expected that the quantity of ventilation air being brought into the building would be unaffected by replacement-in-kind of the existing RTUs.
