MassDOT Quarter 1 Submittal (June 8 – September 7, 2010)

NPDES MS4 General Permit Compliance Water Quality Impaired Waters Assessment and Mitigation Plan

September 8, 2010

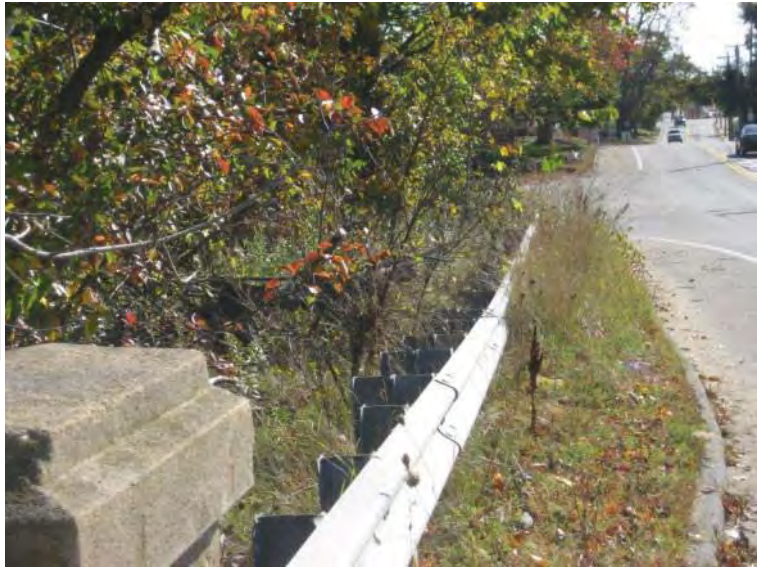
Figure 2. Bents Pond- Outfall 8498

5 ft wide x 10 ft long wooded/wetland buffer between Rt 2A and Outfall 8498 is not owned by MassDOT. This limited space would constrain construction of upgradient BMPs.

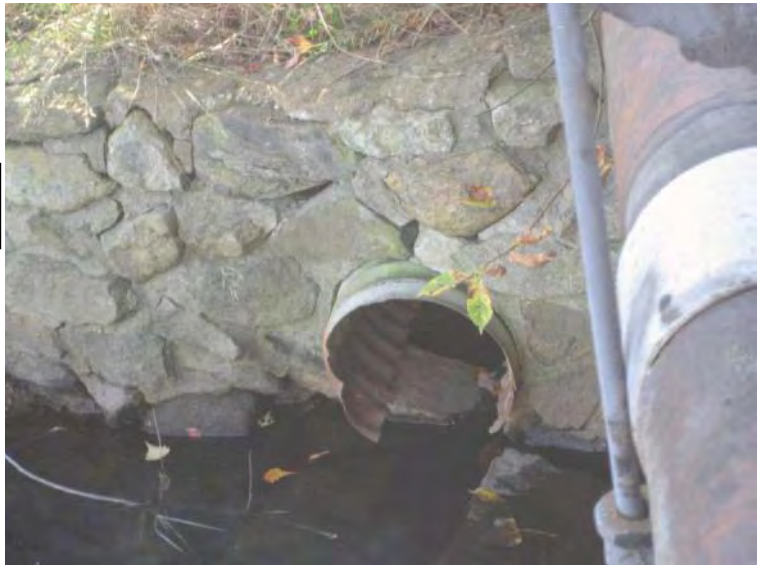
Corrugated metal pipe in stone headwall discharges directly into Travers Pond.

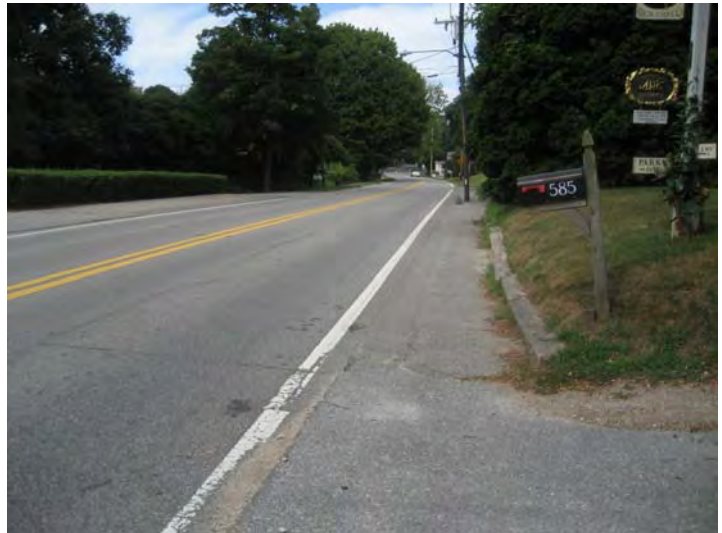
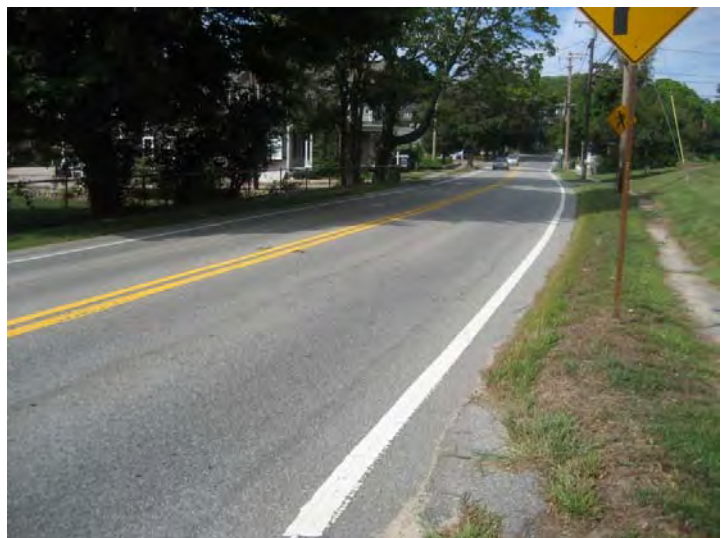
Figure 2. Shore Road/West Falmouth Highway

Views of Shore Road/West Falmouth Highway illustrating the space constraints to installing structural BMPs
