INDOOR AIR QUALITY ASSESSMENT

Lynch Elementary School 10 Brantwood Road Winchester, MA

Prepared by: Massachusetts Department of Public Health Bureau of Environmental Health Indoor Air Quality Program March 2018

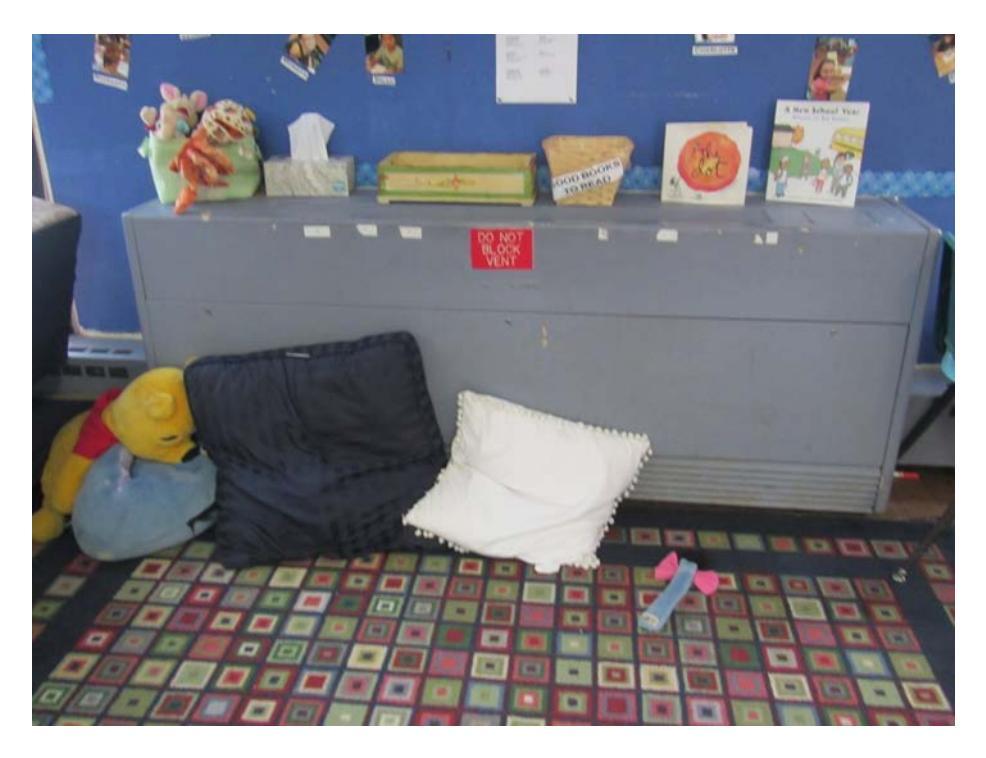
Fresh air in classrooms is supplied by unit ventilators ("univents", Picture 1). Univents draw air from the outdoors through a fresh air intake located on the exterior wall of the building (Picture 2) and return air through an air intake located at the base of the unit. Fresh and return air are mixed, filtered, heated or cooled and provided to rooms through an air diffuser located in the top of the unit (Figure 1). In many areas items were on top or in front of univents (Pictures 1, 3 and 4; Table 1), which can block air circulation. Note that in many areas, particularly along one of the courtyards, the univent fresh air intakes were deliberately blocked to prevent infiltration of cold outside air due to temperature control problems (Picture 2). Other univents may have had air intake louvers closed. This will limit the amount of fresh air available in these classrooms.

Unit ventilator (univent), note items in front blocking return vent

- Operate the HVAC system to provide for continuous fresh air ventilation during occupied hours. Unblock all univent air intakes when possible to allow for a fresh air supply to each classroom.
- 2. Ensure univents can supply heat when needed.
- 3. Ensure univents are not blocked by furniture or items on top or along the front so that they may operate effectively.
- 4. Use openable windows to supplement fresh air during temperate weather. Ensure all windows are closed tightly at the end of each day. Also ensure that windows are closed when WAC are in operation to prevent condensation.
- 5. Ensure all exhaust vents are operating continuously during occupied periods. Reactivate or repair vent motors. Consider developing a plan to check the motors and draw of air from exhaust vents periodically.

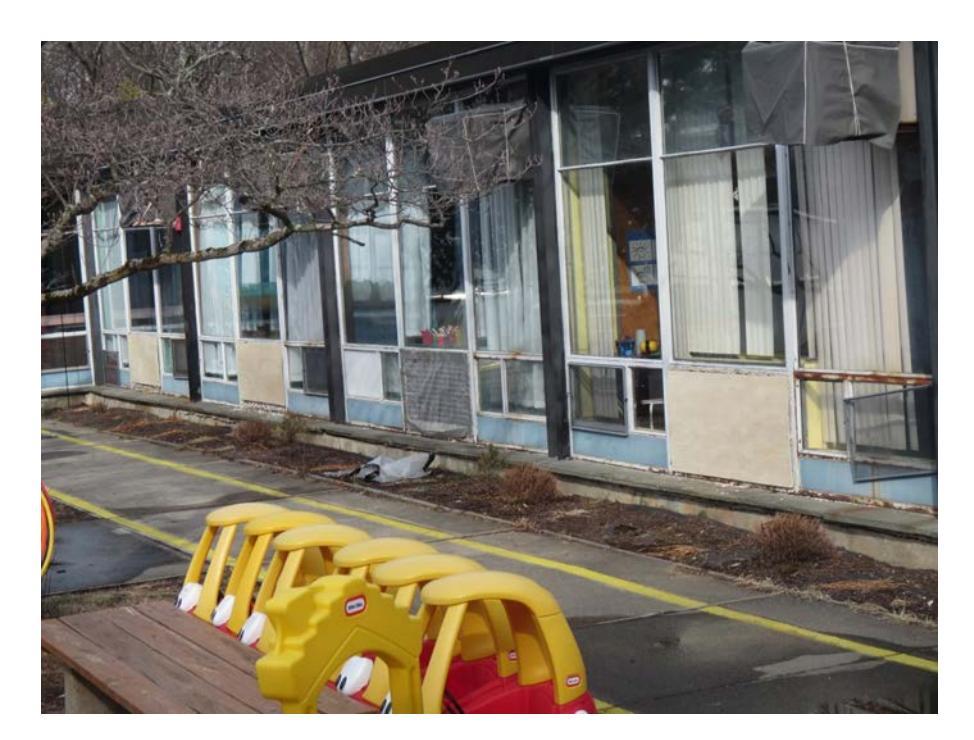
Univent air intakes below windows covered with plywood or plastic, note rust and deterioration of window frames

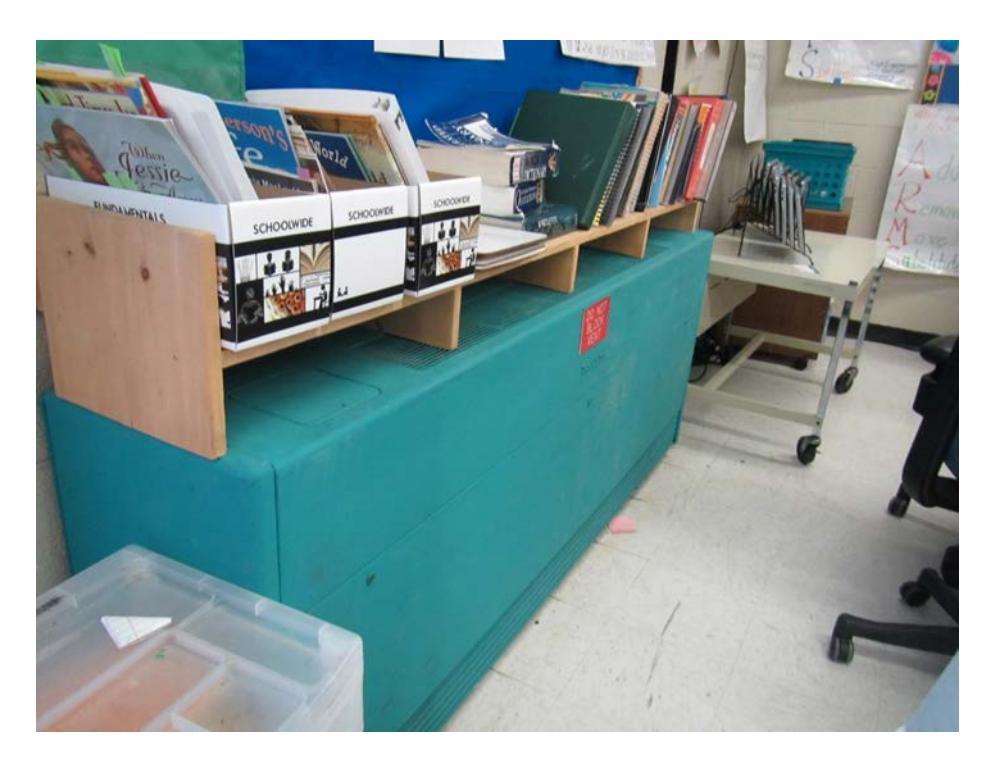
Items on top of univent

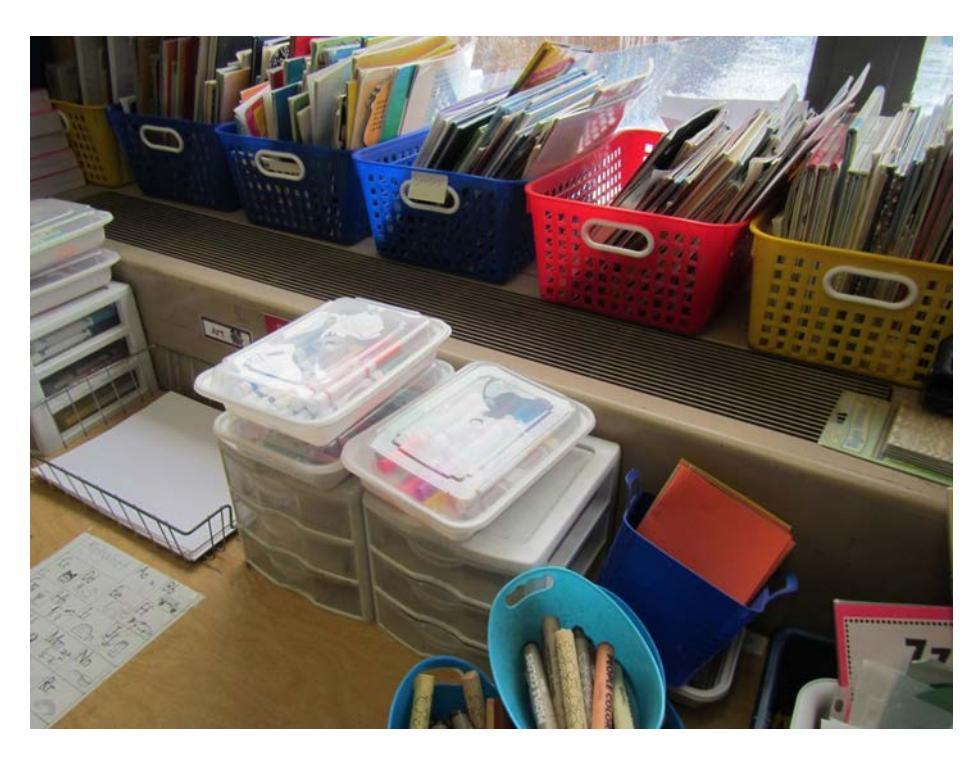
Items and furniture in front of univent

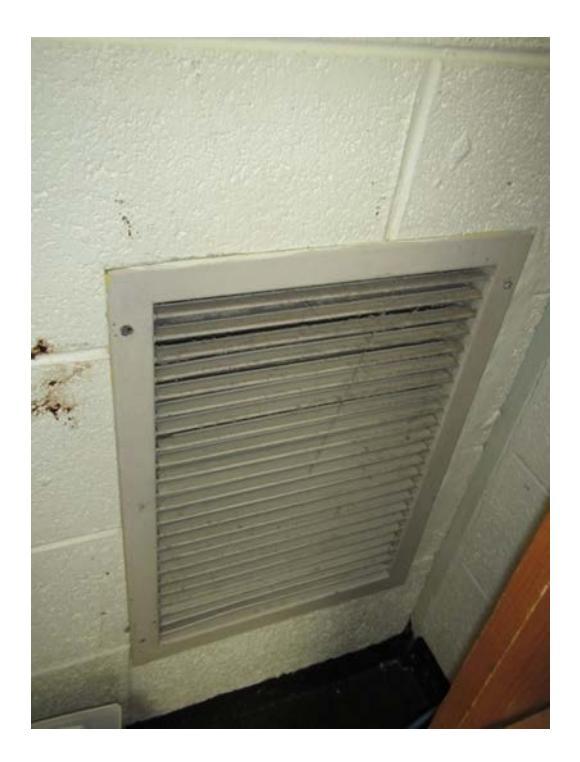
Exhaust is provided by motors on the roof ducted to exhaust vents on the walls of classrooms (Picture 5). Many exhaust vents were also found not to be drawing air (Table 1) which indicates that the motors are not operating and need to be activated or repaired. Note that many of the exhaust vents were partially or fully obstructed by items and furniture (Picture 6; Table 1) which will prevent them from operating efficiently. In addition, many classroom

exhaust vents are located near hallway doors; with doors open the vents can draw air from the hallway instead of the classroom.

Classroom exhaust vent, note proximity to hallway door

- 6. Remove furniture and items from in front of exhaust vents and close classroom doors for best exhaust function.
- 7. Adopt a system to report and track maintenance issues such as broken univents, leaks and plumbing issues so that concerns can be reported by the staff that observe them, and maintenance staff can report when the issues have been resolved.

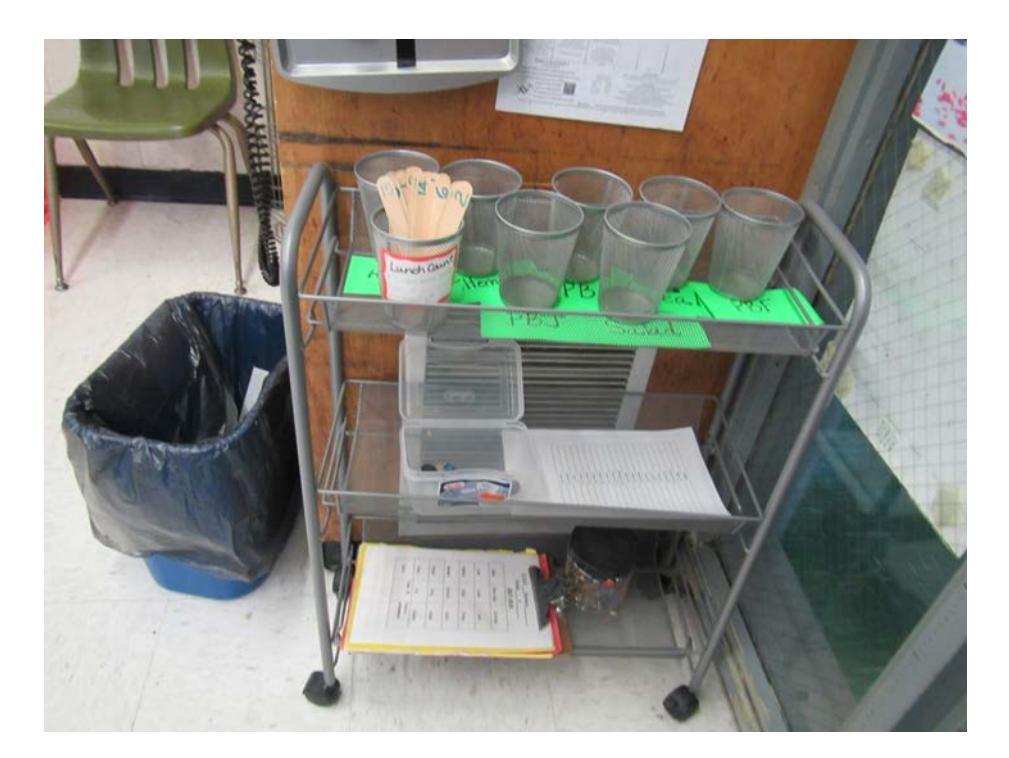
Items blocking exhaust vent

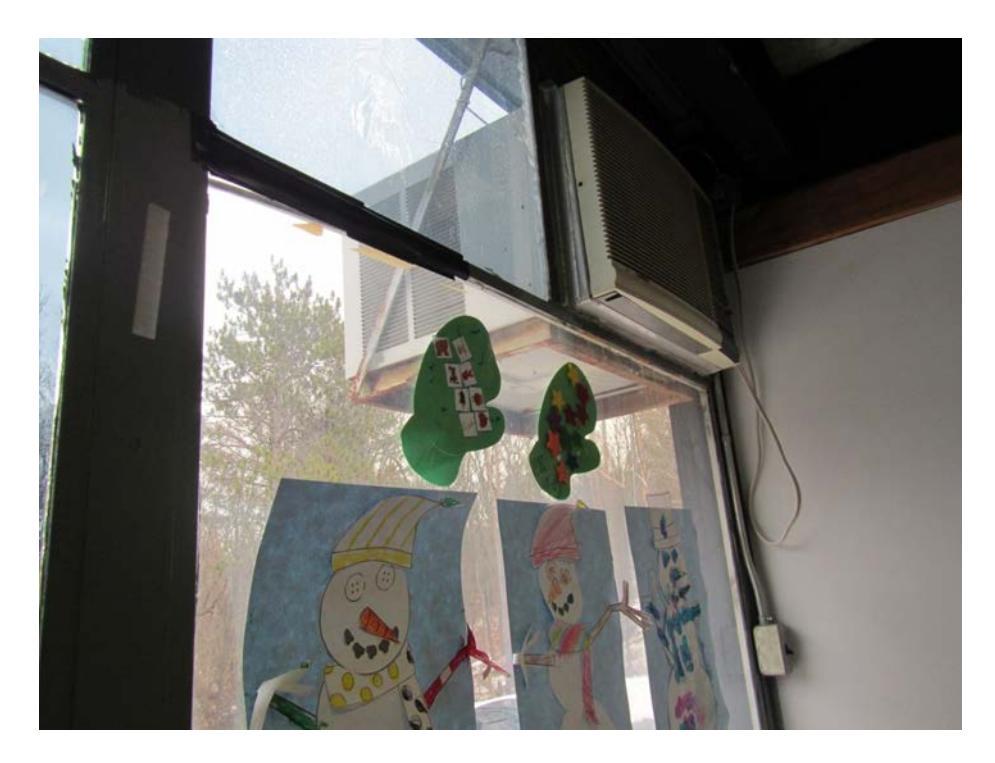
Windowpane duct-taped into frame

- 11. Develop a plan to replace windows in the building with modern, insulated, and tightlyfitted materials. This will greatly improve temperature control and reduce heating costs.

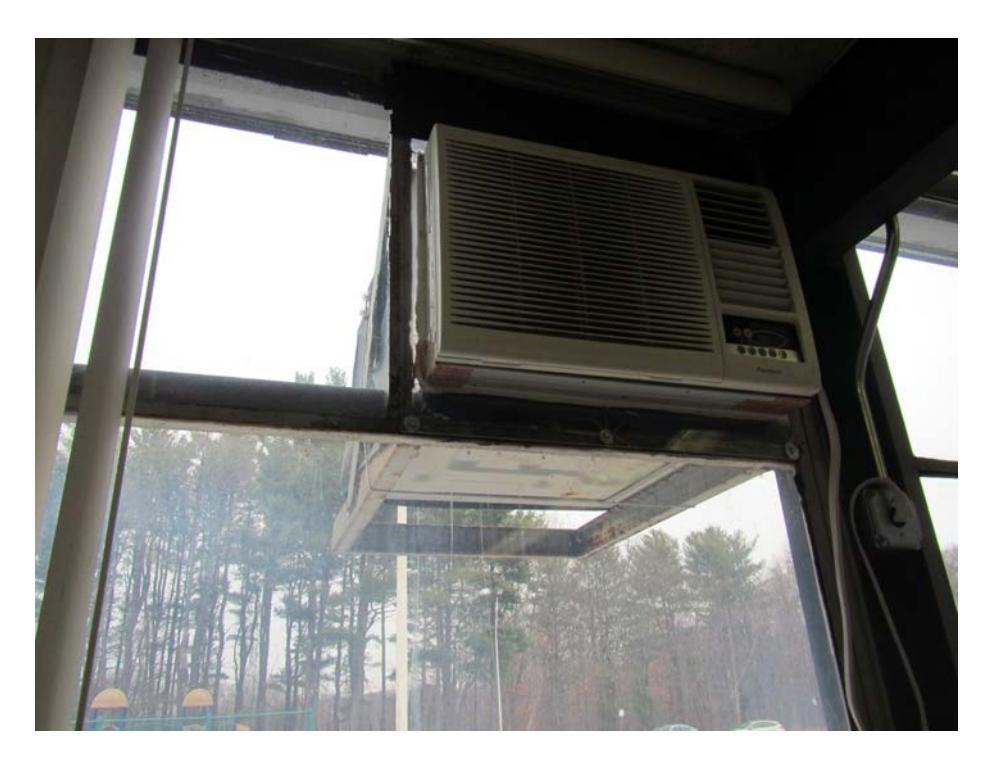
Many classrooms were equipped with window-mounted air conditioners (WAC) for cooling during the summer. These units are in windows year-round and gaps through or around the units may also be a source of cold or unconditioned air and moisture (Picture 8). These units may be used to supplement fresh air during temperate weather by setting them to "fan only" mode.

Gaps around window air conditioner and external portions exposed to the elements

- 10. Ensure that gaps in the building envelope such as with missing window caulking, missing weather stripping and gaps around WAC are appropriately sealed.

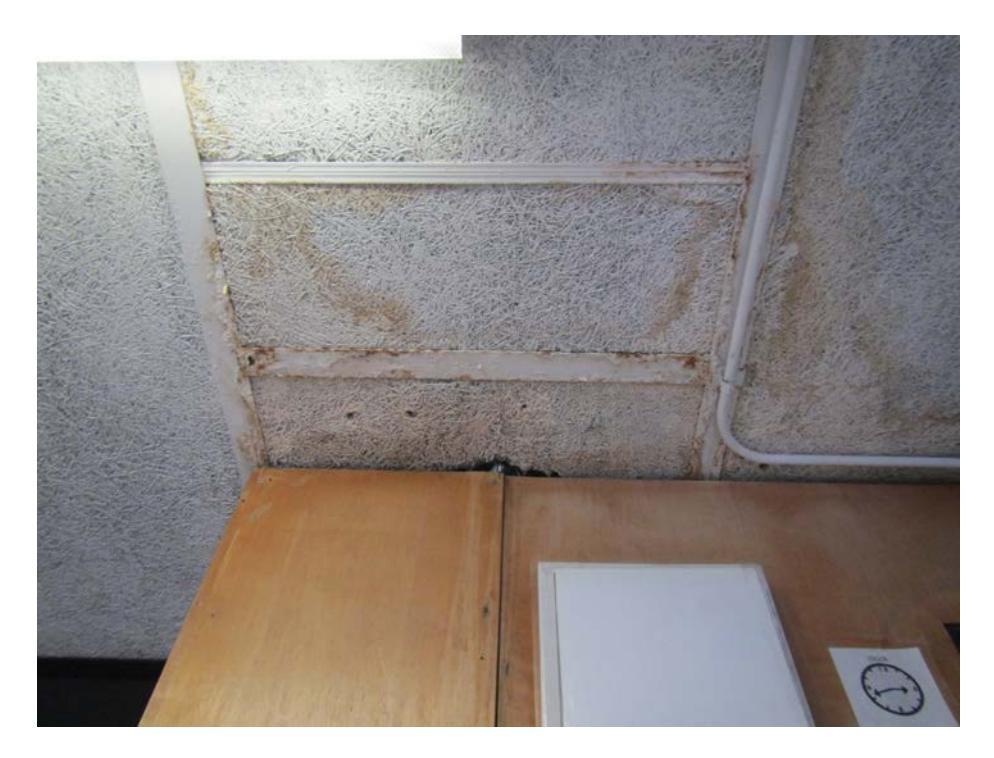
Water-damaged ceiling tiles were observed in some classrooms (Pictures 9 and 10; Table 1). Most of these reportedly stem from roof leaks. While the roof was reportedly replaced in 2006, it has still been a source of problems for the school and repairs are reportedly ongoing. Ceiling tiles in most of the building are of a type that is structural and thick which makes them

Water-stained ceiling tiles

- 12. Replace water-damaged ceiling tiles once leaks are repaired. Inspect the area above the stained tiles for water damage or odors and remediate or clean as necessary.

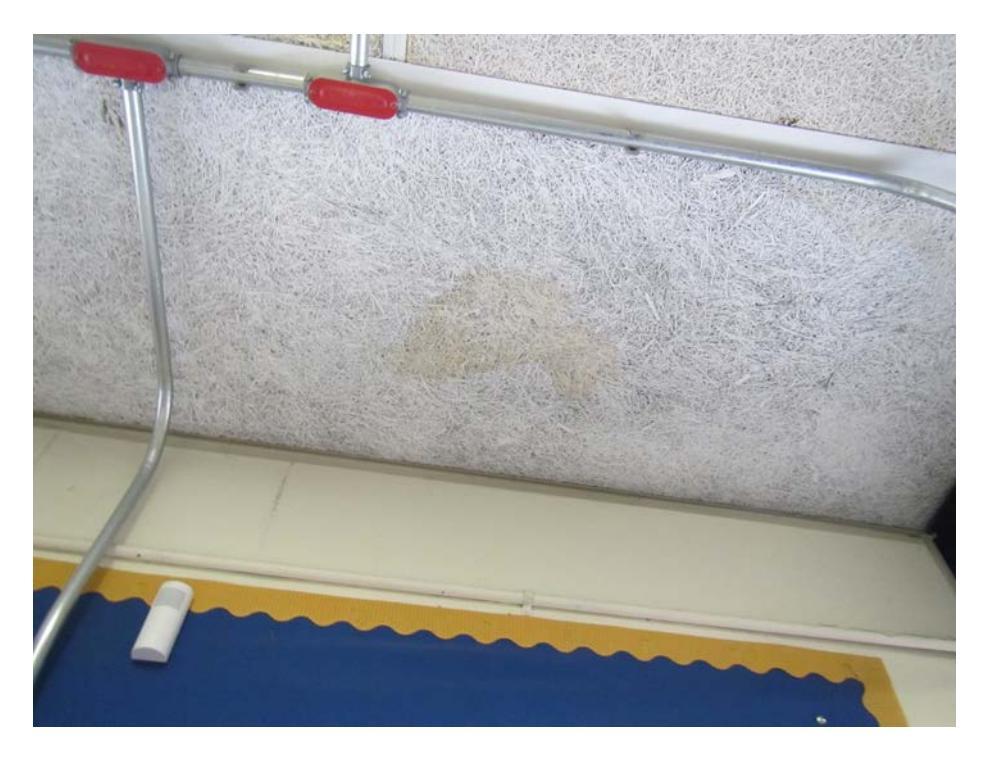
Picture 10

Water-stained ceiling tile

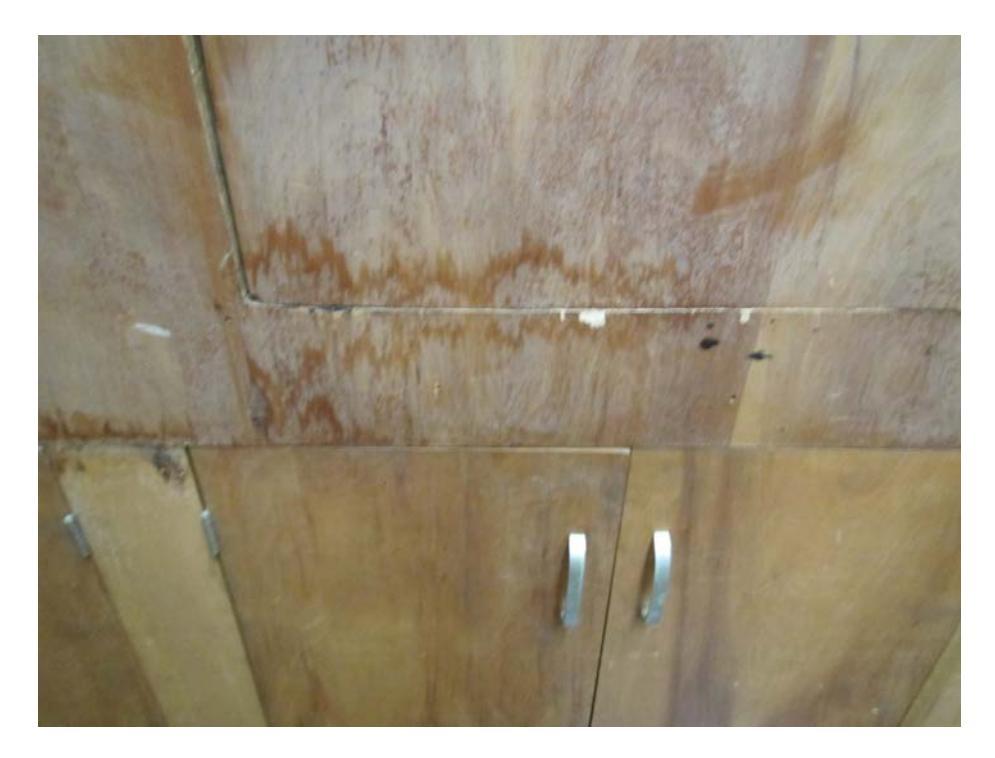
difficult to remove and replace. Roof and HVAC system leaks have also moistened other materials such as wooden cabinets (Picture 11).

Water-stained wood on cabinet

- 13. Continue with efforts to ensure the roof is watertight.
- 14. Remove or remediate/clean other water-damaged materials such as the wooden cabinets shown in Picture 11. Avoid storing porous materials in areas with known or likely water leaks (e.g., next to poorly-sealed windows, under sinks).

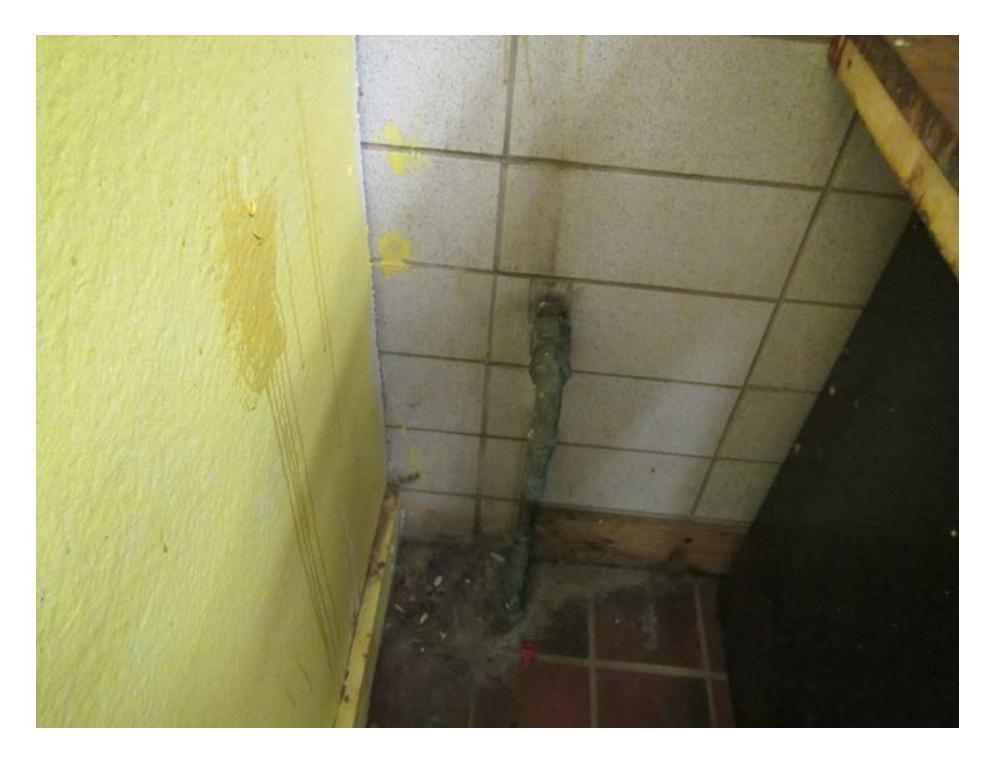
Picture 12

At the time of the visit, an occupant reported a very recent pipe leak in the art room, which had resulted in moistening of walls, furniture and other materials (Picture 12). Other water damage in the art storage room was also of concern due to the large amounts of supplies stored in this area. An old sump pump or similar mechanism was observed in the art area (Picture 13). It was reportedly long disused, but it was not known if the item had been properly sealed and deactivated. Breaches in the casing of this unit could be a source of odors and microbial contamination if it is not properly sealed and deactivated.

New water stains on wall in the art area due to recent pipe leak

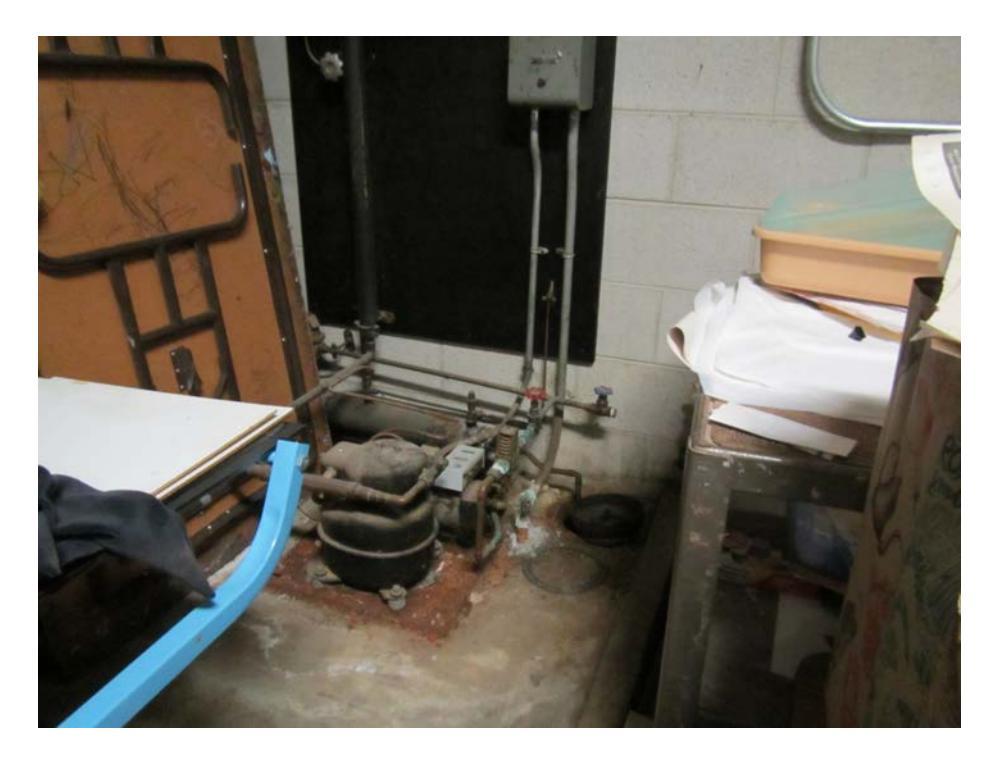
Old, disused pump or related item

- 18. Determine the function and condition of the unit in the art room shown in Picture 13 and ensure it is properly disconnected, deactivated and sealed to prevent moisture and odors from entering occupied areas.

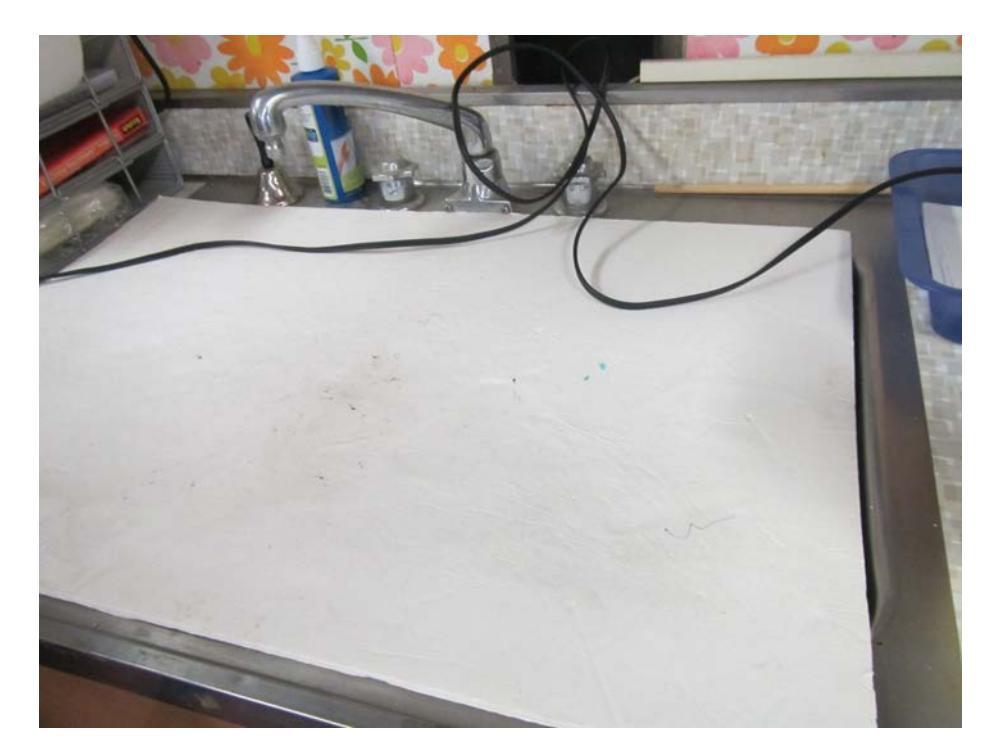
Picture 14

Disused sink, covered with plastic

- 17. Ensure drains on disused sinks and unused floor drains are moistened periodically to prevent the traps from drying out. If sinks are no longer needed, consider plans to have them removed and properly capped.

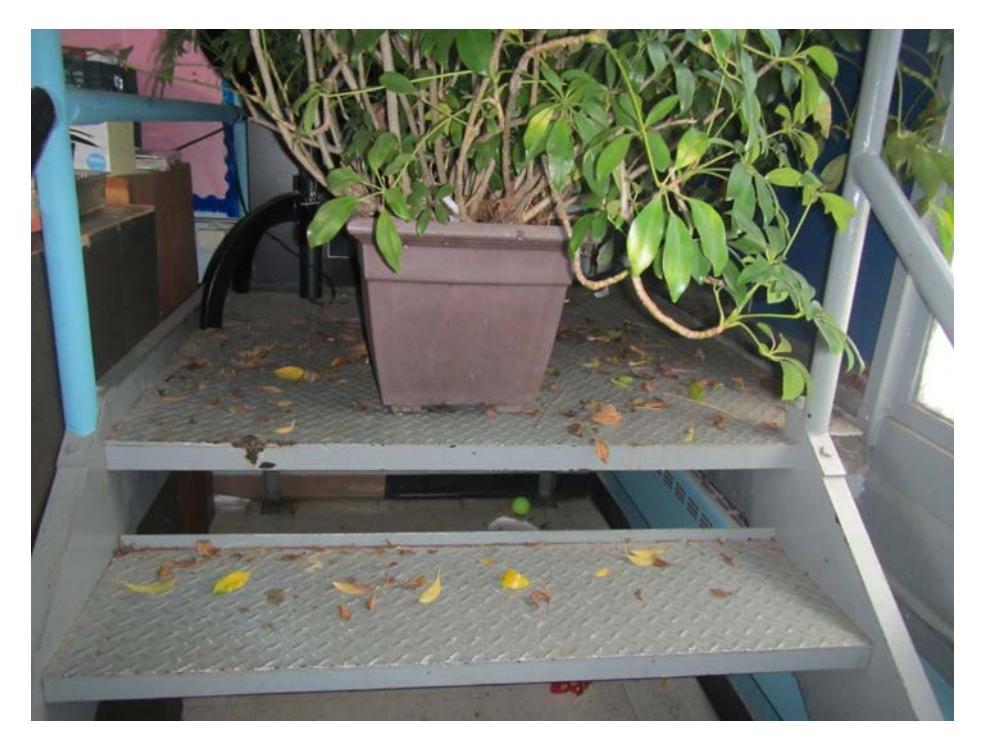
Plants were observed in classrooms and offices (Picture 15; Table 1). Plants should be well maintained, not overwatered and kept away from the airstream of ventilation equipment to prevent odors, water damage, and pests. An aquarium containing a turtle was found in another

Plant without drip pan and with leaves/debris

- 19. Ensure plants are well maintained and not overwatered. Keep them away from the airstream of ventilation equipment.
- 20. Properly maintain any aquariums, terrariums and similar items to prevent odors and microbial growth.

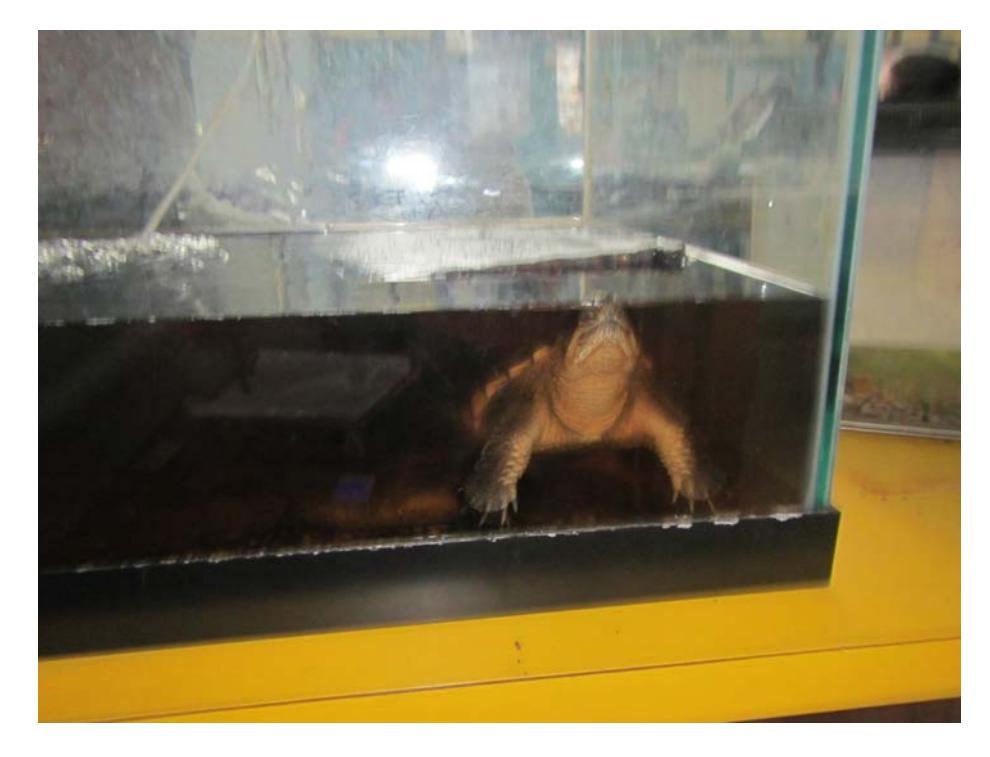
classroom (Picture 16); the water was murky and the aquarium looked like it needed cleaning. Aquariums, terrariums and similar items need to be kept clean to avoid odors and microbial growth.

Turtle in murky water in classroom

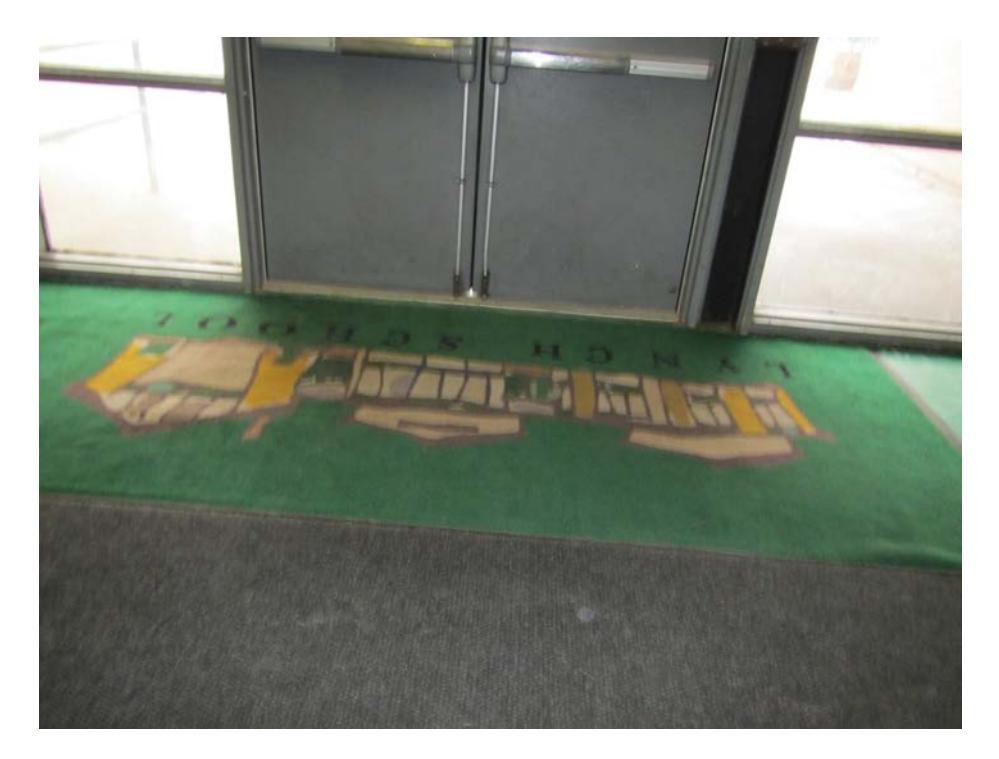
Doors to the outside were observed to have gaps and be missing weather stripping (Picture 17). This can allow moisture, unconditioned air and pests into the building. An examination of the outside of the building was conducted to identify potential sources of water penetration. Shrubs were noted growing close to the building exterior, including directly in front of a window air conditioner (Picture 18) which can hold moisture against the walls and be a source of pollen and debris into the building. This and other tree/plant roots may penetrate the building foundation, creating and widening cracks (Picture 19). Over time, these conditions can undermine the integrity of the building envelope and provide a means of water entry into the building via capillary action through foundation concrete and masonry (Lstiburek & Brennan, 2001). The freezing and thawing action of water during the winter months can create cracks and fissures in the foundation. Other signs of exterior deterioration were also observed, including in concrete next to the foundation (Picture 20), and rust along the edges of windows (Pictures 2 and 18). All these breaches may provide a means for moisture and pests to enter the building

Gap beneath door to outside

- 22. Seal gaps in the building envelope to reduce infiltration of water and potential pest intrusion.
- 23. Remove trees and shrubs from within five feet of the edge of the building and especially around air intakes and windows.

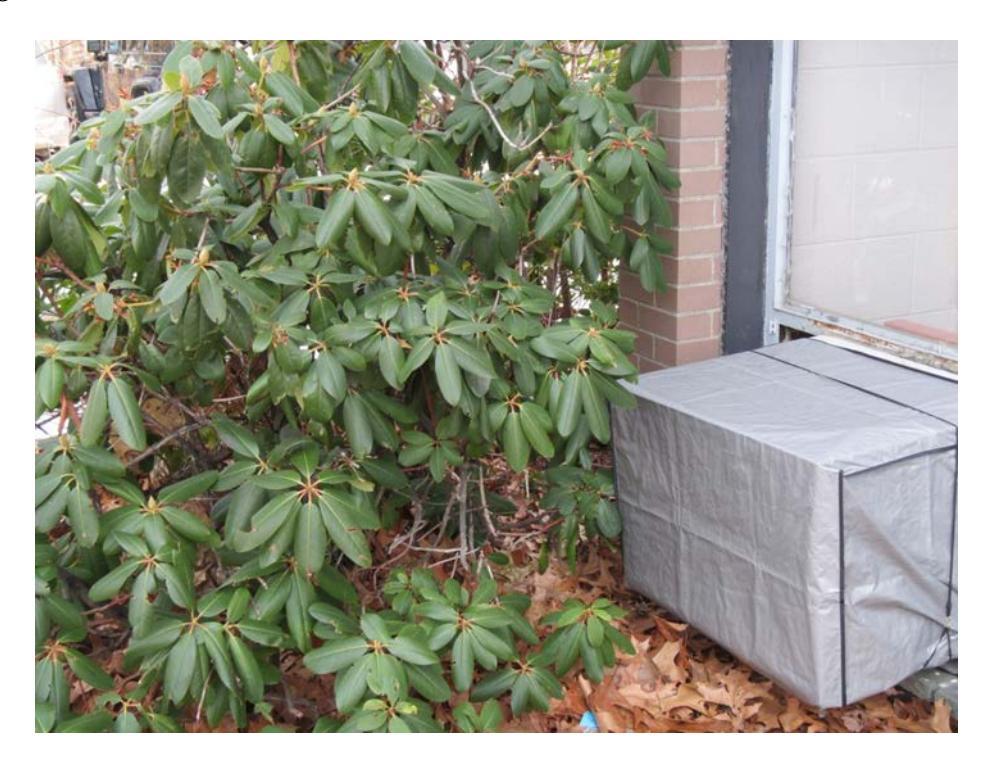
Plant next to foundation and window air conditioner

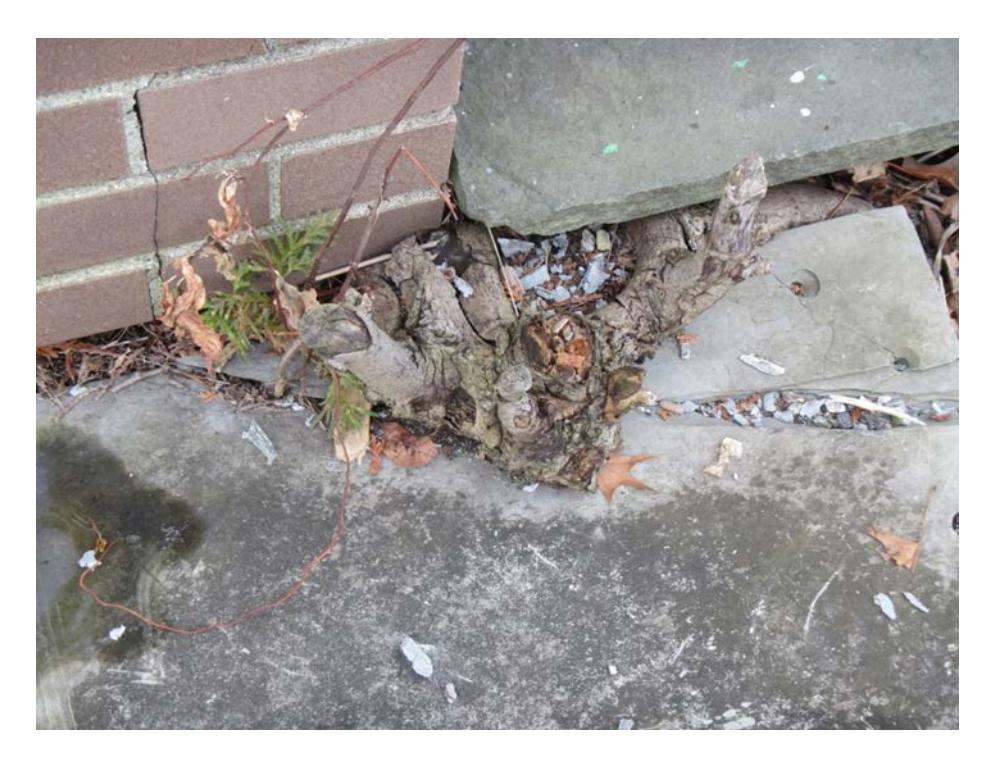
Picture 20

Old plant stems and deteriorated brick, stone and concrete along base of foundation

- 24. Develop a plan to renovate the exterior of the building including repairing deteriorated concrete and cracks in the foundation.
- 25. Reduce or eliminate the use of air fresheners, scented cleaners, hand sanitizers and dry erase materials to reduce irritation.

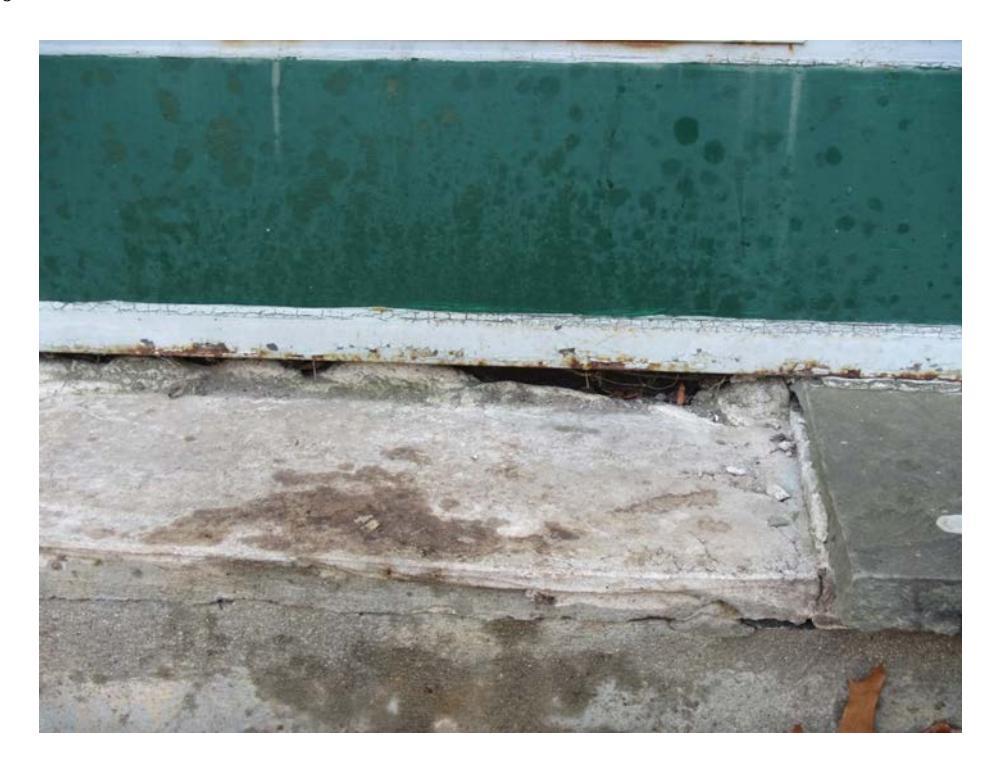
Deteriorated concrete at outside edge of building

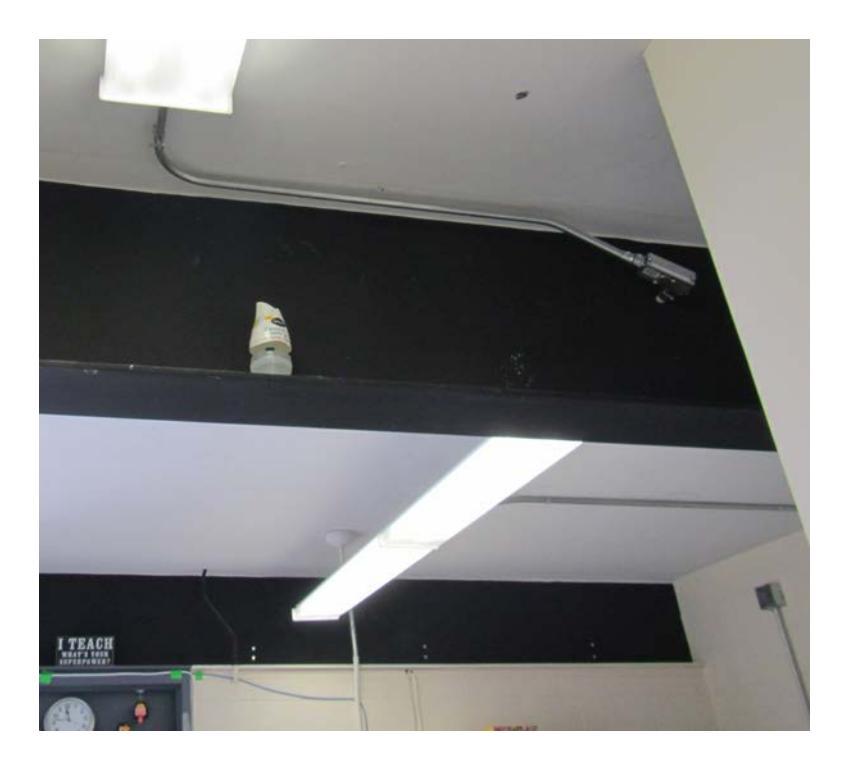
Although levels of TVOCs were non-detectable at the time of the assessment, products were observed that might be sources of TVOCs and irritation to the eyes, nose and respiratory system. Hand sanitizers, cleaning products, air fresheners and dry erase materials were observed in classrooms and offices (Pictures 21 and 22; Table 1). The use of these products, particularly scented products, should be minimized and used only in areas of adequate ventilation.

Pop-up air freshener

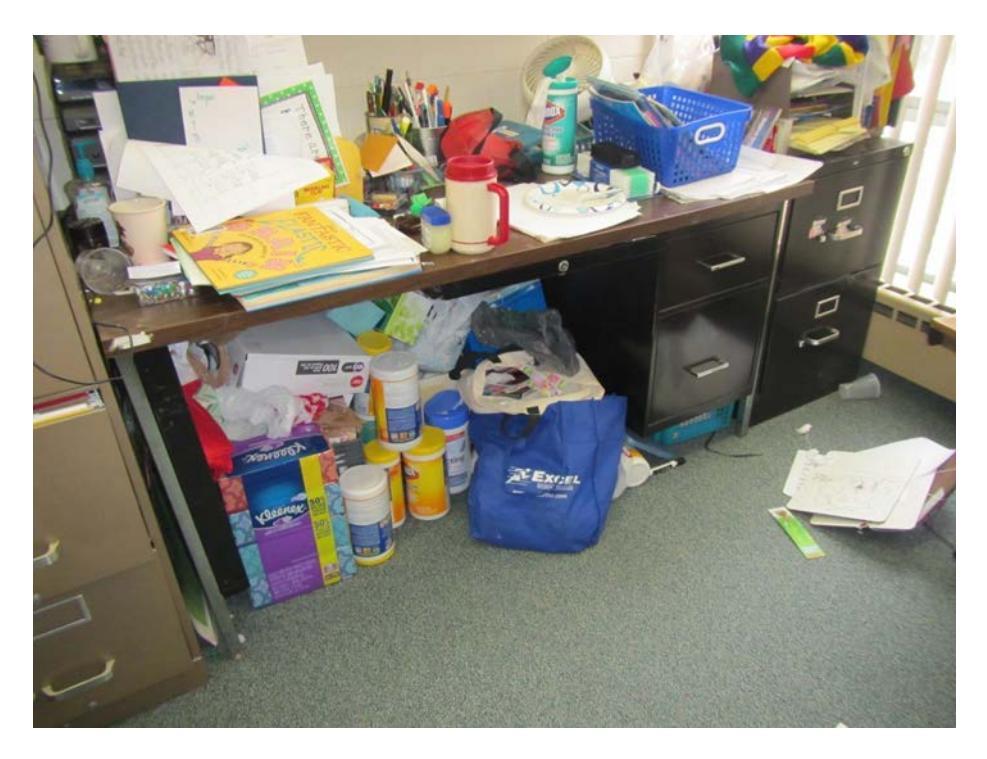
Cleaning and sanitizing products

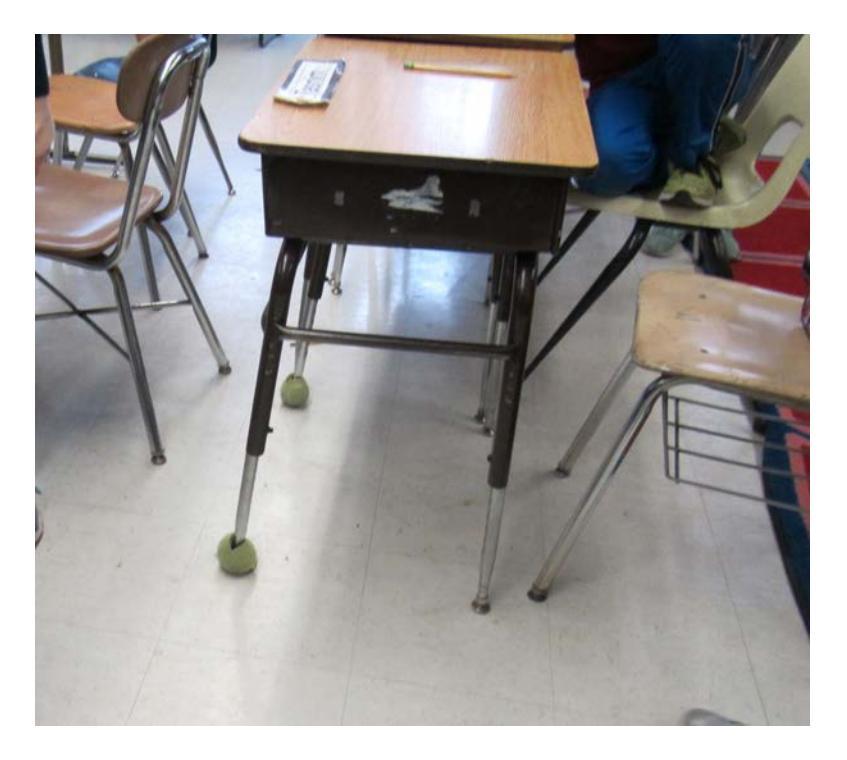
Picture 24

In a few areas, tennis balls had been sliced open and placed on table/chair footings to reduce noise (Picture 23; Table 1). Tennis balls are made of a number of materials that are a source of respiratory irritants. Constant wearing of tennis balls can produce fibers and lead to off-gassing of VOCs. Tennis balls are made with a natural rubber latex bladder, which becomes

abraded when used as a chair leg pad. Use of tennis balls in this manner may introduce latex dust into the school environment. Some individuals are highly allergic to latex (e.g., spina bifida patients) (SBAA, 2001). It is recommended that the use of materials containing latex be limited in buildings to reduce the likelihood of symptoms in sensitive individuals (NIOSH, 1997; NIOSH, 1998).

Tennis balls used as chair glides

- 26. Replace tennis balls on chair/table footings with latex-free glides.
- 27. Clean the melted crayons/plastic from univents.
- 28. Consider reducing the amount of stored materials to allow for more thorough cleaning. Clean items regularly with a wet cloth or sponge to prevent excessive dust build-up.

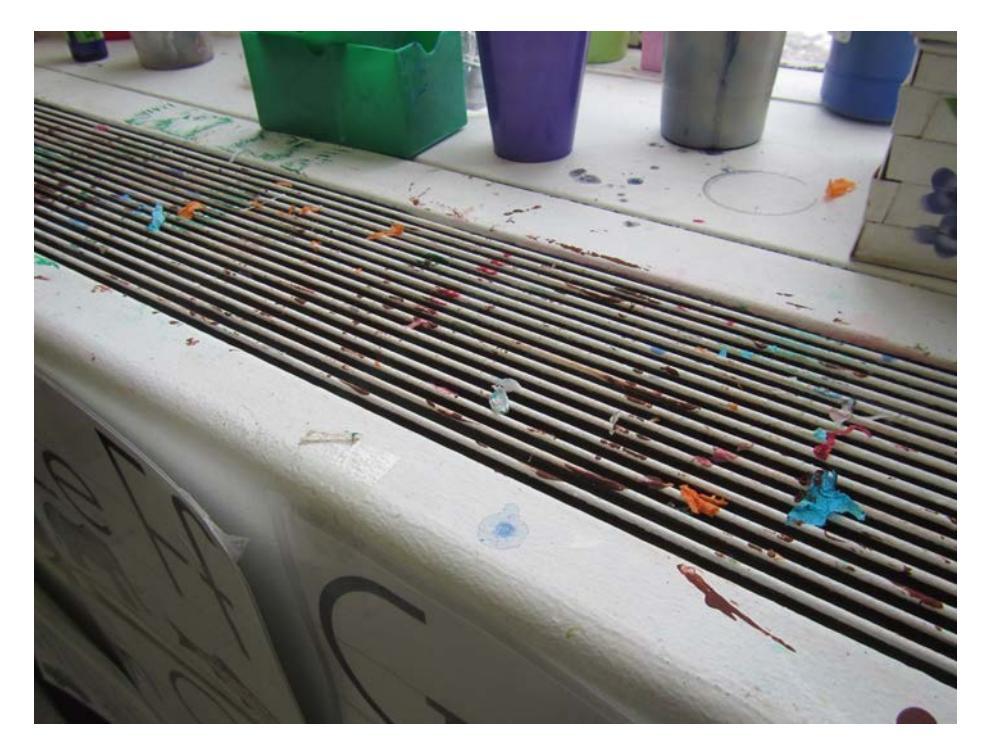
A univent in the lower level was found with melted crayons or other materials on it (Picture 24). This area also had a plastic odor, which is likely from the heating of the material on, and likely inside, the univent. Univents should be cleaned of this material as soon as possible.

Melted crayons/plastic on and in univent

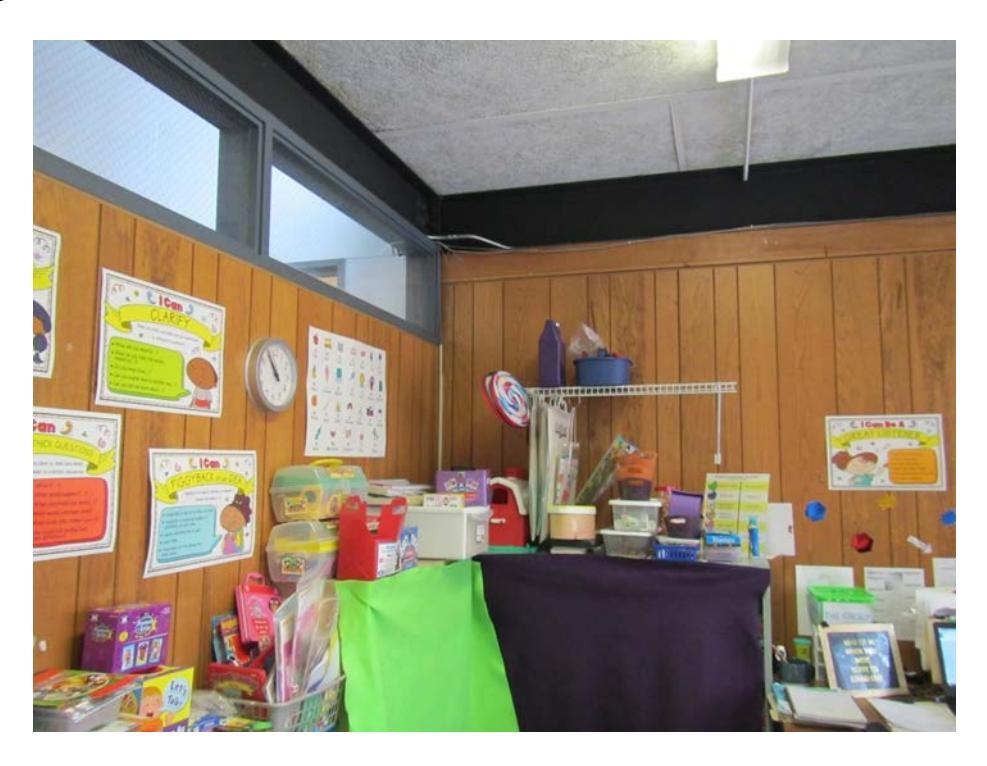
In some areas, items were observed on the floor, windowsills, tabletops, counters, bookcases and desks (Pictures 25 and 26). Stored items provide a source for dusts to accumulate and make it difficult for custodial staff to clean. Items should be relocated and/or be cleaned periodically to avoid excessive dust build up. In many classrooms and hallways, fabric or paper was used as curtains to cover shelving or create areas with more privacy (Picture 27). Hanging fabric, and items hanging from the ceiling or walls can become a source of collected dusts and microbial growth if moistened. These may also be a fire hazard.

Classroom items

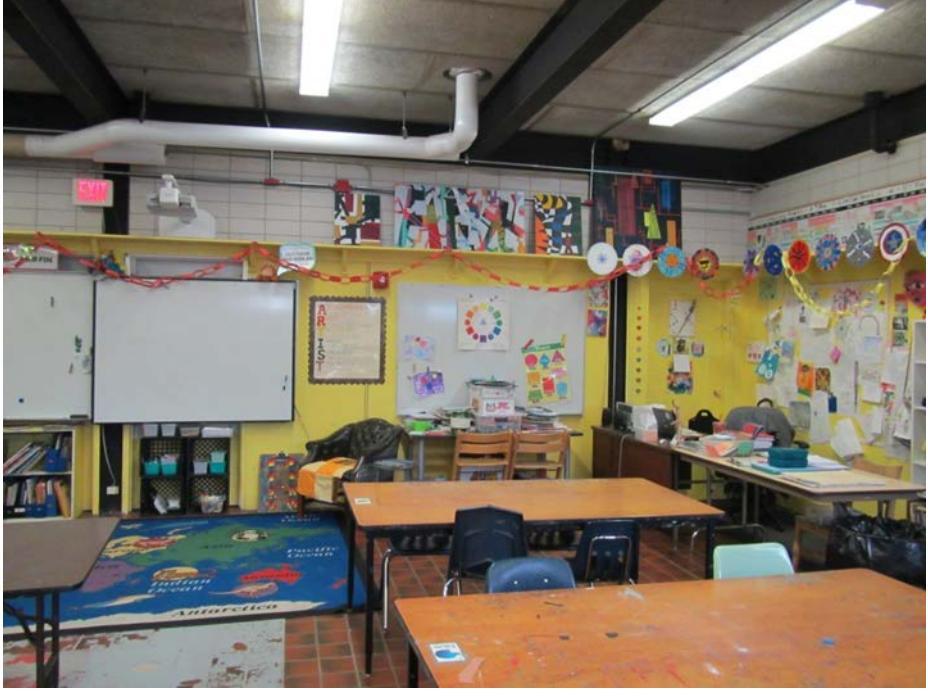
Classroom items including items hanging from walls

- 29. Avoid hanging items from the ceiling to reduce dust accumulation.
- 30. Ensure that fabrics used as curtains are washed regularly; check fire safety regulations to ensure this practice is not in conflict with fire codes.

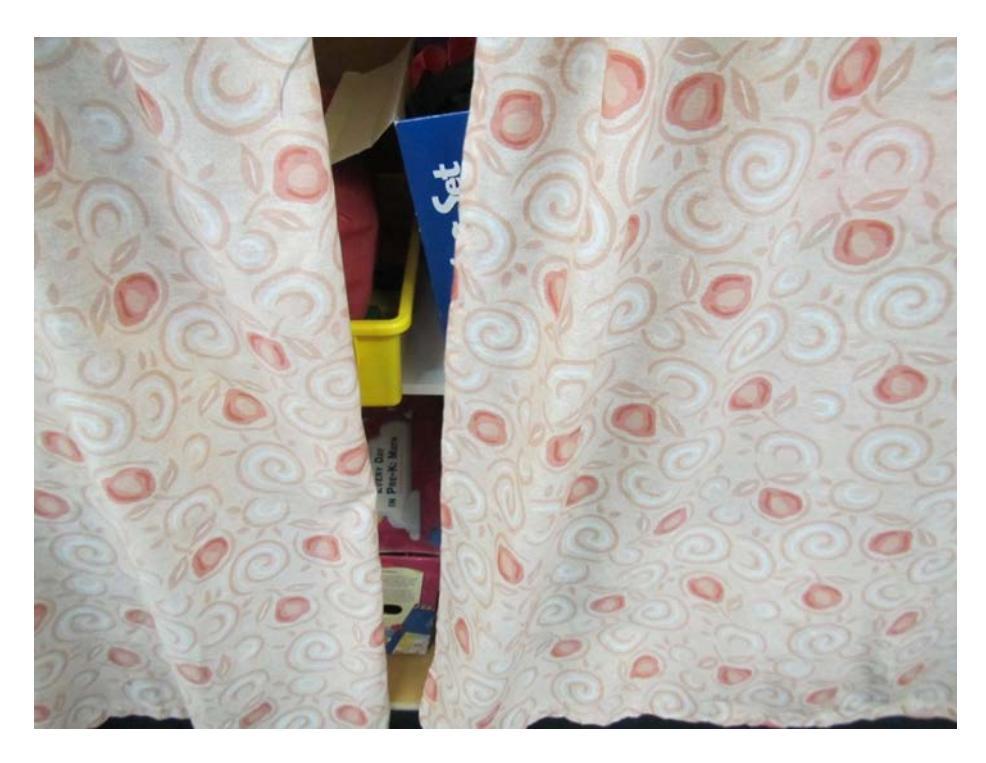
Fabric curtains
