INDOOR AIR QUALITY ASSESSMENT

Lynch Elementary School 10 Brantwood Road Winchester, MA

Prepared by: Massachusetts Department of Public Health Bureau of Environmental Health Indoor Air Quality Program March 2018

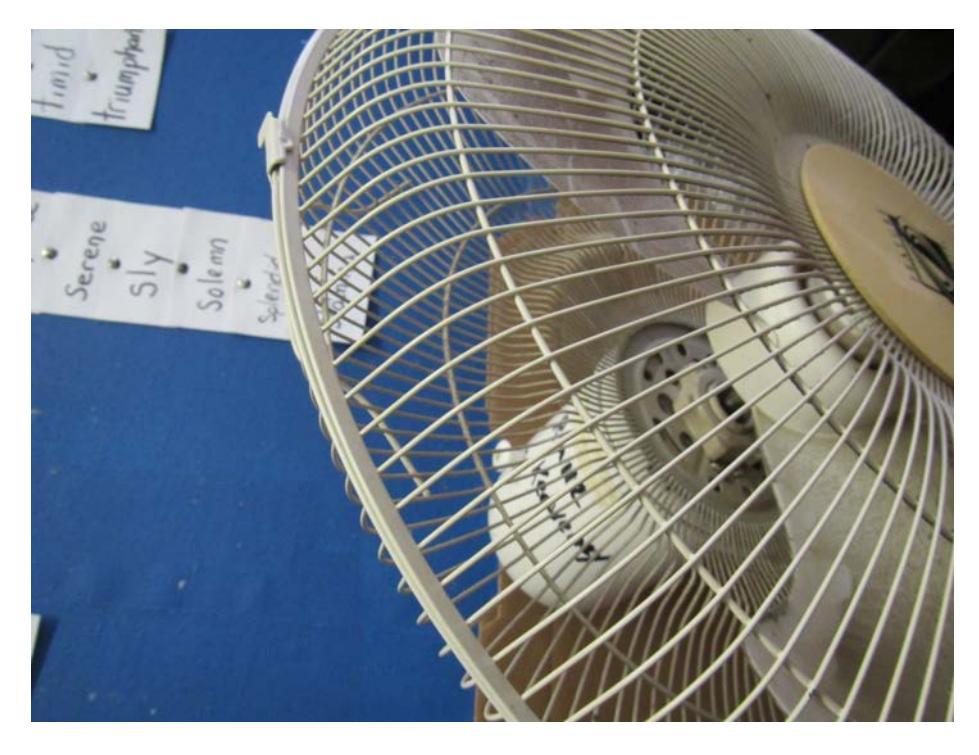
Dust was observed on personal fans (Picture 28), exhaust vents (Picture 29) and radiators (Picture 30). This can be reaerosolized when the equipment is used.

Dusty personal fan

- 31. Ensure pet cages are kept clean to prevent odors and allergens.
- 32. Clean radiators, vents and fans regularly to remove dust build up that may lead to odors when heated.

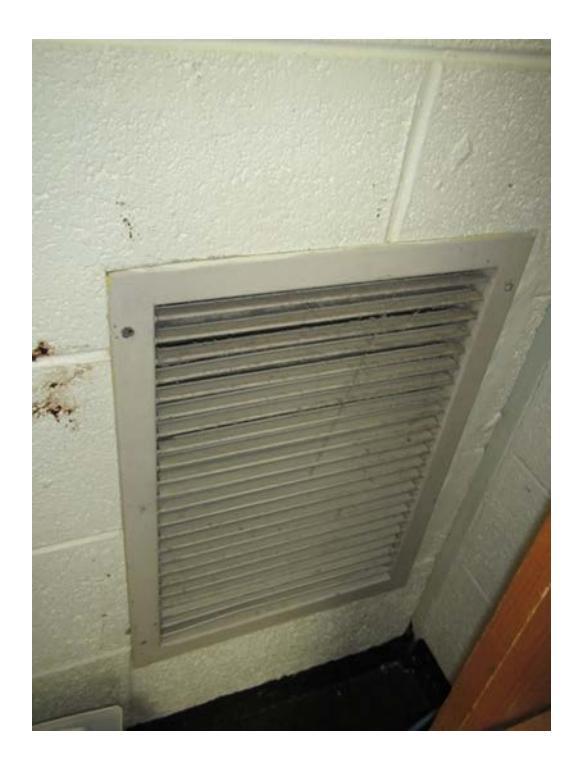
Picture 30

Dust on exhaust vent

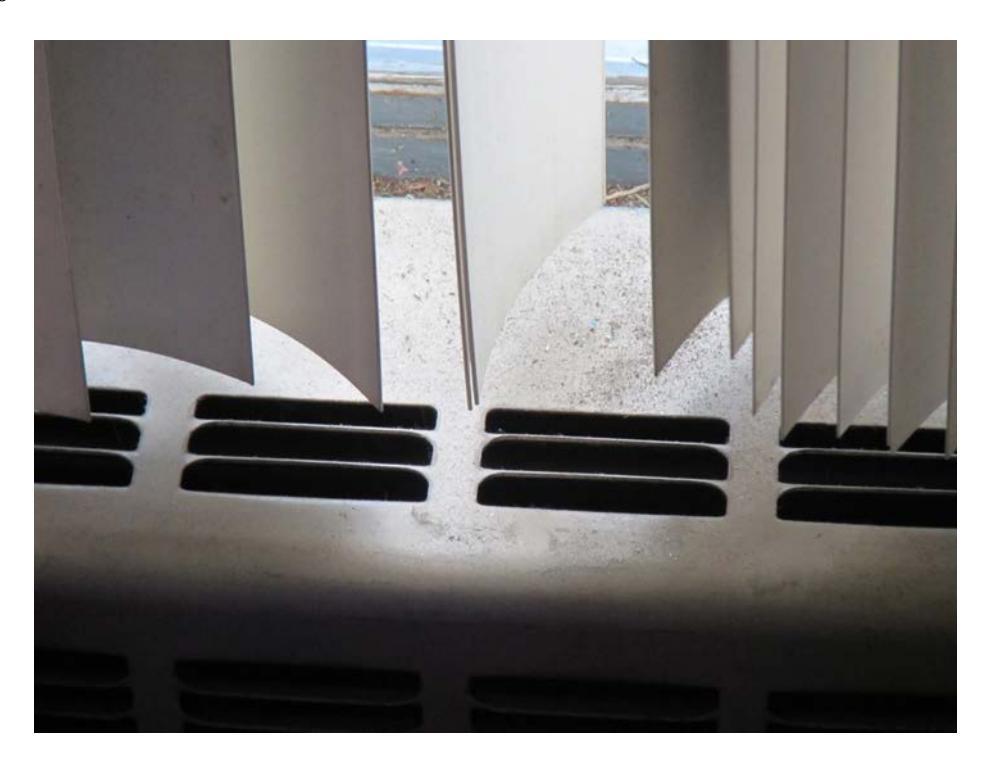
Dust on radiator

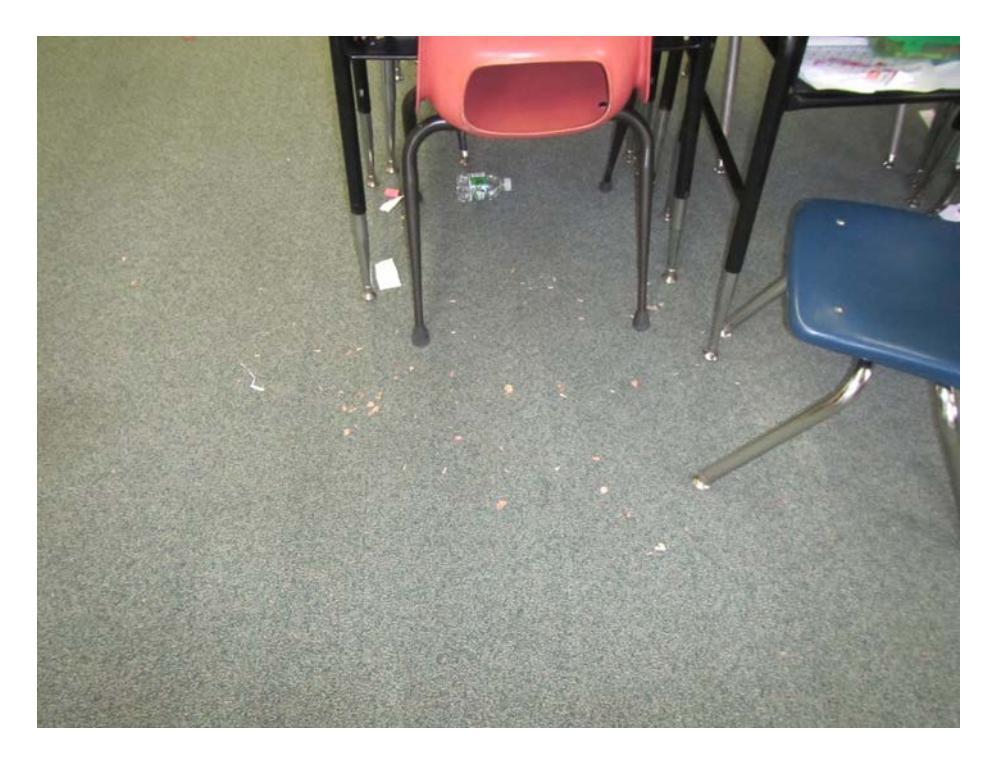
Picture 32

Both wall-to-wall carpeting and area rugs were present in the LES. The Institute of Inspection, Cleaning and Restoration Certification (IICRC), recommends that carpeting be cleaned annually (or semi-annually in soiled high traffic areas) (IICRC, 2012). Some rugs were found soiled, worn or with lifted edges (Pictures 31 and 32), which can be a tripping hazard. If area rugs cannot be cleaned due to age and condition, they should be replaced. Upholstered furniture (such as Picture 33) should also be cleaned regularly in accordance with IICRC recommendations and discarded when they become too worn or soiled to effectively clean.

Worn carpeting with debris

- 33. Clean or change filters on air purifiers and WAC in accordance with manufacturer's instruction or more often if needed.
- 34. Regularly HEPA vacuum remaining carpeting/area rugs and clean carpeting at least once per year according to IICRC recommendations (IICRC 2012). Consider replacing any

carpeting that is beyond its service life. In below-grade areas, consider using non-porous flooring instead of carpeting when flooring is replaced.

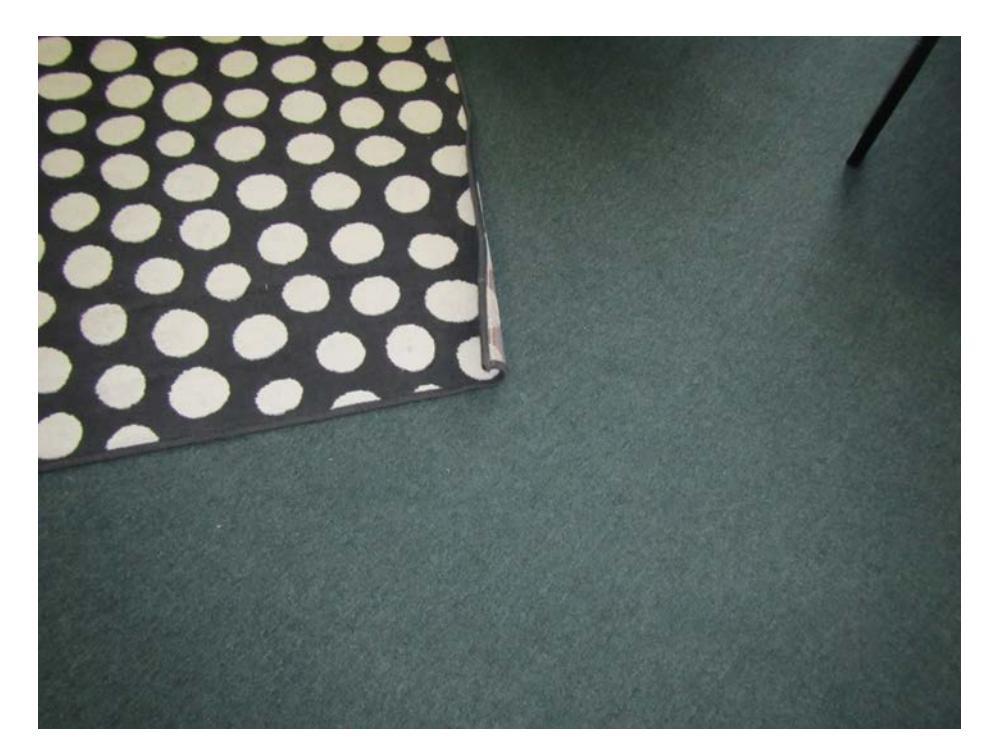
Area rug with lifted edges

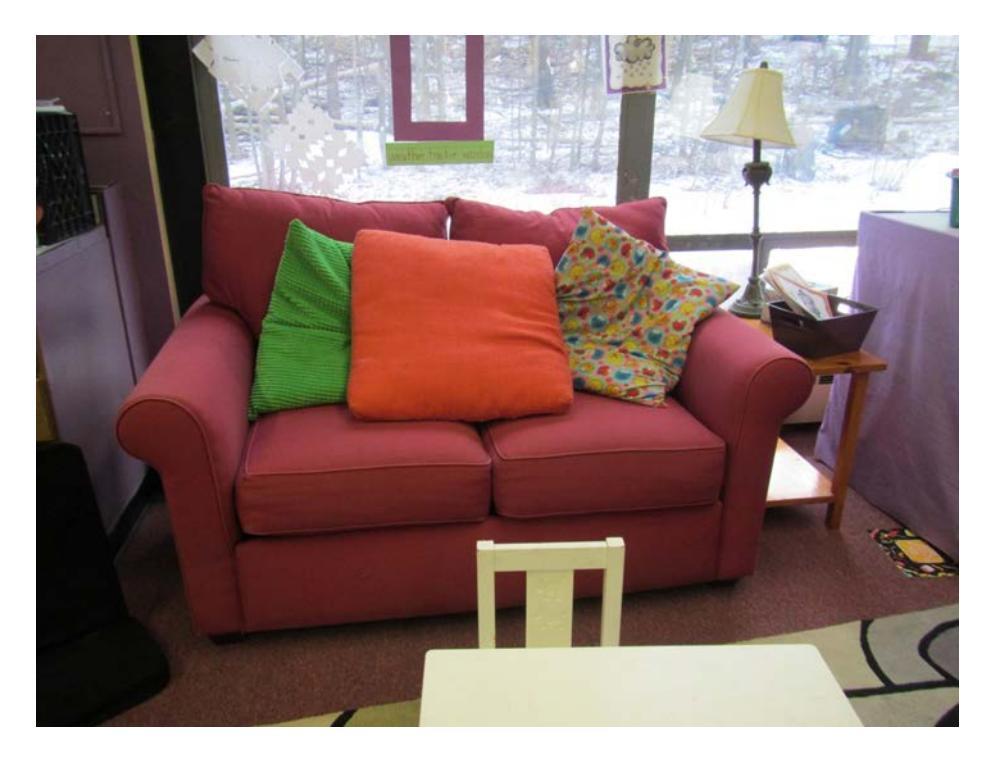
Upholstered furniture
