# The Commonwealth of Massachusetts

DEPARTMENT OF PUBLIC UTILITIES

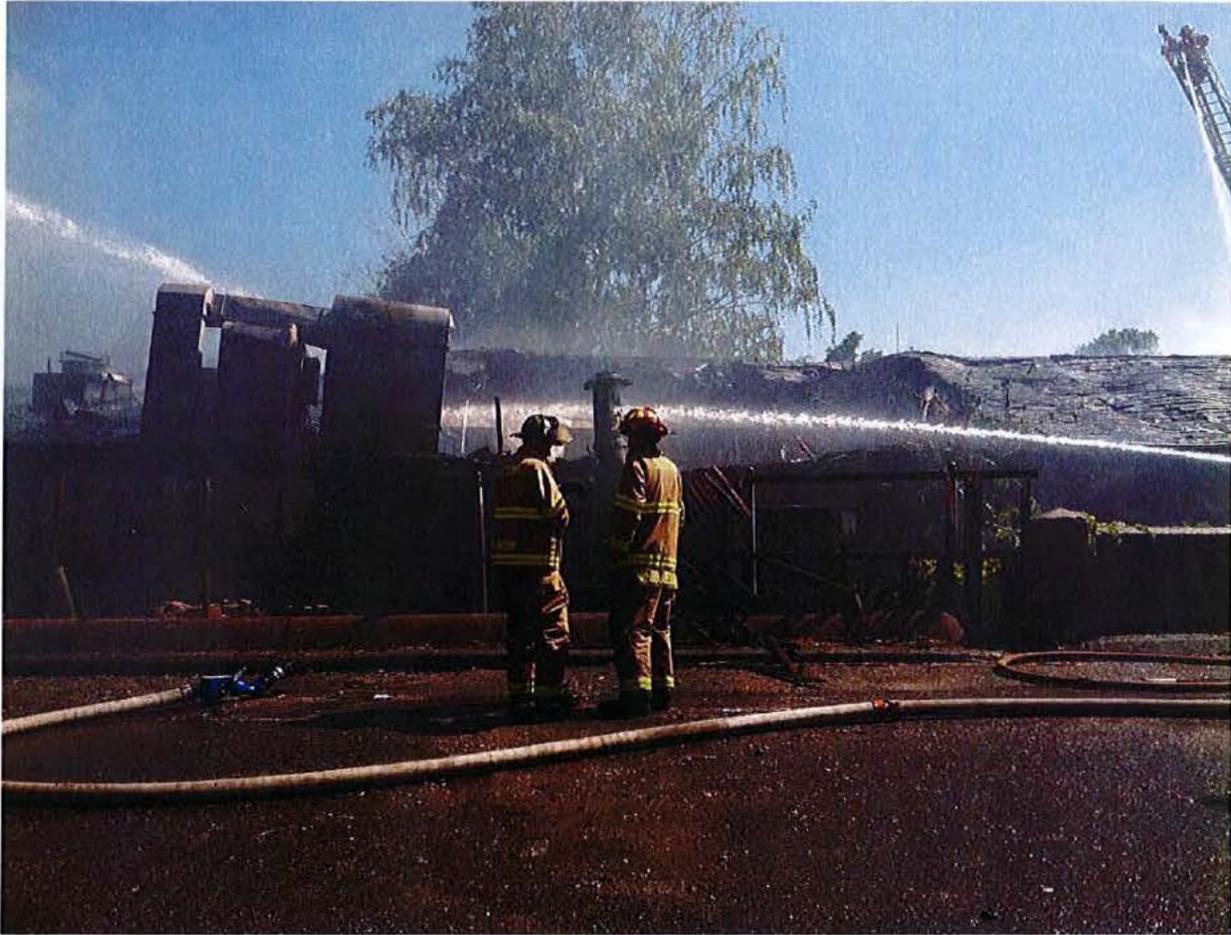
Exhibit 5(a) - Damage to 390 Fall River Avenue, Seekonk

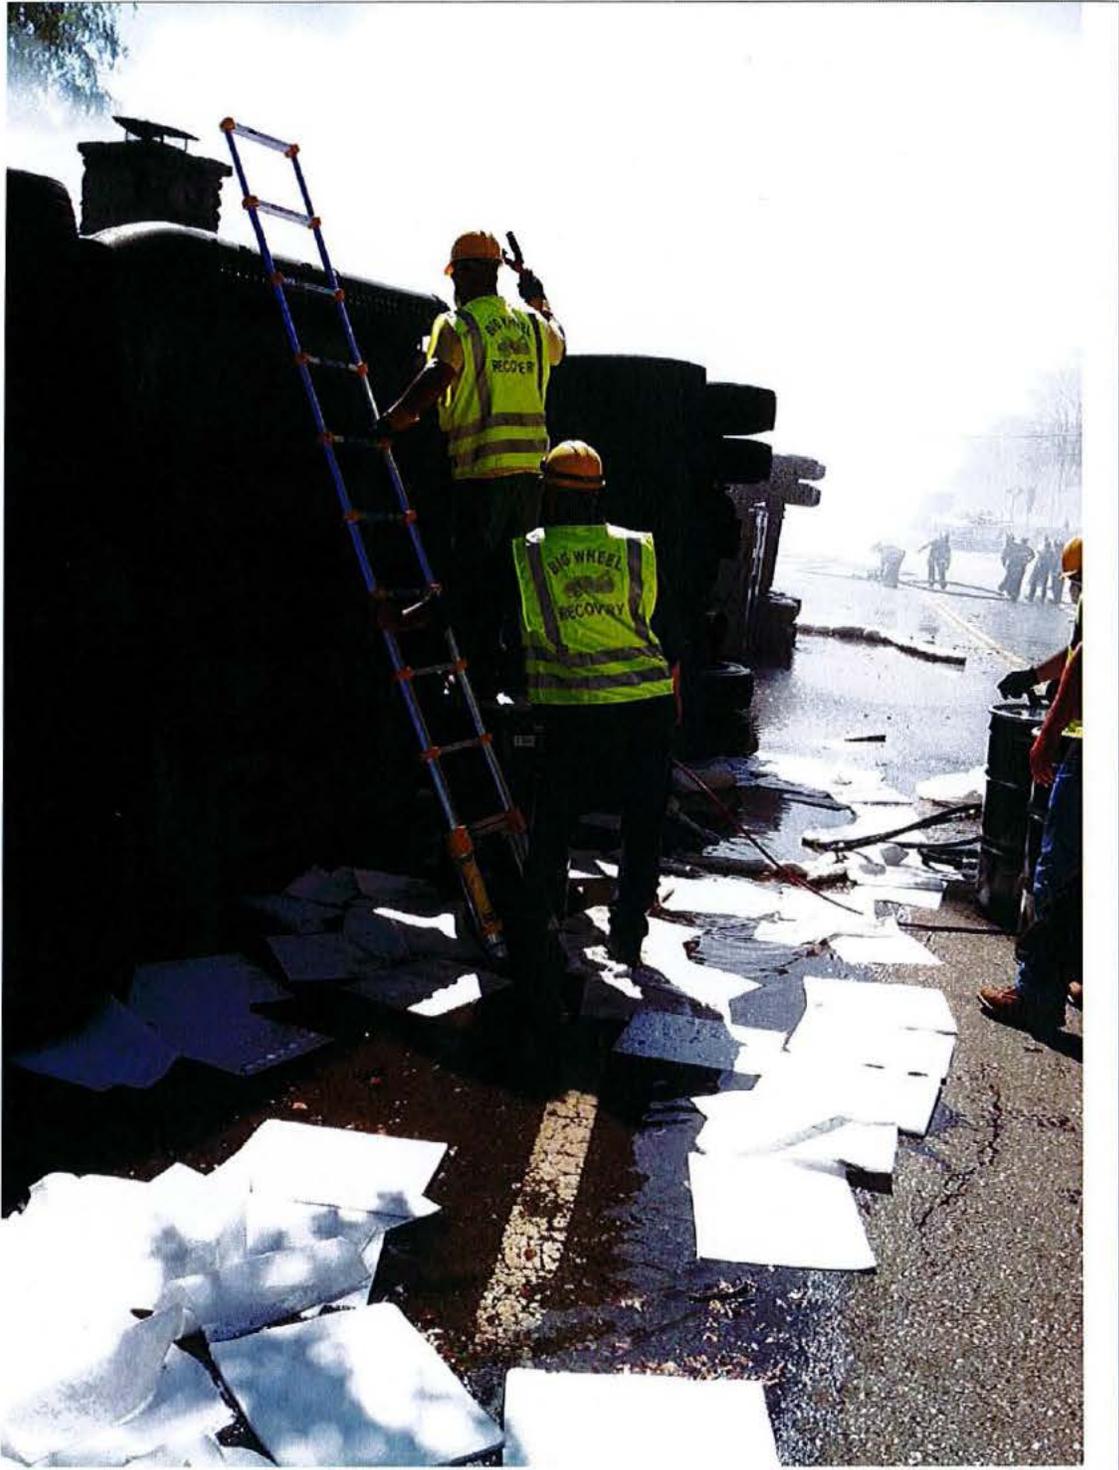
Exhibit 5(b) - Overturned tractor trailer truck at 390 Fall River Avenue, Seekonk

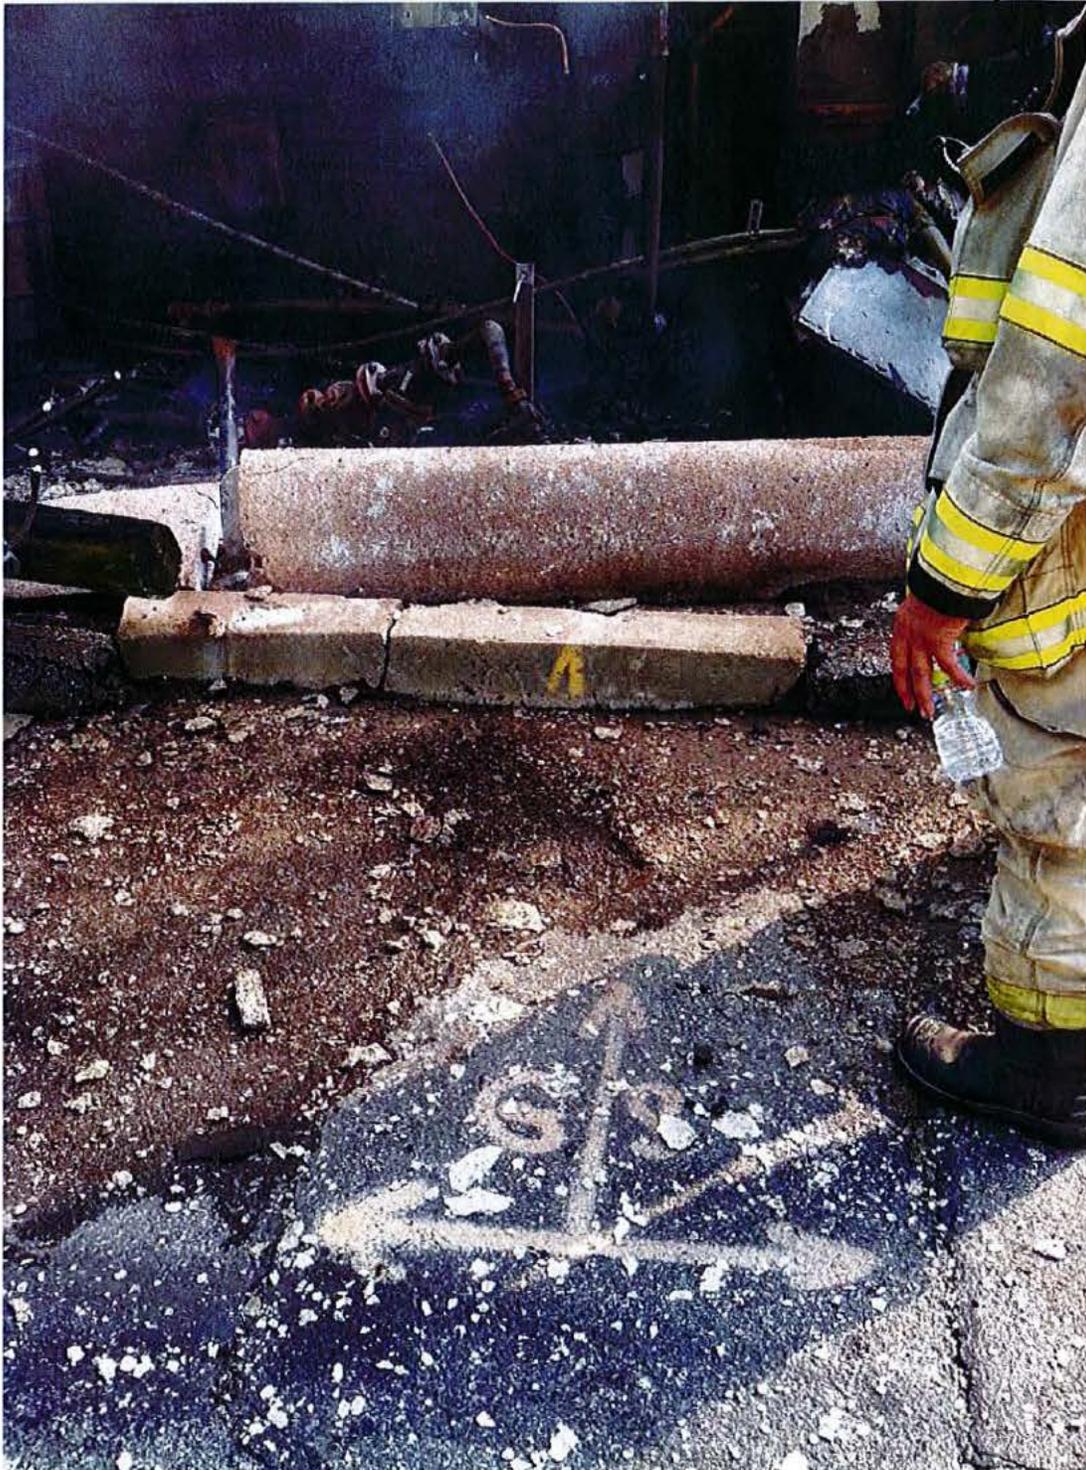
Exhibit 5(c) - Concrete berm in front of damaged gas facility  
at 390 Fall River Avenue, Seekonk

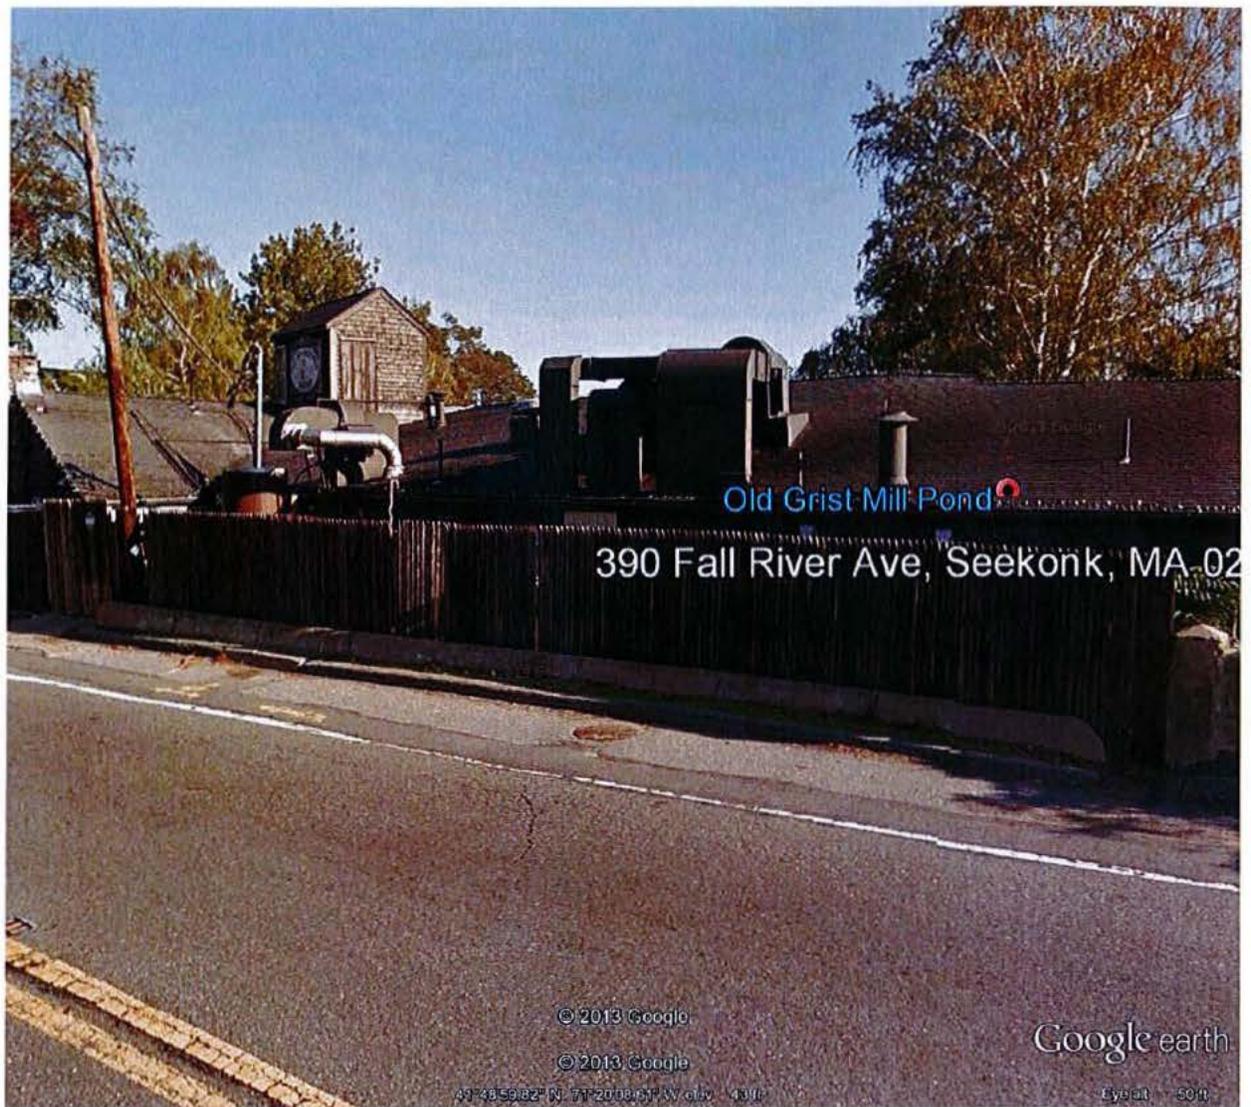
Exhibit 5(d) - 390 Fall River Avenue, Seekonk, before the Incident
