The Commonwealth of Massachusetts

DEPARTMENT OF PUBLIC UTILITIES

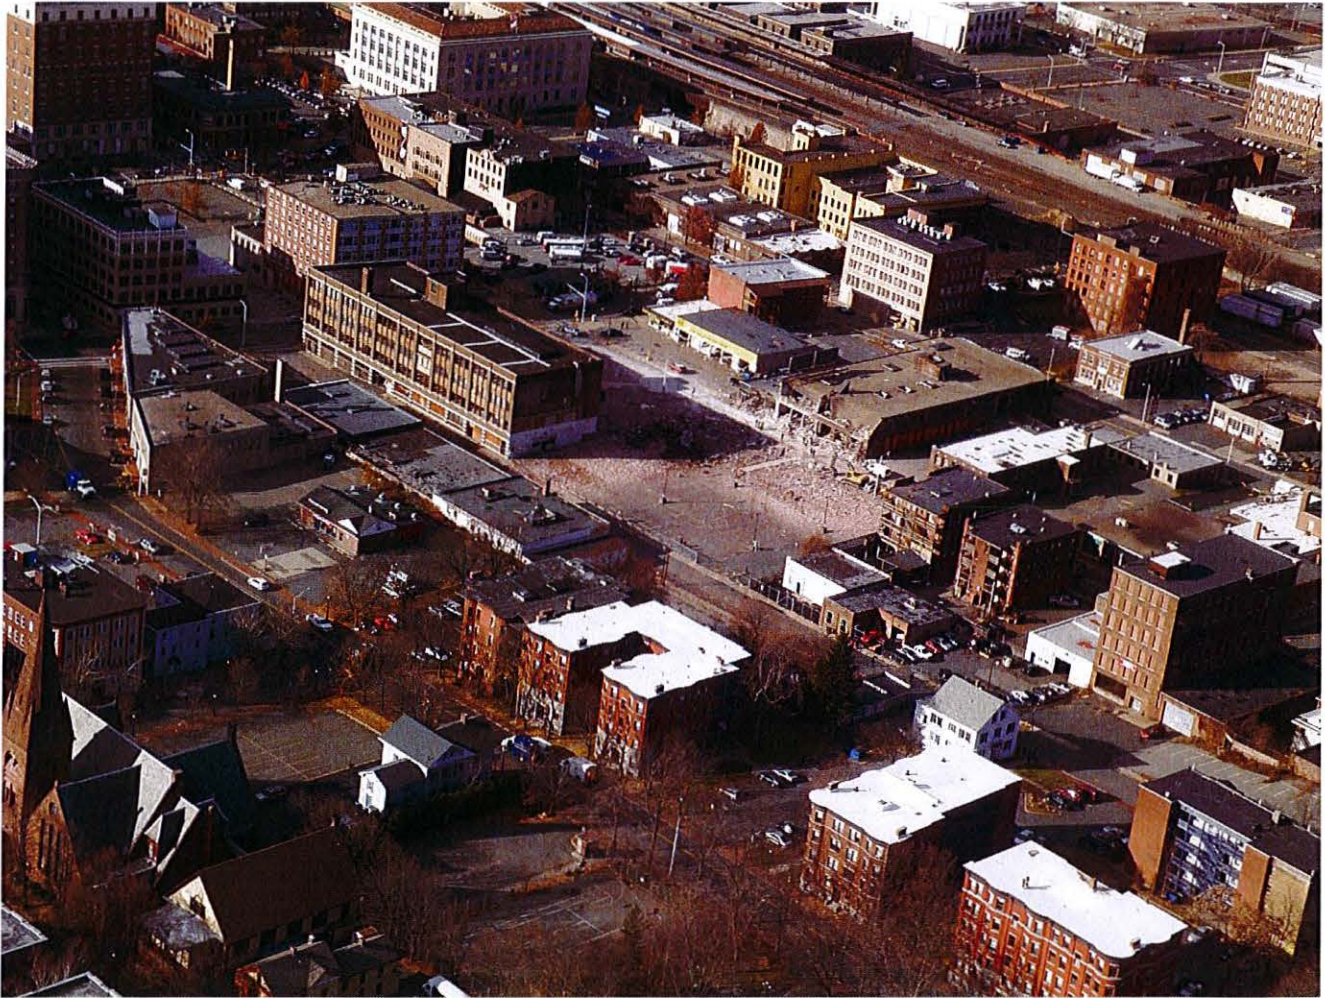
Exhibit 5(b) - Ground View of Incident Site

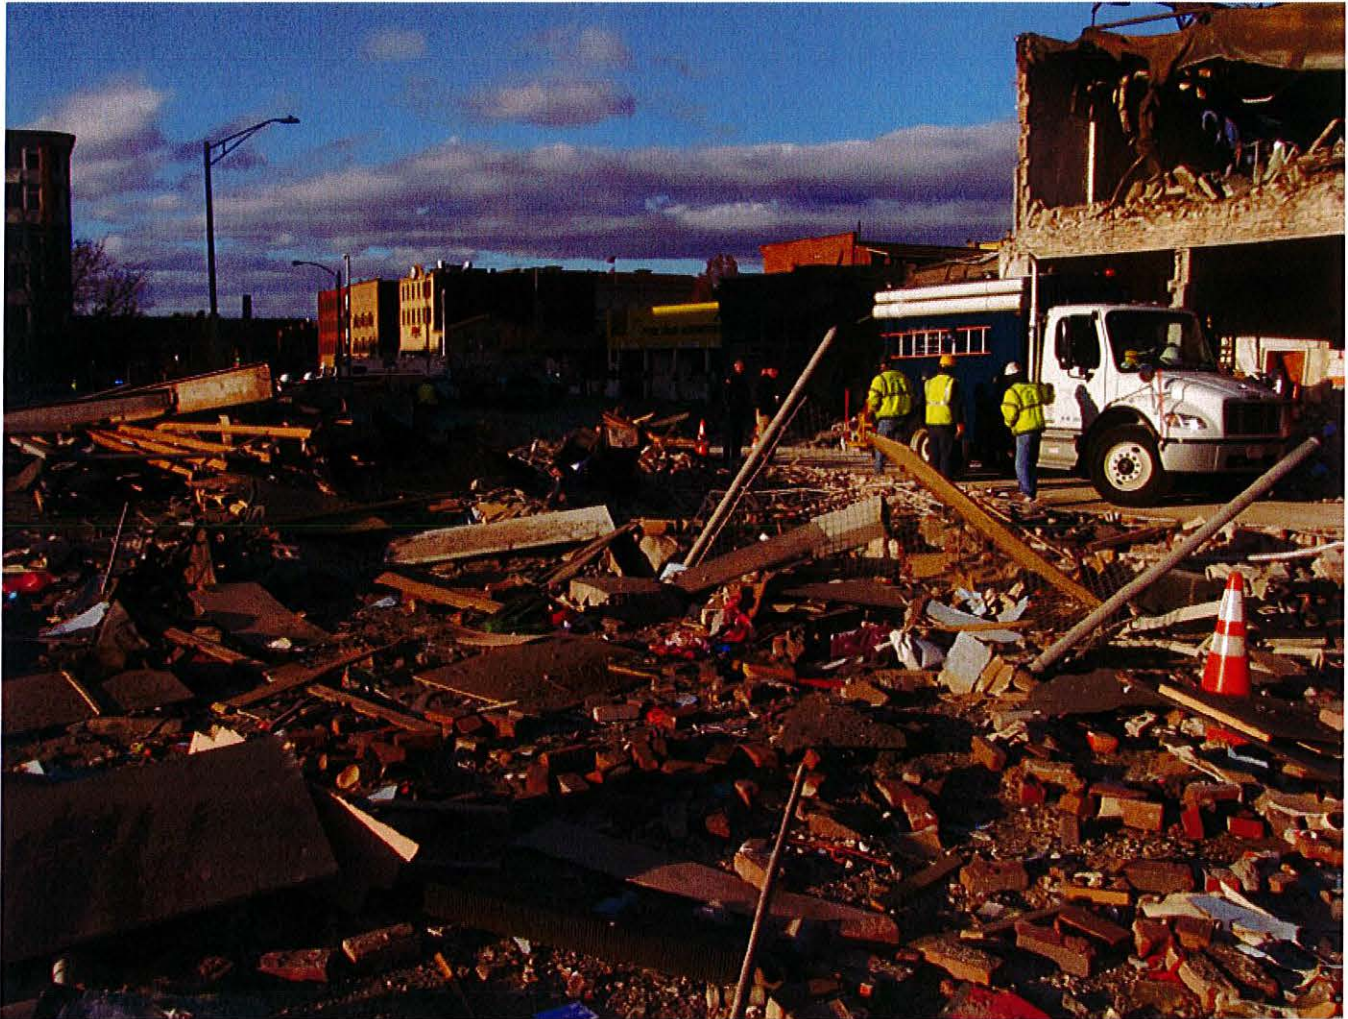
Exhibit 5(c) - The Damaged Gas Service Supplying 453 Washington Street In Situ

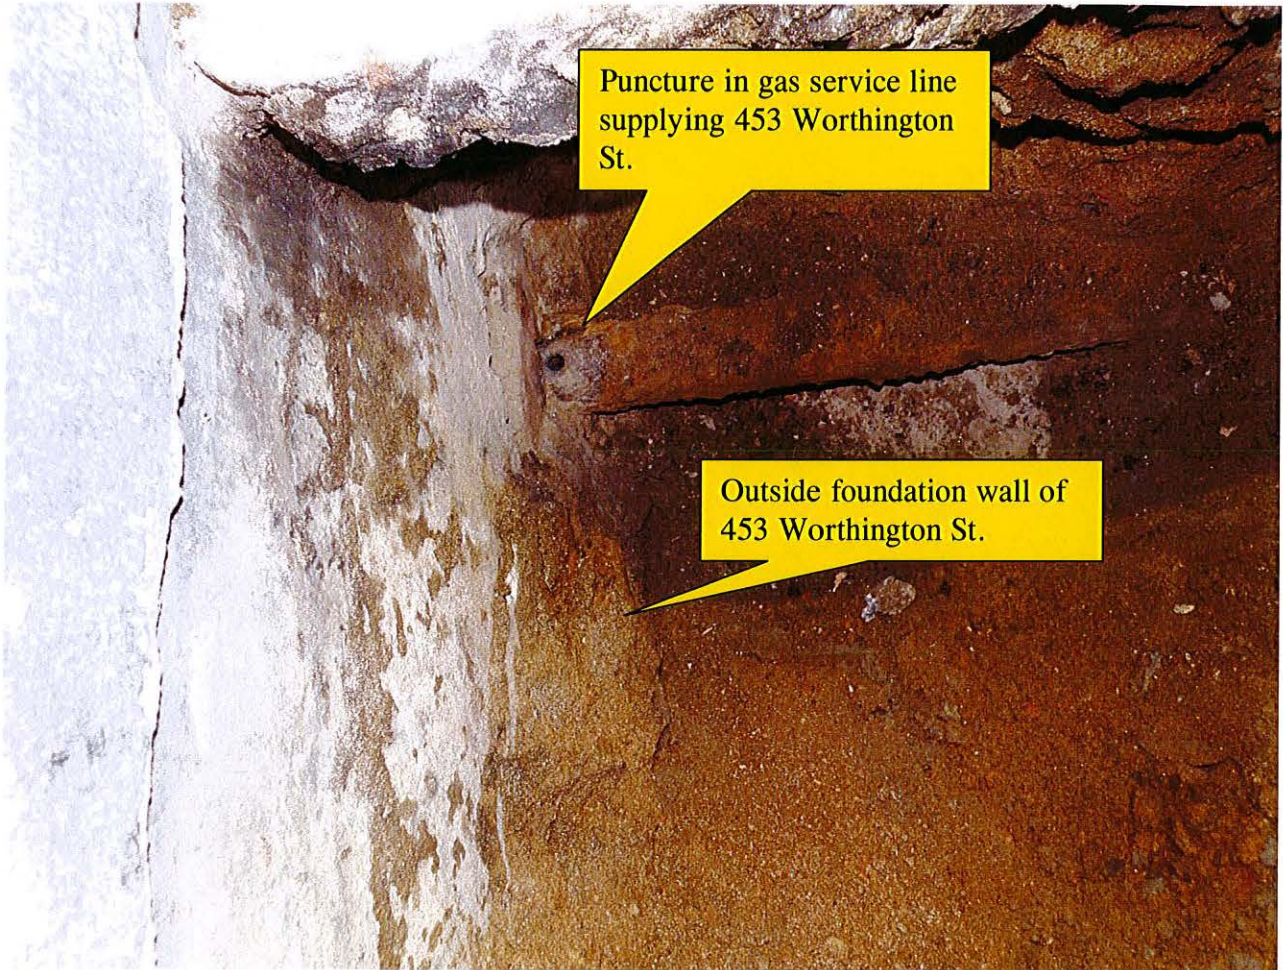
Exhibit 5(d) - The Damaged Gas Service With Probe Bar

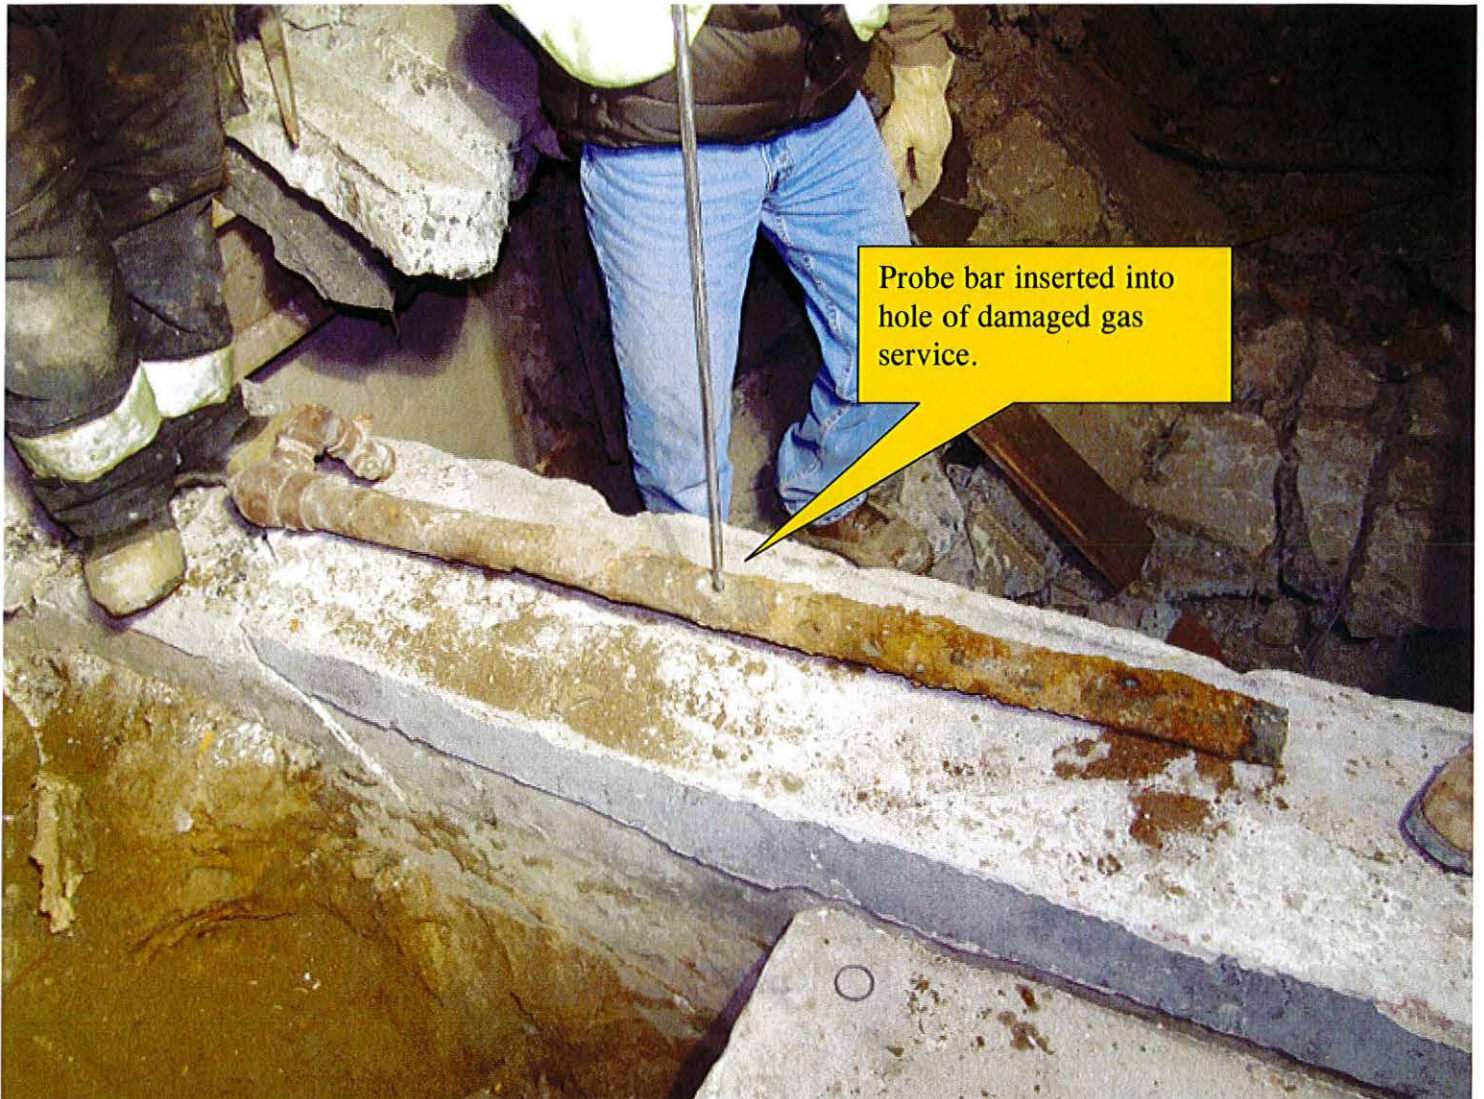
Exhibit 5(e) - Gas Service Connected to the Gas Main in Worthington Street

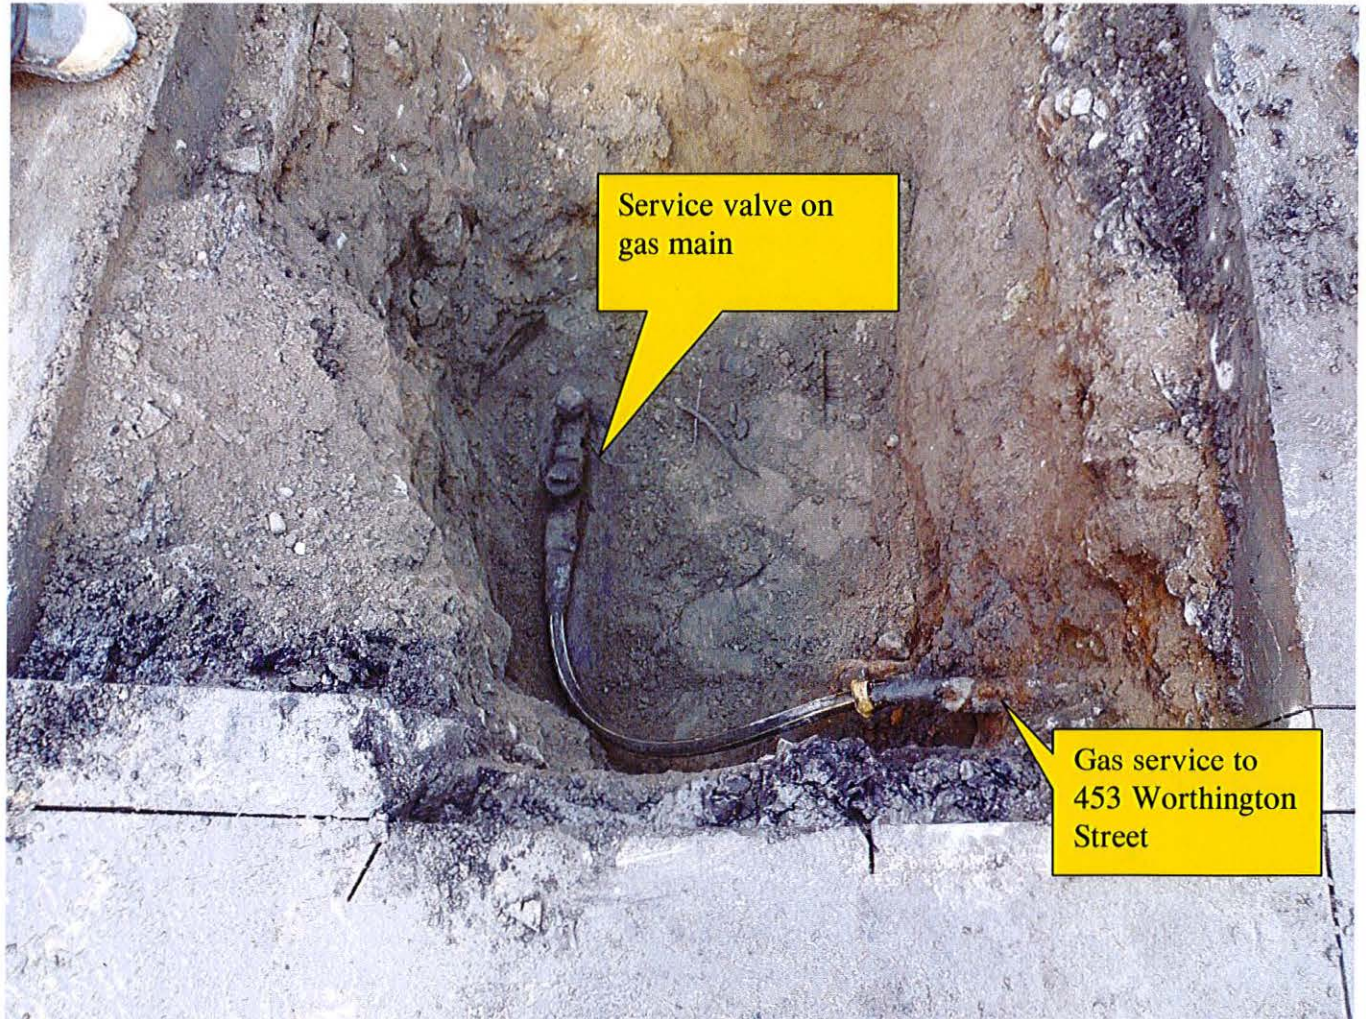
Exhibit 5(f) - The Faded Yellow Line In Relation to the Damaged Service Line In Situ

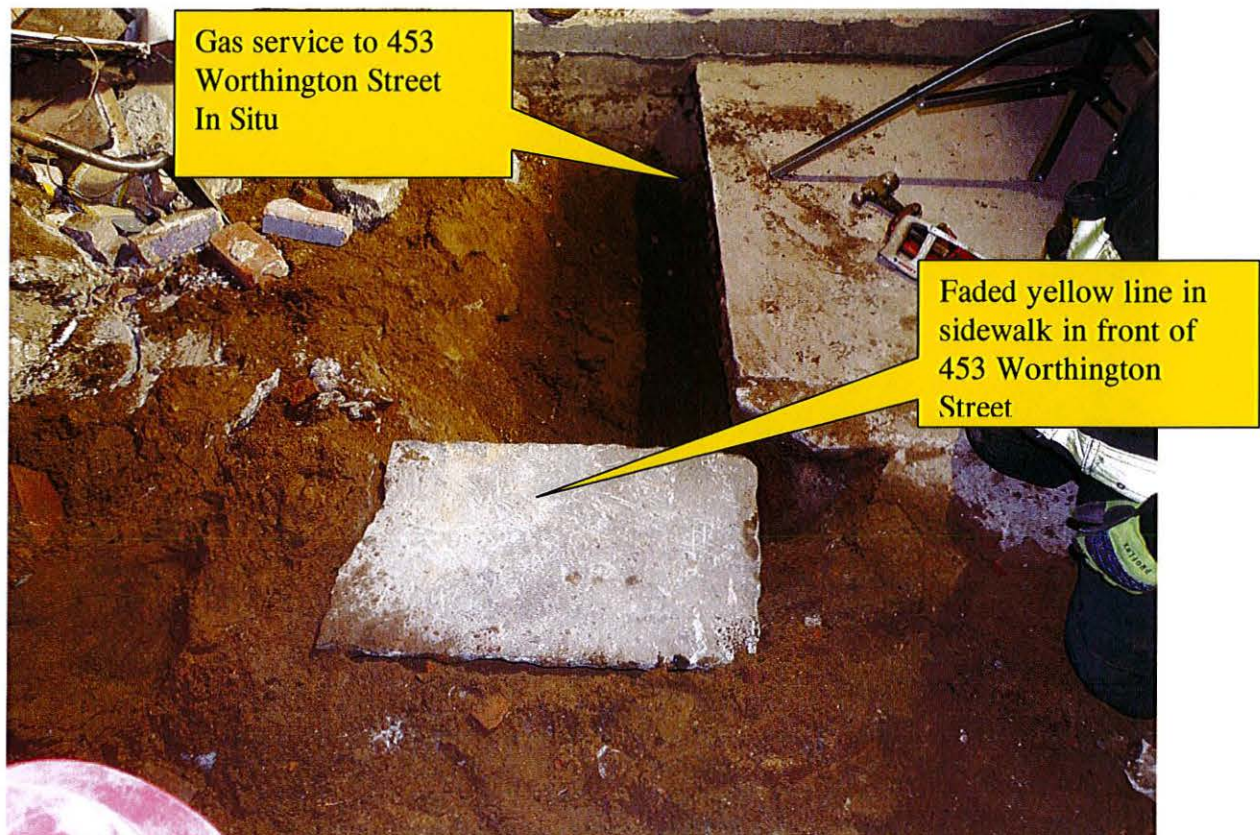
Exhibit 5(g) - Gas Service Regulator
