Request for Proposals for dcr. the Rehabilitation, Reuse & and Maintenance of:

WHITEHEAD

HOUSE

BUILDING CONDITIONS SURVEY WHITEHEAD HOUSE

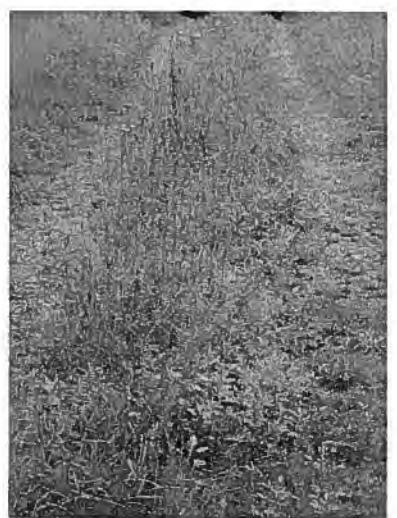
Figure 9. Driveway.

The driveway is overgrown and consists of mainly crushed stone and gravel.

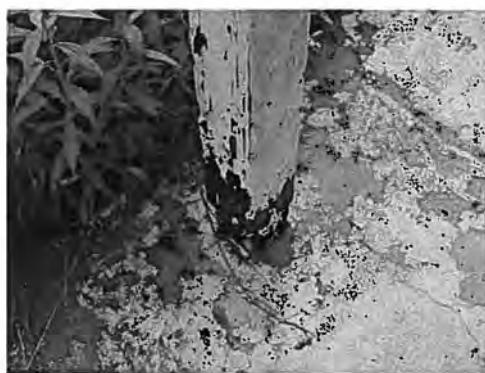
Figure 7. Existing porch post.

The porch roof is in fair condition. Some sheathing has been replaced with inappropriate plywood instead of the original board sheathing (Figure 8). One 6x6 lathe turned post is missing from the west edge of the porch.

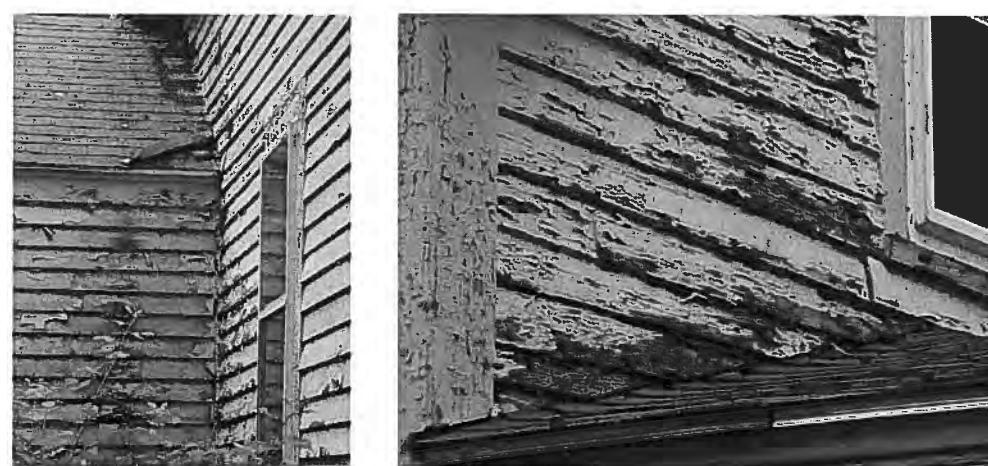
Figure 11. Deterioration of siding. Figure 12. Deteriorated and replacement siding.

Missing or deteriorated exterior elements should be replaced or temporarily secured from pests.

- Repair missing and damaged cornice return moulding. Dutchmen should be used whenever possible in lieu of complete replacement of original.
- Repair the damaged door surround and sill trim at the main entry door. Dutchmen replication pieces should be spliced into the original.
- Replace deteriorated clapboards.
- Replace deteriorated sections of corner boards with Dutchmen.

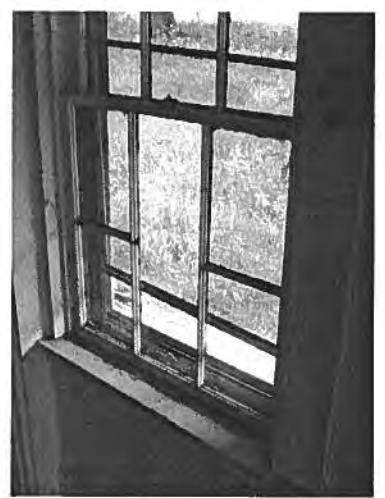
The windows are in fair condition and need minor repairs. There are several cracked window panes, missing muntins (Figure 16) and some missing hardware. The windows have storm/screen panels.

Figure 16. Unprotected windows

- Remove worn and broken aluminum storm windows. Exterior historic storm/screen panels should be installed to protect the historic materials, guard against vandalism, and reduce air loss.
- Clean storm/screen doors.

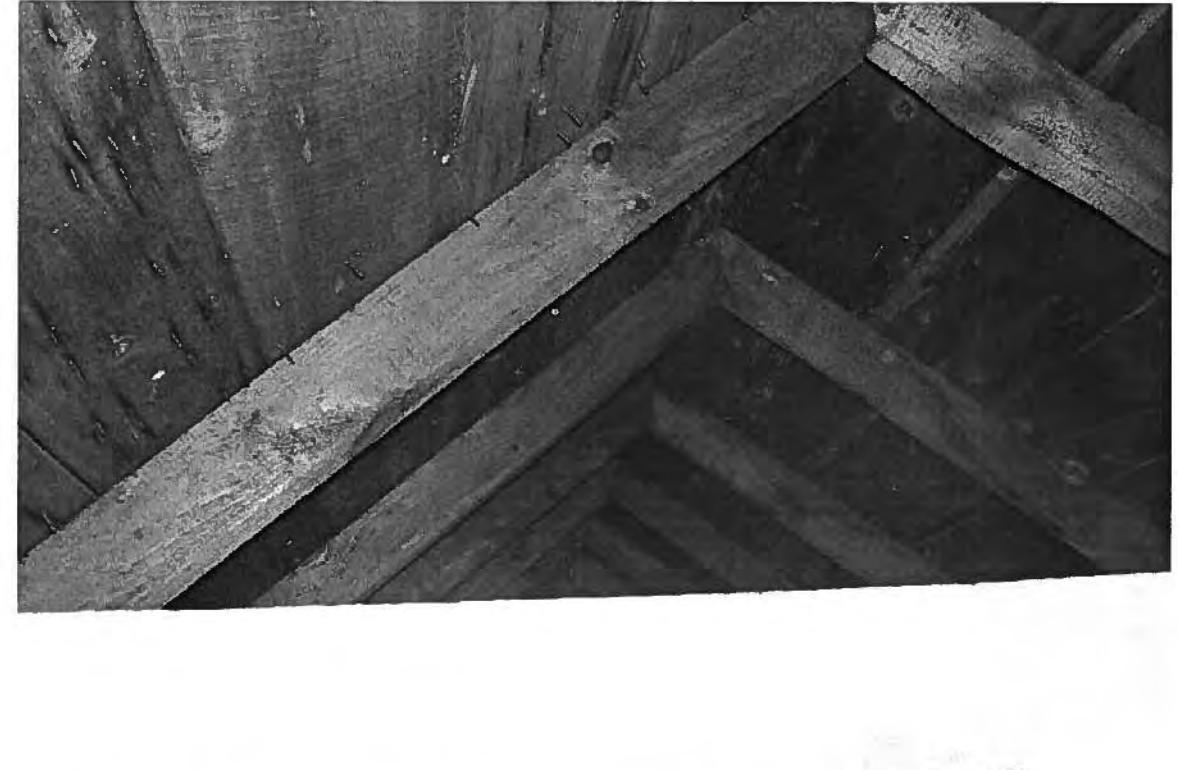
Figure S2

The roof planes were, for the most part, straight and true, indicating good deflection characteristics of the rafters/ties. The gable end wall was studded with $3^{*}x5^{*}$ full-cut members and sheathed with $3^{*}a^{*}-1^{*}$ thick wide horizontal planks (see Fig. S3).

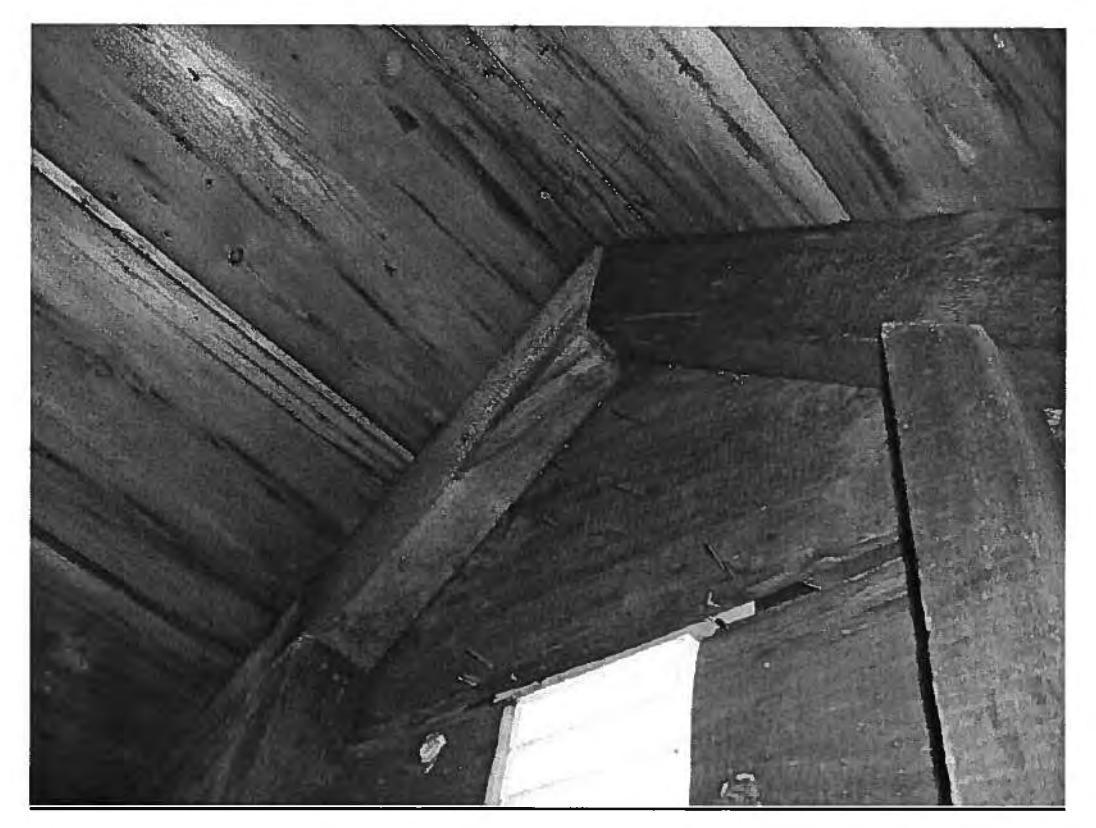
Figure S3

The framing that could be observed appeared to be sound and dry with no obvious stains from past water leakage. Some roof planks near the ridge had moderate concentrations of nails, indicating repairs or shielding of the roofing. Plaster in the closets nearest the eaves on the west side of the house showed evidence of staining, swelling, and cracking from water infiltration. This condition was particularly evident in the front (north) room near the location of the furnace chimney. Further investigation of the entire roof framing system is warranted via exploratory holes in the finishes. The existing roof's framing system is adequate to carry the snow loading required by CMR 780 (Zone 2 - 30 psf) plus up to 17 psf of dead load. This additional capacity is sufficient for the existing asphalt roofing and plaster ceilings (neglecting the contribution of the ceiling ties). Future use of slate roofing would require alteration to the existing framing.

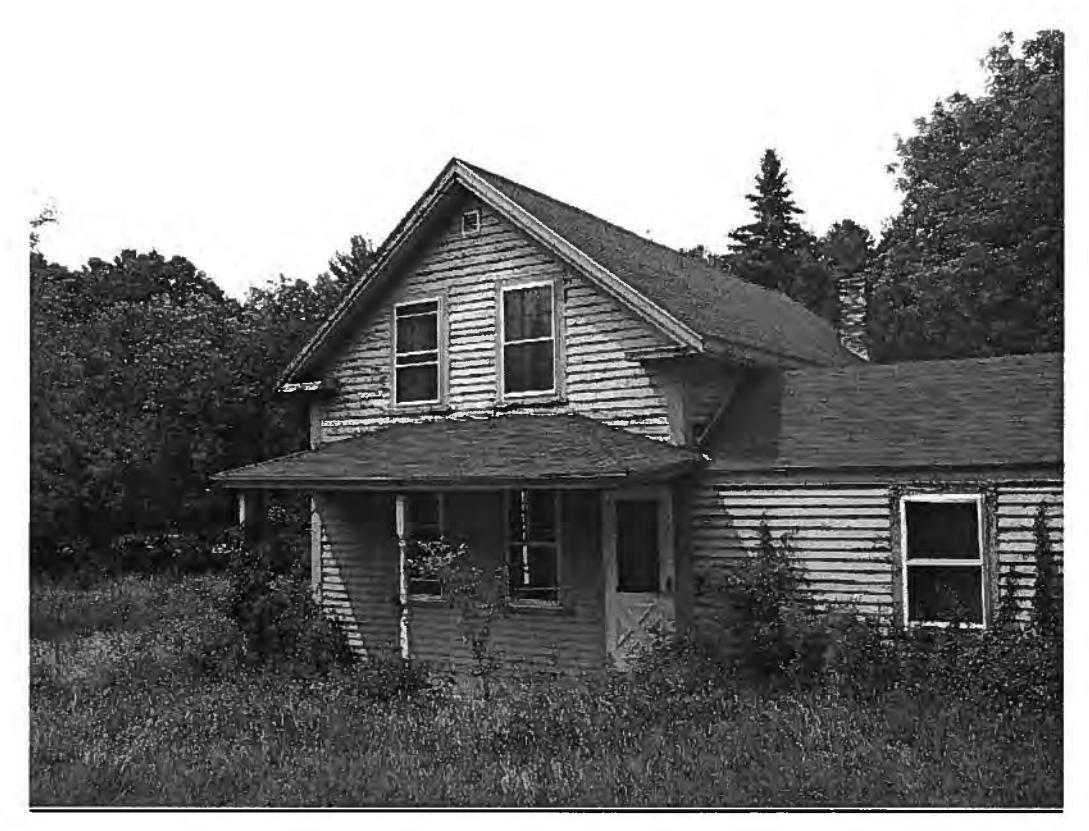
Figure S5

The entry roof is bordered at its eave line with substantial 4"x8" members that support sloping planking directly (see Fig. S4). The 4"x8" members are in turn supported by lathe-turned 6"x6" posts at the corners and middle. The western-most lathe-turned 6"x6" post is missing, apparently having rotted at its base and been removed. While the missing post should be replaced, the roof has maintained its form and levelness (see

Fig. S5). The level condition of the roof is probably due to the angled framing and sheathing which acts as a folded plate. This behavior should not be depended upon, though, to resist code-mandated snow loads, including drifting snow. The remaining posts should be checked for internal damage near their bases.

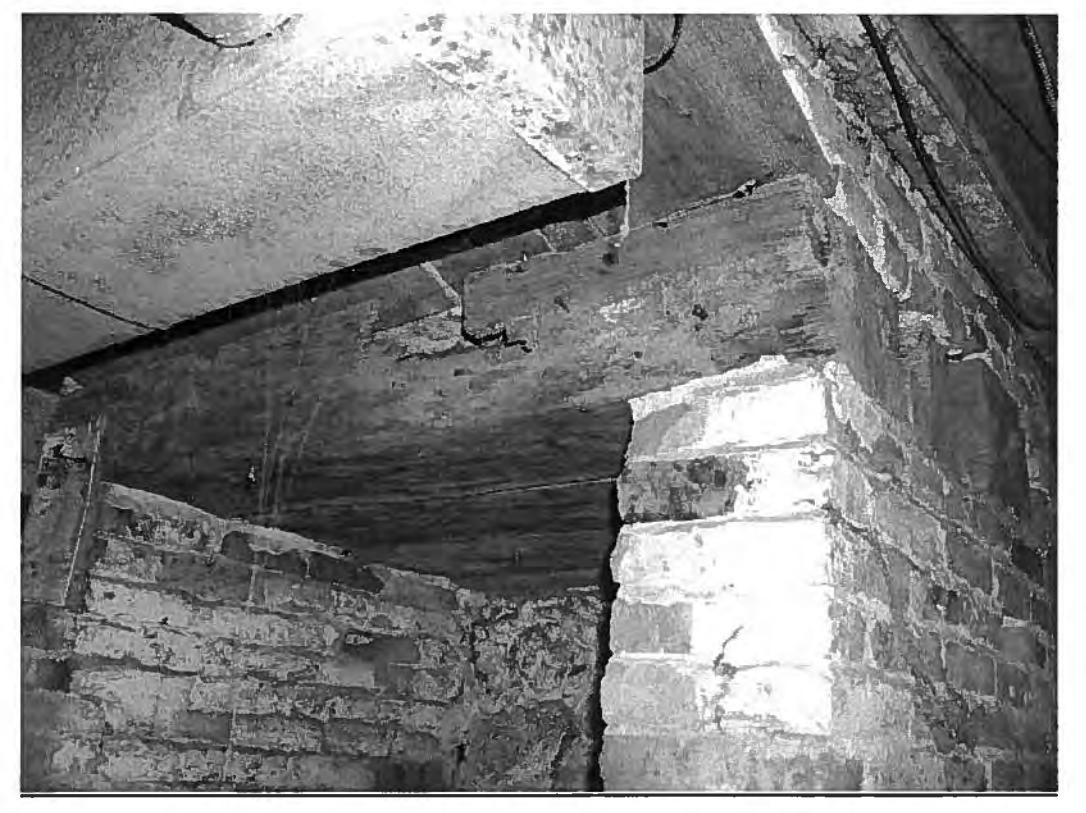
Figure S8

There was evidence of recent basement flooding on the debris material on the basement floor and damp conditions were present. The framing at the original section showed surficial signs of insect damage on many of the purlins and patches on the main beams (Fig. S7 & S9). The depth of this damage did not appear severe, but may require sistering with laminated veneer lumber (LVL) for any members that are found with deep damage. Severe insect damage was noticed at the 6"x6" wooden timbers supporting the brick hearth. The 6"x6" timbers will have to be replaced by steel lintel angles or the brick arch reconstructed due to the poor condition of the wood.

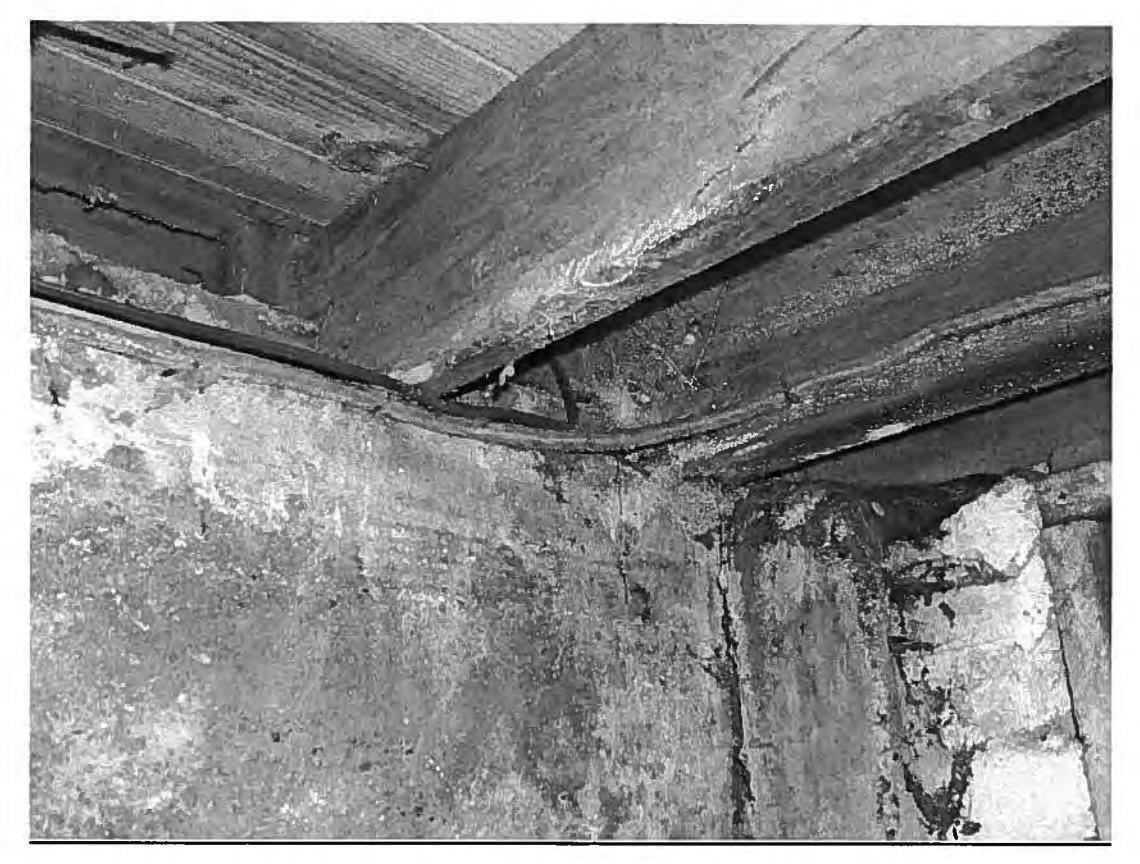
Figure S11

The sills under the kitchen addition appear to be sound with only superficial wetness at spot locations (Fig. S11). They could not be observed from the outside. The sills may be rotted at the exterior and/or damaged from within by insects. This damage would not be detectable from the interior inspection. The lowest clapboards should be removed at a future date to allow for inspection of the sills.
