September 2019

Report No. 19-008

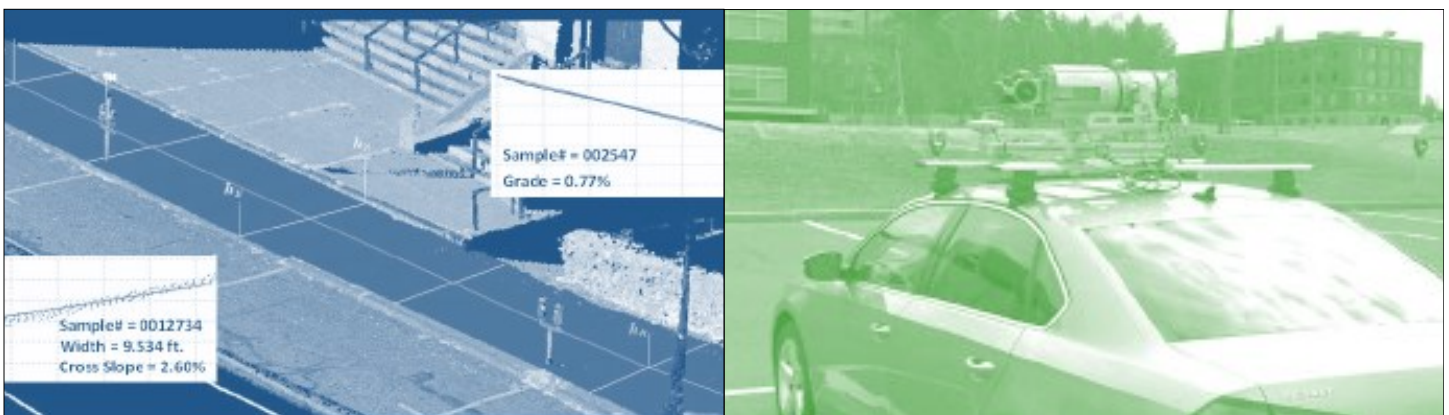
Research and Technology Transfer Section
MassDOT Office of Transportation Planning

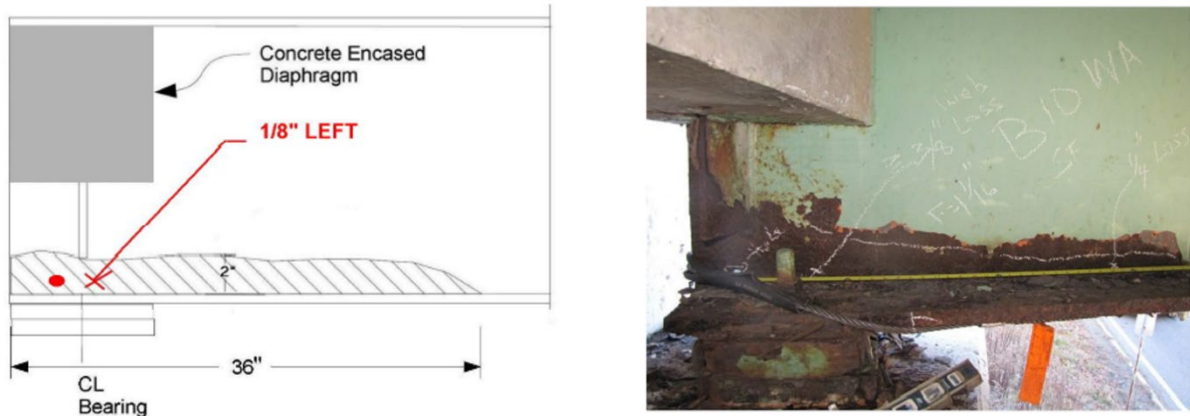
Source: Adopted from W46010-3RY-DOT-NBI (District 5, Town of Wrentham).

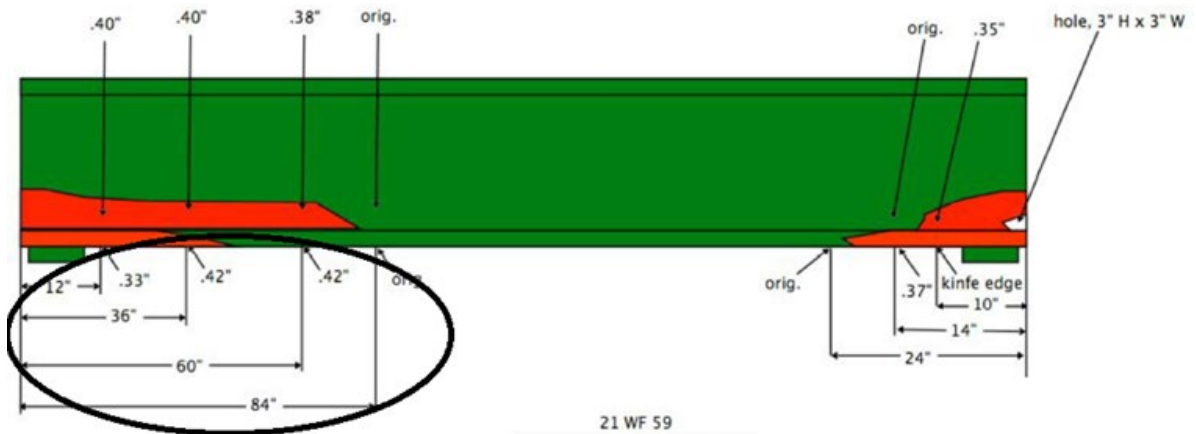
Source: Adopted from S10024-02H-MUN-NBI (District 1, Town of Sheffield).

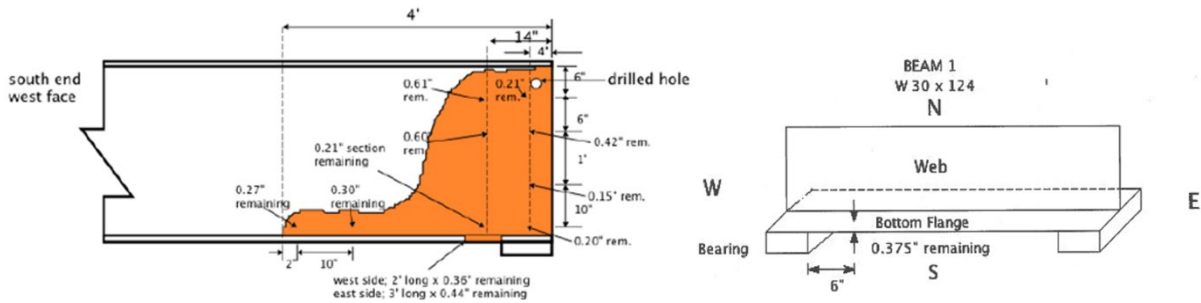
Source: Adopted from H08003-18J-MUN-NBI (District 2, Town of Hardwick) and W07029-4NA-DOT-NBI (District 2, Town of Warren) respectively.

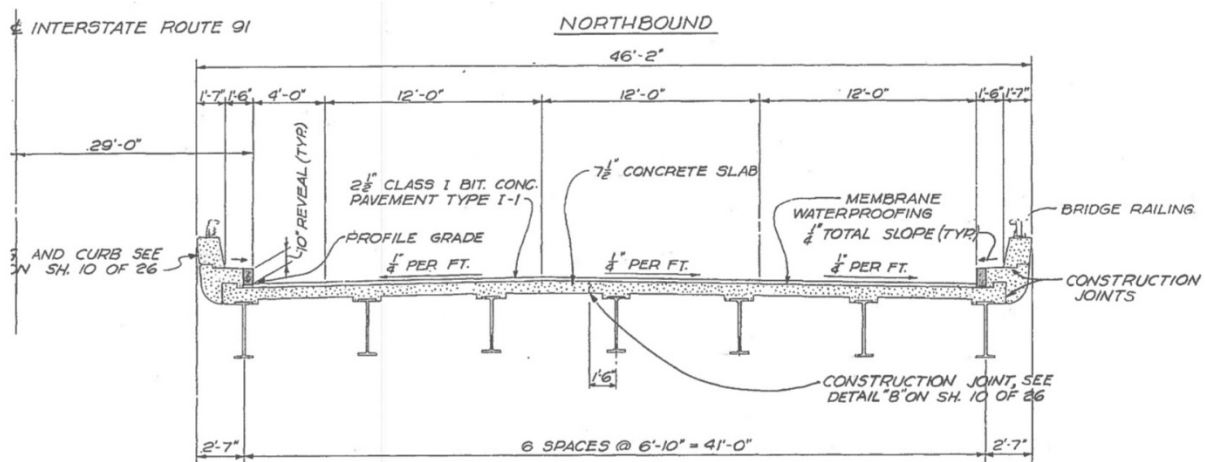
Source: Adopted from N19059-101-DOT-NBI (District 2, City of Northampton).

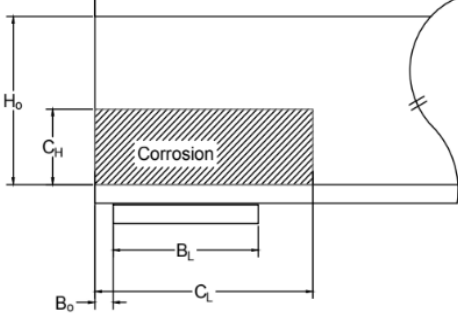
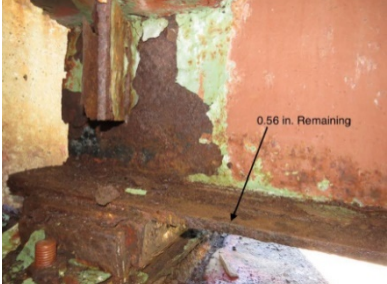
<p>Adopted from H-23-011-1UQ-DOT-NBI (District 3, Town of Hopkinton)</p>
<p>Short description: W1 is a rectangular shape corrosion pattern that appears at the beam end above the bearing. The dimensions of the damaged area are C_H for the depth of the damaged area and C_L for the length. B_L is the bearing length and B_0 is the length of the free end of the beam beyond the bearing. The photograph on the right shows a case of W1 for which the C_H is equal to the depth of the beam web H_0.</p>

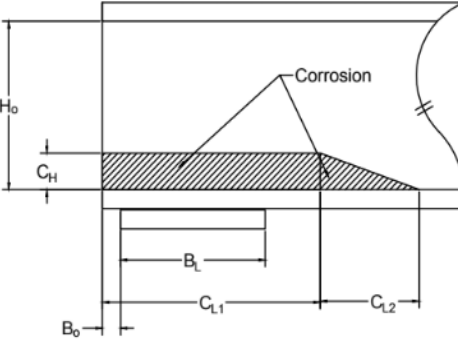
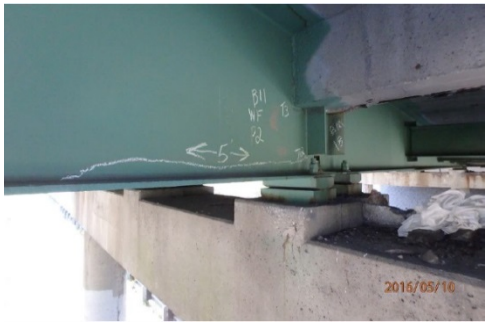
<p>Adopted from N-06-015-3WR-DOT-NBI (District 5, Town of New Bedford)</p>
<p>Short description: W2 is similar to W1, with the addition of a triangular-shaped corrosion area at the end of the rectangular shape. For W2, C_H is the depth of the damaged area, while C_{L1} is the length of the rectangular part of the corrosion. C_{L2} is the length of the triangular damage. B_L is the bearing length, and B_0 is the length of the free end of the beam beyond the bearing. The photograph on the right shows a typical case of W2.</p>

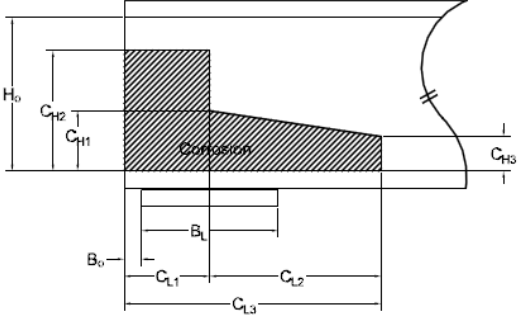
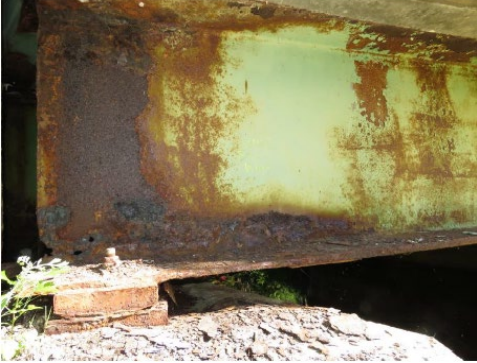
<p data-bbox="987 781 1334 829">Adapted from D-12-026-1XX-DOT-NBI (District 3, Town of Dudley)</p>
<p>Short description: W3 is a more complicated shape than W1 and W2. It can be described by the three areas as shown in the sketch on the left. For W3, the depth of the corroded area is described using C_{H1}, C_{H2} and C_{H3}. Similarly, C_{L1} and C_{L2} are used to provide the length of the corroded area. B_L is the bearing length, and B_0 is the length of the free end of the beam beyond the bearing. The photograph on the right shows a typical case of W3.</p>

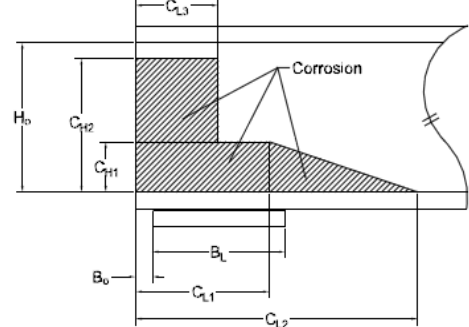
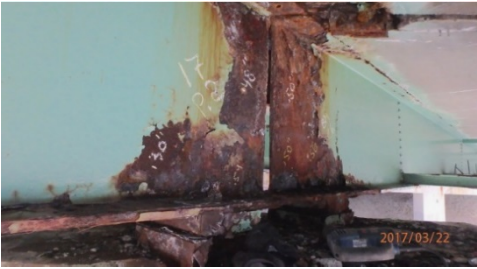
<p data-bbox="987 1516 1334 1564">Adapted from F-01-042-3X5-DOT-NBI (District 5, City of Fall River)</p>
<p>Short description: W4 is a slight modification of W3 to include the complication of the shape of the bottom left rectangular shape. The depth of the corroded area is described using C_{H1} and C_{H2}. Similarly, C_{L1}, C_{L2} and C_{L3} are used to provide the length of the corroded area. B_L is the bearing length, and B_0 is the length of the free end of the beam beyond the bearing. The photograph on the right shows a typical case of W4.</p>

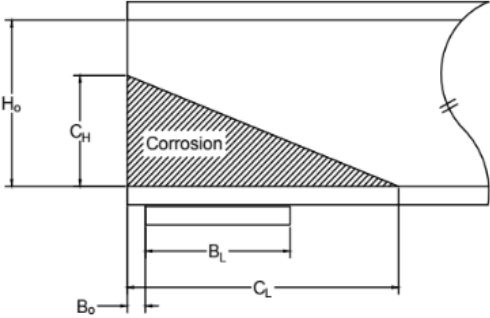
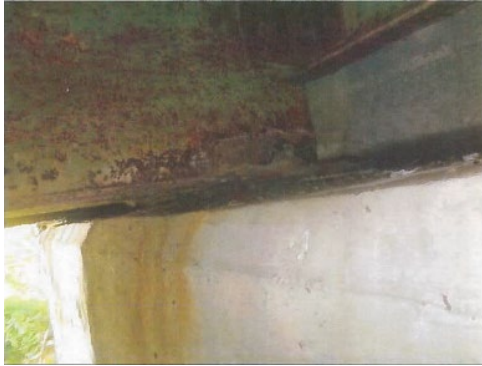
<p data-bbox="982 772 1339 823">Adapted from W-05-024-0T4-MUN-NBI (District 2, Town of Ware)</p> <p data-bbox="365 823 1388 953">Short description: W5 is a simple triangular shape corroded area described by C_H which is the height of the triangle, and C_L which is the length of the triangle. B_L is the bearing width, and B_o is the length of the free end of the beam beyond the bearing. The photograph on the right shows a typical case of W5.</p>

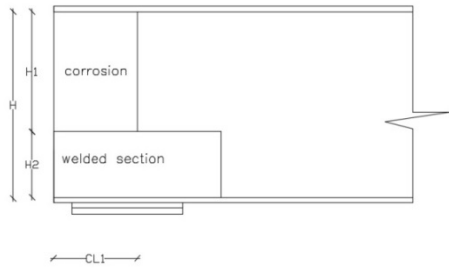
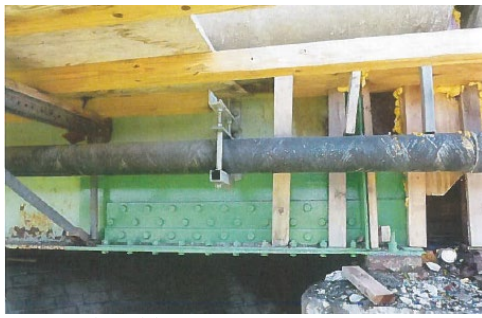
<p data-bbox="982 1486 1339 1537">Adapted from N-19-064-10C-DOT-NBI (District 2, City of Northampton)</p> <p data-bbox="365 1537 1388 1696">Short description: W6 is a rare case, but it is included here for the sake of completeness. It involves a welded plate at the bottom side of the web. The corrosion extends above the welded section as shown in the graph at the left. For this case H_1 is the height of the corroded area, C_{L1} is the length of the corroded area, and H_2 is the height of the welded plate. The photograph on the right shows a typical case of W6.</p>

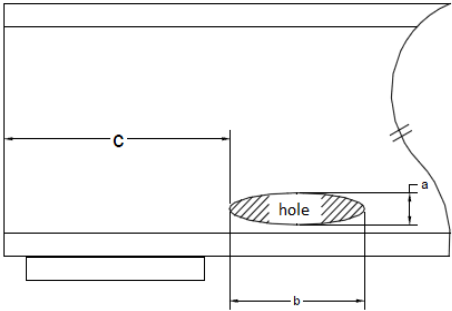
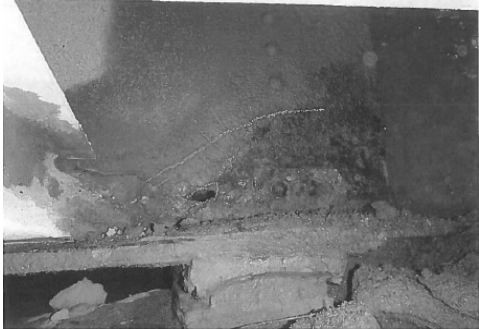
<p data-bbox="964 1383 1302 1430">Adapted from S-24-017-14K-DOT-634 (District 2, City of Springfield)</p> <p data-bbox="367 1436 1372 1570">Short description: M4 is a case where a hole appears away from the bearing at the lower part of the beam. For this case, a is the height of the hole, b is the length of the hole and c is the distance of the end of the hole from the end of the beam. The photograph on the right shows a typical case of M4.</p>

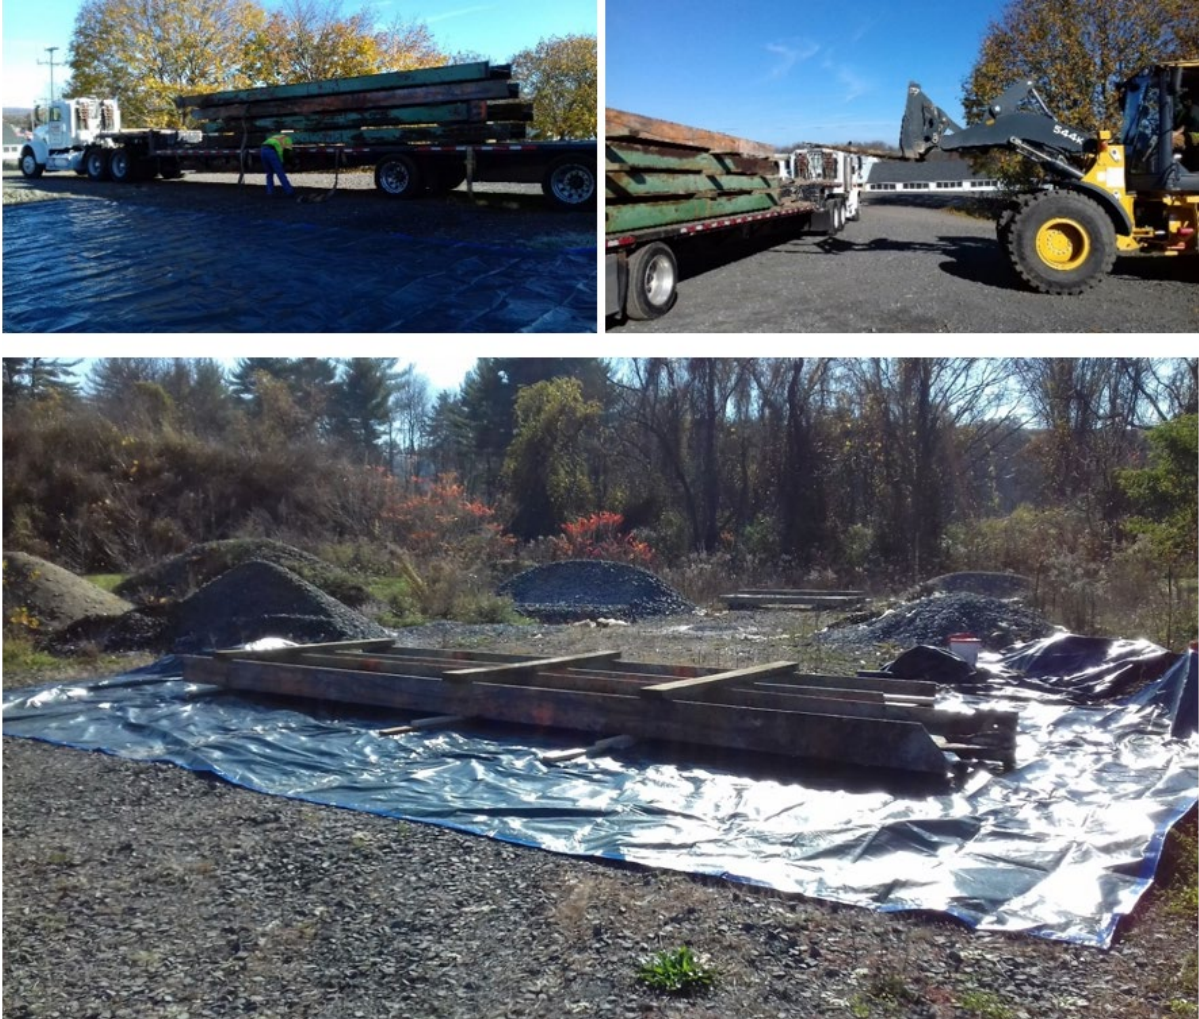
Figure 3.1: Delivery, unloading, and storage of first set of corroded beams from Colrain bridge.

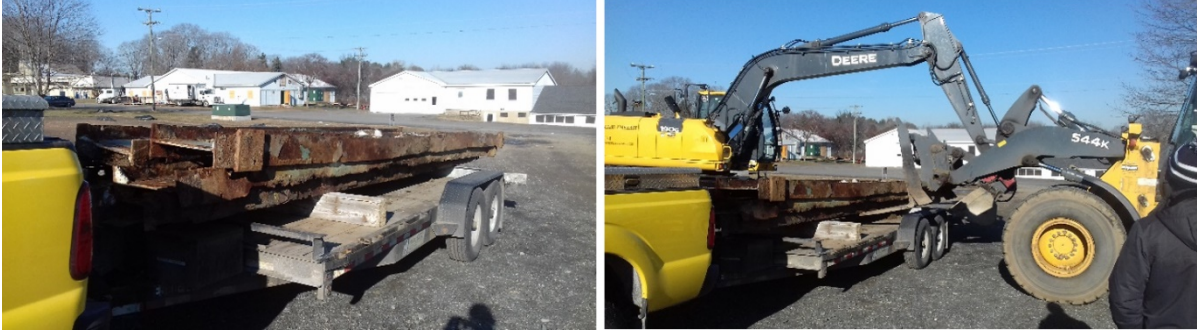
Figure 3.2: Delivery and unloading of corroded beams from Charlemont bridge.

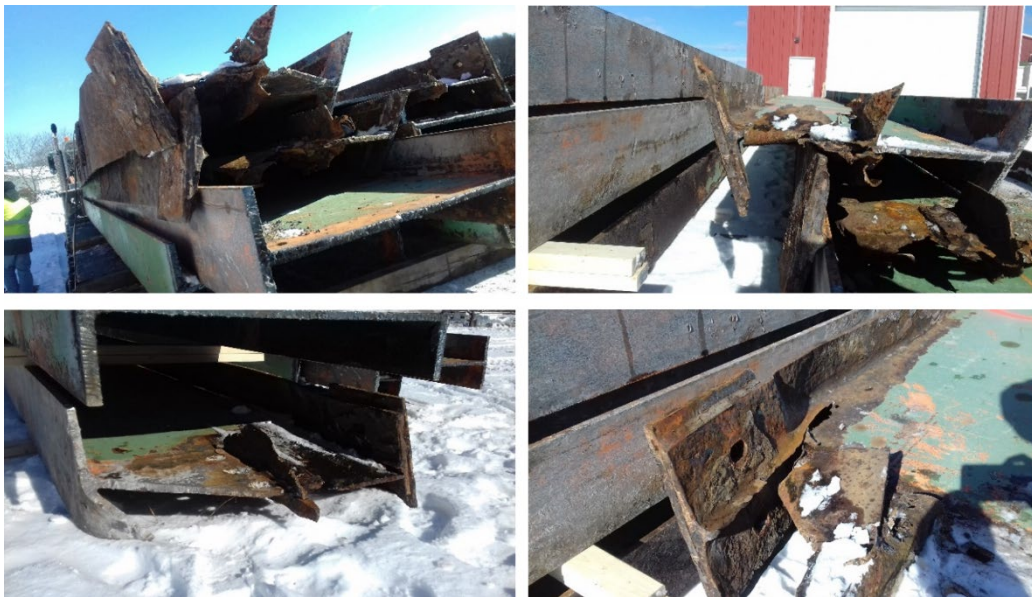
Figure 3.3: Distorted beams rejected for experimental testing due to condition.

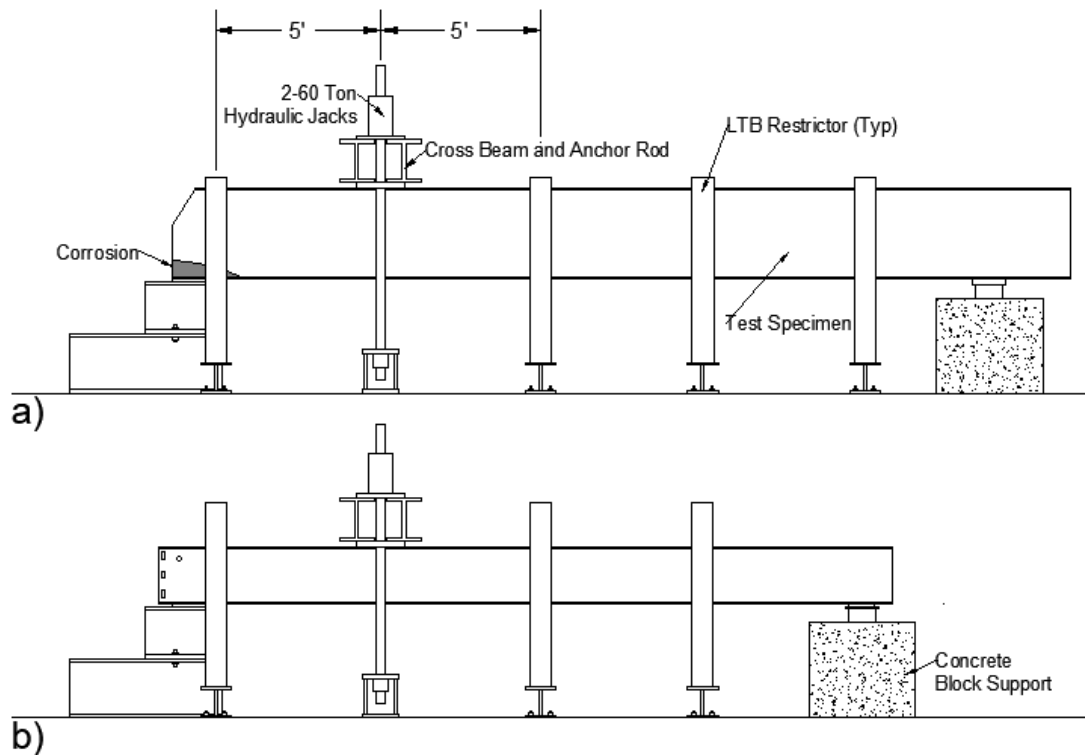
Figure 3.4: Experimental rig for (a) Specimens 1 to 3 and (b) 4 to 6.

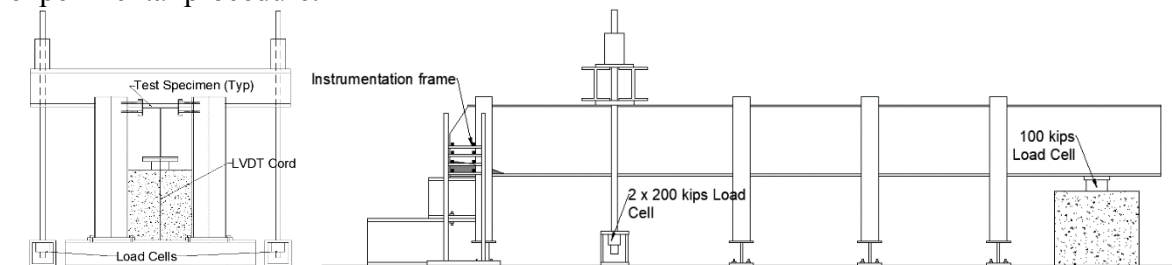
Figure 3.5: Side and front view of the instrumentation configuration.

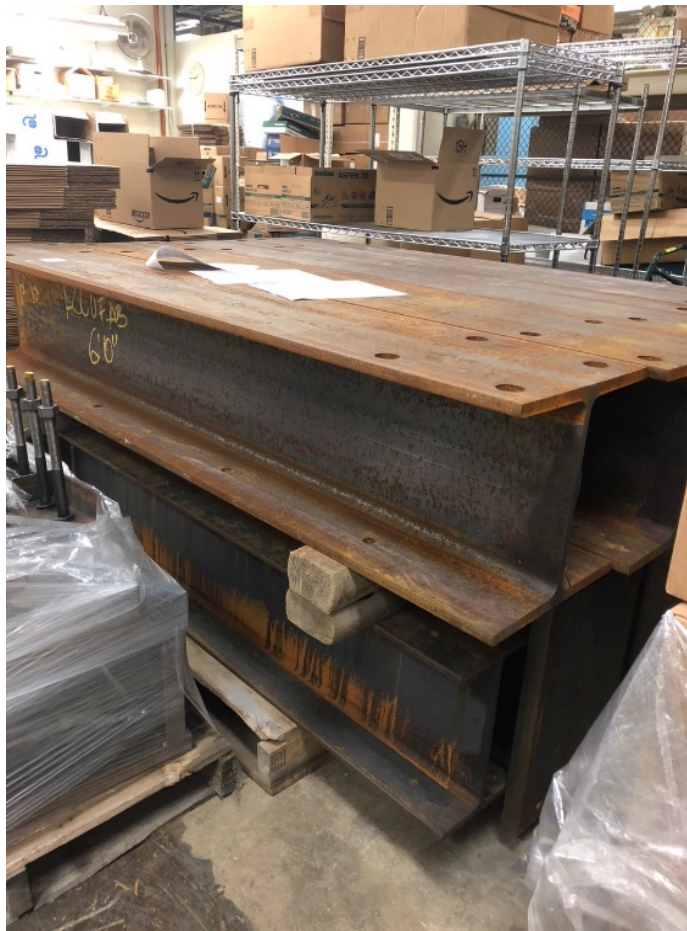
Figure 3.6: The steel for the experimental configuration.

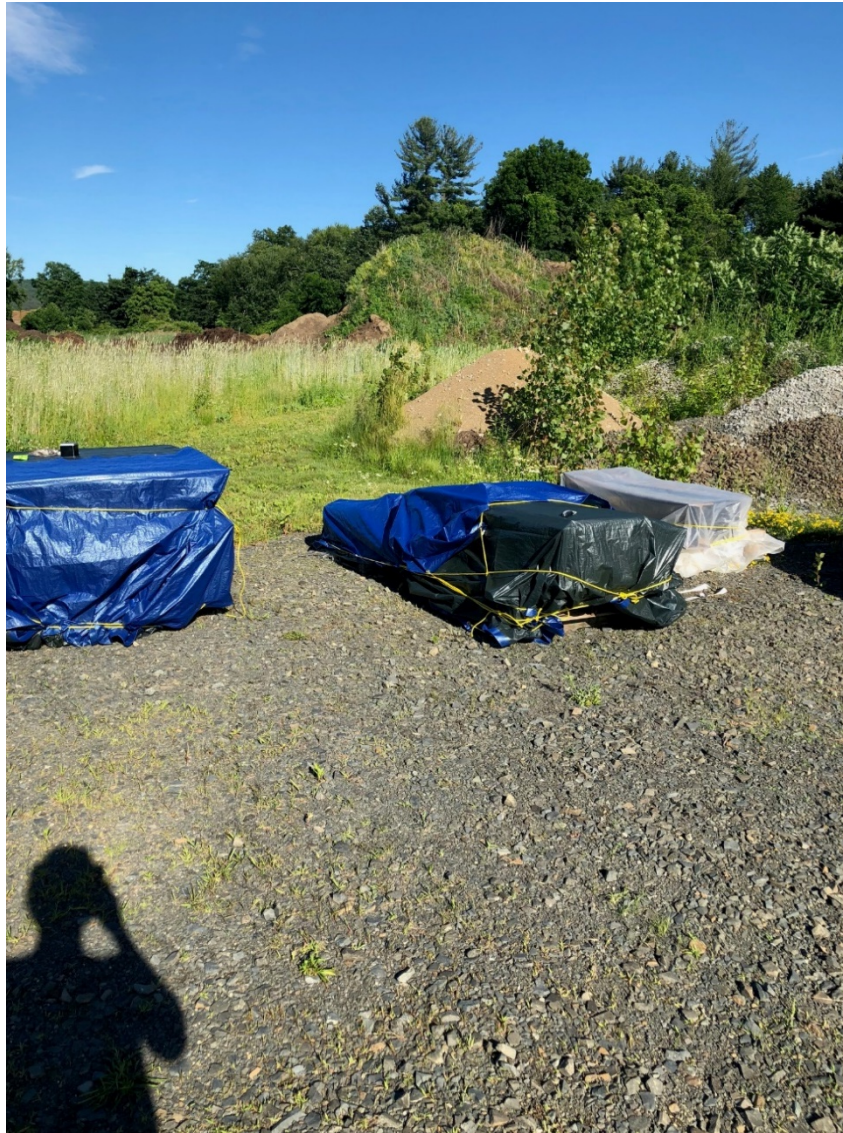
Figure 3.7: Beams painted with steel rust primer, and tarped and stored at the backyard of Brack lab.

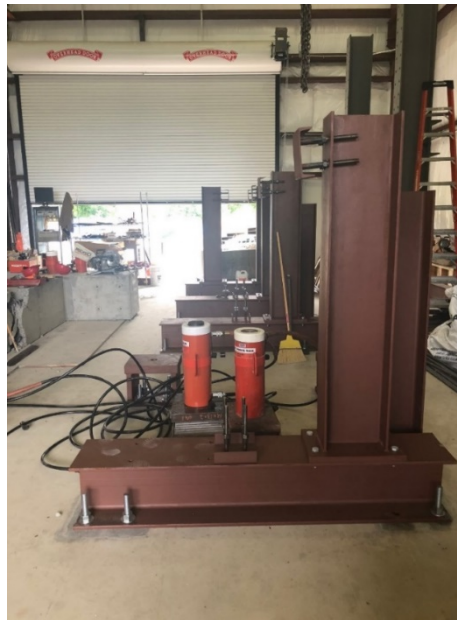
Figure 3.10: Experimental configuration in Aug. 2018; anchor block, floor beams, and lateral bracing in position.

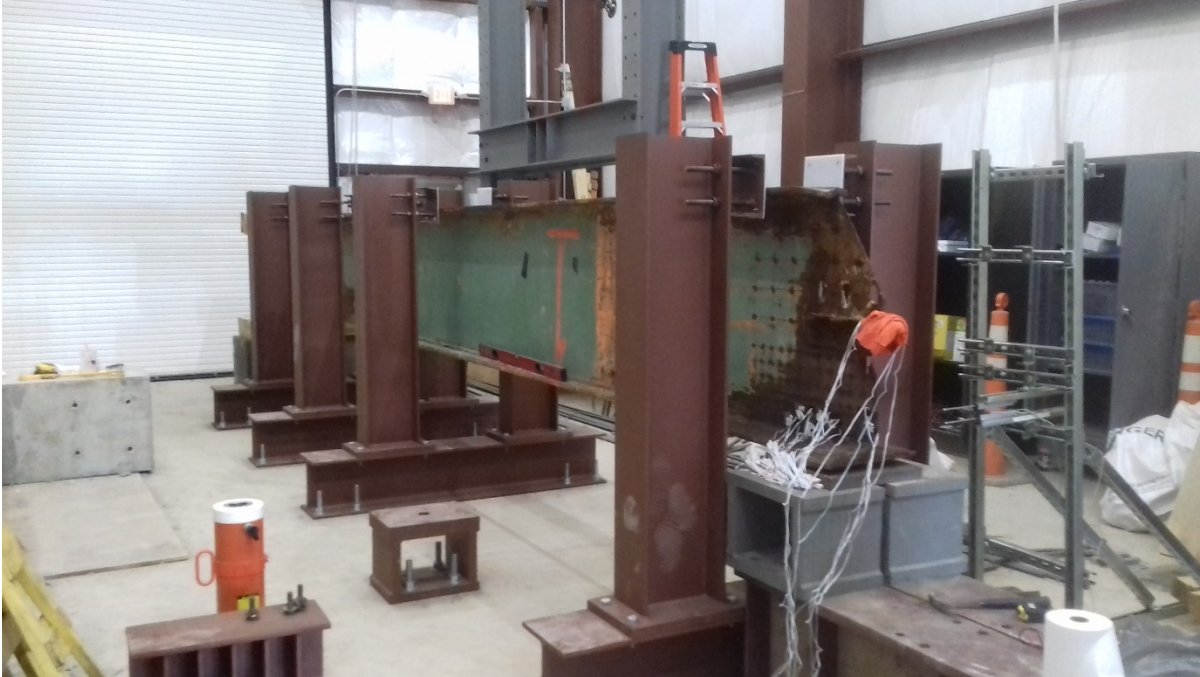
Figure 3.11: First test specimen moving in position.

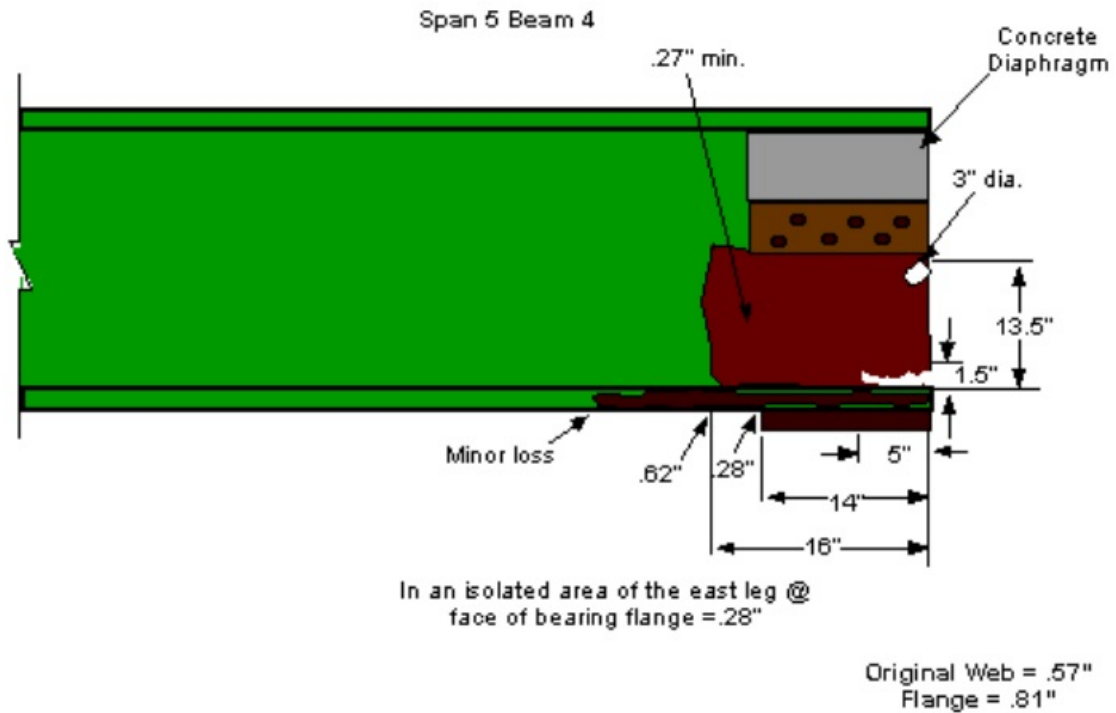
Figure 3.12: Specimen 1 as reported in MassDOT inspection report (31).

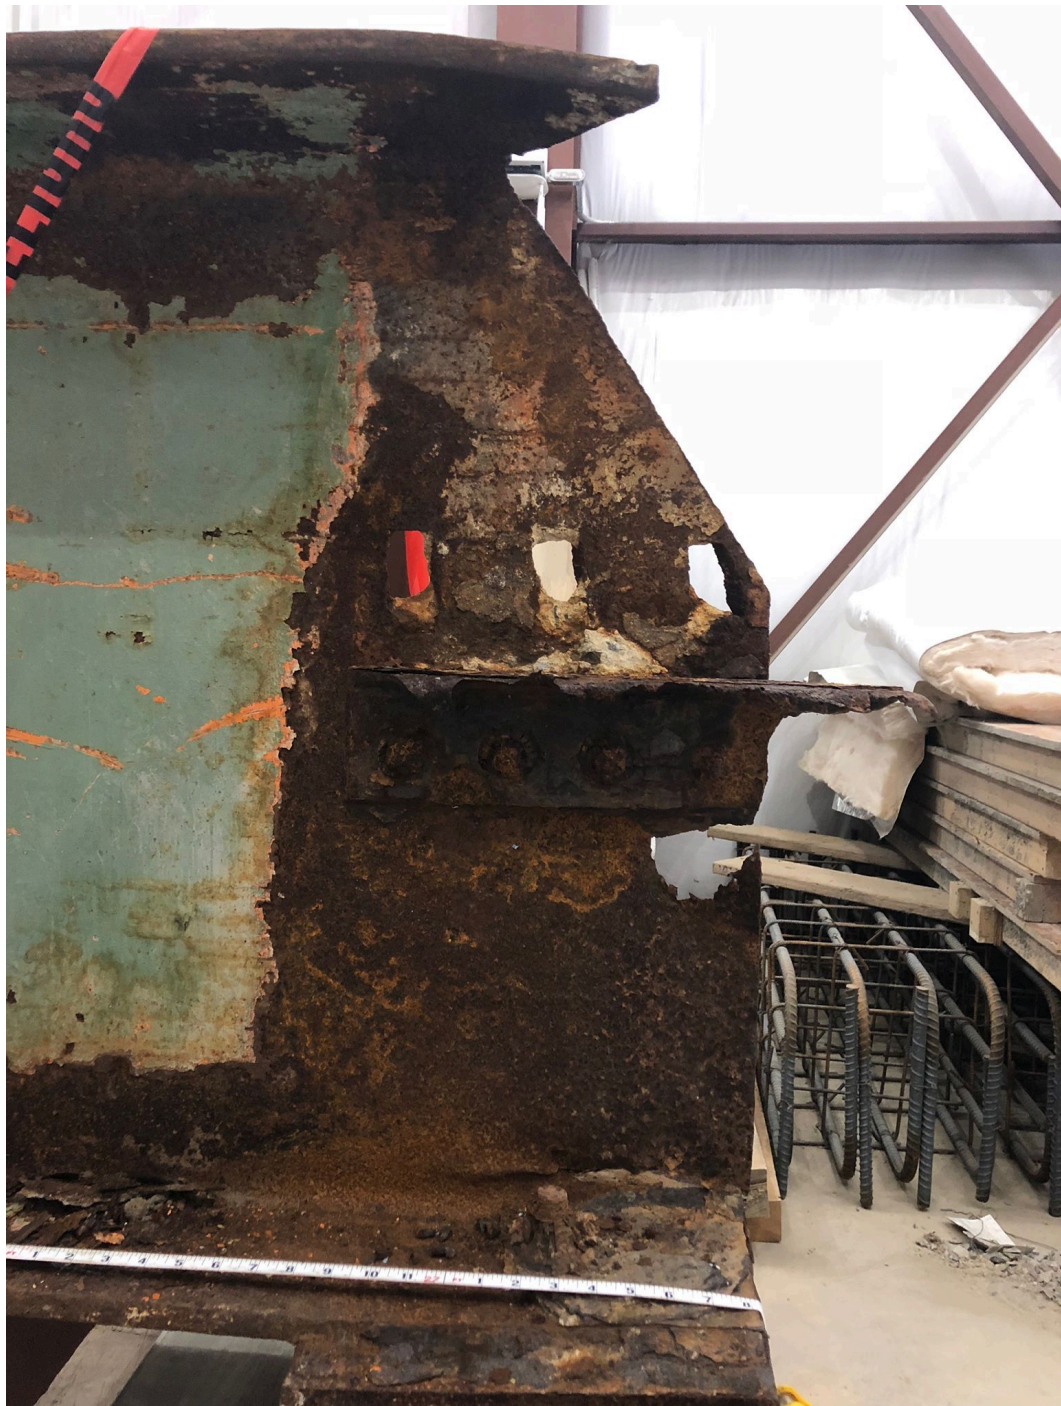
Figure 3.13: Corroded end of Specimen 1.

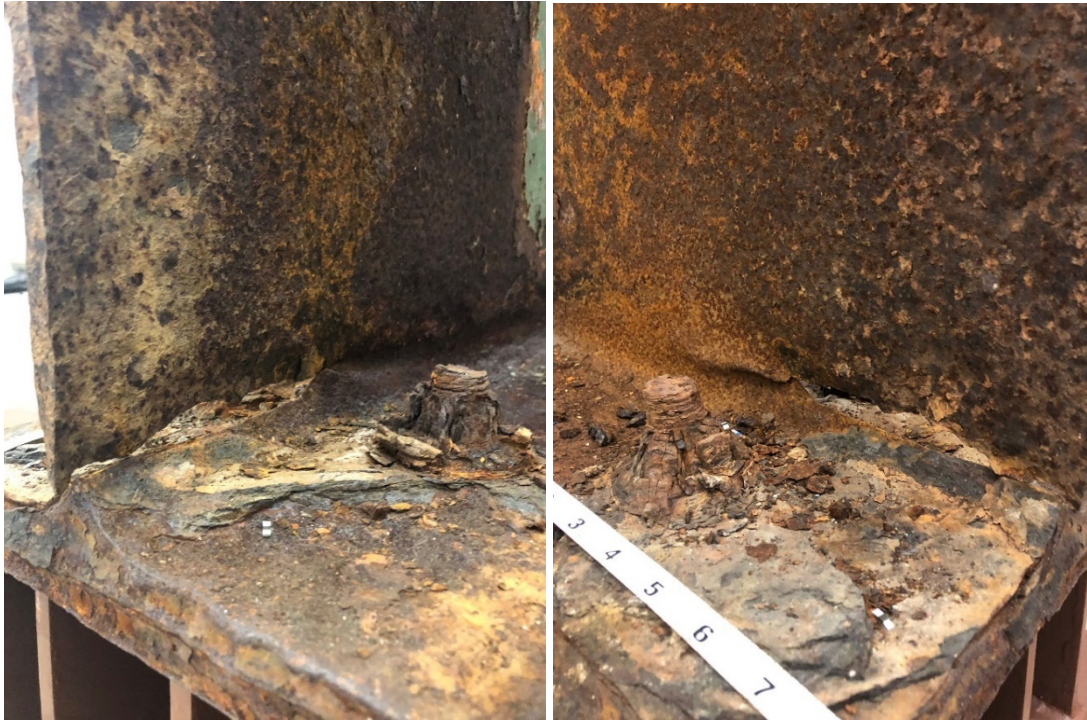
Figure 3.14: Area with 100% section loss above the flange, shown from both web sides.

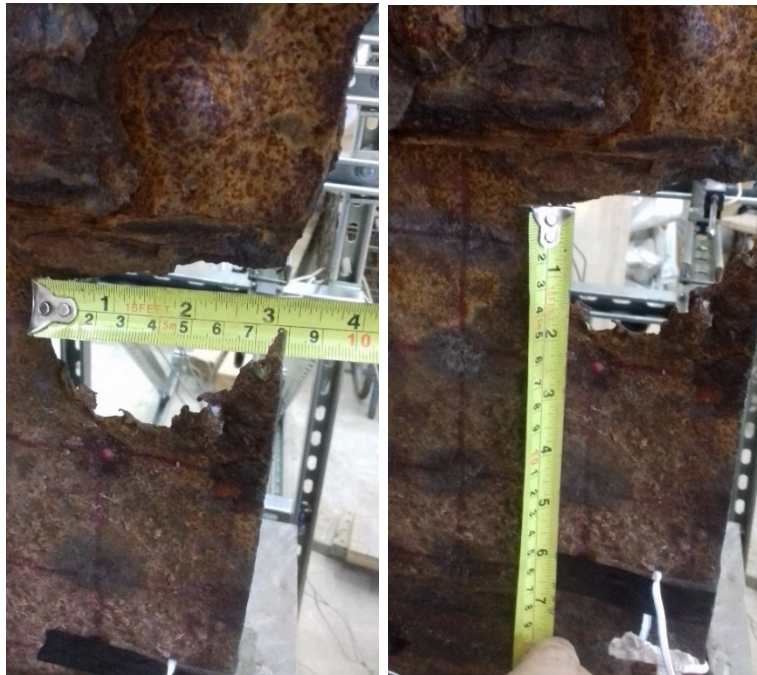
Figure 3.15: Area with 100% section loss below area where diaphragm was originally located.

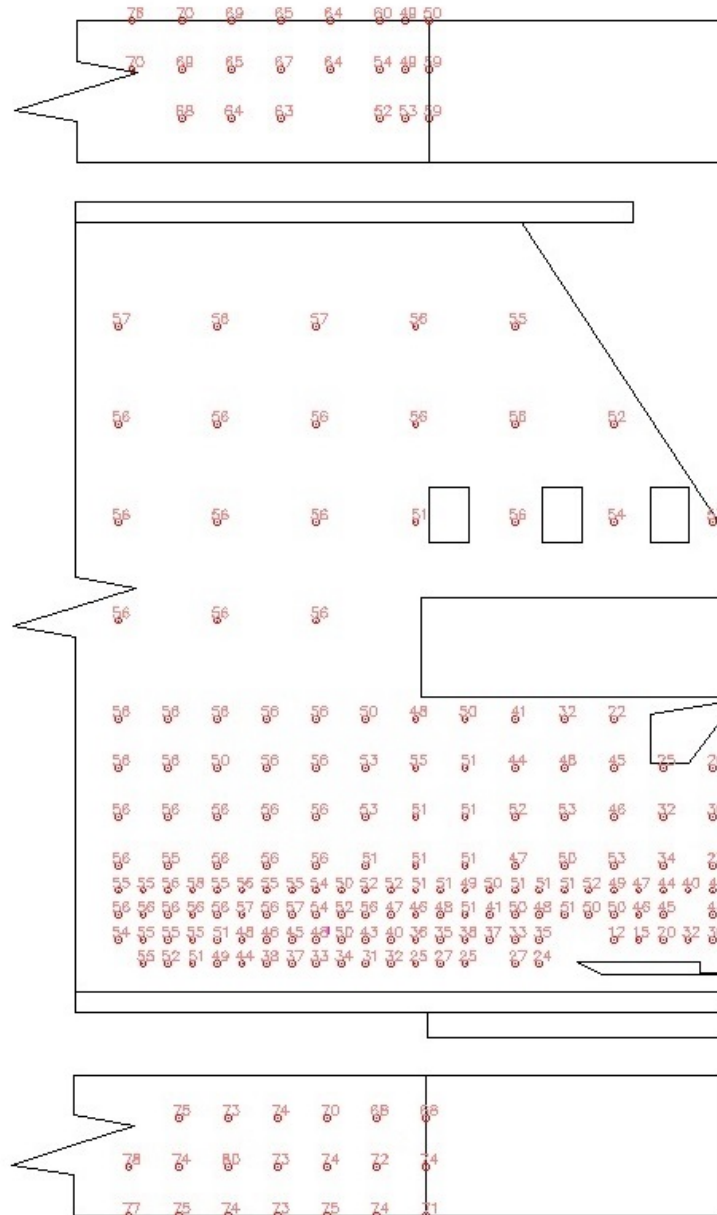
Figure 3.16: Measurement locations of web and flange thickness for Specimen 1.

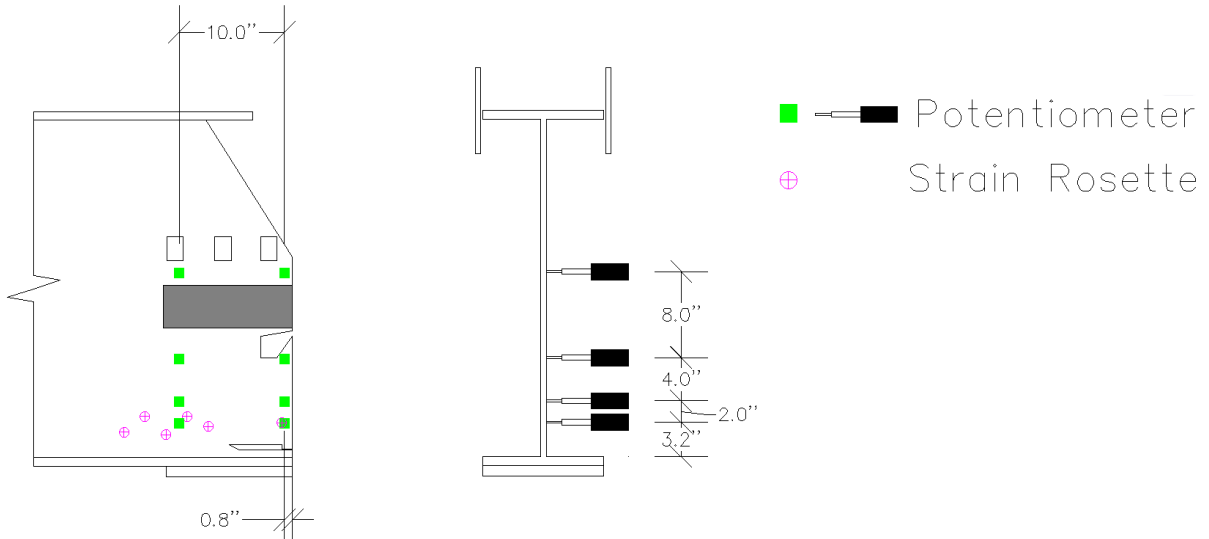
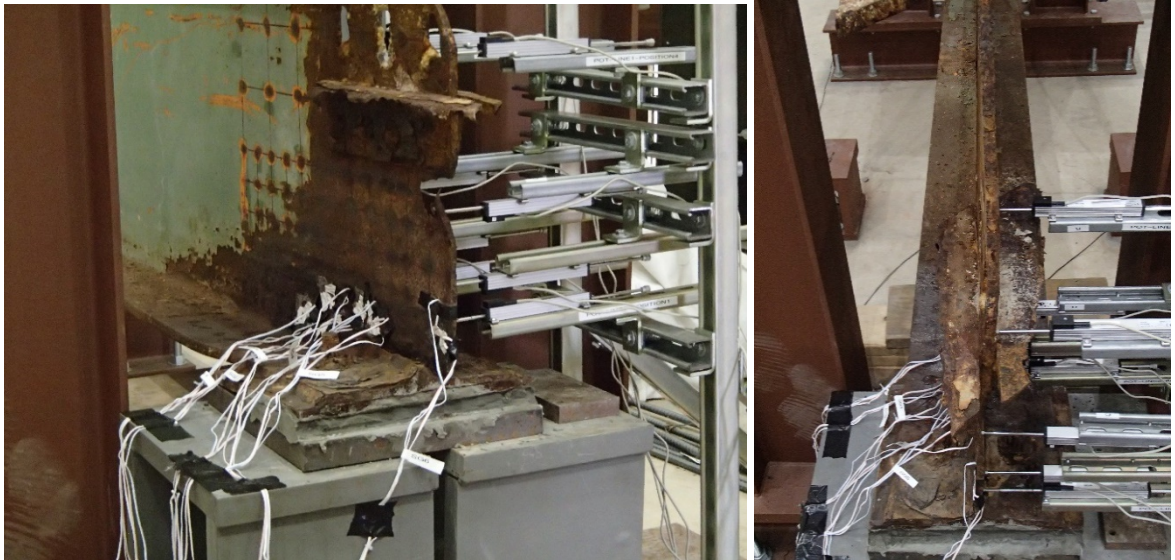
Figure 3.18: Instrumentation configuration at corroded end of Specimen 1.

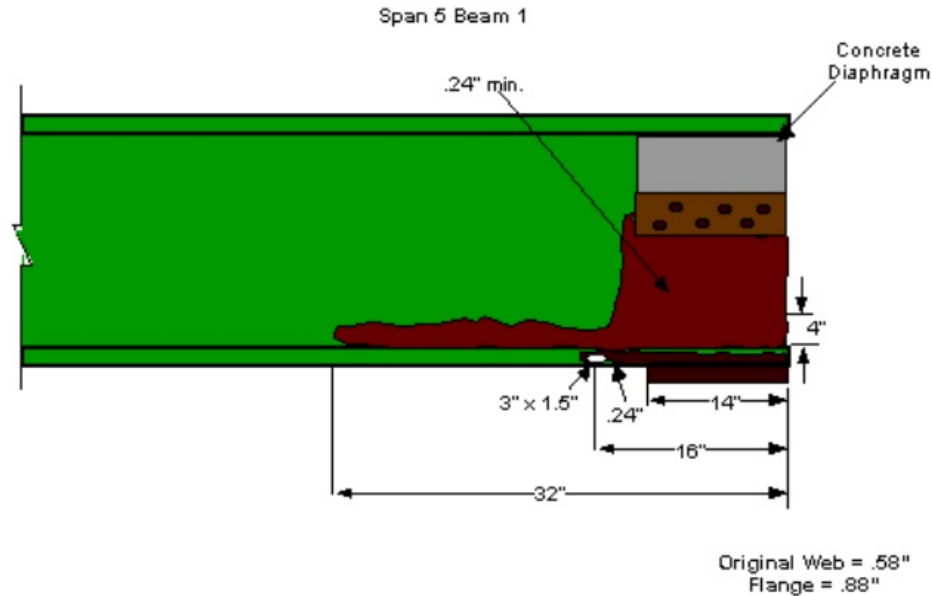
Figure 3.19: Specimen 2 as reported in MassDOT inspection report (31).

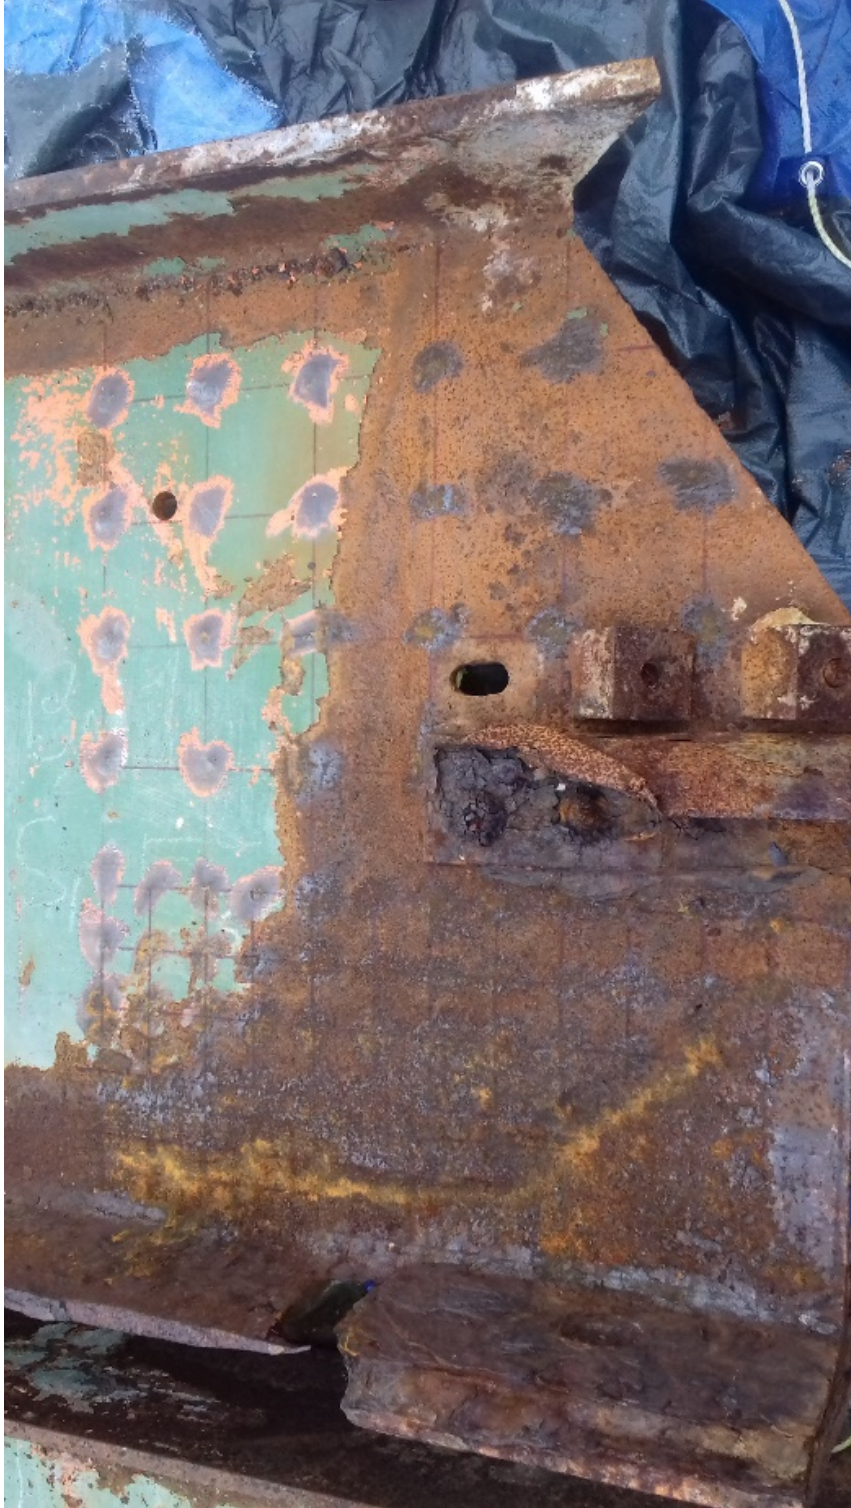
Figure 3.20: Corroded end of Specimen 2.

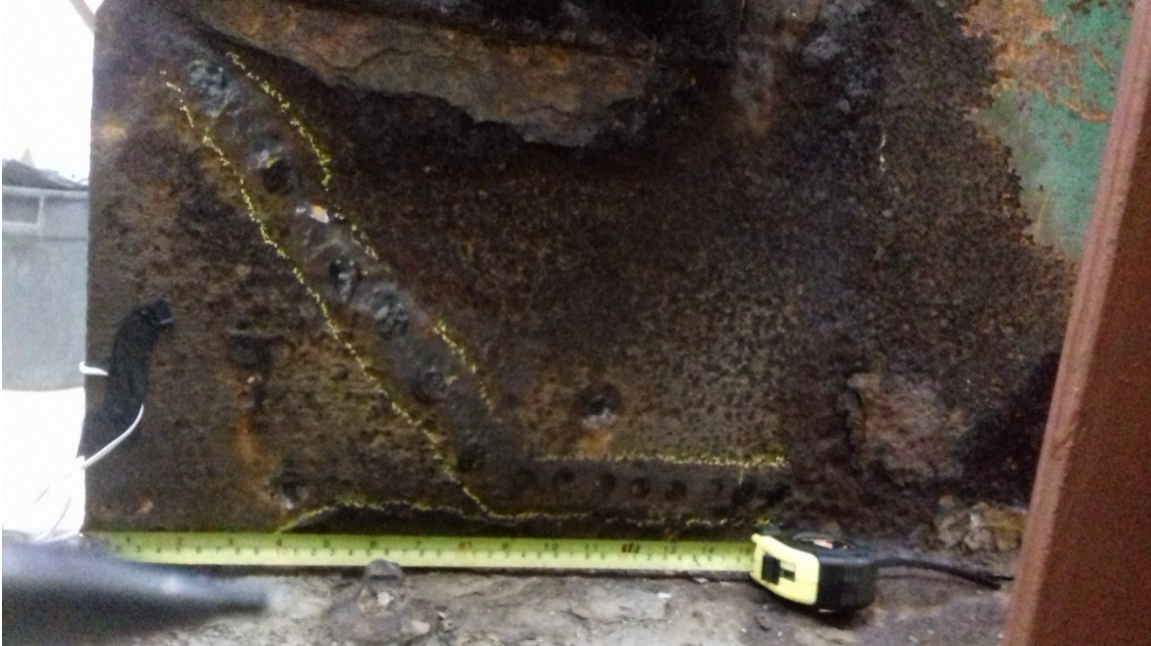
Figure 3.21: The two areas with extensive section loss at Specimen 2's web.

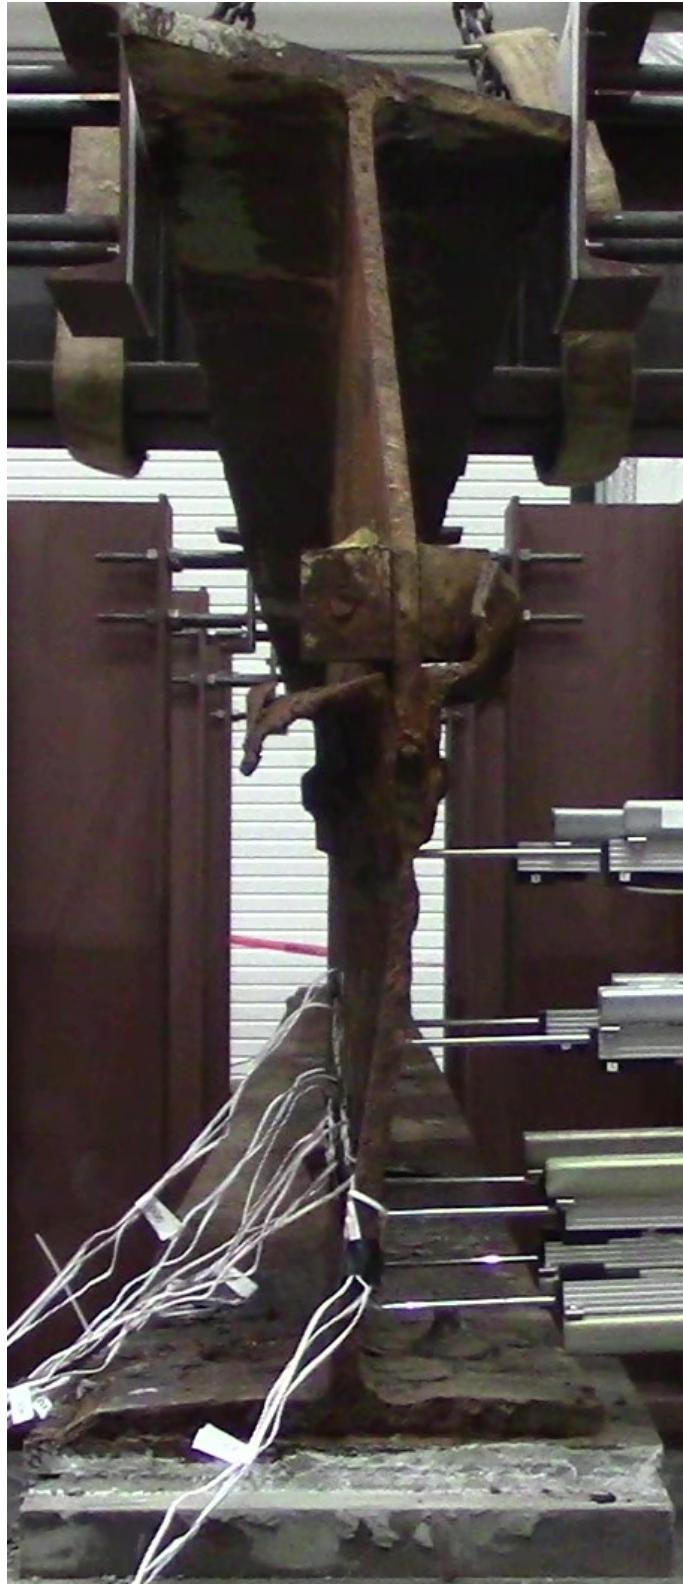
Figure 3.23: Front view of Specimen 2; maximum initial lateral displacement is 1.58 in.

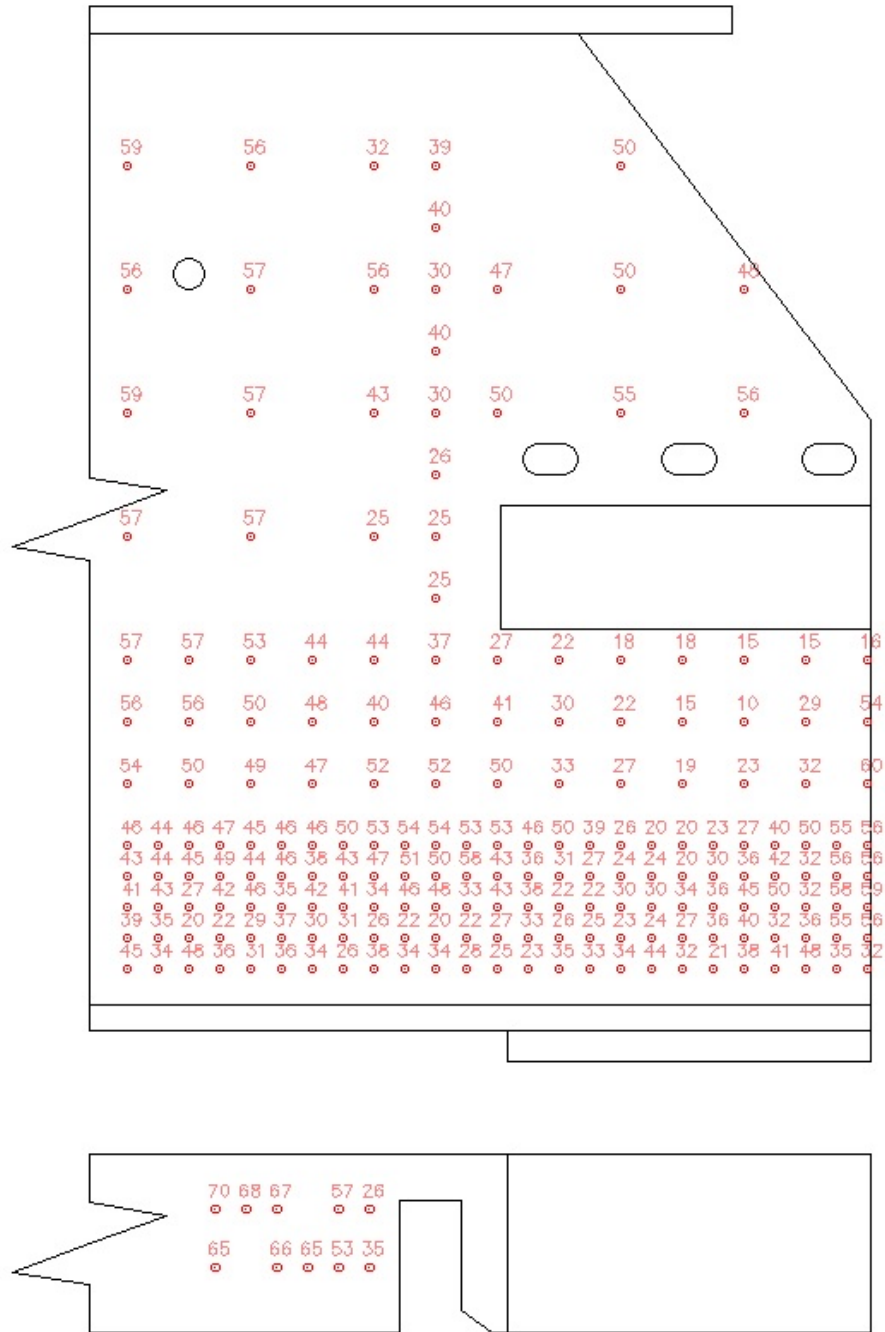
Figure 3.24: Measurement of web and flange thicknesses, Specimen 2.
