September 2019

Report No. 19-008

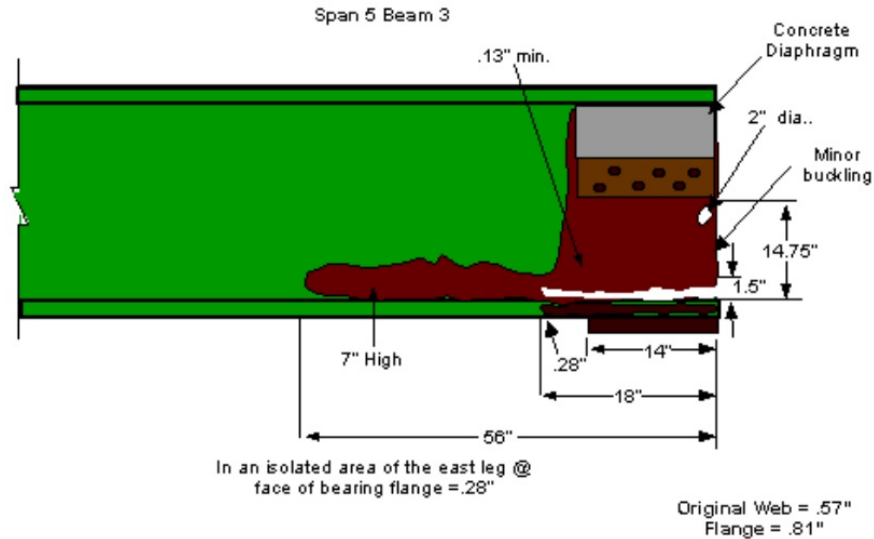
Figure 3.27: Specimen 3 as described in MassDOT inspection report (31).

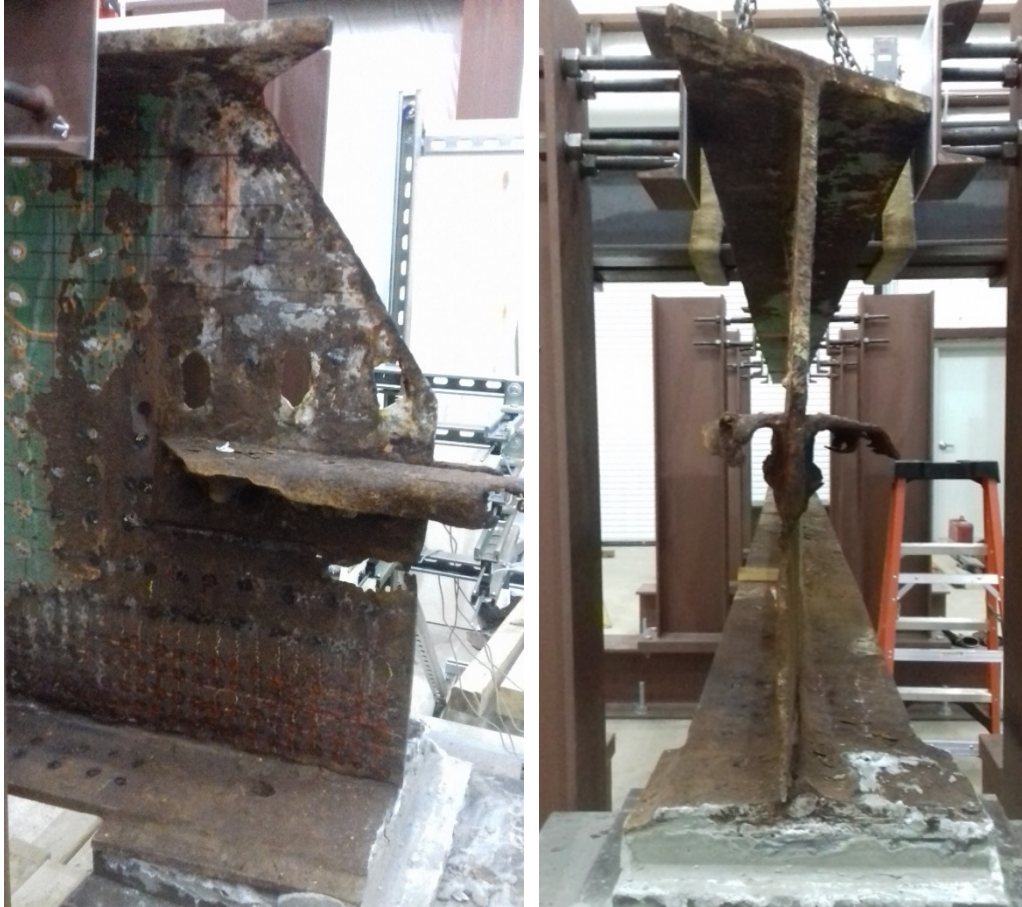
Figure 3.28: Side and front view of Specimen 3.

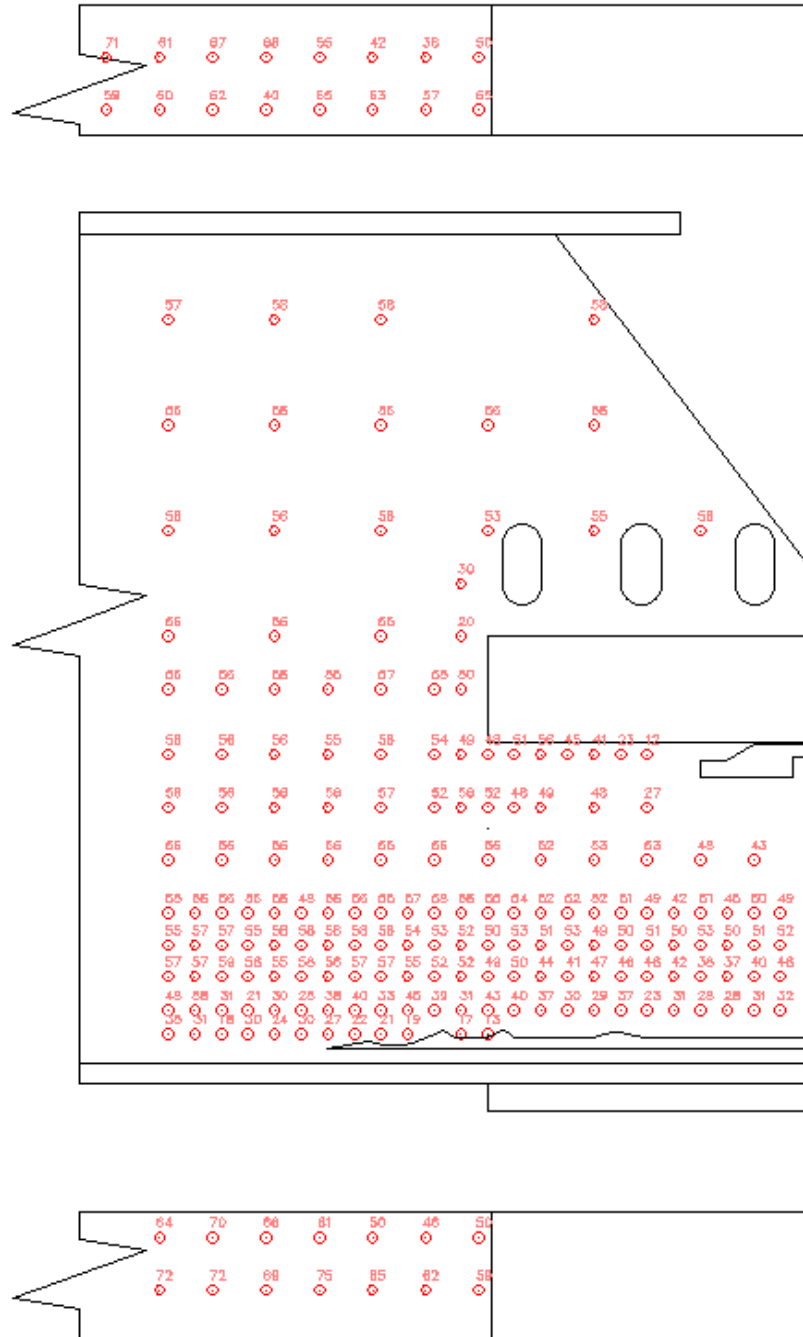
Figure 3.30: Web and flange thickness for Specimen 3.

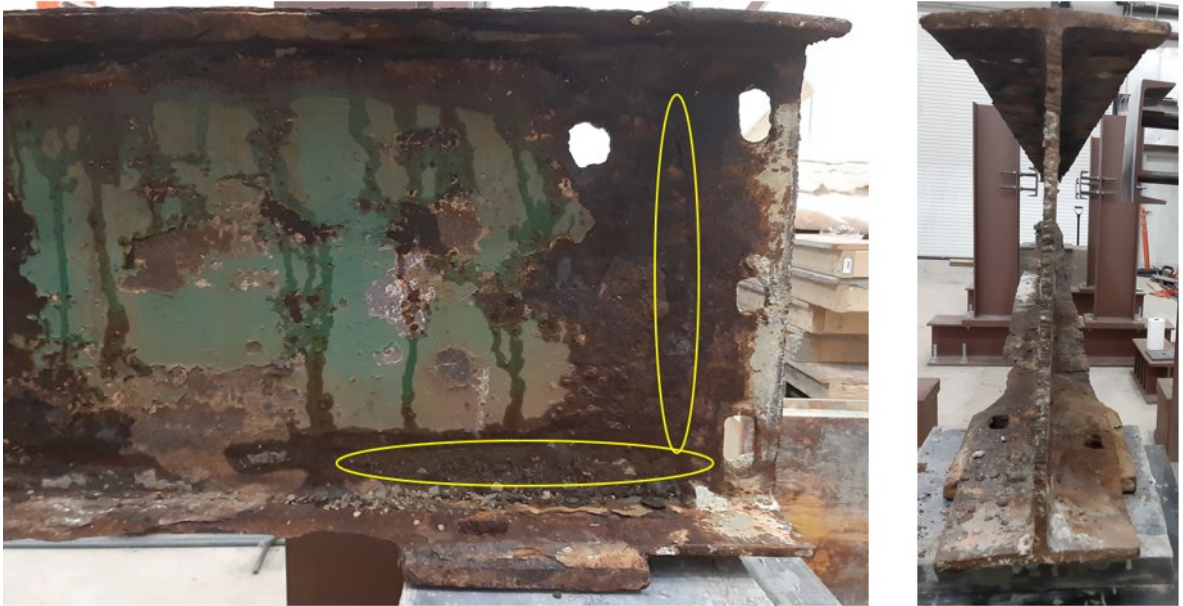
Figure 3.34: Side and front view of Specimen 4; yellow circles illustrate two areas with extensive section loss.

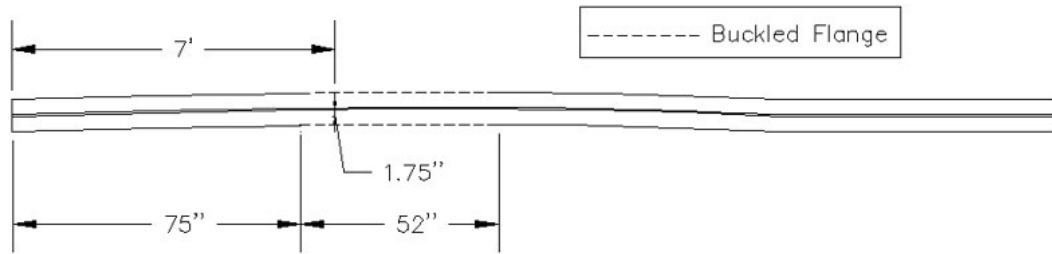
No initial web sideways deflection was observed at the bearing area. However, the specimen was heavily distorted and bent along the transverse axis of the web. The maximum deflection equaled 1.75 in. and was located 7 ft. away from the intact end. This deflection resulted in local buckling of the flange as is illustrated in Fig. 3.35. It is possible this deformation could be attributed to the demolition process.

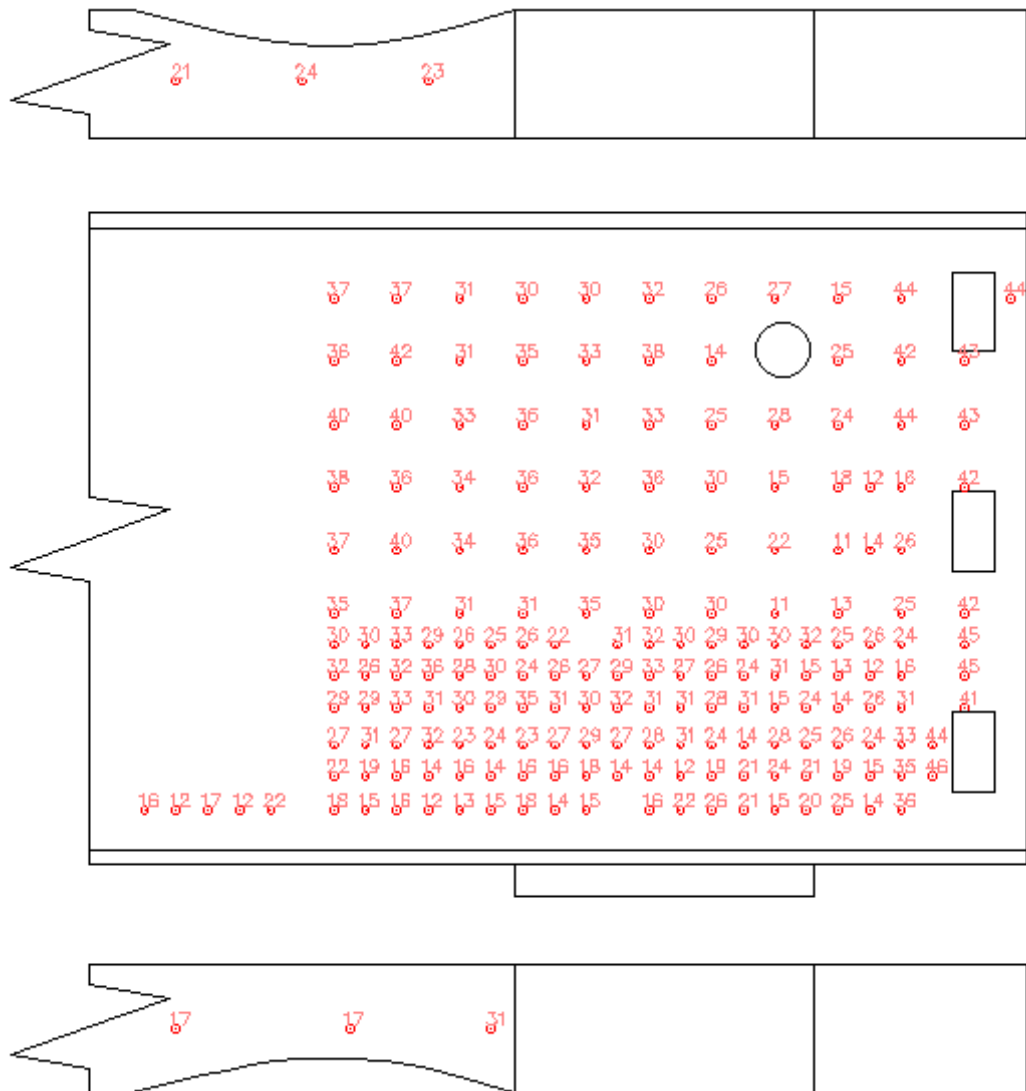
Figure 3.36: Web and flange thicknesses for Specimen 4.

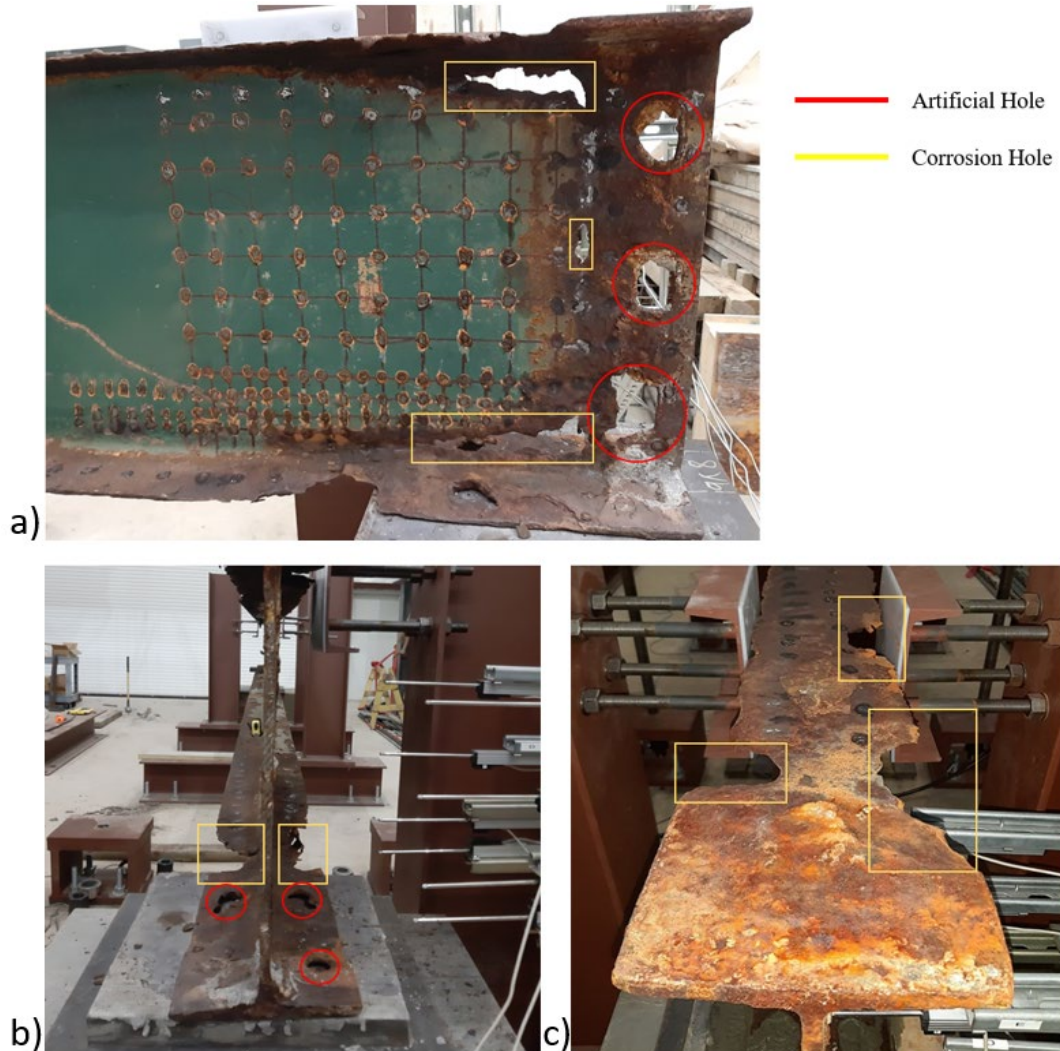
Figure 3.39: Artificial and corrosion holes of Specimen 5, photos (a), (b), and (c).

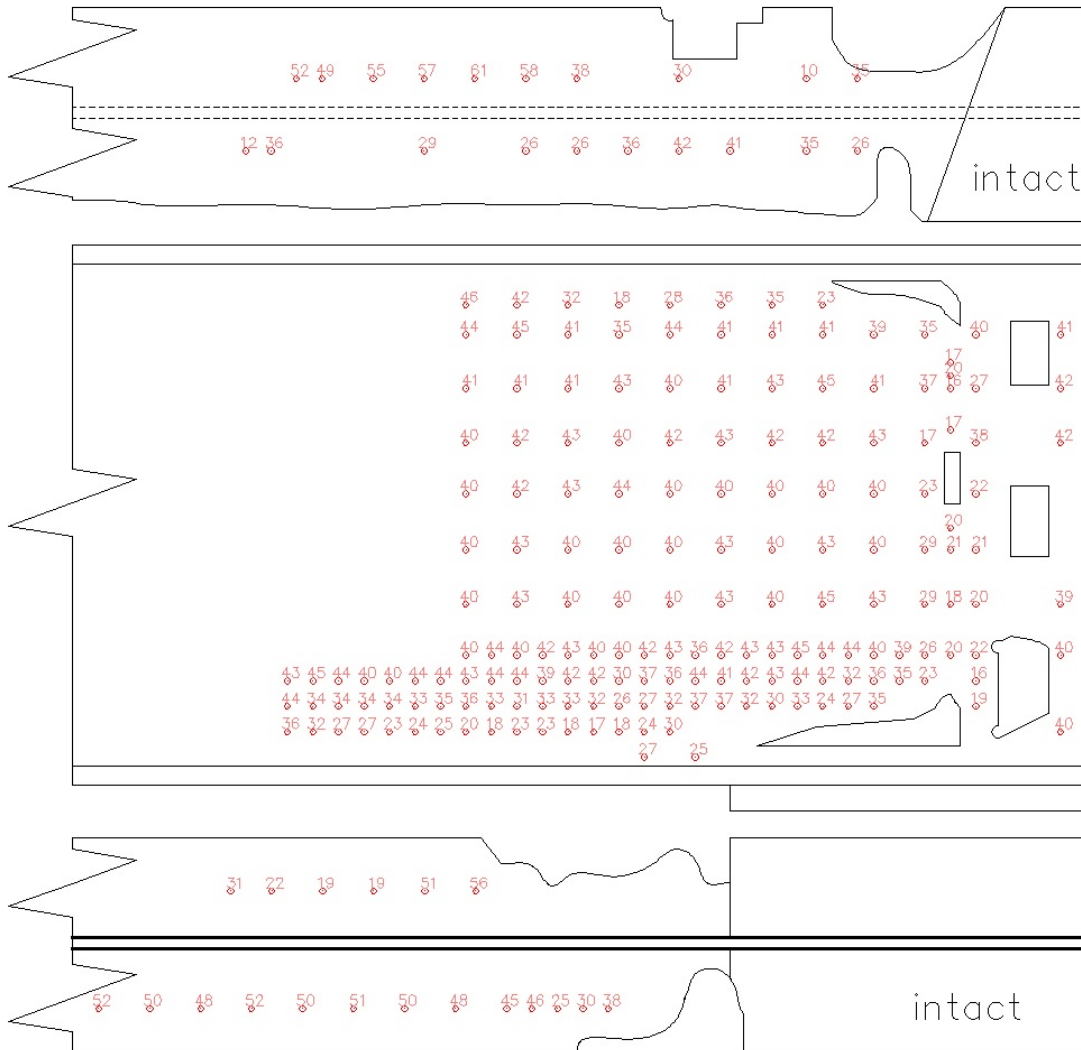
Figure 3.40: Web and flange thicknesses for Specimen 5.

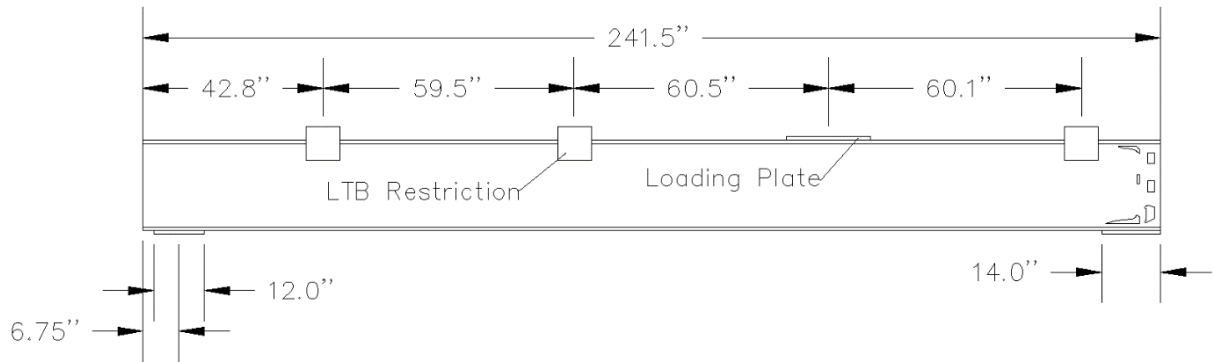
Figure 3.41: Specimen 5 experimental configuration and dimensions.

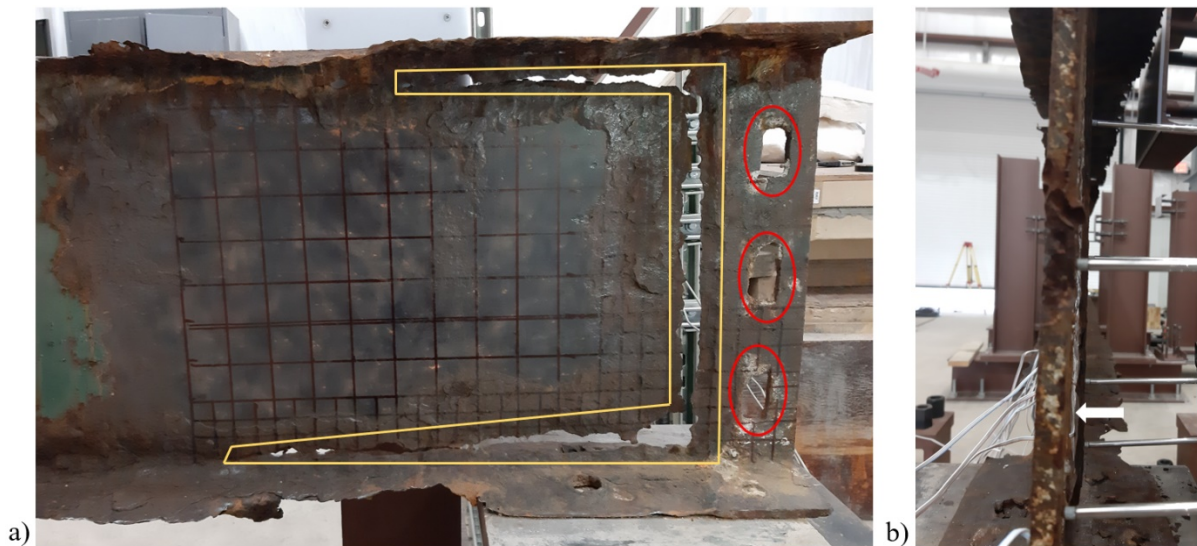
Figure 3.43: Side (a) and cross section (b) views of Specimen 5.

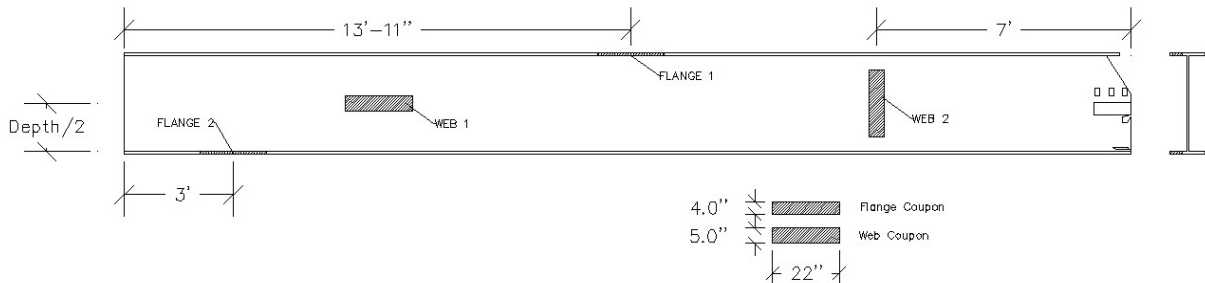
Figure 3.47: Location and nomenclature of the extracted coupons.

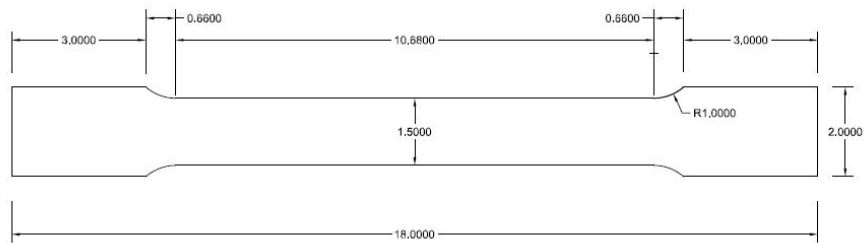
Figure 3.48: Specifications of dogbone specimen in inches.

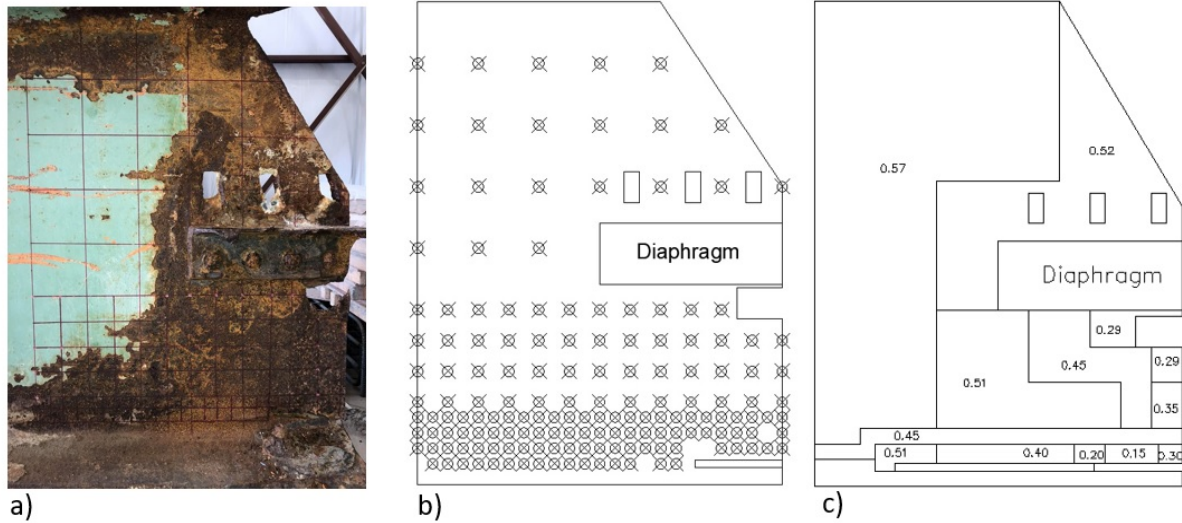
Figure 4.1a-c: Definition of material loss at the corroded end of Specimen 1.

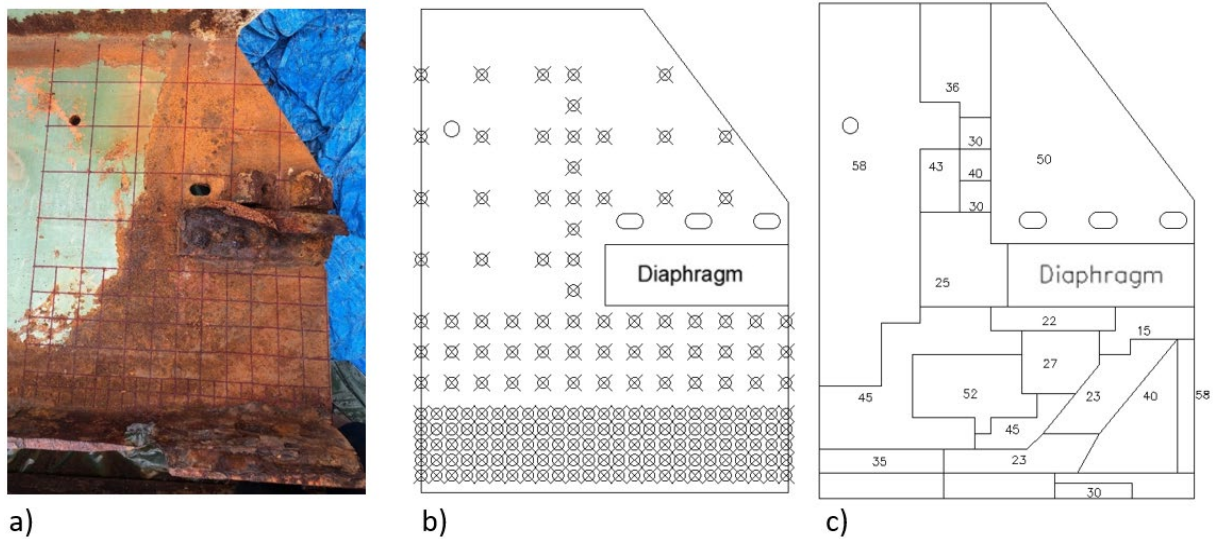
Figure 4.2a-c: Definition of material loss at corroded end of Specimen 2.

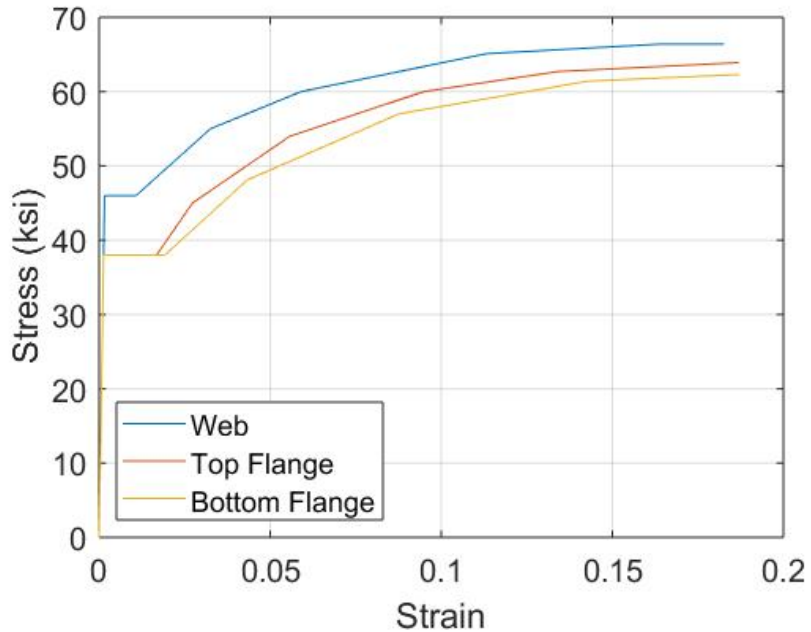
Figure 4.3: Stress strain curves of tested coupon as imported in the finite element software.

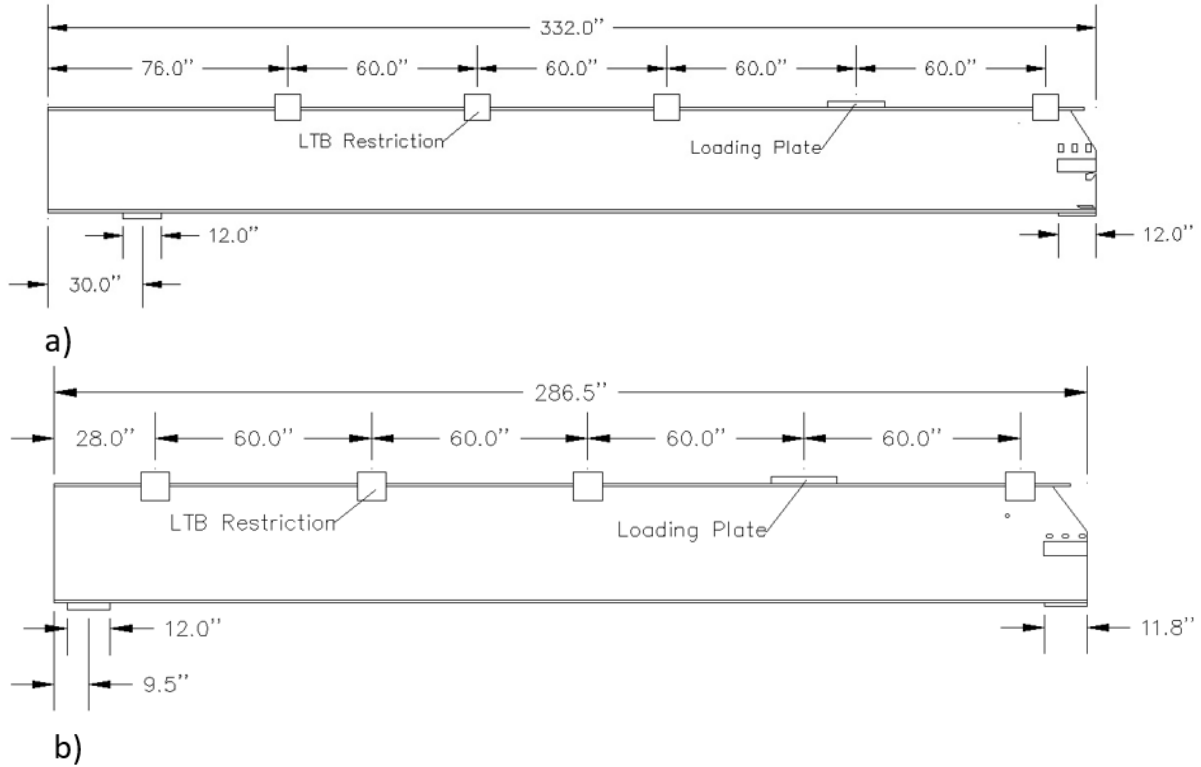
Figure 4.4: Exact experimental configuration and dimensions for (a) Specimen 1 and (b) Specimen 2

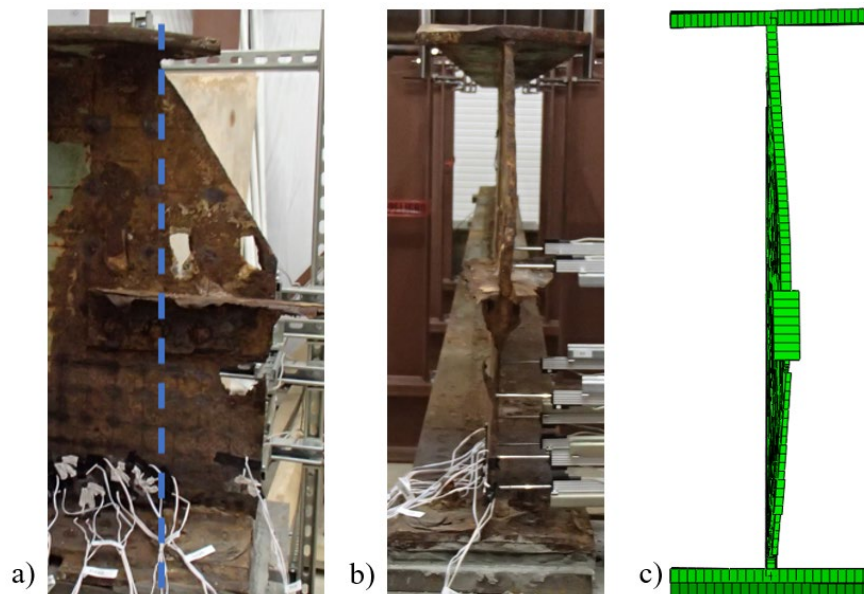
Figure 4.5: Lateral displacement of Specimen 1, from (a) side view and (b) front view; (c) imported eigenmode as imperfection to the FEM.

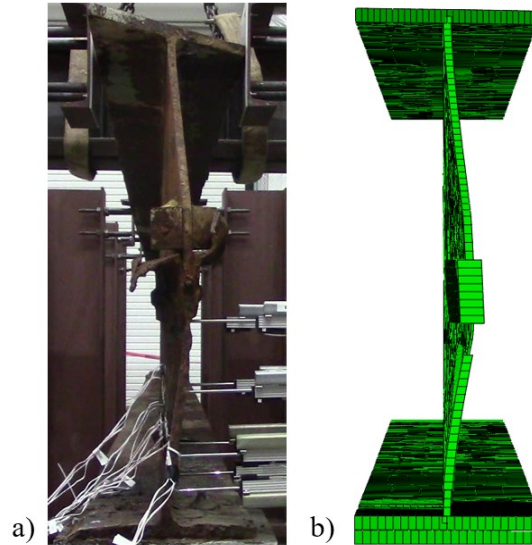
Figure 4.6: (a) Front view of Specimen 2; and (b) initial geometric imperfection as was imported to the FEM.

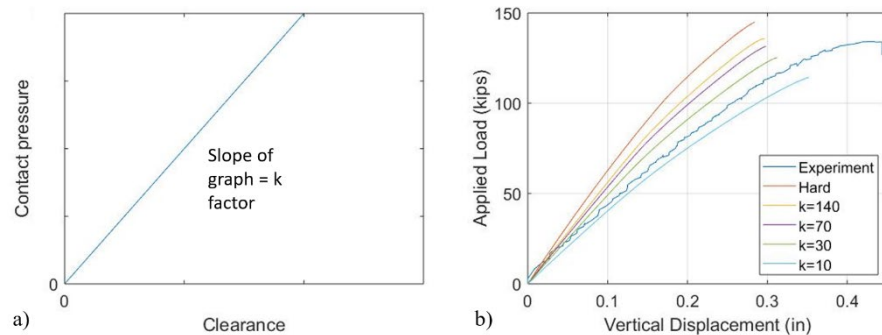
Figure 4.7: (a) For softened contact, the pressure-overclosure relationship is defined by assigning value to k factor; (b) comparison between numerical and experimental results for variety of k factors.

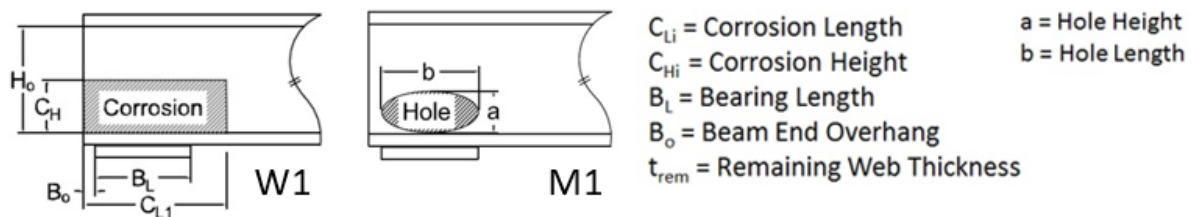
Figure 4.9: Shape and location of the examined deterioration topologies.

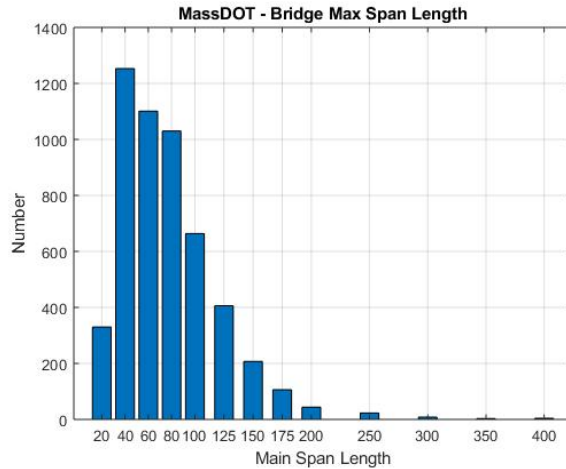
Figure 4.10: Bridge max span length in Massachusetts.

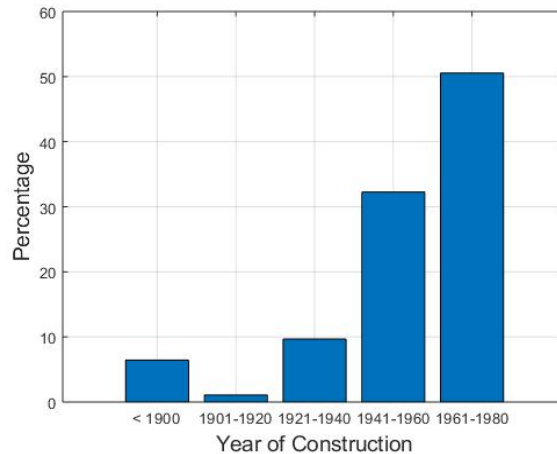
Figure 4.11: Year of construction distribution for 93 bridges in study.

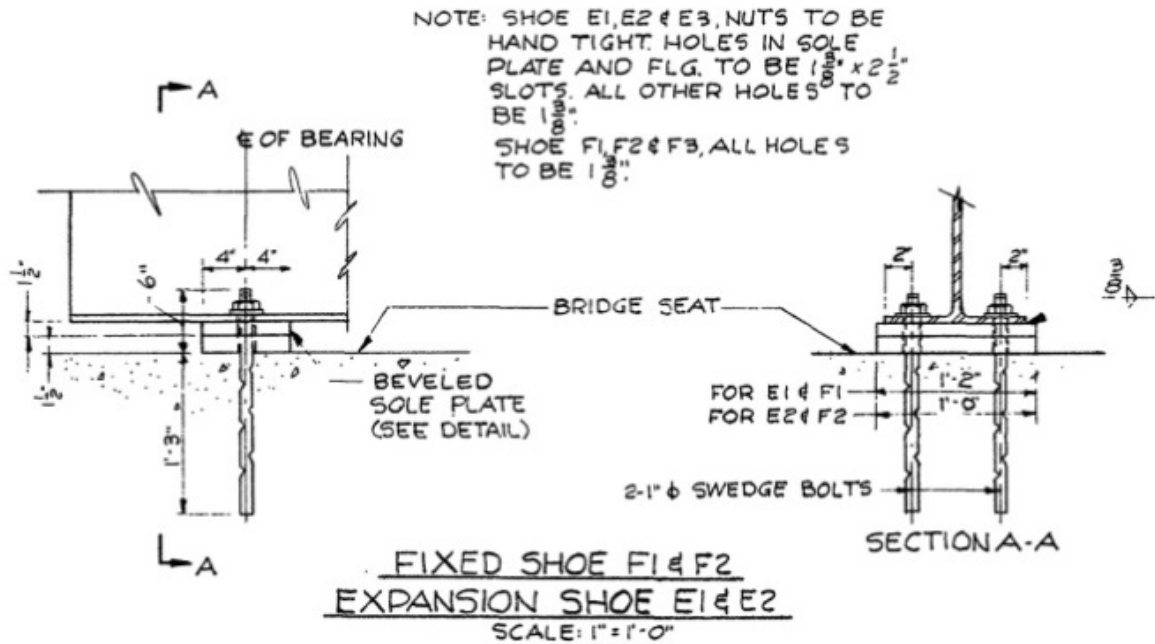
Figure 4.12: Bearing drawing details from B-10-18, showing bottom flange of girder, the two bearing plates, and anchor bolts. Note describes the holes, which allow the longitudinal translation.

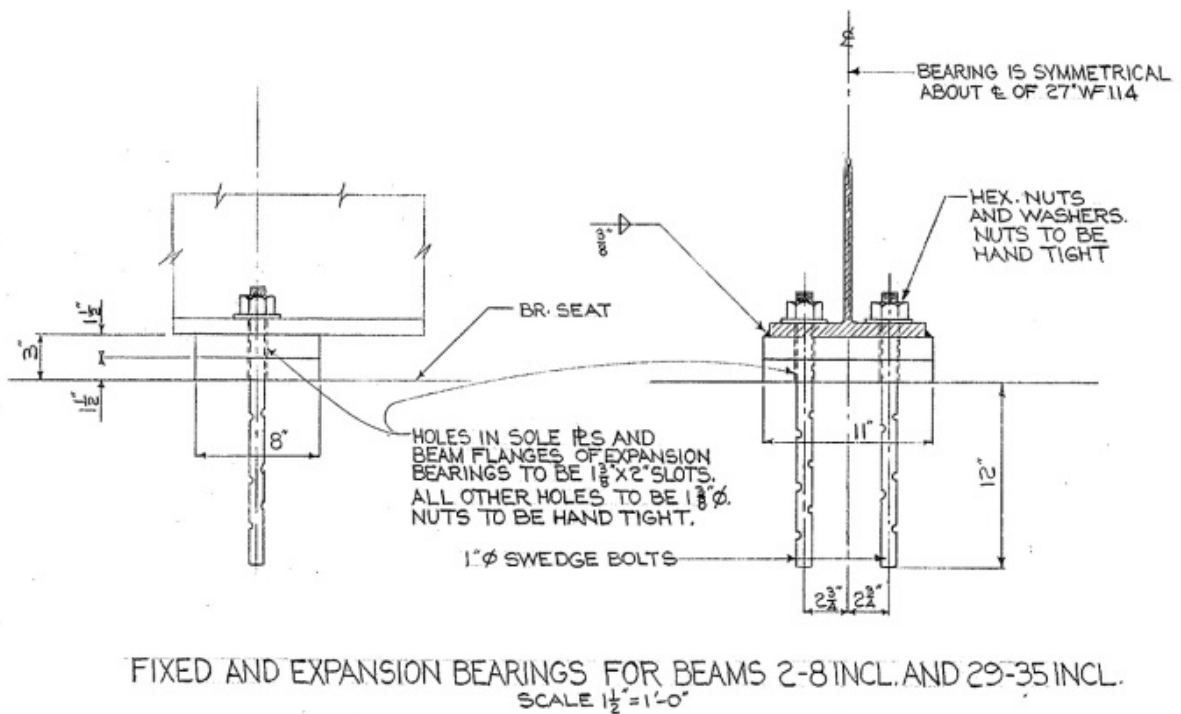
Figure 4.13: Bearing drawing details from F-2-42, showing bottom flange of girder, the two bearing plates, and anchor bolts. Note describes holes, which allow the longitudinal translation.

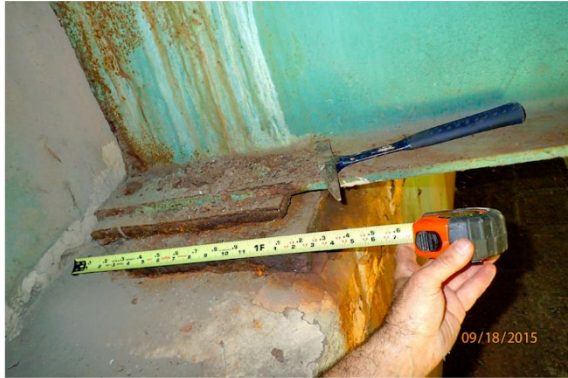
Photo 30: Typical bearing, over extended without anchor bolts.

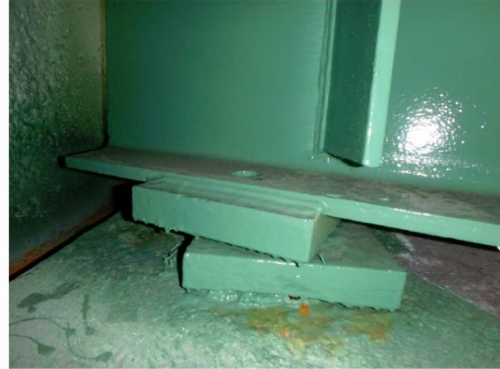
Photo 21: Span 4, Beam 31, West Abutment: Missing south anchor bolt and rotated bearing

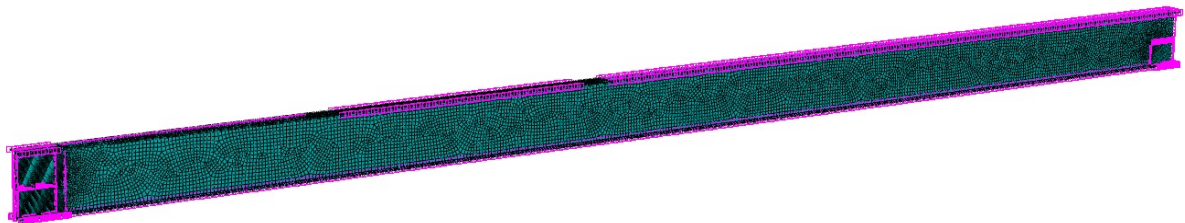
Figure 4.16: Mesh partition for quality mesh.

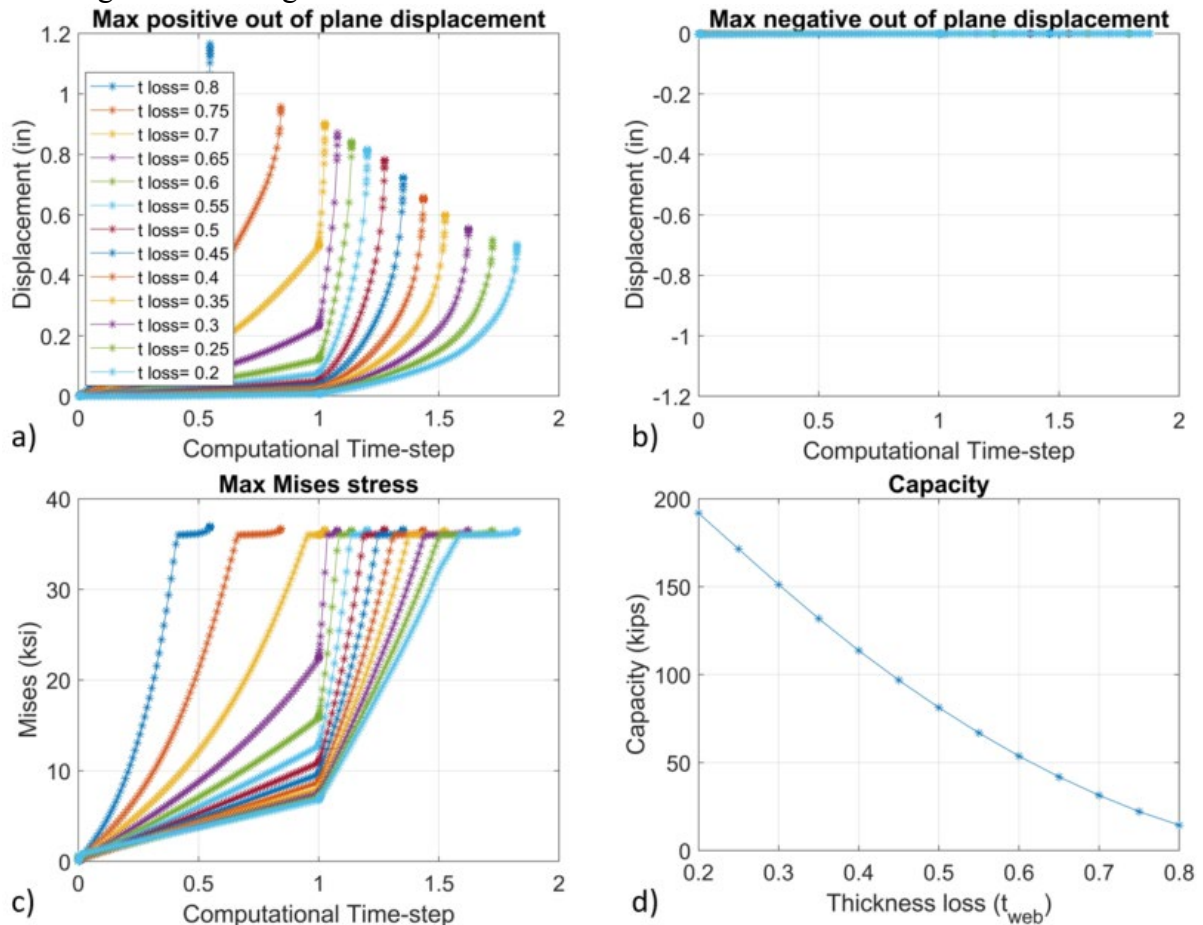
Figure 4.17a-d: Data extracted and plotted from every set of analyses, for a 36WF150 beam with full section loss in the range of 20% to 80% intact web thickness.

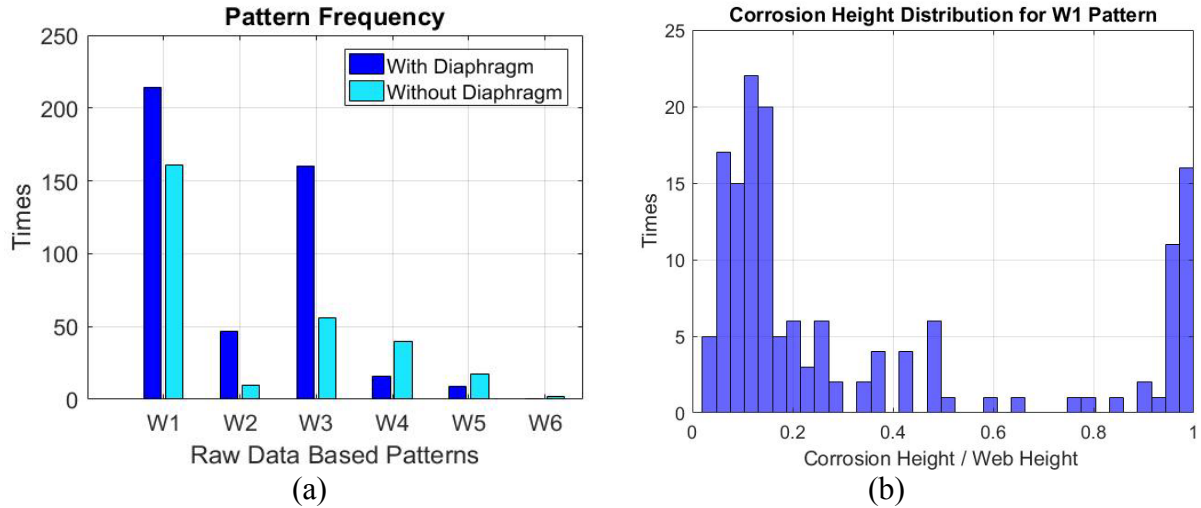
Figure 5.1: (a) Visualization of corroded area of beam end showing extreme W1 case on top of extreme W2 scenario, as produced by new MATLAB code; (b) correlation between beam type and W3 corrosion pattern.

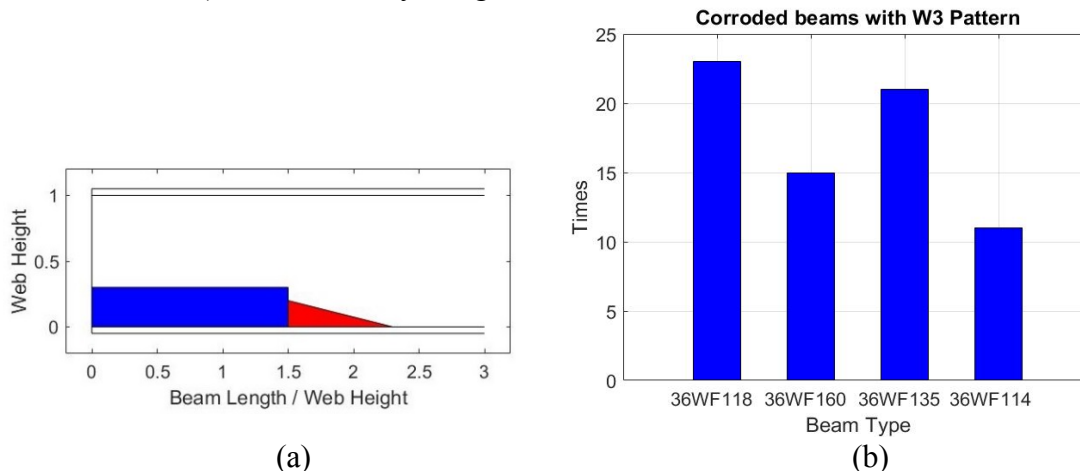
Figure 5.2: (a) Visualization of corroded area of a beam end showing extreme W1 case on top of extreme W2 scenario as produced by new MATLAB code; (b) correlation between beam type and W3 corrosion pattern.

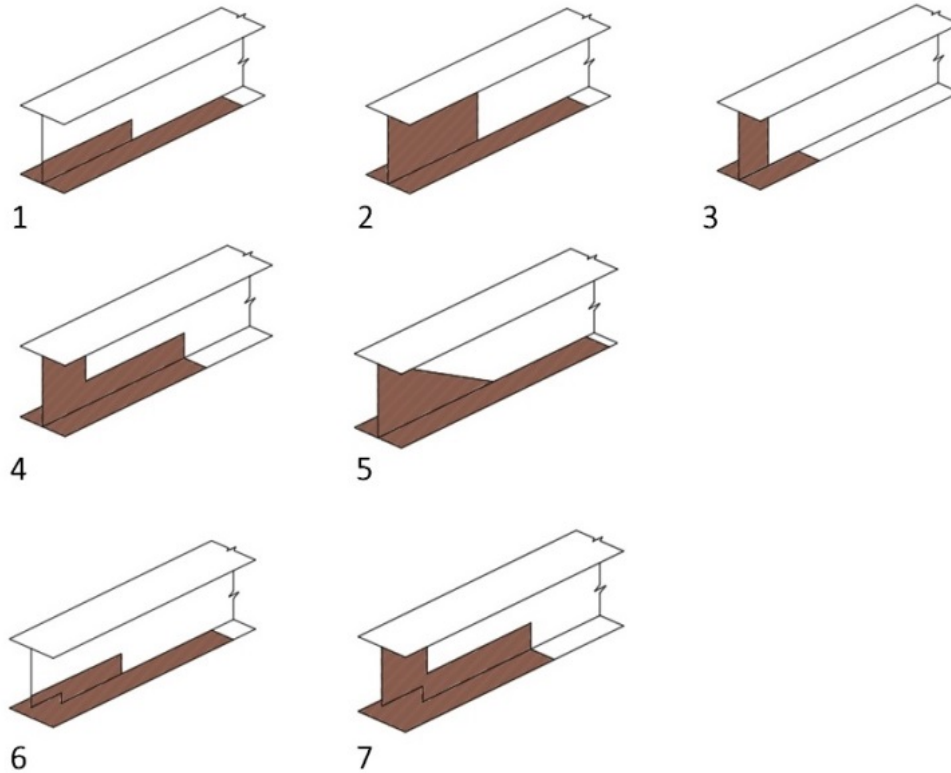
Figure 5.3: The seven final corrosion patterns for beam ends without a diaphragm.

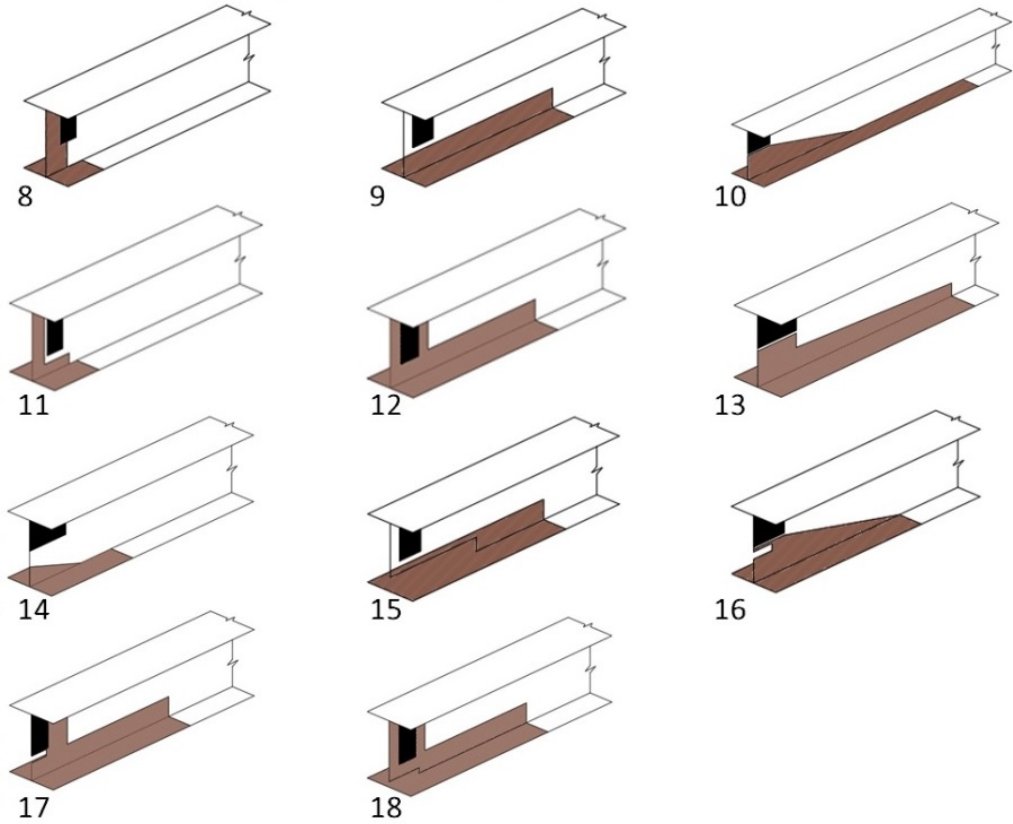
Figure 5.4: Eleven final corrosion patterns for beam ends with a diaphragm. Diaphragm is indicated as a black box located at the top part of the web.

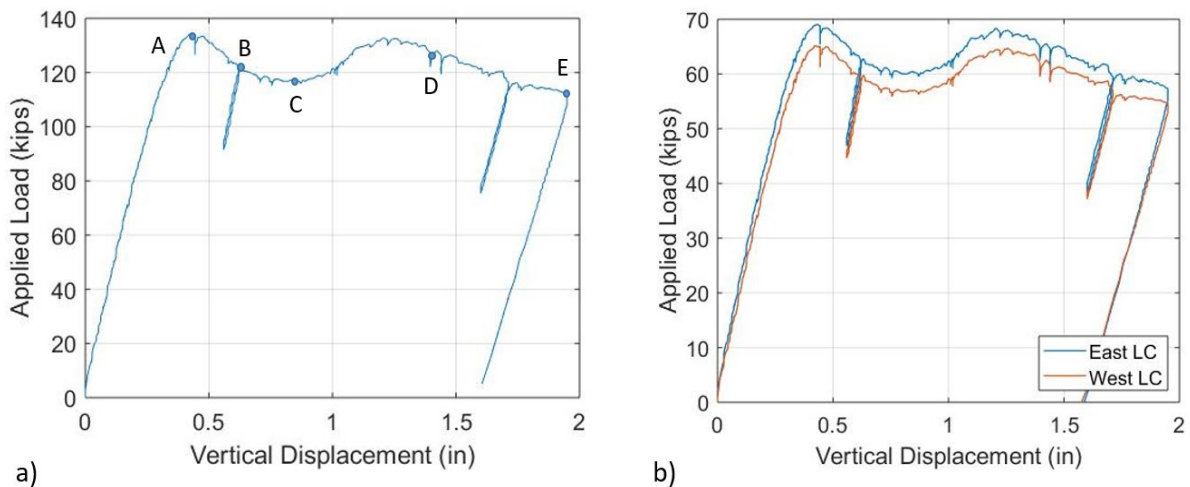
Figure 6.1: (a) Total applied load—vertical displacement plot for the first specimen; (b) Total applied load was calculated from summation of two load cells installed at bottom of each rod (west and east side of Specimen 1).

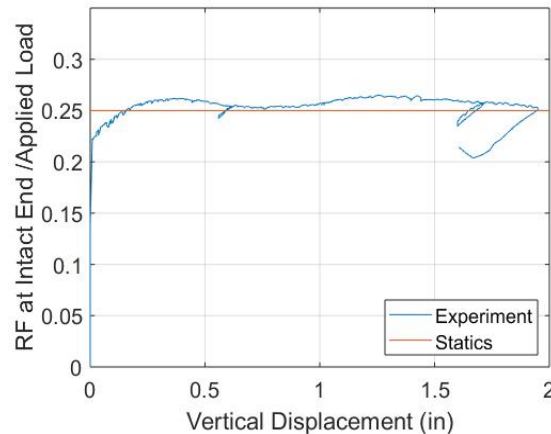
Figure 6.2: Ratio of reaction force developed at intact end to total applied load, as recorded by load cells during experimental process.

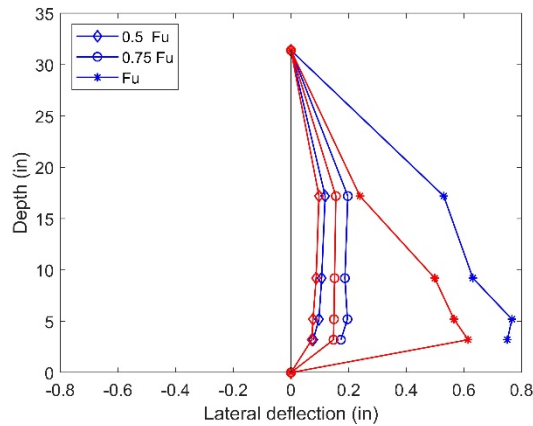
Figure 6.4: Beam's end lateral displacement profile as recorded from outer (blue) and inner (red) column of potentiometers, for three different loads: 0.5, 0.75, and 1 F_u .

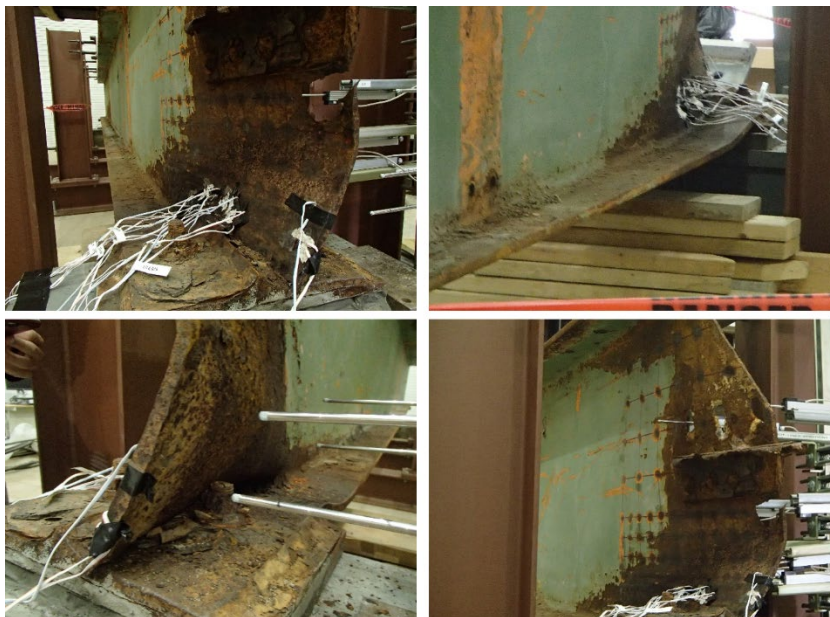
Figure 6.5: The residual deformation after unloading Specimen 1.

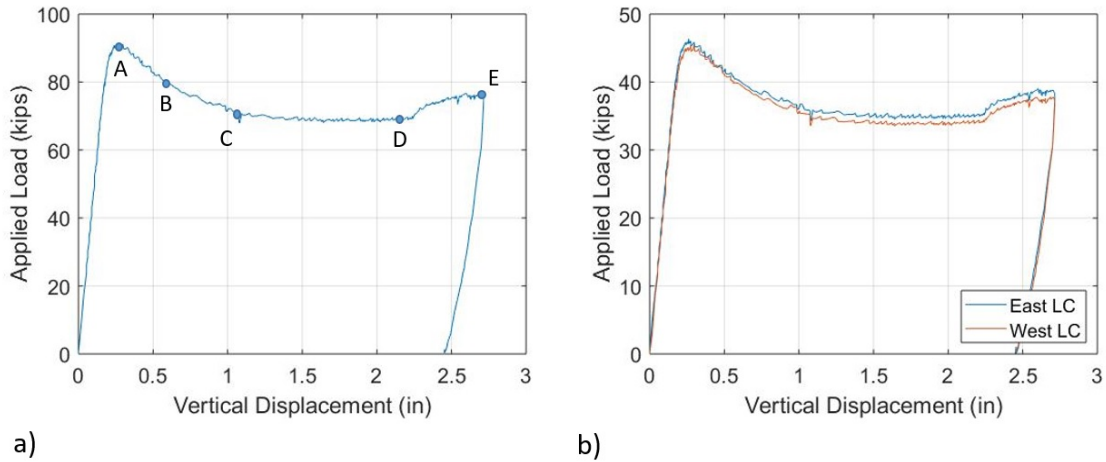
Figure 6.8: (a) Applied load vs. vertical displacement plot for Specimen 2; (b) total applied load was calculated from summation of two load cells installed at bottom of each rod (west and east side of specimen).

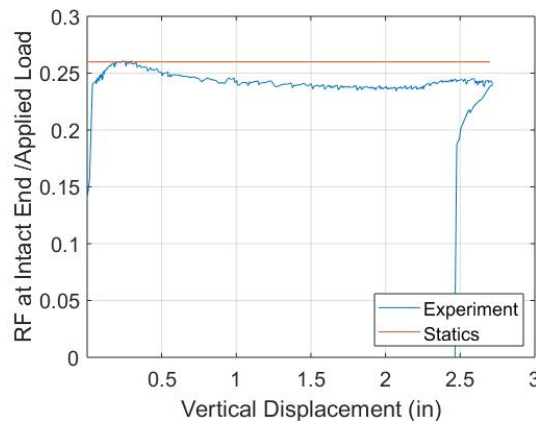
Figure 6.9: Ratio of reaction force of intact end to total applied load; based on statics, ratio should be equal to 0.26.

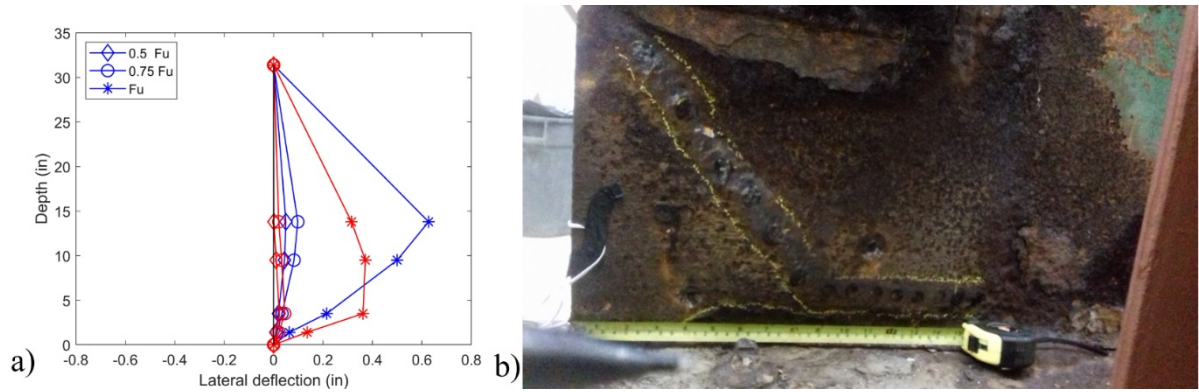
Figure 6.11: (a) Measured web lateral deflections recorded above outer web edge (blue) and above inner one (red) for 0.5, 0.75, and 1 F_u , where F_u denotes maximum applied load; (b) Area with extensive section loss at web of Specimen 2.
