September 2019

Report No. 19-008

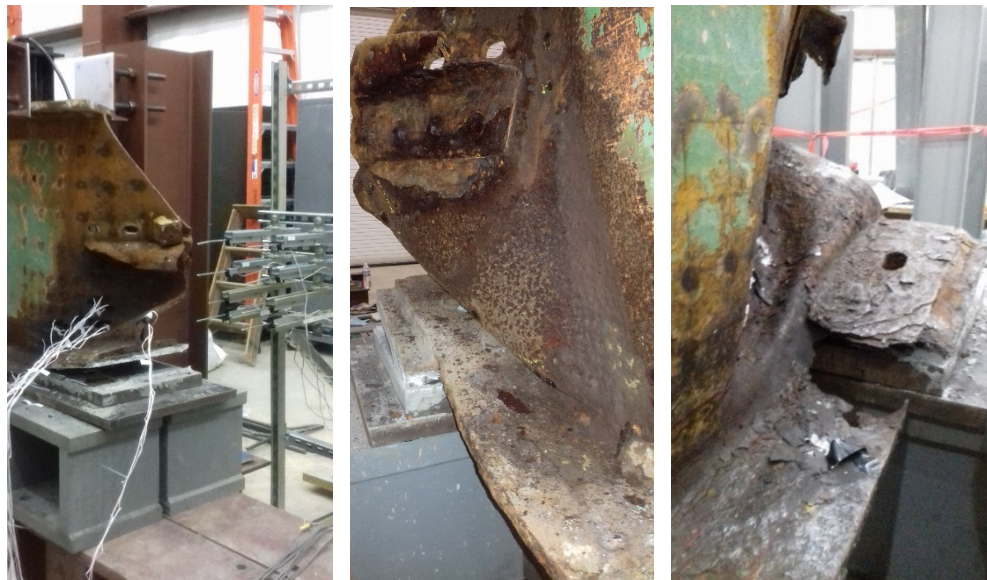
Figure 6.12: Residual deformation after unloading Specimen 2.

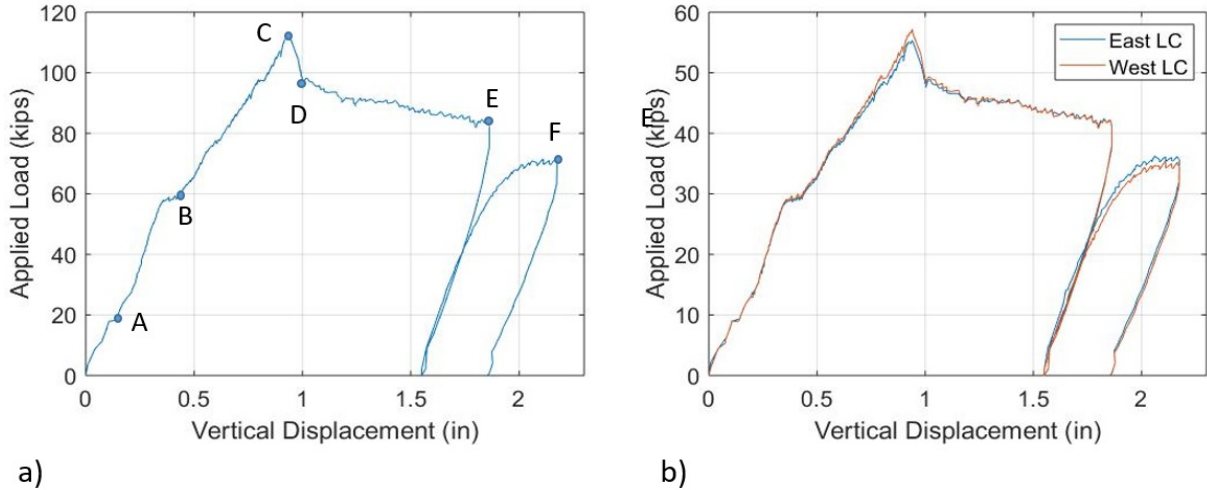
Figure 6.15: (a) Applied load vs. vertical displacement plot for Specimen 3; (b) total applied load was calculated from summation of two load cells installed at bottom of each rod (west and east side of specimen).

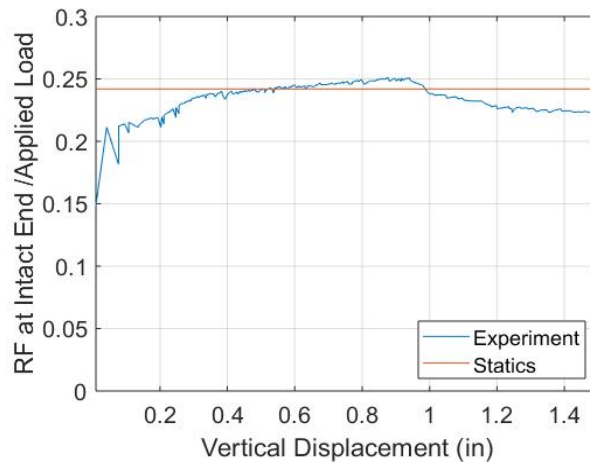
Figure 6.16: Ratio of reaction force of intact end to total applied load. Based on statics, ratio should be equal to 0.24.

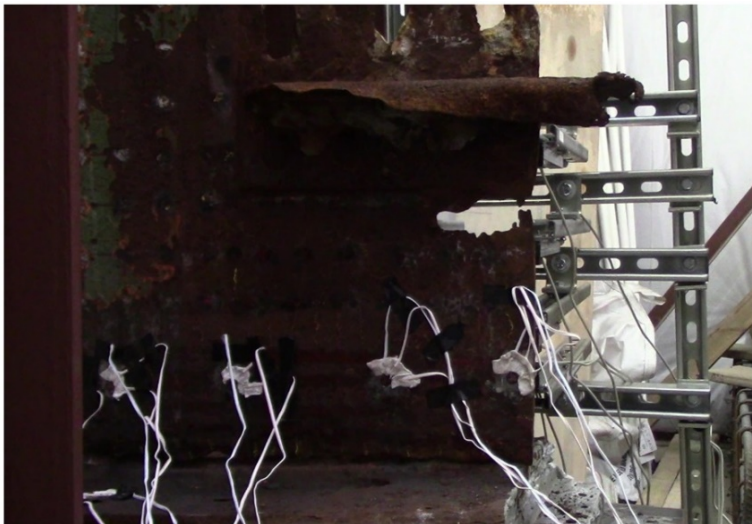
Compared to the results of the first two specimens, this was the first time that a sudden stiffness loss was observed after peak load was reached (leading to Point D). Beyond that point, the load was reducing under a constant rate up to Point E, where unloading took place. In order to further investigate the behavior of the specimen, the research team reloaded the specimen. The girder initially had the same stiffness, following the unloading path of the plot. Close to 50 kips applied load, the stiffness began reducing. At Point F, the experiment was terminated because the top flange reached the boundary of the lateral support.

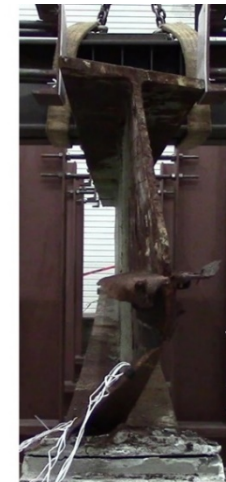
Figure 6.17: Side-by-side images showing side view of web and profile view of beam during experiment. Letters A-F correspond to Fig. 6.15a.

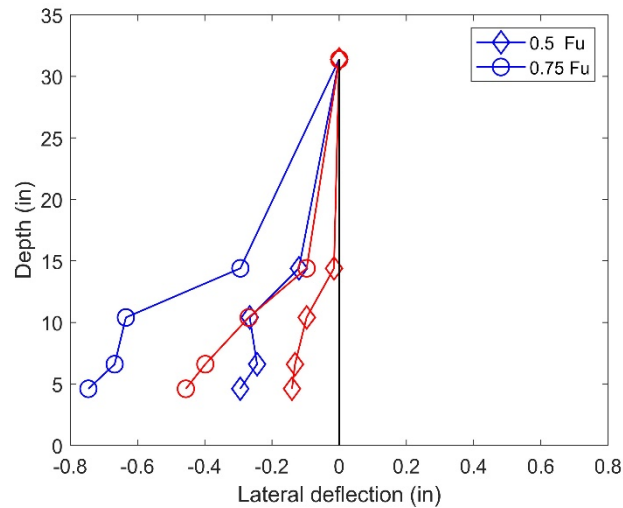
Figure 6.18: Measured web lateral deflection recorded above outer web edge (blue) and above inner one (red) for 0.5 and 0.75 F_u , where F_u denotes maximum applied load.

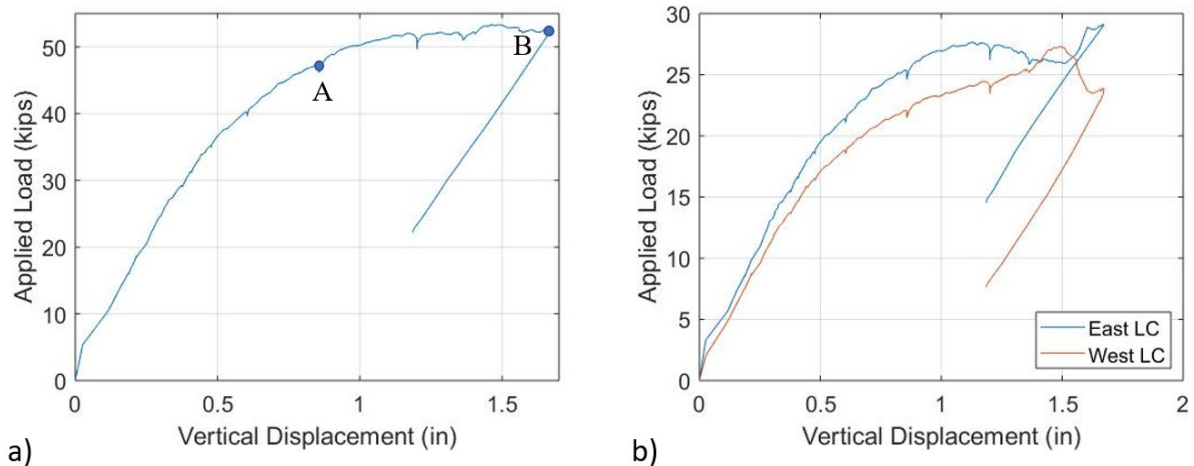
Figure 6.22: Applied load vs. vertical displacement plot for Specimen 4; b) total applied load was calculated from summation of two load cells installed at bottom of each rod (west and east side of specimen).

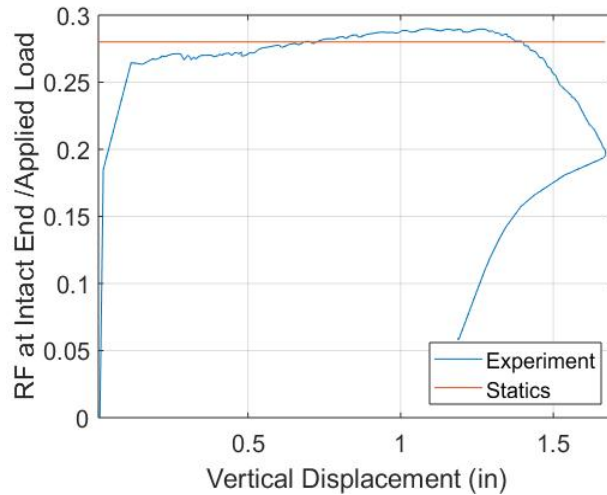
Figure 6.23: Ratio of reaction force developed at intact end to total applied load, as recorded by load cells during experimental process.

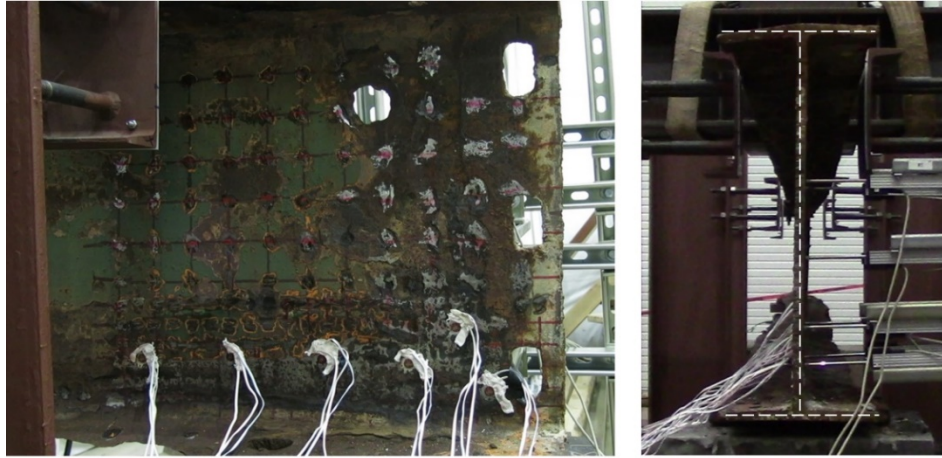
Additionally, SR recordings, Fig. 6.27, revealed stress redistribution taking place between SRs 2, 4, and 5 for applied load equal to 35 kips. In particular, the strain magnitude was reducing at the location of the first two sensors, while it was rapidly increasing at the location of SR5. These clues denoted that local instability phenomenon potentially occurred at this area. Indeed, the videos, along with a close look at the residual deformation, revealed that local buckling took place at the narrow strip with limited remaining thickness, expanding along the longitudinal axis between the strain gauges and the bearing plate. The buckling area is highlighted with a yellow line in Fig. 6.24. It is unclear if the observed local buckling came before the long wave instability, or if it was a second-order phenomenon resulting from the extensive midspan lateral and torsional deflection.

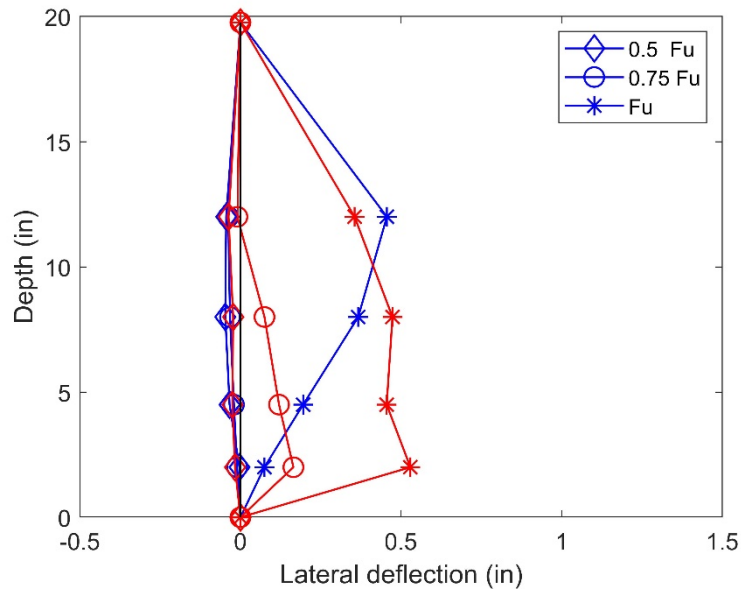
Figure 6.25: Measured web lateral deflection recorded at overhang length (blue) and above center of bearing (red) for 0.5, 0.75, and 1 F_u , where F_u denotes maximum applied load.

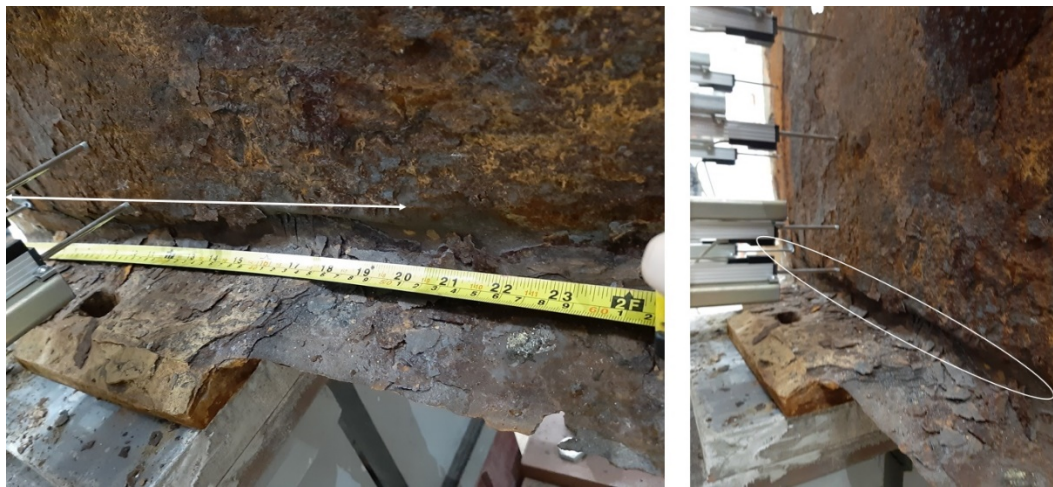
Figure 6.26: Residual deformation of studied end.

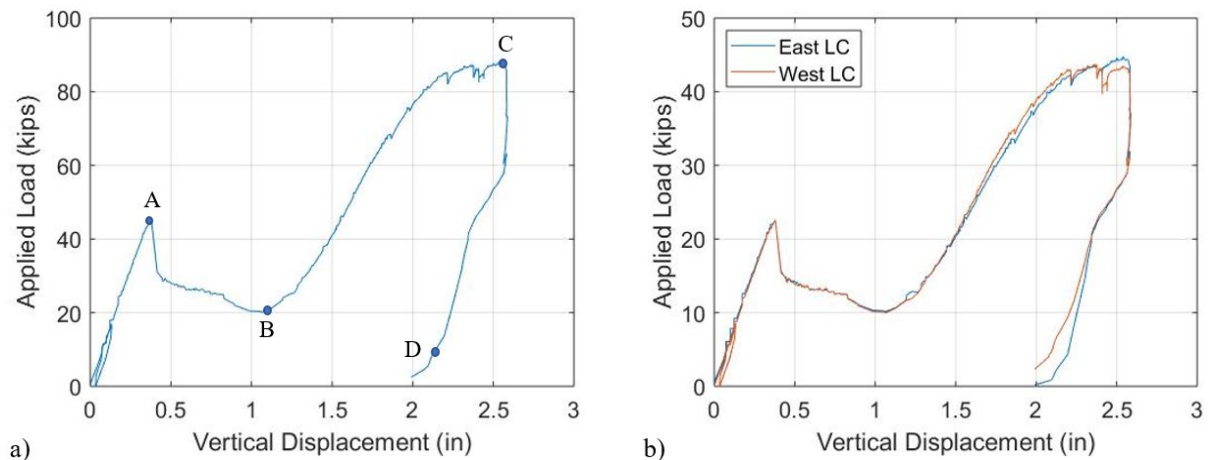
Figure 6.29: (a) Applied load vs. vertical displacement plot for Specimen 5; (b) total applied load was calculated from summation of two load cells installed at bottom of each rod (west and east side of specimen).

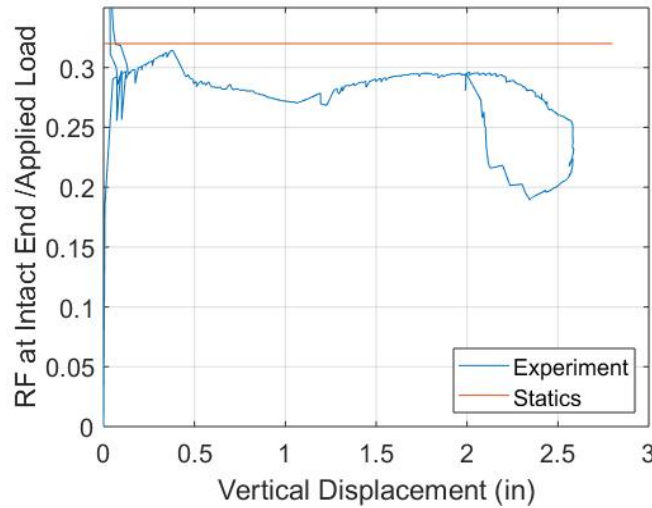
Figure 6.30: Ratio of reaction force of intact end to total applied load. Based on statics, ratio is equal to 0.32.

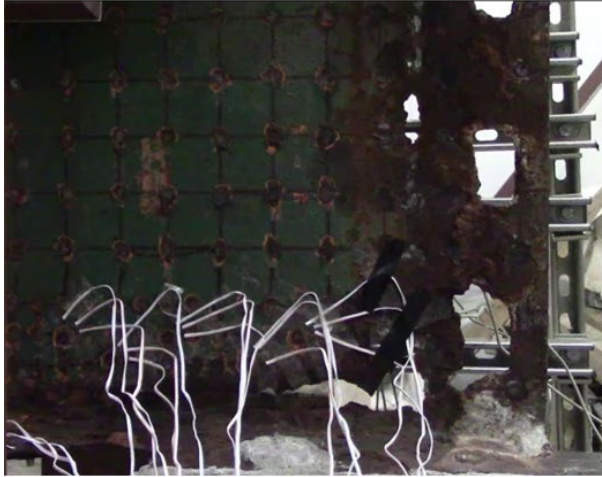
The continuously reducing specimen's stiffness continued up to Point B, where the protruding web part started bearing on the bottom flange. The system gained stiffness and began retaining additional load, up to the total load of 88.28 kips at Point C, where a global system failure mode initiated. The extensive lateral displacements at the corroded end distorted the member's center line for its straightness. This condition could have triggered the long wave instability mode that resulted in the lateral translation of the corroded end. The experiment was terminated due to the distortion of the experimental support configuration under the corroded end at Point D.

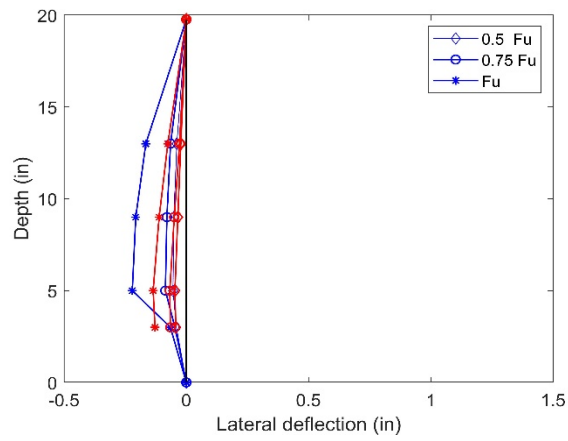
Figure 6.32: Measured web lateral deflection recorded above outer bearing edge (blue) and above inner one (red).

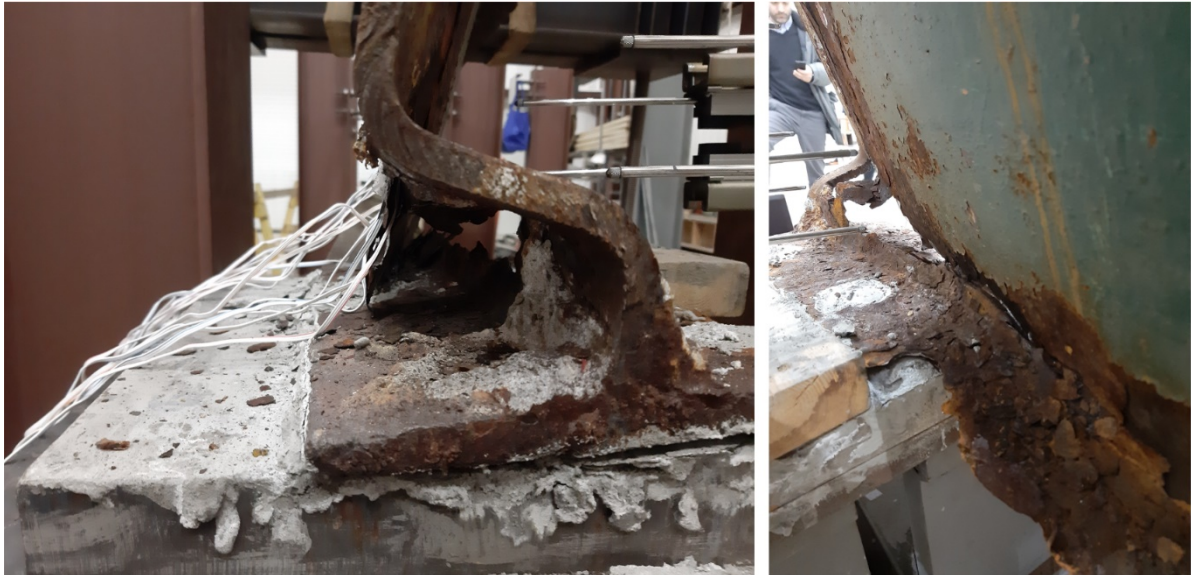
Figure 6.33: Residual deformation of corroded end after unloading.

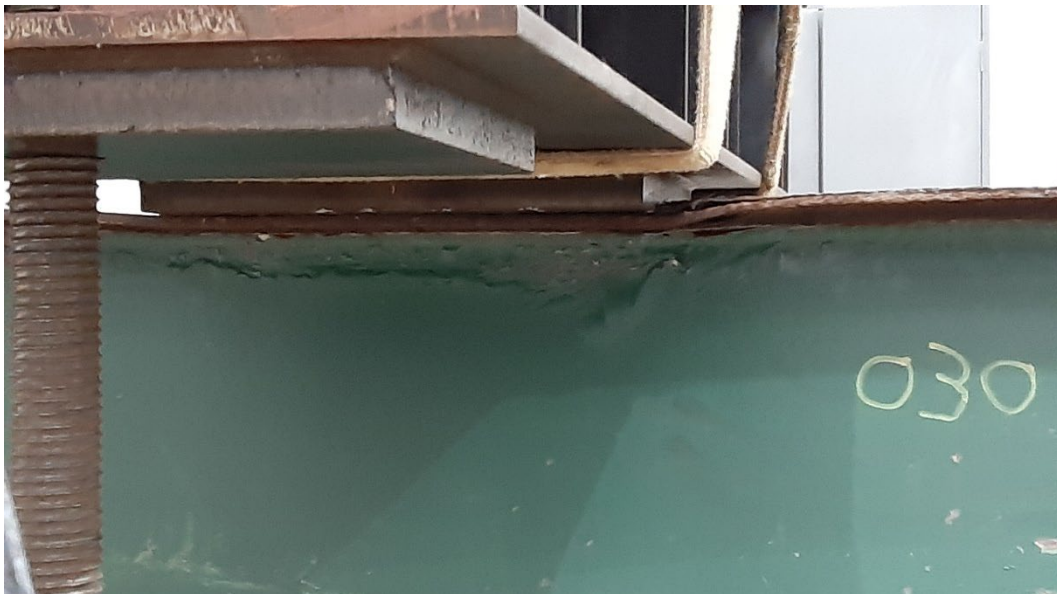
Figure 6.34: Web crippling observed underneath area of loading.

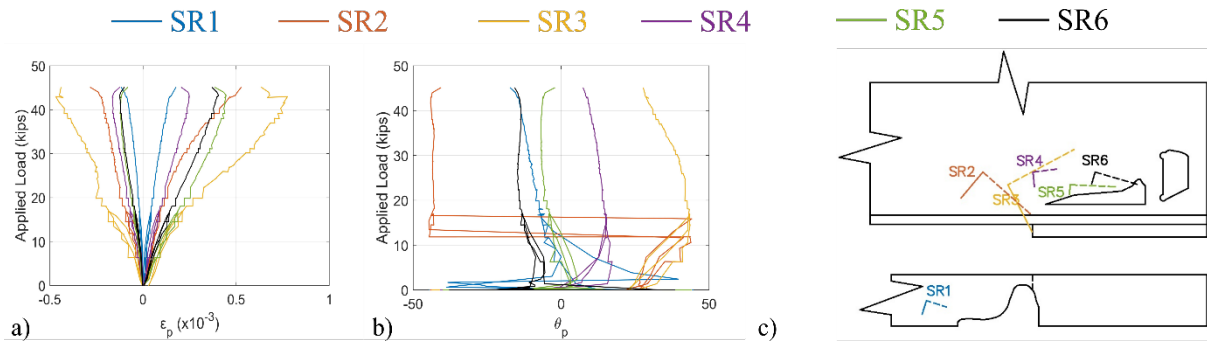
Figure 6.35: (a) Principal strains and (b) directions up to 45.14 applied kips. (c) Direction and normalized magnitude in respect to maximum strain at peak load; the dashed line illustrates the compressive direction, and the solid line the tensile one.

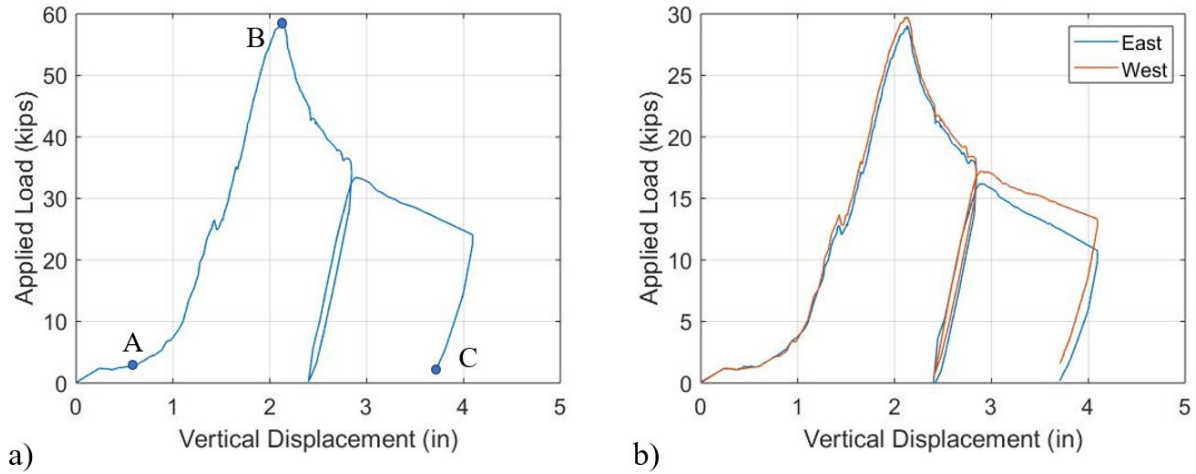
Figure 6.37: (a) Applied load vs. vertical displacement plot for Specimen 6; (b) total applied load was calculated from summation of two load cells installed at bottom of each rod (west and east side of specimen).

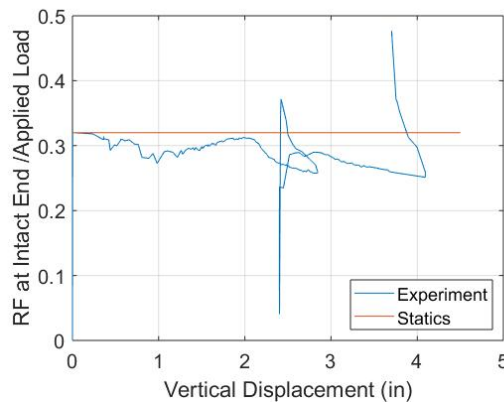
Figure 6.38: Ratio of reaction force of intact end to total applied load. Based on statics, ratio is equal to 0.32.

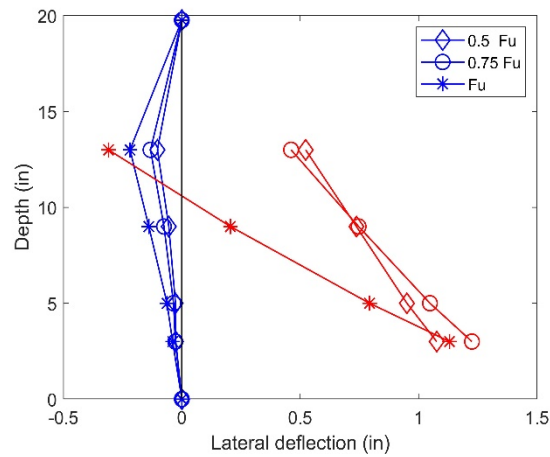
Figure 6.40: Measured web lateral deflection profiles recorded above outer bearing edge (blue) and inner one (red).

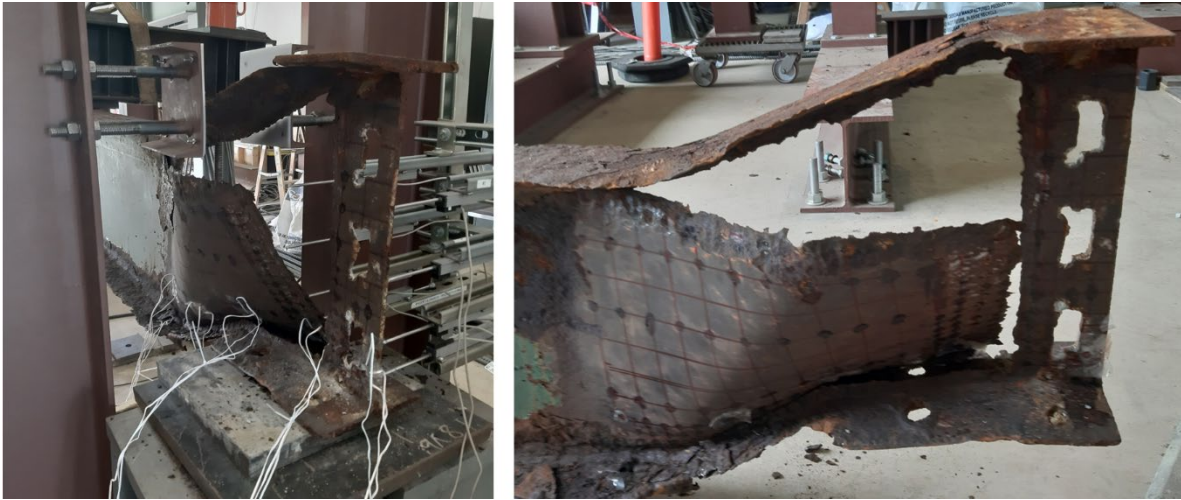
Figure 6.41: Residual deformation of Specimen 6.

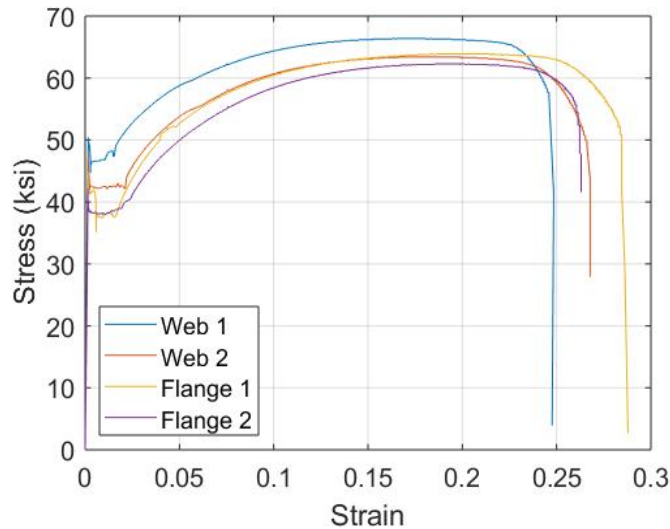
Figure 6.44: Stress strain curves for four coupons extracted from Specimen 1. Nomenclature of specimens is according to Figure 3.47.

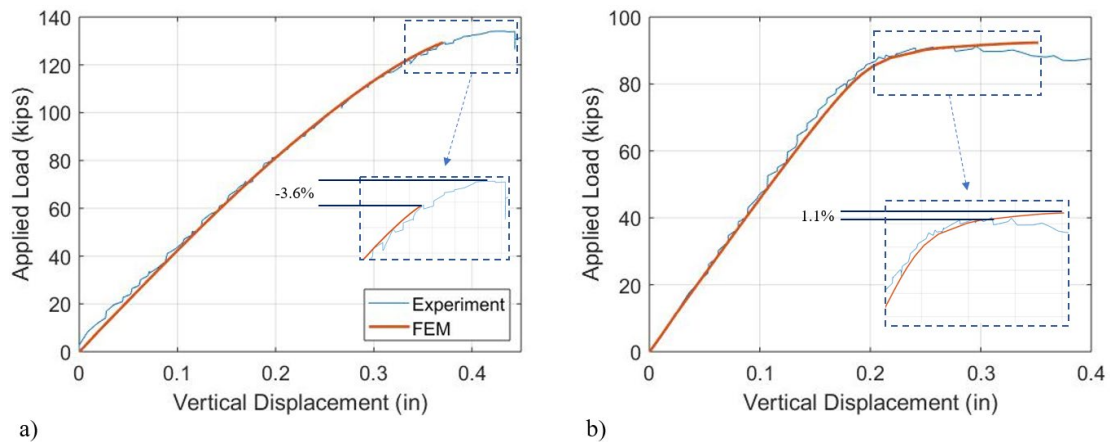
Figure 7.1: Comparison of experimental and numerical results for (a) Specimen 1 and (b) Specimen 2.

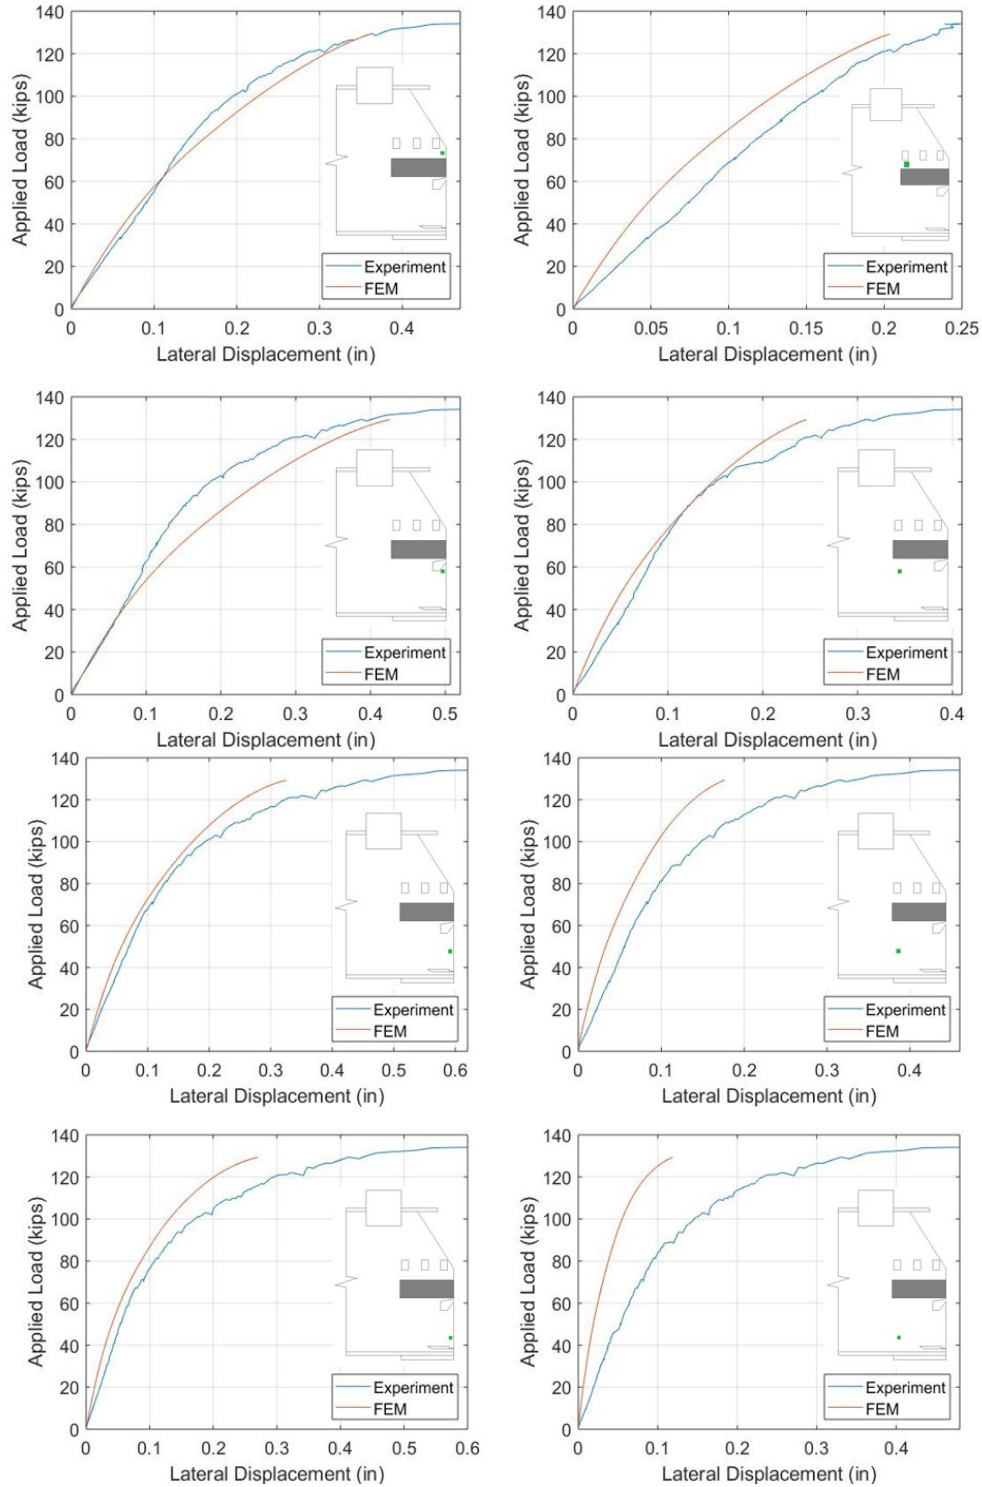
Figure 7.2: Comparison of experimentally and computationally obtained lateral displacements for Specimen 1. Potentiometer locations are illustrated with a green rectangle.

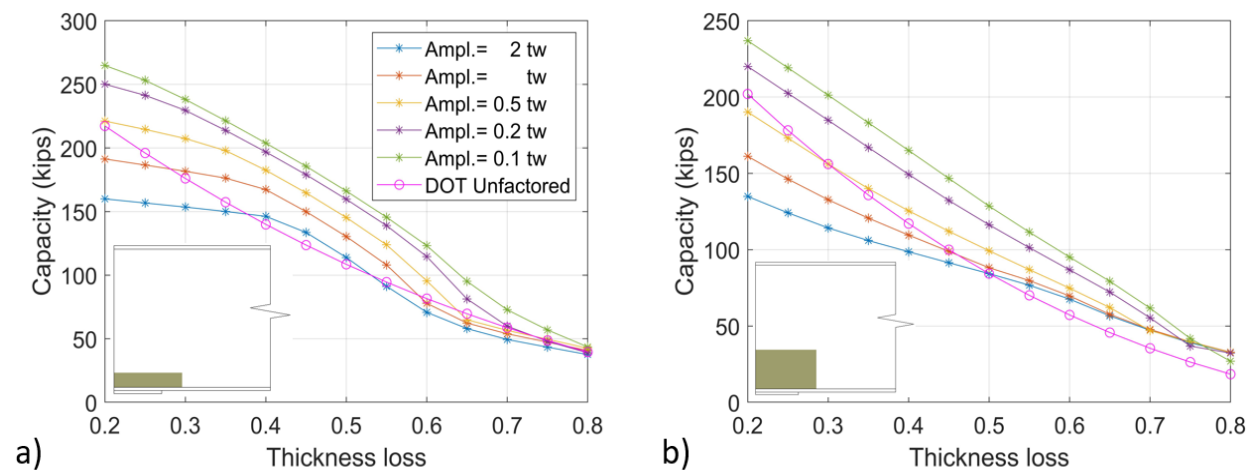
Figure 7.4: Imperfection amplitude effect on a 36WF150 beam with rectangular corrosion topology initiated at bottom of web for corrosion height (a) 10% and (b) 30% of depth.

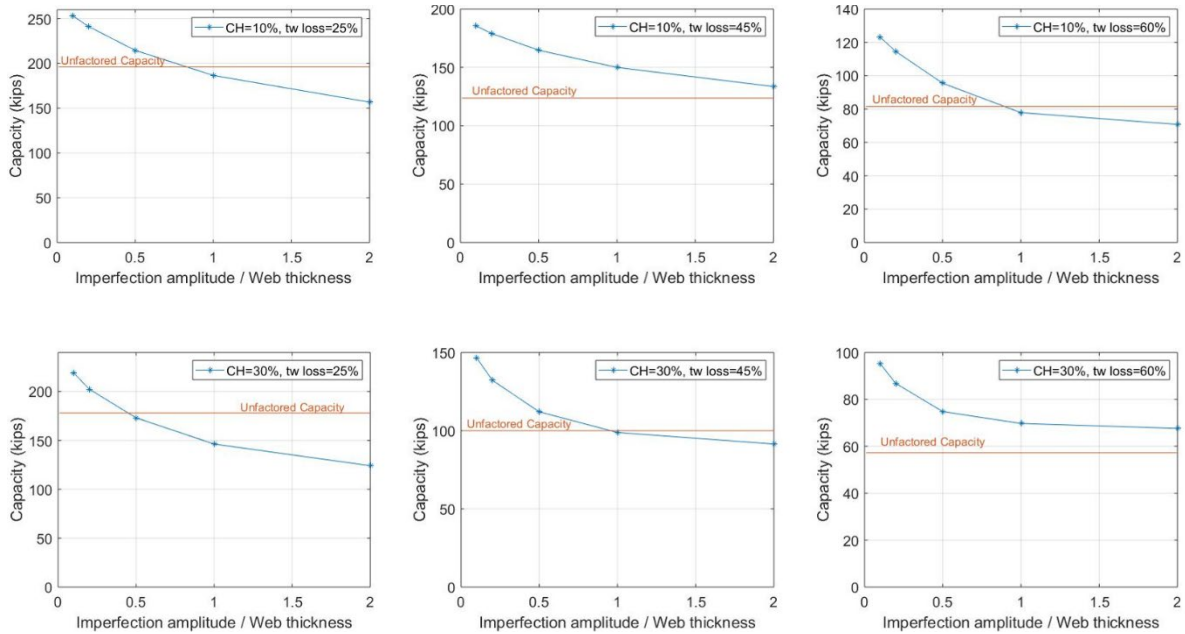
Figure 7.5: Comparison of numerically obtained with nominal capacities.

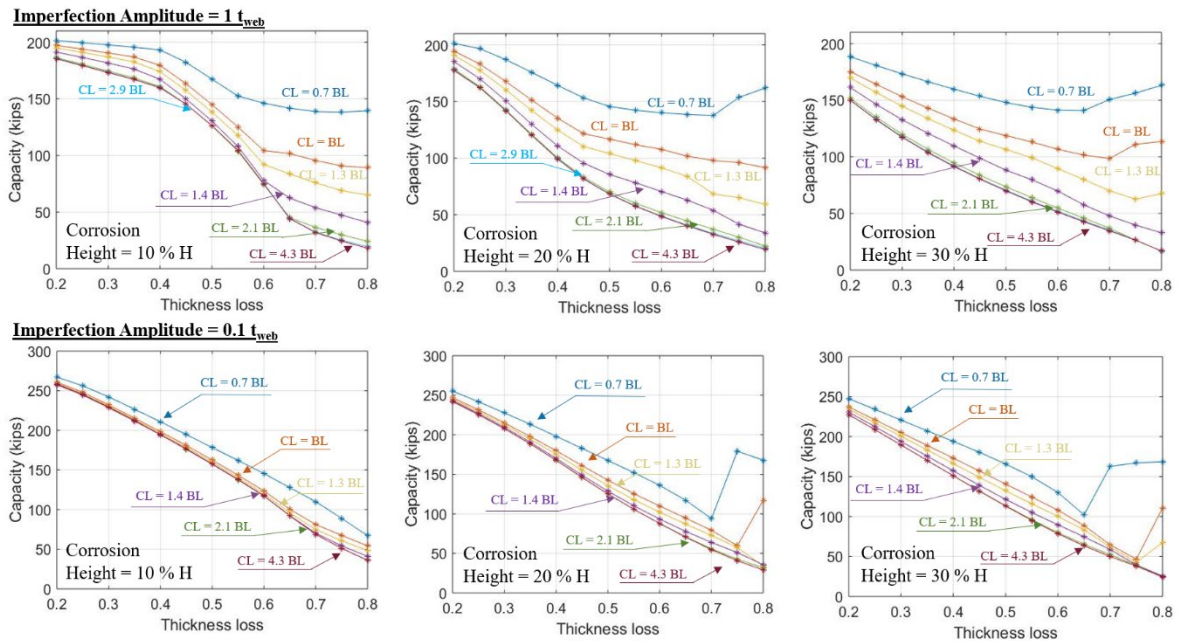
Figure 7.6: Capacity of beam ends with rectangular corrosion topology and imperfection amplitude 1 and $0.1 t_{web}$, for corrosion height 10%, 20%, and 30% of depth.

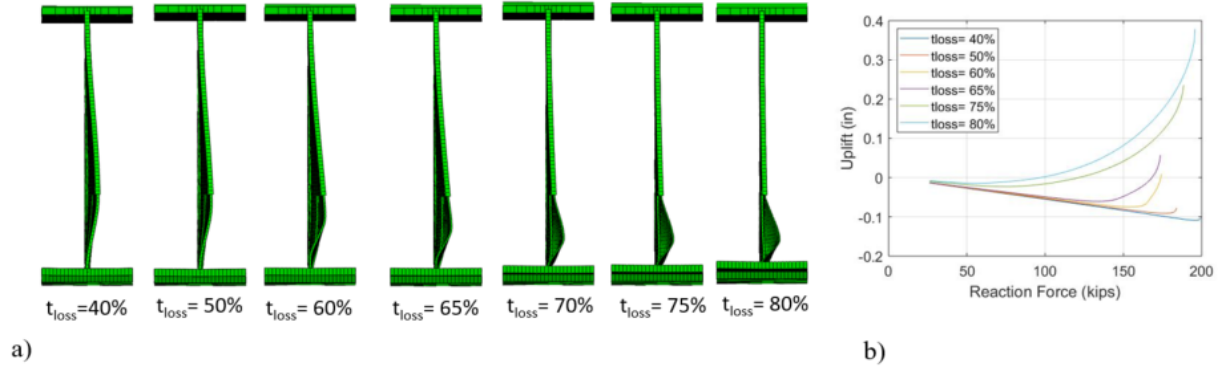
Figure 7.7: (a) Failure modes for corrosion height 30% and corrosion length 0.7 of bearing length; (b) measured uplifts at outer flange edge.

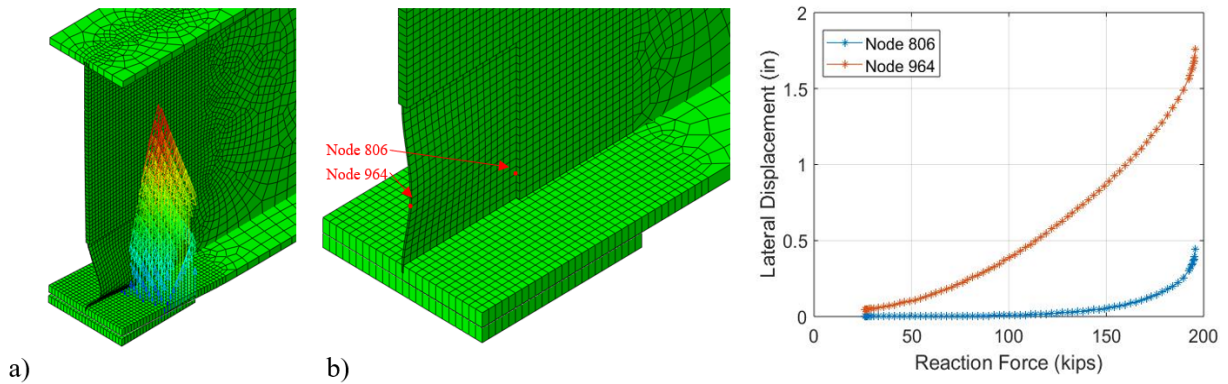
Figure 7.8: (a) Reaction forces profile, developed at beam's end where web corrosion length does not exceed bearing length; (b) web lateral displacements for node 806 located at edge between corroded and intact geometry.

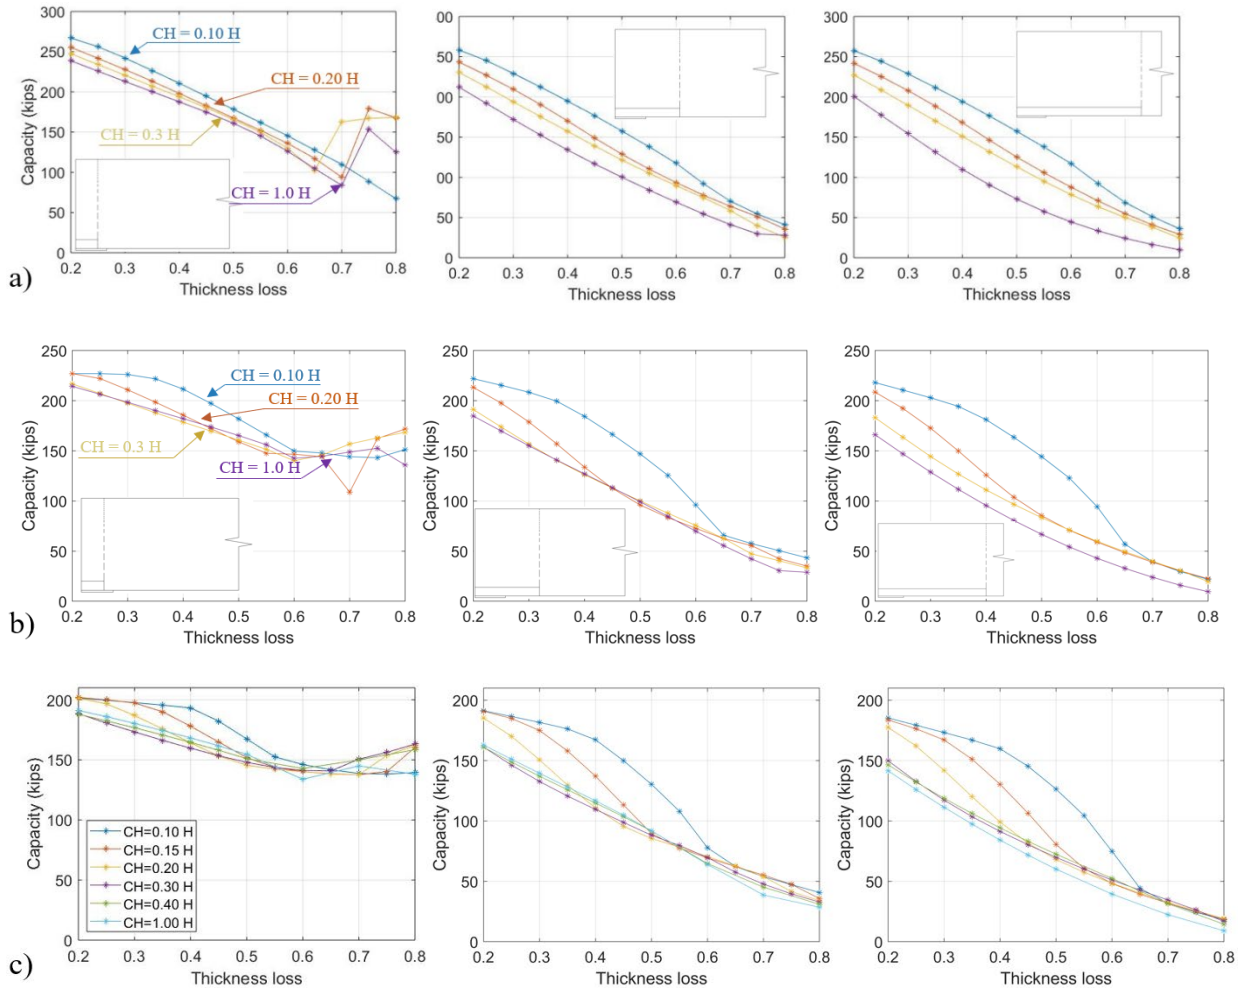
Figure 7.9: Corrosion height effect for corrosion length equal to 75-140-430% of bearing length. Analyses performed for imperfection amplitude (a) 0.1, (b) 0.5, and (c) 1 t_{web} .

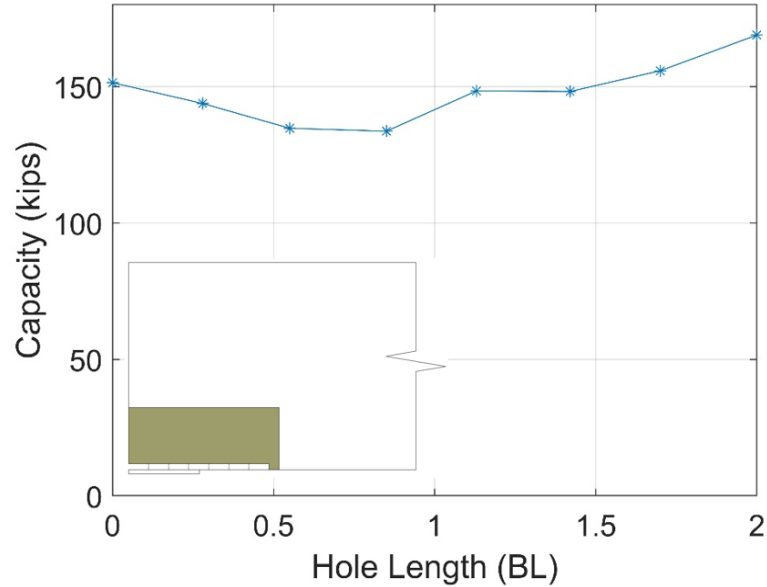
Figure 7.10: Effect of hole length on corroded 36WF150 end (20% section loss with CH=30%, CL= 2.1 B_L), for constant hole height equal to 3% of depth.

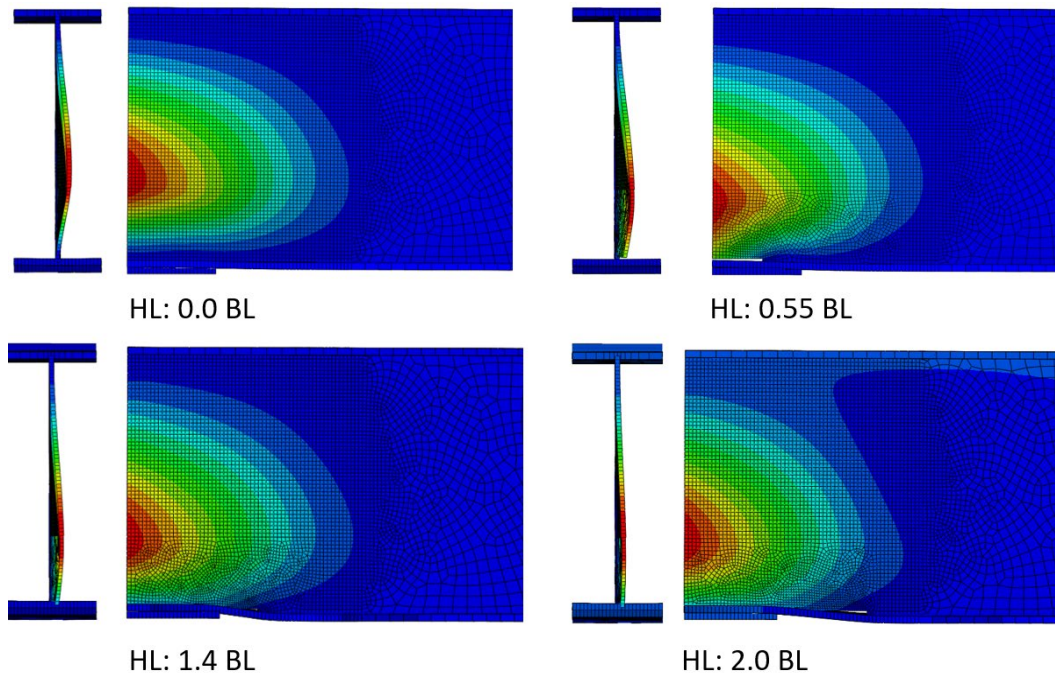
Figure 7.11: Failure modes for hole scenarios presented in Fig. 7.10

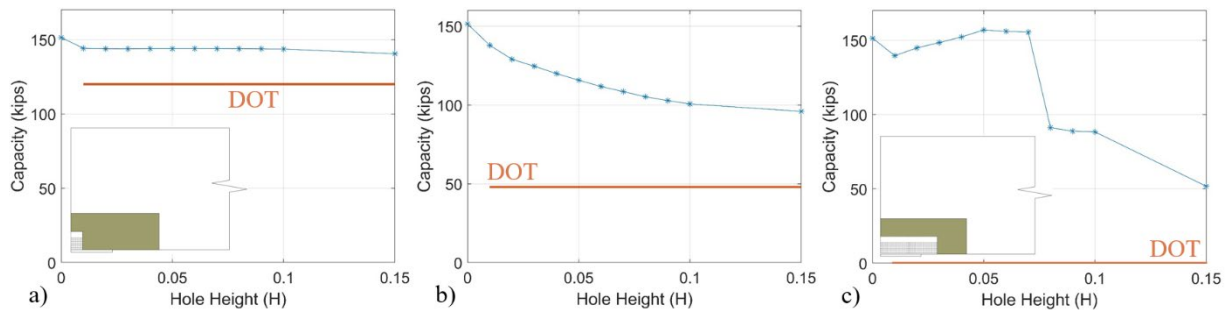
Figure 7.12: Effect of hole height on a corroded 36WF150 end (20% section loss with CH=30%, CL= 2.1 B_L), for hole length equal to a)28% b)70% and c) 140% of depth. The capacity according to the current procedures is also included.

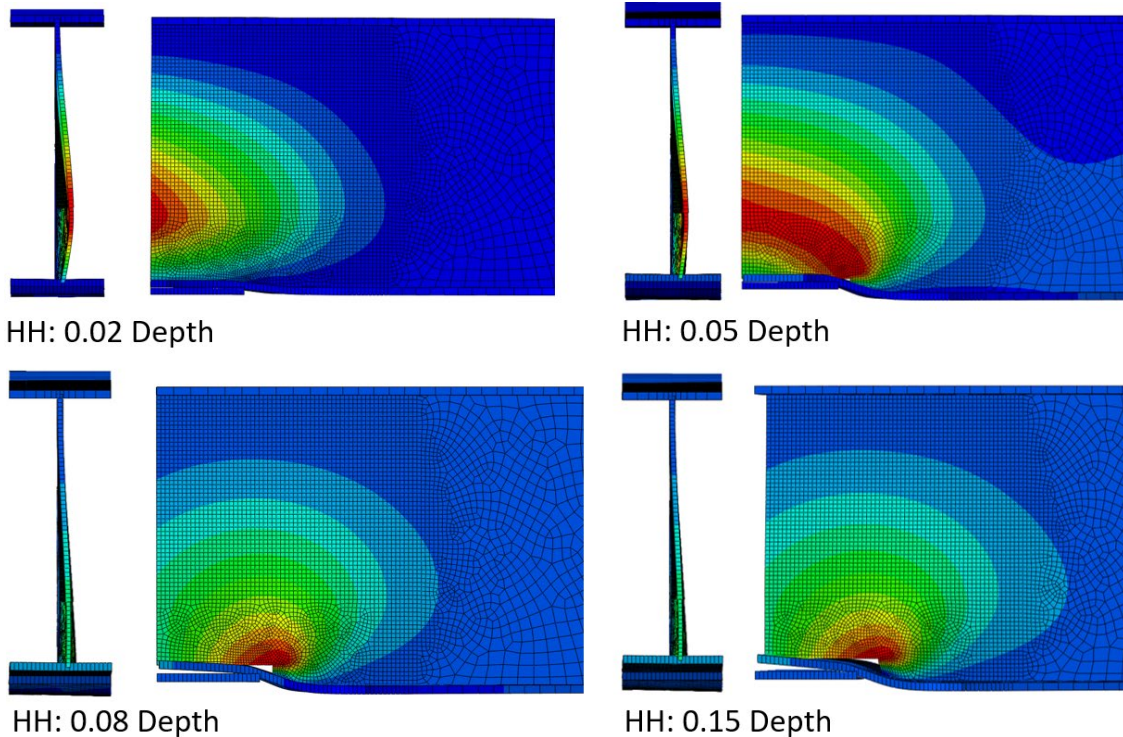
Figure 7.13: Failure modes for hole scenarios presented in Fig. 7.12. Lateral displacement contours are plotted on web surface.

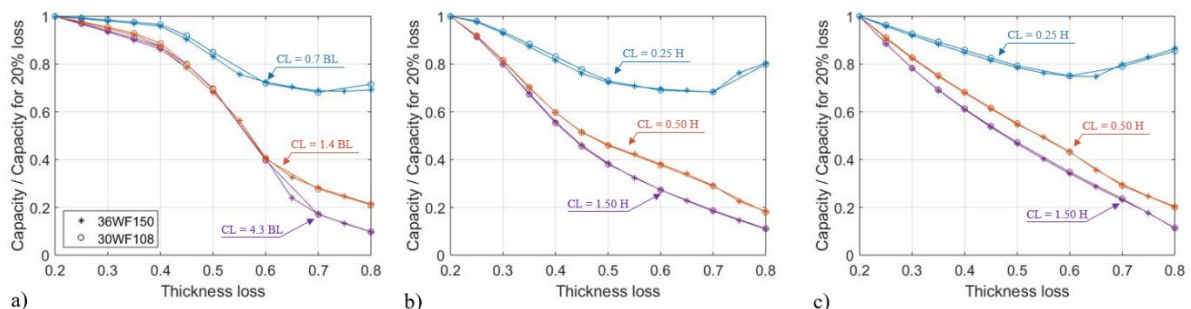
Figure 7.14: Beam effect for corrosion height (a) 10%, (b) 20%, and (c) 30% of depth.

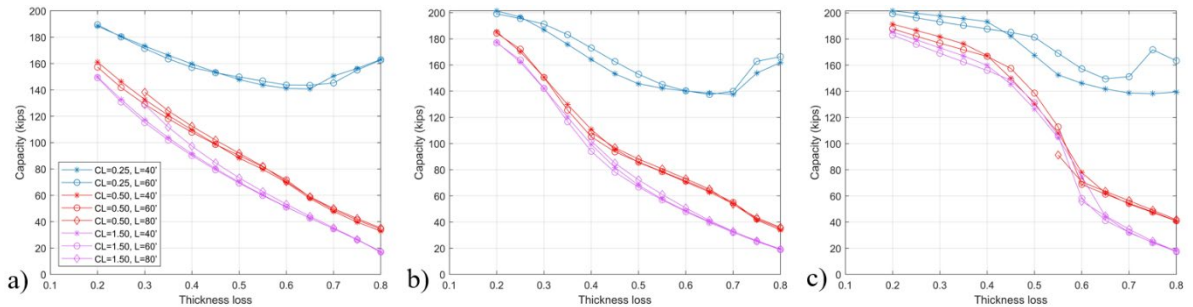
Figure 7.15: Effect of beam length on capacity of deteriorated beams. Corrosion height equals a) 30%, b) 20%, and c) 10% of depth.

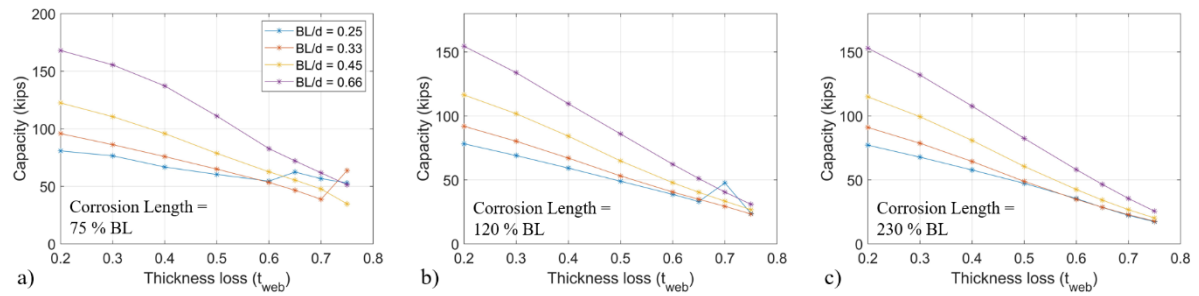
Figure 7.16: Effect of bearing length (B_L) on capacity of deteriorated beams. Corrosion length equals (a) 75%, (b) 120%, and (c) 230% of bearing length.

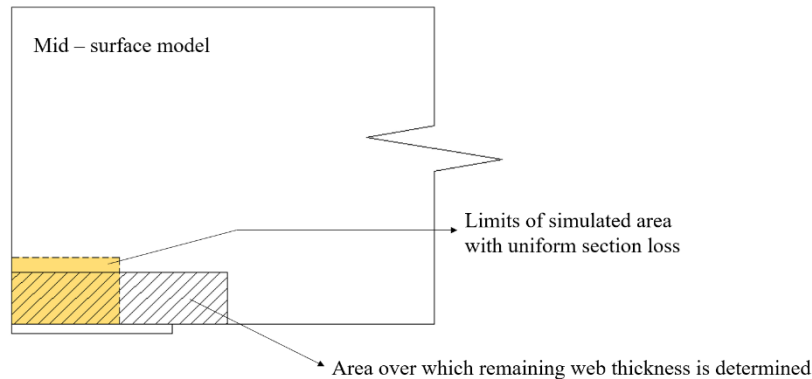
Figure 8.1: Beam end with corrosion scenario projected on bottom of web.

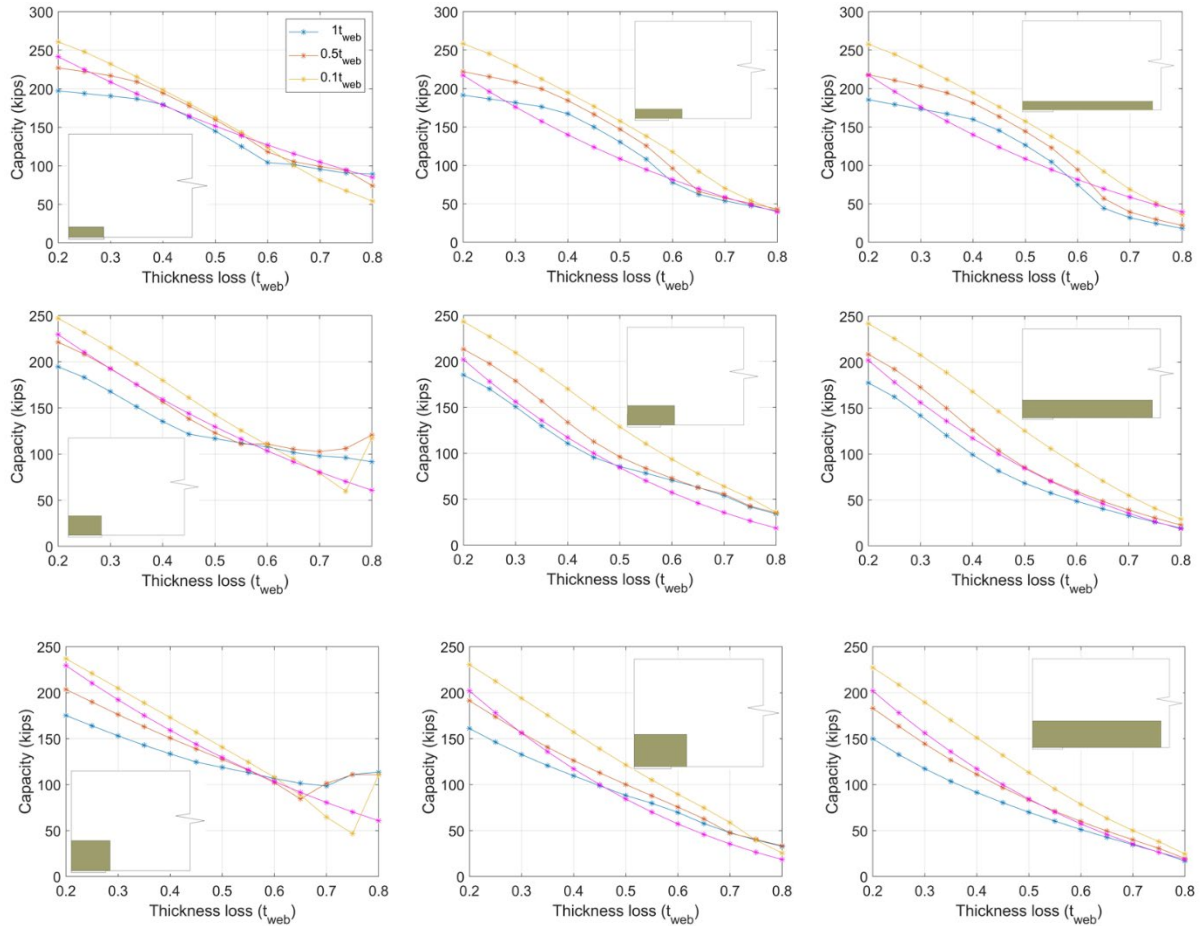
Figure 8.2: Comparison between numerically obtained capacities and failure load predictions based on current procedures for 36WF150 beam with $N/d = 0.33$ and imperfection amplitude 1, 0.5, and 1 t_{web} . Corrosion height equals 10%, 20%, or 30% of depth, and corrosion length 1.1, 1.4, or 4.25 times bearing length.
