September 2019

Report No. 19-008

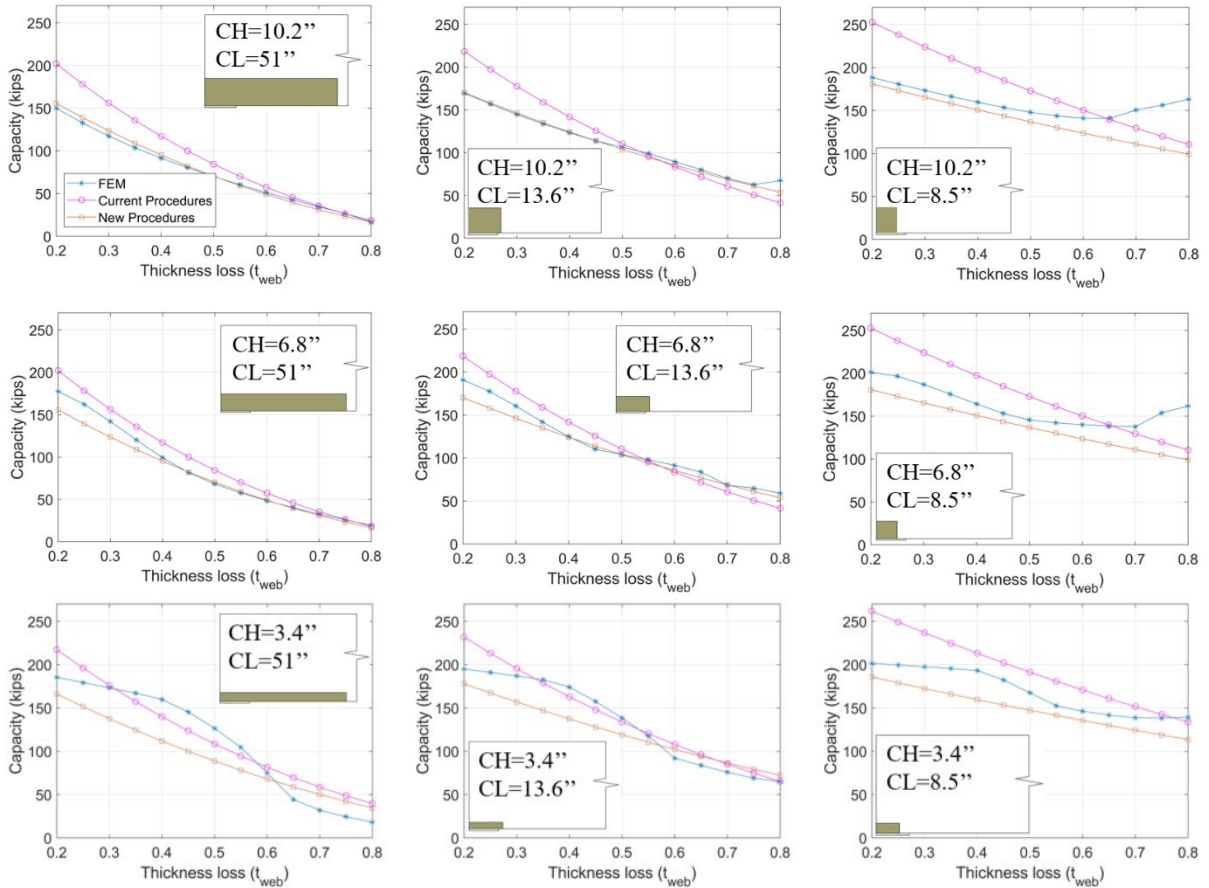
Figure 8.3: Comparison between numerically obtained capacities and failure load predictions based on current and proposed procedures, for $N/d=0.33$ and imperfection amplitude t_{web} .

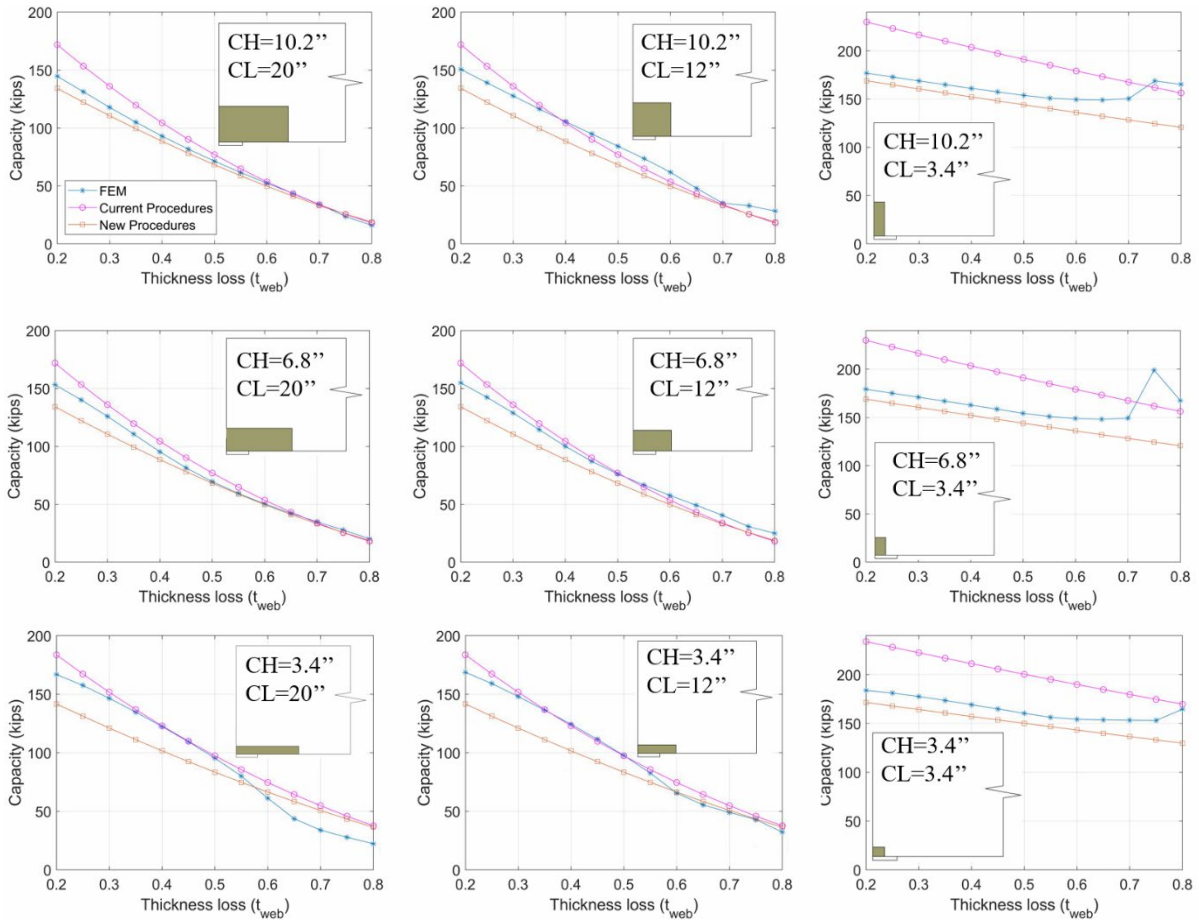
Figure 8.4: Comparison between numerically obtained capacities and failure load predictions based on current and proposed procedures, for $N/d \leq 0.2$ and imperfection amplitude $0.5 t_{web}$.

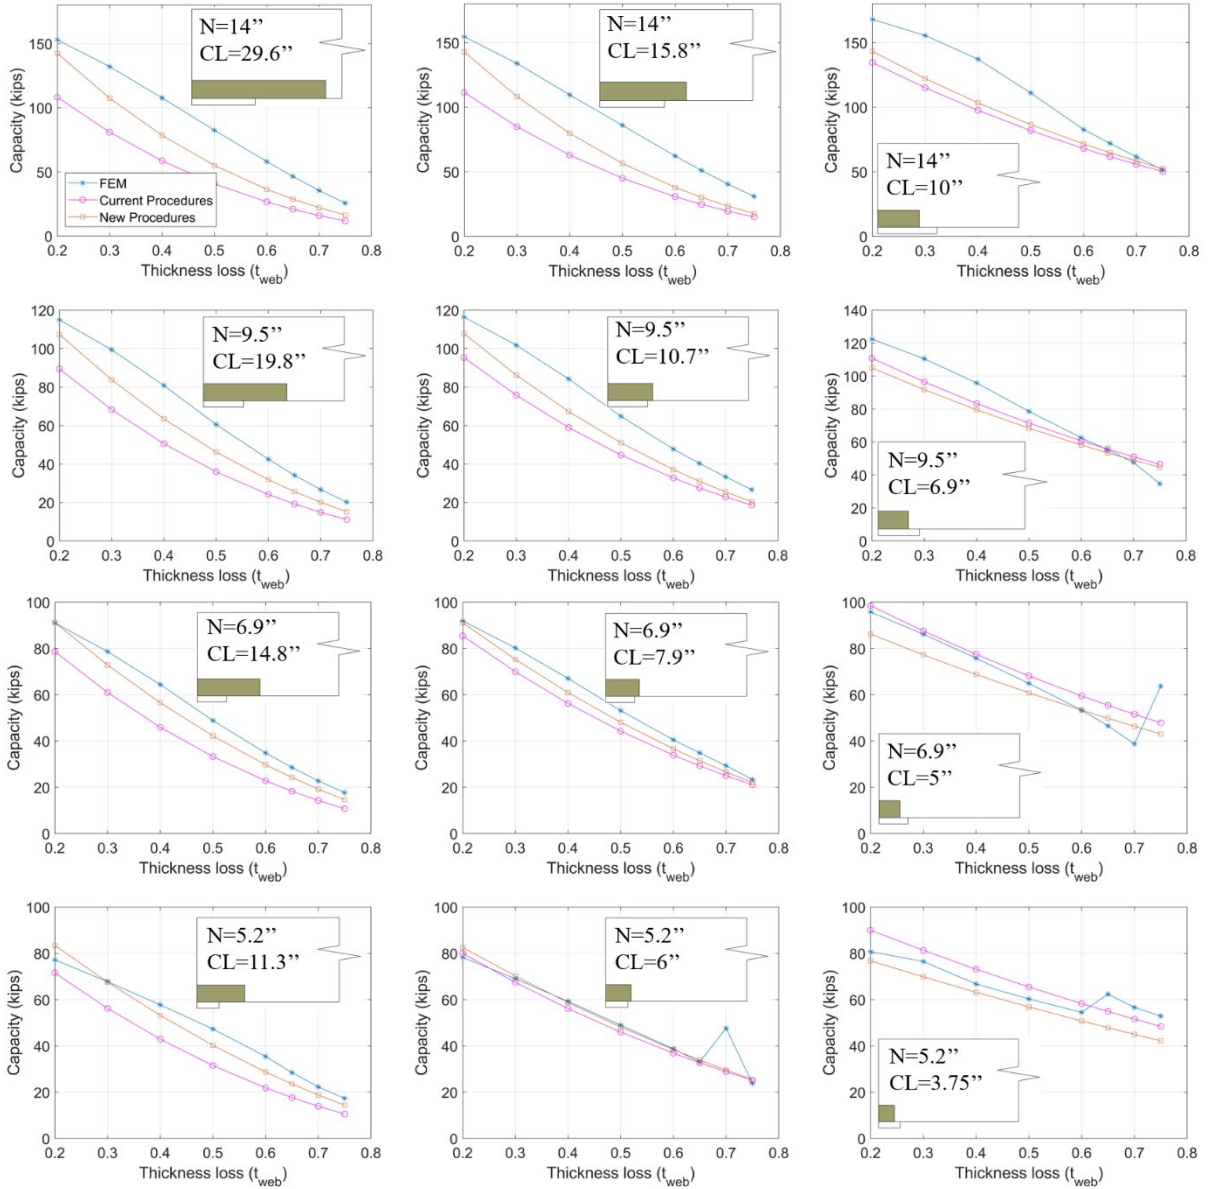
Figure 8.5: Comparison between numerically obtained capacities and failure load predictions based on current and proposed procedures, for a variety of N/d ratios and imperfection amplitude $0.1 t_{web}$.

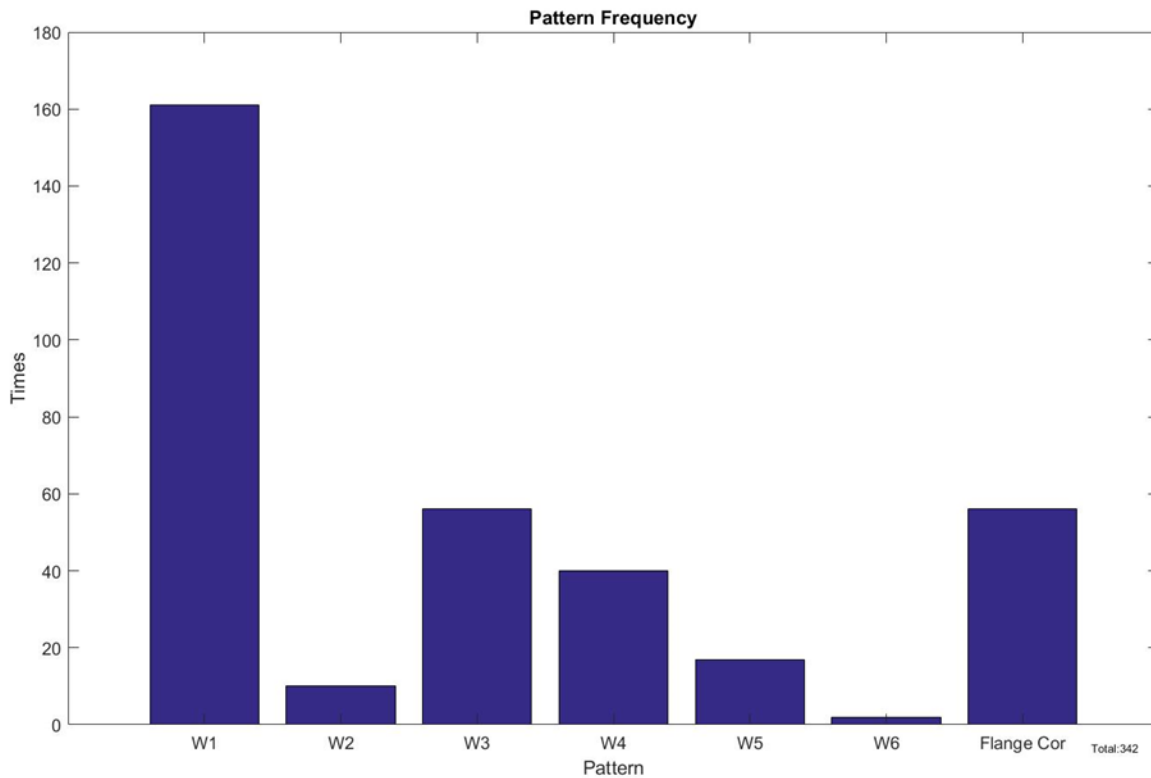
Figure 12.1: Web corrosion patterns distribution for beams without diaphragm.

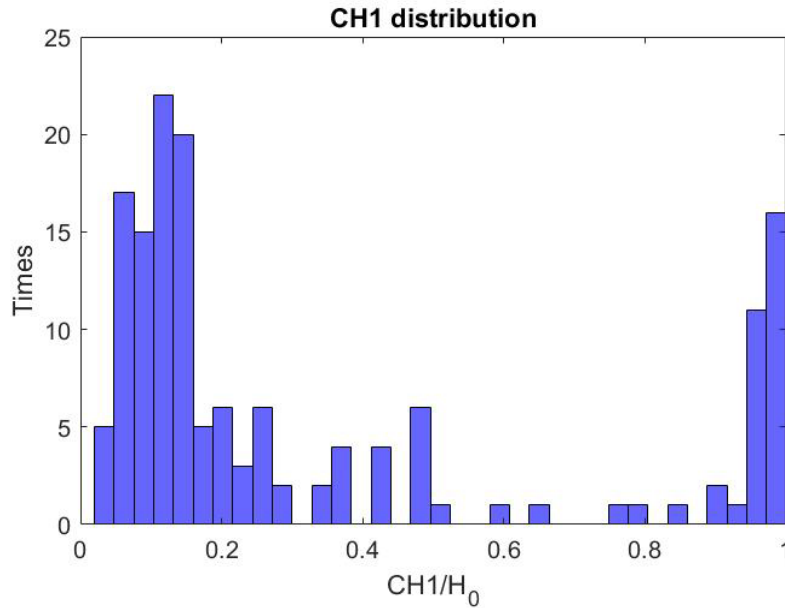
Figure 12.2: CH_1 distribution of W1 pattern for beams without diaphragm.

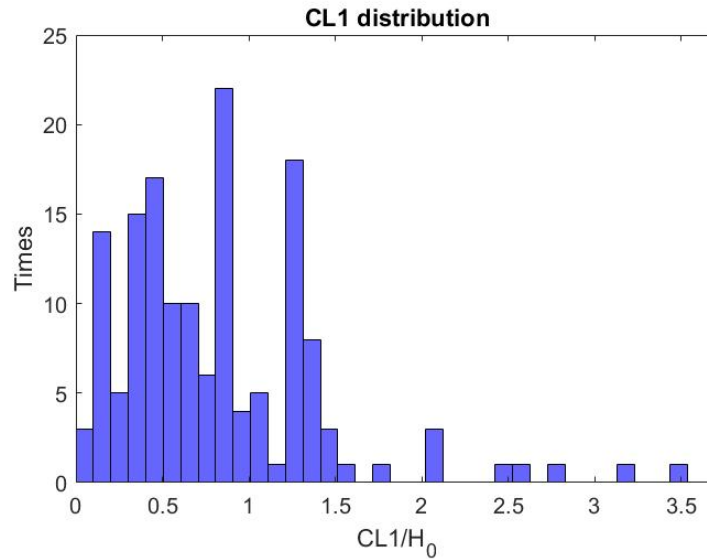
Figure 12.3: CL_1 distribution of W1 pattern for beams without diaphragm.

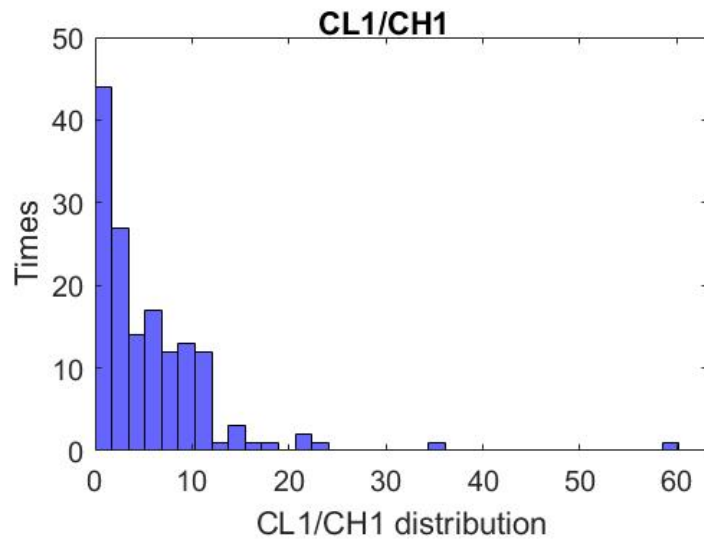
Figure 12.4: Ratio of corrosion length (CL_1) to corrosion height (CH_1) of W1 pattern for beams without diaphragm.

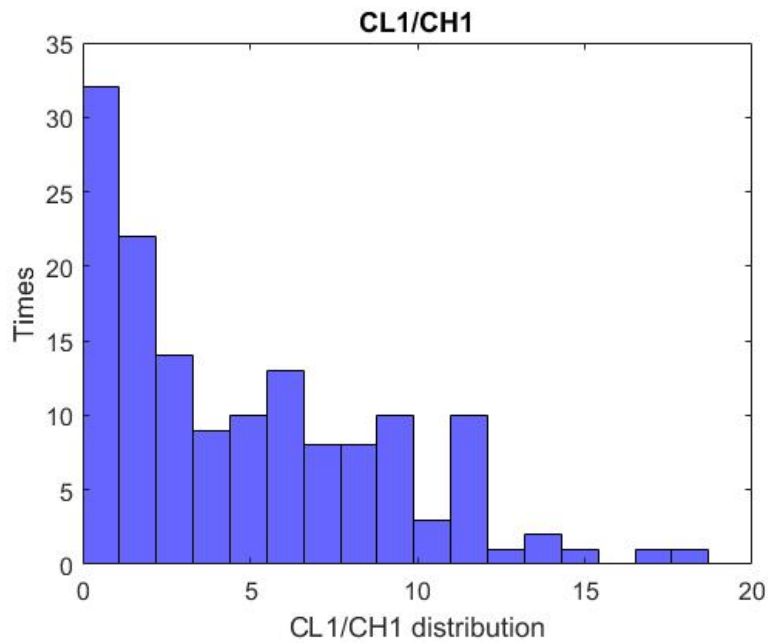
Figure 12.5: Ratio of corrosion length (CL_1) to corrosion height (CH_1) of W1 pattern for beams without diaphragm (range 0-15).

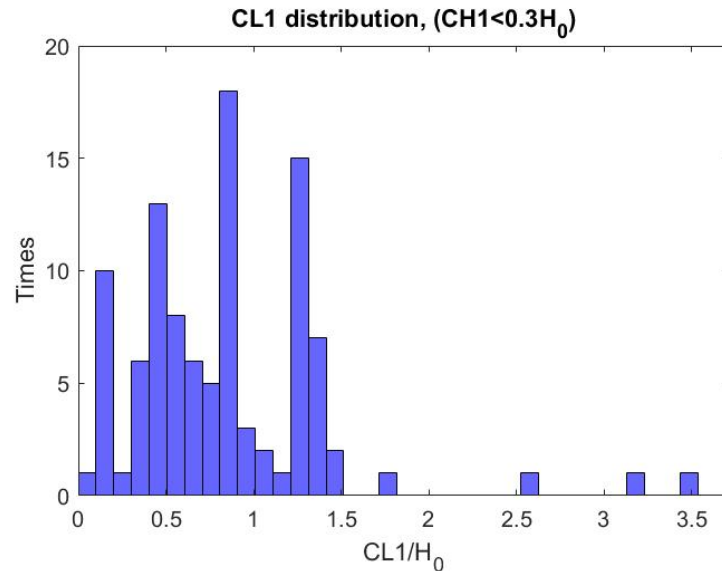
Figure 12.6: CL1 distribution of W1 web corrosion pattern, with corrosion height up to 30% of H_0 for beams without diaphragm.

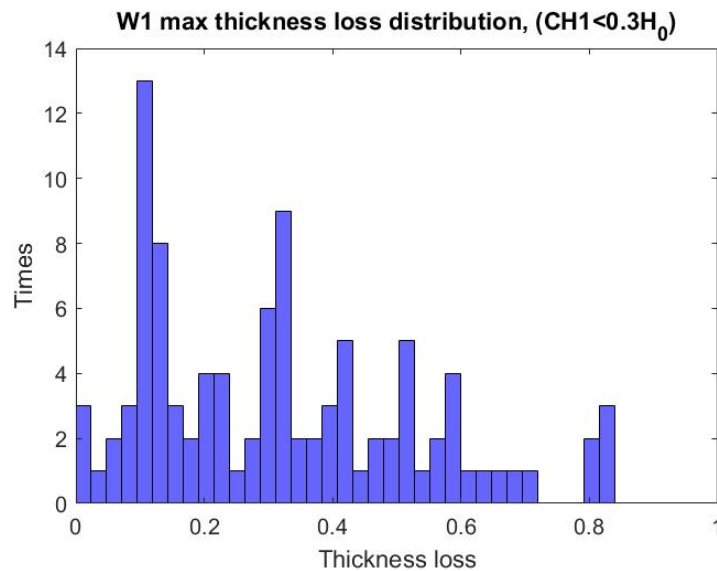
Figure 12.7: Max thickness loss distribution of W1 web corrosion pattern, with corrosion height up to 30% of H_0 for beams without diaphragm.

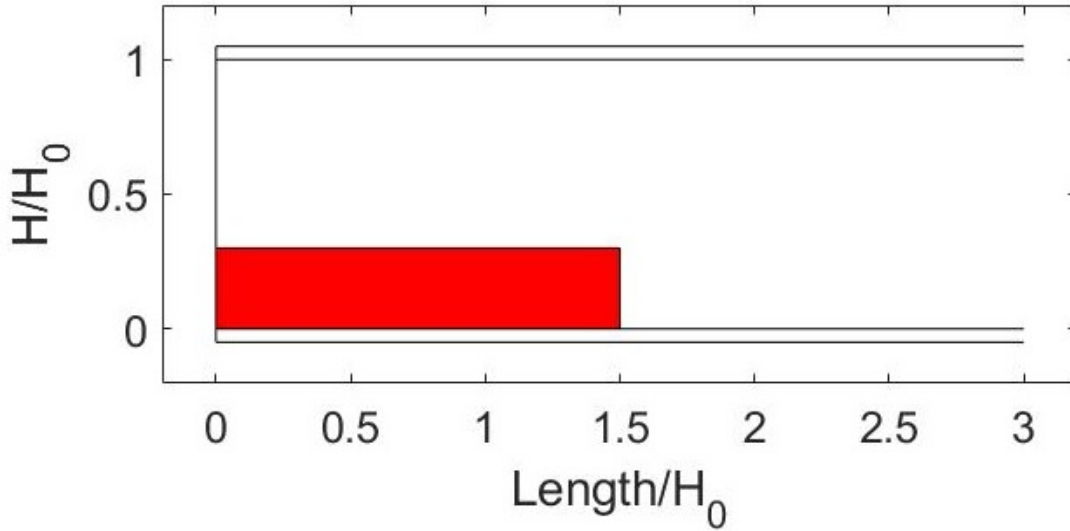
Figure 12.8: First extreme W1 web corrosion pattern, with corrosion height up to 30% of H_0 for beams without diaphragm.

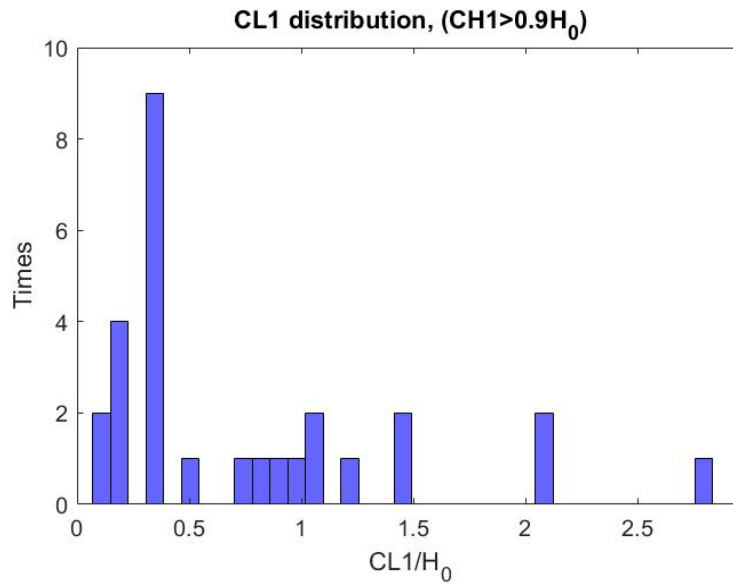
Figure 12.9: CL_1 distribution of W1 web corrosion pattern with corrosion greater than 90% of H_0 for beams without diaphragm.

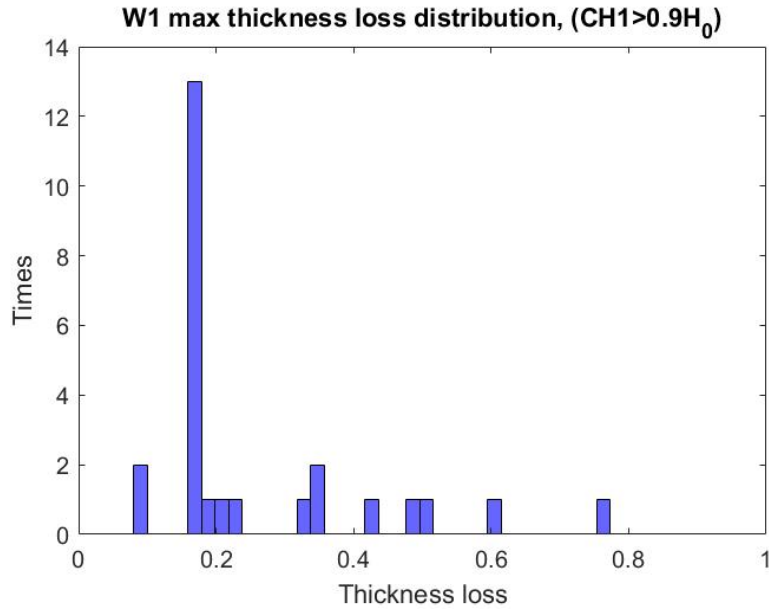
Figure 12.10: Max thickness loss distribution of W1 web corrosion pattern with corrosion height greater than 90% of H_0 for beams without diaphragm.

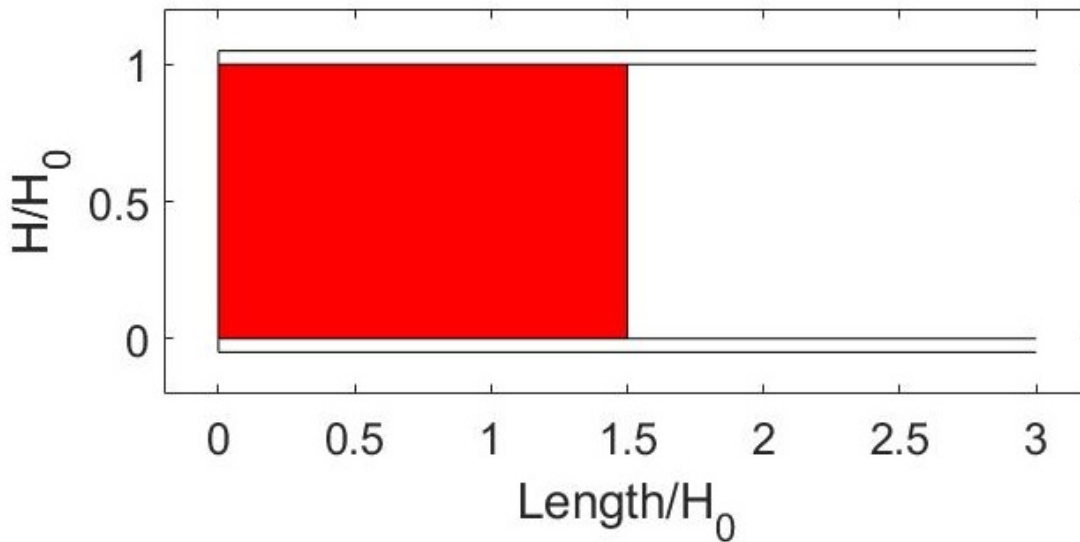
Figure 12.11: Second extreme W1 web corrosion pattern, with corrosion height greater than 90% of H_0 for beams without diaphragm.

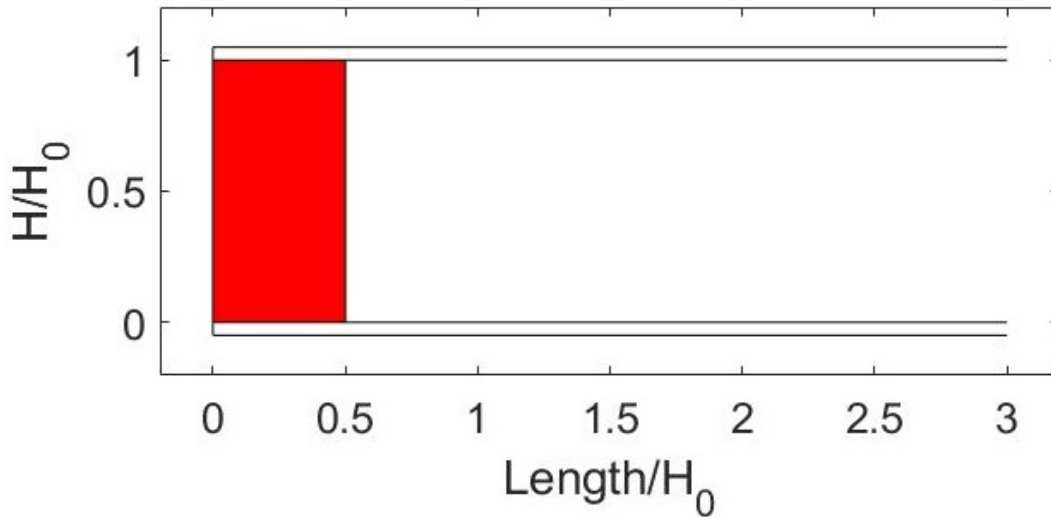
Figure 12.12: Third extreme W1 web corrosion pattern, with corrosion height greater than 90% of H_0 for beams without diaphragm.

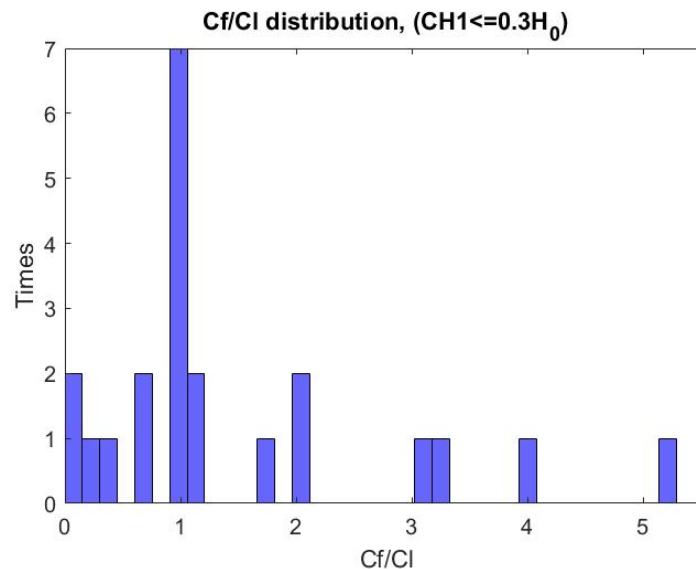
Figure 12.13: Ratio of flange to web corrosion length distribution of W1 web corrosion pattern with corrosion height up to 30% of H_0 for beams without diaphragm.

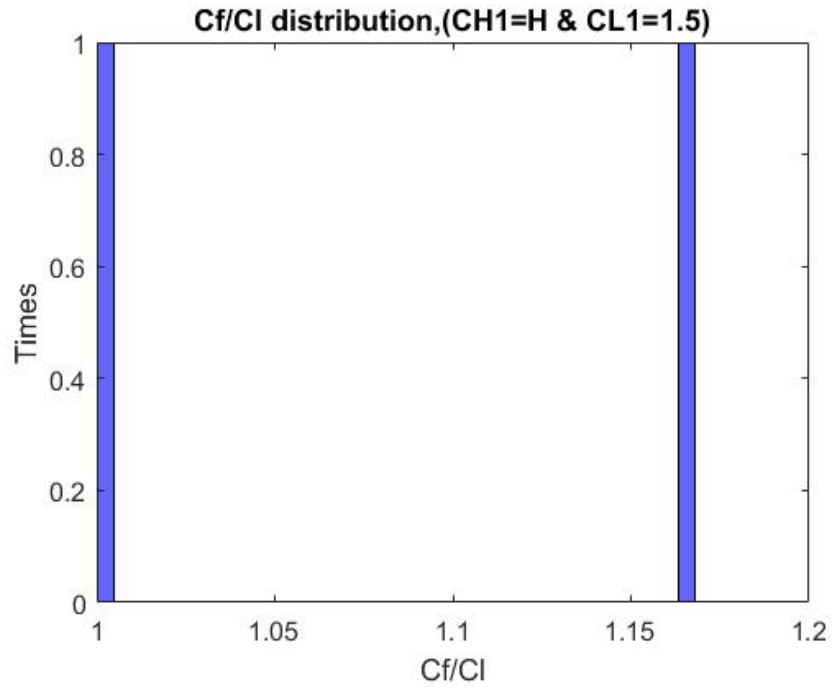
Figure 12.14: Ratio of flange to web corrosion length distribution of W1 web corrosion pattern for extreme scenario CASE B for beams without diaphragm.

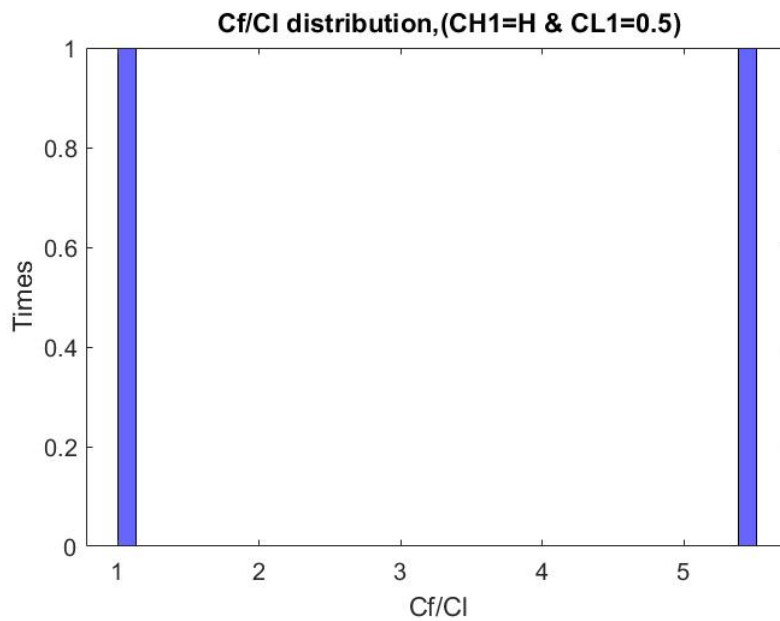
Figure 12.15: Ratio of flange to web corrosion length distribution of W1 web corrosion pattern for extreme scenario CASE C for beams without diaphragm.

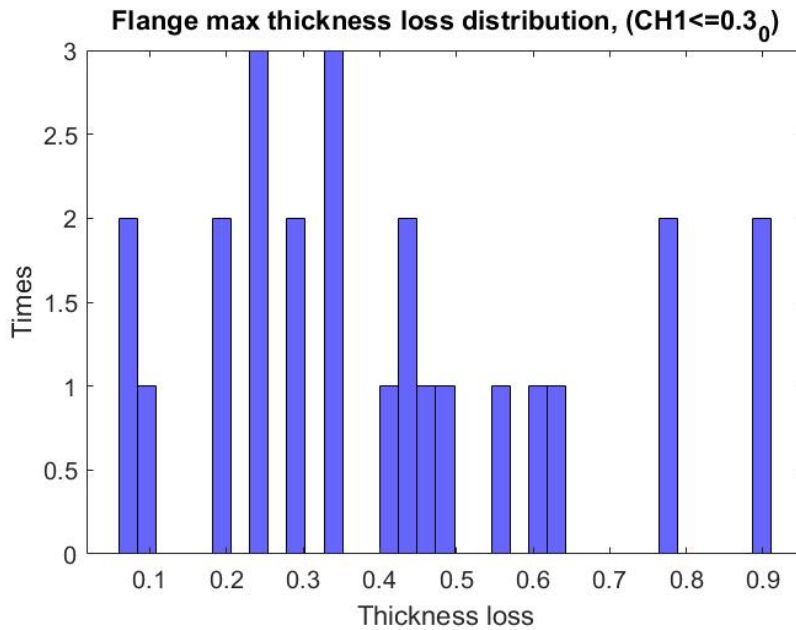
Figure 12.16: Max flange thickness loss distribution of W1 web corrosion pattern with corrosion height up to 30% of H₀ for beams without diaphragm.

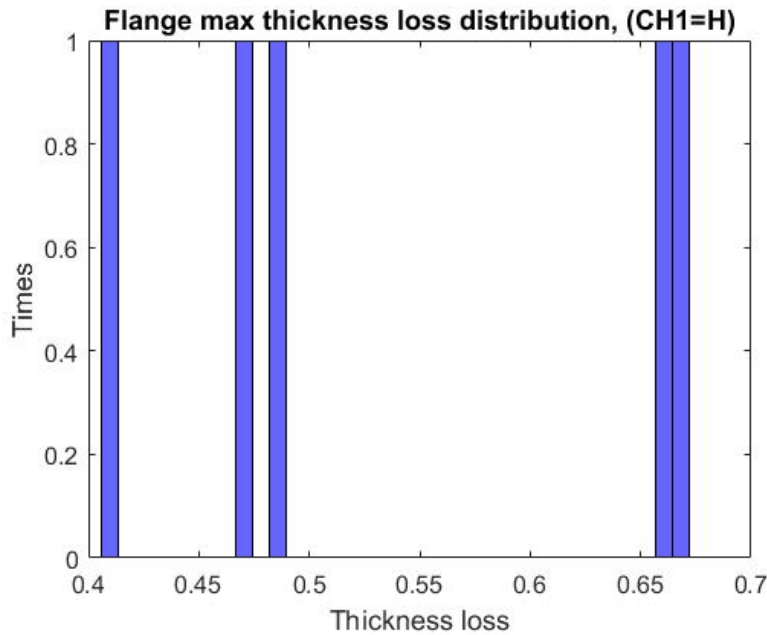
Figure 12.17: Max flange thickness loss distribution of W1 web corrosion pattern with full height corrosion for beams without diaphragm.

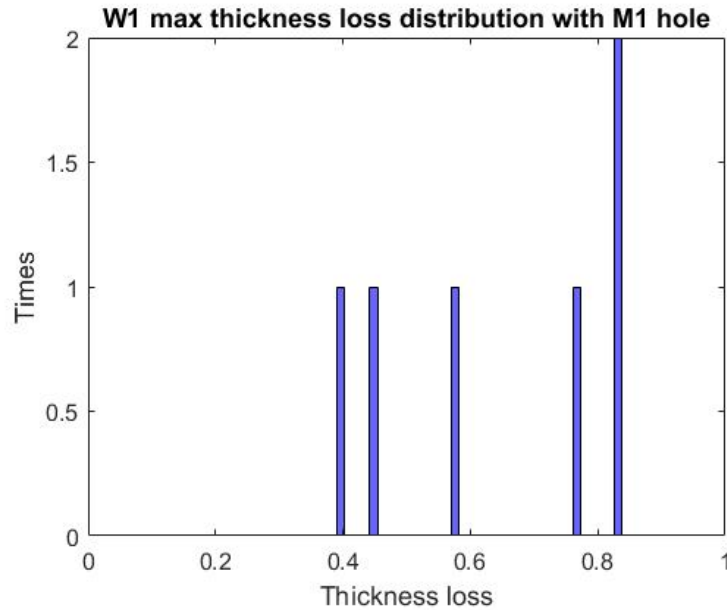
Figure 12.18: Max thickness loss distribution for W1 web corrosion patterns and M1 hole for beams without diaphragm.

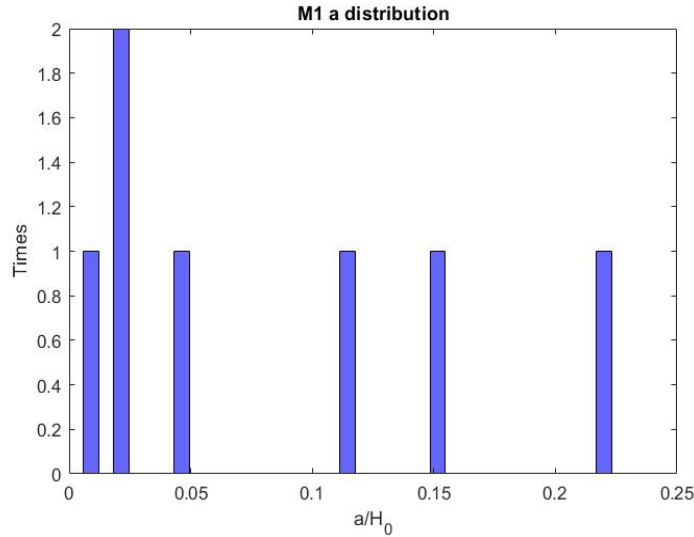
Figure 12.19: M1 web hole's pattern height distribution of W1 web corrosion pattern for beams without diaphragm.

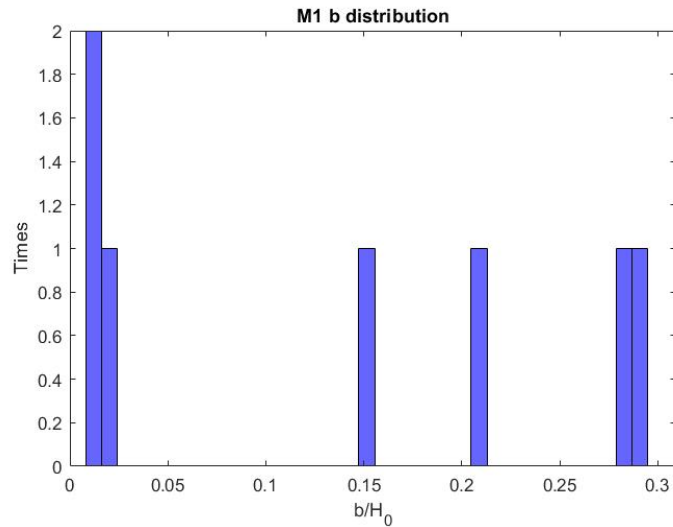
Figure 12.20: M1 web hole's pattern length distribution of W1 web corrosion pattern for beams without diaphragm.

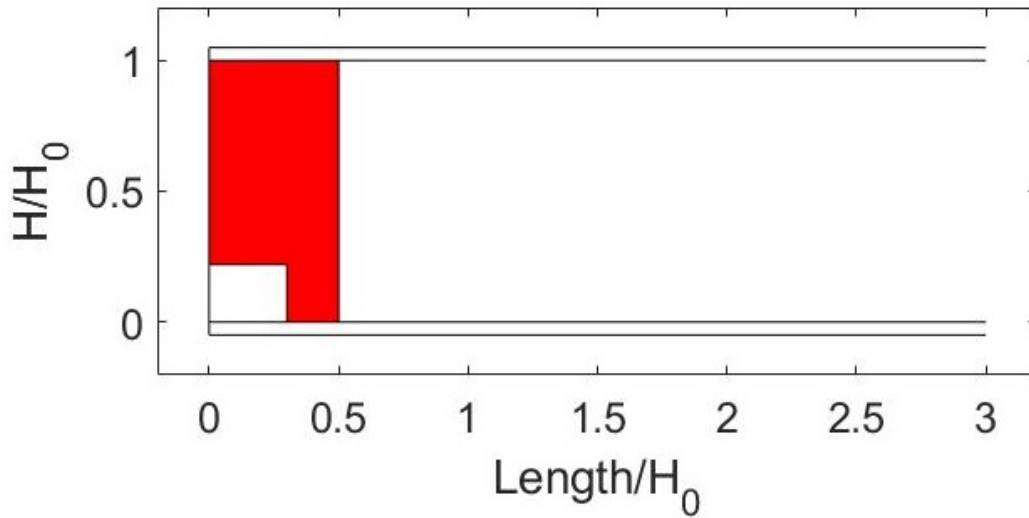
Figure 12.21: M1 extreme web hole pattern scenario of W1 web corrosion pattern, projected on W1 CASE C, for beams without diaphragm.

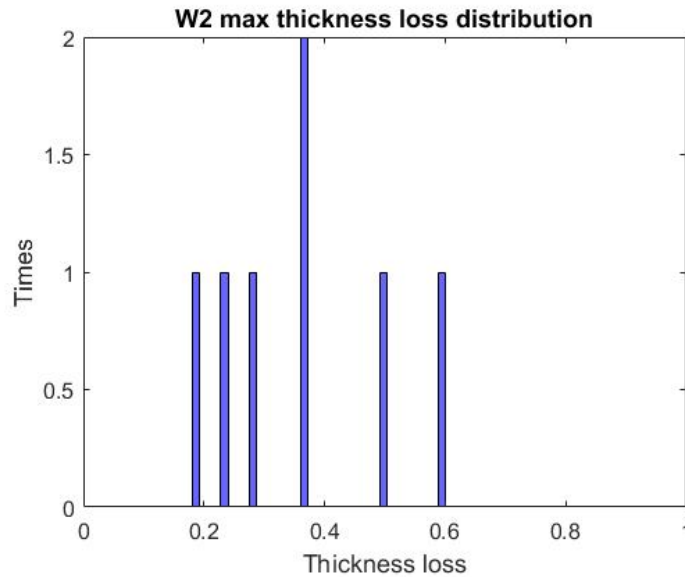
Figure 12.22: Web thickness loss distribution of W2 pattern for beams without diaphragm.

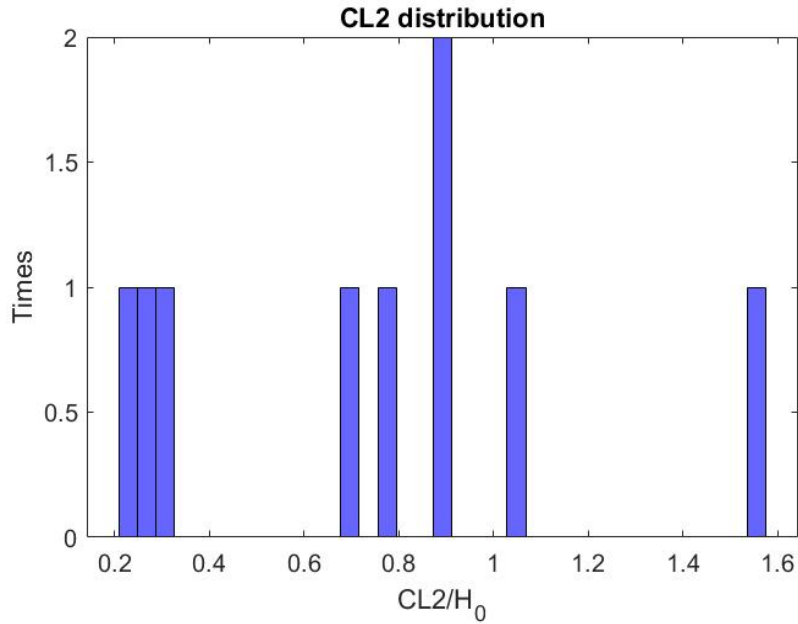
Figure 12.25: CL₂ distribution of W2 pattern for beams without diaphragm.

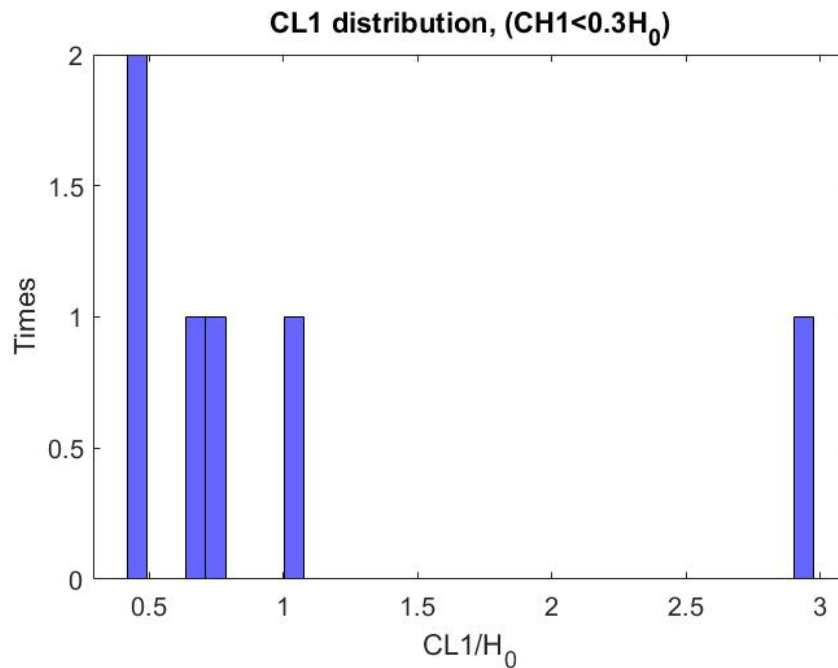
Figure 12.26: CL₁ distribution of W2 web corrosion pattern corroded up to 30% of H₀ for beams without diaphragm.

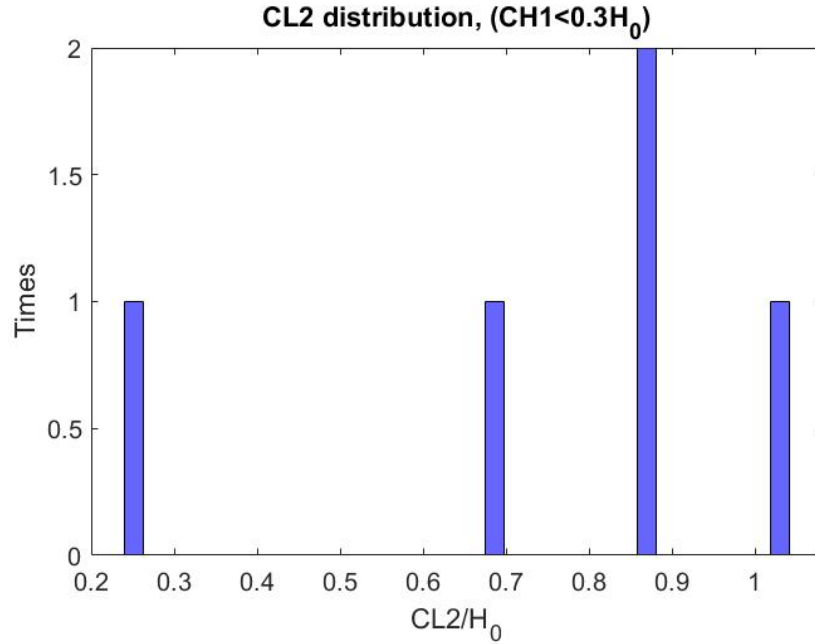
Figure 12.27: CL2 distribution of W2 web corrosion pattern corroded up to 30% of H_0 for beams without diaphragm.

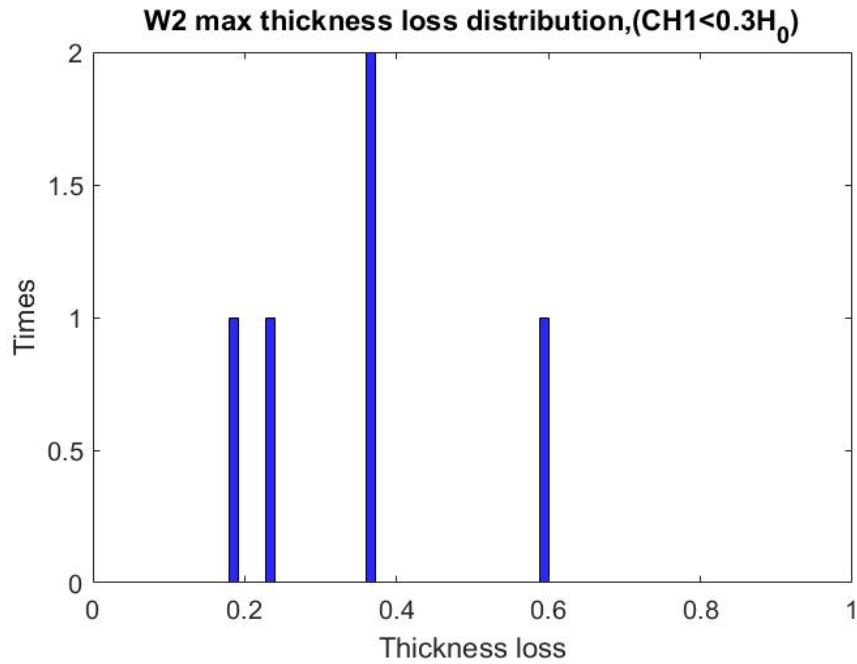
Figure 12.28: Max thickness loss distribution of W2 web corrosion pattern corroded up to 30% of H_0 for beams without diaphragm.

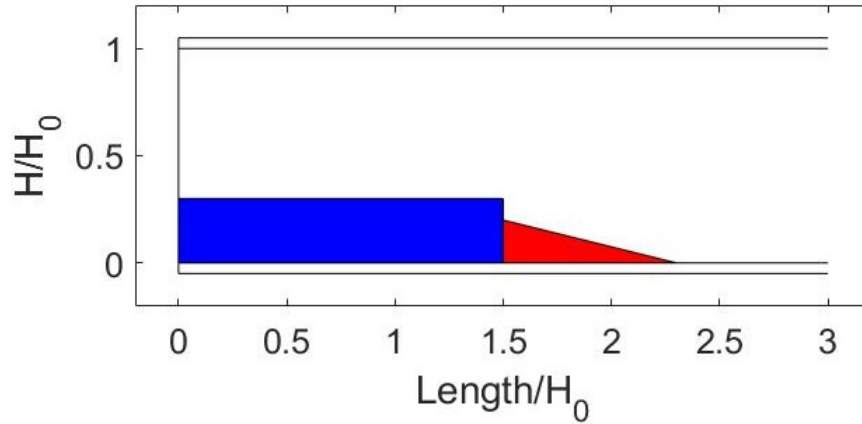
Figure 12.29: W1 CASE A extreme web corrosion scenario projected over W2 extreme web corrosion scenario.

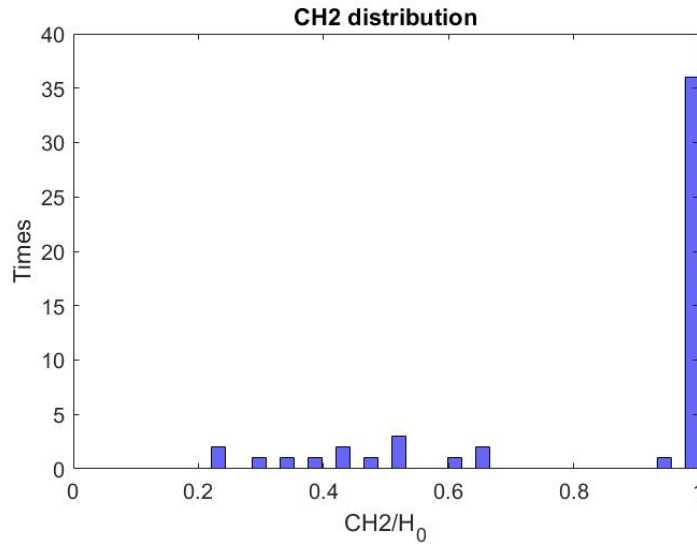
Figure 12.30: CH₂ distribution of W3 web corrosion pattern for beams without diaphragm.

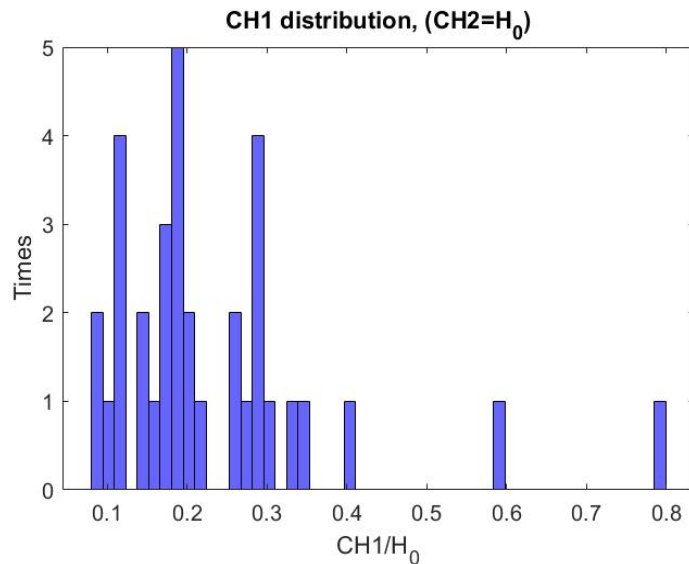
Figure 12.31: CH₁ distribution of W3 web corrosion pattern with full height corrosion for beams without diaphragm.

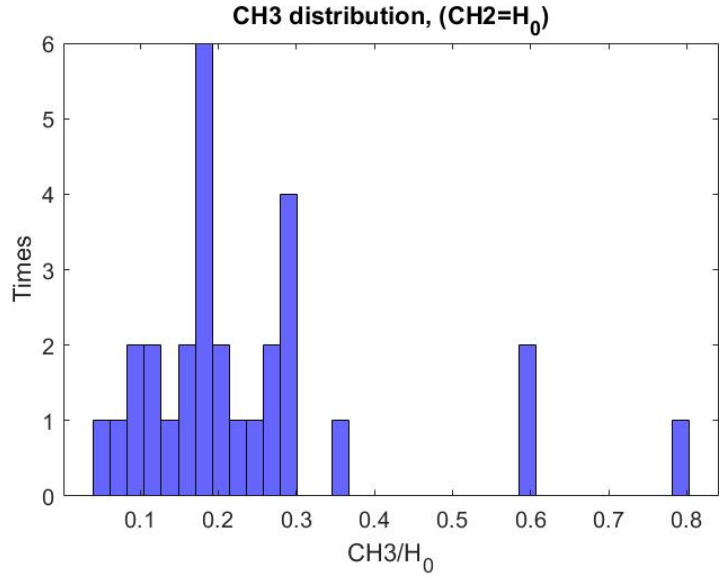
Figure 12.32: CH₃ distribution of W3 web corrosion pattern with full height corrosion for beams without diaphragm.

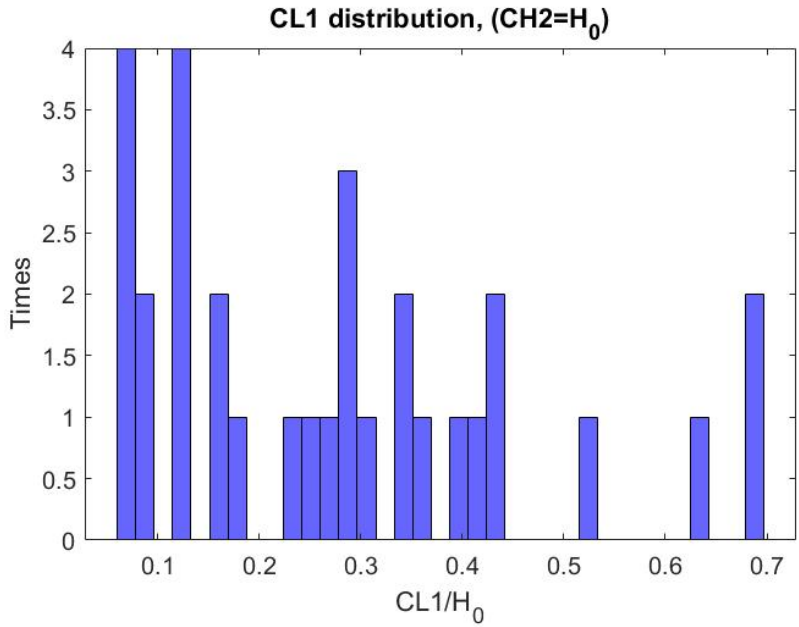
Figure 12.33: CL1 distribution of W3 web corrosion pattern with full height corrosion for beams without diaphragm.

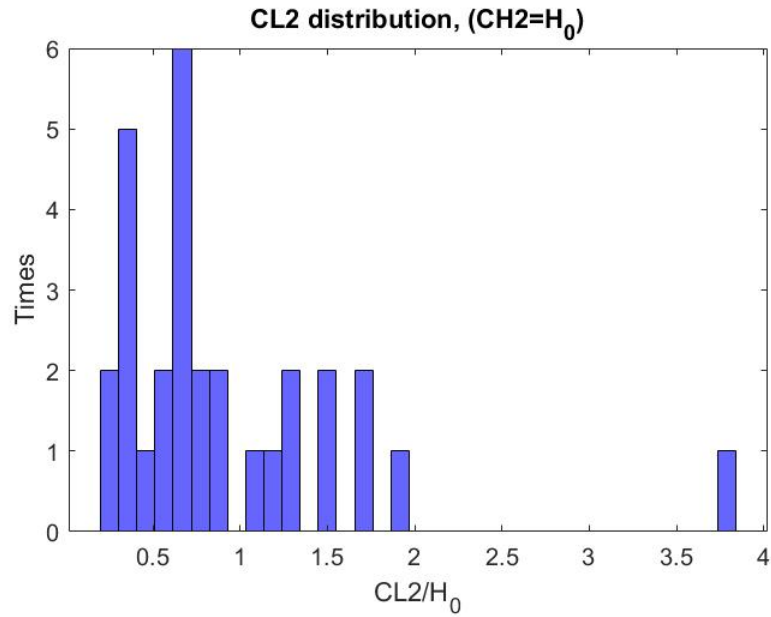
Figure 12.34: CL₂ distribution of W3 web corrosion pattern with full height corrosion for beams without diaphragm.

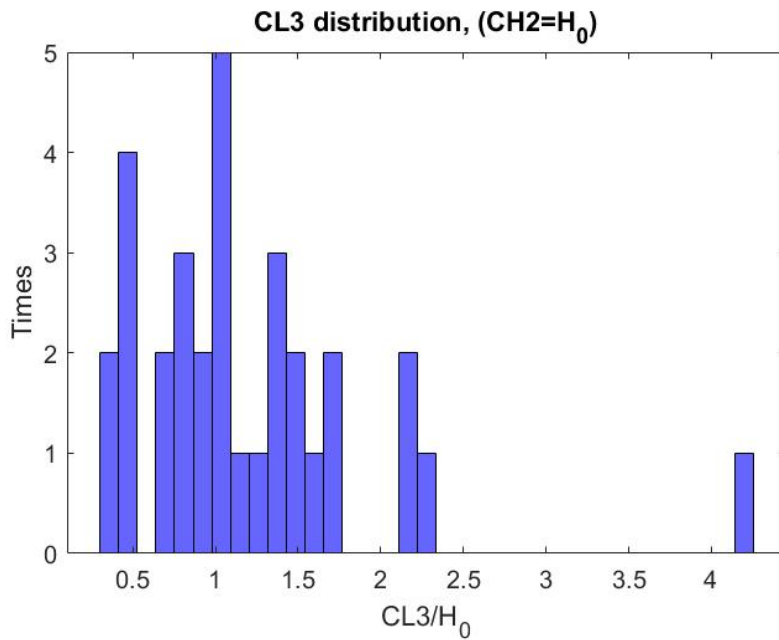
Figure 12.35: CL₃ distribution of W3 web corrosion pattern with full height corrosion for beams without diaphragm.

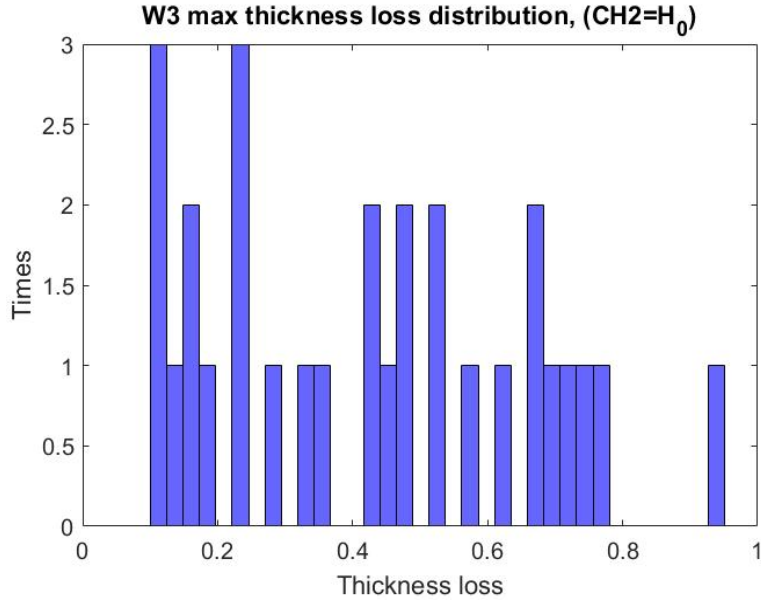
Figure 12.36: Max web thickness loss distribution of W3 web corrosion pattern with full height corrosion for beams without diaphragm.

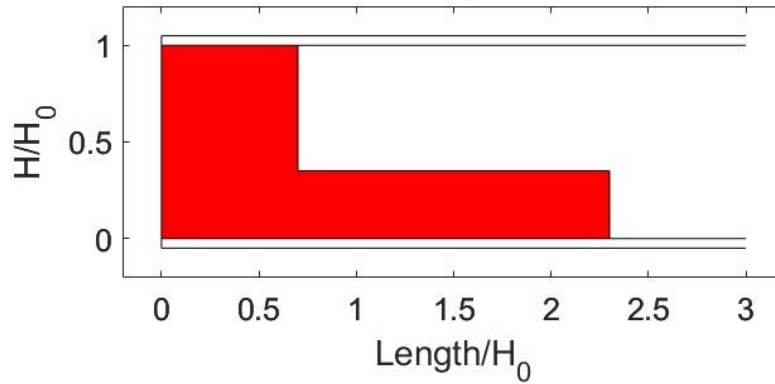
Figure 12.37: Extreme W3 web corrosion scenario for beams without diaphragm.

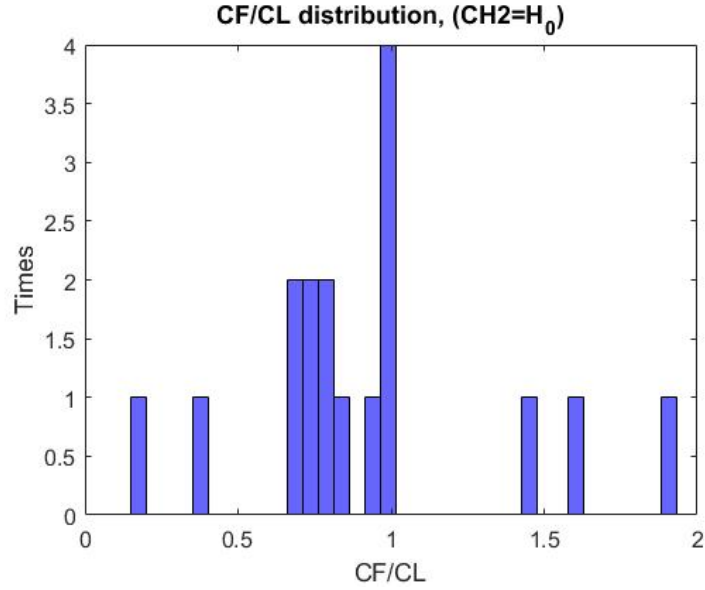
Figure 12.38: Ratio of flange to web corrosion length distribution of W3 web corrosion pattern with full height corrosion for beams without diaphragm.

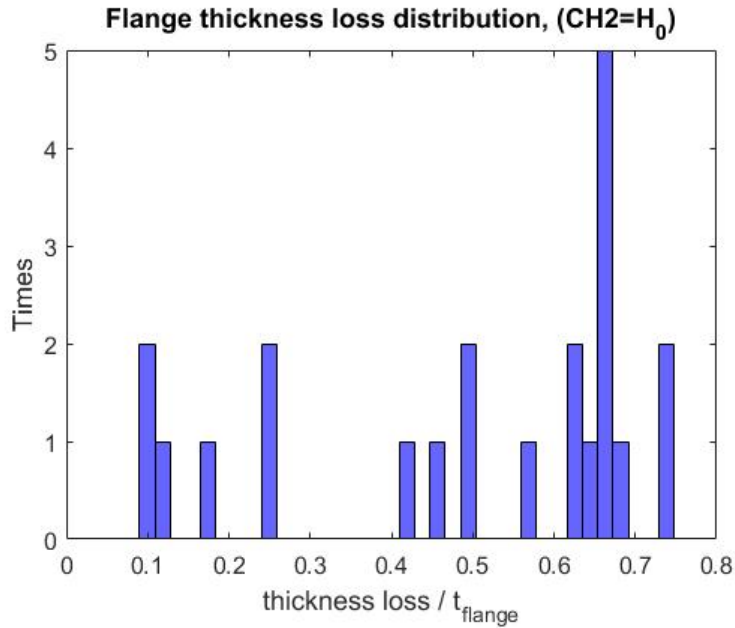
Figure 12.39: Max flange loss thickness distribution of W3 web corrosion pattern with full height corrosion for beams without diaphragm.

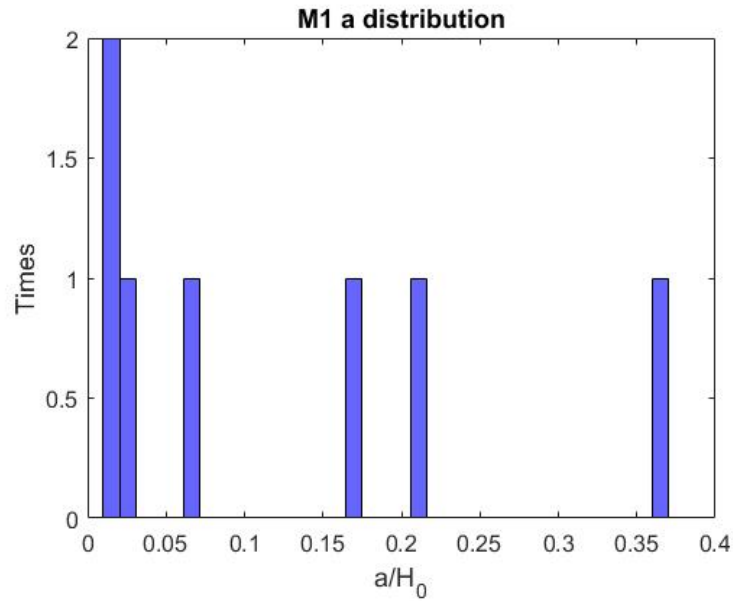
Figure 12.40: M1 web hole's pattern height distribution of W3 web corrosion pattern for beams without diaphragm.
