September 2019

Report No. 19-008

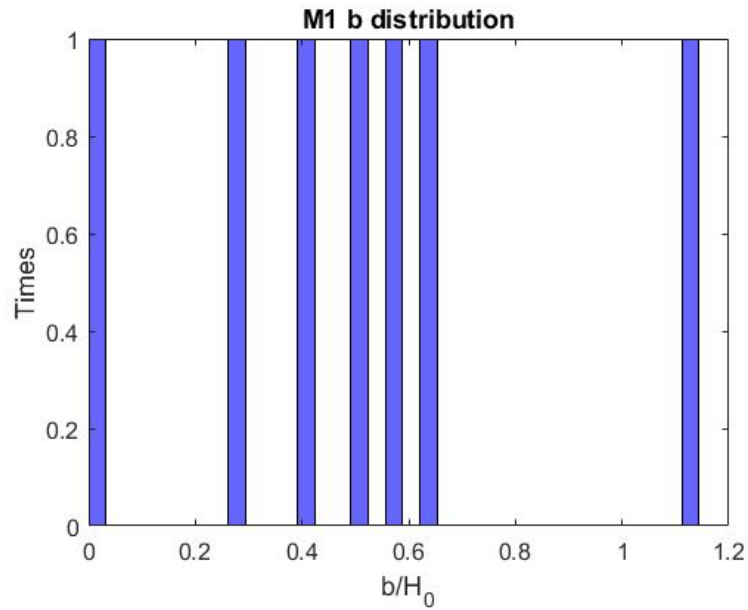
Figure 12.41: M1 web hole's pattern length distribution of W1 web corrosion pattern for beams without diaphragm.

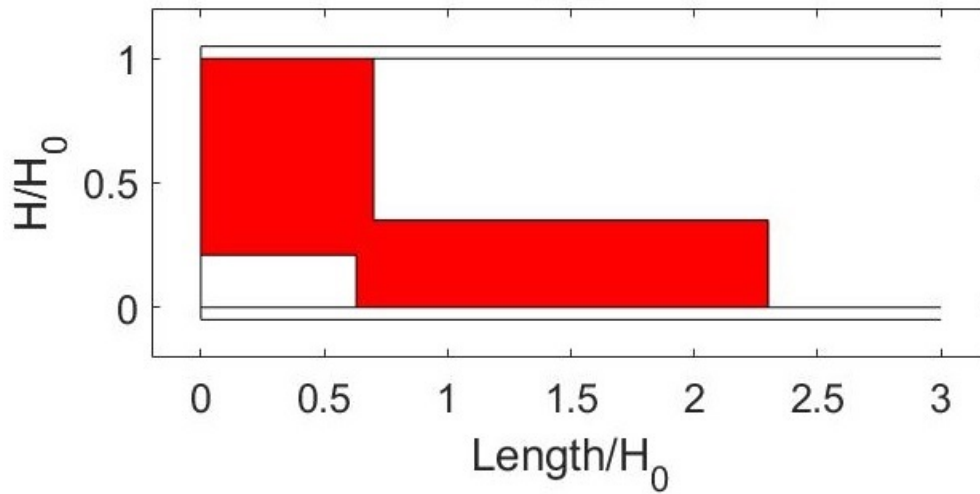
Figure 12.42: M1 extreme web hole pattern scenario of W1 web corrosion pattern, projected on W3 extreme corrosion scenario, for beams without diaphragm.

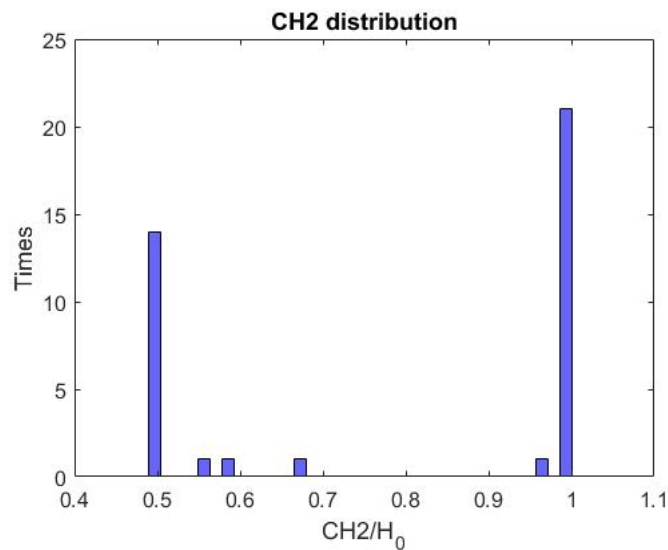
Figure 12.43: CH2 distribution of W4 web corrosion pattern for beams without diaphragm.

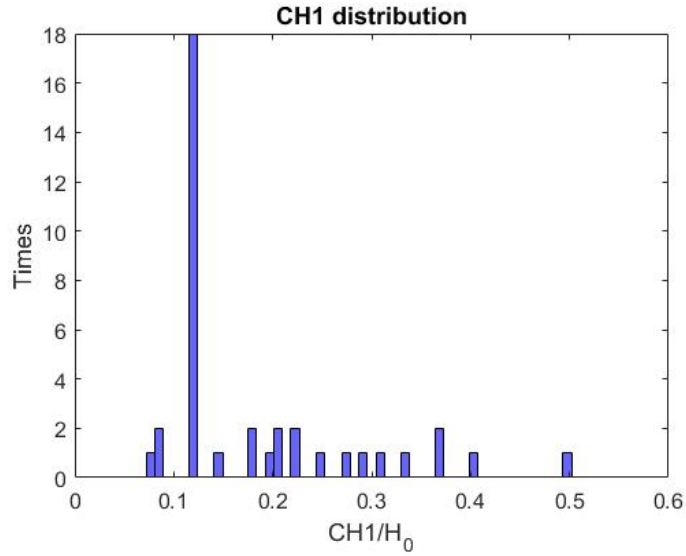
Figure 12.44: CH1 distribution of W4 web corrosion pattern for beams without diaphragm.

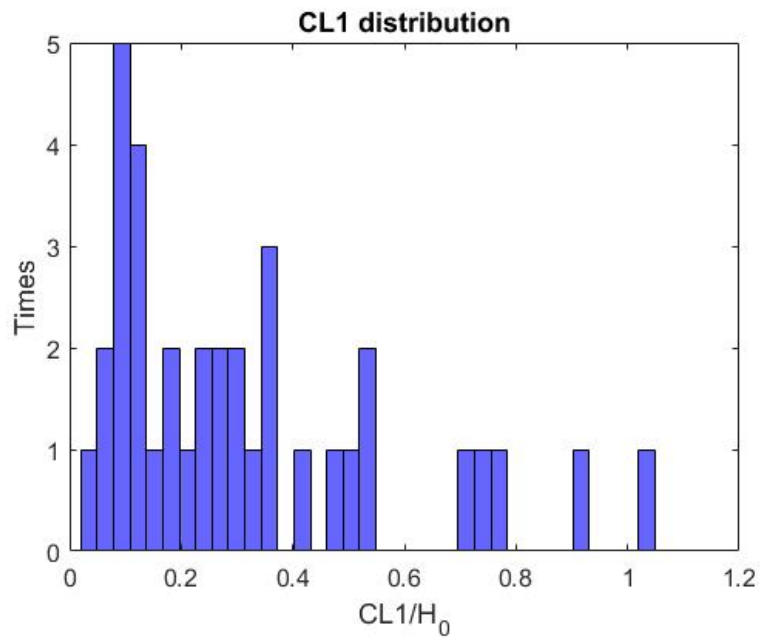
Figure 12.45: CL1 distribution of W4 web corrosion pattern for beams without diaphragm.

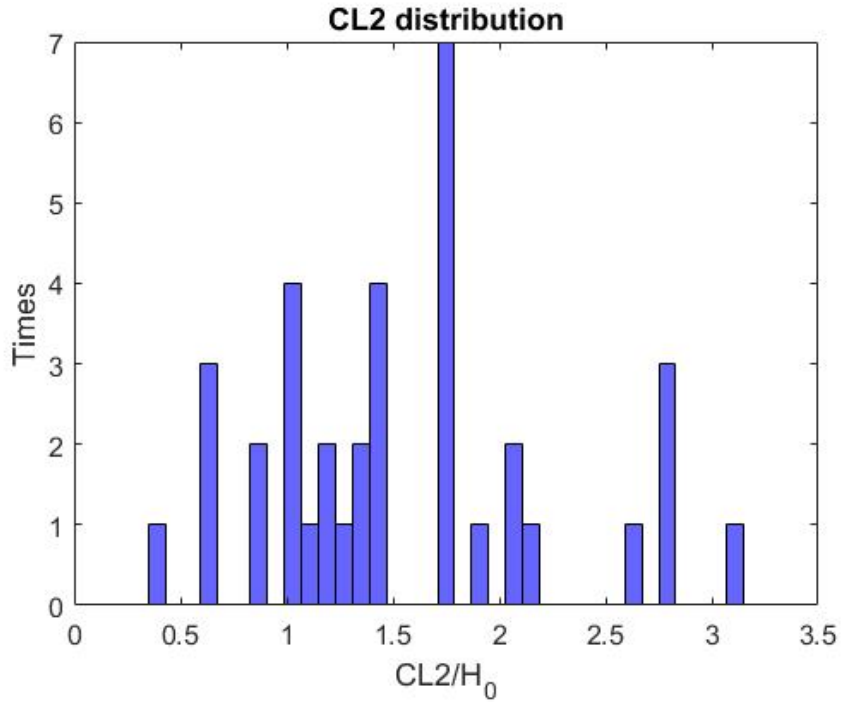
Figure 12.46: CL2 distribution of W4 web corrosion pattern for beams without diaphragm.

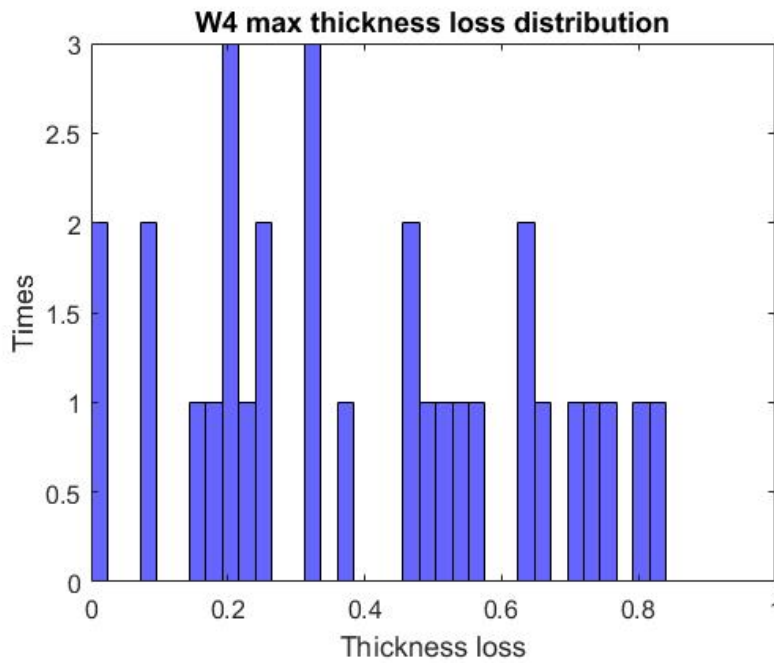
Figure 12.47: Max web thickness loss distribution of W4 web corrosion pattern for beams without diaphragm.

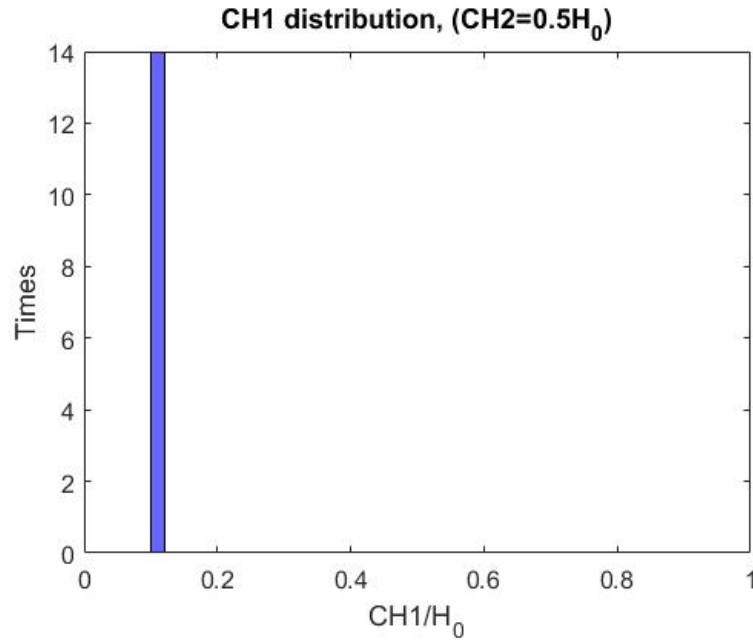
Figure 12.48: CH1 distribution of W4 web corrosion pattern, with corrosion height up to 50% of H_0 for beams without diaphragm.

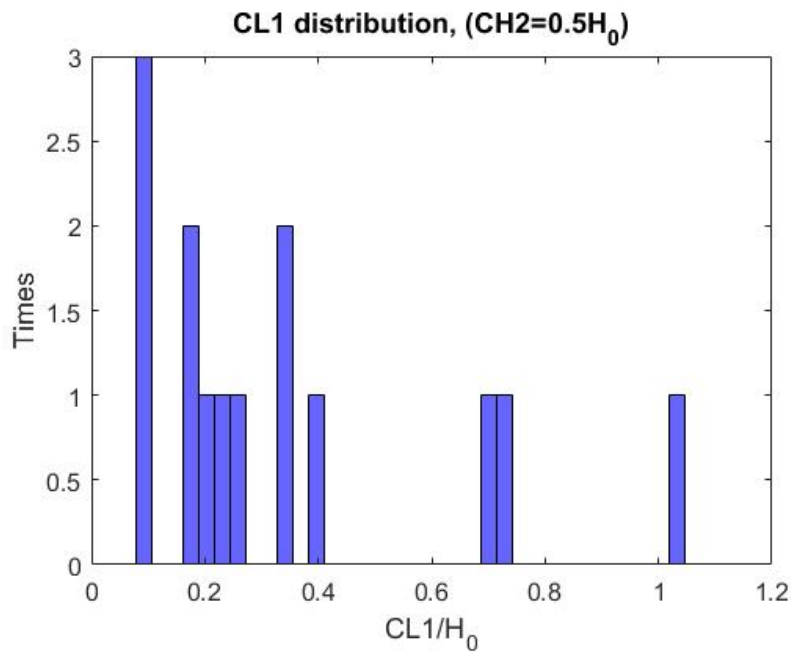
Figure 12.49: CL1 distribution of W4 web corrosion pattern, with corrosion height up to 50% of H_0 for beams without diaphragm.

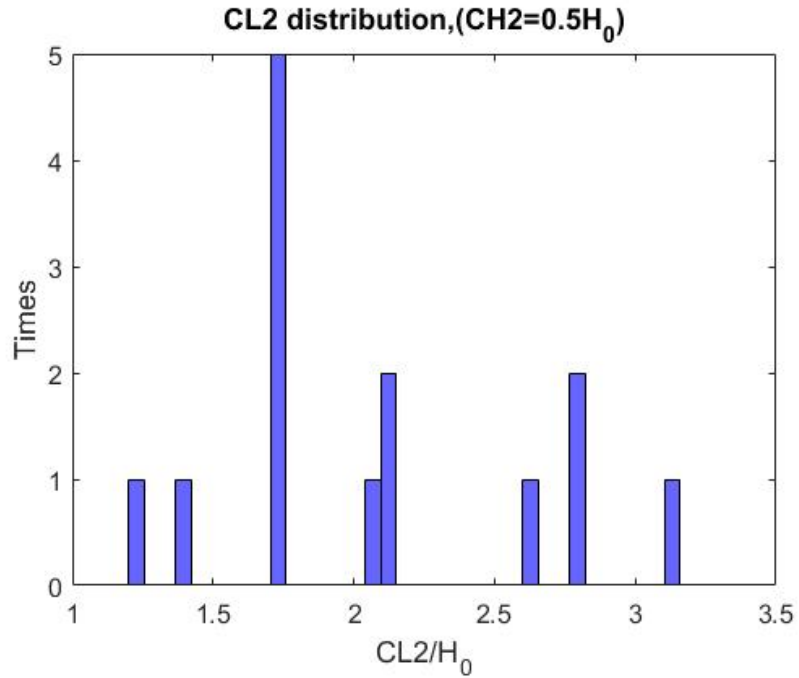
Figure 12.50: CL2 distribution of W4 web corrosion pattern, with corrosion height up to 50% of H_0 for beams without diaphragm.

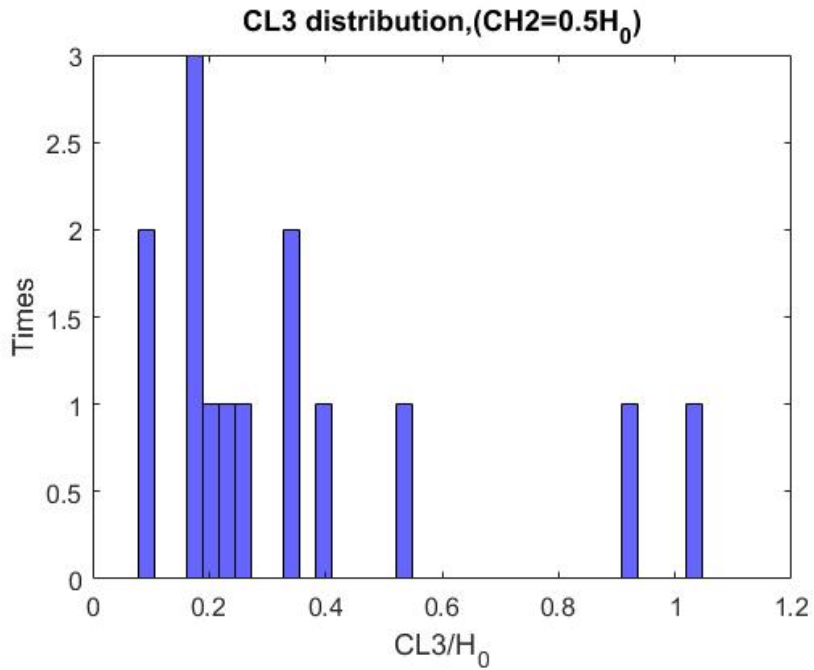
Figure 12.51: CL3 distribution of W4 web corrosion pattern, with corrosion height up to 50% of H_0 for beams without diaphragm.

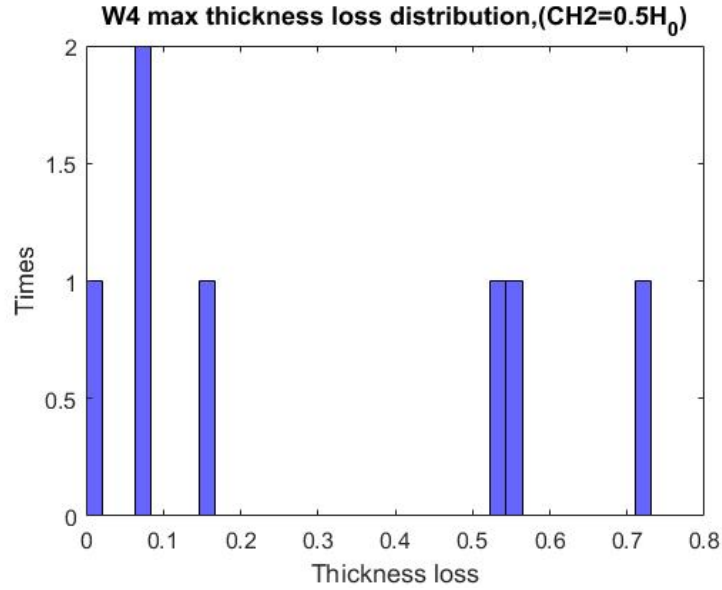
Figure 12.52: Max web thickness loss distribution of W4 web corrosion pattern, with corrosion height up to 50% of H_0 for beams without diaphragm.

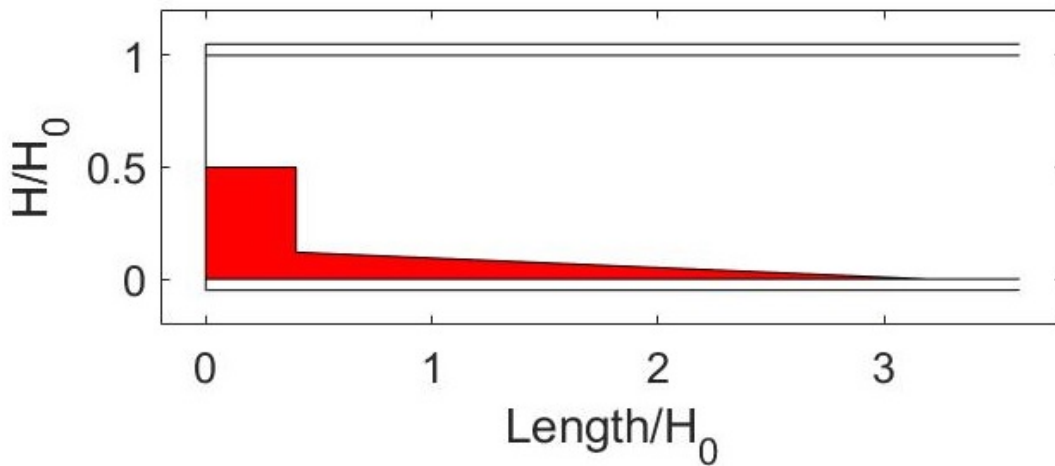
Figure 12.53: First extreme W4 web corrosion scenario for beams without diaphragm.

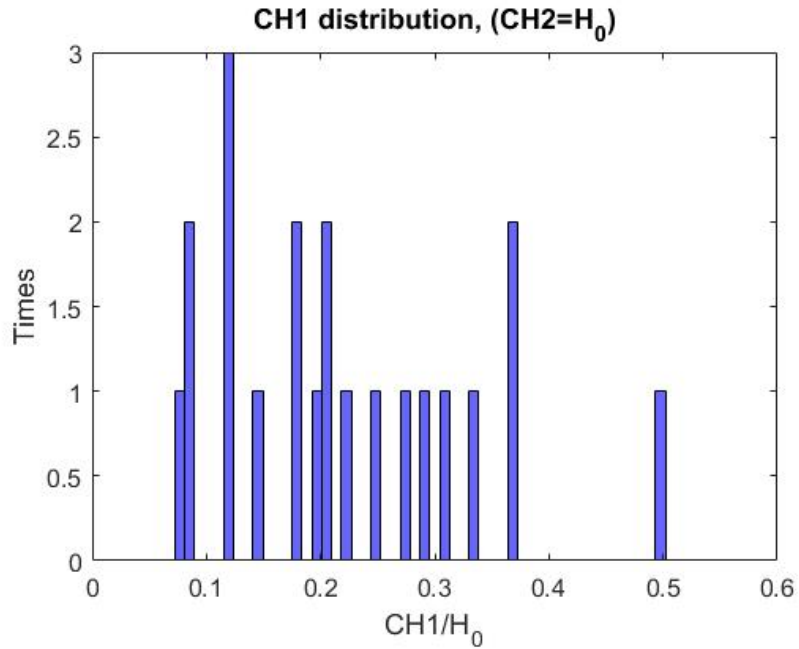
Figure 12.54: CH1 distribution of W4 web corrosion pattern, with full height corrosion for beams without diaphragm.

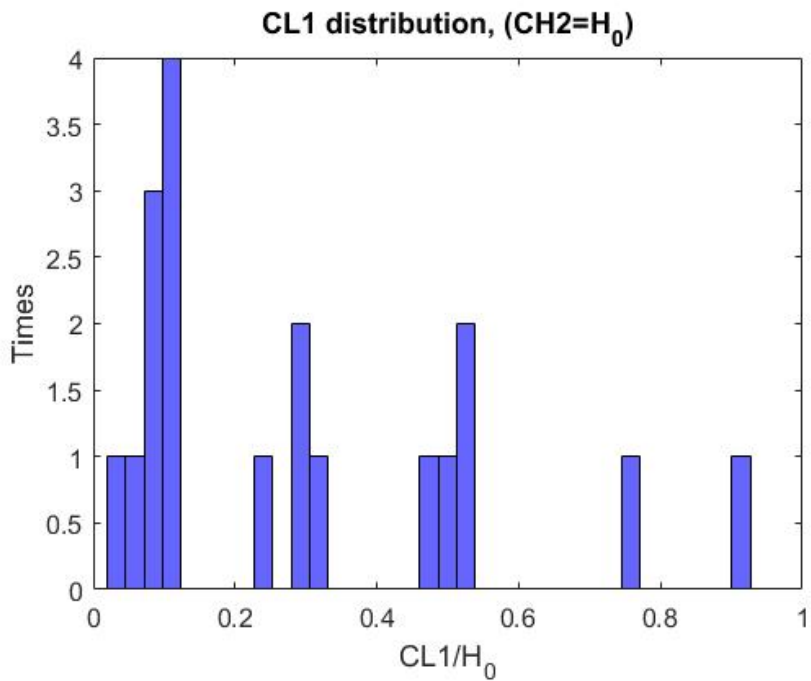
Figure 12.55: CL1 distribution of W4 web corrosion pattern, with full height corrosion for beams without diaphragm.

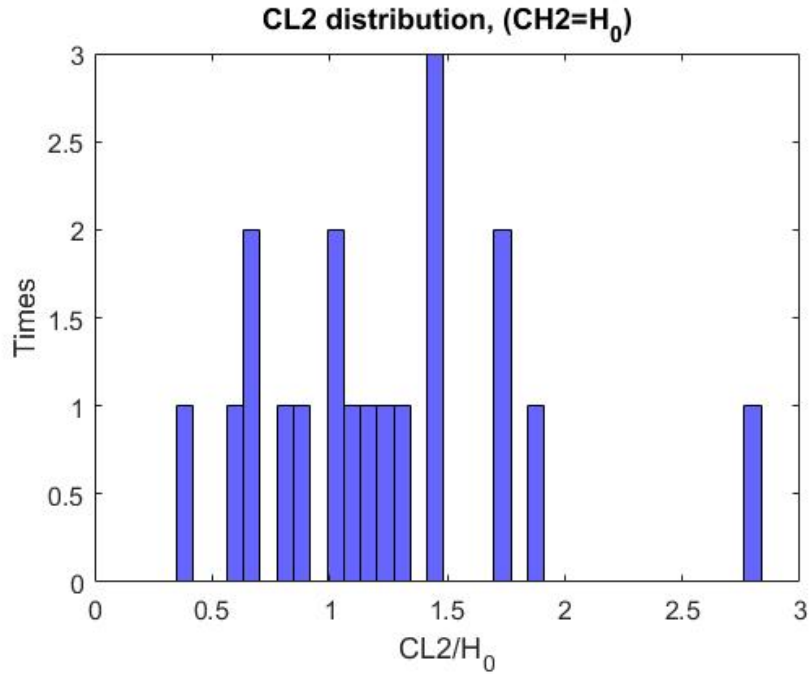
Figure 12.56: CL2 distribution of W4 web corrosion pattern, with full height corrosion for beams without diaphragm.

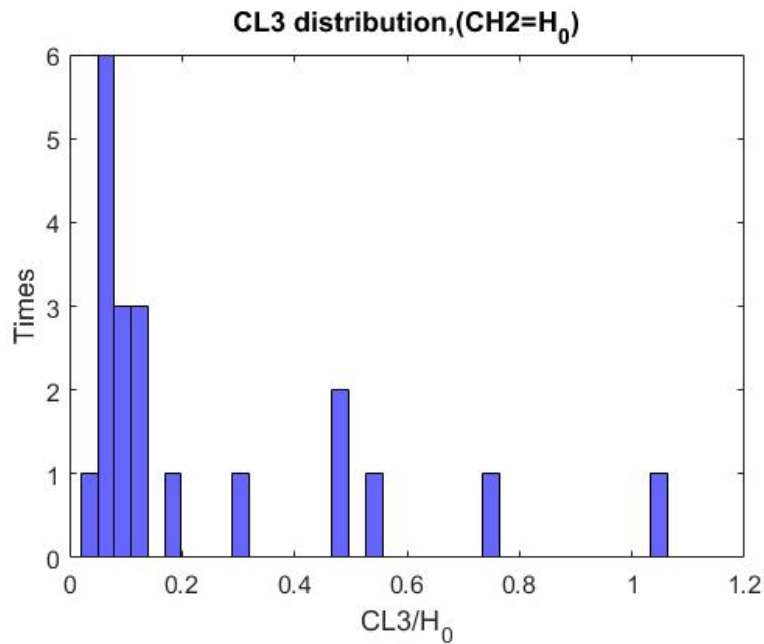
Figure 12.57: CL3 distribution of W4 web corrosion pattern, with full height corrosion for beams without diaphragm.

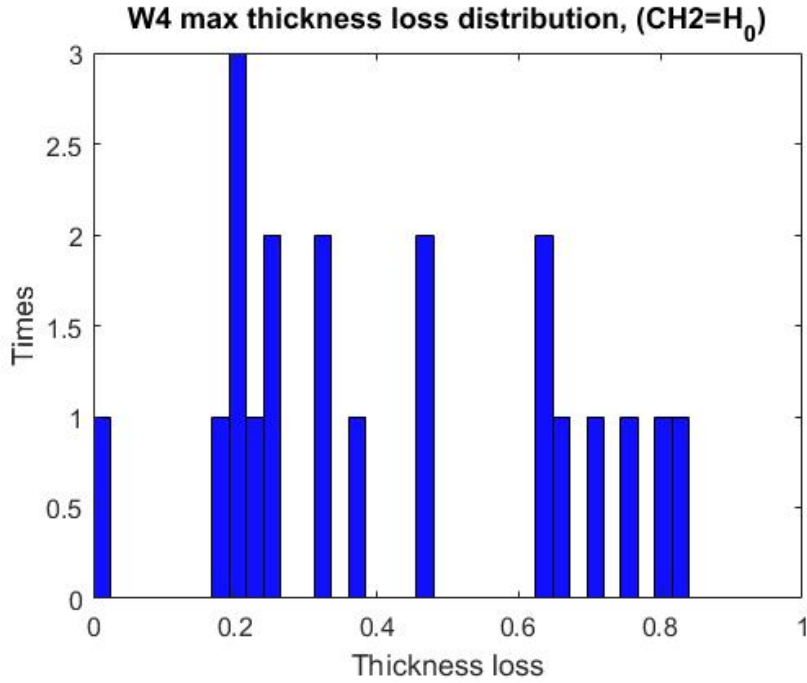
Figure 12.58: Max web thickness loss distribution of W4 web corrosion pattern, with full height corrosion for beams without diaphragm.

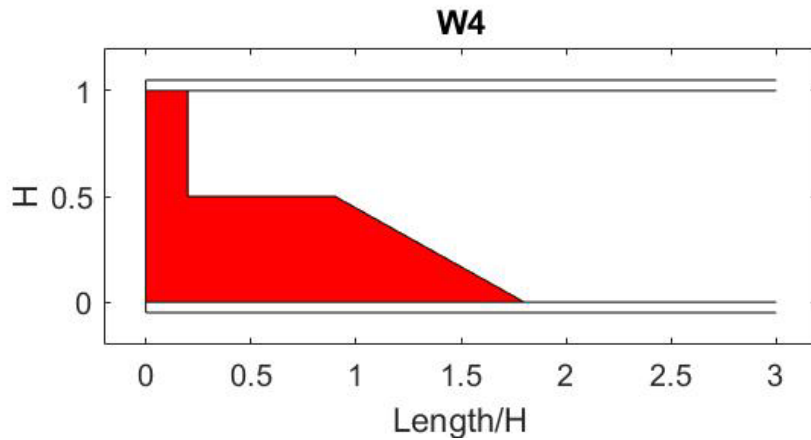
Figure 12.59: Second extreme W4 web corrosion scenario for beams without diaphragm.

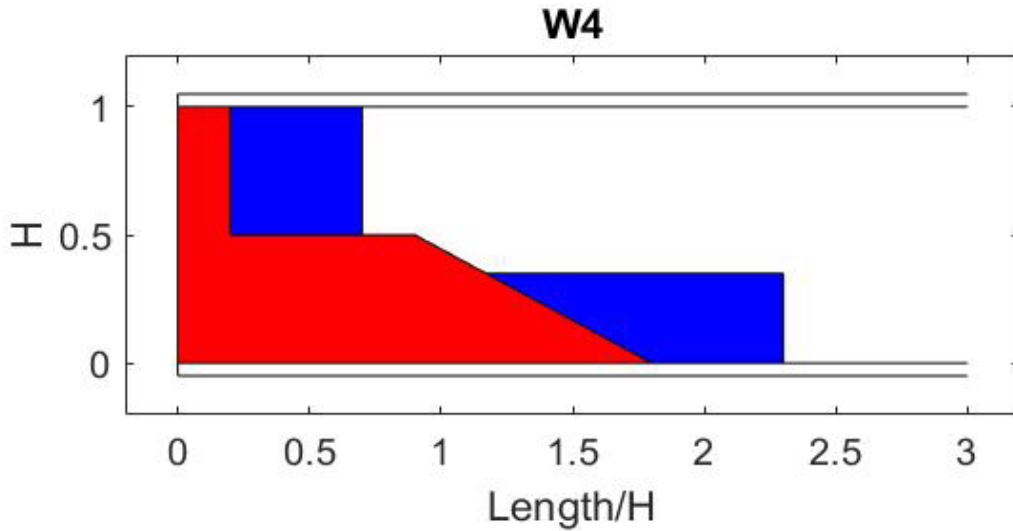
Figure 12.60: First extreme W4 scenario (red) projected over extreme W3 web corrosion scenario (blue).

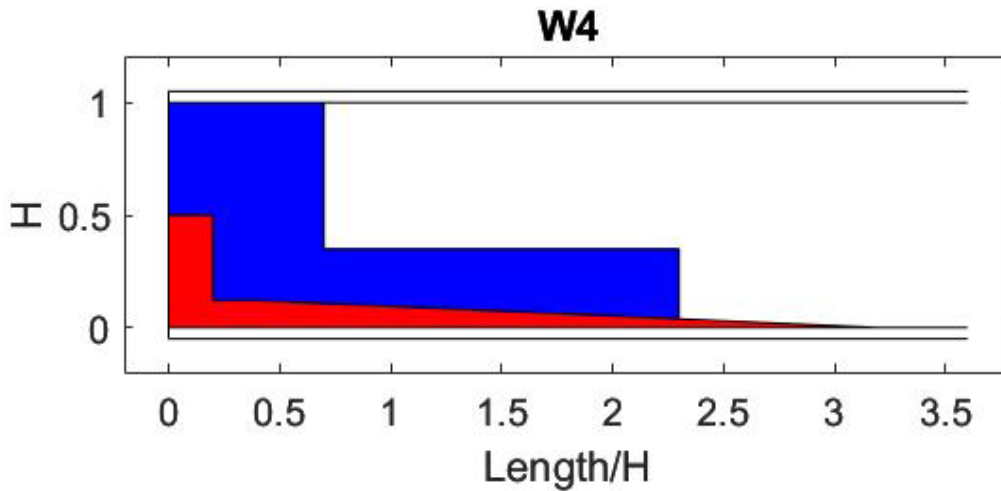
Figure 12.61: Second extreme W4 scenario (red) projected over extreme W3 web corrosion scenario (blue).

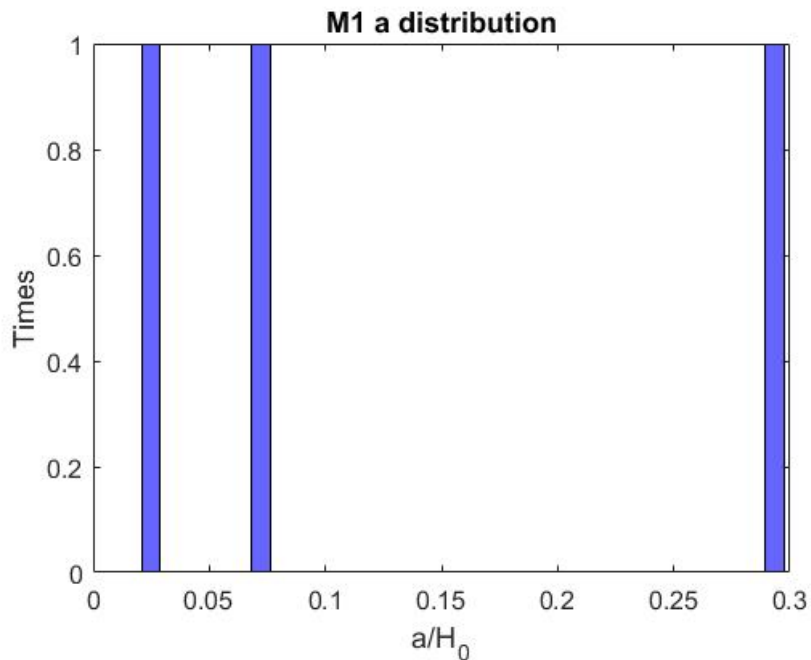
Figure 12.62: M1 web hole's pattern height distribution of W4 web corrosion pattern for beams without diaphragm.

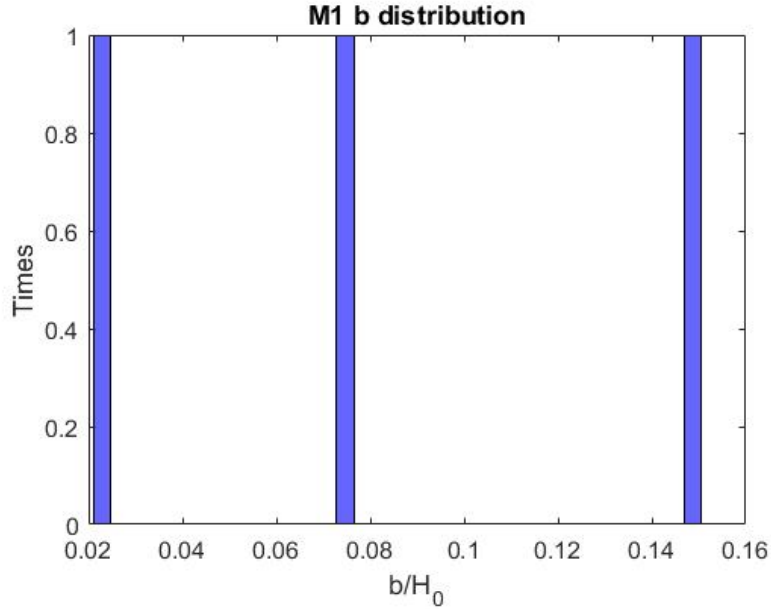
Figure 12.63: M1 web hole's pattern length distribution of W3 web corrosion pattern for beams without diaphragm.

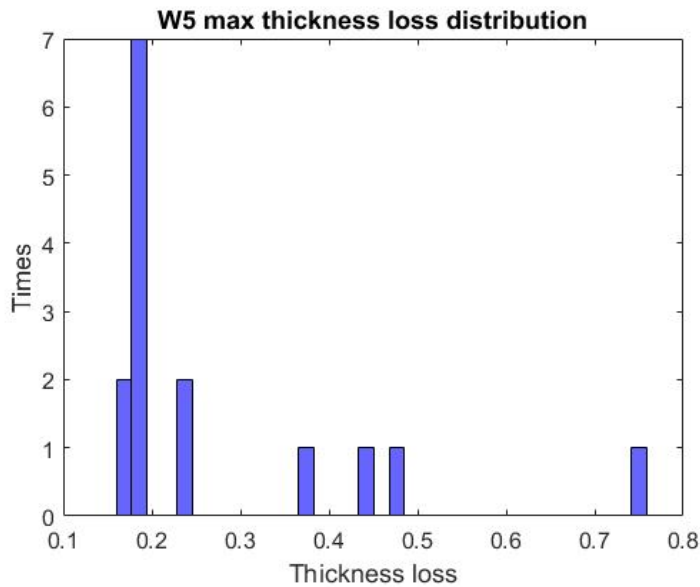
Figure 12.64: Max web thickness loss distribution of W5 web corrosion pattern for beams without diaphragm.

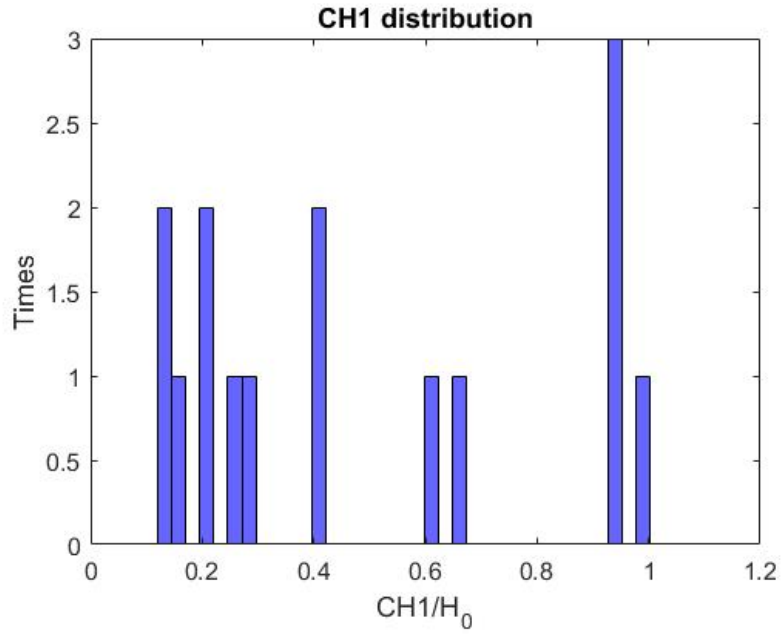
Figure 12.65: CH2 distribution of W5 web corrosion pattern for beams without diaphragm.

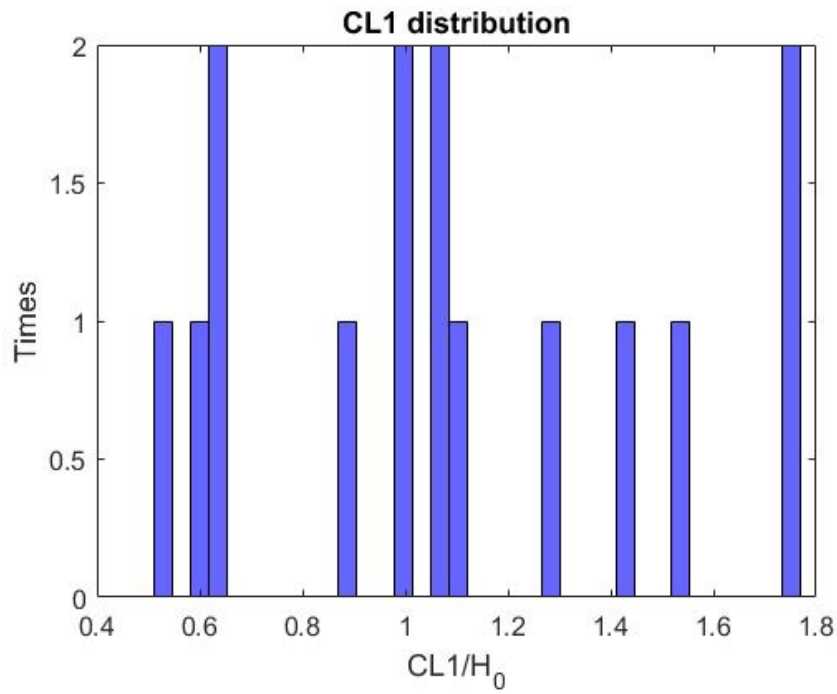
Figure 12.66: Max web thickness loss distribution of W5 web corrosion pattern for beams without diaphragm.

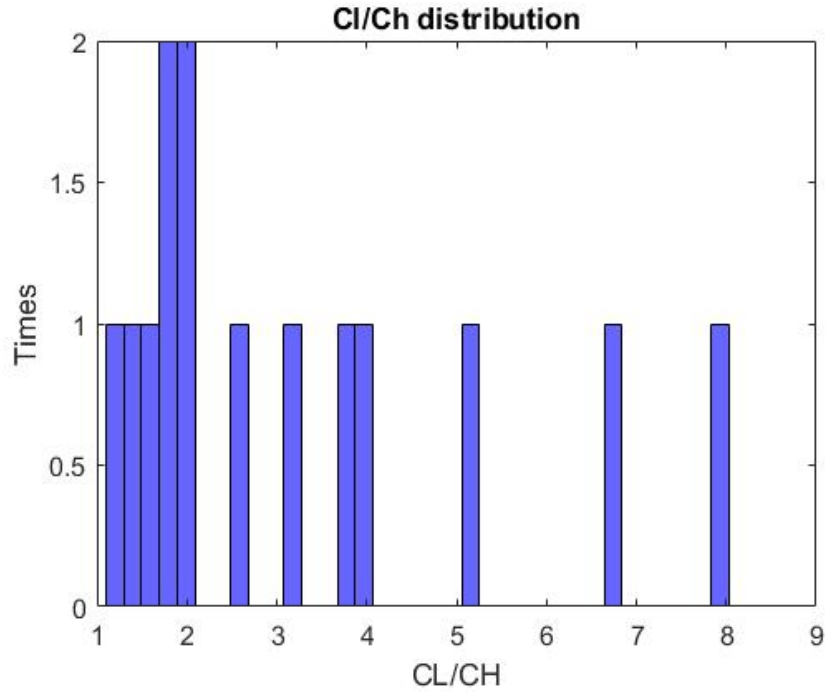
Figure 12.67: Ratio of corrosion length to height of W1 web corrosion pattern for beams without diaphragm.

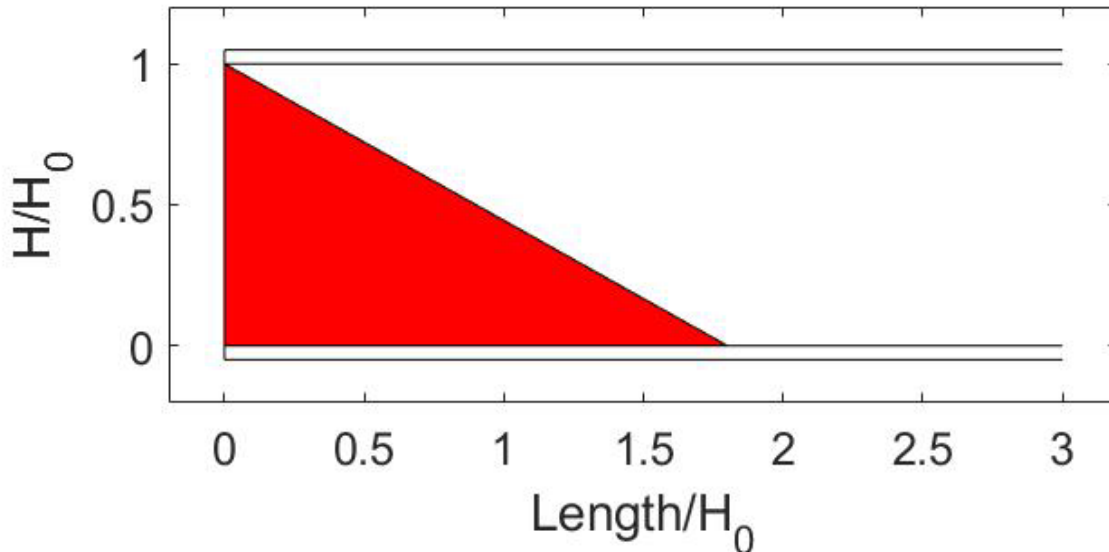
Figure 12.68: Extreme W4 web corrosion scenario for beams without diaphragm.

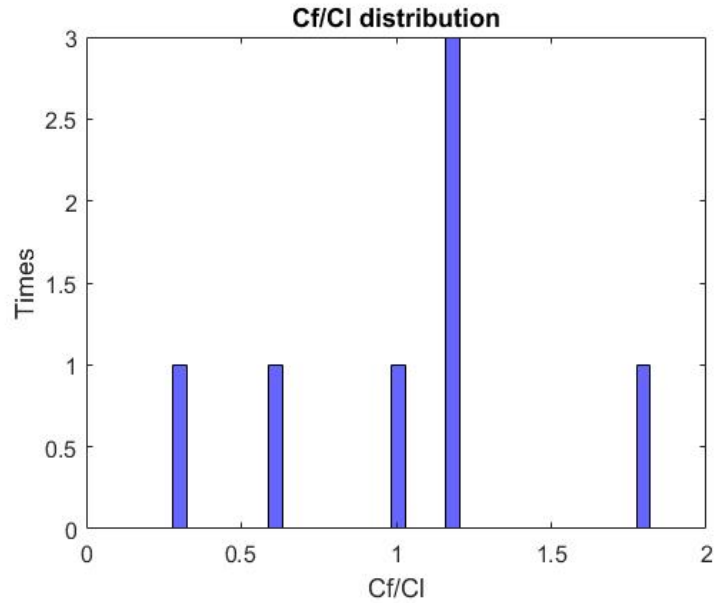
Figure 12.69: Ratio of flange to web corrosion length distribution of W5 web corrosion pattern for beams without diaphragm.

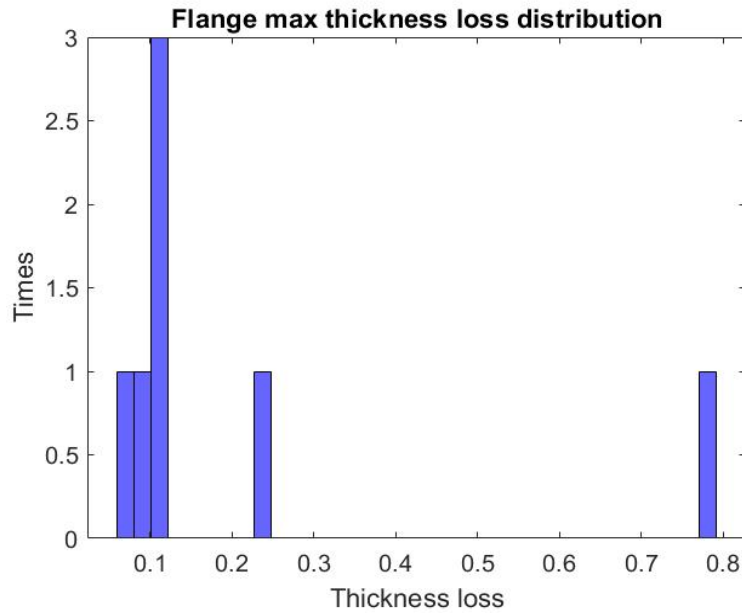
Figure 12.70: Max flange thickness loss distribution of W5 web corrosion pattern for beams without diaphragm.

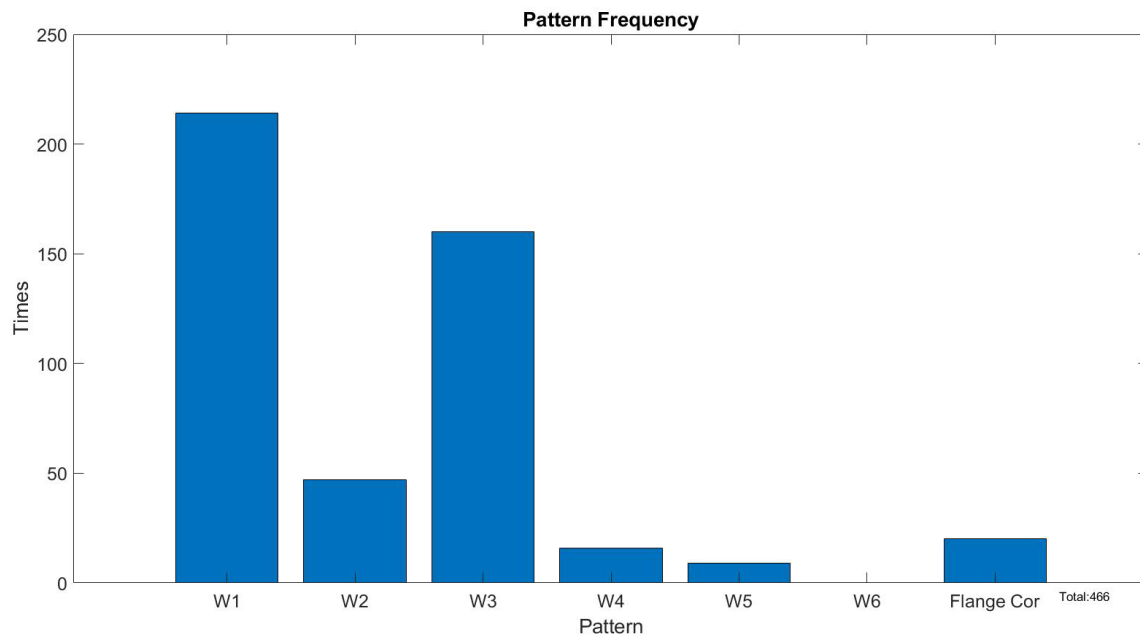
Figure 12.71: Web corrosion patterns distribution for beams with diaphragm.

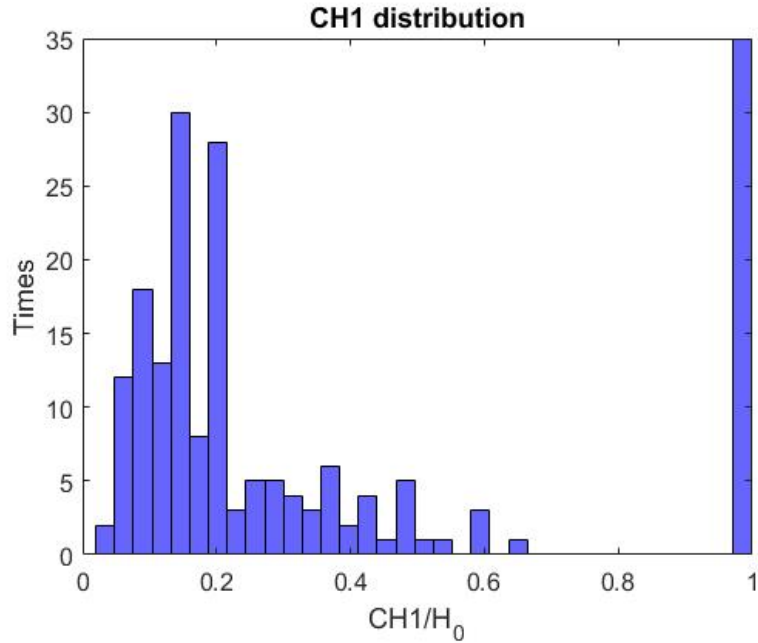
Figure 12.72: CH1 distribution of W1 web pattern for beams with diaphragm (total = 189).

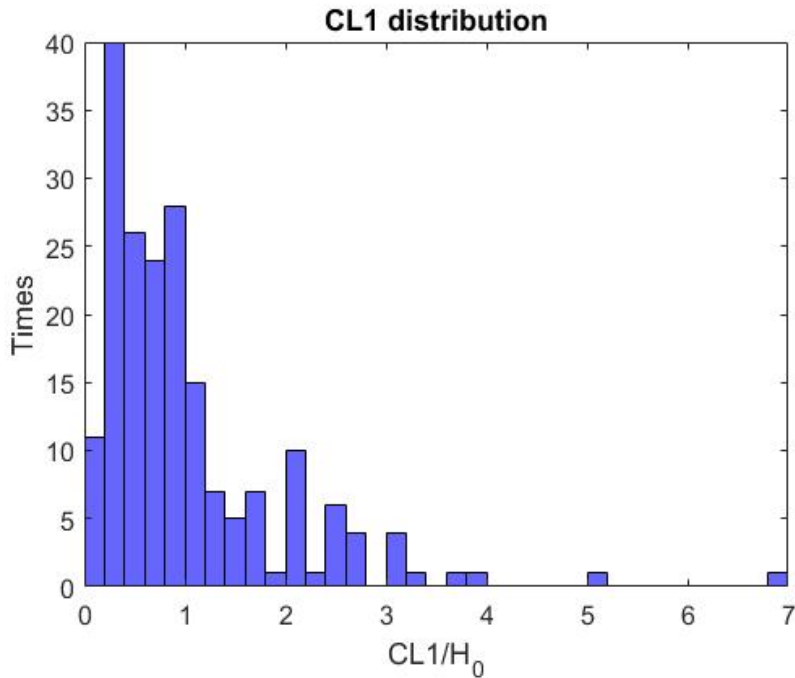
Figure 12.73: CL1 distribution of W1 web corrosion pattern for beams with diaphragm.

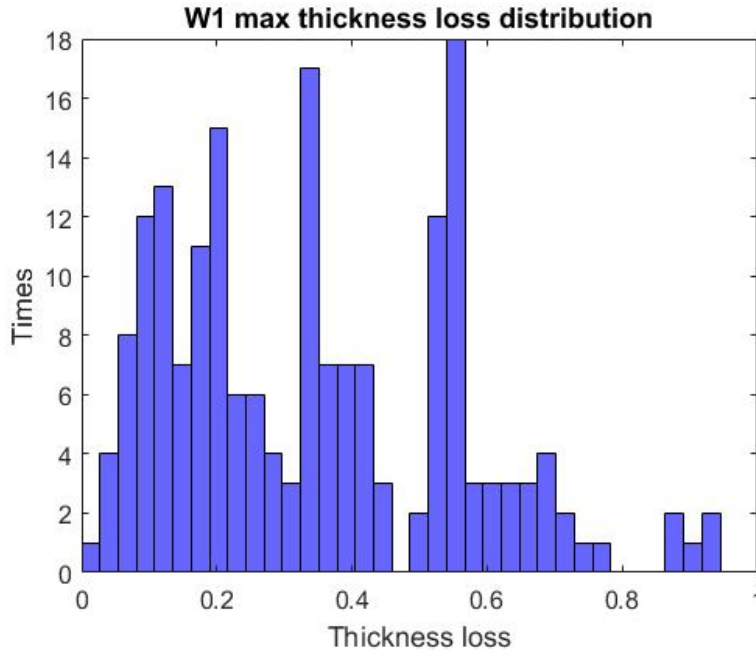
Figure 12.74: Max thickness loss distribution of W1 web corrosion pattern for beams with diaphragm.

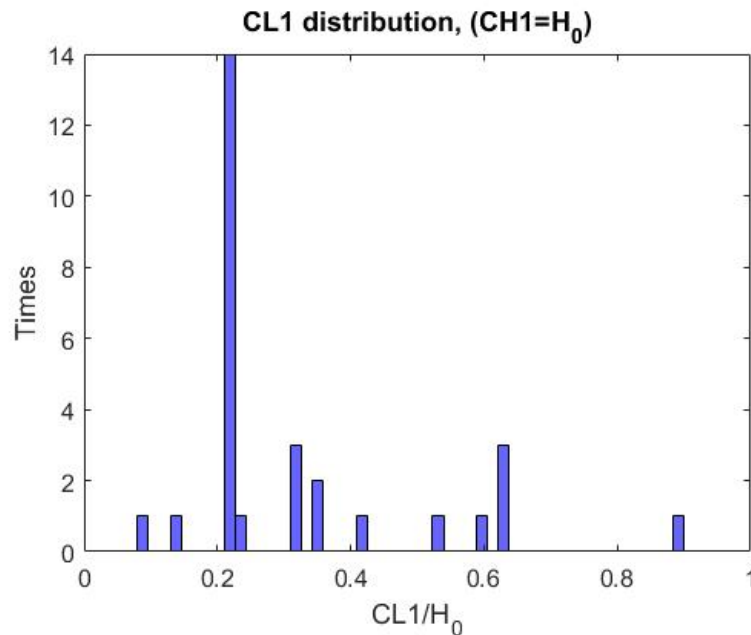
Figure 12.75: CL1 distribution of full height W1 web corrosion pattern for beams with diaphragm.

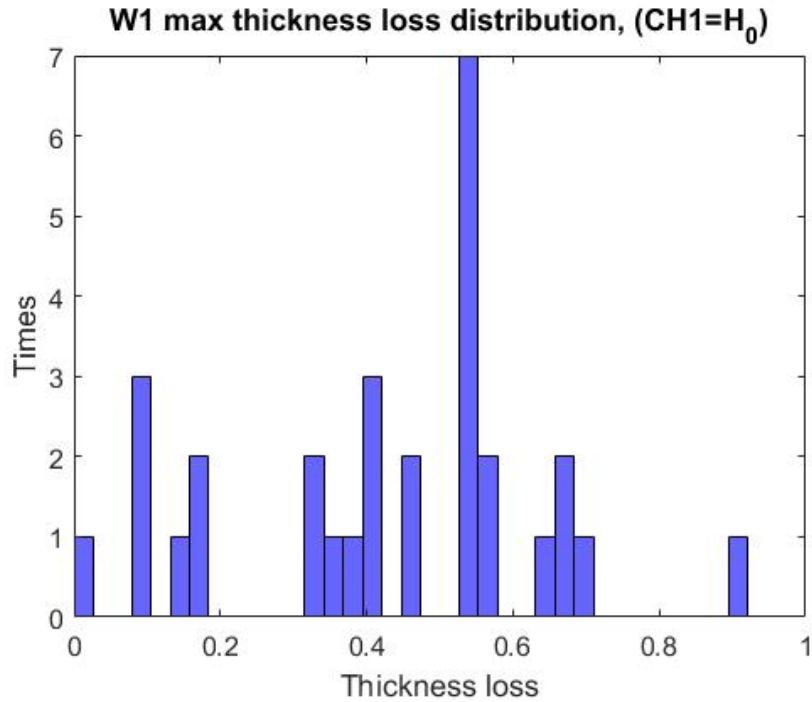
Figure 12.76: Max thickness loss distribution of full height W1 web corrosion pattern for beams with diaphragm.

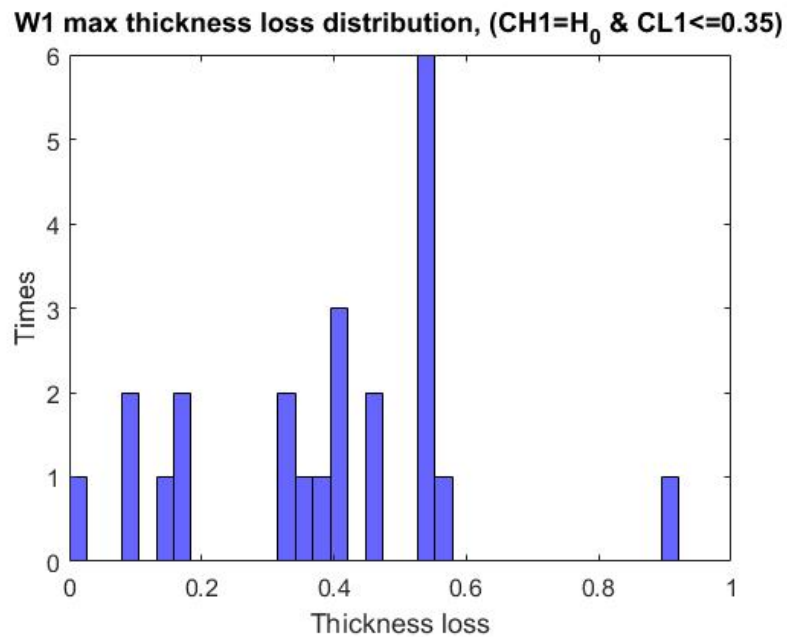
Figure 12.77: Max web thickness loss distribution of W1 web corrosion pattern, with corrosion height up to 35% of H₀, for beams with diaphragm.

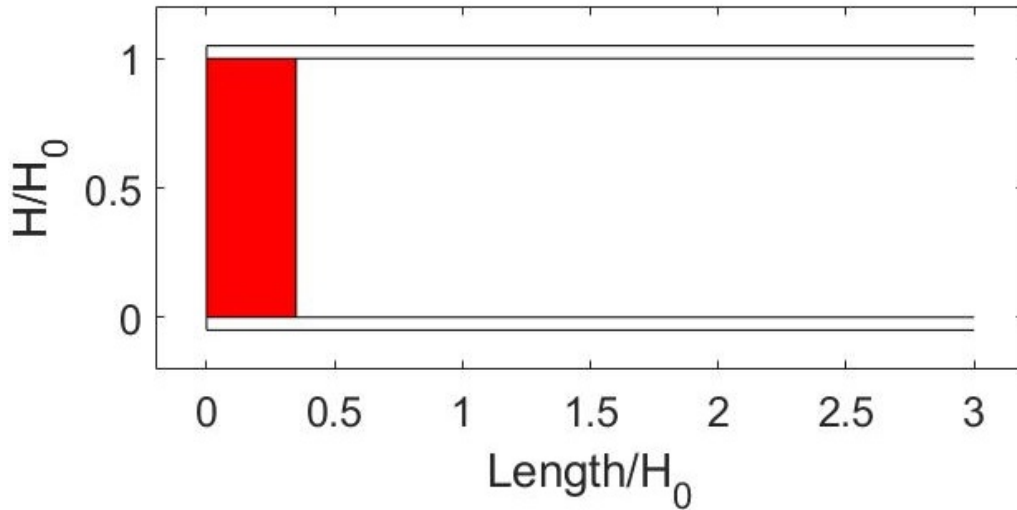
Figure 12.78: First extreme W1 web corrosion pattern, with full height corrosion for beams with diaphragm.

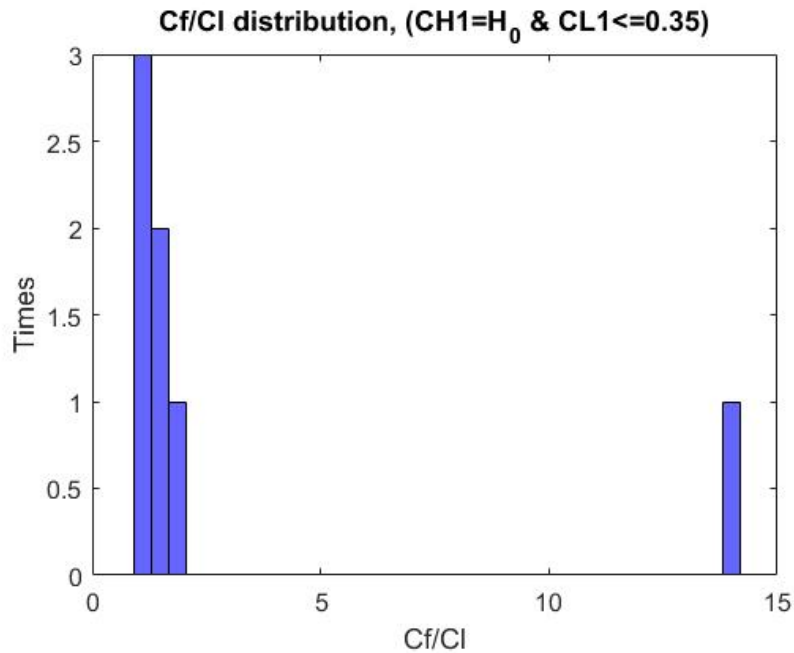
Figure 12.79: Ratio of flange to web corrosion length distribution of W1 web corrosion pattern, with full height corrosion and up to 35% of H_0 length, for beams with diaphragm.

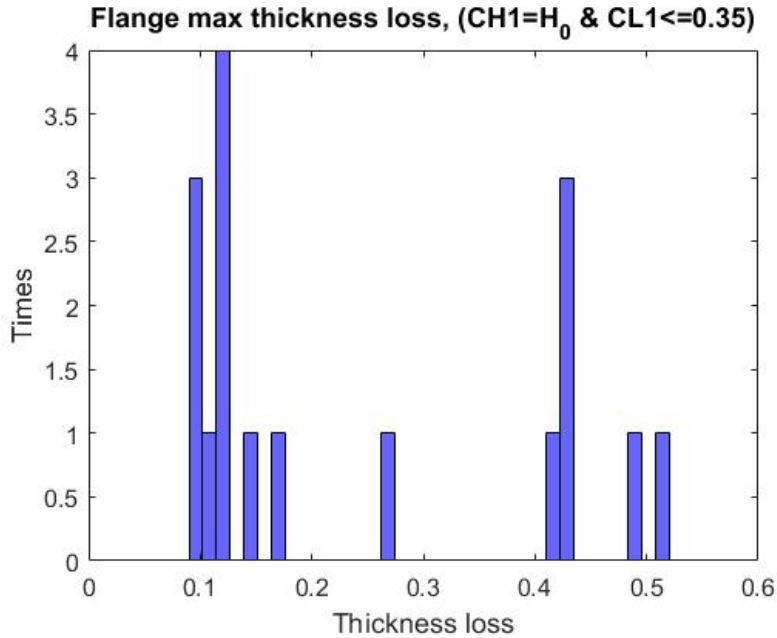
Figure 12.80: Max flange thickness loss distribution of W1 web corrosion pattern, with full height corrosion and up to 35% of H_0 length, for beams with diaphragm.

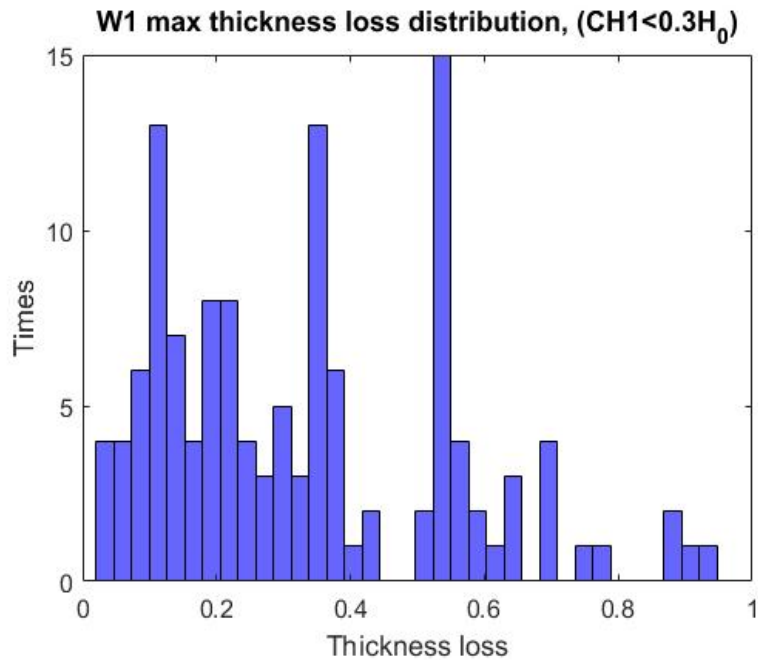
Figure 12.81: Max web thickness loss distribution of W1 web corrosion pattern with corrosion height up to 30% of H_0 for beams with diaphragm.

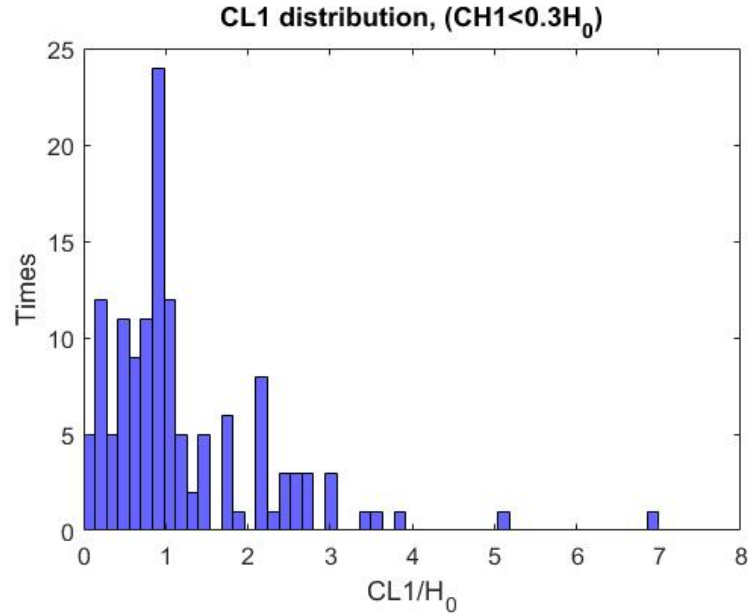
Figure 12.82: CL1 thickness loss distribution of W1 web corrosion pattern with corrosion height up to 30% of H_0 for beams with diaphragm.

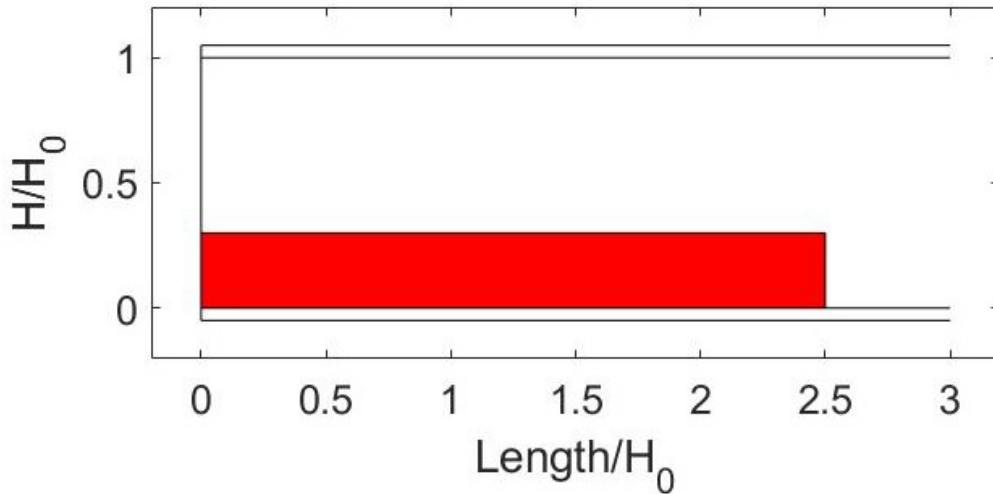
Figure 12.83: Second extreme W1 web corrosion pattern, with corrosion height up to 30% of H_0 for beams with diaphragm.
