September 2019

Report No. 19-008

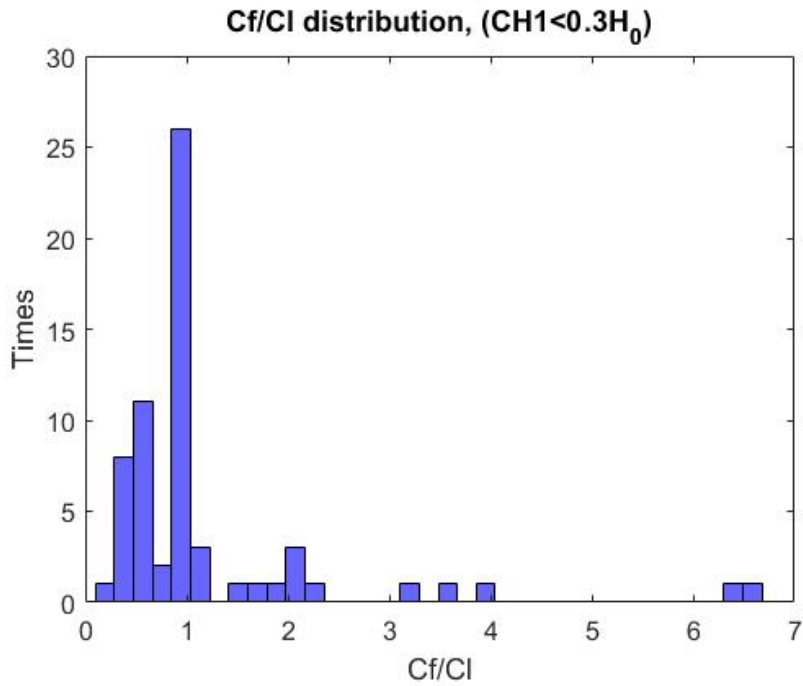
Figure 12.84: Ratio of flange to web corrosion length distribution of W1 web corrosion pattern with corrosion height up to 30% of H_0 for beams with diaphragm.

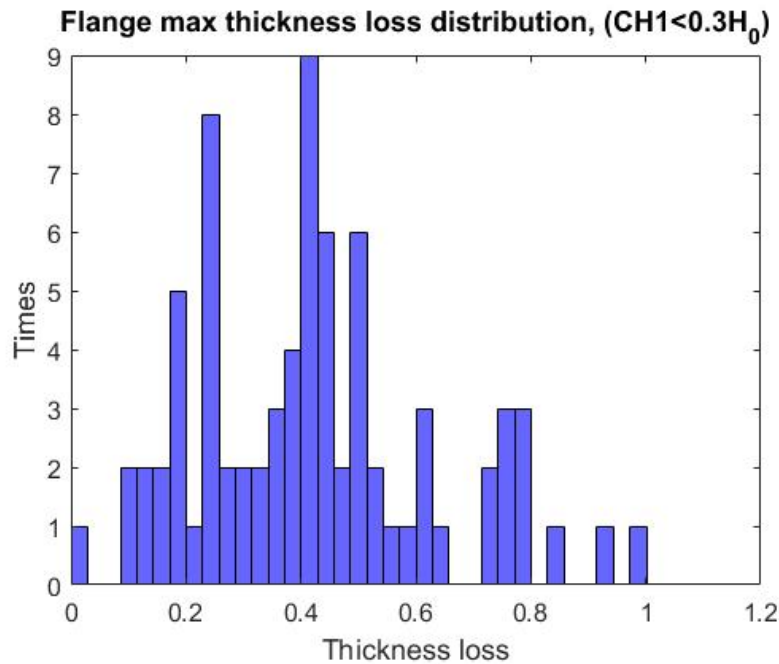
Figure 12.85: Max flange thickness loss distribution of W1 web corrosion pattern with corrosion height up to 30% of H_0 for beams with diaphragm.

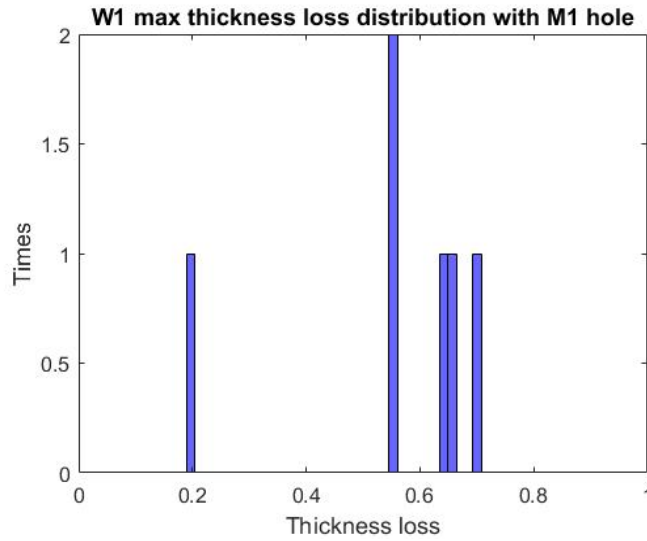
Figure 12.86: Max thickness loss distribution for W1 web corrosion patterns and M1 hole for beams with diaphragm.

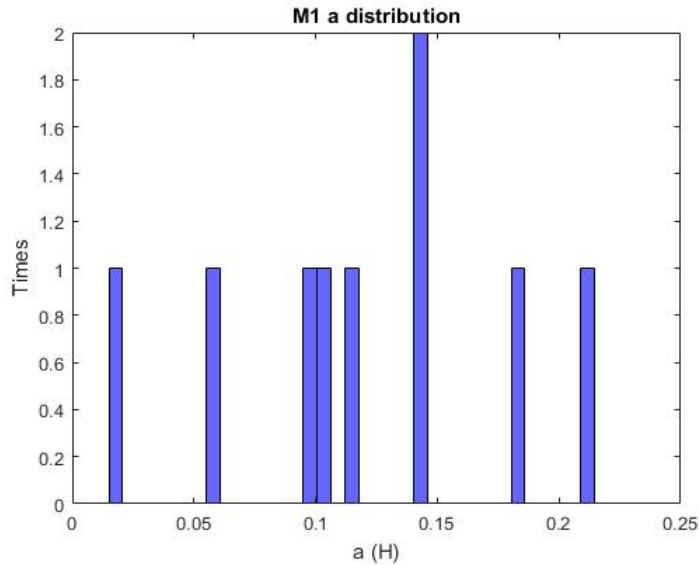
Figure 12.87: M1 web hole's pattern height distribution of W1 web corrosion pattern for beams with diaphragm.

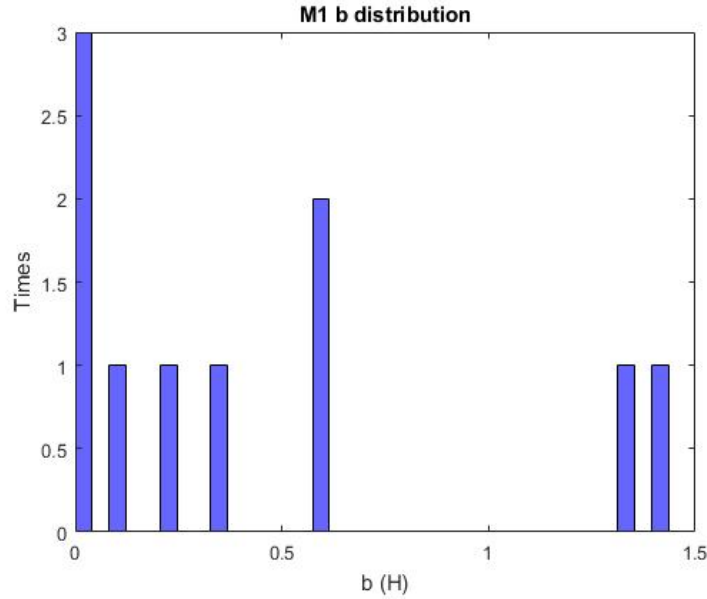
Figure 12.88: M1 web hole's pattern length distribution of W1 web corrosion pattern for beams with diaphragm.

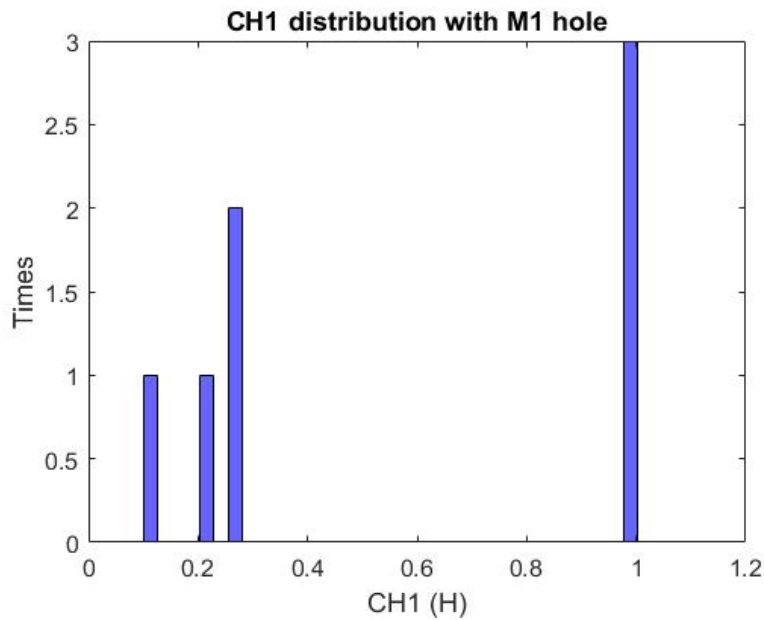
Figure 12.89: CH1 distribution for beams with M1 hole and W1 web corrosion pattern and diaphragm.

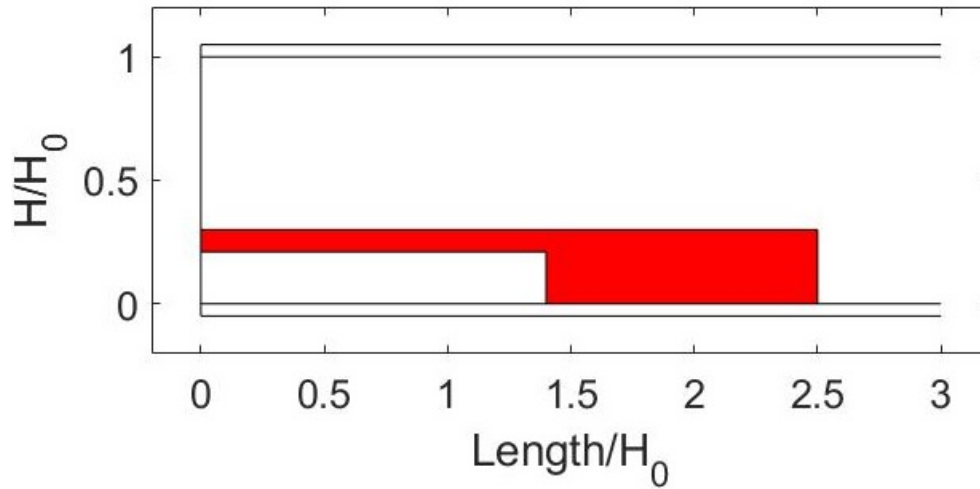
Figure 12.90: M1 extreme web hole pattern scenario of W1 web corrosion pattern, for beams with diaphragm.

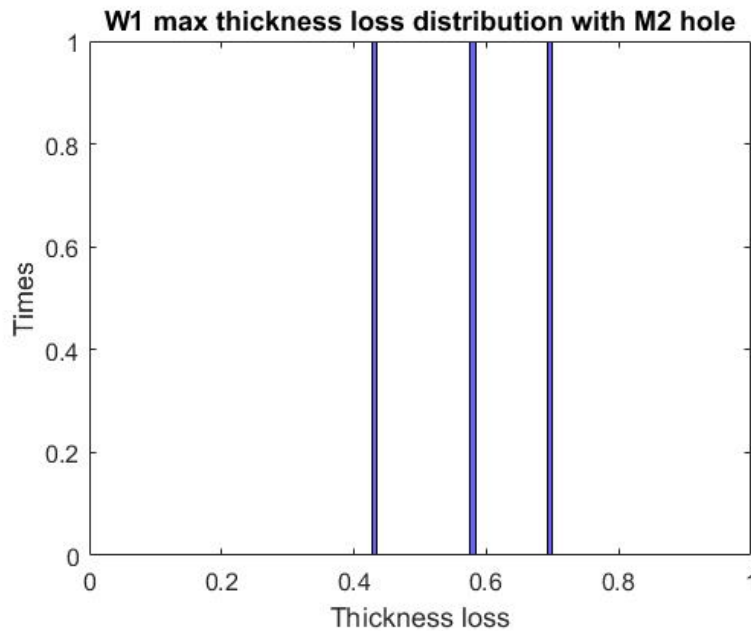
Figure 12.91: Max thickness loss distribution for W1 web corrosion patterns and M2 hole for beams with diaphragm.

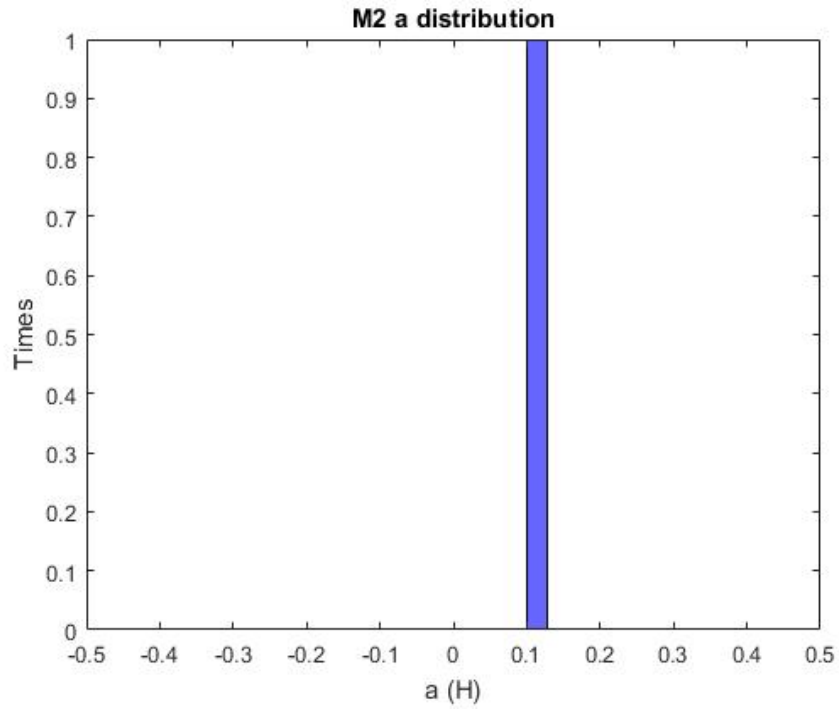
Figure 12.92: M2 web hole's pattern height distribution of W1 web corrosion pattern for beams with diaphragm.

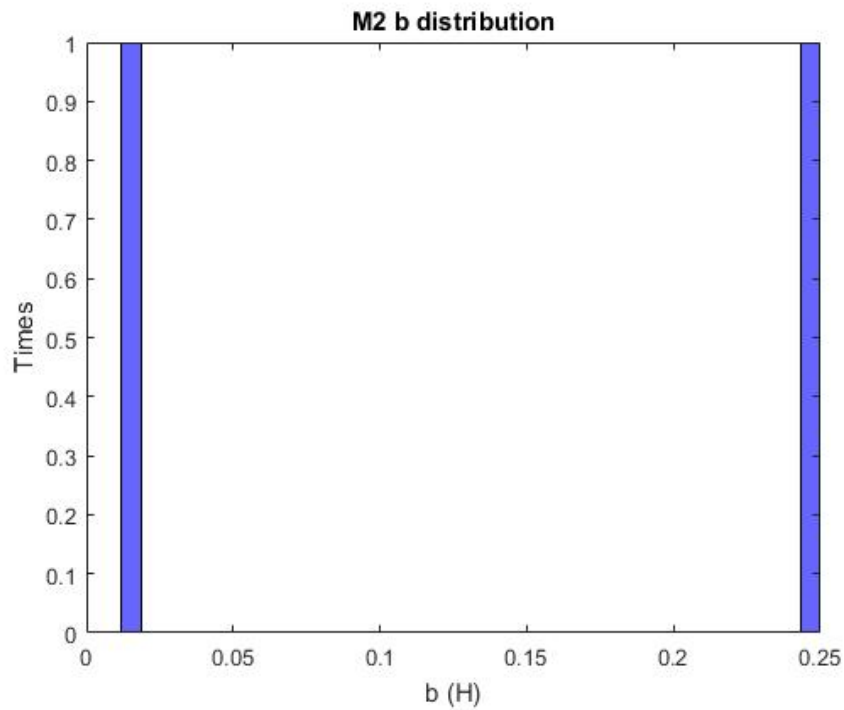
Figure 12.93: M2 web hole's pattern length distribution of W1 web corrosion pattern for beams with diaphragm.

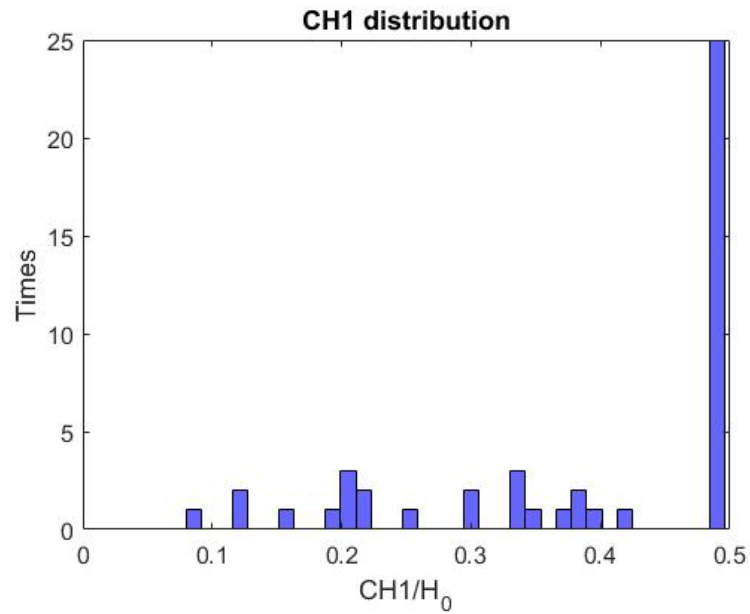
Figure 12.94: CH1 distribution of W2 pattern for beams with diaphragm.

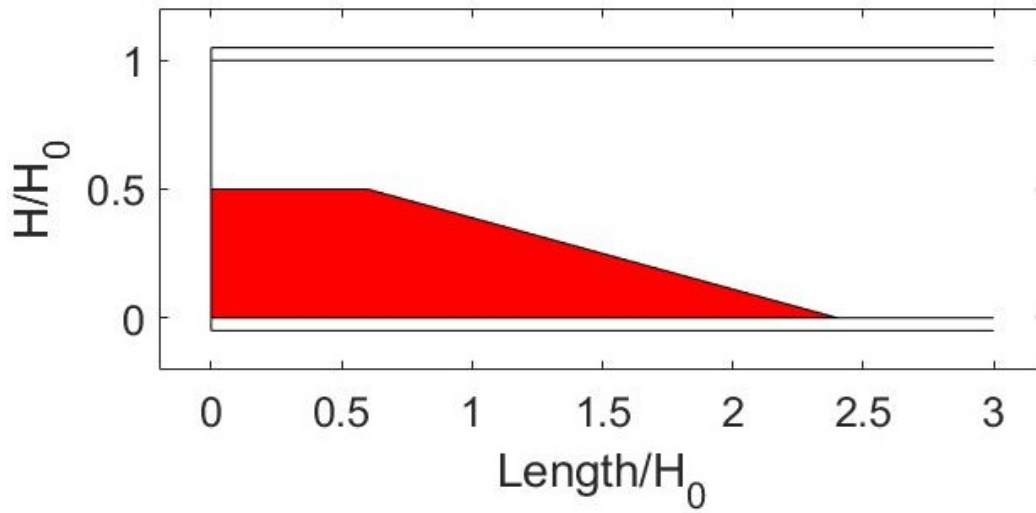
Figure 12.98: Extreme W2 web corrosion pattern for beams with diaphragm.

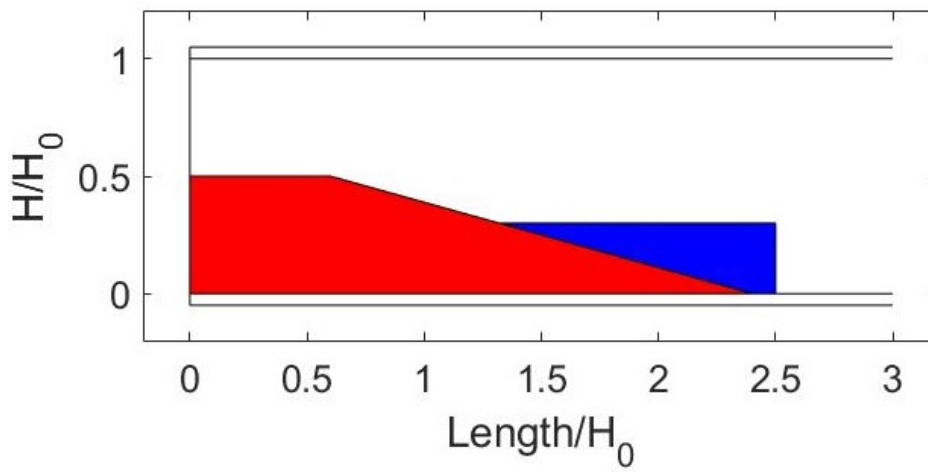
Figure 12.99: W2 extreme web corrosion scenario (with red color) projected over W1 CASE B extreme web corrosion scenario (with blue color).

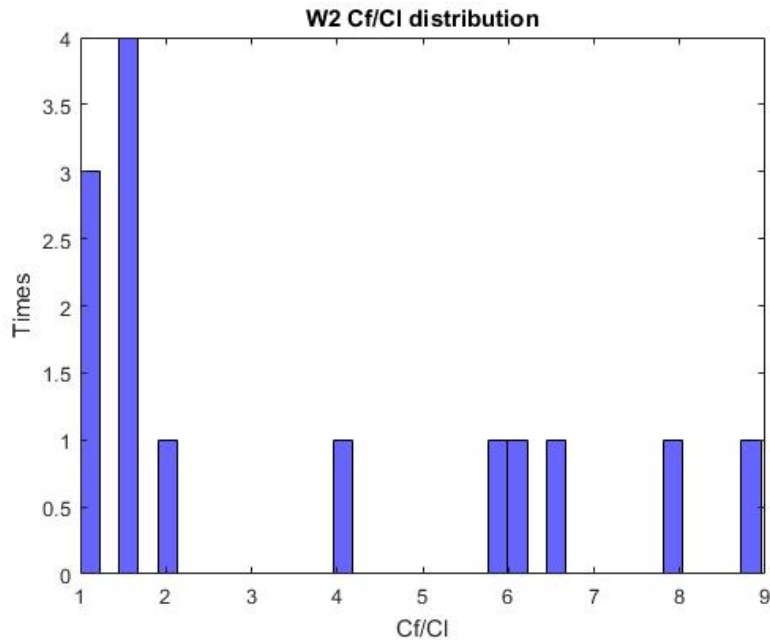
Figure 12.100: Ratio of flange to web corrosion length distribution of W2 web corrosion pattern corrosion for beams with diaphragm.

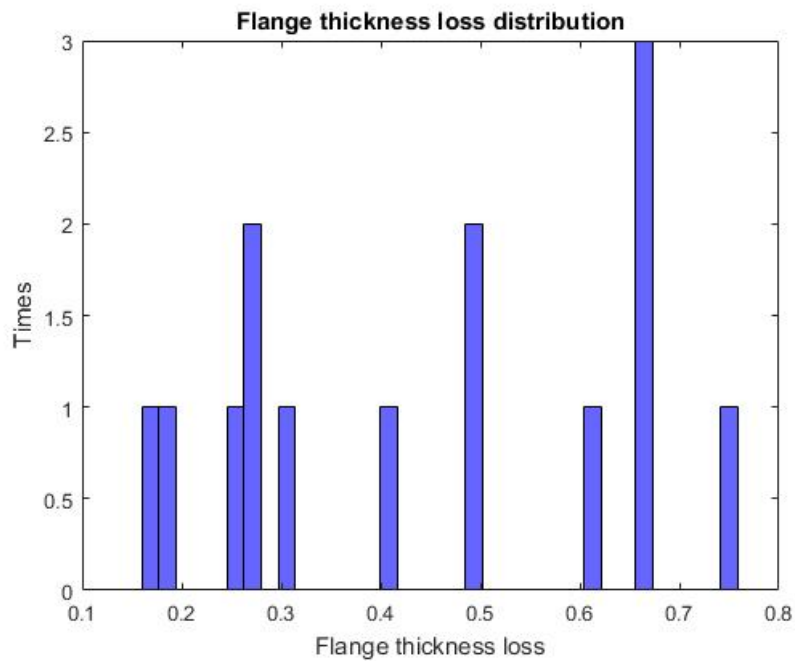
Figure 12.101: Max flange loss thickness distribution of W2 web corrosion pattern for beams without diaphragm.

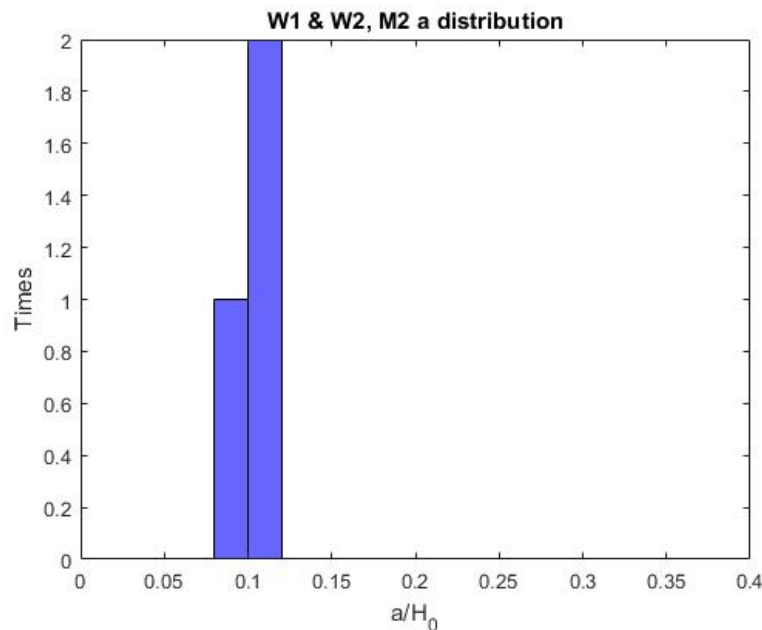
Figure 12.102: M2 web hole's pattern height distribution of W1 and W2 web corrosion patterns for beams with diaphragm.

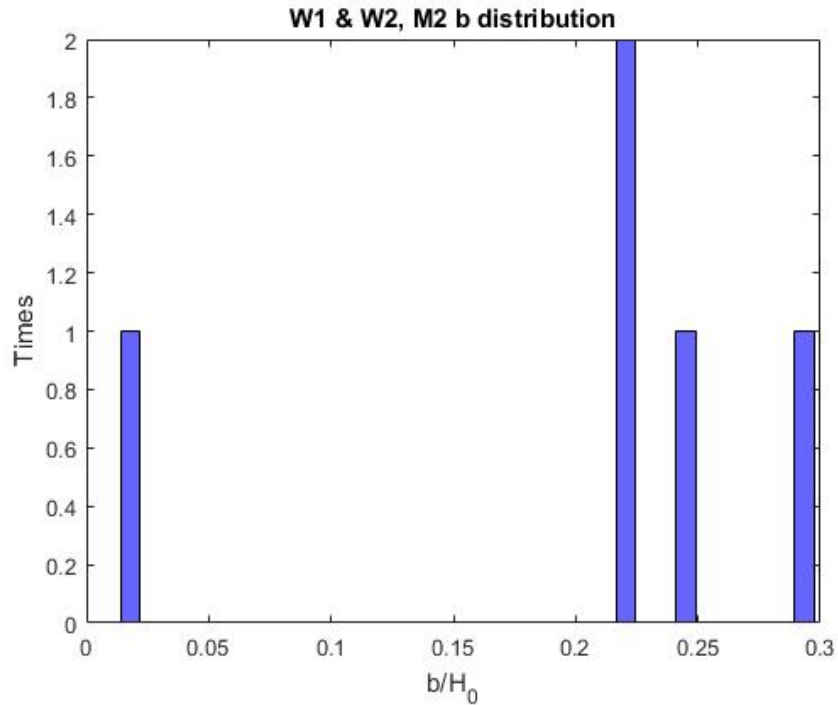
Figure 12.103: M2 web hole's pattern length distribution of W1 and W2 web corrosion patterns for beams with diaphragm.

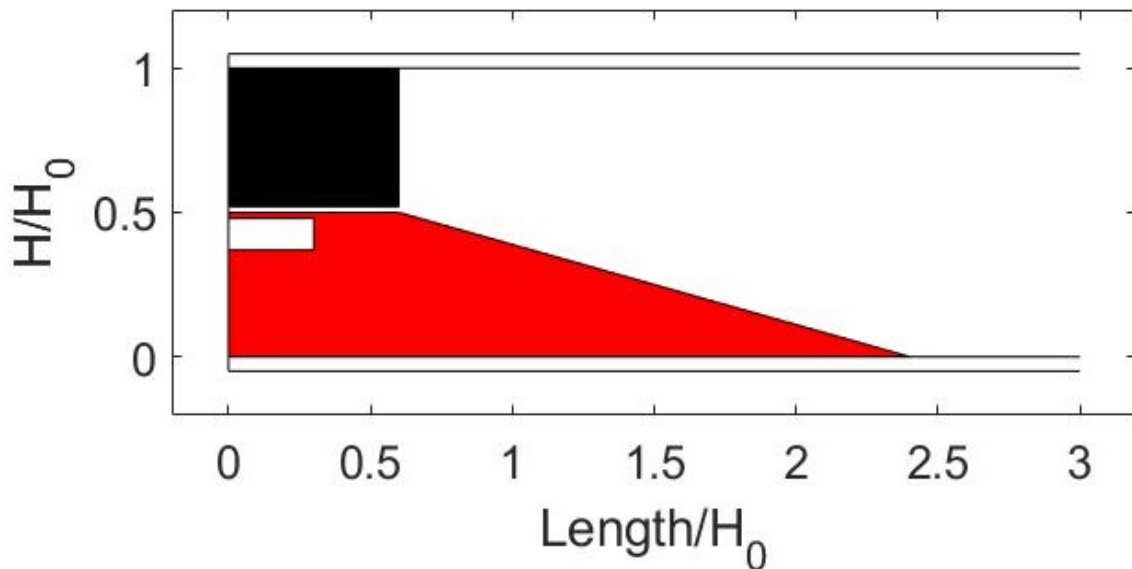
Figure 12.104: M2 hole pattern projected on the extreme W2 web corrosion pattern. With black color is illustrated the diaphragm that could be found with these patterns.

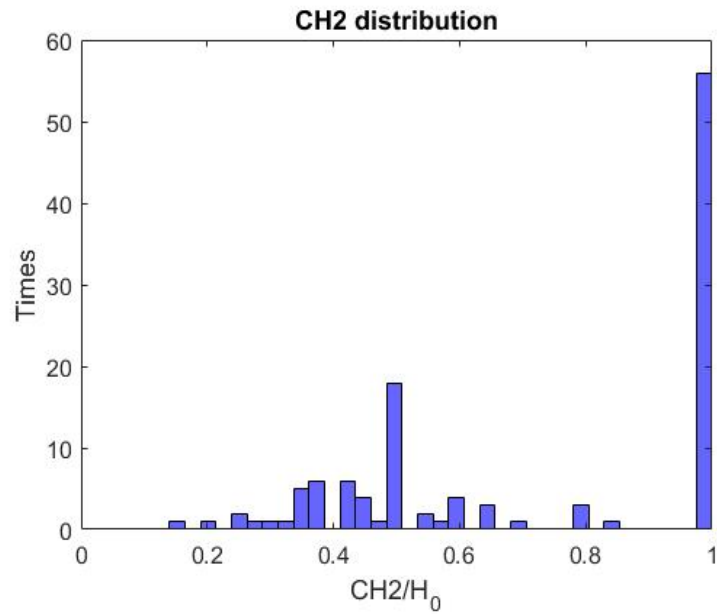
Figure 12.105: CH2 distribution of W3 web corrosion pattern for beams with diaphragm.

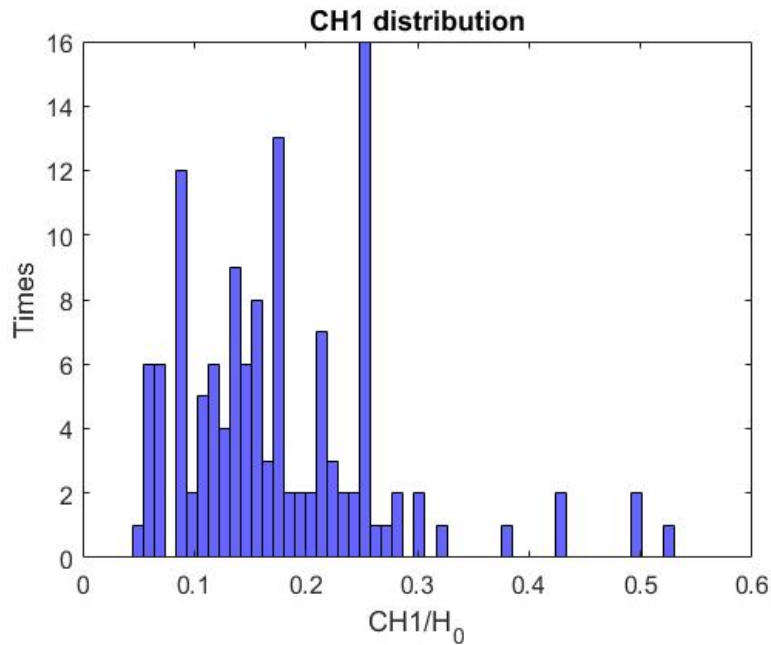
Figure 12.106: CH1 distribution of W3 web corrosion pattern for beams with diaphragm.

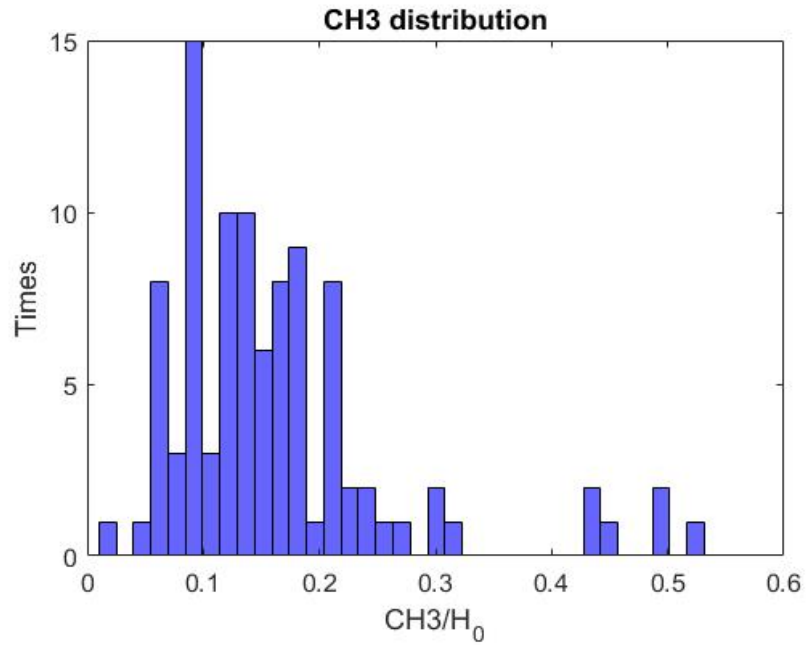
Figure 12.107: CH3 distribution of W3 web corrosion pattern for beams with diaphragm.

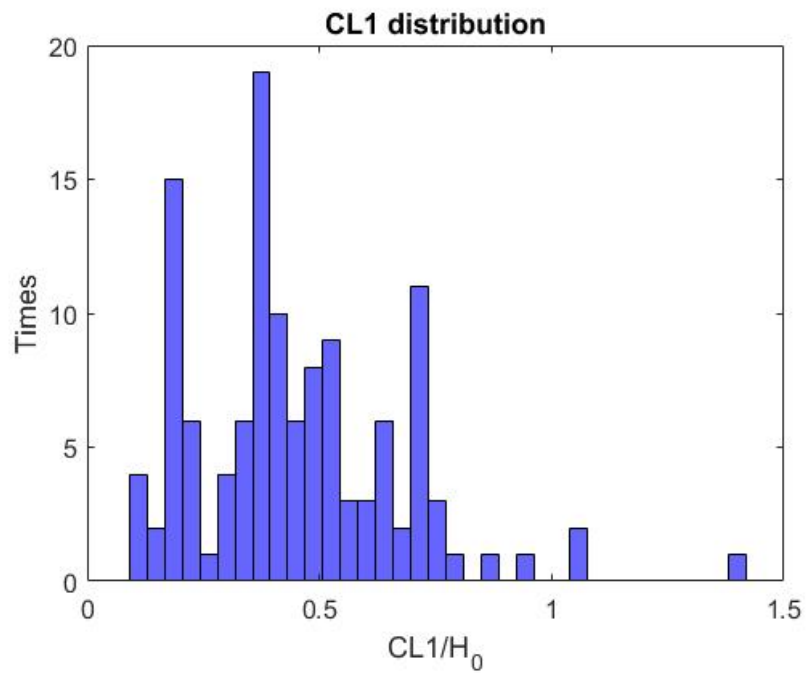
Figure 12.108: CL1 distribution of W3 web corrosion pattern for beams with diaphragm.

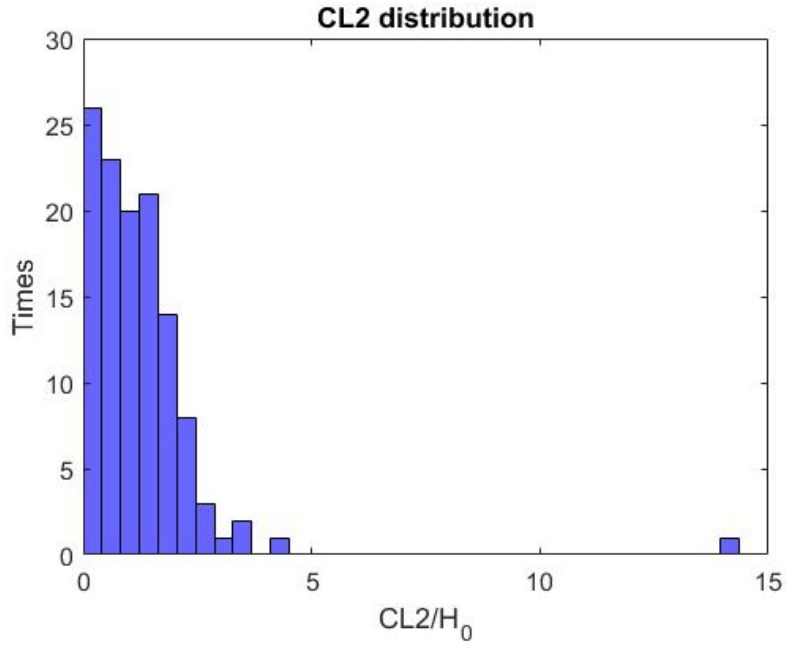
Figure 12.109: CL2 distribution of W3 web corrosion pattern for beams with diaphragm.

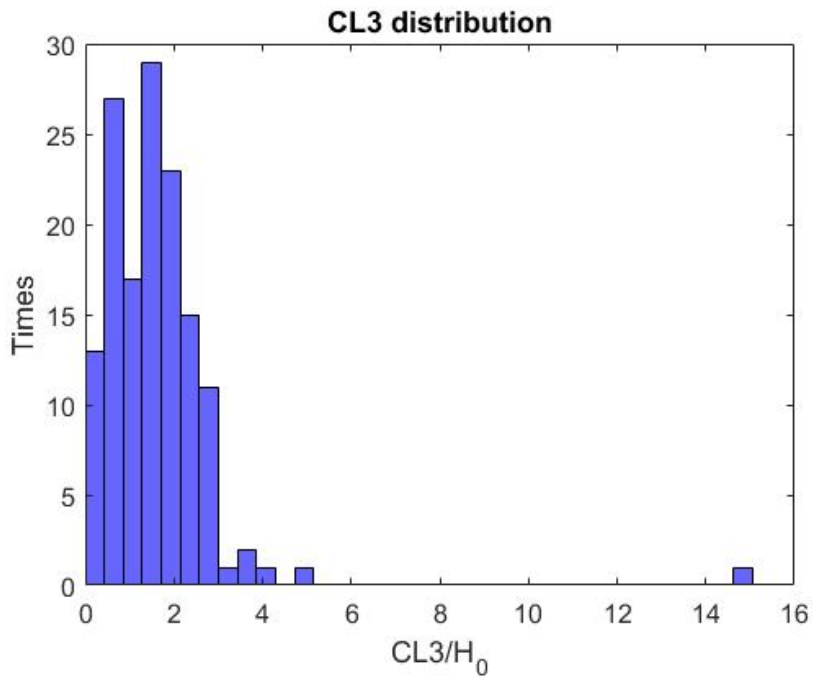
Figure 12.110: CL3 distribution of W3 web corrosion pattern for beams with diaphragm.

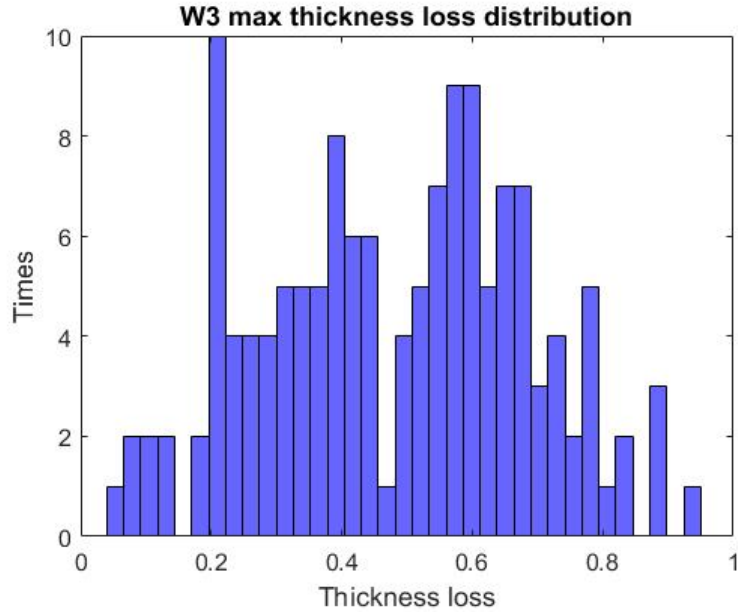
Figure 12.111: Max web thickness loss distribution of W3 web corrosion pattern for beams with diaphragm.

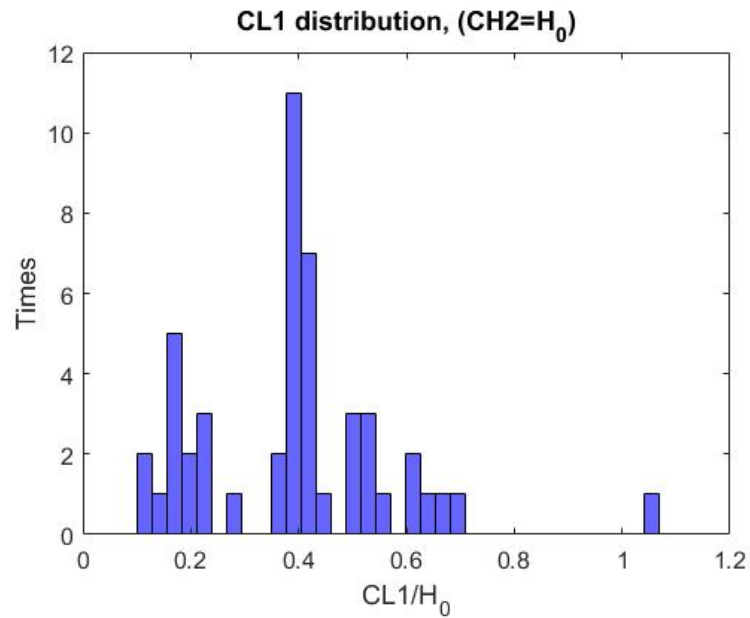
Figure 12.112: CL1 distribution of W3 web corrosion pattern with full height corrosion for beams with diaphragm.

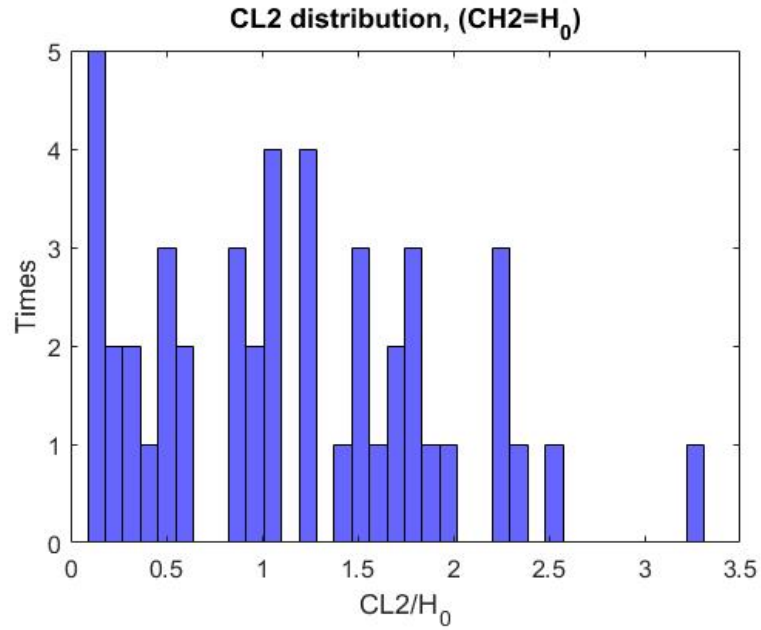
Figure 12.113: CL2 distribution of W3 web corrosion pattern with full height corrosion for beams with diaphragm.

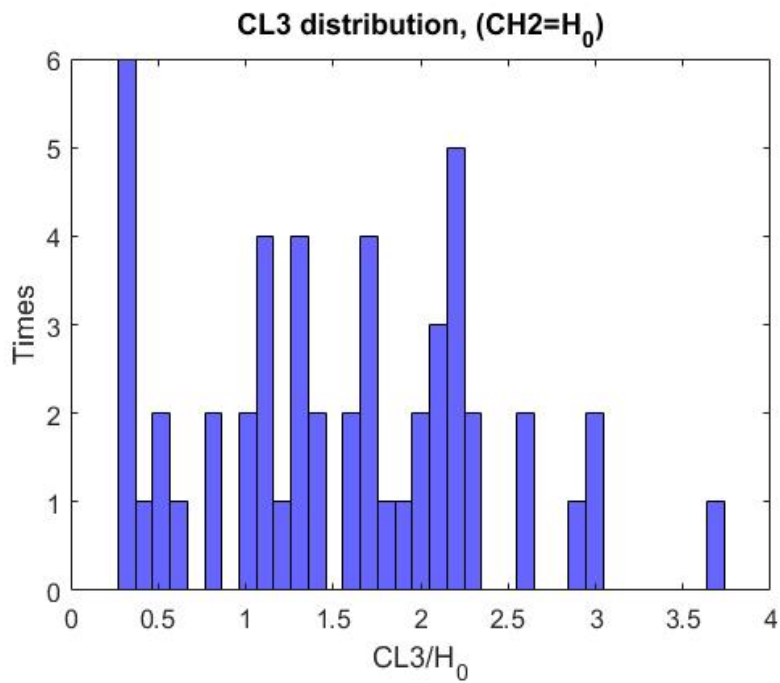
Figure 12.114: CL3 distribution of W3 web corrosion pattern with full height corrosion for beams with diaphragm.

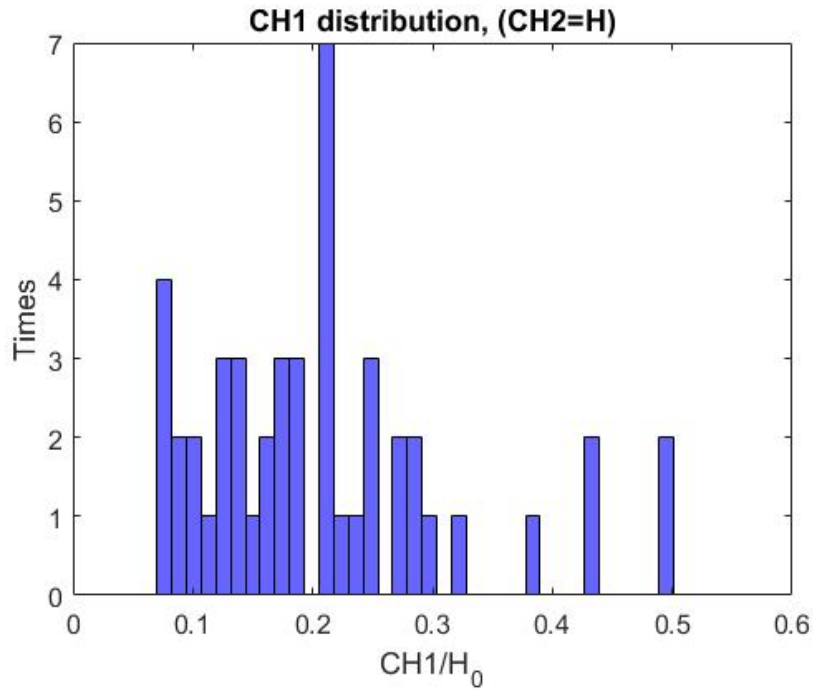
Figure 12.115: CH1 distribution of W3 web corrosion pattern with full height corrosion for beams with diaphragm.

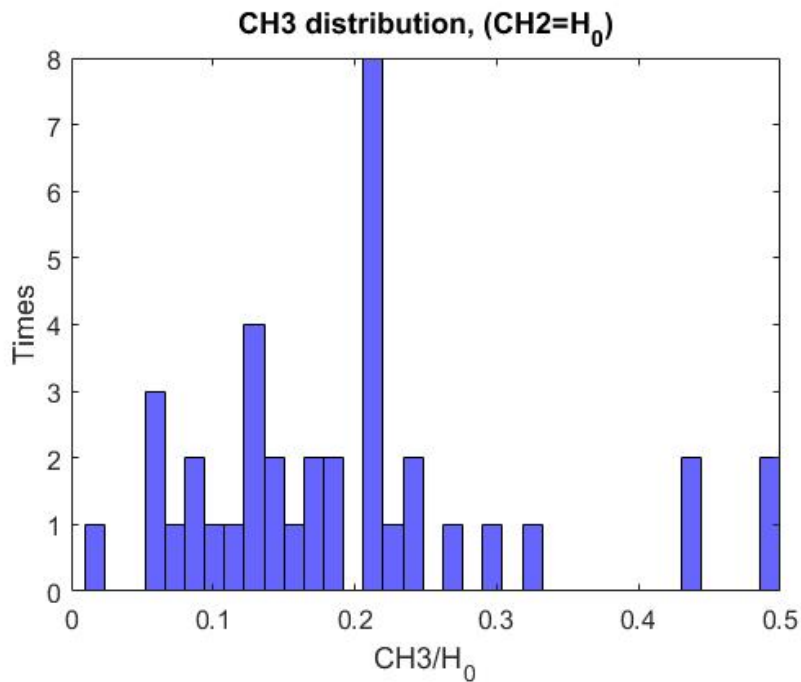
Figure 12.116: CH3 distribution of W3 web corrosion pattern with full height corrosion for beams with diaphragm.

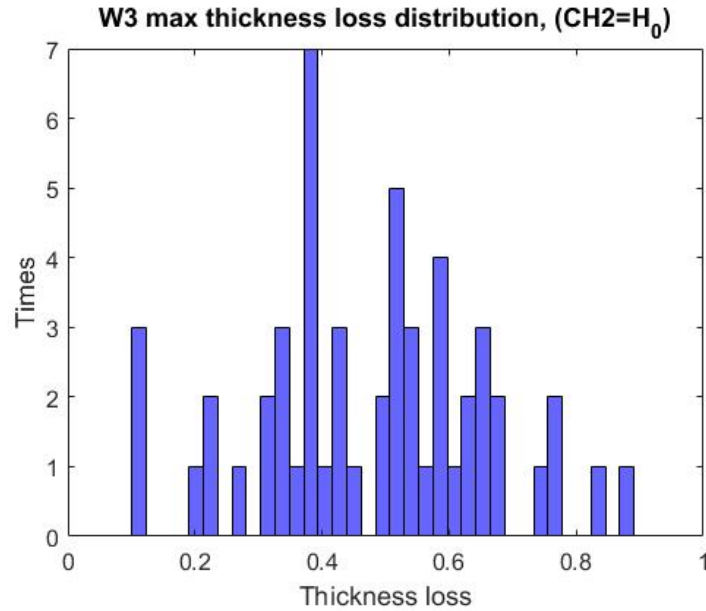
Figure 12.117: Max web thickness loss distribution of W3 web corrosion pattern with full height corrosion for beams with diaphragm.

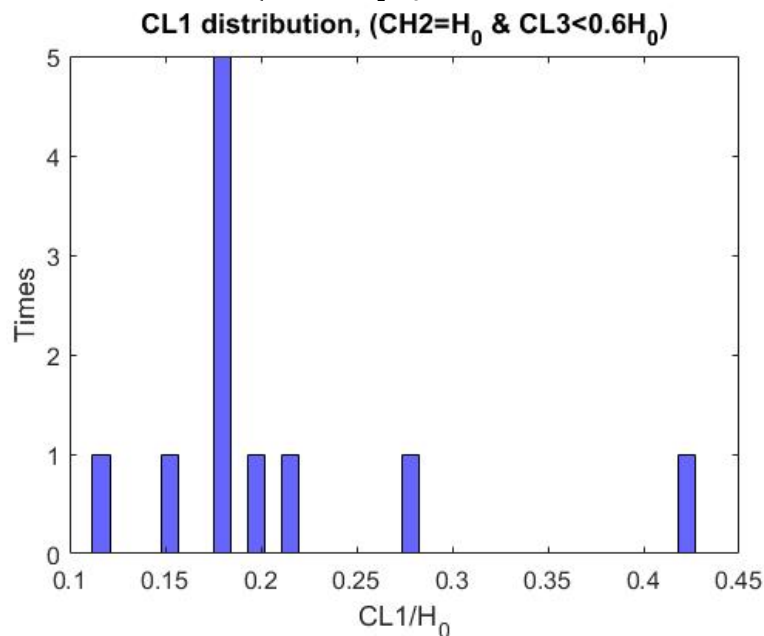
Figure 12.118: : CL1 distribution of W3 web corrosion pattern with full height corrosion and deteriorated length up to 60% of H_0 for beams with diaphragm.

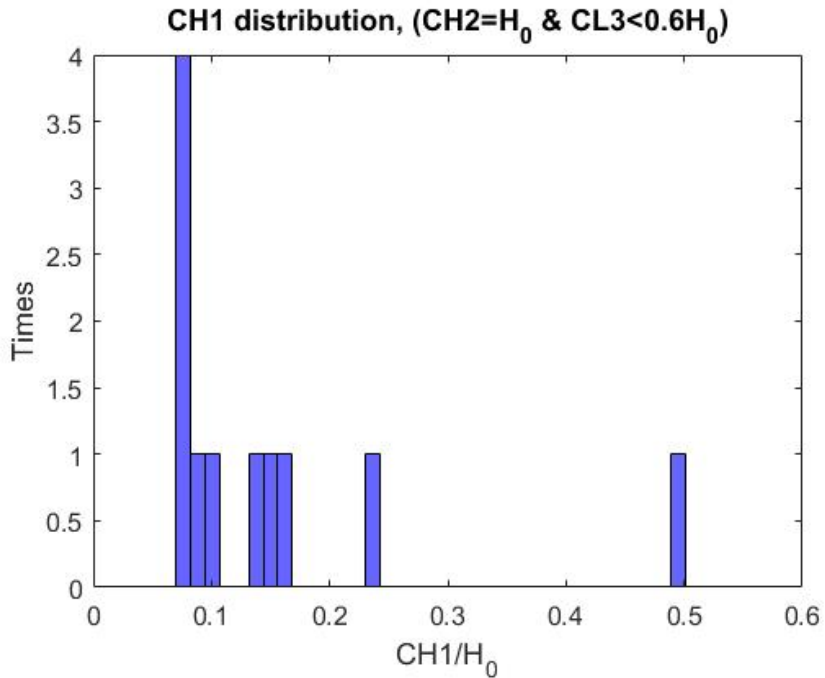
Figure 12.119: CH1 distribution of W3 web corrosion pattern with full height corrosion and deteriorated length up to 60% of H_0 for beams with diaphragm.

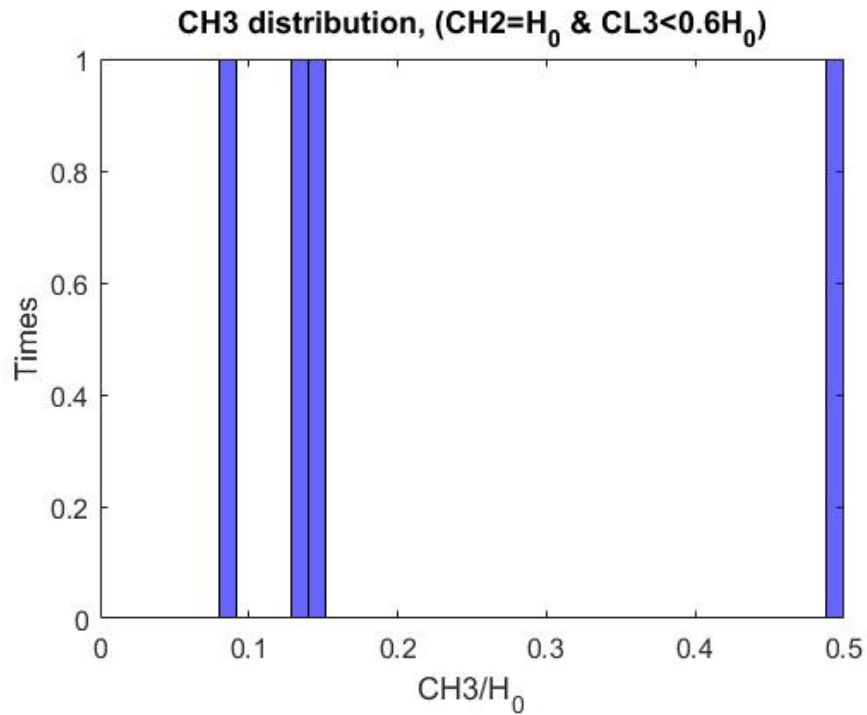
Figure 12.120: CH3 distribution of W3 web corrosion pattern with full height corrosion and deteriorated length up to 60% of H_0 for beams with diaphragm.

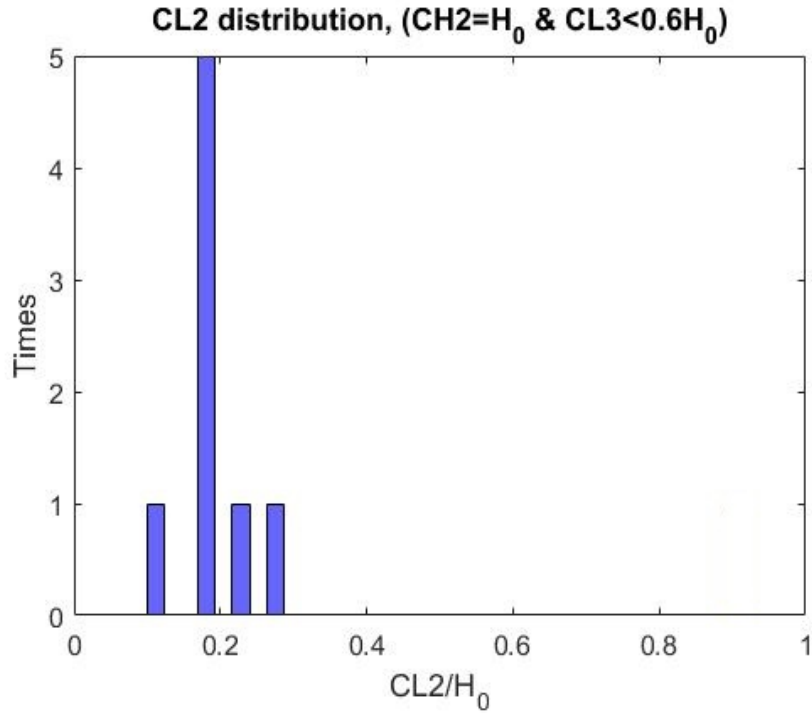
Figure 12.121: CL2 distribution of W3 web corrosion pattern with full height corrosion and deteriorated length up to 60% of H_0 for beams with diaphragm.

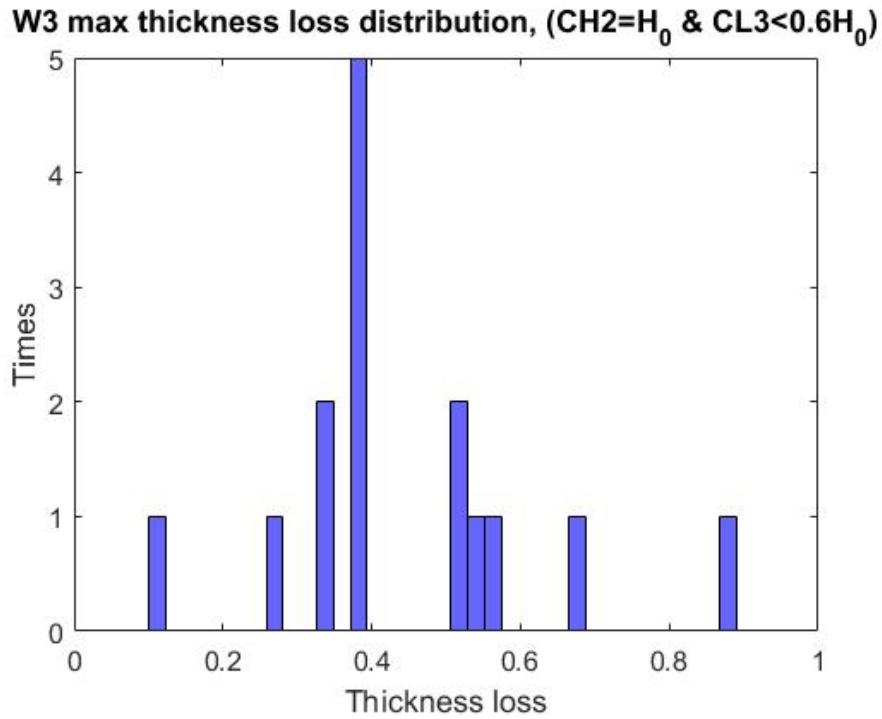
Figure 12.122: Max web thickness loss distribution, of W3 web corrosion pattern, with full height corrosion and deteriorated length up to 60% of H_0 for beams with diaphragm.

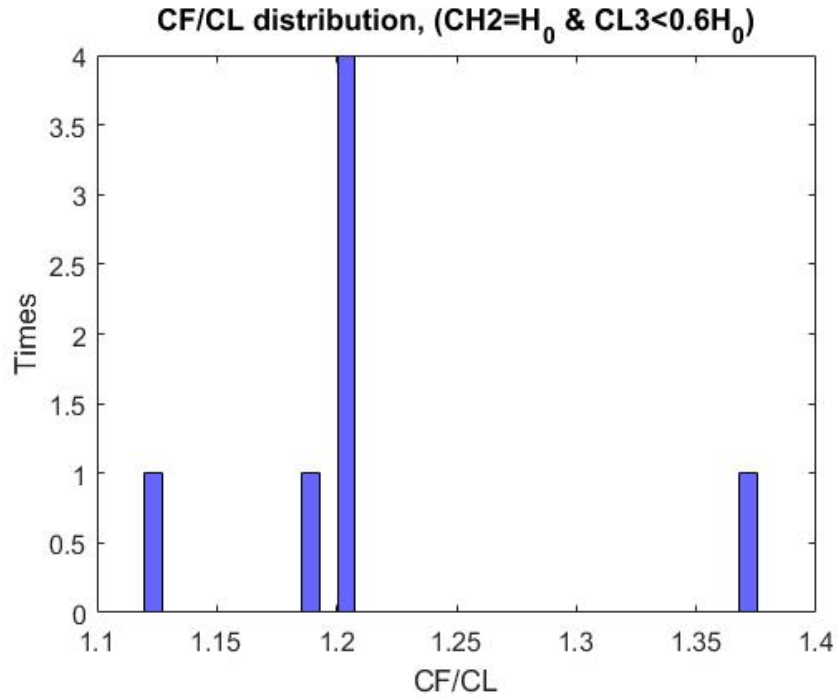
Figure 12.123: Ratio of flange to web corrosion length distribution, of W3 web corrosion pattern, with full height corrosion and deteriorated length up to 60% of H_0 for beams with diaphragm.

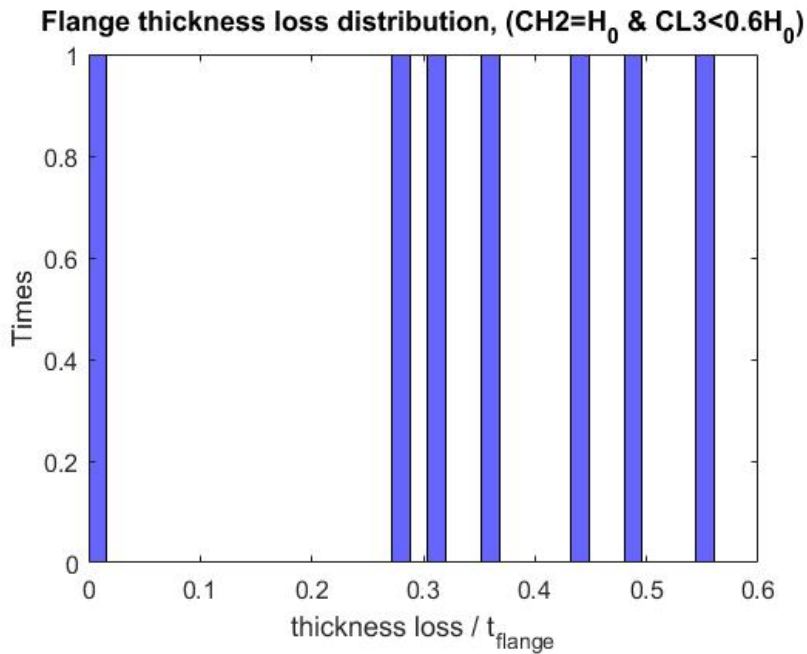
Figure 12.124: Max flange loss thickness distribution, for beams with W3 web corrosion pattern, with full height corrosion, deteriorated length up to 60% of H_0 and with diaphragm.

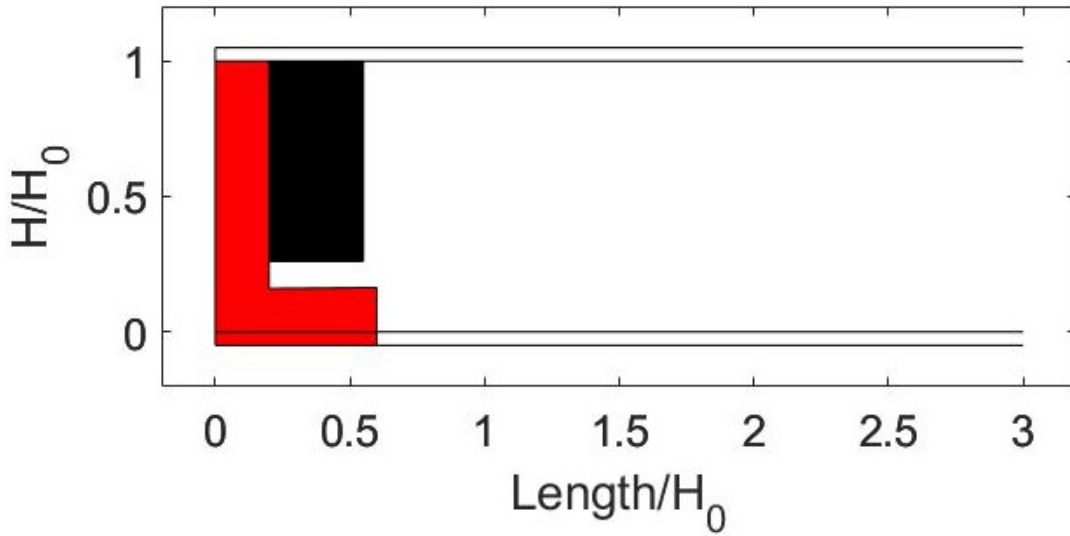
Figure 12.125: First extreme flange and W3 web corrosion scenario for beams with diaphragm.

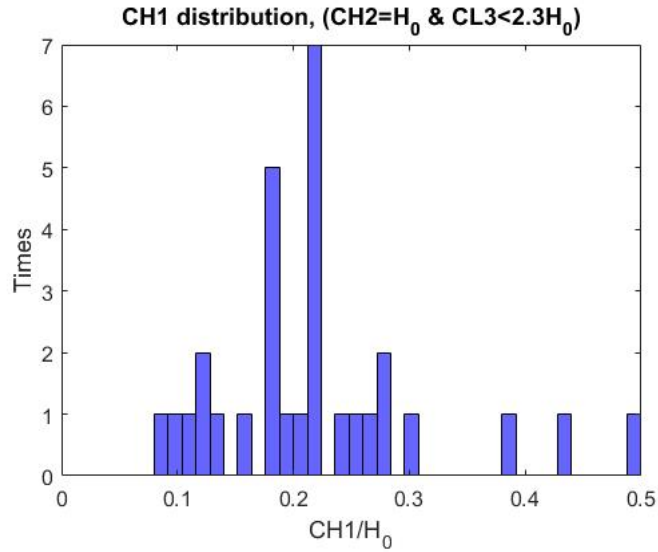
Figure 12.126: CH1 distribution of W3 web corrosion pattern, with full height corrosion and deteriorated length up to 230% of H_0 , for beams with diaphragm.

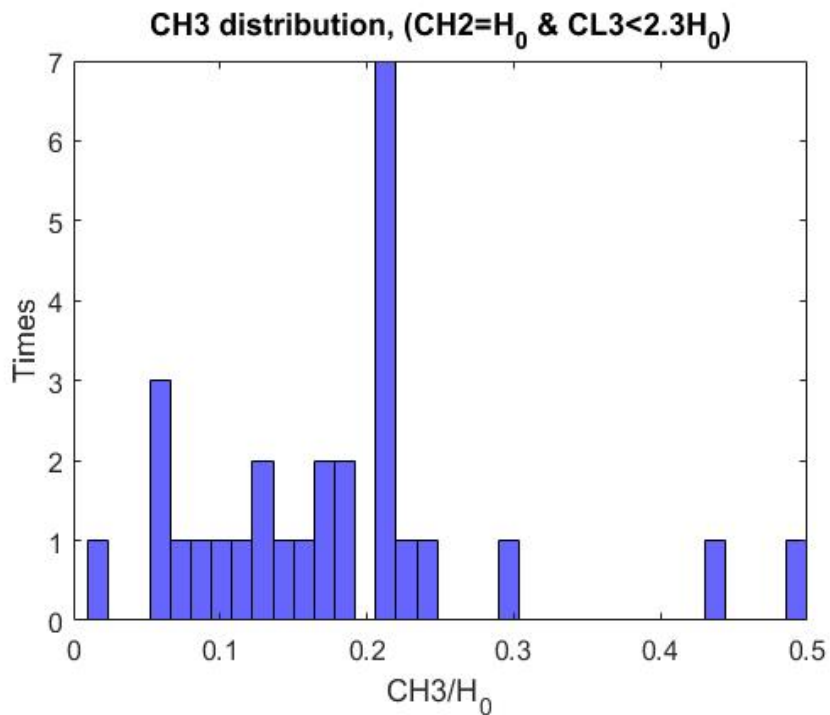
Figure 12.127: CH3 distribution of W3 web corrosion pattern, with full height corrosion and deteriorated length up to 230% of H_0 , for beams with diaphragm.

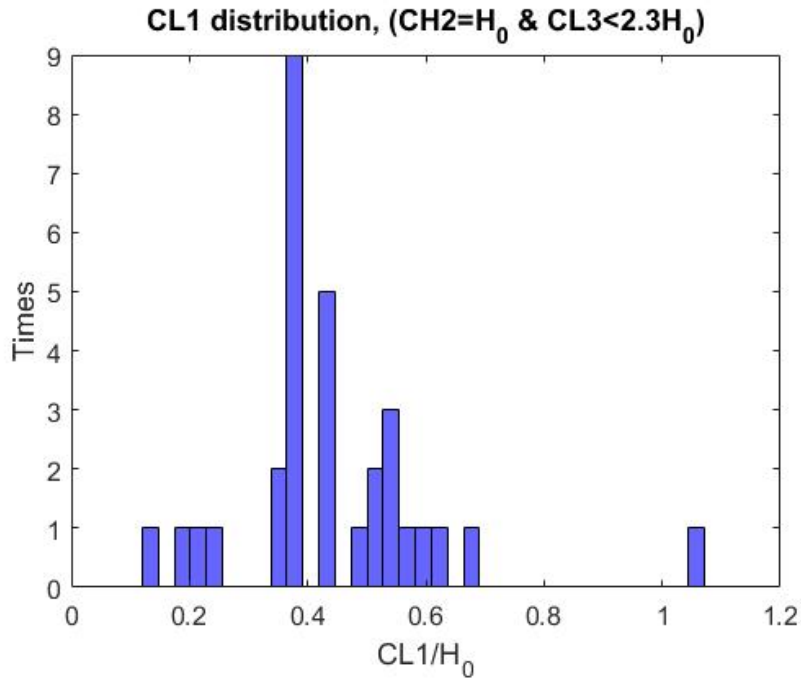
Figure 12.128: CL1 distribution of W3 web corrosion pattern, with full height corrosion and deteriorated length up to 230% of H₀, for beams with diaphragm.
