September 2019

Report No. 19-008

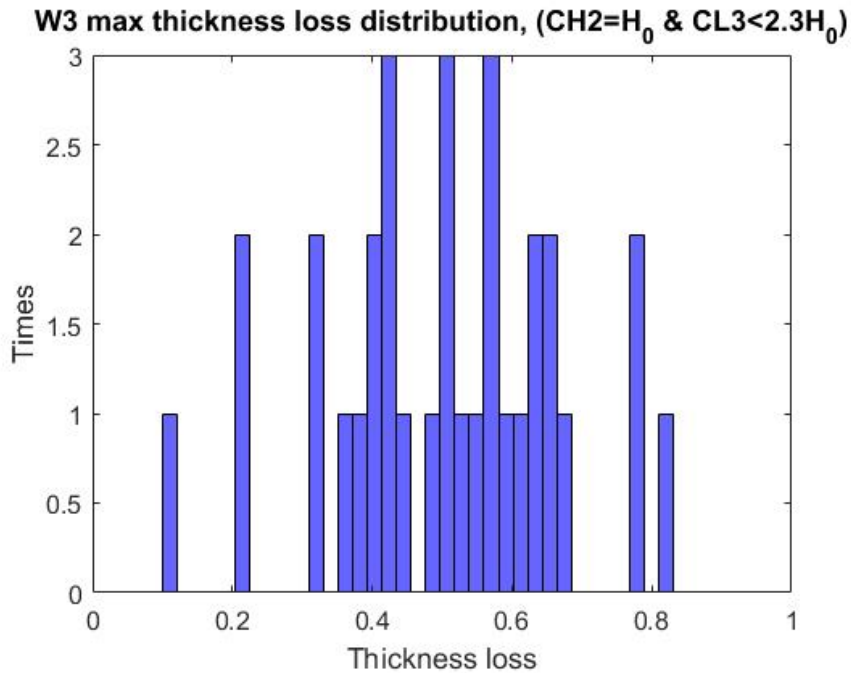
Figure 12.129: Max web thickness loss distribution, of W3 web corrosion pattern, with full height corrosion and deteriorated length up to 230% of H₀, for beams with diaphragm.

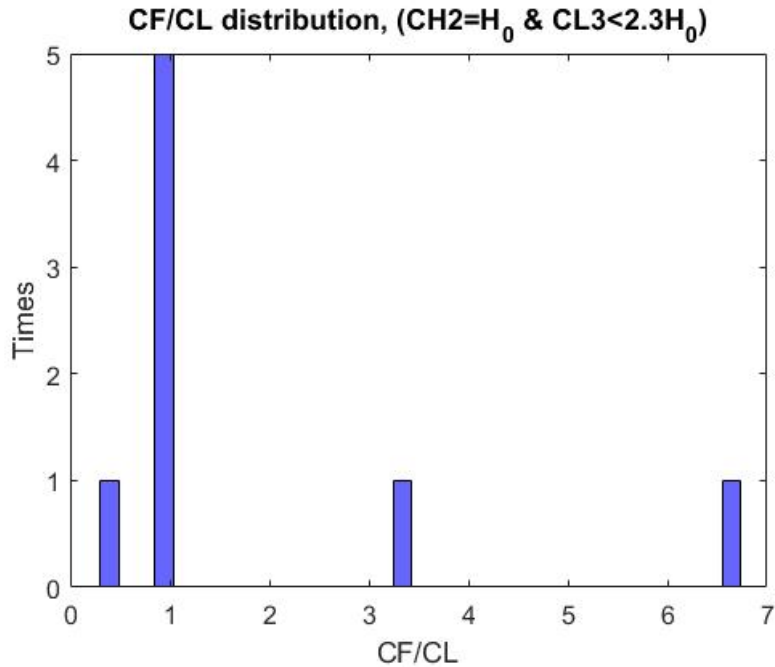
Figure 12.130: Ratio of flange to web corrosion length distribution, of W3 web corrosion pattern, with full height corrosion and deteriorated length up to 230% of H₀ for beams with diaphragm.

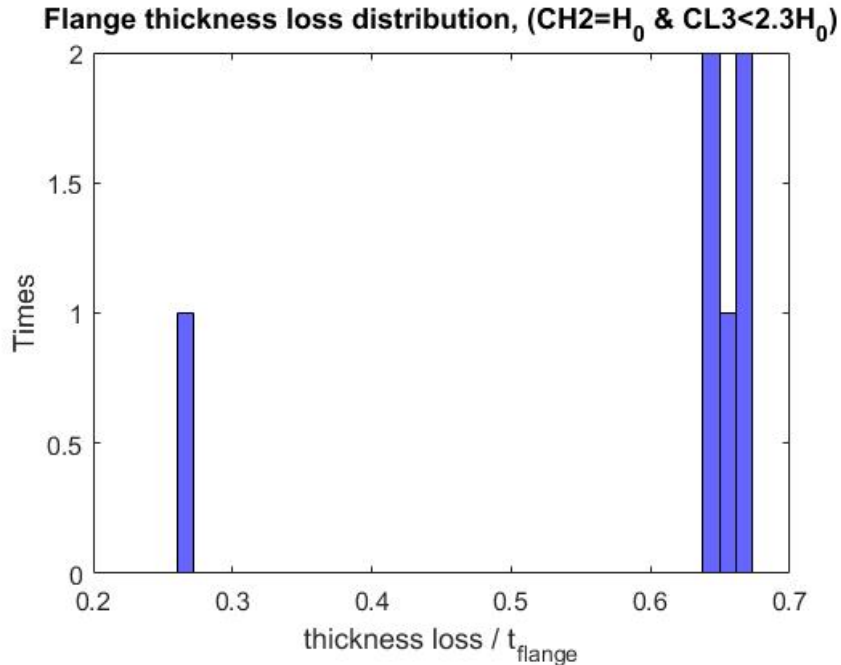
Figure 12.131: Max flange loss thickness distribution, for beams with W3 web corrosion pattern, with full height corrosion, deteriorated length up to 230% of H₀ and with diaphragm.

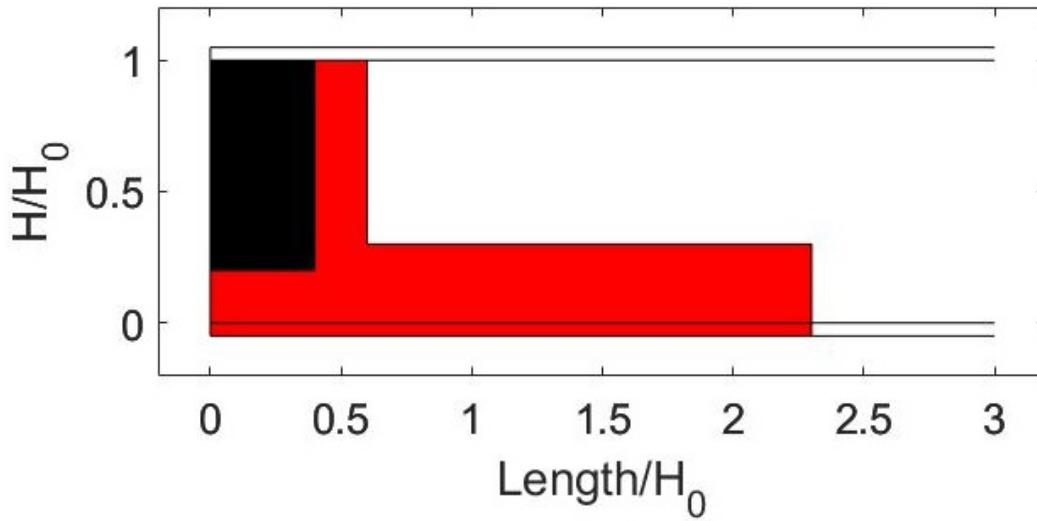
Figure 12.132: Second extreme flange and W3 web corrosion scenario for beams with diaphragm.

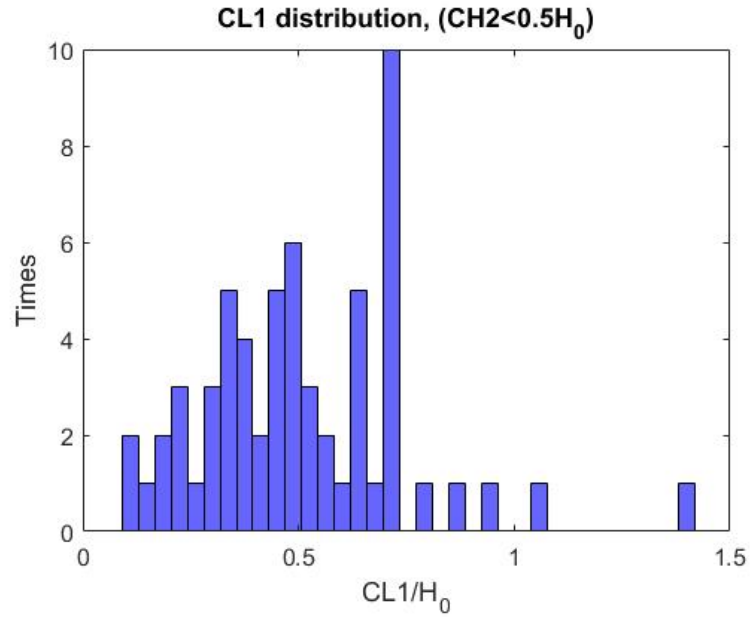
Figure 12.133: CL1 distribution of W3 web corrosion pattern, with corrosion height up to 50% of H_0 , for beams with diaphragm.

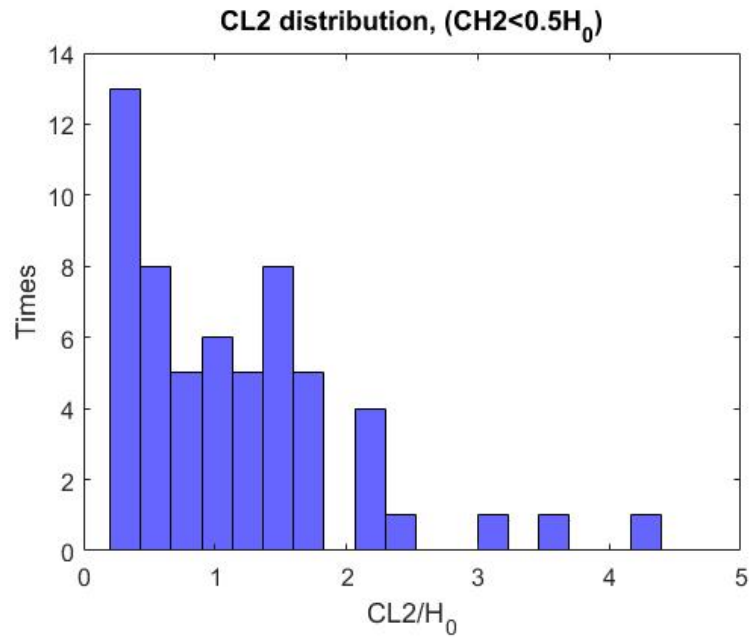
Figure 12.134: CL2 distribution of W3 web corrosion pattern, with corrosion height up to 50% of H_0 , for beams with diaphragm.

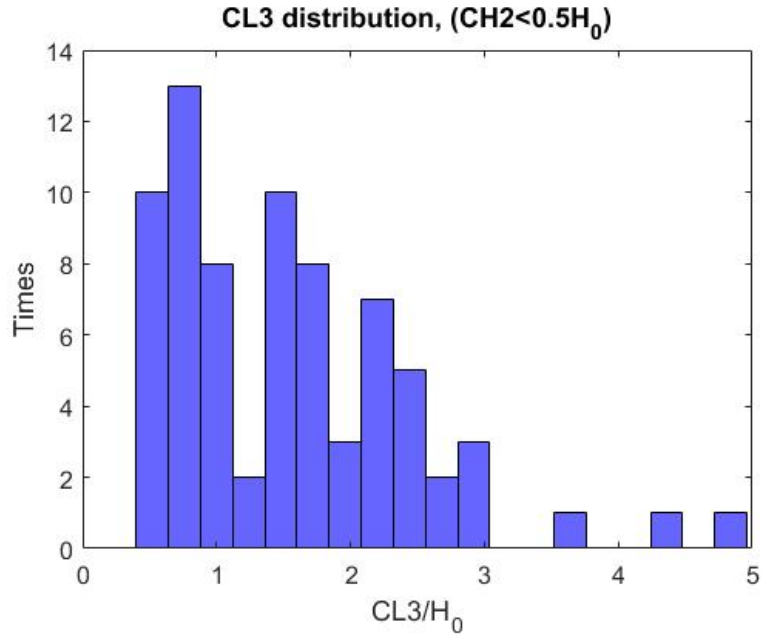
Figure 12.135: CL3 distribution of W3 web corrosion pattern, with corrosion height up to 50% of H₀, for beams with diaphragm.

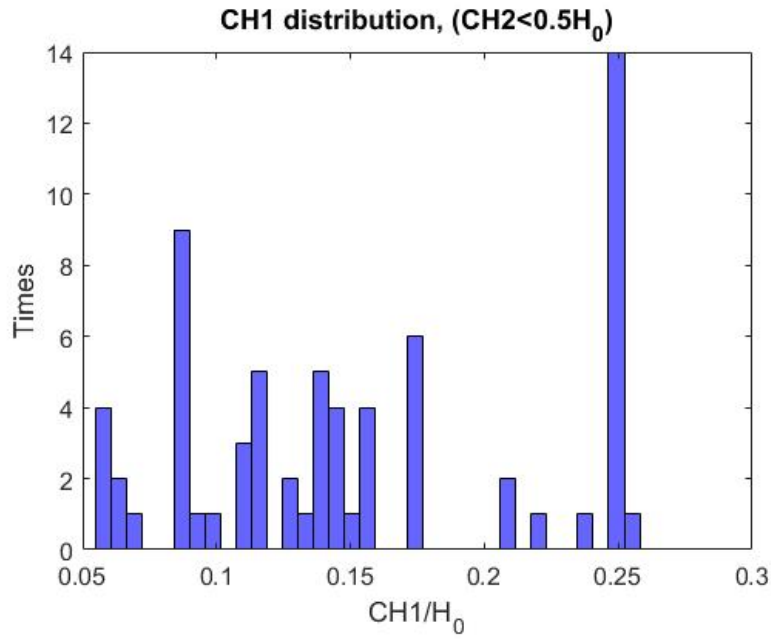
Figure 12.136: CH1 distribution of W3 web corrosion pattern, with corrosion height up to 50% of H₀, for beams with diaphragm.

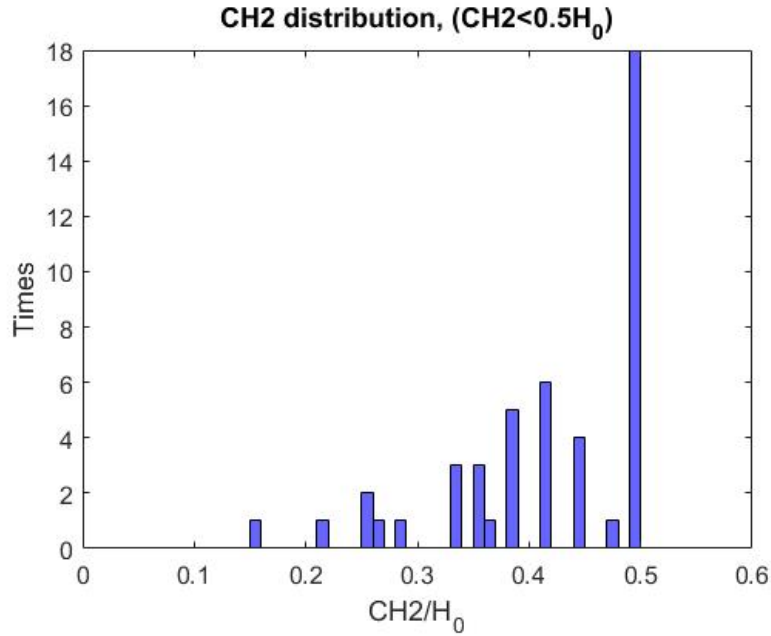
Figure 12.137: CH2 distribution of W3 web corrosion pattern, with corrosion height up to 50% of H_0 , for beams with diaphragm.

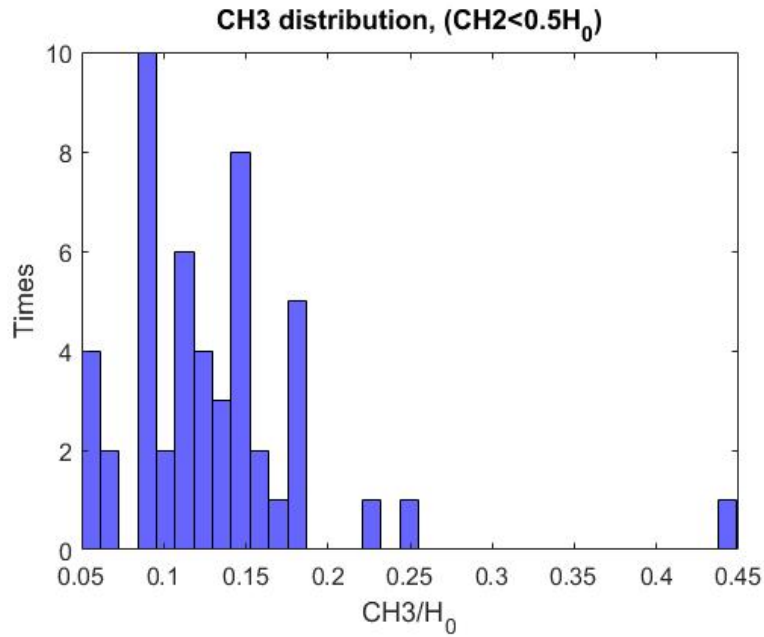
Figure 12.138: CH3 distribution of W3 web corrosion pattern, with corrosion height up to 50% of H_0 , for beams with diaphragm.

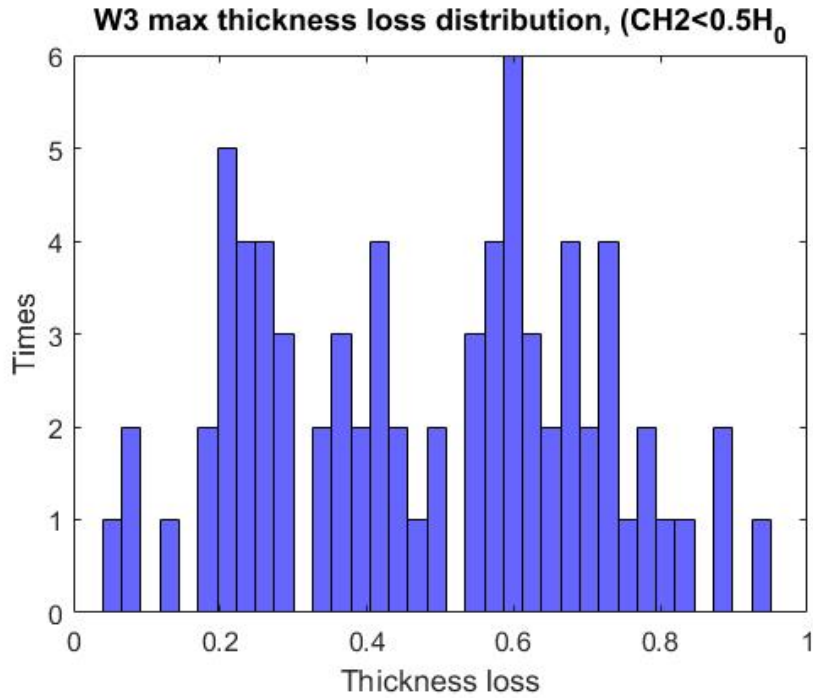
Figure 12.139: Max web thickness loss distribution of W3 web corrosion pattern, with corrosion height up to 50% of H₀, for beams with diaphragm.

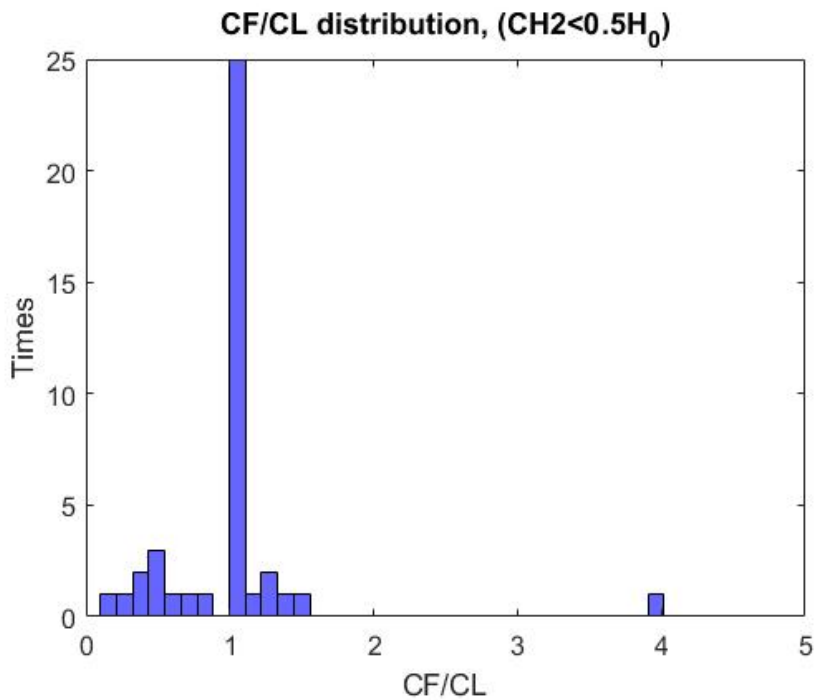
Figure 12.140: Ratio of flange to web corrosion length distribution, of W3 web corrosion pattern, with corrosion height up to 50% of H₀, for beams with diaphragm.

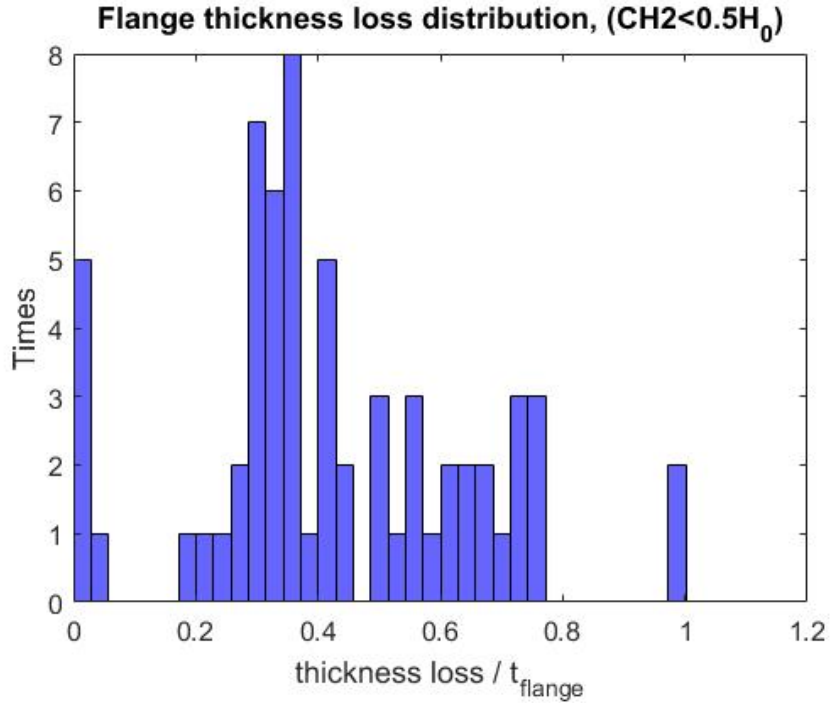
Figure 12.141: Max flange loss thickness distribution, for beams with W3 web corrosion pattern, with corrosion height up to 50% of H₀, for beams with diaphragm.

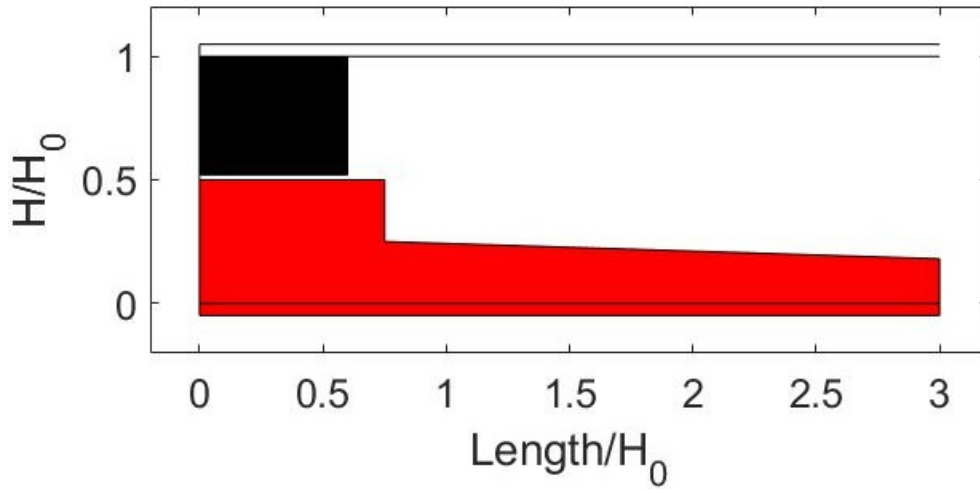
Figure 12.142: Third extreme flange and W3 web corrosion scenario for beams with diaphragm.

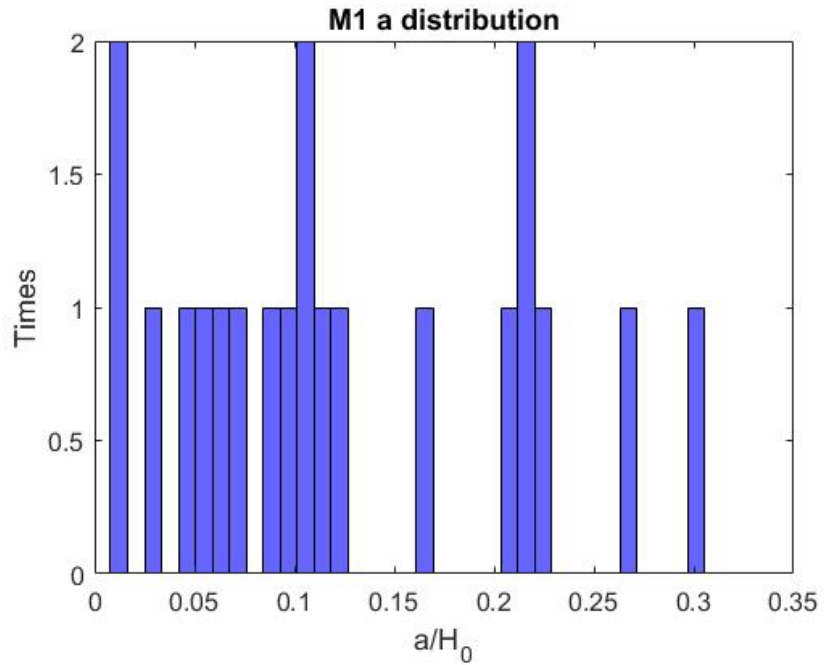
Figure 12.143: M1 web hole's pattern height distribution of W3 web corrosion pattern for beams with diaphragm.

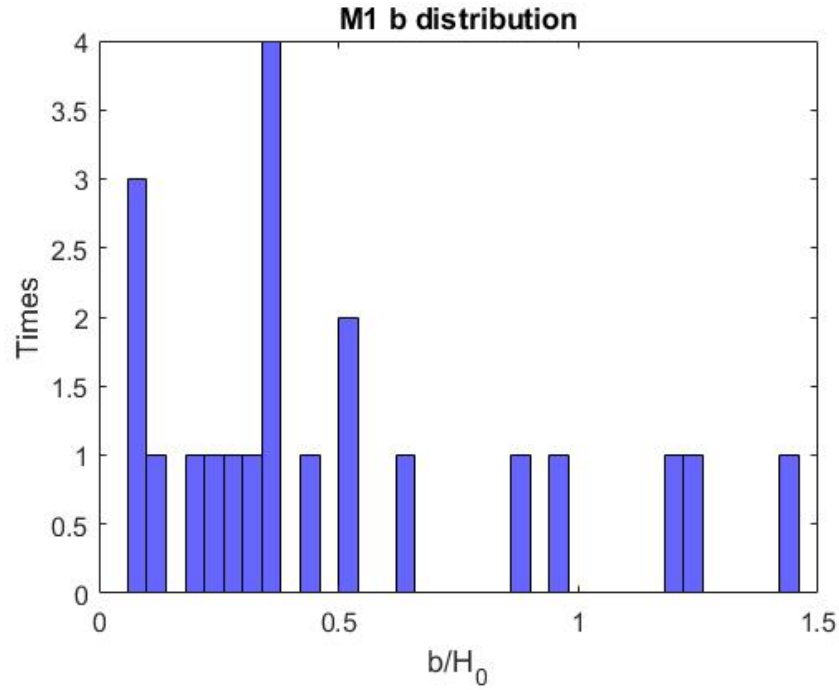
Figure 12.144: M1 web hole's pattern length distribution of W3 web corrosion pattern for beams with diaphragm.

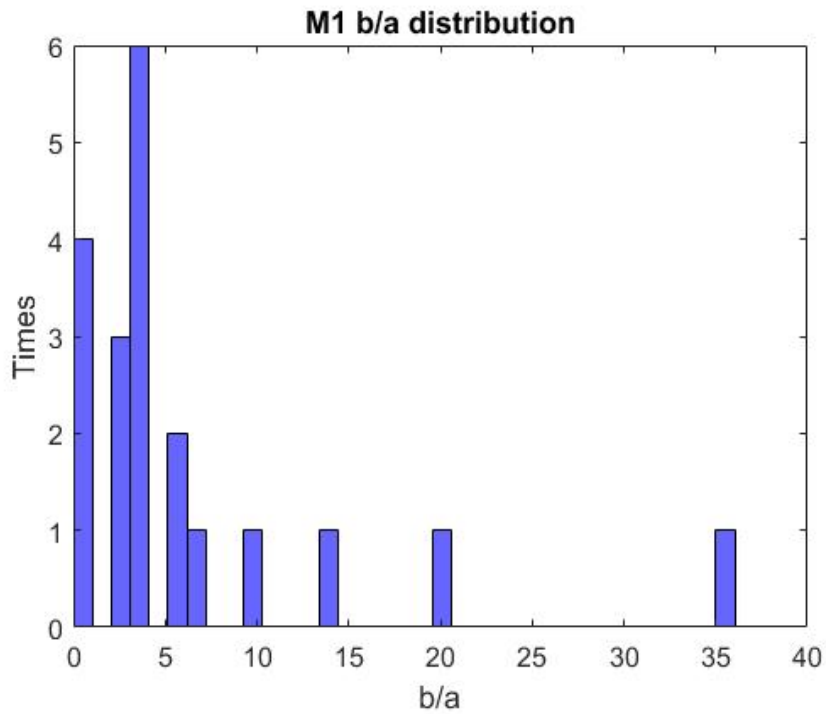
Figure 12.145: M1 web hole's ratio length to height distribution of W3 web corrosion pattern for beams with diaphragm.

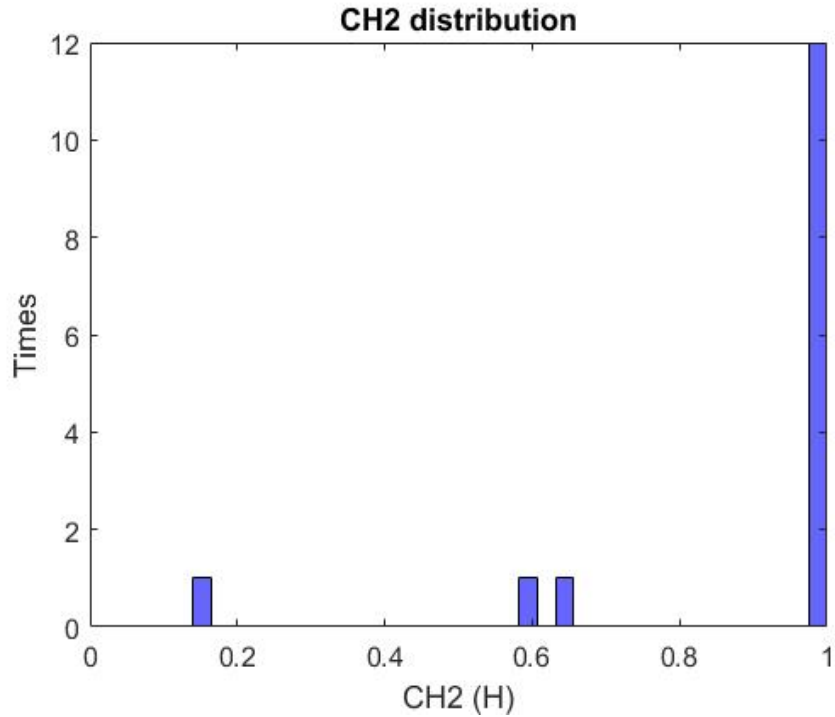
Figure 12.146: Max corrosion height distribution of W3 pattern with M1 hole, for beams with diaphragm.

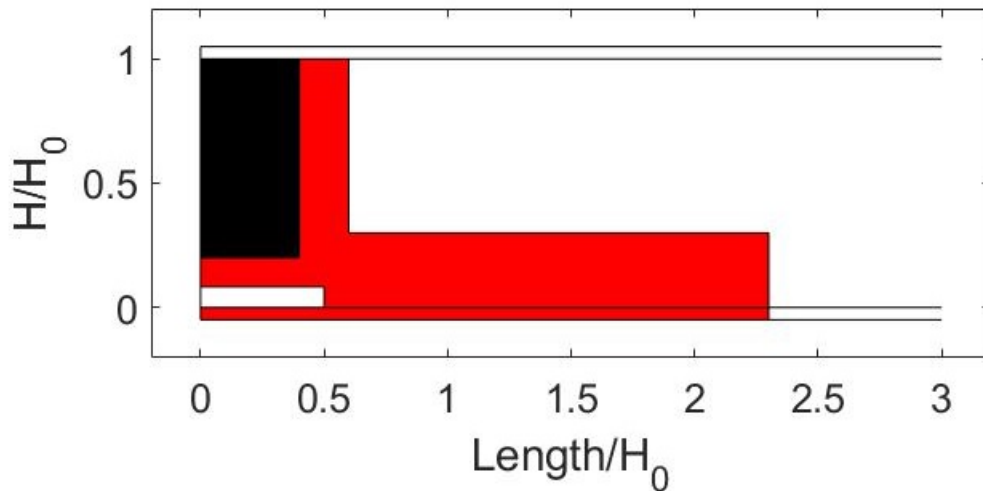
Figure 12.147: M1 hole pattern projected on the second extreme W3 web corrosion pattern scenario. Black illustrates the diaphragm that could be found with these patterns.

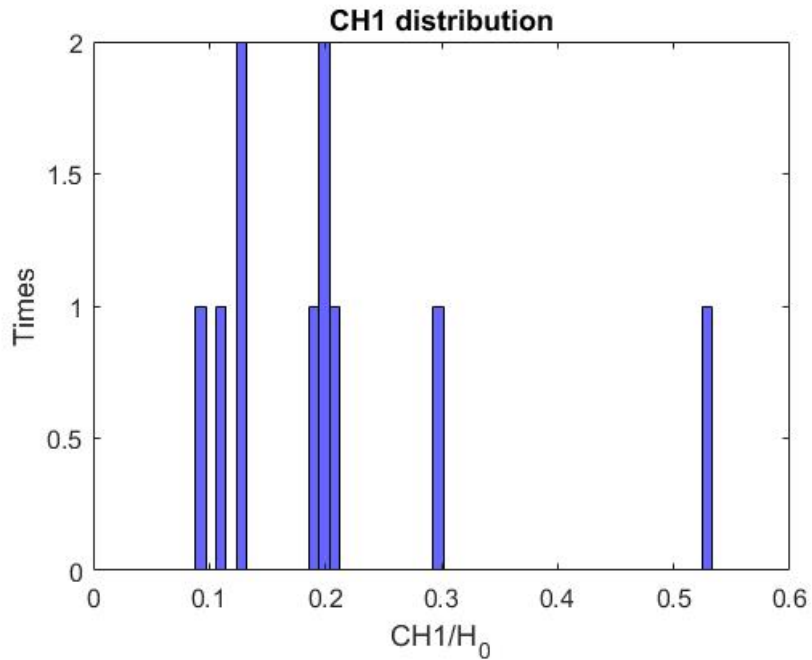
Figure 12.148: CH1 distribution of W4 web corrosion pattern for beams with diaphragm.

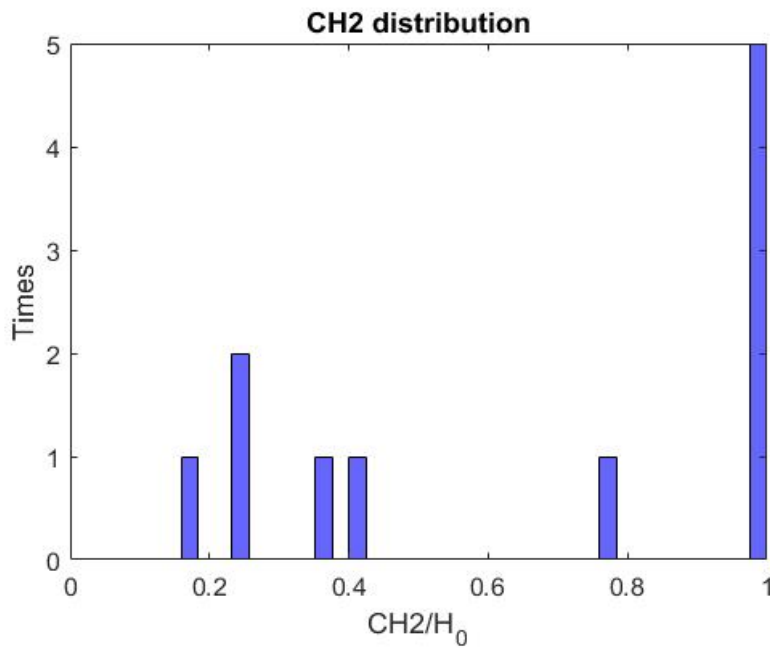
Figure 12.149: CH2 distribution of W4 web corrosion pattern for beams with diaphragm.

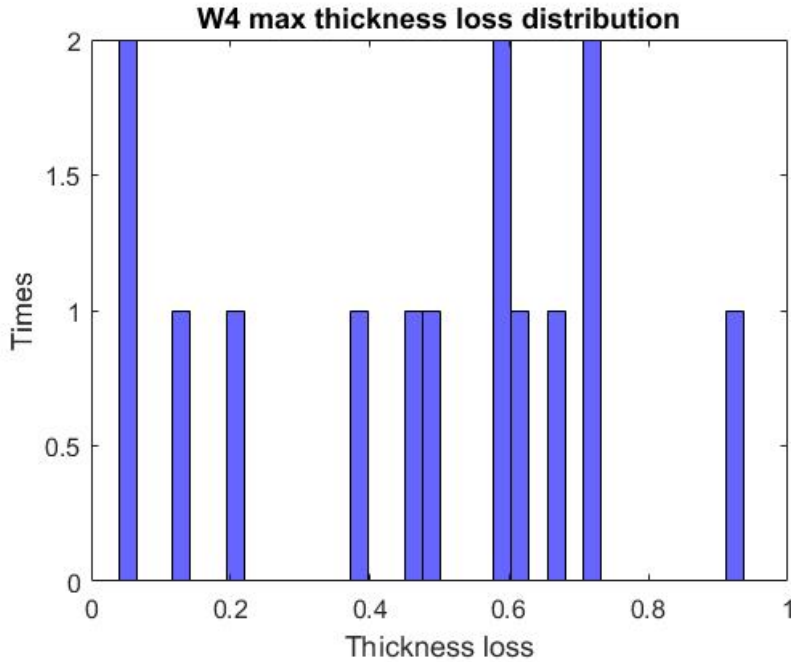
Figure 12.150: Max web thickness loss distribution of W4 web corrosion pattern for beams with diaphragm.

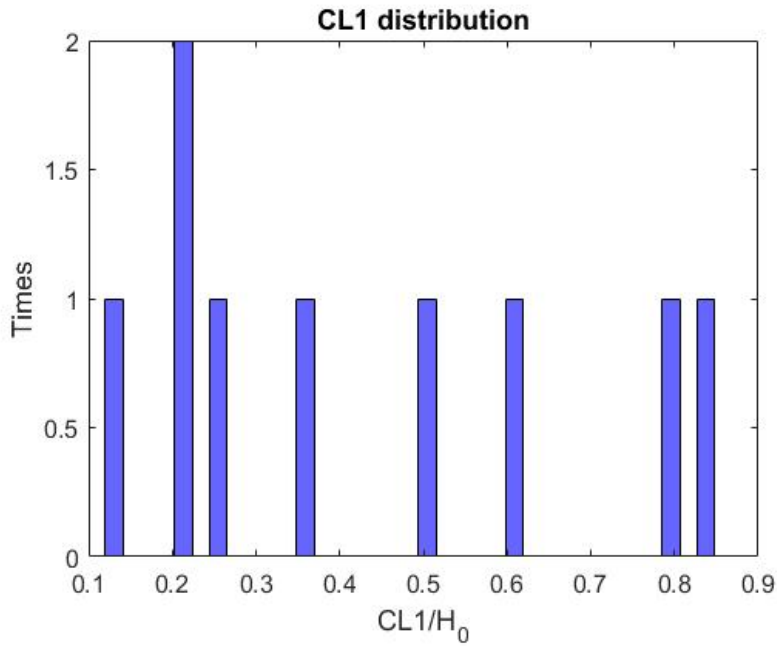
Figure 12.151: CL1 distribution of W4 web corrosion pattern for beams with diaphragm.

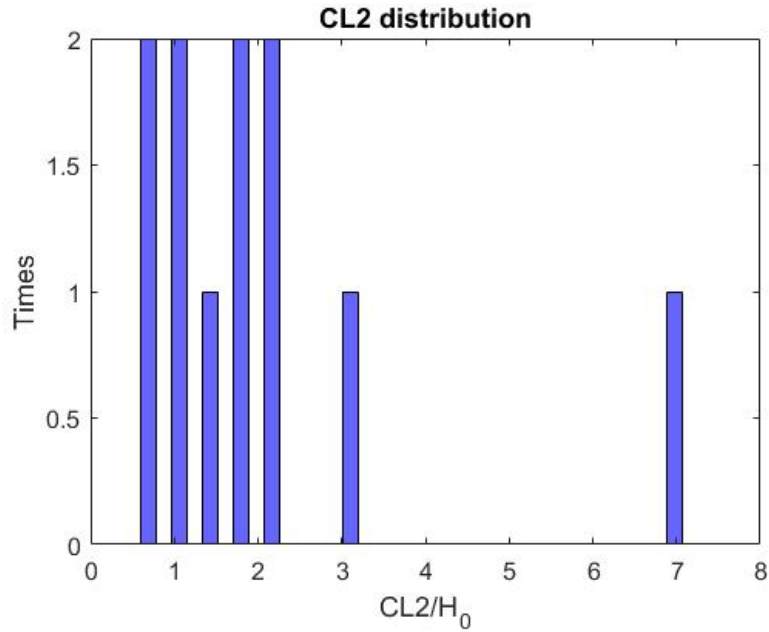
Figure 12.152: CL2 distribution of W4 web corrosion pattern for beams with diaphragm.

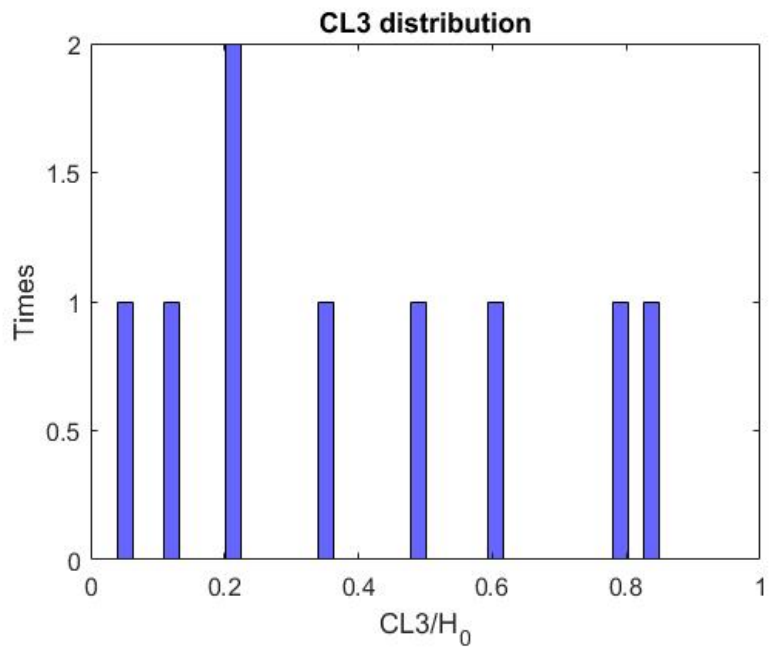
Figure 12.153: CL3 distribution of W4 web corrosion pattern for beams with diaphragm.

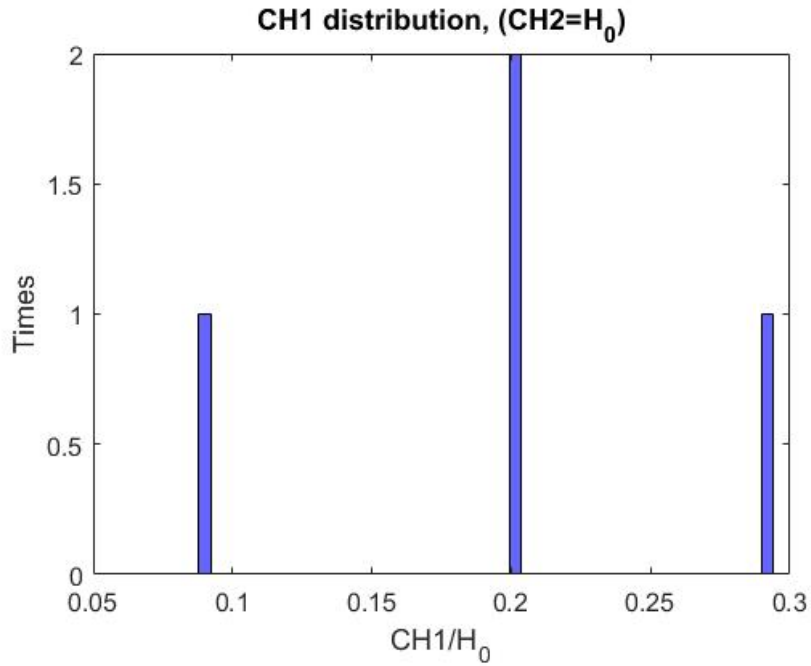
Figure 12.154: CH1 distribution of W4 web corrosion pattern with full height corrosion for beams with diaphragm.

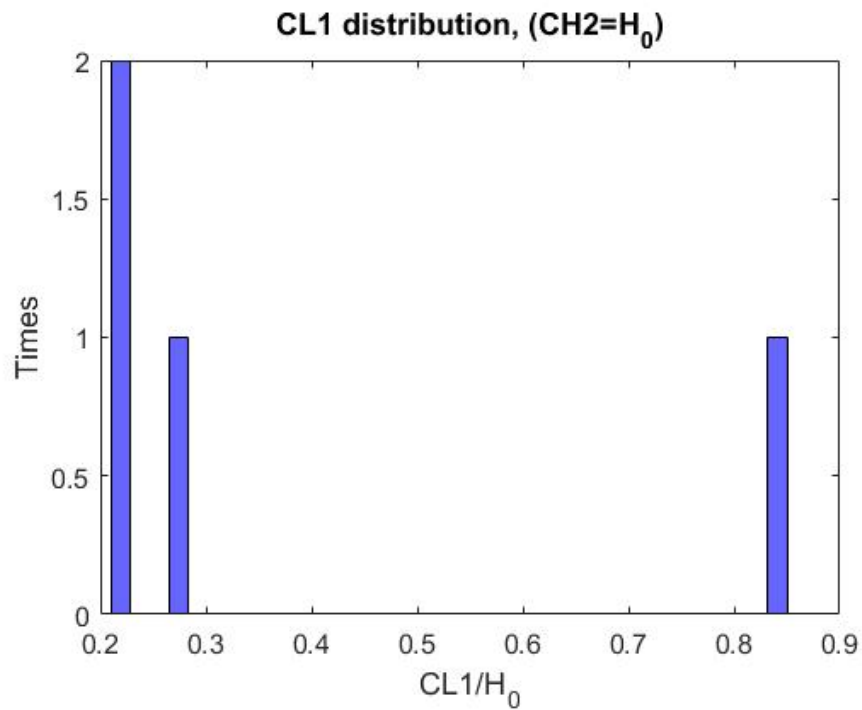
Figure 12.155: CL1 distribution of W4 web corrosion pattern with full height corrosion for beams with diaphragm.

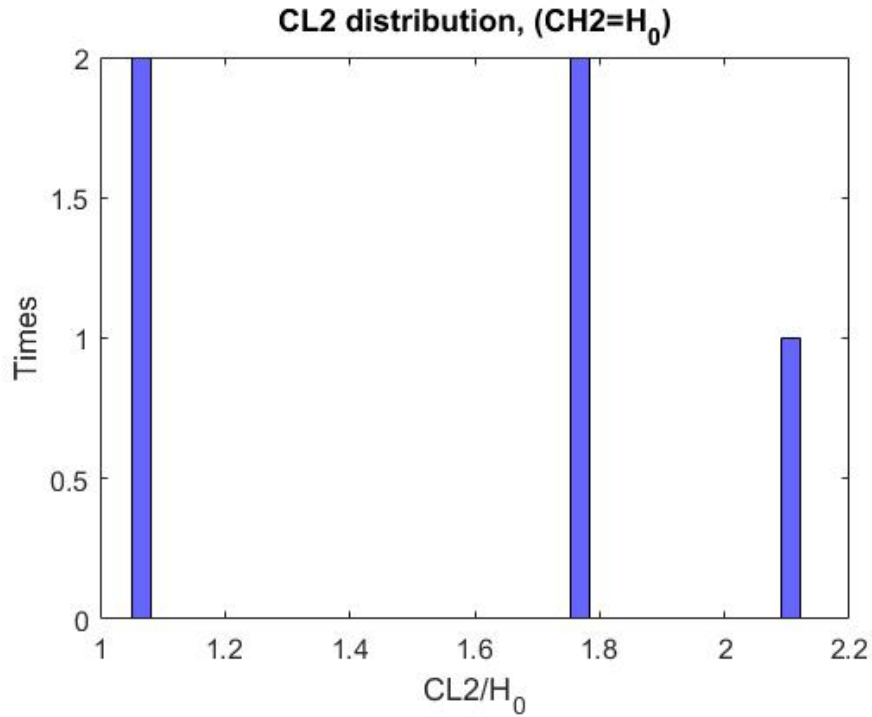
Figure 12.156: CL2 distribution of W4 web corrosion pattern with full height corrosion for beams with diaphragm.

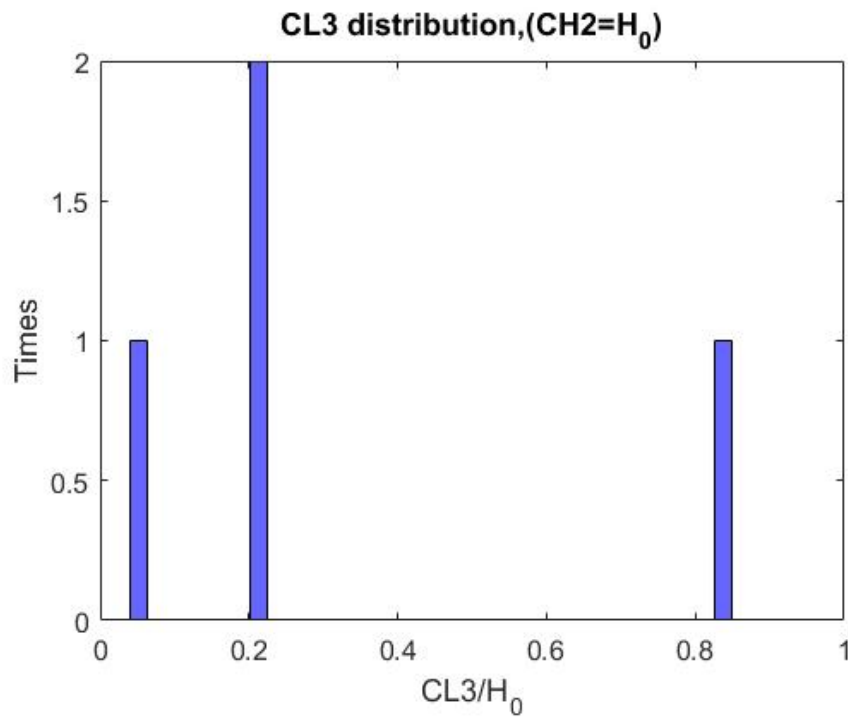
Figure 12.157: CL3 distribution of W4 web corrosion pattern with full height corrosion for beams with diaphragm.

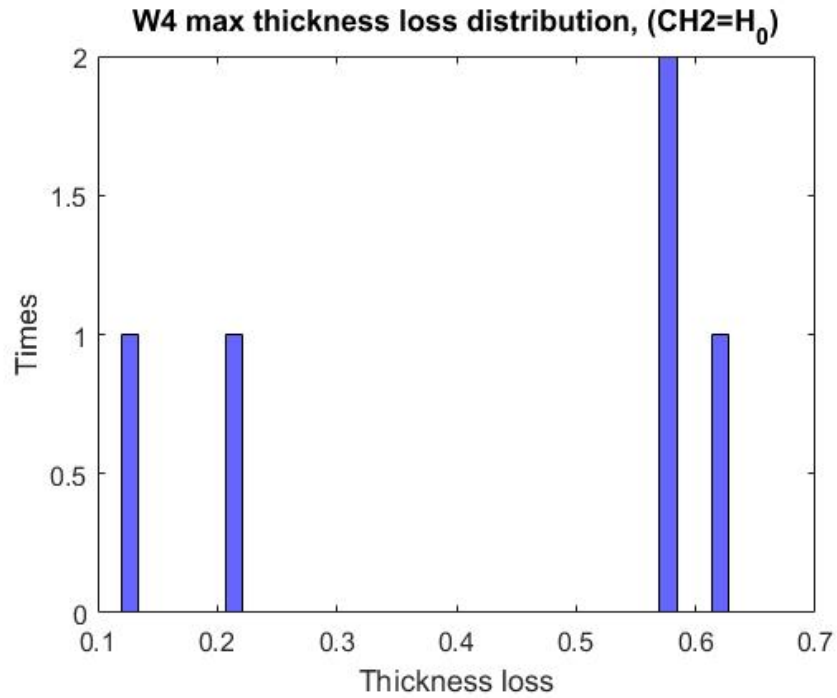
Figure 12.158: Max web thickness loss distribution of W4 web corrosion pattern with full height corrosion for beams with diaphragm.

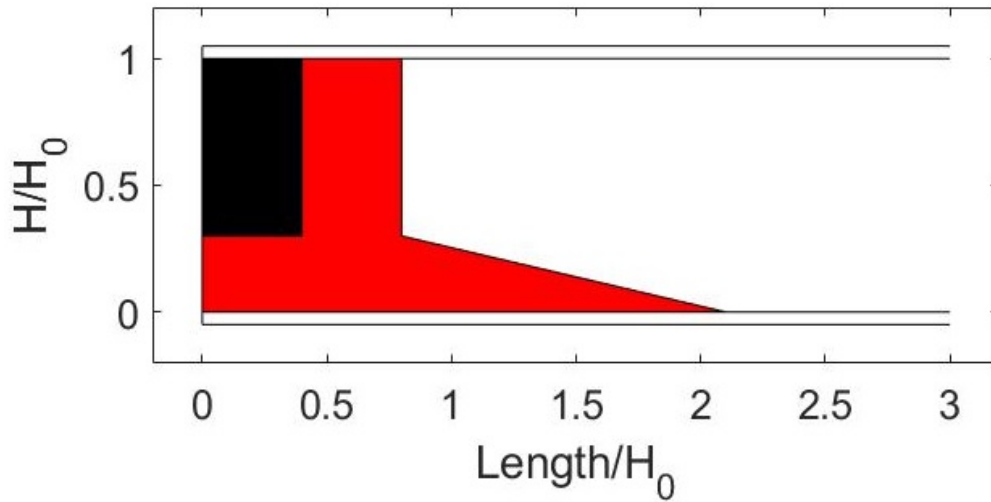
Figure 12.159: First extreme W4 web corrosion scenario for beams with diaphragm.

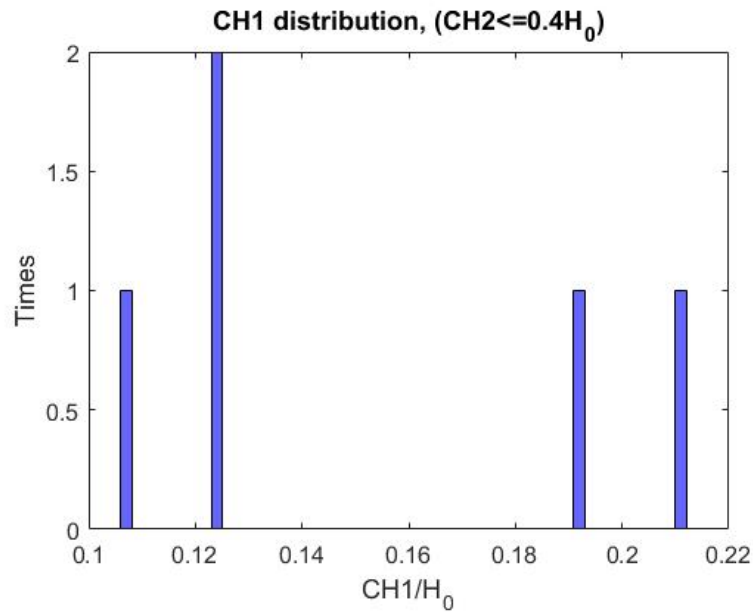
Figure 12.160: CH1 distribution of W4 web corrosion pattern, with corrosion height up to 40% of H_0 , for beams with diaphragm.

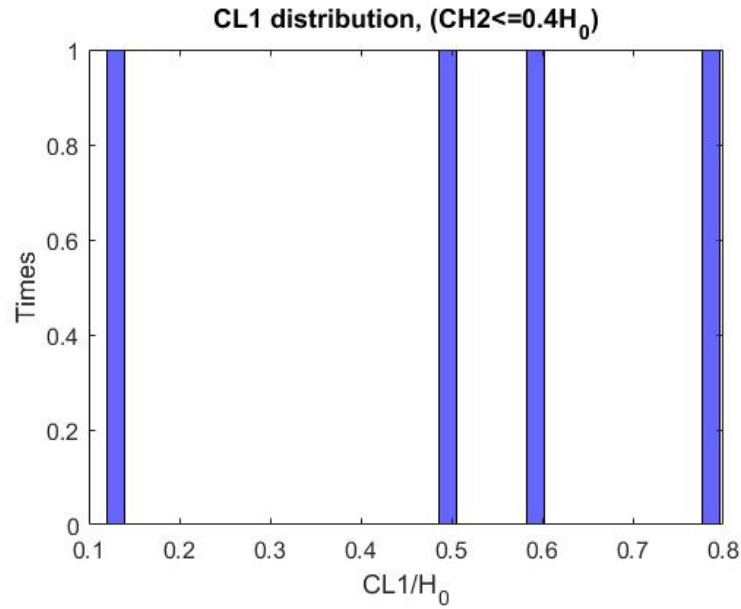
Figure 12.161: CL1 distribution of W4 web corrosion pattern, with corrosion height up to 40% of H₀, for beams with diaphragm.

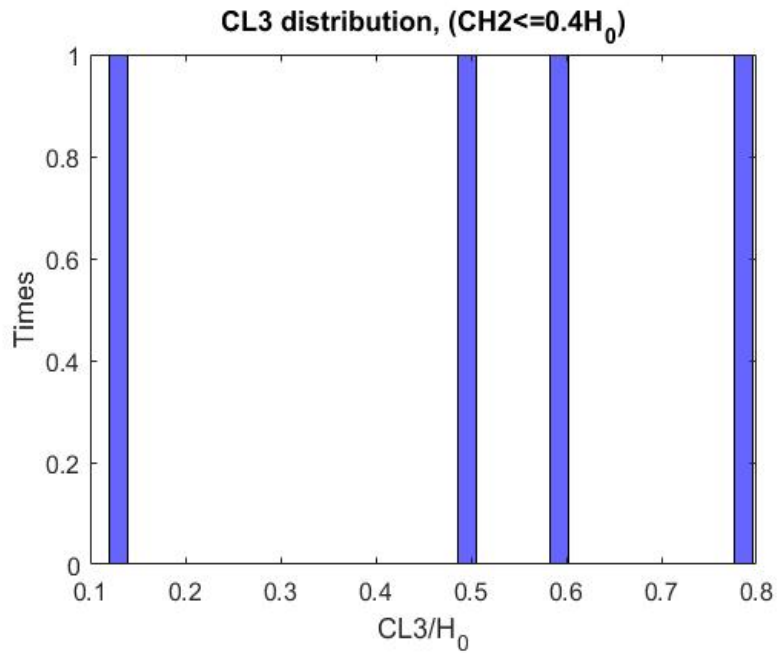
Figure 12.162: CL3 distribution of W4 web corrosion pattern, with corrosion height up to 40% of H₀, for beams with diaphragm.

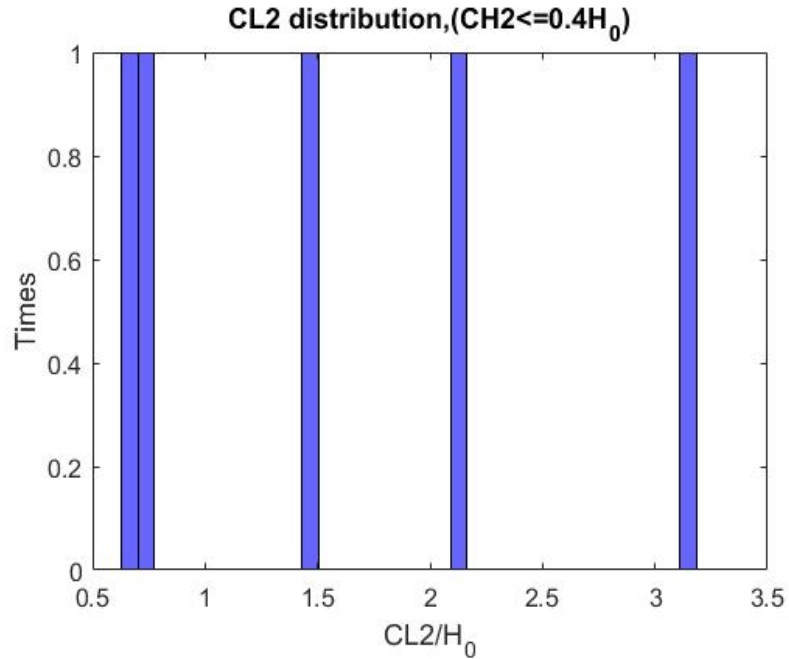
Figure 12.163: CL2 distribution of W4 web corrosion pattern, with corrosion height up to 40% of H_0 , for beams with diaphragm.

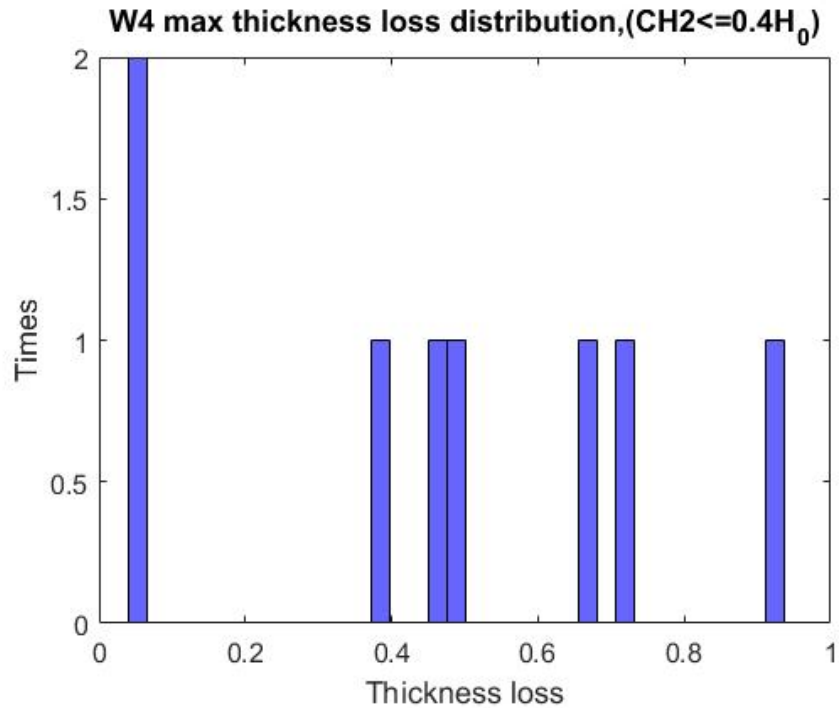
Figure 12.164: Max web thickness loss distribution of W4 web corrosion pattern, with corrosion height up to 40% of H_0 , for beams with diaphragm.

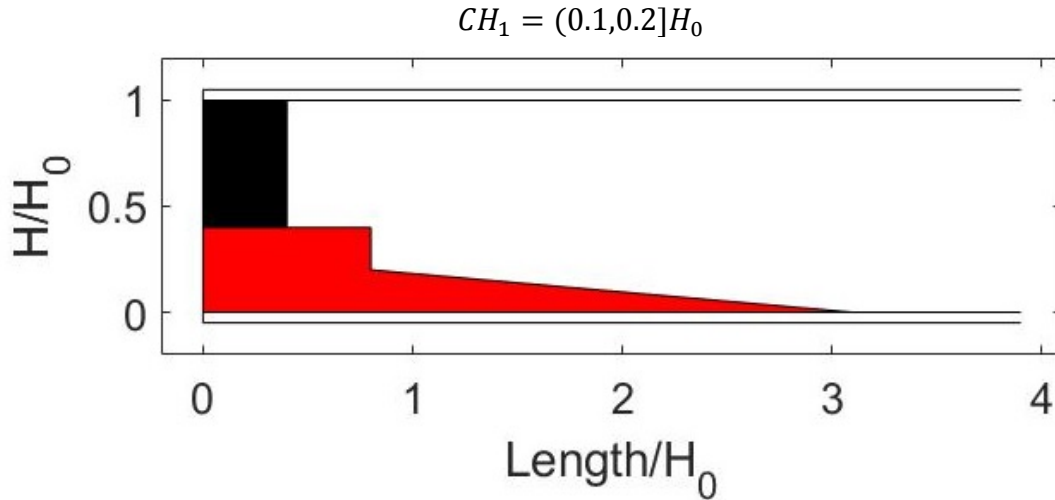
Figure 12.165: Second extreme W4 web corrosion scenario for beams with diaphragm.

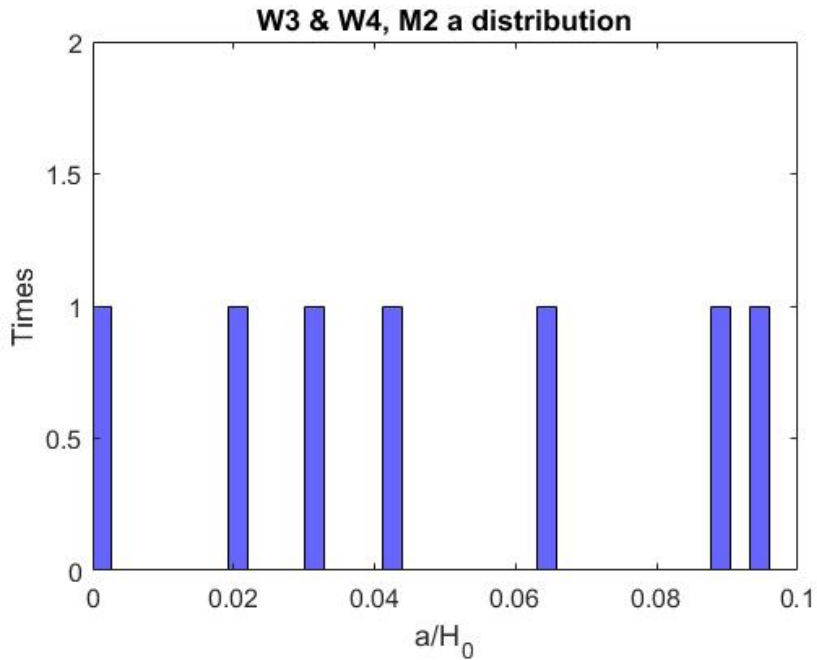
Figure 12.166: M2 web hole's pattern height distribution of W3 and W4 web corrosion pattern for beams with diaphragm.

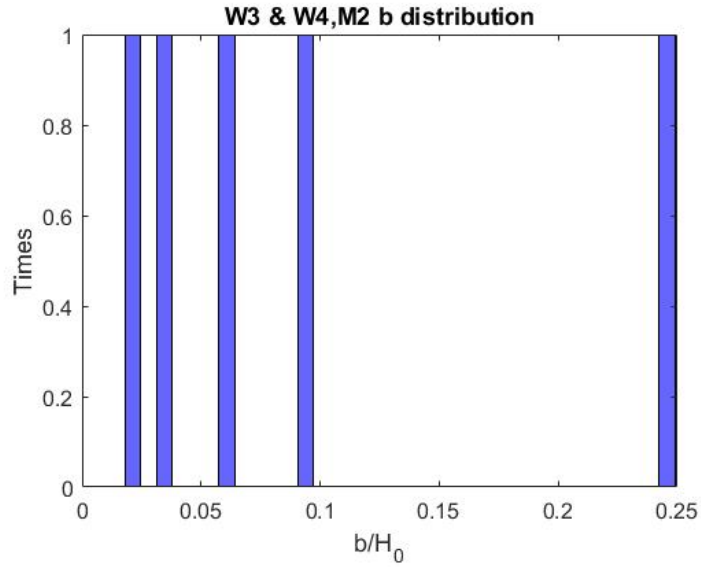
Figure 12.167: M2 web hole's pattern length distribution of W3 and W4 web corrosion pattern for beams with diaphragm.

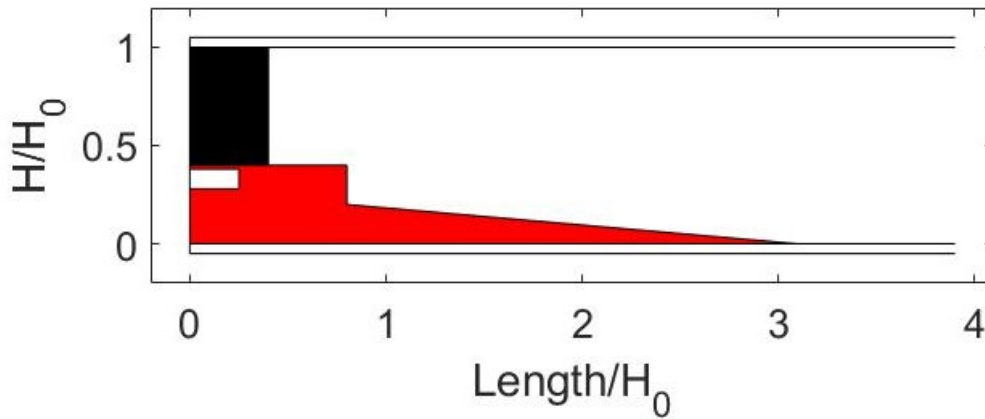
Figure 12.168: Extreme M2 hole pattern scenario projected on second extreme W4 web corrosion scenario for beams with diaphragm.

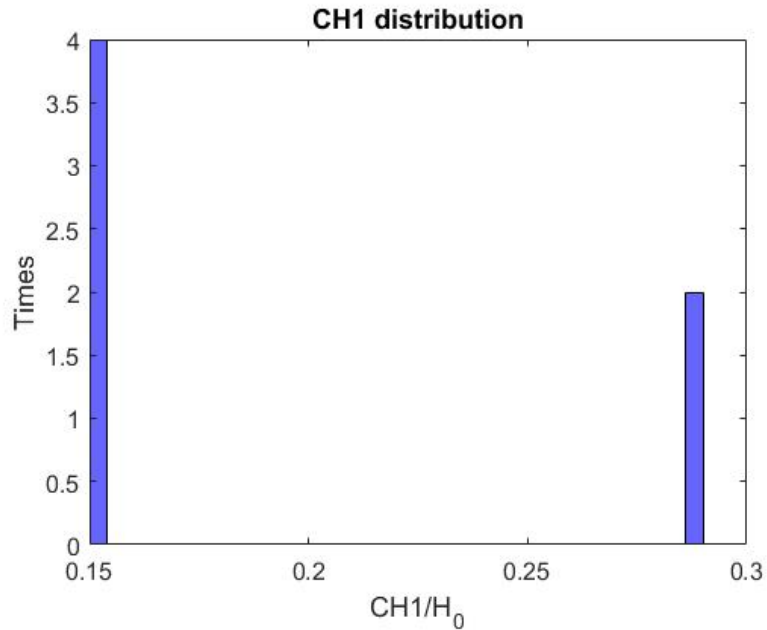
Figure 12.169: CH1 distribution of W5 web corrosion pattern for beams with diaphragm.
