September 2019

Report No. 19-008

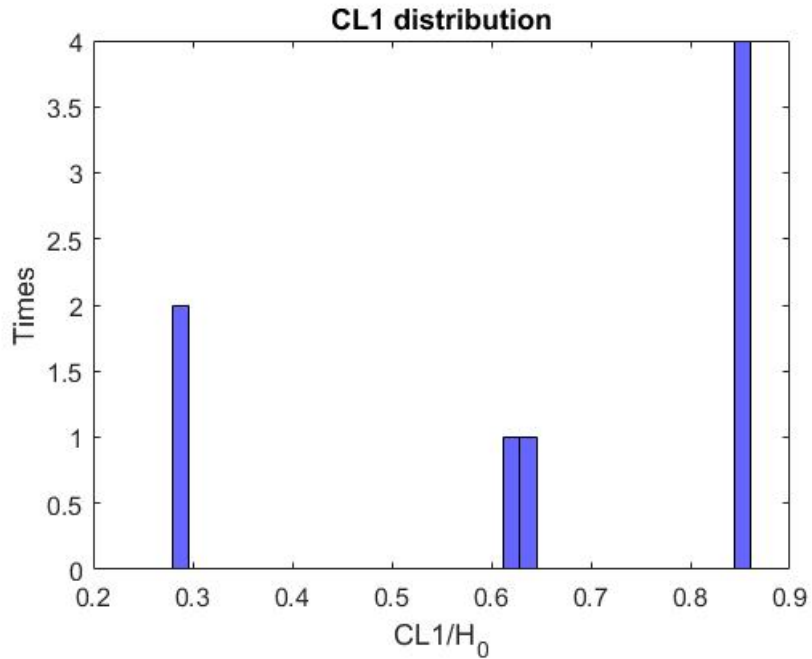
Figure 12.170: CL1 distribution of W4 web corrosion pattern for beams with diaphragm.

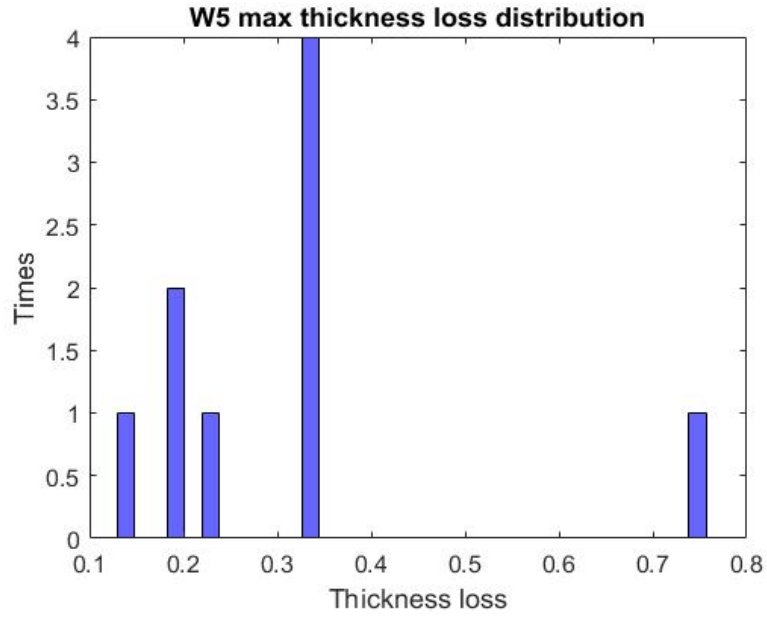
Figure 12.171: Max web thickness loss distribution of W5 web corrosion pattern for beams with diaphragm.

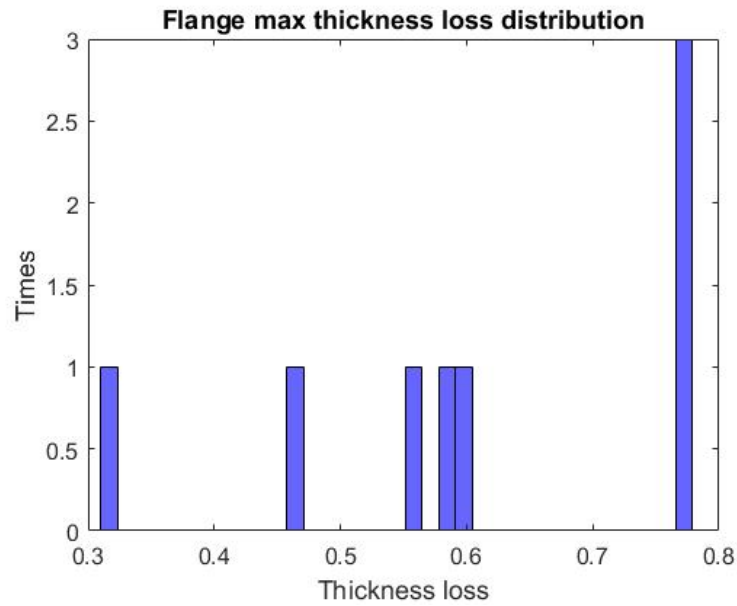
Figure 12.172: Max flange thickness loss of beams with W5 web corrosion pattern for beams with diaphragm.

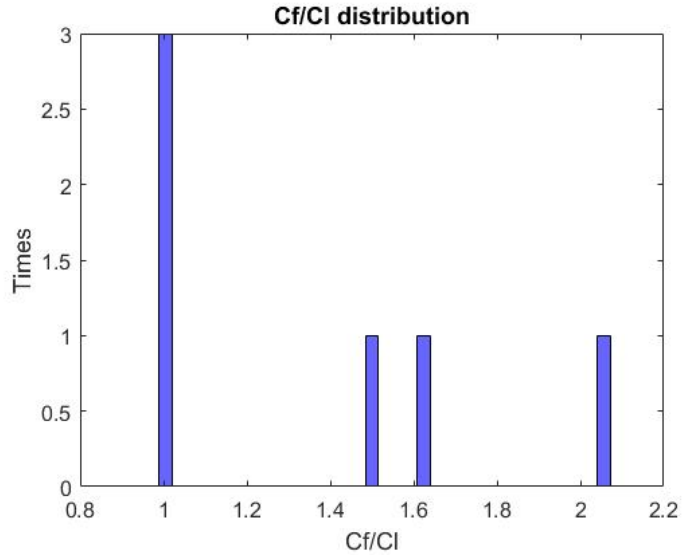
Figure 12.173: Ratio of flange to web corrosion length distribution, of W5 web corrosion pattern for beams with diaphragm.

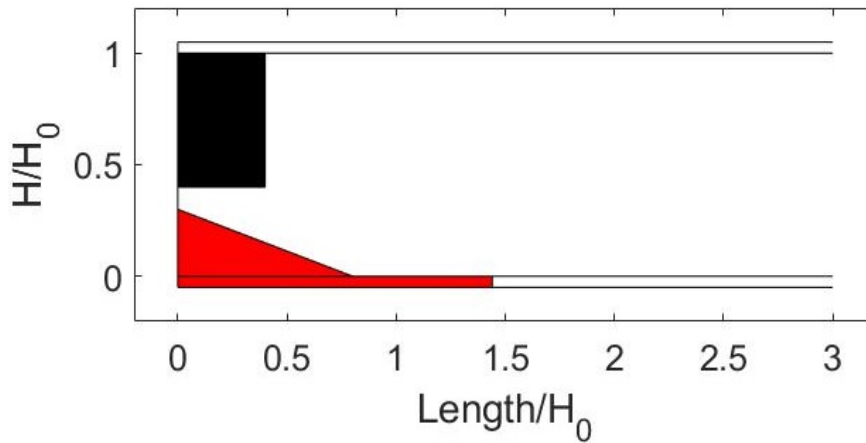
Figure 12.174: Extreme W5 web corrosion scenario for beams with diaphragm.
