Rehabilitation of Upper Mystic Lake Dam Medford and Arlington, MA

PUBLIC MEETING

Thursday, September 24, 2009

GZA
GeoEnvironmental,
Inc.

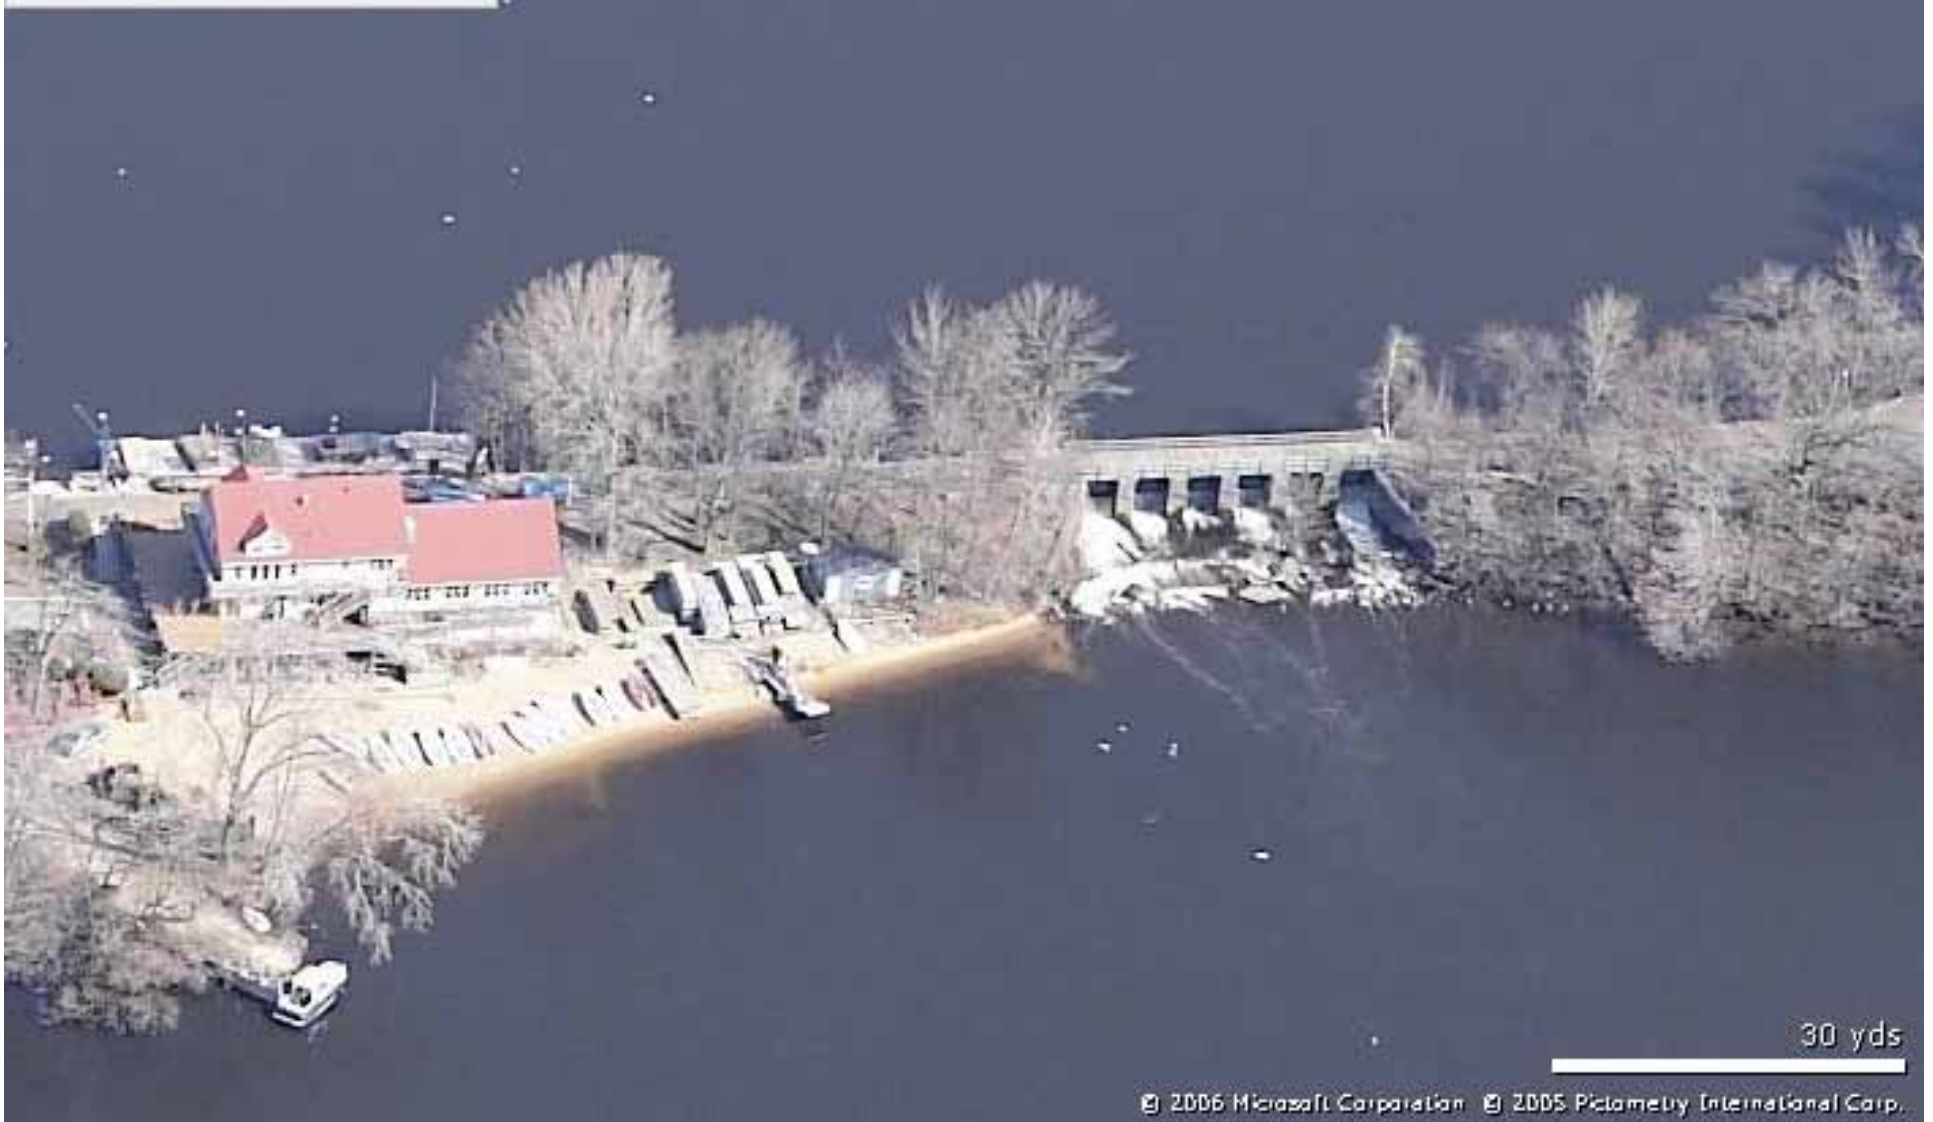
DCR Public
Parking Area

Main Dam

Overflow Location

Spillway

Medford Boat Club

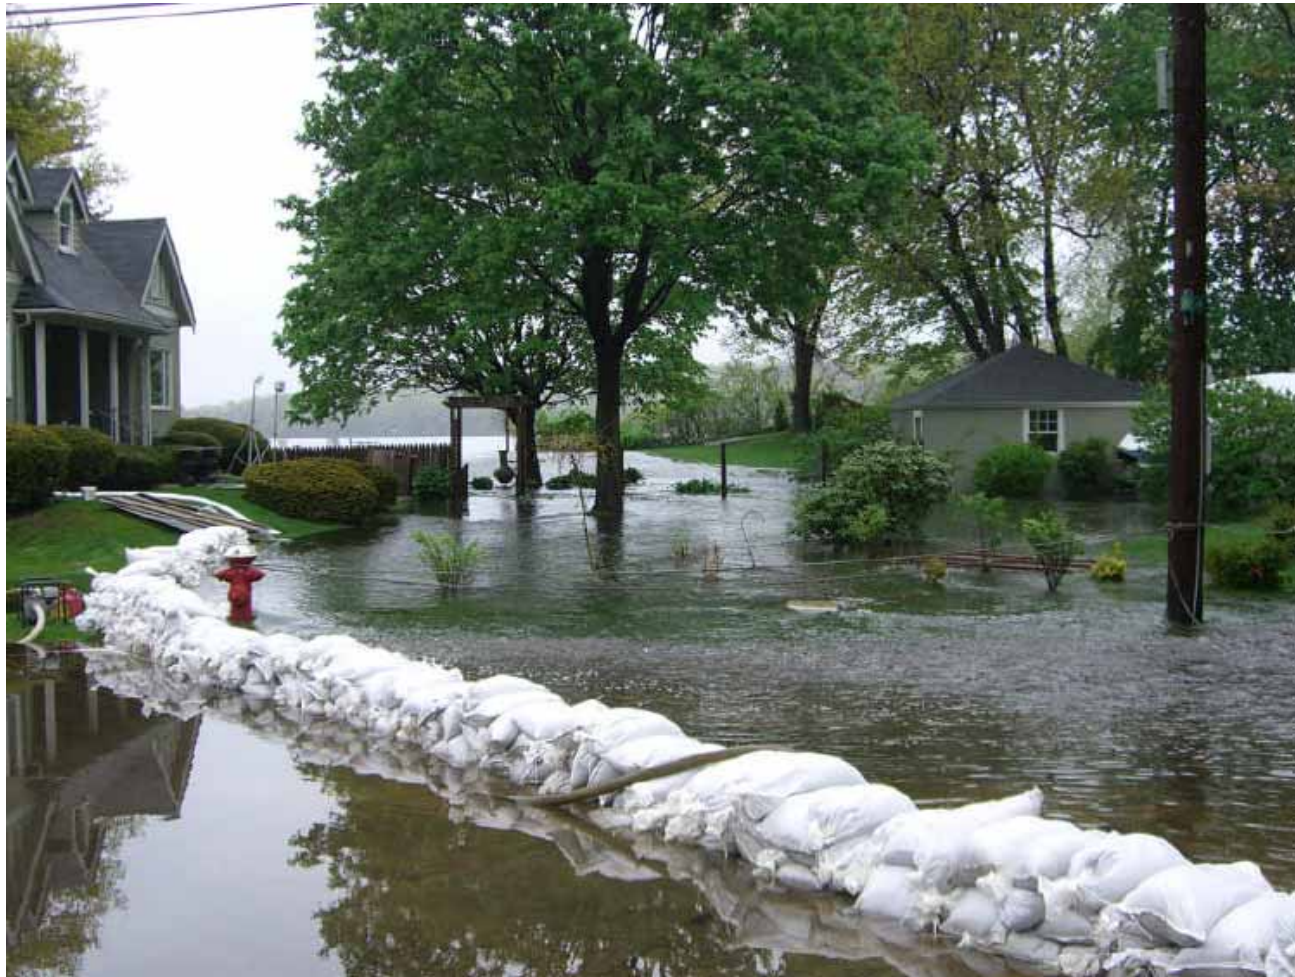
Inadequate Spillway Capacity

Deficiency	Corrective Design Element
Inadequate Spillway Capacity	<ul style="list-style-type: none">•New secondary spillway•Close existing overflow area
Damage to Existing Spillway	<ul style="list-style-type: none">•Repair historic masonry structures•New concrete apron
Leaking / Inoperative Spillway Controls	<ul style="list-style-type: none">•Replace stop logs with concrete ogees•Install two bottom-hinged crest gates
Bridge Inadequate	<ul style="list-style-type: none">•New spillway bridge (test piers)
Inadequate Slope Stability	<ul style="list-style-type: none">•Flatten slopes
Inadequate Erosion Protection	<ul style="list-style-type: none">•Provide riprap and revetment stone
Trees on Embankment	<ul style="list-style-type: none">•Remove trees
Uncontrolled Seepage	<ul style="list-style-type: none">•New sheetpile cutoff•Downstream filter soils
Low-Level Outlet Malfunctioning	<ul style="list-style-type: none">•Replace existing slide gates•Modifications to aqueduct

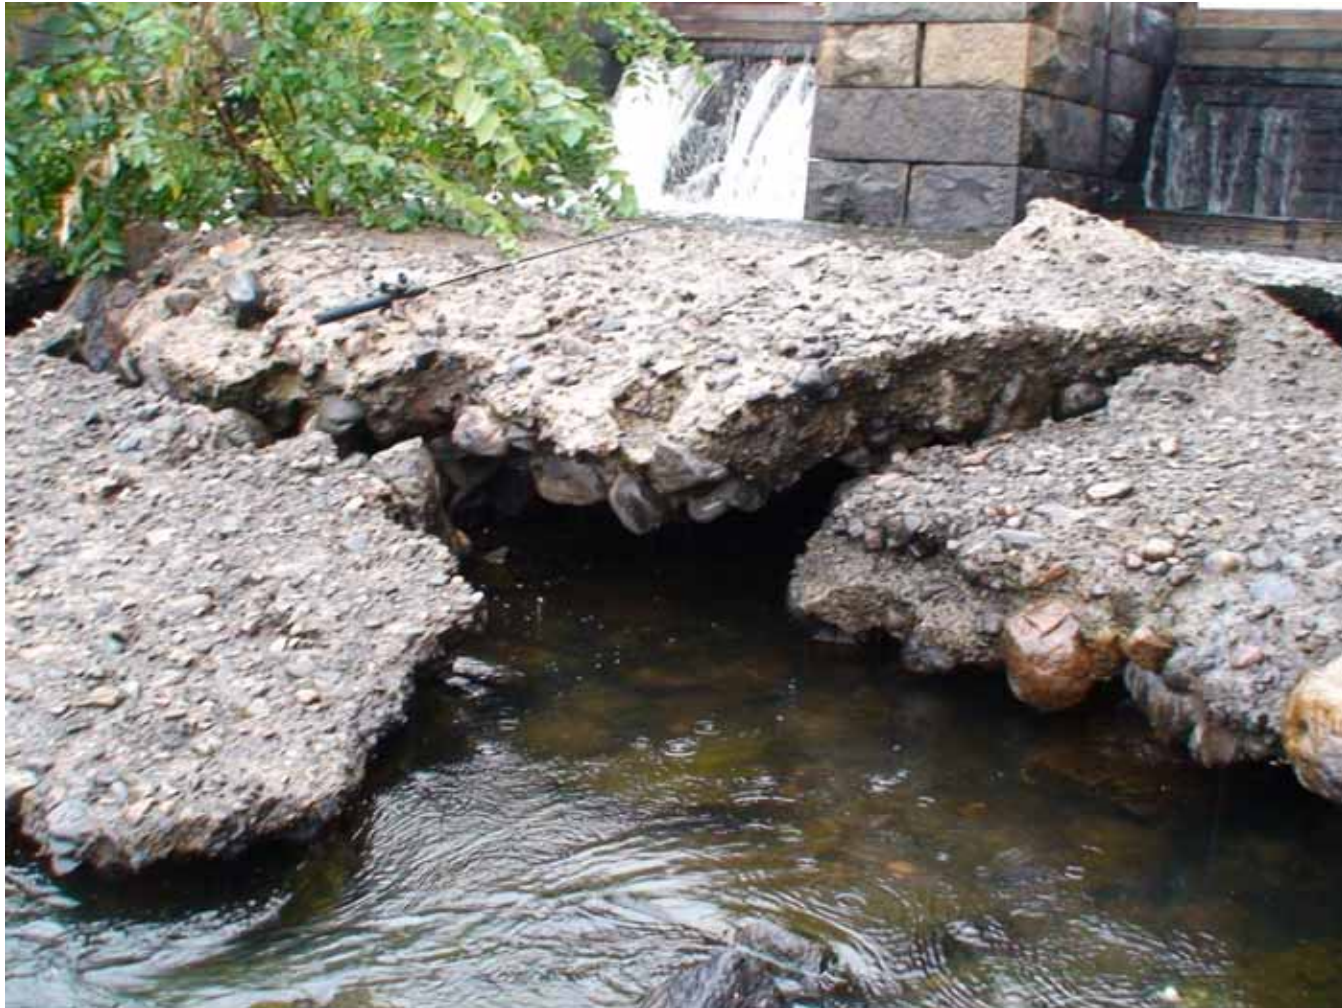
Current Dam Safety Deficiencies Damaged Primary Spillway Apron and Masonry

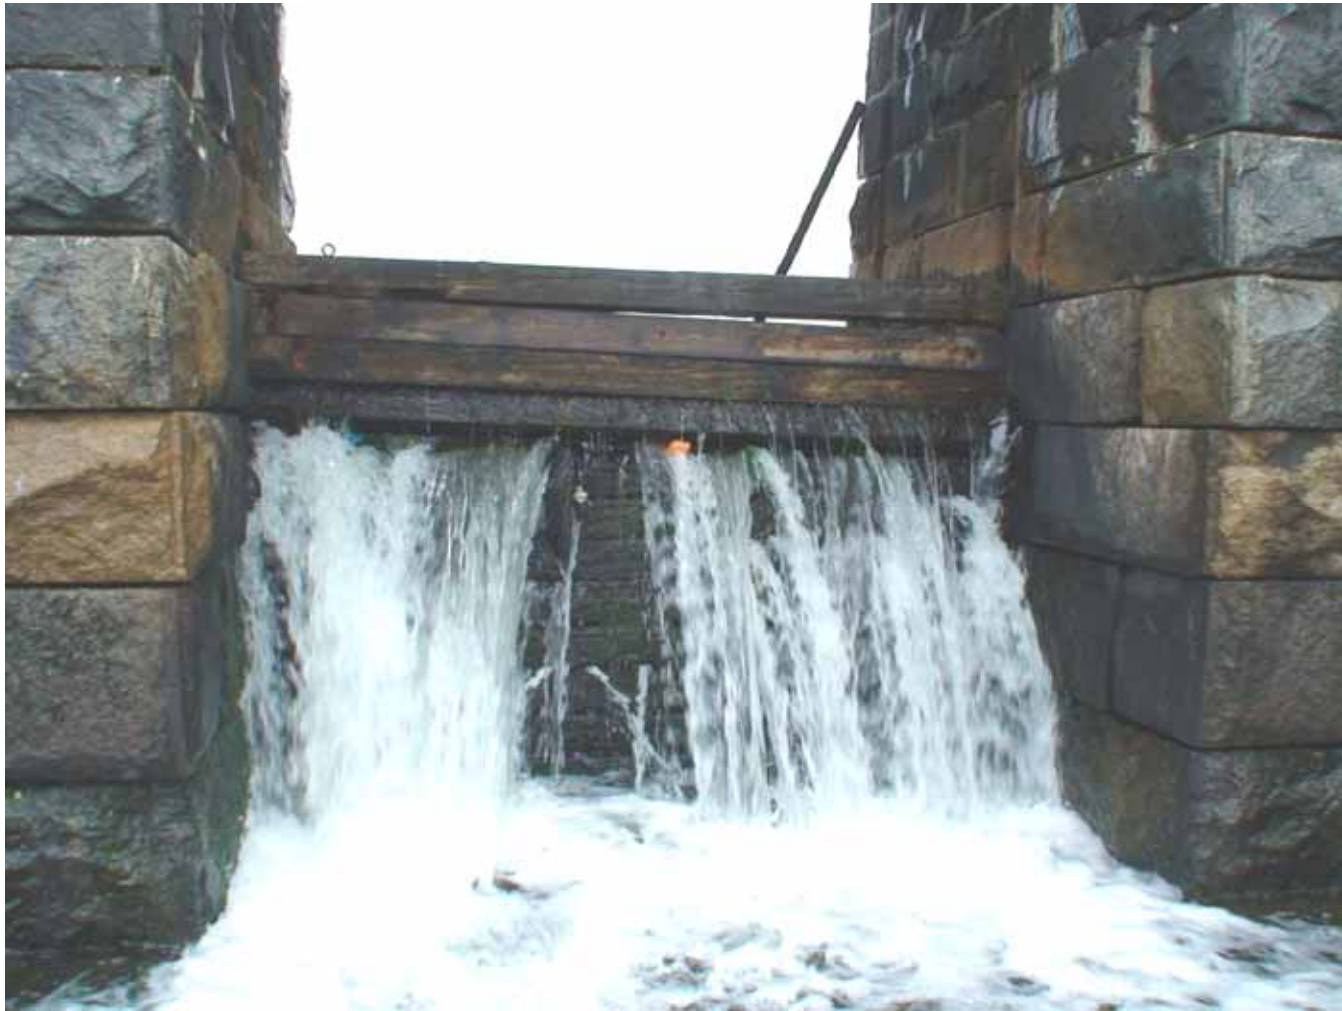
Current Dam Safety Deficiencies Leaking and Poorly Functioning Controls

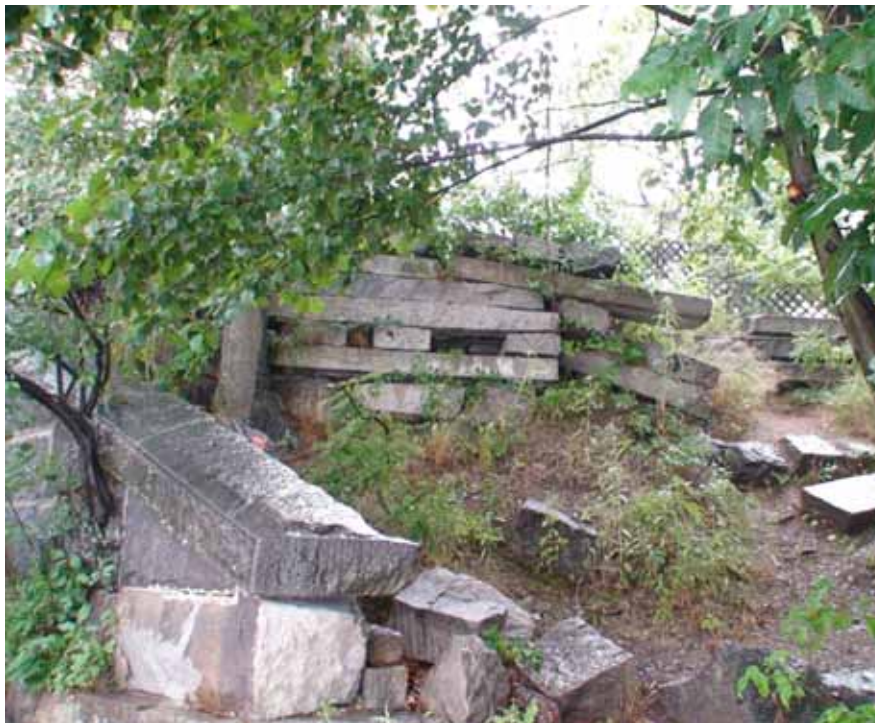
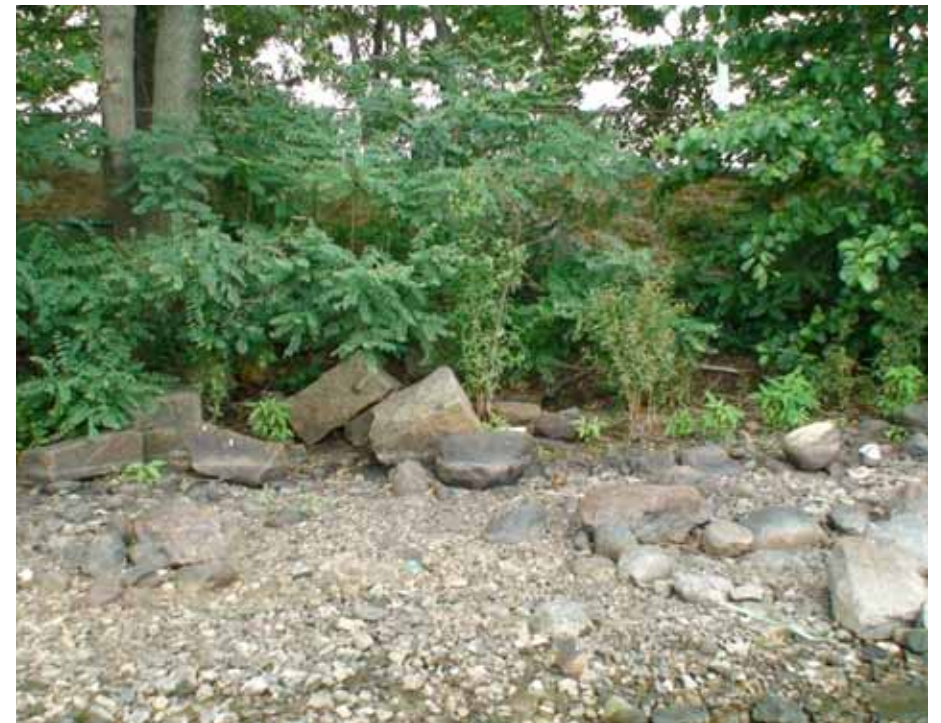
Current Dam Safety Deficiencies Slope Stability and Erosion Problems

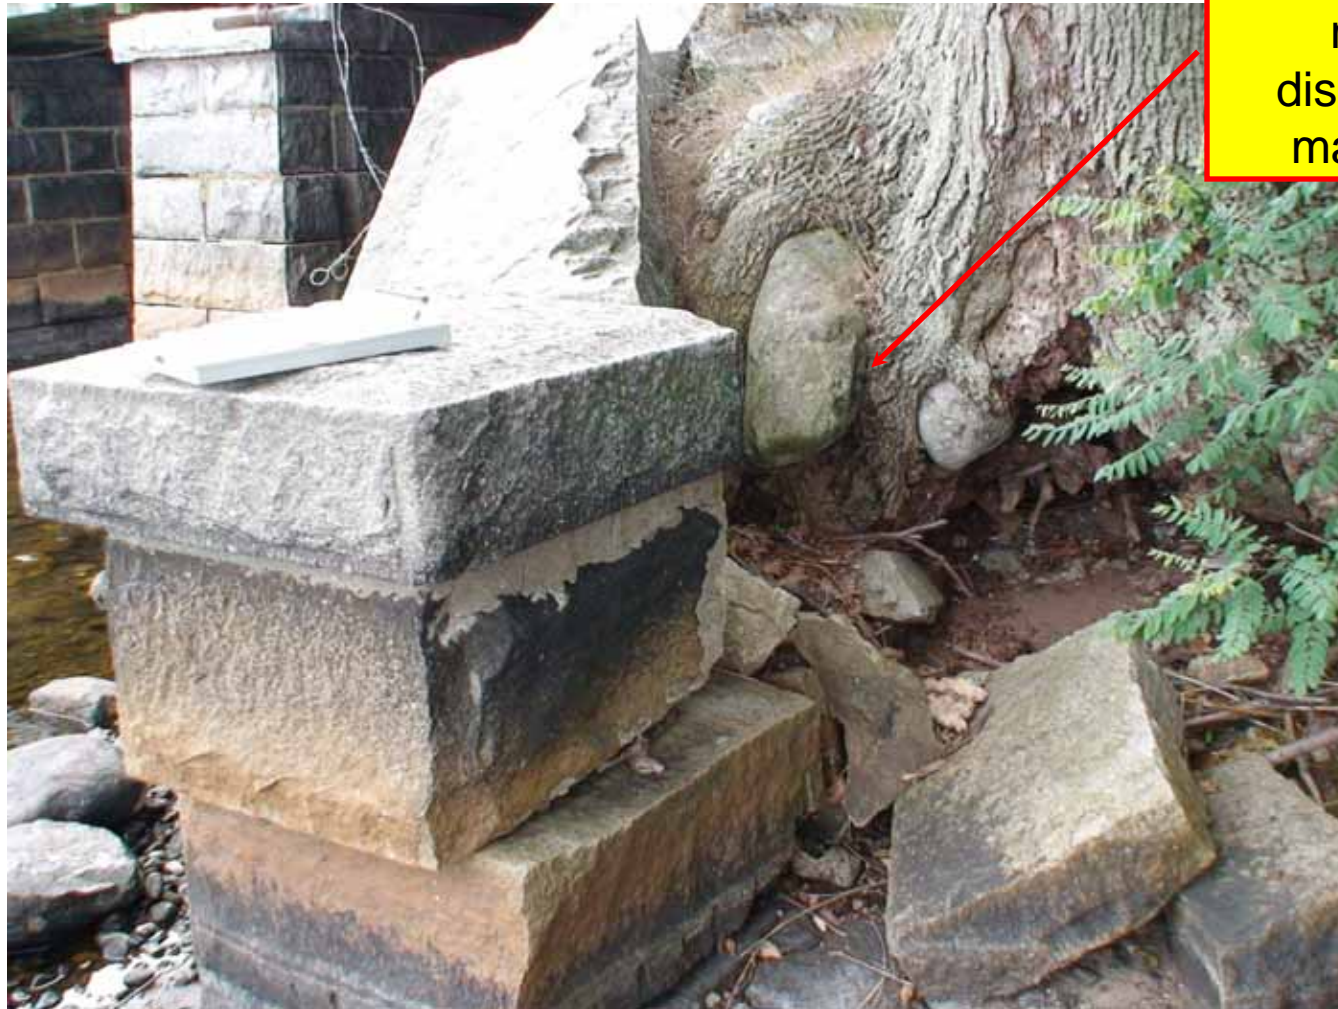
Current Dam Safety Deficiencies Trees on Embankment

Tree with roots displacing masonry

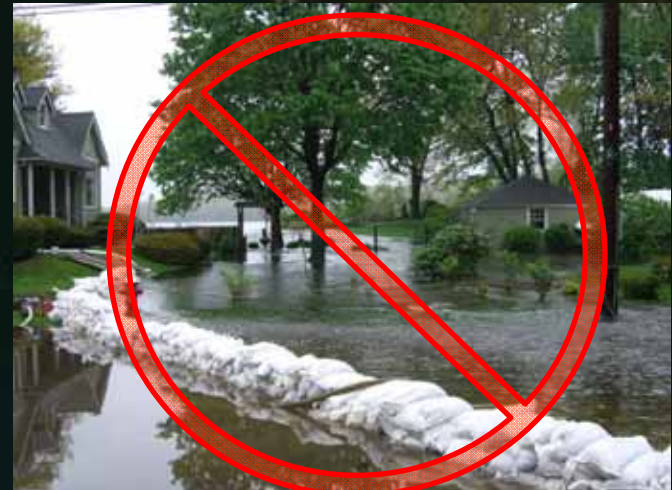
Upper Mystic Lake Dam Rehabilitation Right Abutment

Minor
Grading

Right Side
Lake Wall

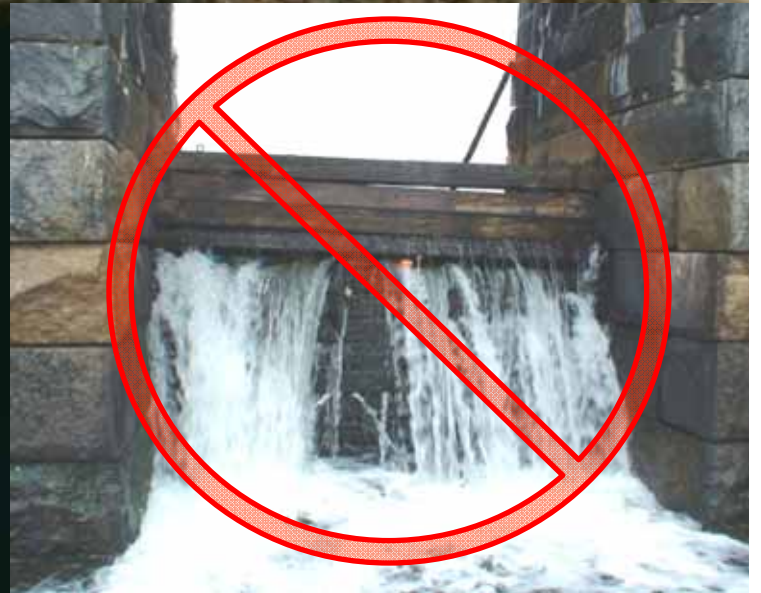
Upper Mystic Lake Dam Rehabilitation Central Embankment and Primary Spillway

3:1 Slope
and Riprap

New
Sheetpile
Cutoff

3:1 Slope
and
Revetment
Stone

Rehabilitate
d Primary
Spillway
And Bridge

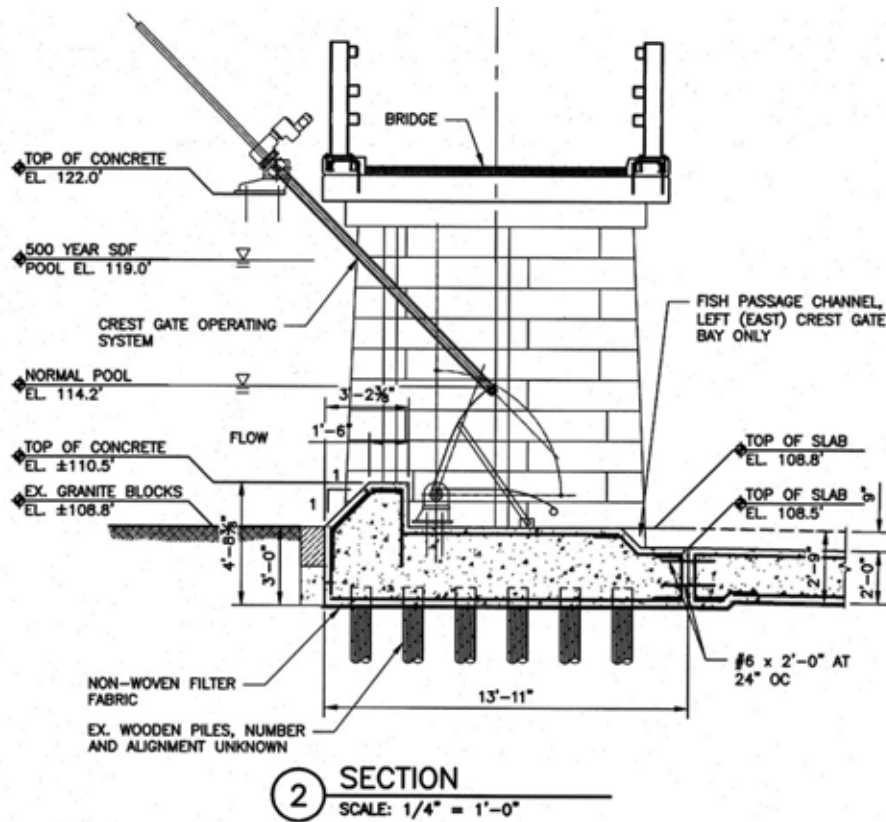
Crest Gate Bays

Upper Mystic Lake Dam Rehabilitation Primary Spillway Sections

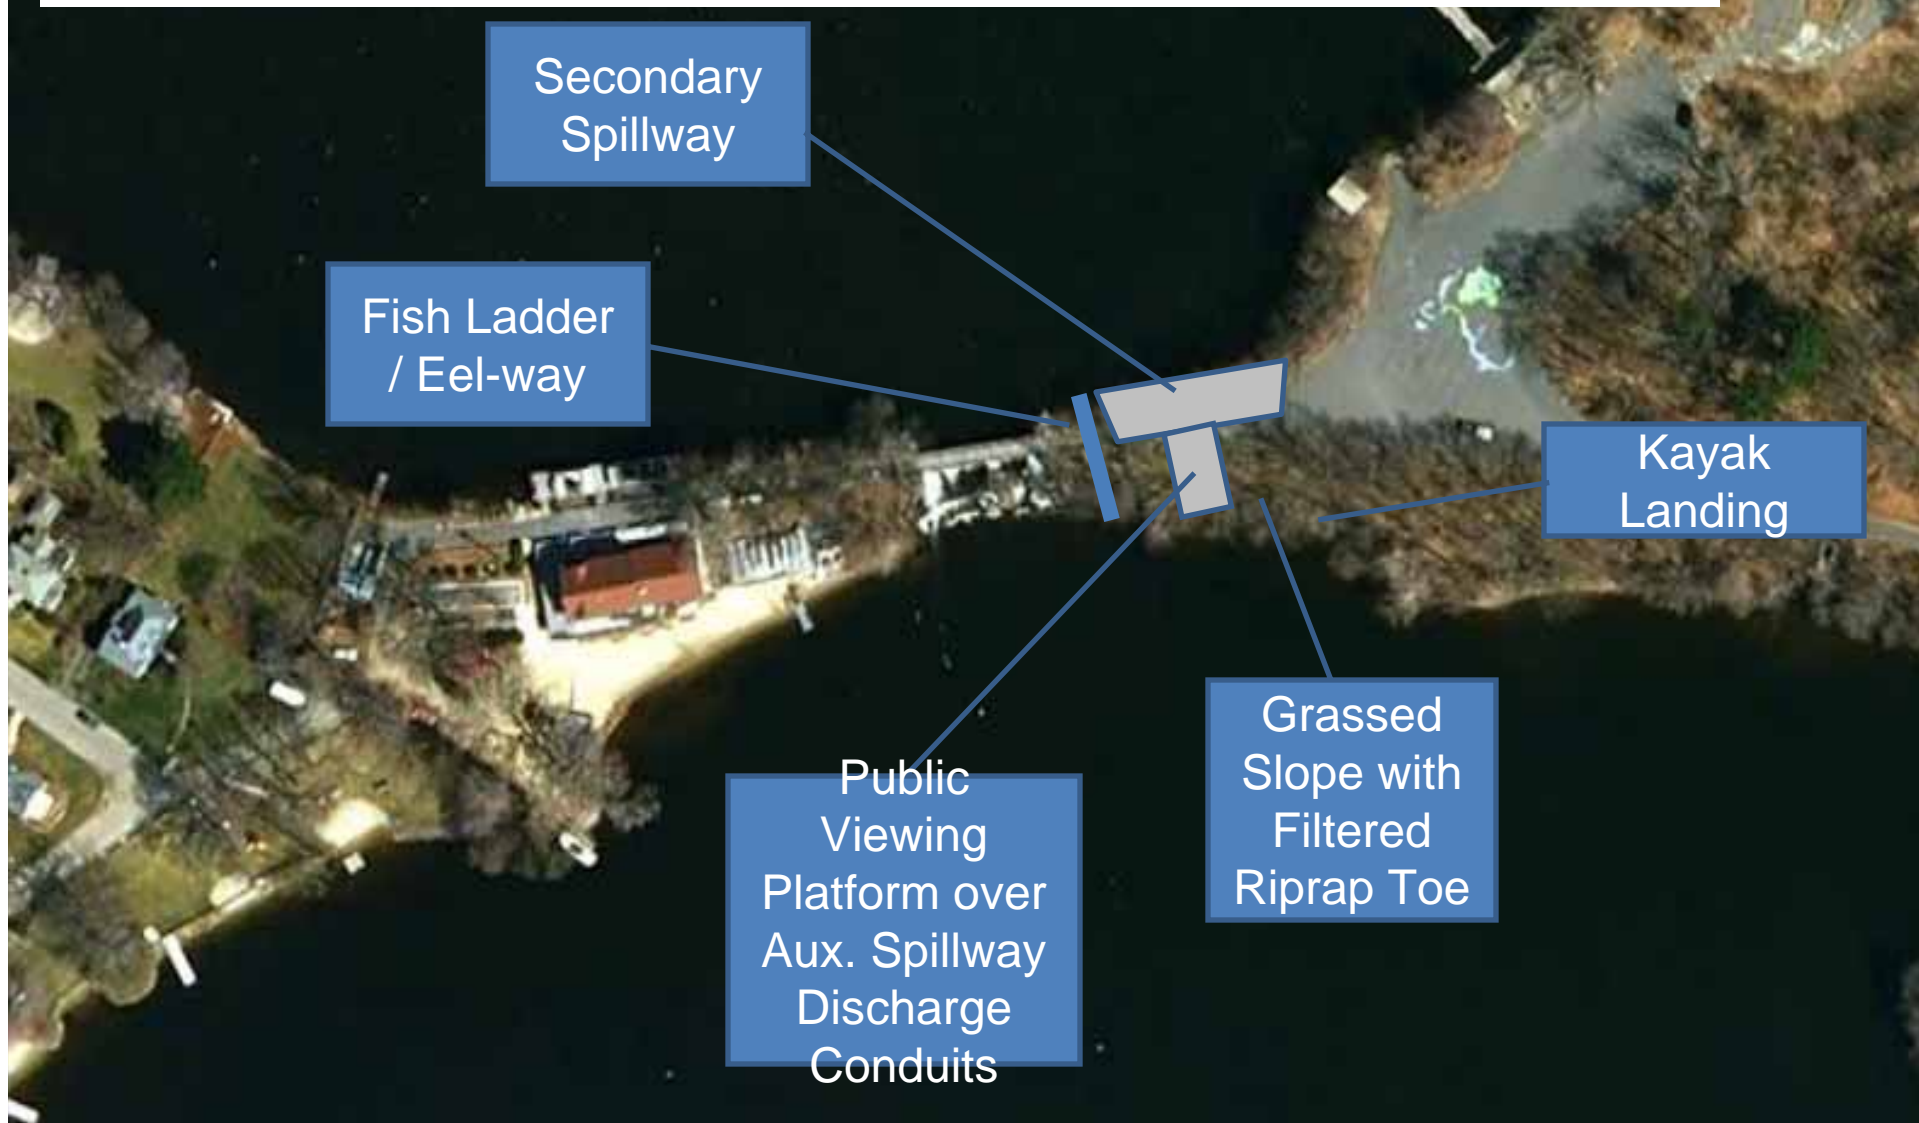
Upper Mystic Lake Dam Rehabilitation East Embankment, Fish Ladder and Secondary Spillway

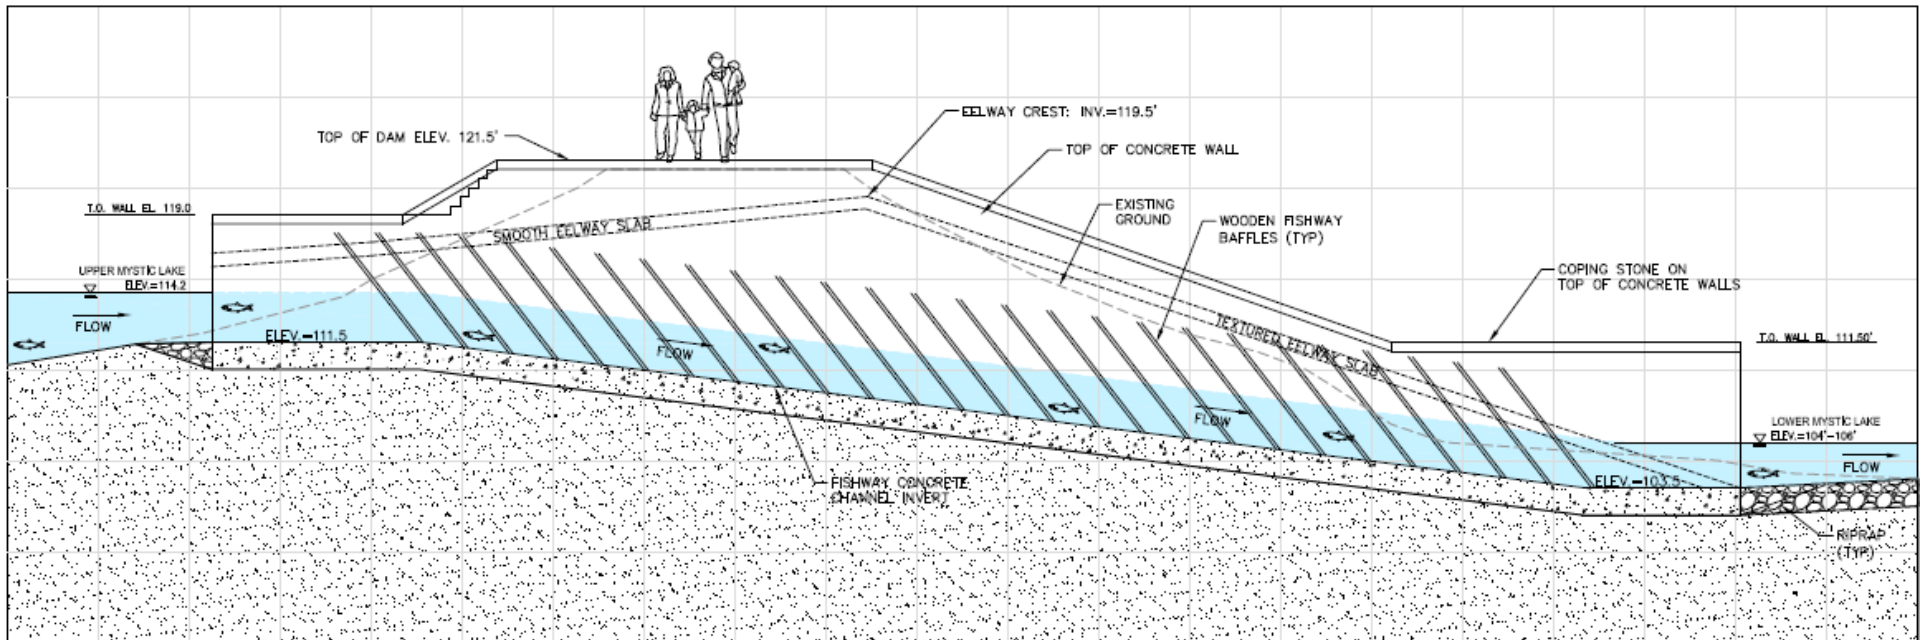
PROFILE: FISHWAY & EELWAY

Upper Mystic Lake Dam Rehabilitation Fish Ladder / Eel-way
