Recent Drought Impacts on Rivers

Massachusetts Rivers Alliance Presentation to Drought Management Task Force October 7, 2020

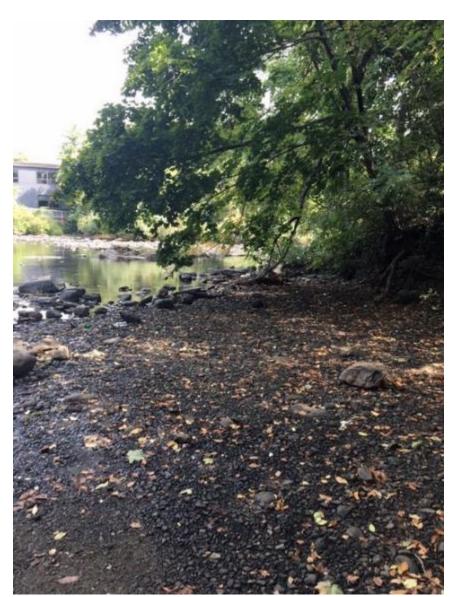
Charles River, 9/17

- Watertown, just downstream of the dam
- Entire gravel section is normally underwater.
- Trees are growing from the bank.

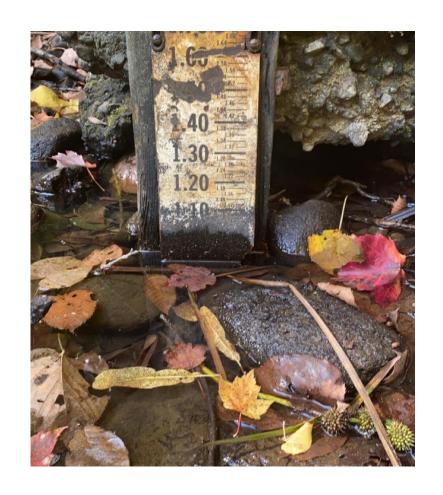
Fort River, Amherst 9/27/20.

- USGS staff gauge (USGS 01171300)
- River is below the entire staff gauge!
- Appears to be slightly less than 0.9 foot, the lowest field observation ever at that gauge.
- Gauge was maintained from 1966 to 1996.

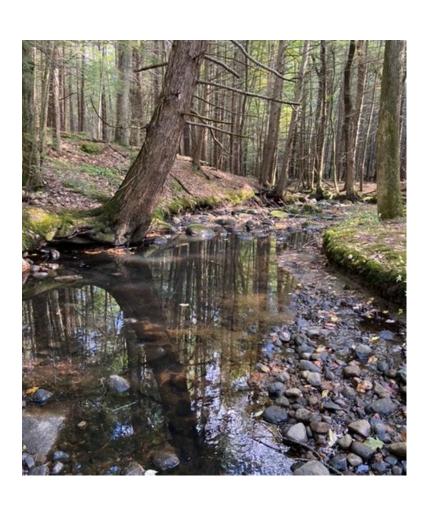
Mulpus Book in Lunenberg October 5, 2020

- Coldwater fishery
- Very low flow, some sections are disconnected, so no fish movement
