WELLINGTON PARK AND MILL BROOK CORRIDOR RESTORATION

WELLINGTON PARK FLOOD RESILIENCE

PHASE I PLAN FOR WELLINGTON PARK

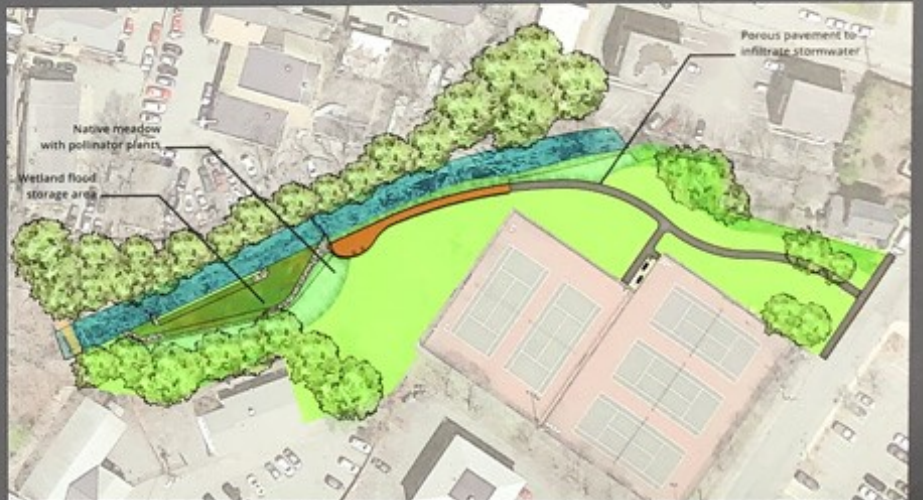
Several native species have been planted in an area previously overgrown with six types of invasive plants, primarily Japanese knotweed (*Fallopia japonica*) and Asian bittersweet (*Celastrus orbiculatus*). Invasive plants are species that are not native to a specific location and tend to spread to such a degree that causes damage to the environment. Native plants have many benefits including managing stormwater and providing habitat for wildlife.

Schizachyrium capense - Little Bluestem

Lupinus perenne - Wild Lupine

Achillea millefolium - Yarrow

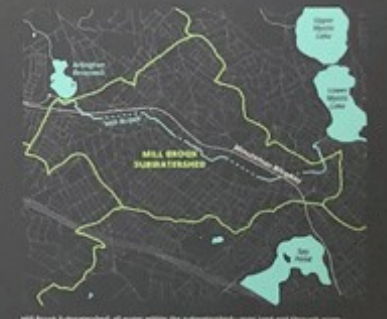
Mill Brook Watershed: all water within the watershed flows into Mill Brook.

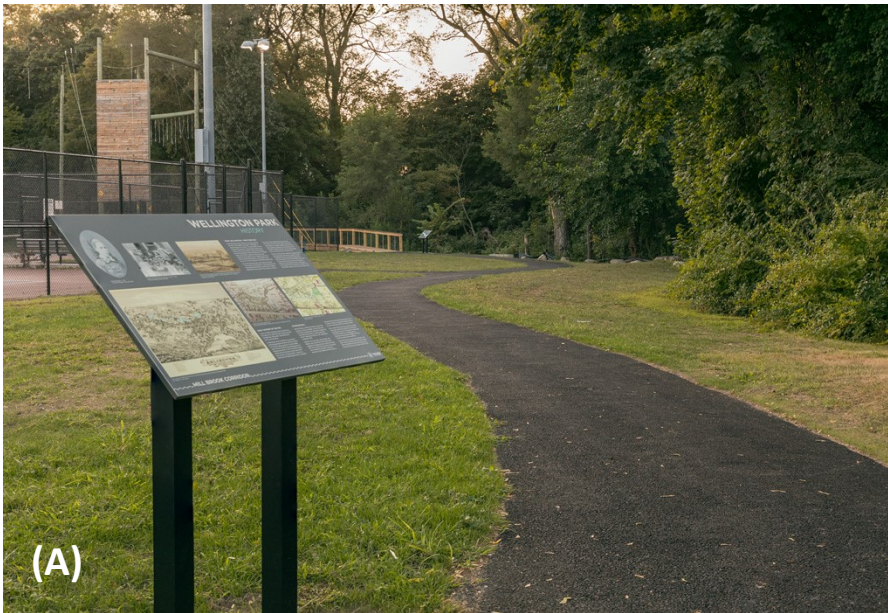
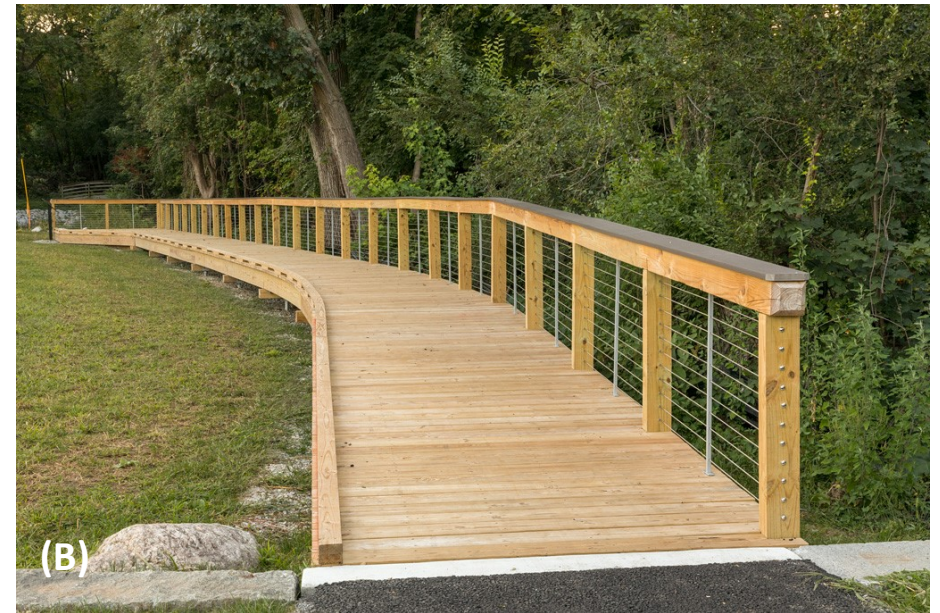
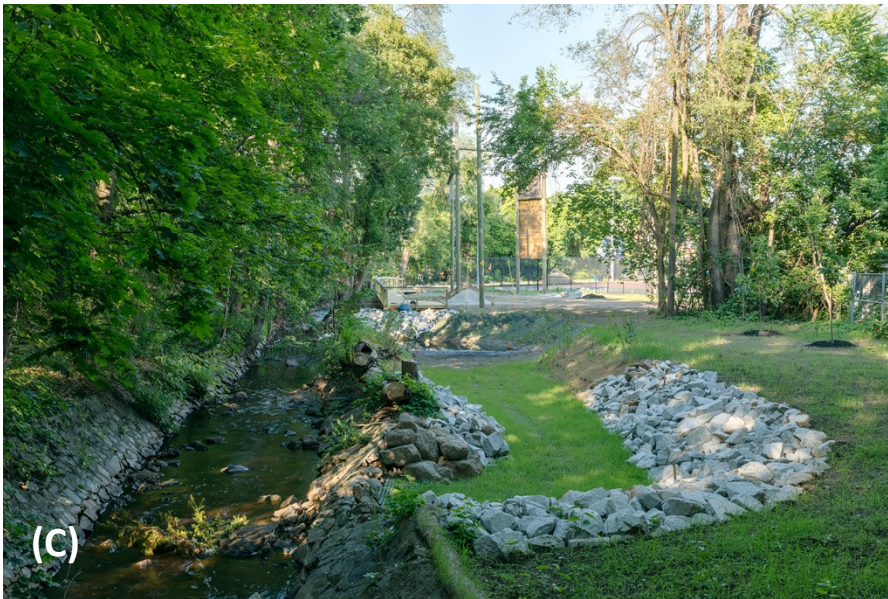
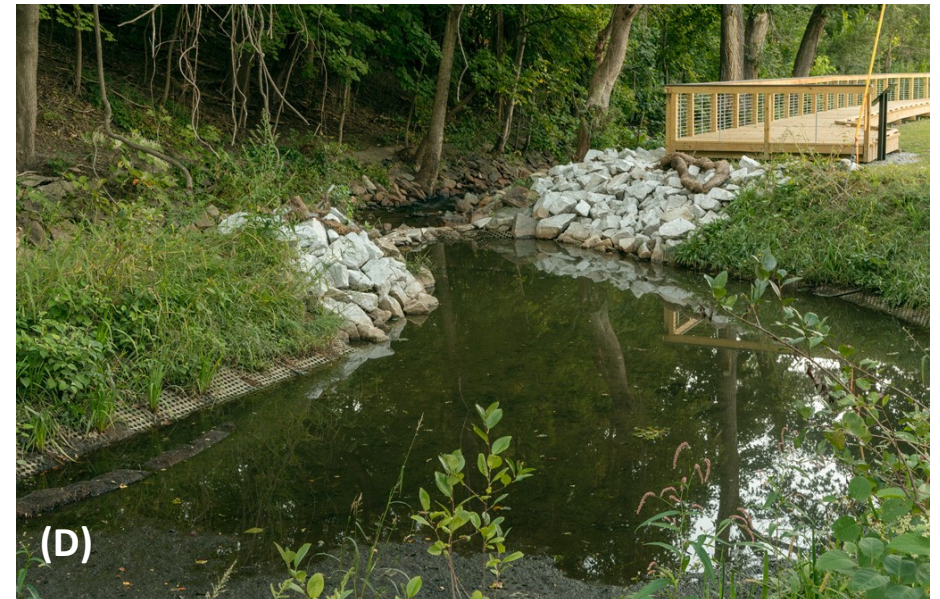
WELLINGTON PARK AND MILL BROOK CORRIDOR RESTORATION

- Porous asphalt pathway (A) with educational sign leading to elevated boardwalk (B), which increases and improves access to Wellington Park and to Mill Brook
- Overflow channel designed to capture stormwater (C & D), thereby reducing downstream flooding
