## PITTSFIELD PROBATE AND FAMILY COURTHOUSE HVAC SYSTEM EVALUATION SUMMARY

**Pittsfield Probate & Family  
Courthouse  
Pittsfield, MA**

## **HVAC SYSTEM EVALUATIONS COVID-19**

March 22, 2021

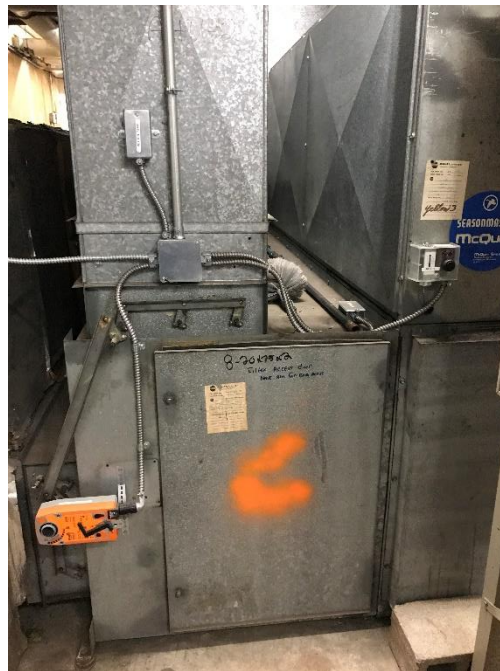
Photo 1 – Air Handler HVAC-2

Both air handling units and the return fans appear to be from the 1978 renovation project, are in fair to poor condition, and are past their useful life expectancy. The outdoor air and return air dampers are in fair condition. The damper actuators serving HVAC-1 appear to be new and are in good condition, and the damper actuators serving HVAC-2 are in fair condition. At the time of our site visit, the outdoor air damper serving HVAC-1 was closed, while the outdoor air damper serving HVAC-2 was open. The 3-way hot water coil control valves appear to be in fair condition and actuators are in good condition. The heating and cooling coils for both air handling units were dirty as well as the intake air louver screens.

Unit	Original Design Airflow (CFM)	Original Design Min. O.A. (CFM)	Filters	Condition
HVAC-1	13,200	3,300	2" MERV 10 in OA duct only	Poor
HVAC-2	9,200	2,300	2" MERV 10	Poor

Indoor air handling units have a life expectancy of 35-45 years. The air handlers are approximately 42 years old and should be considered for replacement within the next 5 years. Replacing the return fans should also occur in conjunction with the replacement of the air handling units and should be sized correctly to provide an overall positive building pressure to reduce infiltration.
