Winthrop Beach Nourishment

Conservation Commission
Hearing
June 13, 2012

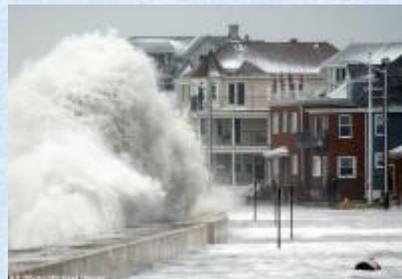
FEMA repetitive flood insurance claims for properties along and near Winthrop Beach

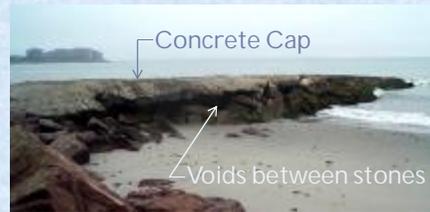
- Removal of Concrete Cap
- Removal of Upper Layer of Armor Stone
- Resetting of Armor Stone
- Chinking of Crest

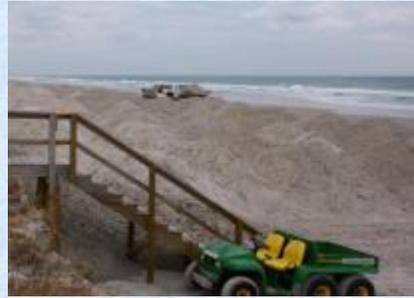
Stockpiling of sand on the Figure Eight Island Beach north (updrift) of Mason Inlet, NC. The material was later graded.
