Design and Construction of Asphalt Paved Shared Use Paths

Norwottuck Rail Trail
Rehabilitation

Amherst/Hadley/Northampton

John J. Mastera, P.E.
MassDOT Highway Design

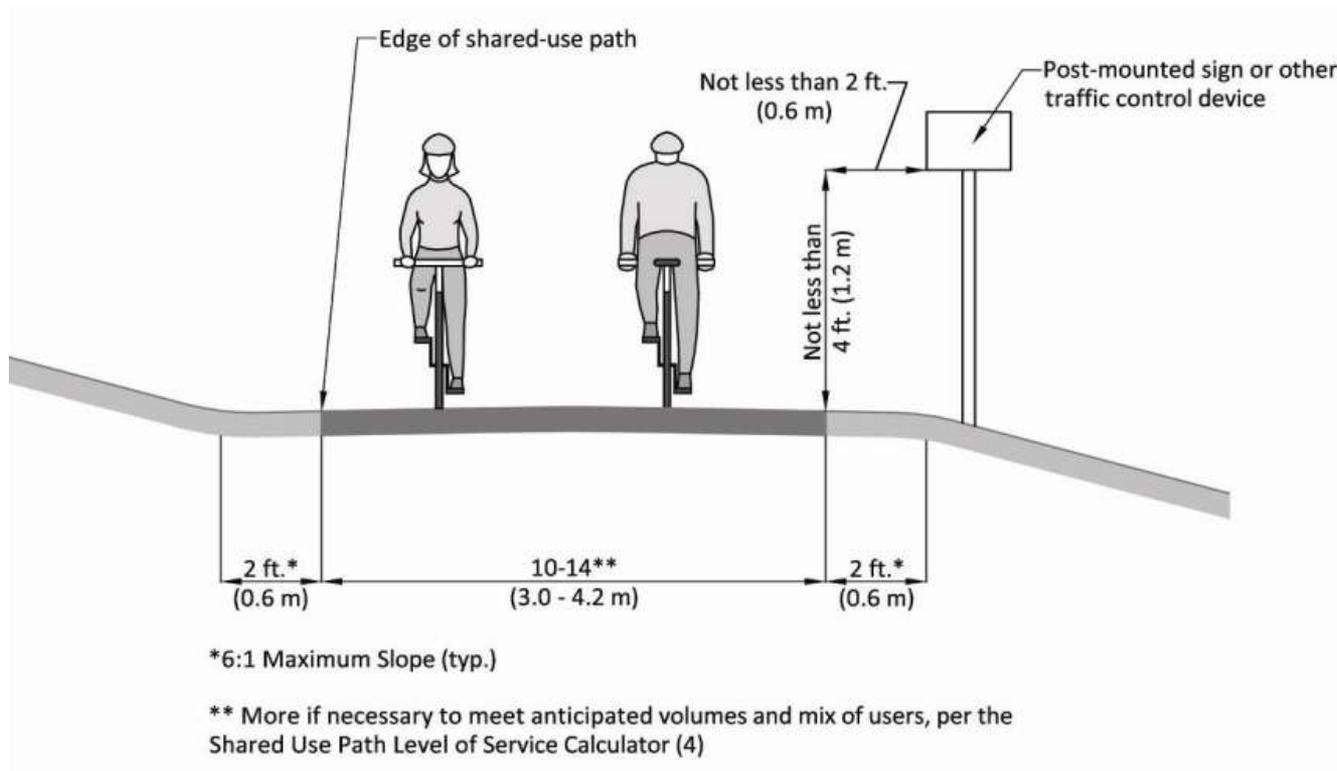
□ Path Width and Clearance

Source: AASHTO Guide for the Development of Bicycle Facilities

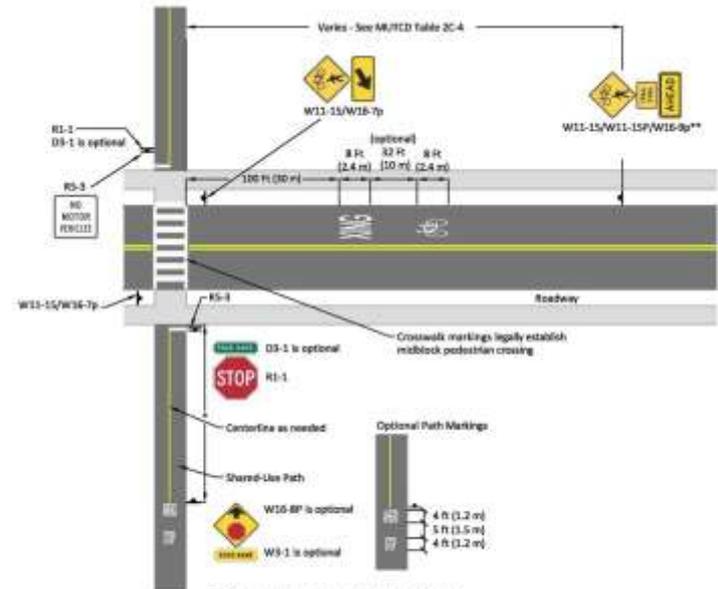
□ Mid-Block Crossing

- Designs should be apparent to both the user and vehicles
- Sight distance is especially critical
- May be stop controlled, yield controlled, and even Signal controlled
- Proper Signage is important

* Advance warning signs and solid centerline striping should be placed at the required stopping sight distance from the roadway edge but not less than 50 feet (15m).

**W11 series sign is required, supplemental plaques are optional.

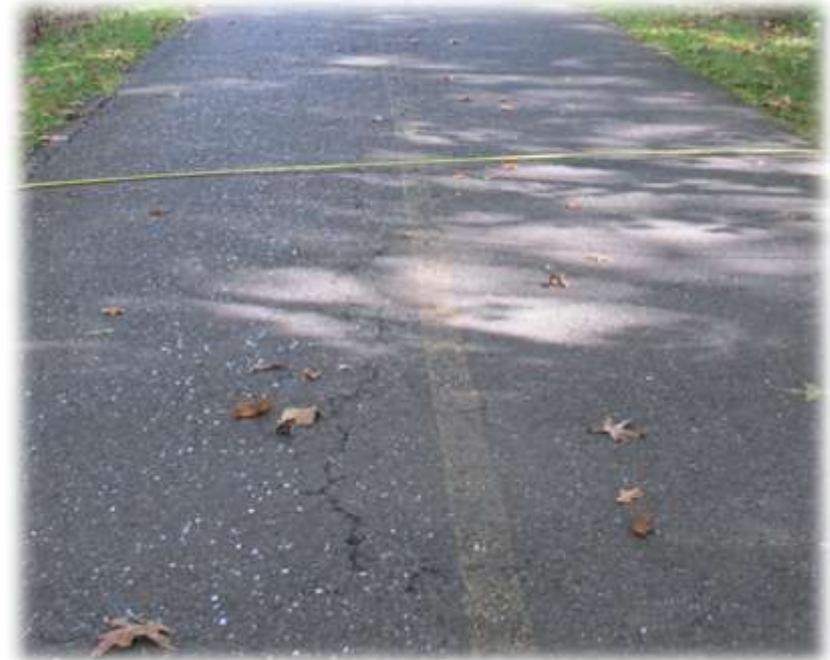
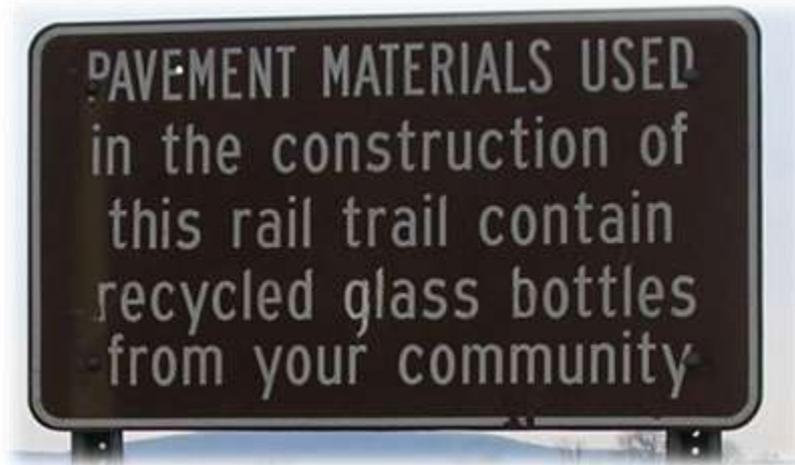
Glass Aggregate

□ Issue:

- Pavement contains recycled glass aggregate
- Tire punctures

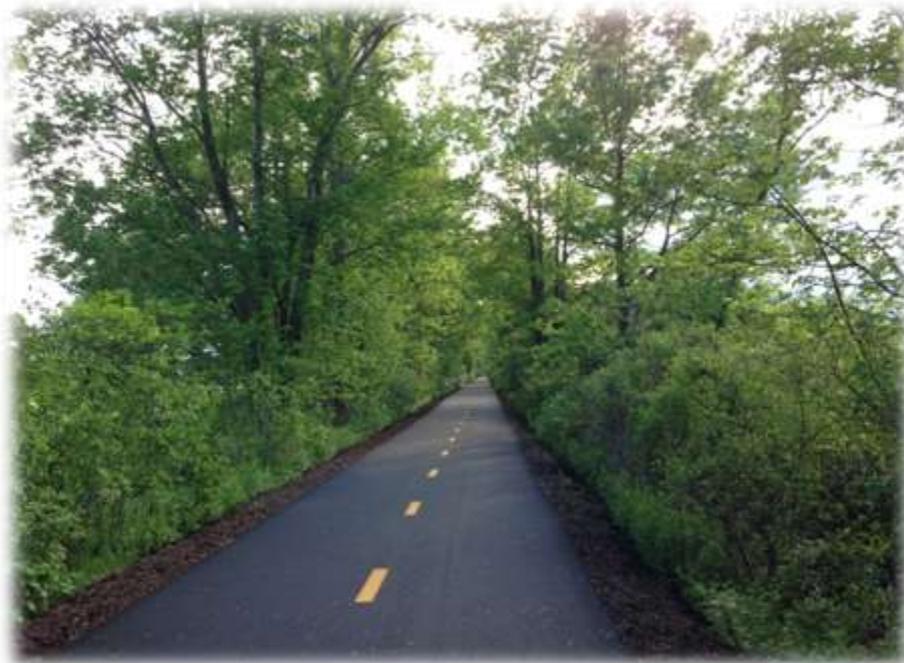
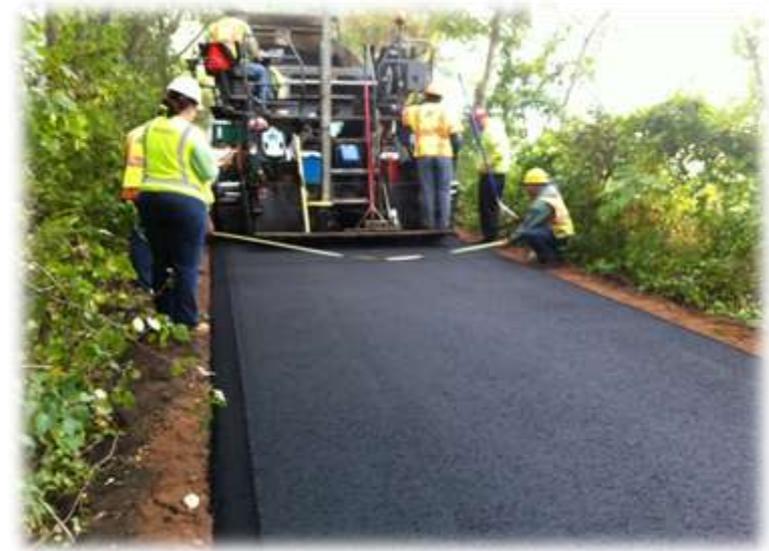
Glass Aggregate

□ Solution:

- Remove and replace pavement

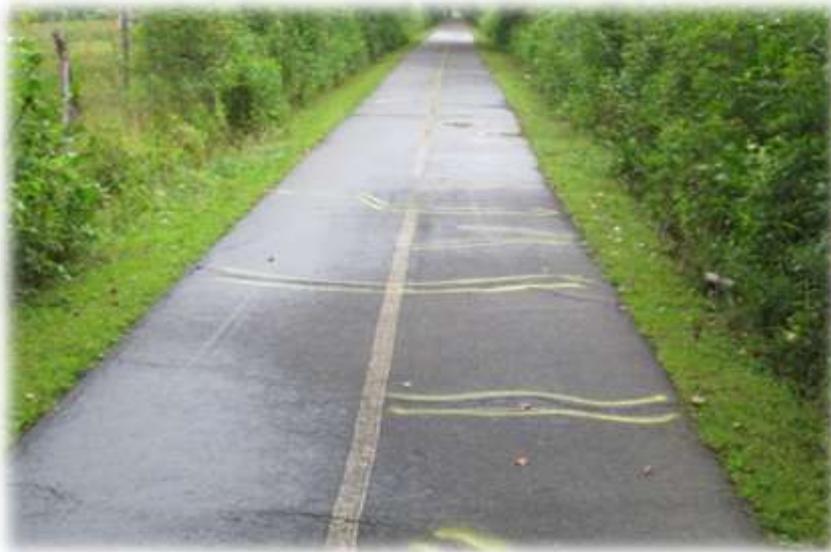
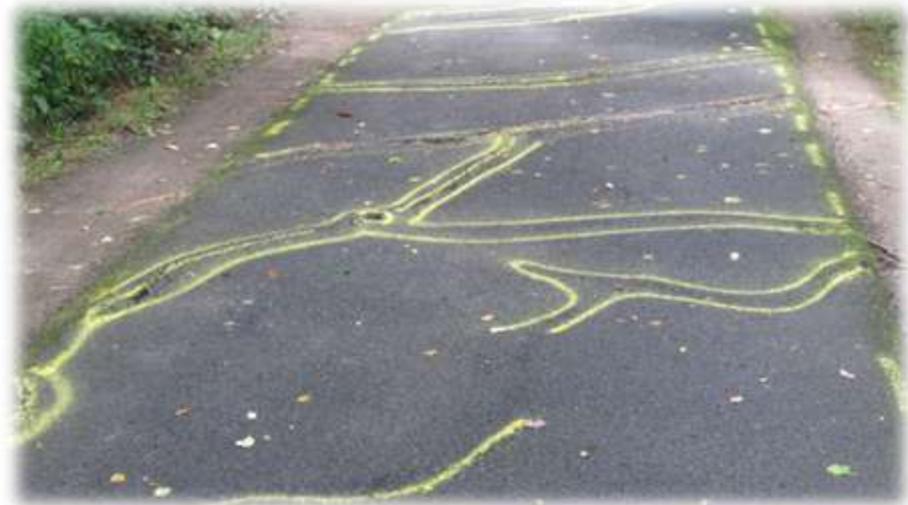
Root Damage

□ Issue:

- Systemic root damage
- Main Culprit: Black Locust and other select species

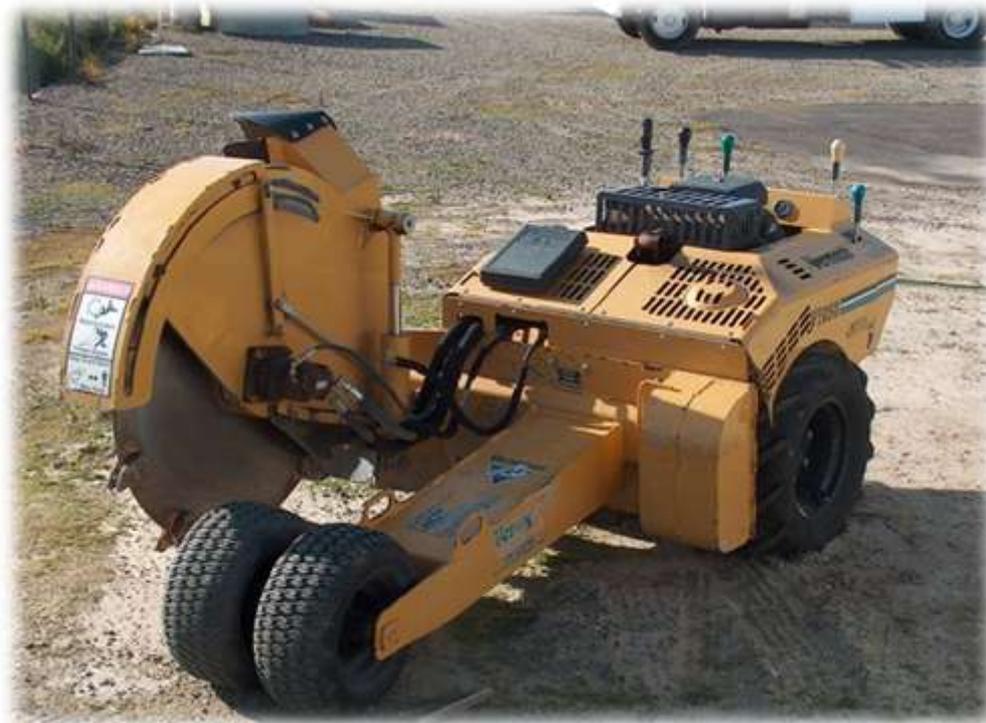
Root Damage

□ Solution:

- Remove roots as part of path rehabilitation and remove selected trees causing damage

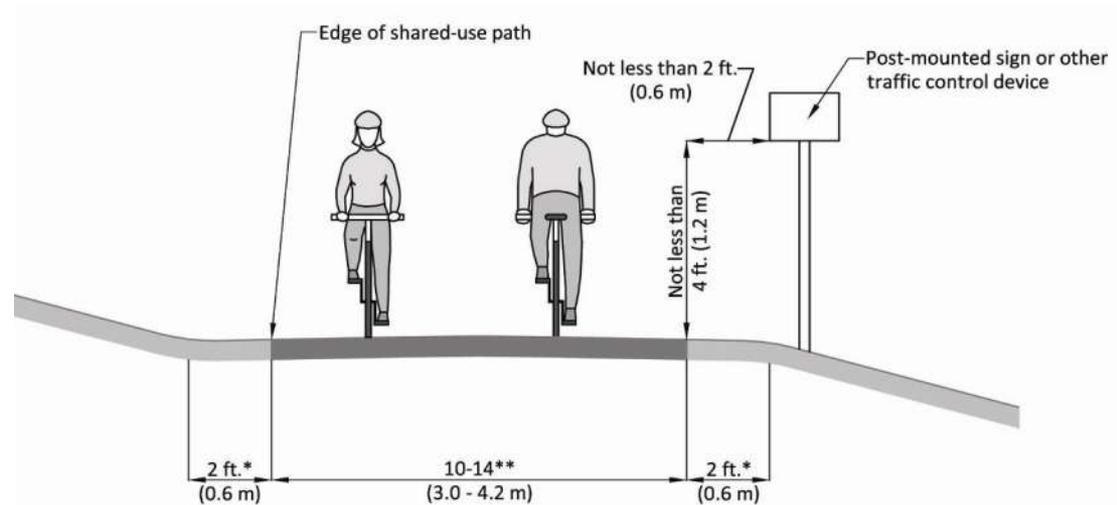
Trail Widening

- 8' path width is considered substandard for trails with high volume and mixed use. 10' minimum and in many cases 12'-14' are considered more desirable.

*6:1 Maximum Slope (typ.)

** More if necessary to meet anticipated volumes and mix of users, per the Shared Use Path Level of Service Calculator (4)

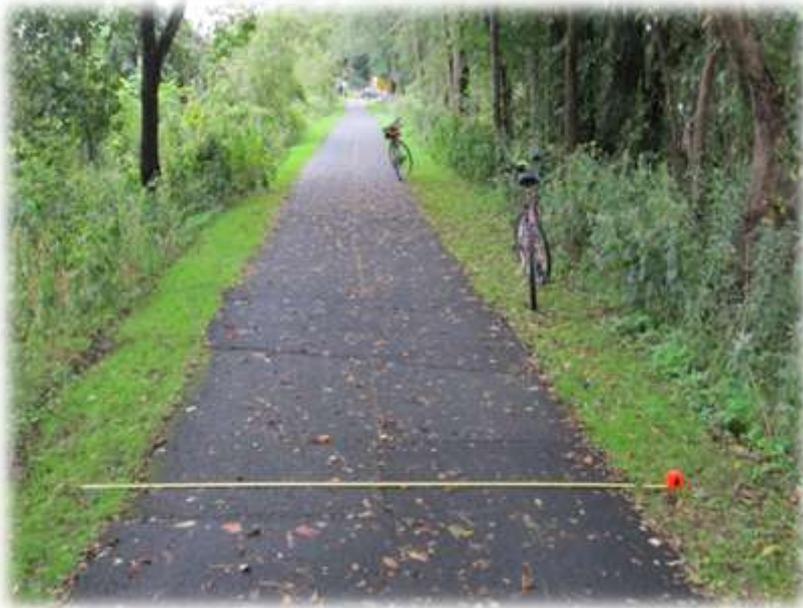
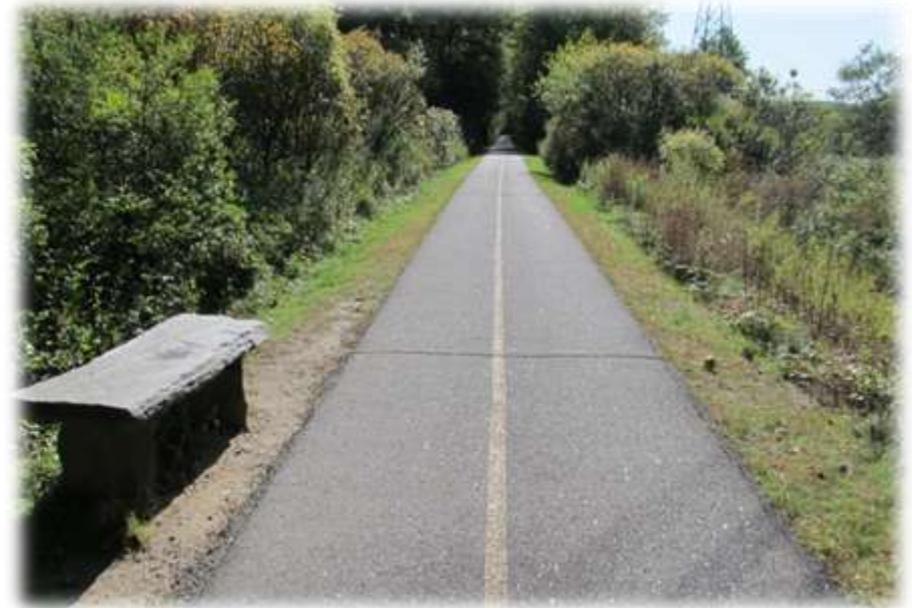
Proposed 10 FT Path

Cross Path Road

Grampa's Bench

Note: Widening only in areas where impacts can be avoided.

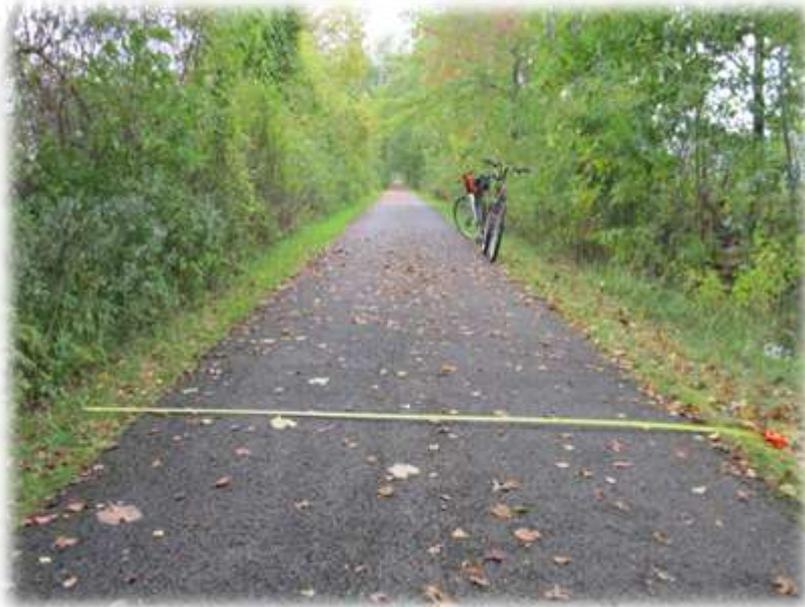
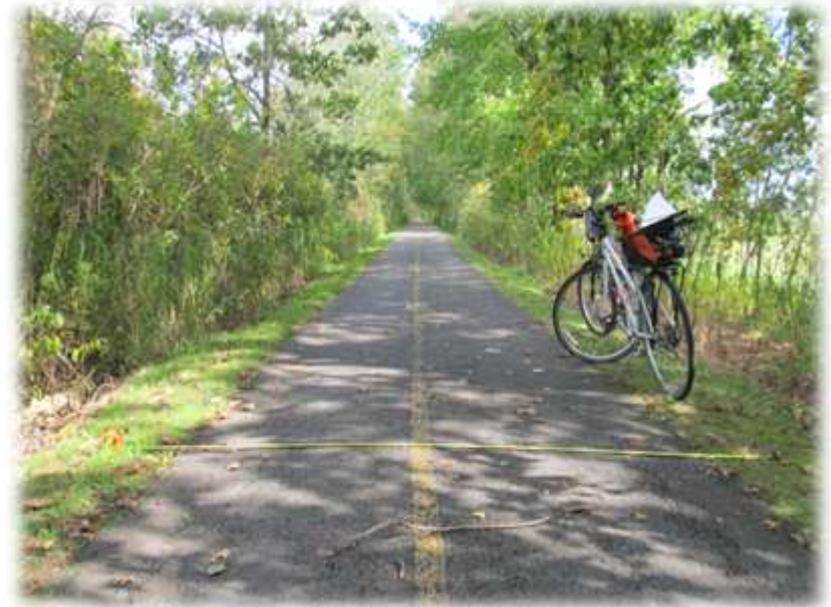
Proposed 9.5 FT Path

East of Route 9 tunnel

Near Wal-Mart

Note: The section from Route 9 tunnel to Wal-Mart is only widening to 9.5 ft to avoid wetland impact.

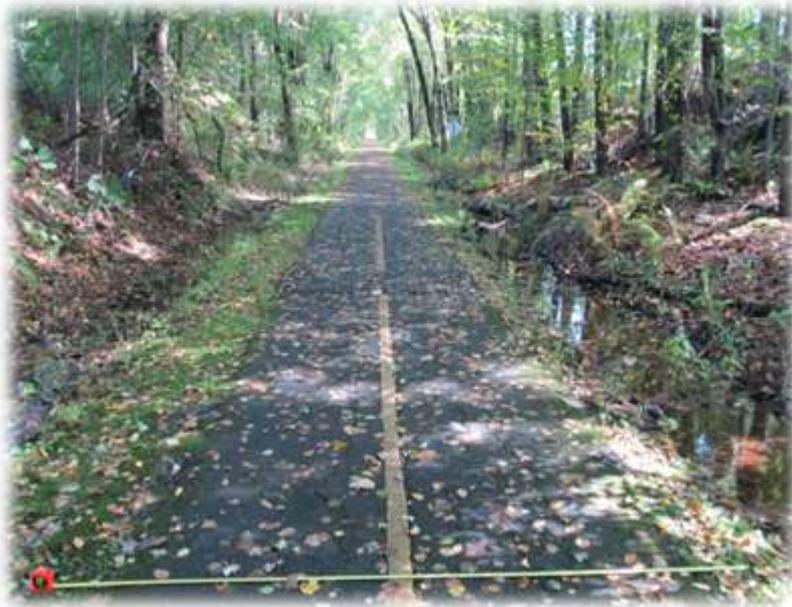
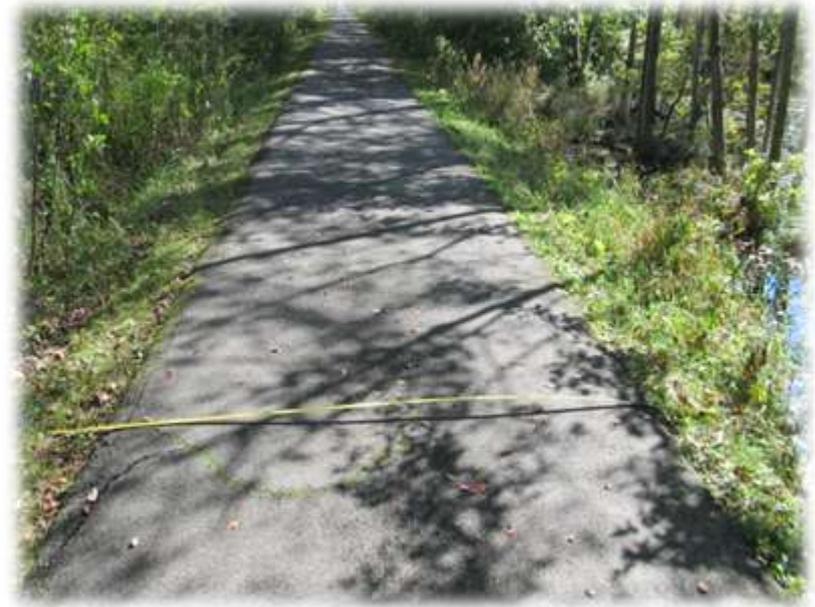
Maintain Current Width

Spruce Hill Road

Hop Brook

Note: The path will be rehabilitated at its current width where widening is not possible.

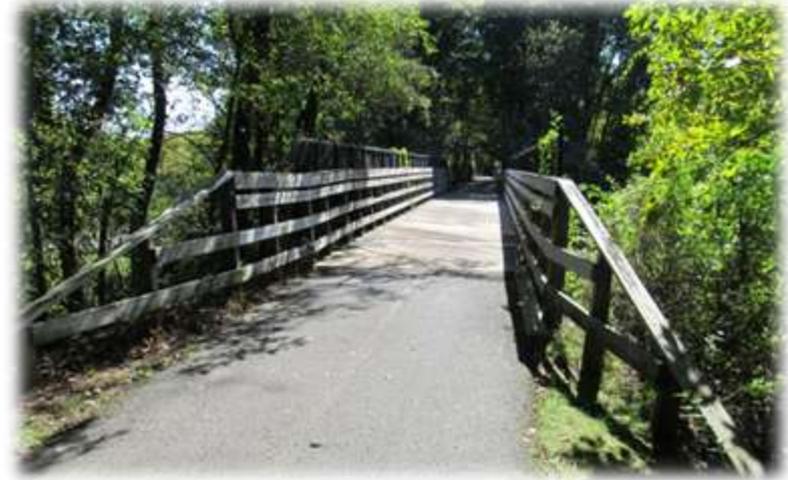
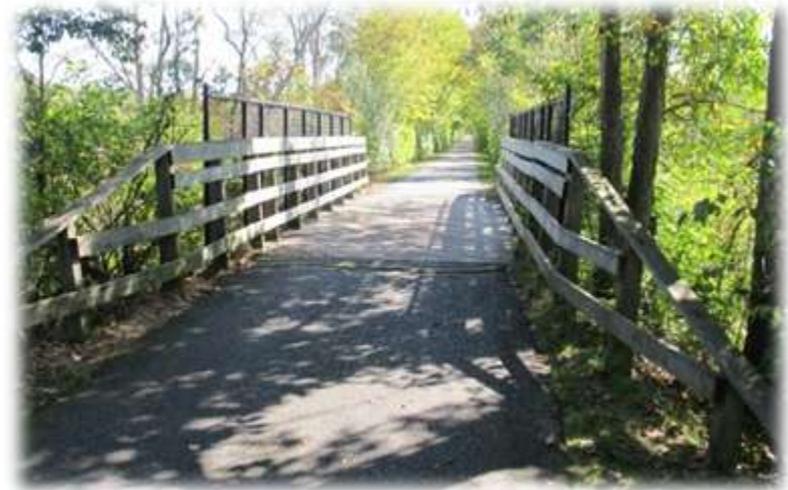
❑ Issues:

- Old wood railings and decking
- Narrow 10' width

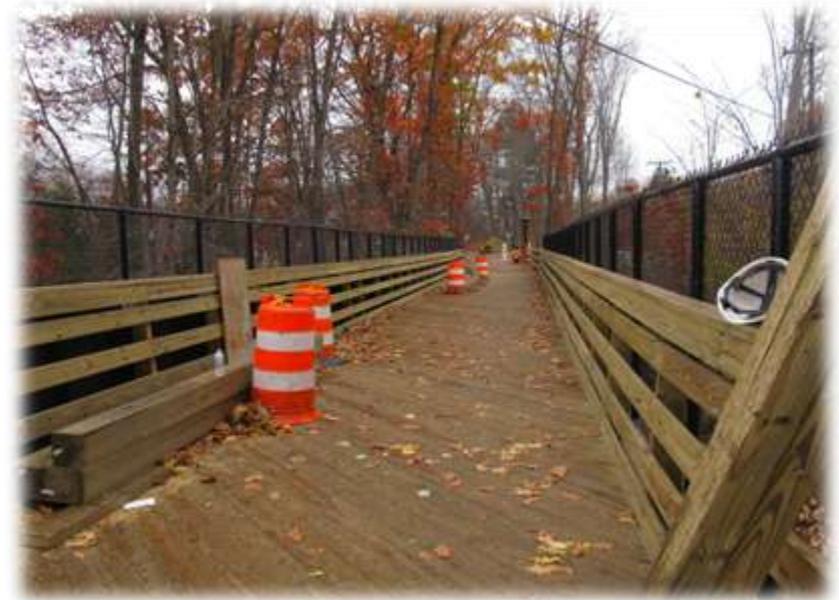
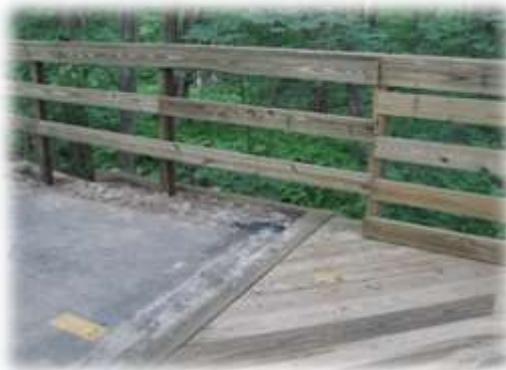
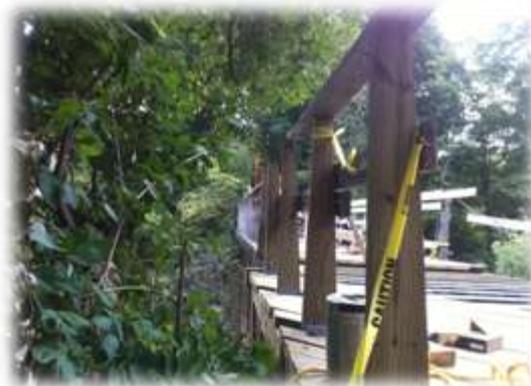
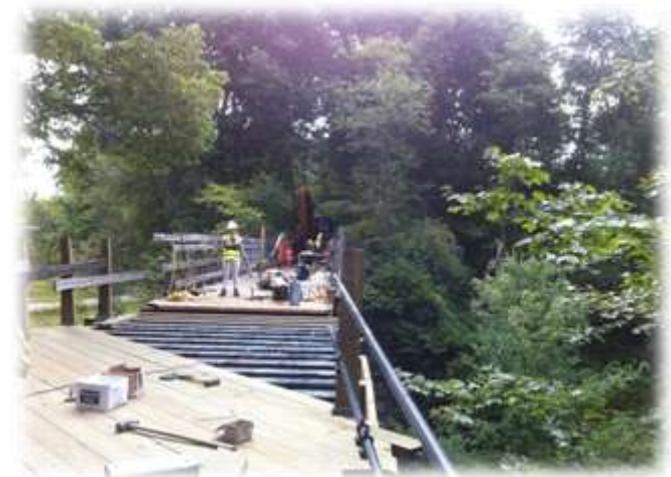
□ Solutions:

- Replace wood decking and wood railing
- Widen Bridges (10ft exist.)
 - Cattle Pass (13 Feet)
 - Fort River (12 Feet)
 - S. East St. (12 Feet)
 - Hop Brook (13 Feet)

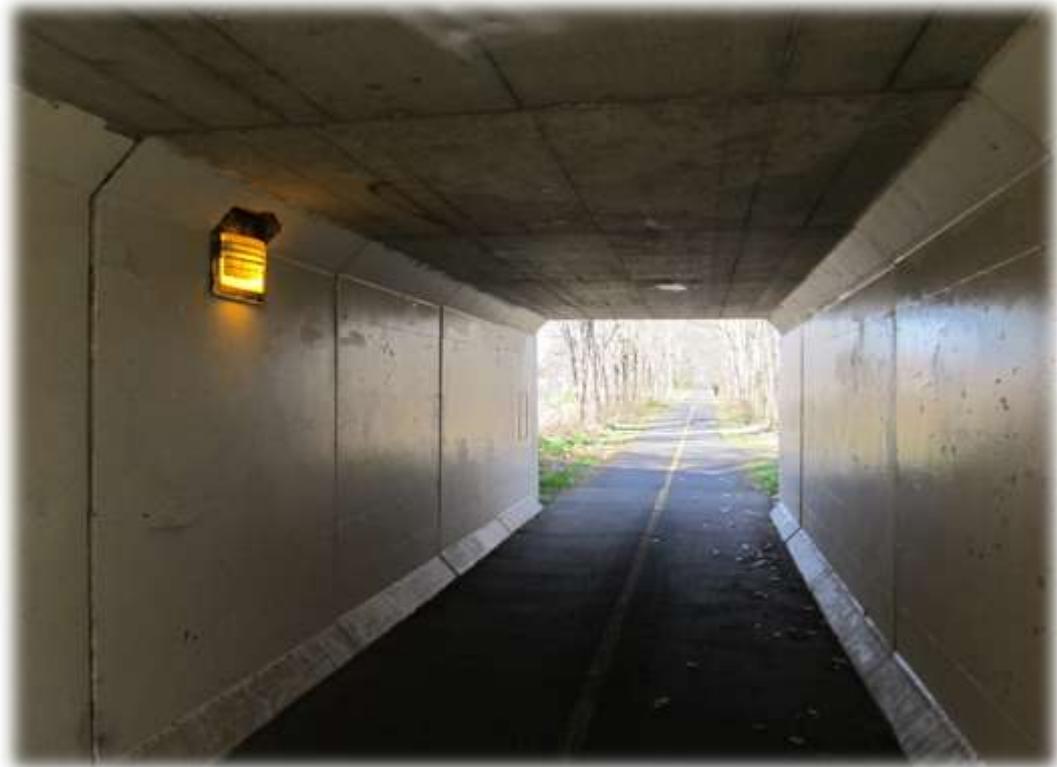
□ Issue:

- Tunnels are poorly lit
- Old Fixtures w/ poor efficiency

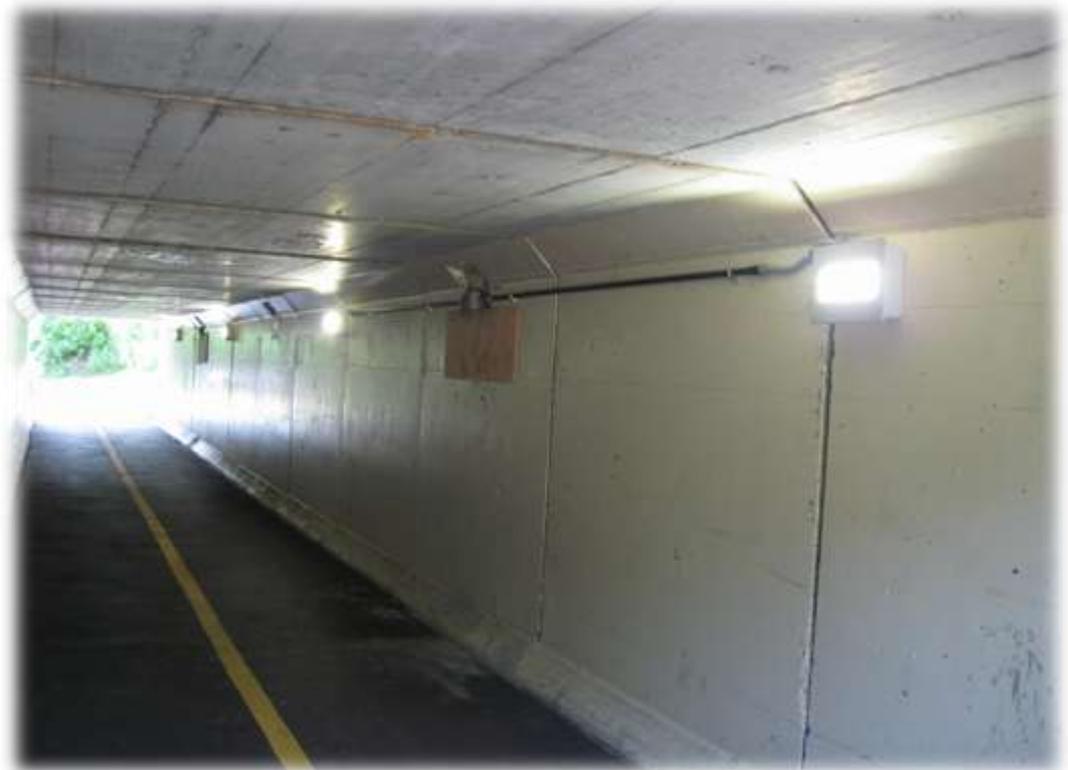
□ Solution:

- Install new LED high efficiency fixtures
- Add additional fixtures to improve lighting

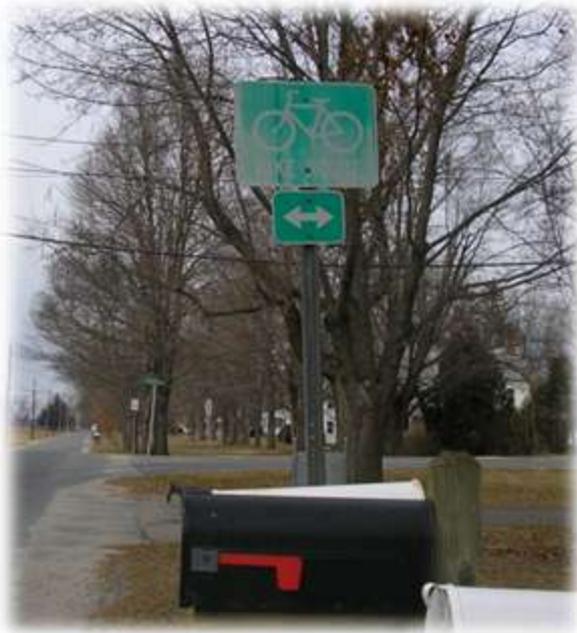
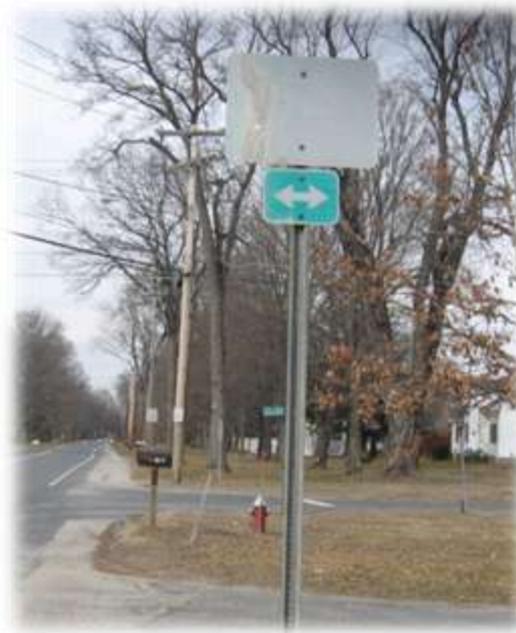
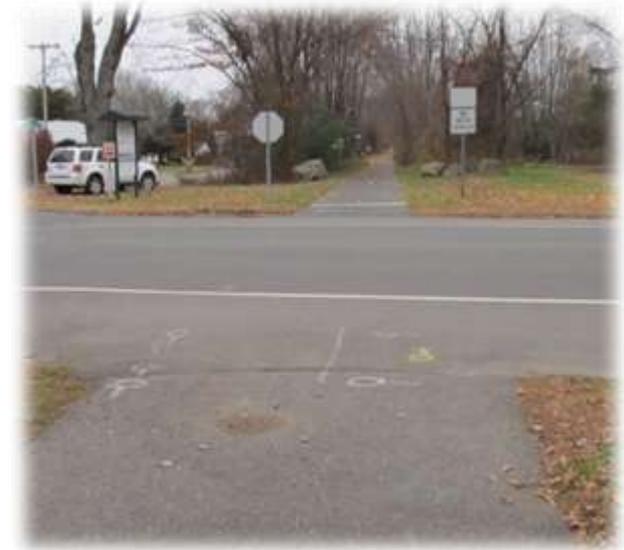
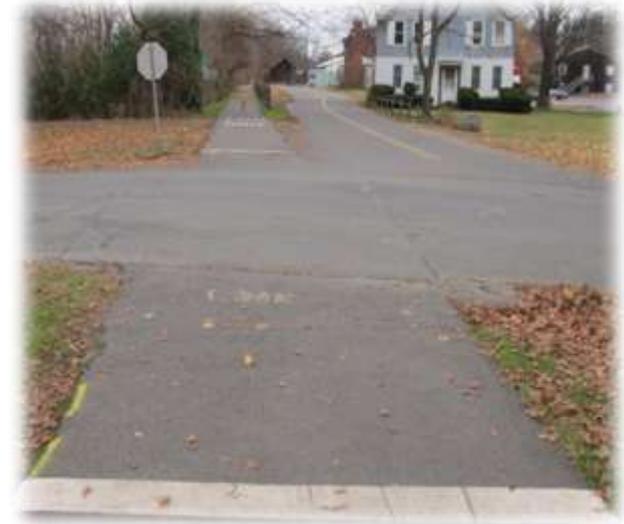
❑ Issue:

- Faded old signs
- Poorly Marked

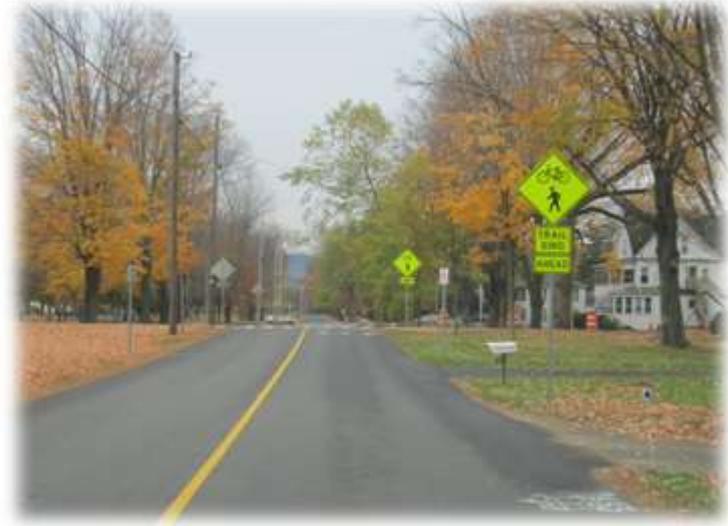
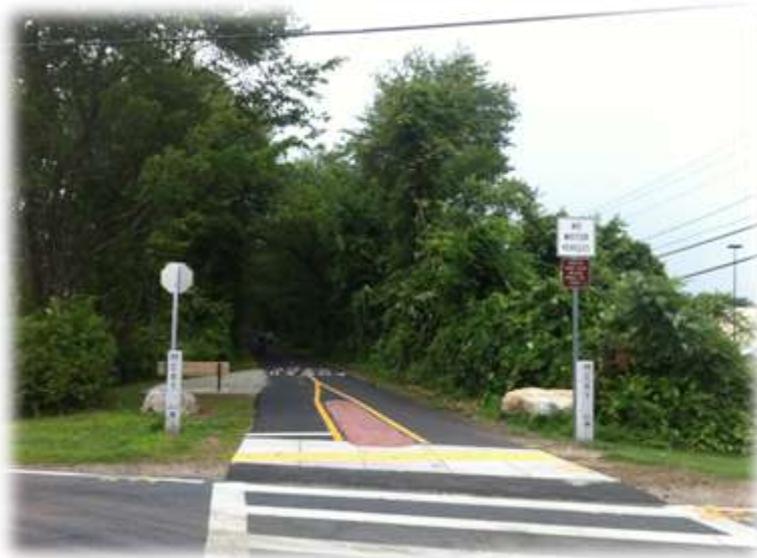
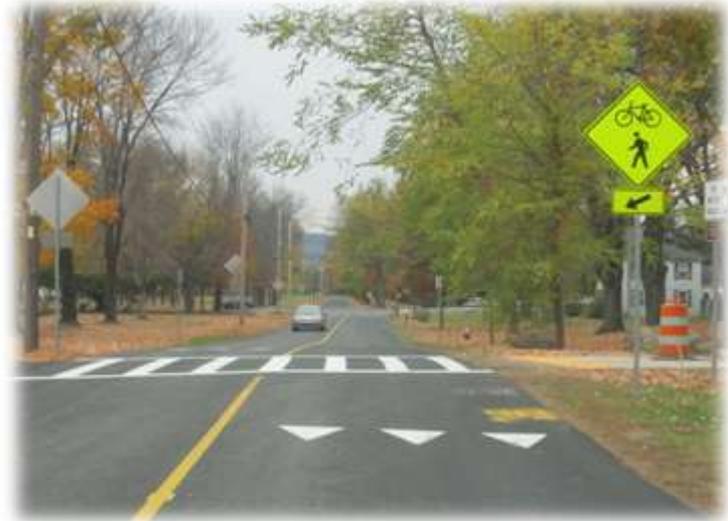
□ Solution:

- Improved Signage
- Pavement Markings
- Splitter Islands

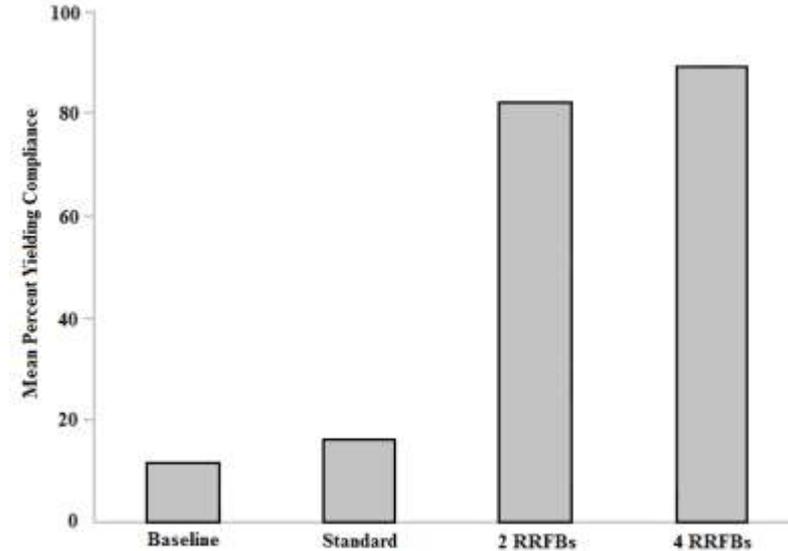
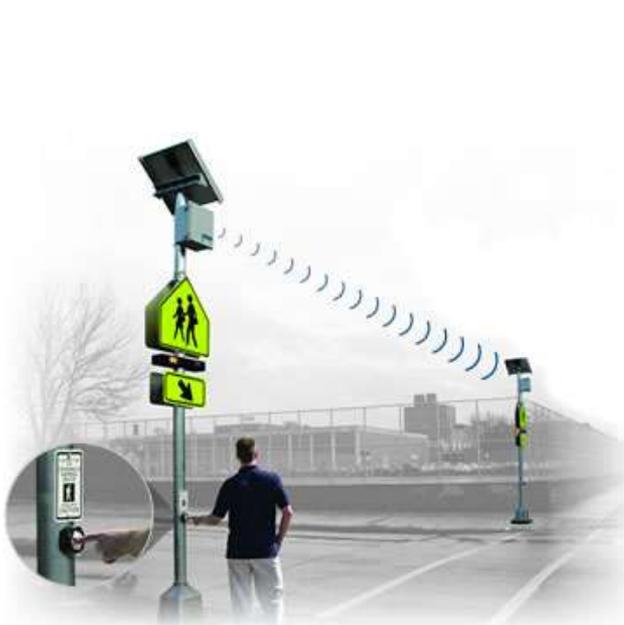
Rectangular Rapid Flashing Beacon

RRFB's are user-activated amber flashing LED's to supplement warning signs at mid-block crossings. They will be activated manually by a push-button. (MUTCD 2009)

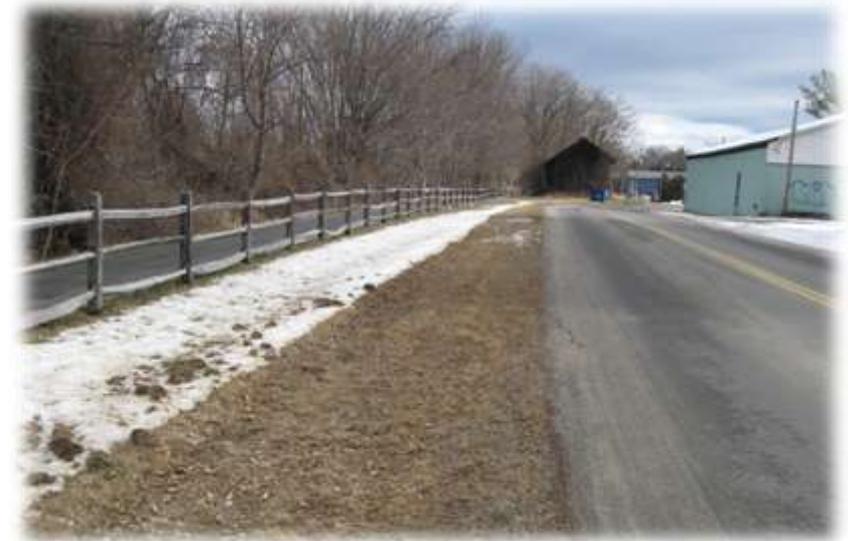
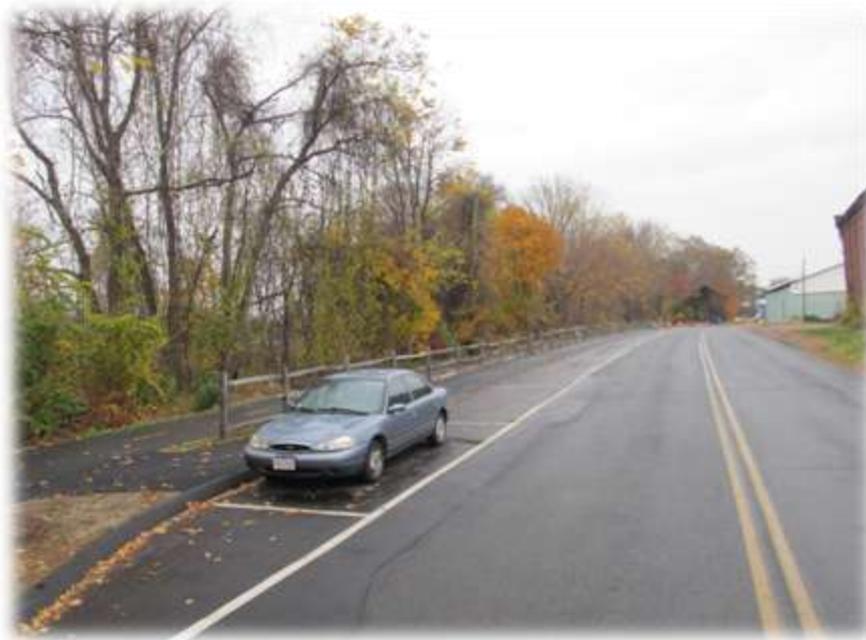
Proposed Parking Lot

- ❑ **Location: Along Railroad Street**
- ❑ **Proposed 18 Spaces**
(2 Accessible)

- ❑ **Railroad Street will remain a two-way street**

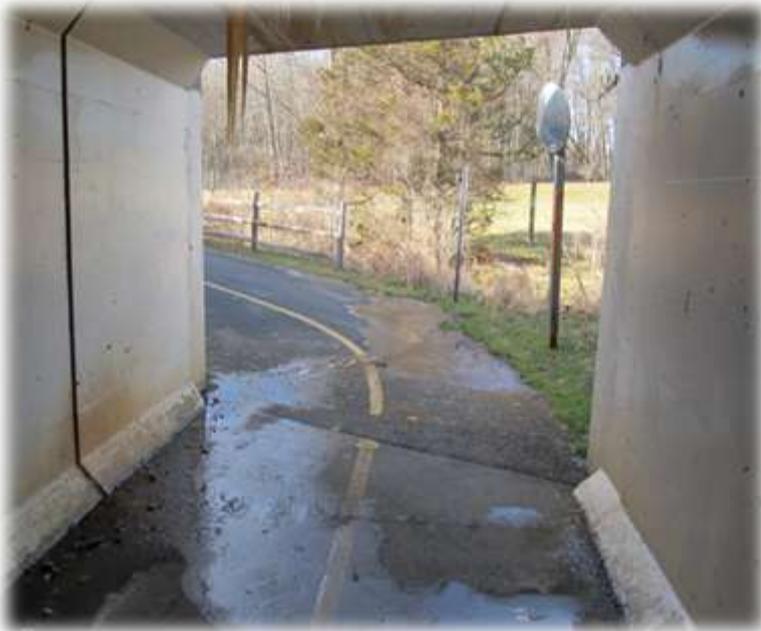
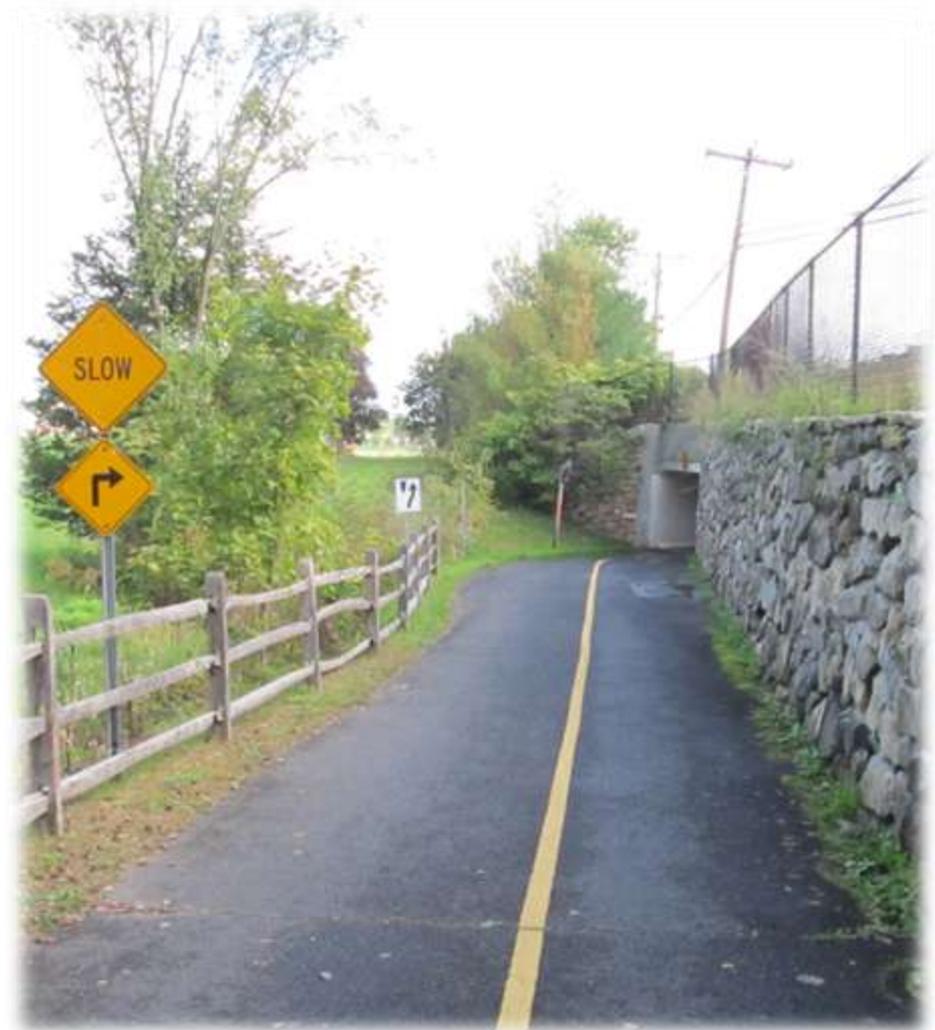
❑ Issue:

- Sharp Curve
- Limited Sight Distance

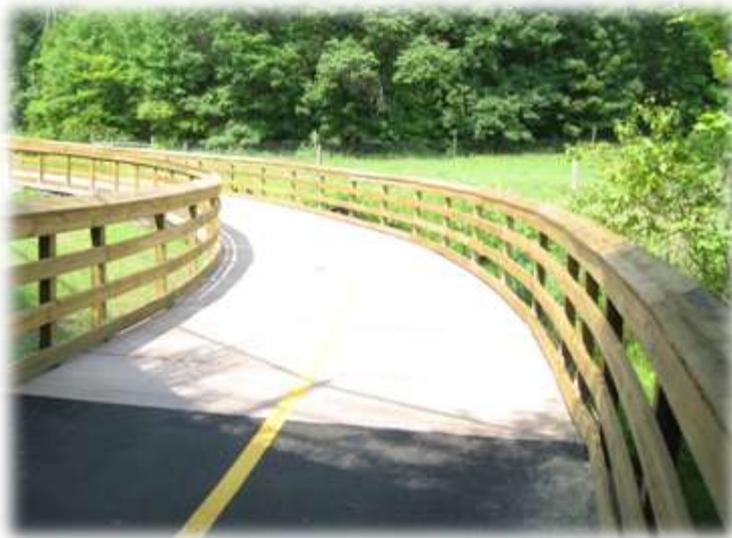
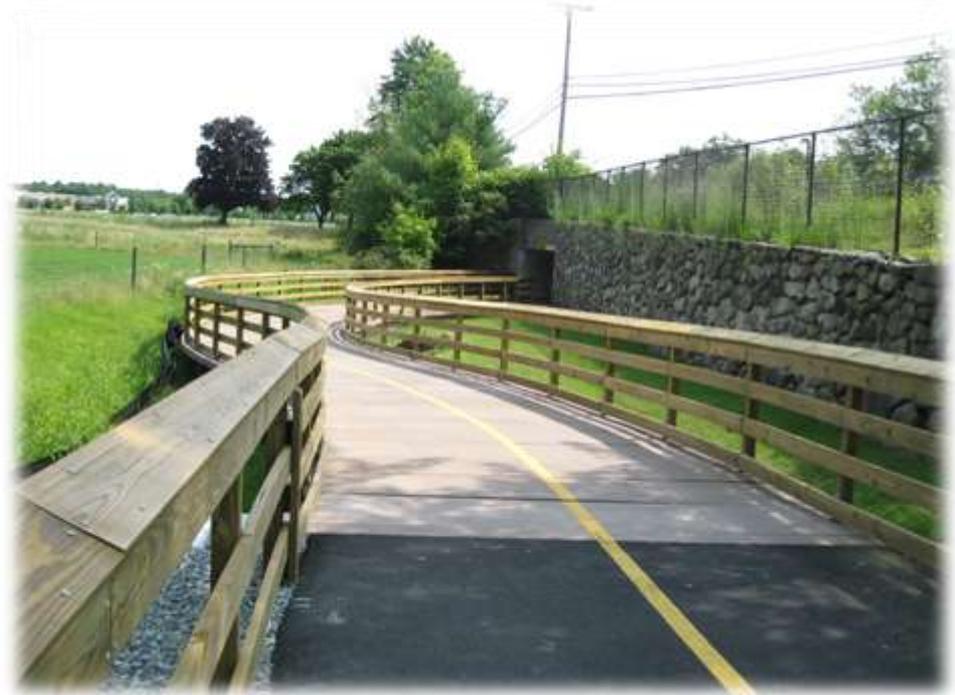
□ Solution:

- Re-alignment of north side approach
- A pre-cast concrete boardwalk to reduce wetland impacts
